# **BIOLOGICAL RESOURCES ASSESSMENT**

## **LANDS OF MORGAN SOLANO COUNTY, CALIFORNIA**

February 2019

Project No. WIM1801

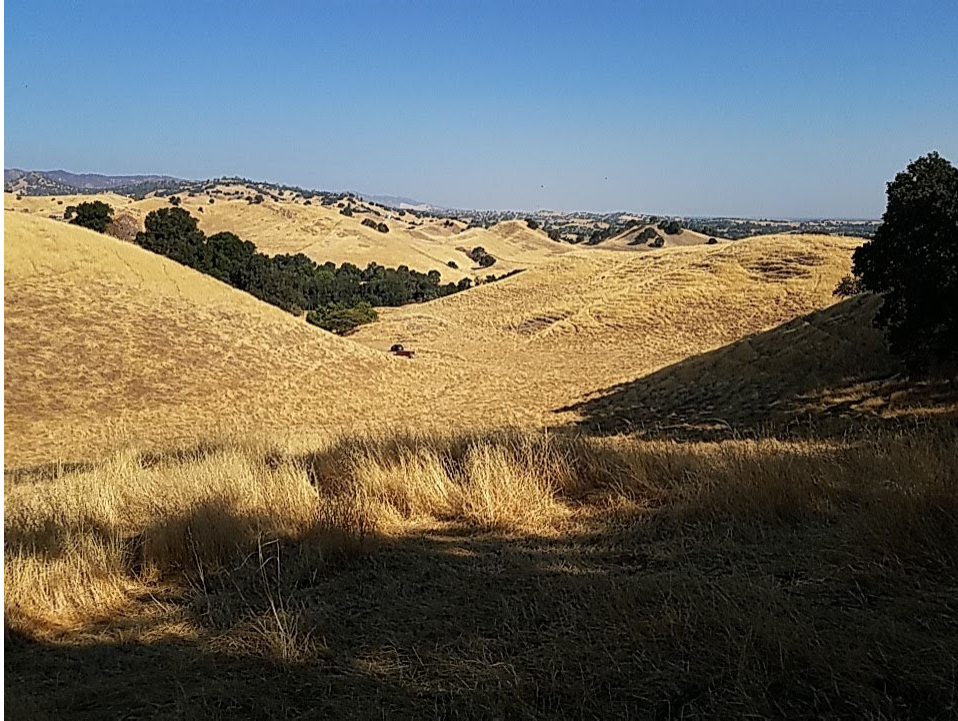
Photo 1: Typical annual grasslands of the assessment area.

Inner Coast Range grasslands are associated with the dry conditions that typically occur on hillsides, slopes, ridges, and flat areas with well-drained soil within the Inner Coast Range and foothill terraces (see Photos 1-3 in Appendix A). Annual grasslands can fluctuate in species composition and production, mostly due to variable precipitation and temperature, presence/absence of fire, site-specific management, etc. Annual grasslands in the assessment area are a naturalized plant community, because they are comprised mostly of nonnative annual grasses with a small constituent of forbs. Common species at the site include many alien and native annual grasses, such as ripgut brome (*Bromus diandrus*), soft chess (*Bromus hordeaceus*), foxtail chess (*Bromus madritensis*), slender wild oat (*Avena barbata*), common wild oat (*Avena fatua*), and ryegrass (*Festuca multiflorum*). Forbs can be abundant in spring, including filarees (*Erodium botrys* and *E. cicutarium*). Fall temperatures and precipitation are major factors determining grassland composition, along with light intensity affected by shading from plants and litter, and differences in micro-topography and grazing history.

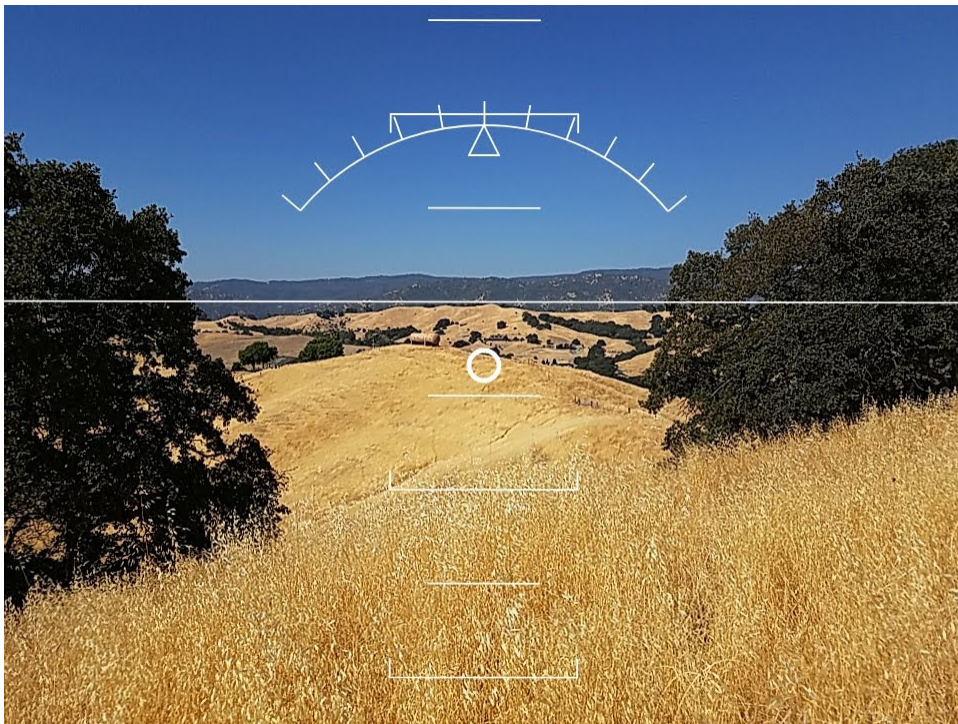
Photo 2: Typical annual grassland on ridgetops.

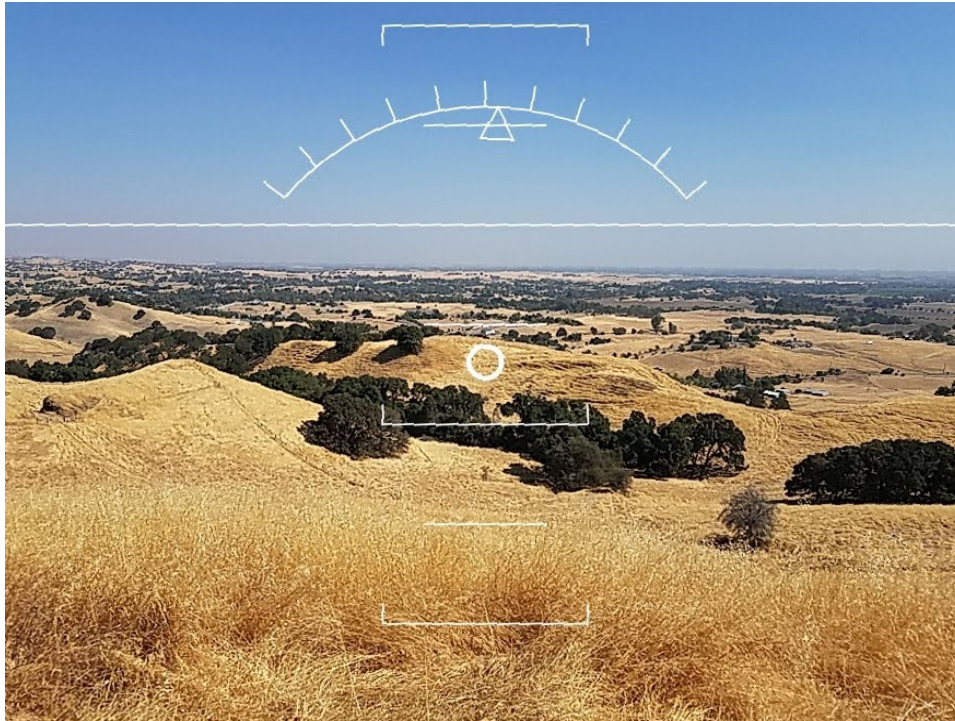
Photo 3: Typical annual grassland with interspersed oak savanna and oak woodlands.

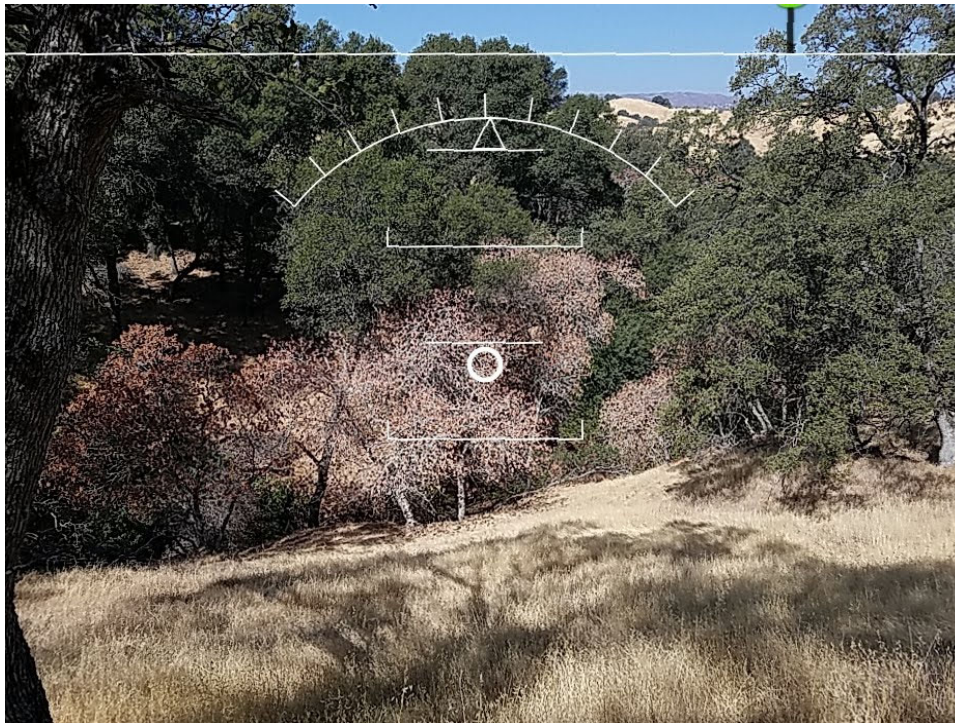
Photo 4: Oak savanna, consisting of grassland with interspersed blue oak (*Quercus douglasii*) and California buckeye (*Aesculus californicus*).

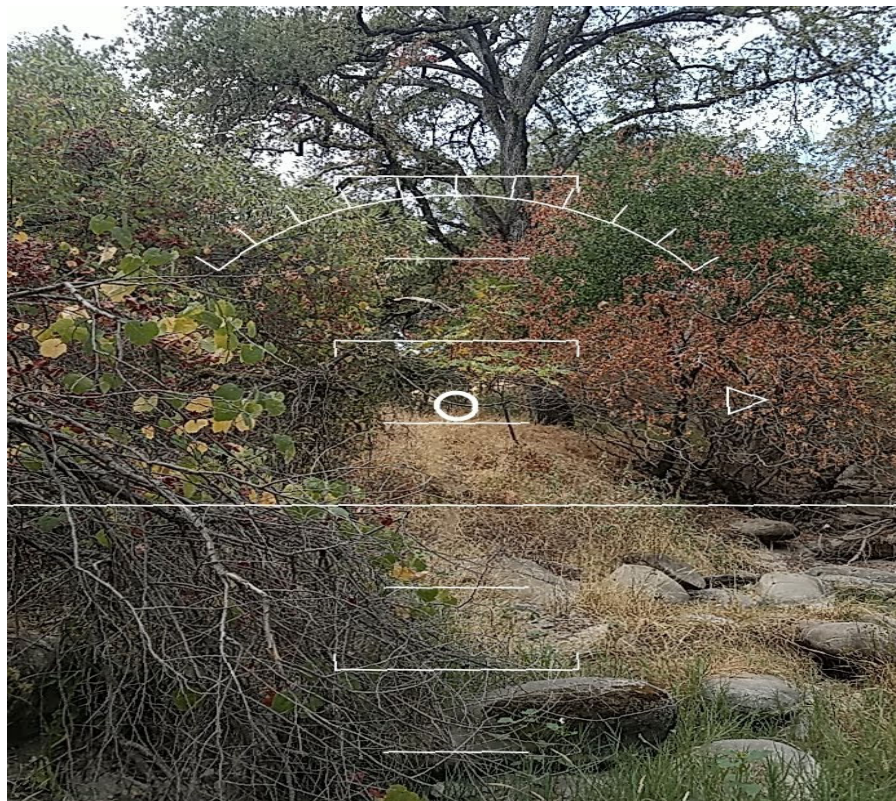
Photo 6: Riparian habitat, along English Creek.
