Lake Street Storage Project

**Phase 1 Environmental Site Assessment Report, PIC Environmental
Services, January 18, 2017**

PHASE I ENVIRONMENTAL SITE ASSESSMENT REPORT

**31000 LAKE STREET
LAKE ELSINORE, CA 92530**
(Riverside County Assessor's Parcel Number [APN] 390-130-018)

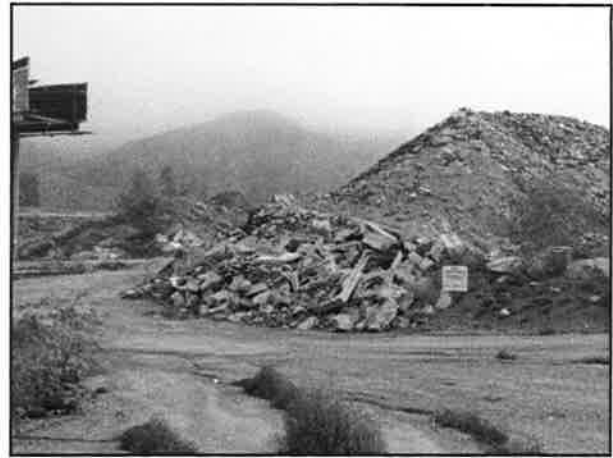
Concrete/asphalt stockpiles in western portion of site

Stockpiles of broken concrete and asphalt which were used as a source material for aggregate processing are located in the western portion of the subject property. It is possible that small quantities of asbestos containing materials (ACMs) are present within these debris piles. In the event that these debris stockpiles are disturbed in the future, efforts should be made to identify and segregate potential ACMs, and these materials should be managed/disposed of in accordance with all applicable regulatory requirements. In PIC's judgement, the possible presence of ACMs in debris piles represents a *de minimus* condition that does not warrant further investigation at this time.

In addition, there is a possibility that asbestos containing materials (ACMs) are present in the broken concrete and asphalt stockpiles at the property. If these debris stockpiles are disturbed, efforts should be made to identify and segregate potential ACMs, and these materials should be managed/disposed of in accordance with all applicable regulatory requirements at the time of material processing. No Further Action is warranted, in our judgment, prior to the processing and recycling of the concrete and asphalt debris.

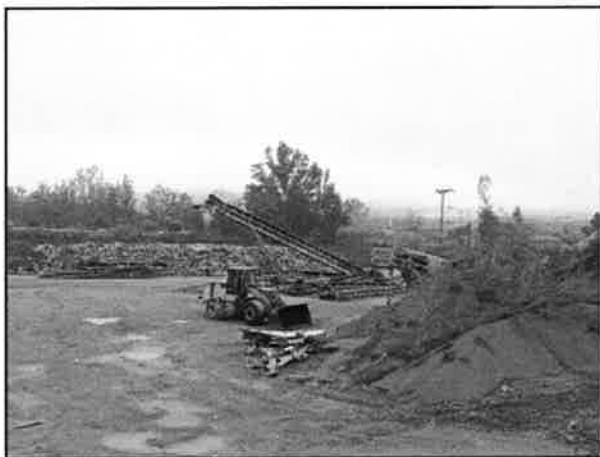
Aggregate processing equipment in central portion of site

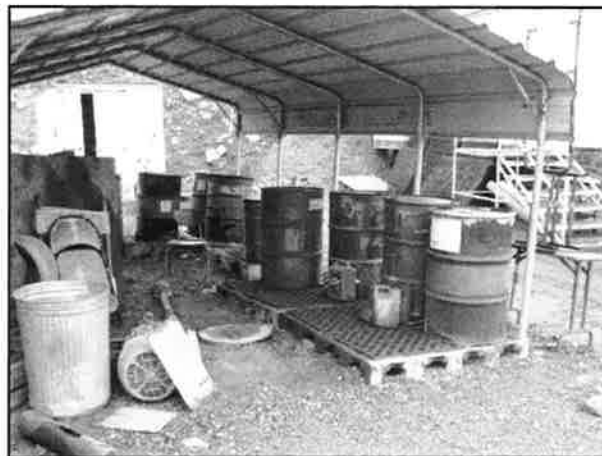
Enlarged view of drums beneath canopy

Hazardous materials and/or regulated substances observed at the subject property were limited to items associated with vehicle/equipment maintenance operations. These items included several 55 gallon drums and smaller containers of used motor oil, used oil filters, and possibly other petroleum products which are stored beneath a canopy in the central portion of the subject property. Relatively small areas of oil-stained surficial soil were observed in the immediate vicinity of these drums. In PIC's judgement, this oil-stained surficial soil represents a *de minimus* condition that does not warrant further investigation at this time. Petroleum impacted soil is likely limited to surficial and near surficial (upper few feet) and is limited to a relatively small lateral area. This petroleum impacted soil does not pose a significant threat to public health or the environment.

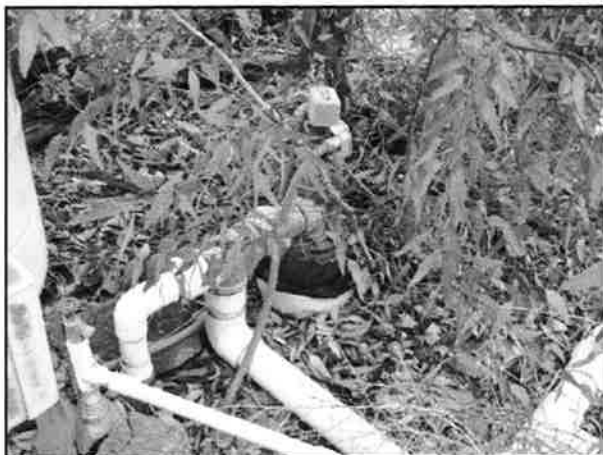
Water well in western portion of site

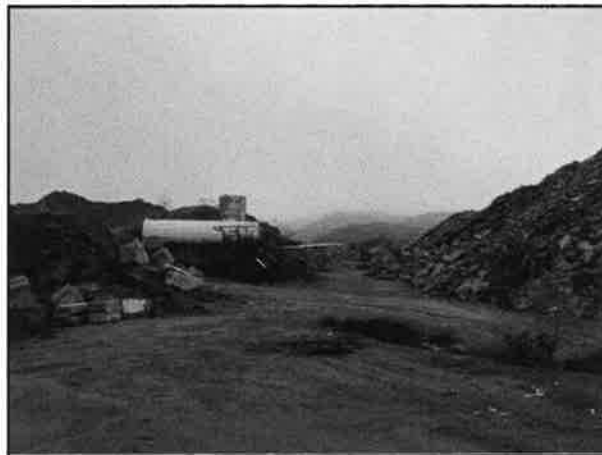
Water storage tanks in western portion of site

Two (2) above ground storage tanks (ASTs) used to store water are located in the western portion of the subject property. An AST used to store diesel fuel was reportedly formerly located west of the water ASTs (GeoTek, 2005). GeoTek noted in 2005 that no evidence of significant spills or releases was observed in the vicinity of the diesel AST, and according to Mr. Jeff Halloran of WYROC Materials, the diesel AST was removed in approximately 2006 or 2007.

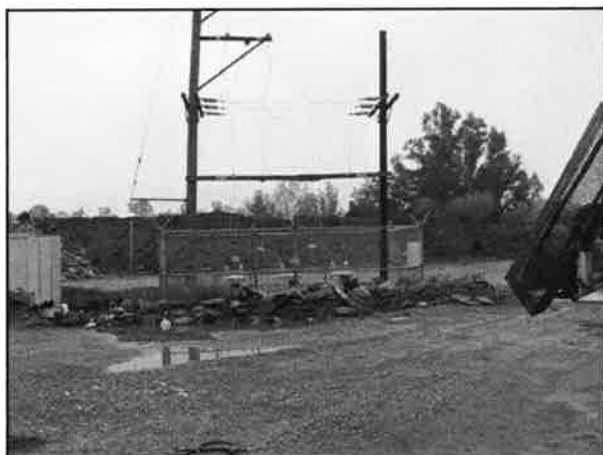
Electrical transformers in south-central portion of site

No evidence of leakage and/or spillage from equipment possibly containing polychlorinated biphenyls (PCBs) was observed at the site.

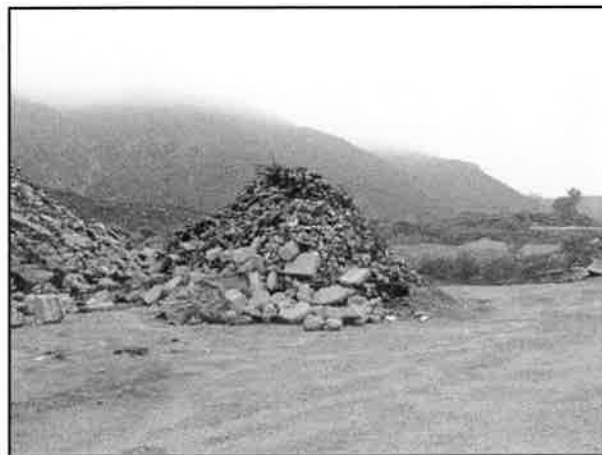
Stockpile of broken concrete and asphalt
