## **Biological Resources Assessment for the Cloverdale High School Stadium Improvement Project, Sonoma County, California**

### **Cloverdale Unified School District**

**DUDEK**

# **JANUARY 2020**

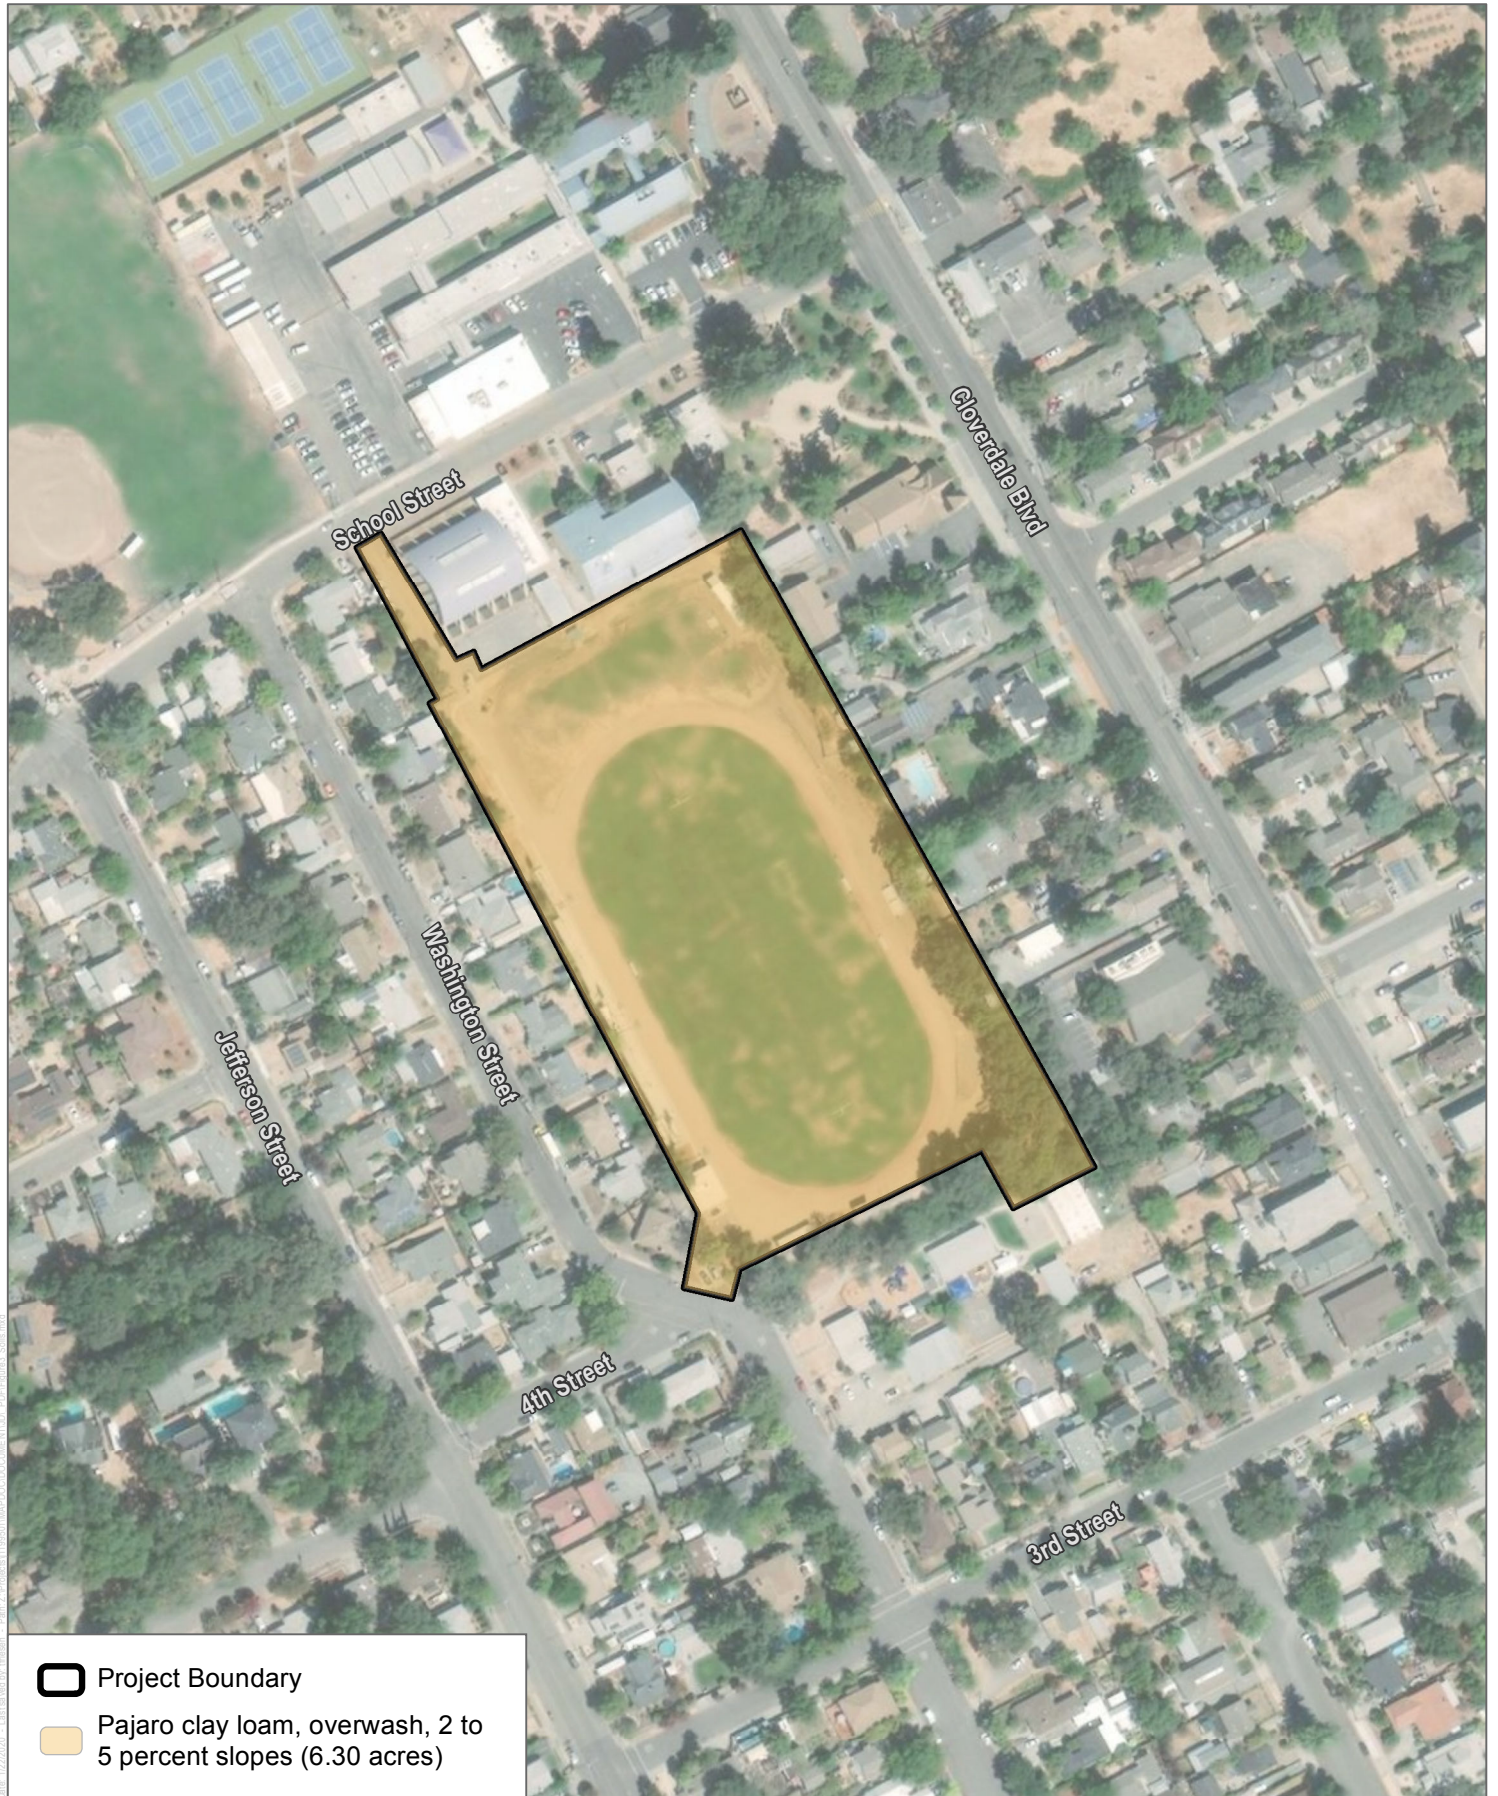
**FIGURE 3**  
**Soils Map**

One soil type occurs in the project site: Pajaro clay loam, overwash, 2 to 5 percent slopes (Figure 3, Soils). The Pajaro clay loam series consist of somewhat poorly-drained soils derived from alluvium from sedimentary rock. They are typically located on terraces and footslopes (USDA 2019a). Pajaro clay loam, overwash, 2 to 5 percent slopes is not considered a hydric soil (USDA 2019b).

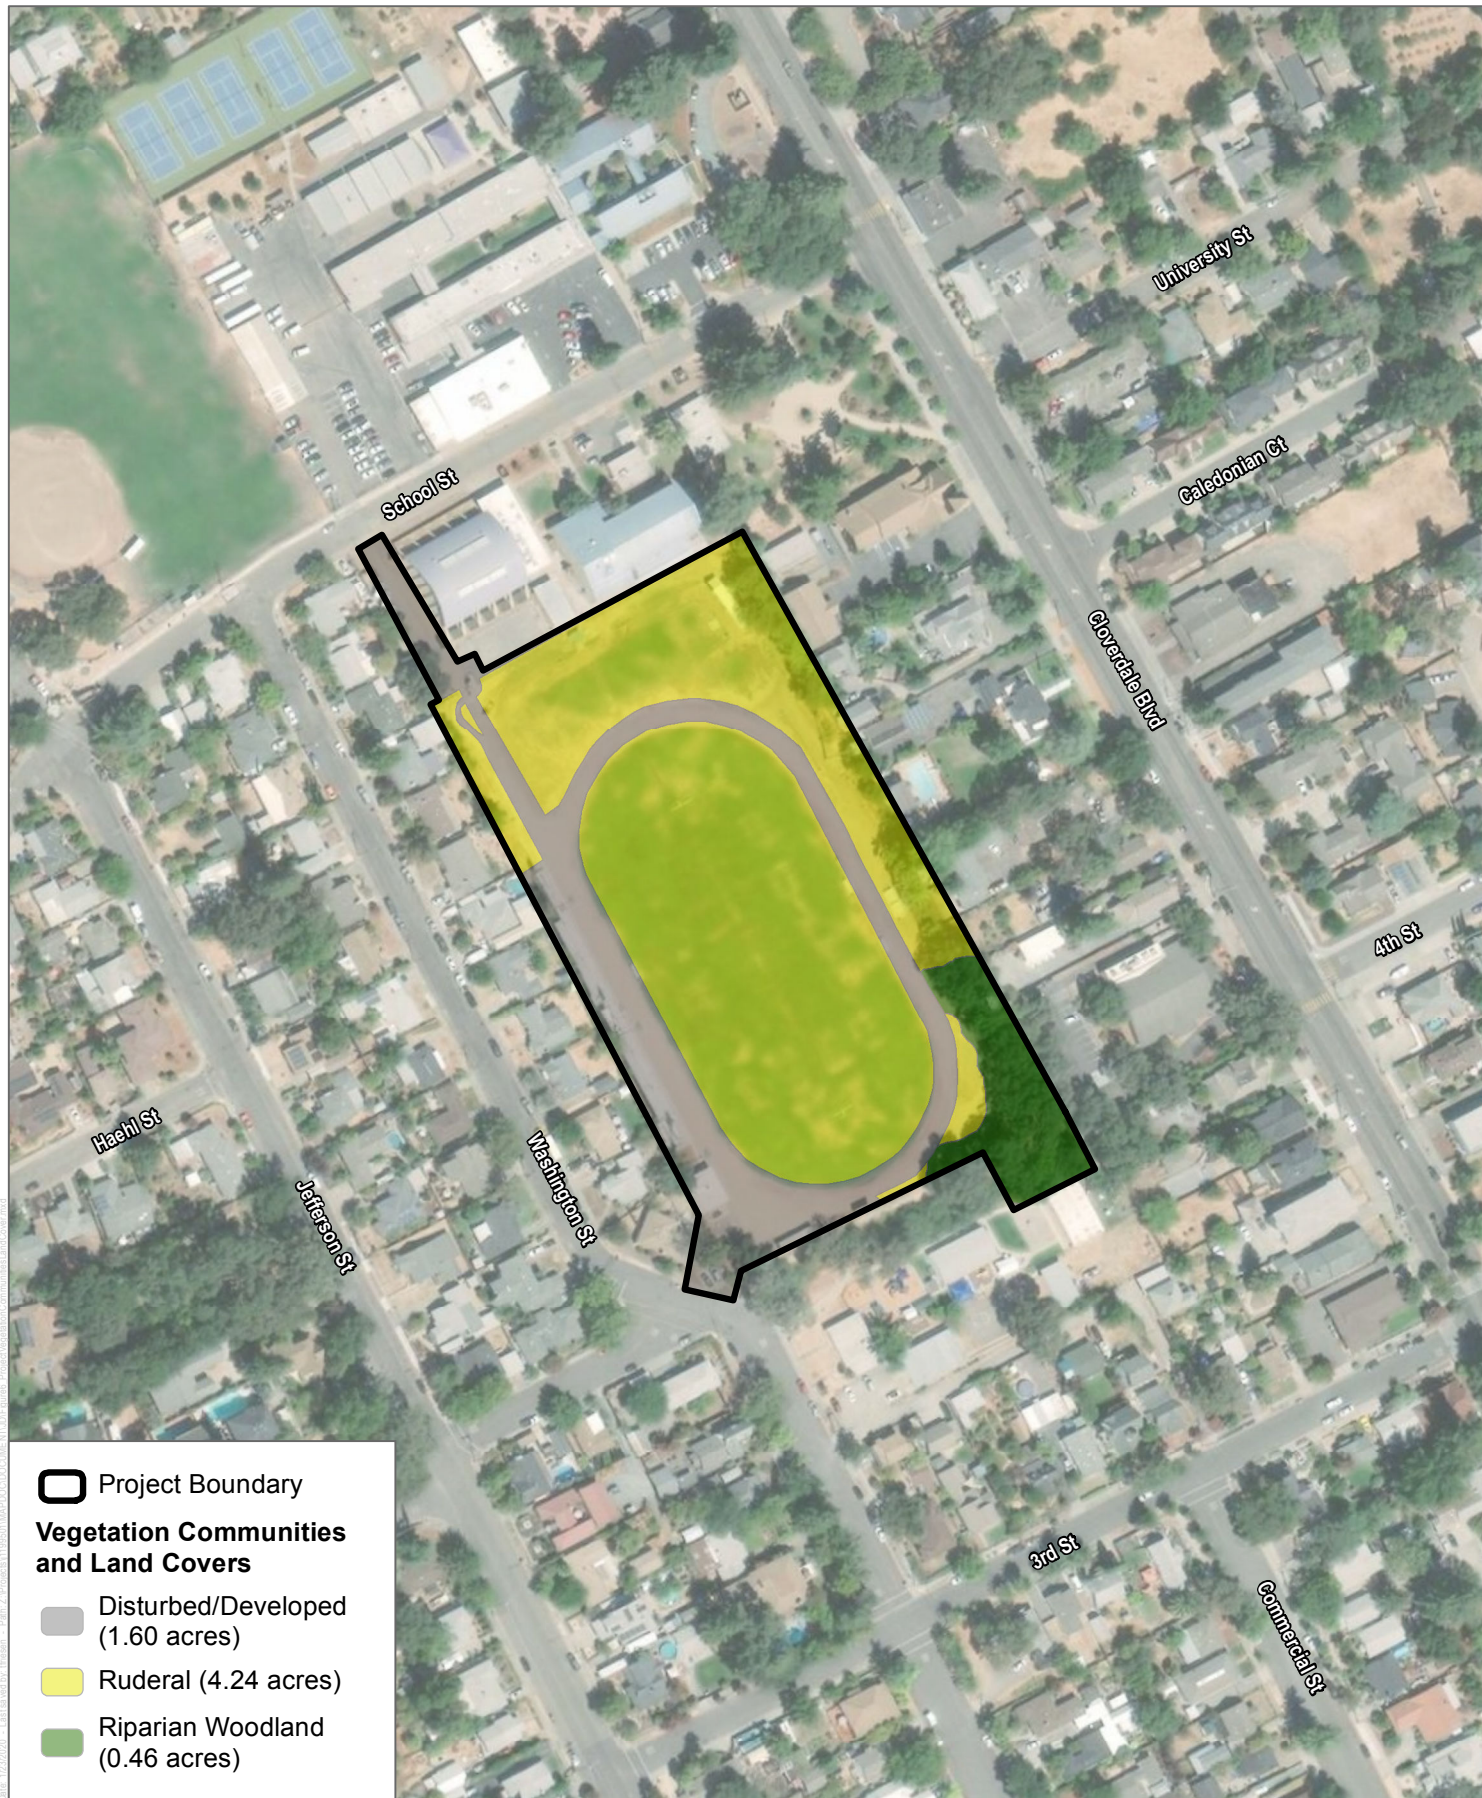
**FIGURE 6**

The land cover within the project area consists of a combination of terrestrial non-vegetative land covers and natural vegetation communities (Figure 6, Project Vegetation Communities and Land Cover Types), as well as aquatic land cover types (Figure 7, Preliminary Jurisdictional Delineation of Wetlands and Other Waters). The vegetation communities and land covers have been adapted from the California Wildlife Habitat Relationships System (CDFW 2019a). The following vegetation communities and land cover types were documented onsite and are described in further detail later in this section: riparian woodland, ruderal, disturbed/developed, drainage swale, ditch, and intermittent drainages (see Table 1). Refer to Attachment B for representative photographs of onsite vegetation communities and land cover types.

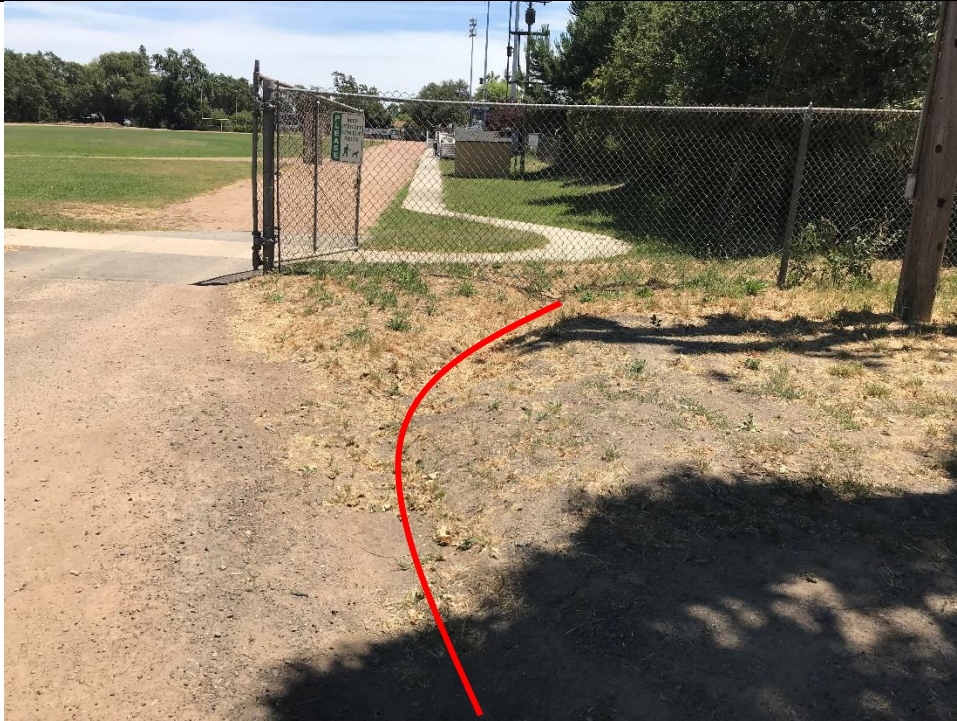
**Photo 1.** View of ditch 1 (indicated by red line). Facing south. June 24, 2019.

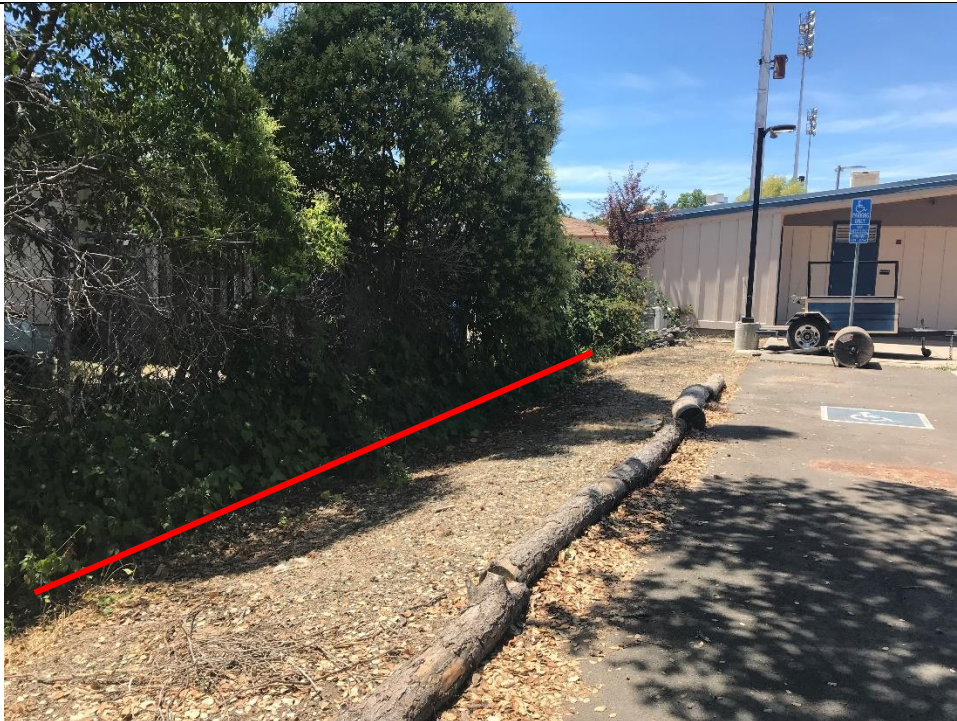
**Photo 2.** View of ditch 2 (indicated by red line). Facing northwest. June 24, 2019.

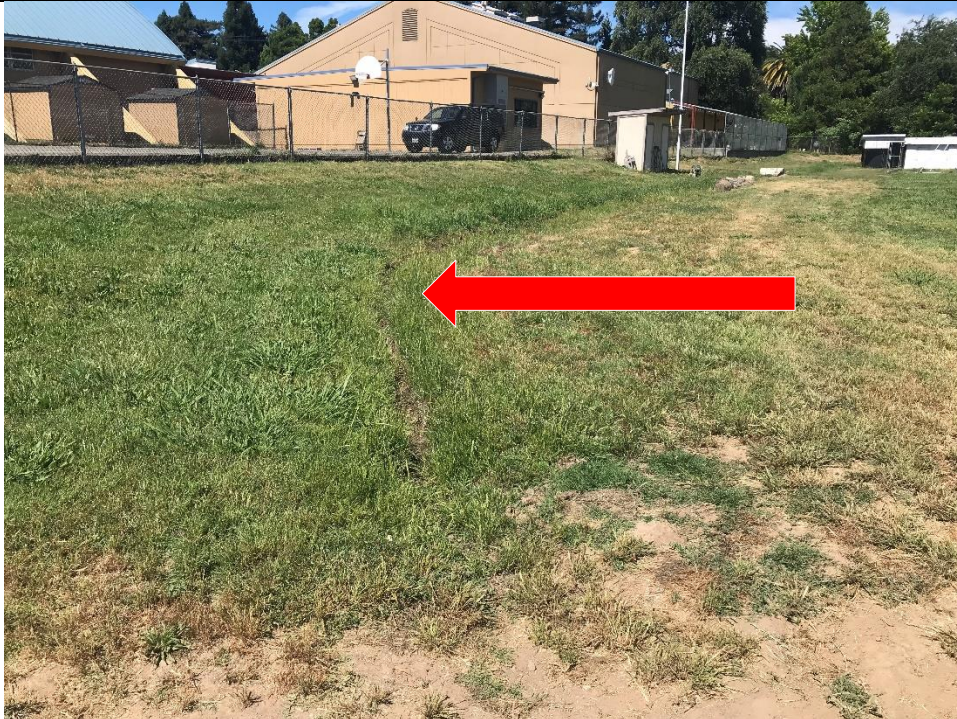
**Photo 3.** View of ditch 3 (indicated by red arrow). Facing northeast. June 24, 2019.

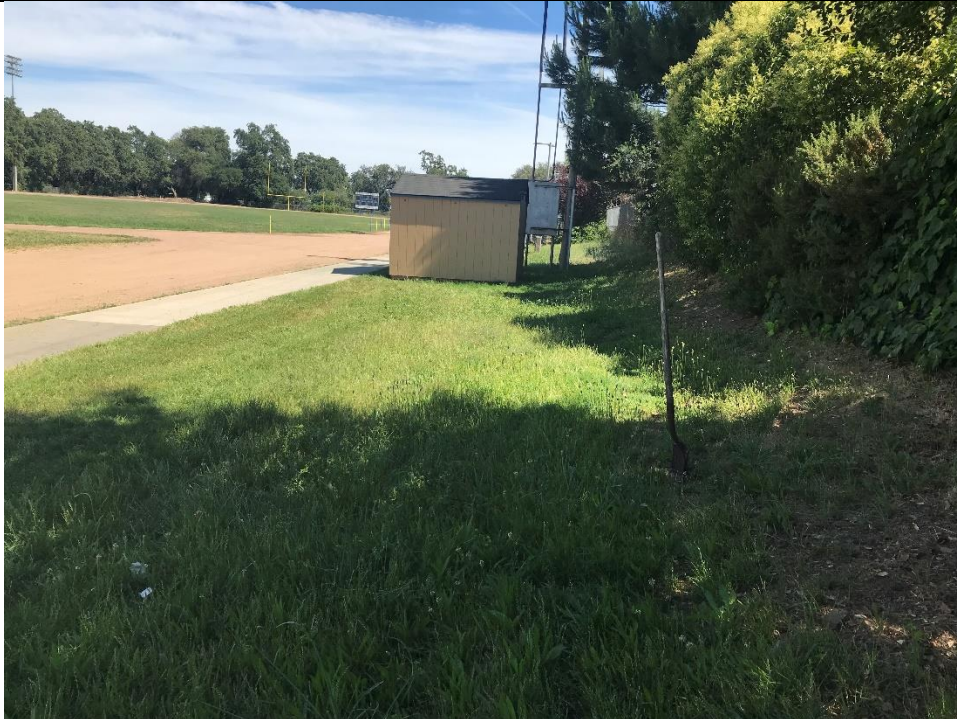
**Photo 4.** View of the drainage swale. Facing southwest. June 24, 2019.

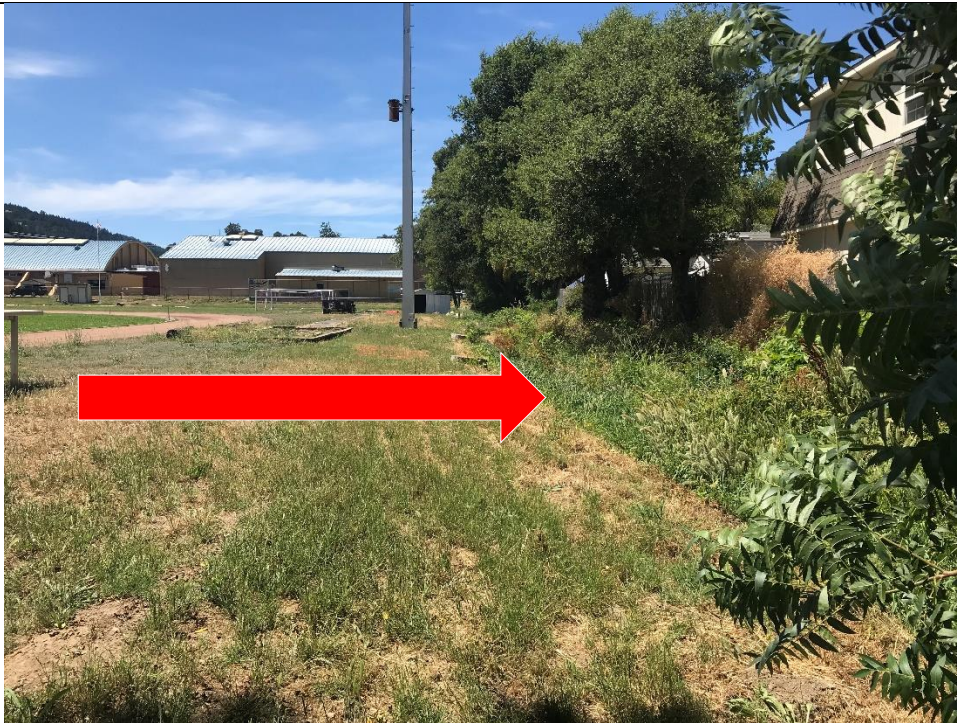
**Photo 5.** View of ditch 4 (indicated by red arrow). Facing north. June 24, 2019.

Ditch 4 transitions into a more natural drainage after it exits the property fence line near the middle of the east boundary, just south of a culvert outlet that empties school run-off into the drainage. Outside of the school property, the drainage widens and contains a more defined bed and bank. Channel scour is evident in the form of undercut banks and exposed roots. The bed substrate contains a mix of soil, small gravel, and miscellaneous trash and debris, including broken glass and woody debris. This segment of ditch 4 is surrounded by a narrow riparian corridor similar to the one discussed above. When inundated, the ditch empties into an unnamed intermittent drainage in the southeast corner of the project site (discussed below). Ditch 4 appears to contain intermittent hydrology based on conditions observed in the field.

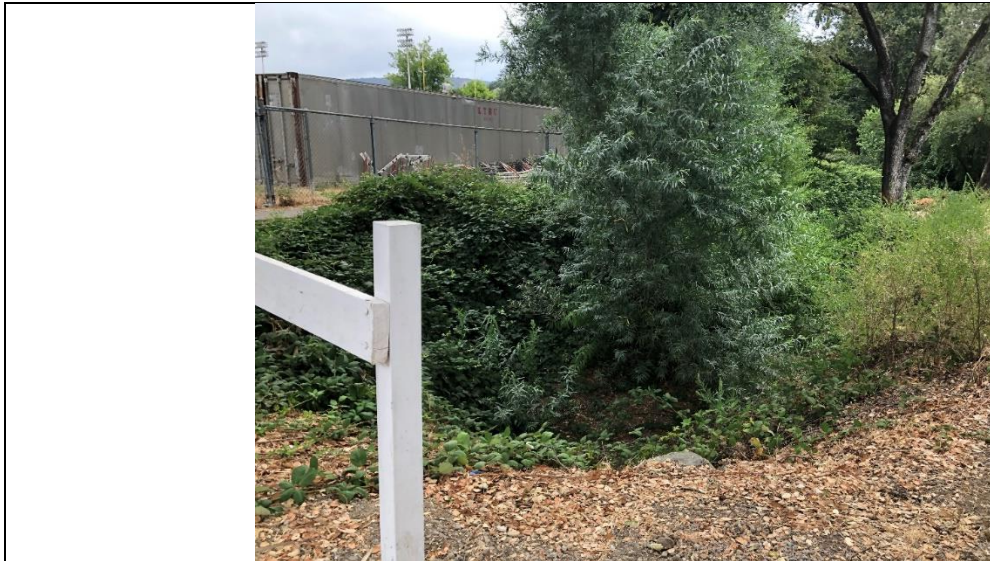
**Photo 9.** View of intermittent drainage. Facing northeast. August 9, 2019 (photo taken by Dudek archeologist).

Intermittent Drainage. There is one unnamed drainage that flows east through the south end of the project site. The drainage is not identified on the Cloverdale USGS quad map, but appears to contain intermittent hydrology based on conditions observed in the field. Ponded water, approximately 2 inches deep, was present intermittently in the drainage during the June 2019 fieldwork. Evidence of an OHWM includes bed and bank, wracking, sediment sorting, and destruction of vegetation. The drainage bed contains a mix of soil and small to large gravel and sparse vegetation, with the exception of areas dominated by Himalayan blackberry, which creep across the bed. Where present, vegetation in the drainage bed also includes tall flatsedge, curly dock, and cut leaved geranium (*Geranium dissectum*; NL). A narrow riparian corridor is present along both banks of the drainage (discussed above).

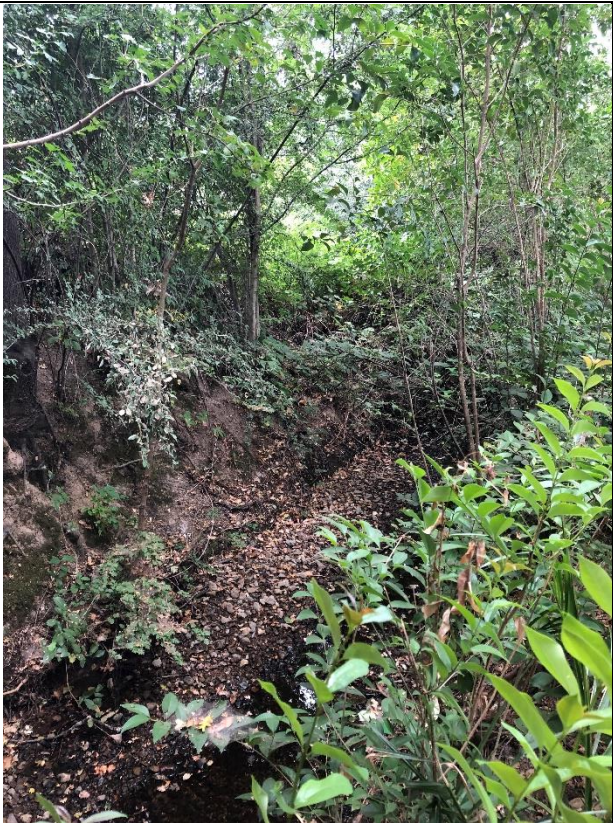
**Photo 10.** View of the intermittent drainage and adjacent riparian corridor. August 9, 2019 (photo taken by Dudek archeologist).

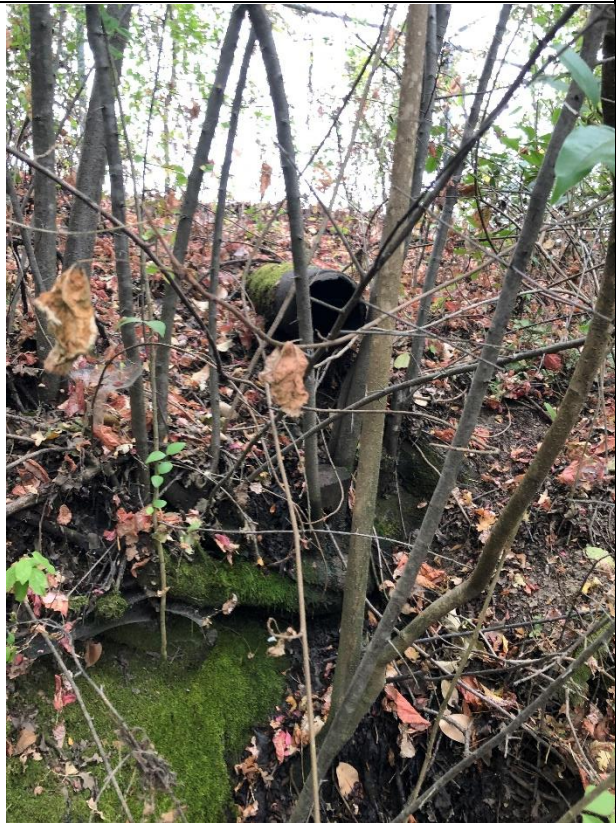
**Photo 11.** View of culvert outfall into ditch 4 where it occurs east of the school fence line. August 9, 2019 (photo by Dudek archeologist).

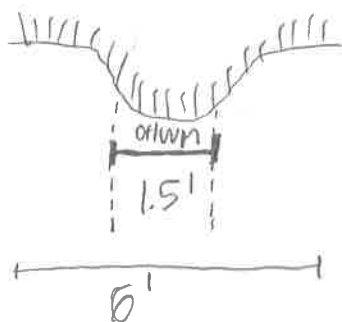
Ditch - 3

The ditch, when innundated, flows through two culverts.  
Evidence of mowing & manipulation of the ditch observed.  
Likely constructed to direct run-off, including football field  
irrigation, to ditches that flow off site

N ← → S  
looking E

**Break in Slope at OHWM:** ☐ Sharp ( $> 60^\circ$ ) | ☐ Moderate ( $30-60^\circ$ ) | ☒ Gentle ( $< 30^\circ$ ) | ☐ None

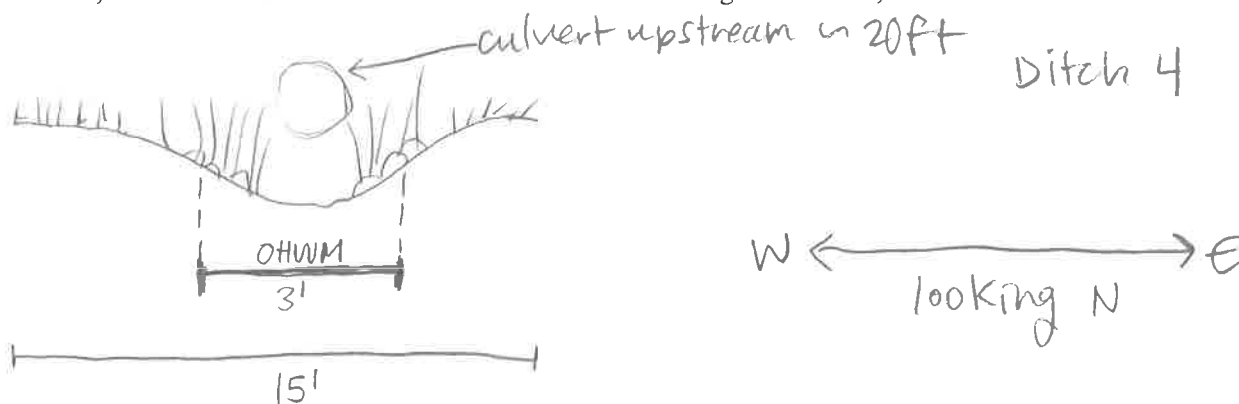
**Transect (cross-section) drawing:** (choose a location that is representative of the dominant stream characteristics over some distance; label the OHWM and other features of interest along the transect; include an estimate of transect length)

**Break in Slope at OHWM:** ☐ Sharp ( $> 60^\circ$ ) | ☐ Moderate ( $30-60^\circ$ ) | ☒ Gentle ( $< 30^\circ$ ) | ☐ None

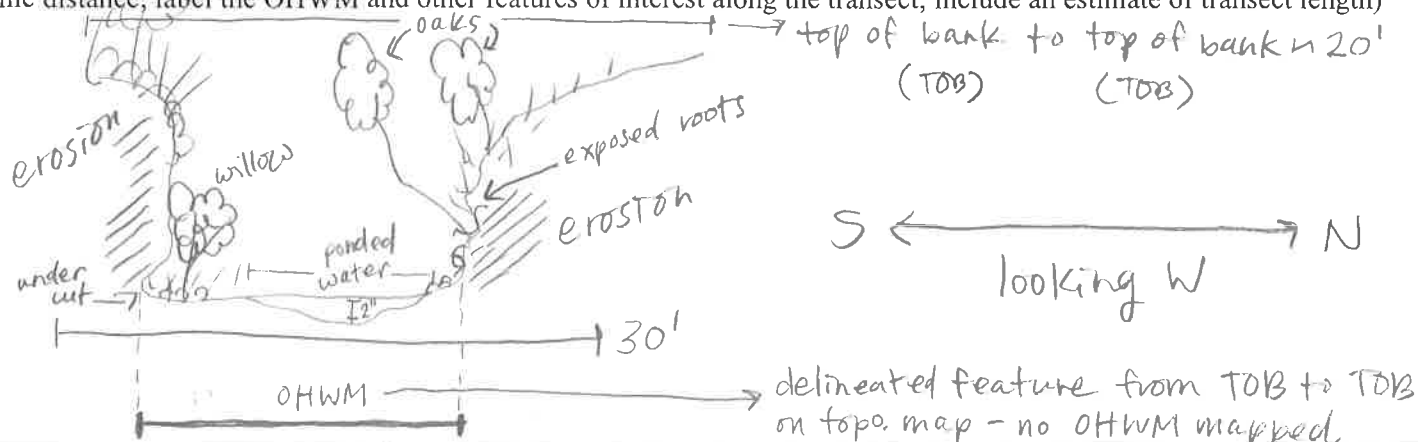
**Transect (cross-section) drawing:** (choose a location that is representative of the dominant stream characteristics over some distance; label the OHWM and other features of interest along the transect; include an estimate of transect length)

**Break in Slope at OHWM:** ☒ Sharp ( $> 60^\circ$ ) | ☐ Moderate ( $30-60^\circ$ ) | ☐ Gentle ( $< 30^\circ$ ) | ☐ None
