Rincon Consultants, Inc.

May 4, 2018

Subject: Wetland Delineation within the Guadalupe Ranch Acres Property, Guadalupe, Santa Barbara County, California

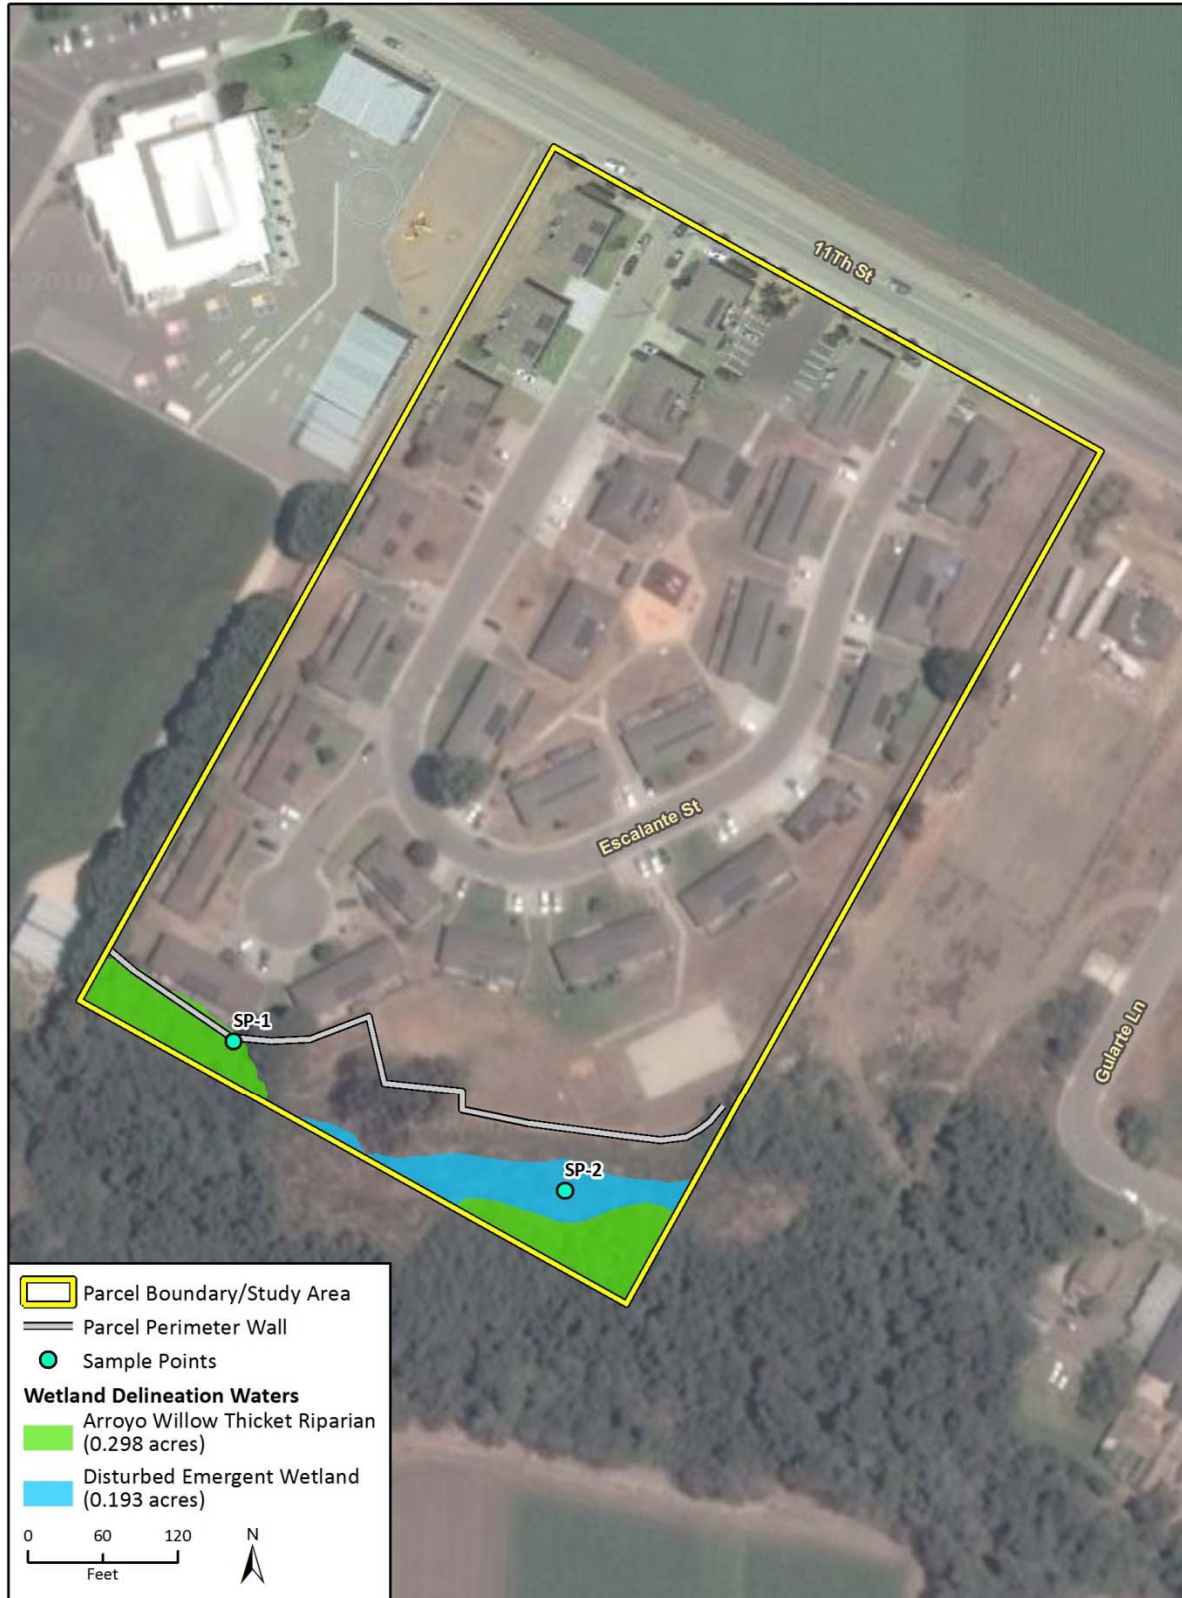
Figure 2: Wetland Delineation Waters

Fig 2 Wetland Delineation Waters

A disturbed emergent County-defined wetland was observed at the southeastern corner of the parcel (Figure 2). The wetland contained very dense coverage of cattails, an OBL species. The County-defined wetland may also be classified as a potential federally defined wetland expanding beyond the limits of the parcel along with a dense arroyo willow canopy. No sample point was excavated because the soil map unit, Riverwash, is confirmed as a hydric soil and hydrophytic vegetation passed the dominance test confirming the feature meets the County's definition of a wetland. The feature is closely associated with riparian vegetation, and thus likely also falls under CDFW's jurisdiction as part of the streambed.

To verify the NWI and NHD mapping of a forested/shrub wetland where the arroyo willow thicket riparian habitat abuts the parcel perimeter wall in the southwest area of the parcel, a full sample point was collected, termed SP-1 (see Figure 2). The willow canopy with an understory of kikuyu grass (FACU) and wild radish (*Raphanus sativus*, UPL) did not pass the hydrophytic dominance test. Furthermore, the sample lacked hydric soils and hydrology. Numerous obstructions were found in the soil sample including glass and plastic waste from neighboring residences. Although the arroyo willow thicket riparian vegetation adjacent to the parcel perimeter wall was previously mapped as a forested/shrub wetland, it did not meet the USACE or the County's definition. In addition, the top of bank and arroyo willow riparian vegetation also meets the definition of a CDFW streambed and likely falls under CDFW jurisdiction under Section 1600 *et seq.* of the California Fish and Game Code.

The parcel limits has a disturbed emergent defined wetland that meets the County's definition of a wetland that would regulated by the County, and may also be regulated by the RWQCB under the Porter-Cologne Act. Additionally, areas up to the top of bank, as well as riparian vegetation to the outer dripline of the riparian community, is subject to jurisdiction of the CDFW pursuant to Section 1600 *et seq.* of the California Fish and Game Code. Potentially jurisdictional areas within the parcel limits are shown on Figure 2.

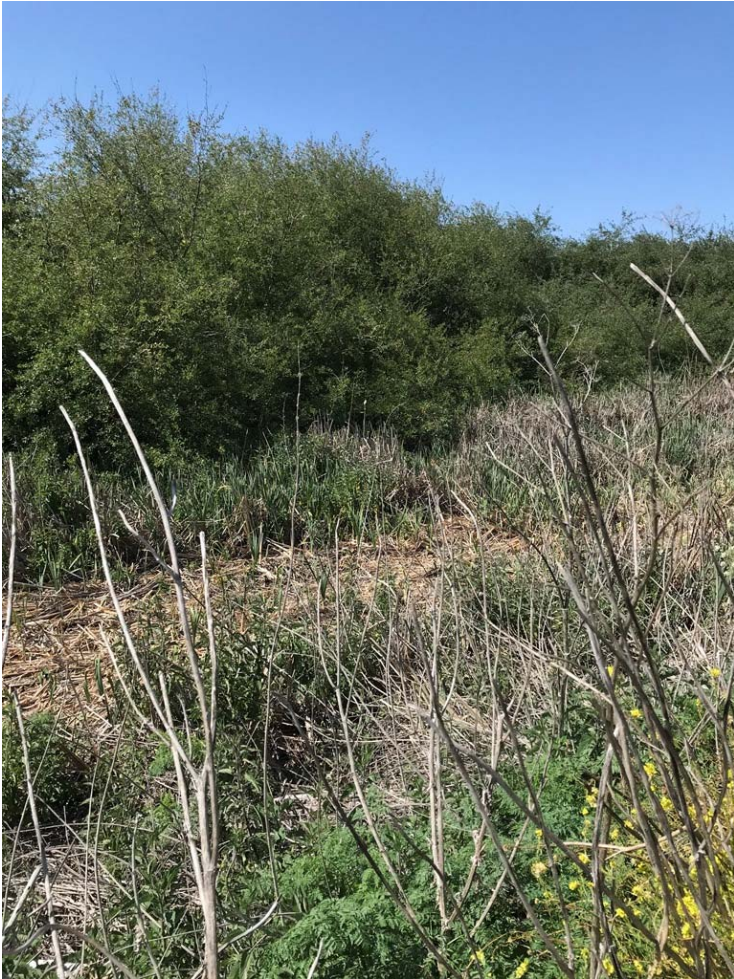
Representative Photo 1: Disturbed emergent wetland, facing south.

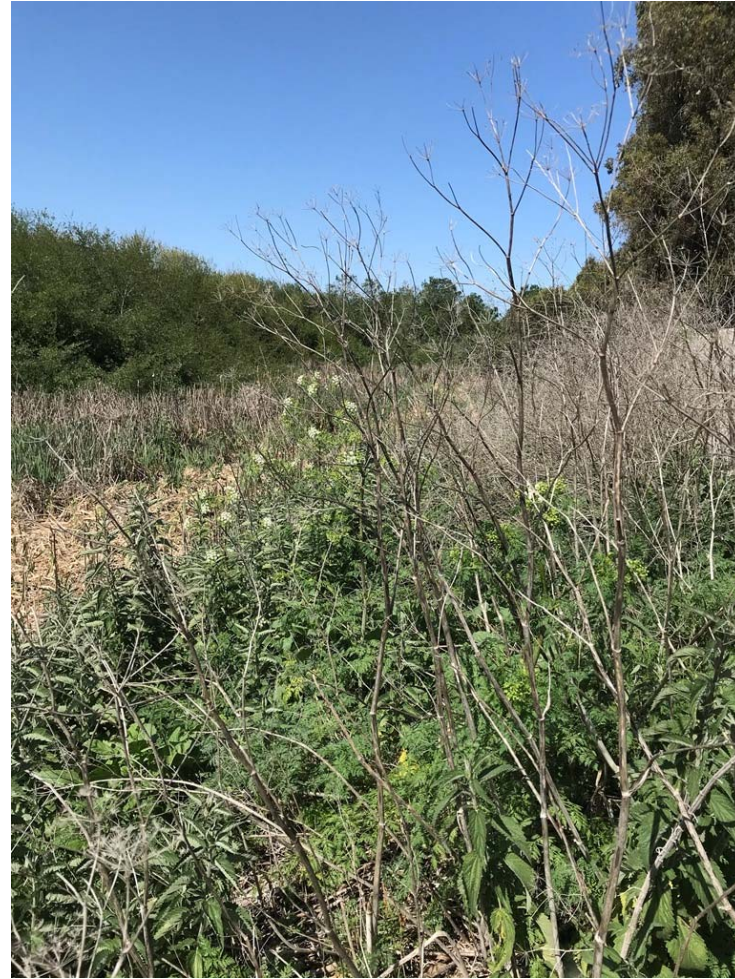
Representative Photo 2: Upland and transitional habitat form emergent wetland, facing southwest.

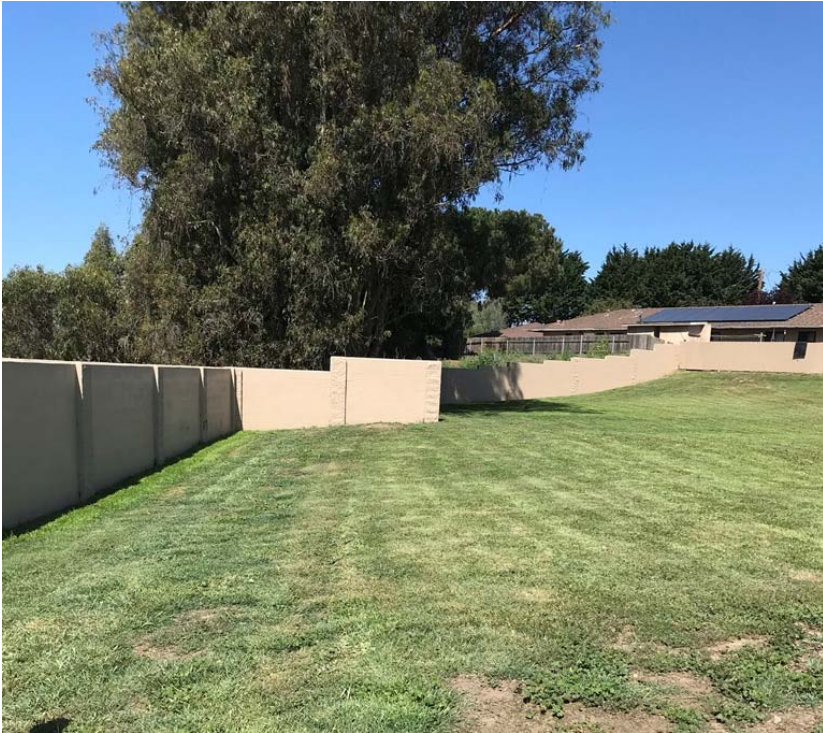
Representative Photo 3: Landscape with parcel perimeter wall, facing west.

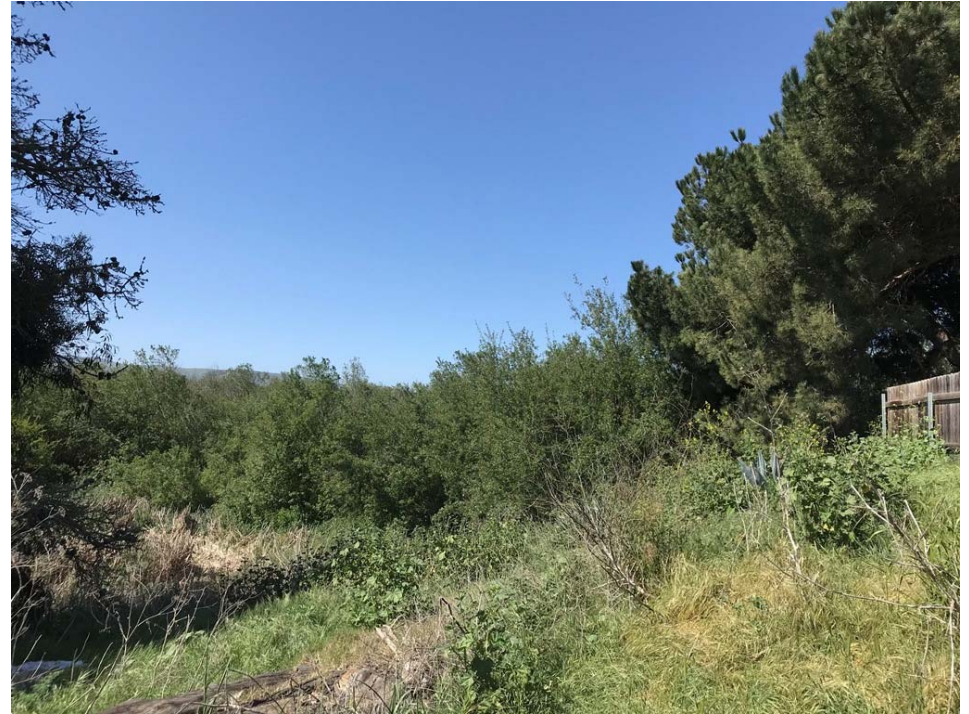
Representative Photo 4: Western extent of emergent wetland downslope of the parcel perimeter wall with arroyo willow thicket riparian surrounding the wetland and along the slope, facing southwest.

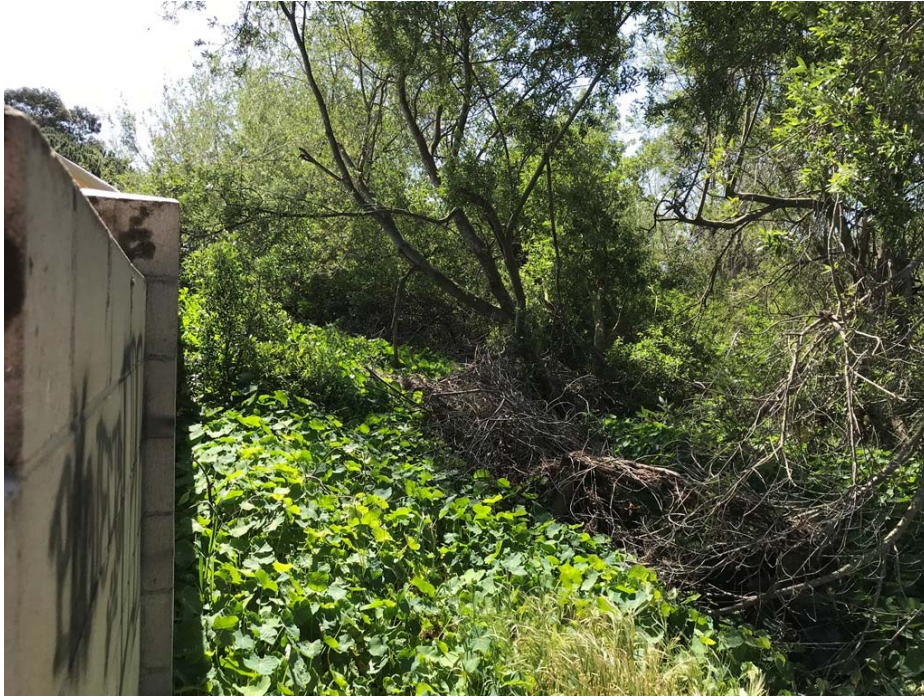
Representative Photo 5: Arroyo willow thicket riparian adjacent to the parcel perimeter wall in the southwest corner of the parcel, facing east.

Within the parcel, the arroyo willow vegetation extends approximately 50 feet from the southern limits of the parcel, connected to the fragmented riparian corridor. Arroyo willow thickets are defined in *A Manual of California Vegetation, Second Edition* (Sawyer *et al.* 2009) as having arroyo willow (*Salix lasiolepis*) as the primary dominant species in the shrub canopy. The community within the parcel is extremely dense but not diverse, with arroyo willow accounting for the vast majority of the canopy vegetation. The understory is comprised of garden nasturtium (*Tropaeolum majus*) and kikuyu grass (*Pennisetum clandestinum*) with occasional callalily (*Zantedeschia aethiopica*). Large amounts of residential waste were observed within this vegetation adjacent to the parcel perimeter wall. Within the southern end of the parcel the arroyo willow vegetation is along the hillslope leading down to the confined riparian corridor and adjacent to the parcel perimeter wall with slight overhang. Recent trimming of willow limbs was observed at the residence at the southwest corner of the parcel.

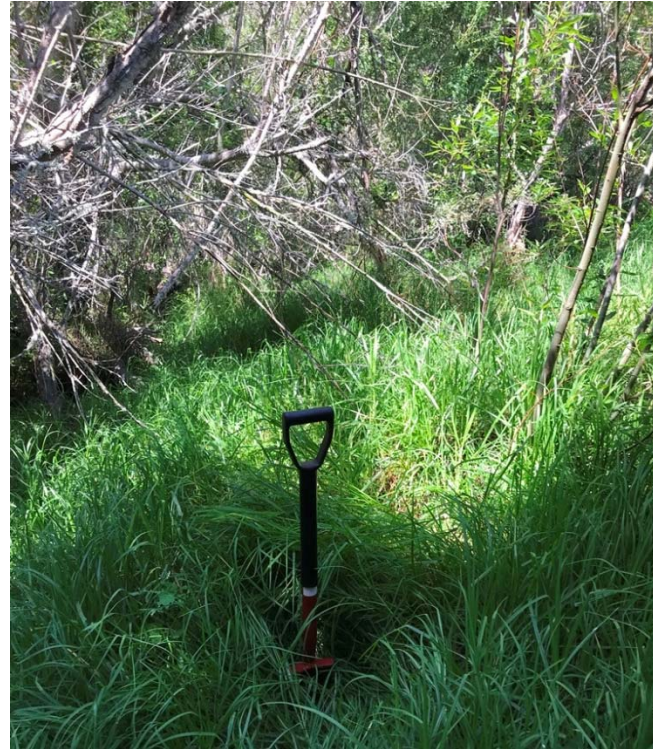
Representative Photo 6: Sample Point 1 location near the parcel perimeter wall on the edge of the arroyo willow thicket riparian, facing west.
