PHASE I ENVIRONMENTAL SITE ASSESSMENT

ELK GROVE CENTER, COSUMNES RIVER COLLEGE 10051 BIG HORN BOULEVARD ELK GROVE, CALIFORNIA

PROJECT NUMBER: 2019-00100 January 20, 2020

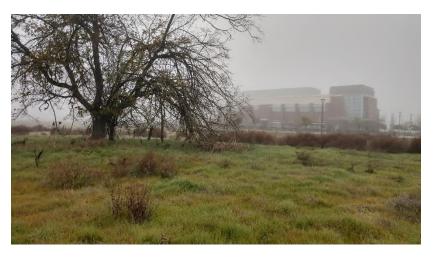
Figure 15 – View of western boundary of subject property looking east.
