## **Appendix F: Hazards and Hazardous Materials Supporting Information**

## **F.1 - Phase I Environmental Site Assessment**

Project No. 034-17125

RE: Phase I Environmental Site Assessment  
Proposed Residential Development Property  
28195 Highway 101  
APNs 117-040-053 and -084  
Cloverdale, California 95425

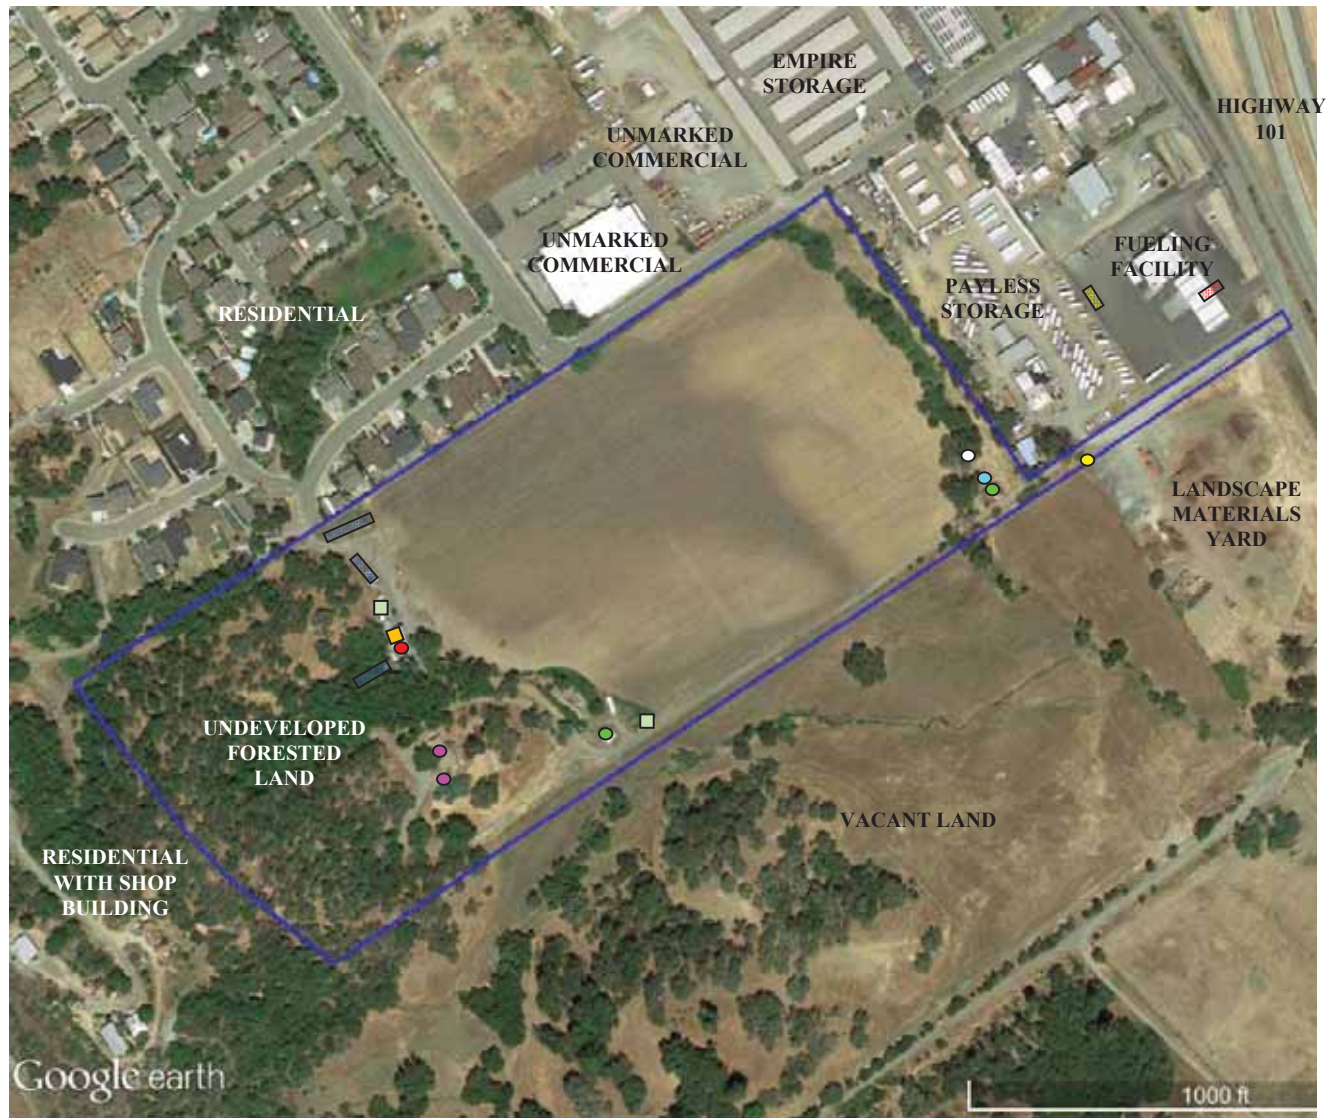
The following Table II summarizes conditions encountered during our site reconnaissance. A discussion of visual observations is presented in the following table. Refer to the Site Map (Figure No. 2) and color photographs following the text for the locations of items discussed in this section of the report.

- = SUBJECT SITE BOUNDARY (APPROXIMATE)
- = STORAGE SHED OR BARN CONTAINING FUNCTIONAL & NON-FUNCTIONAL TRACTORS/EQUIPMENT
- = DWELLING AND DETACHED STORAGE BUILDING
- = WASTE OIL AST
- = TRACTORS/VEHICLES/EQUIPMENT IN EXTERIOR AREA (SOME APPARENTLY NON-FUNCTIONAL)
- = POLE-MOUNTED ELECTRICAL TRANSFORMER
- = APPROXIMATE LOCATION OF WASTE OIL UST & DIESEL UST REMOVED IN DECEMBER 2016
- = APPROXIMATE LOCATION OF 3 FUEL USTs REMOVED IN 1990
- = DRY GOODS STORAGE CONTAINER
- = WATER WELL/SHED/PRESSURE TANK
- = DISCARDED MATERIALS RESTING ON GROUND SURFACE
- = SHOP BUILDING/MAINTENANCE MATERIALS

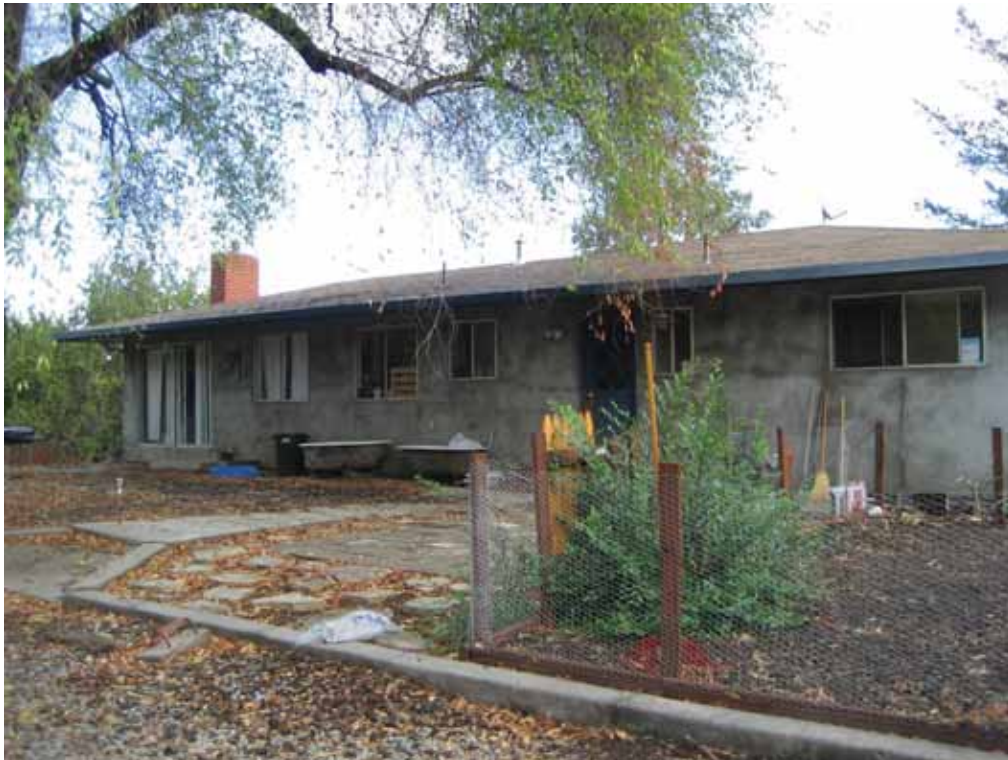
- The western portion of the subject site was observed to be occupied by a rural residential area, including a single-family dwelling reported to be 1,625 square feet (See Photographs No. 1 and No. 2), a detached storage building associated with the dwelling (See Photographs No. 3 and No. 4), a canopy structure utilized as a shop and equipment storage facility (See Photographs No. 5 and No. 6), a dilapidated tractor storage shed (See Photographs No. 7 and No. 8), an home gardening area (See Photograph No. 9), several truck trailers/shipping containers being utilized for storage of personal property (See Photographs No. 10 – No. 12), unpaved and gravel-paved

**Photo 1:** Northern-facing view of the single-family dwelling located in the western portion of the subject site.

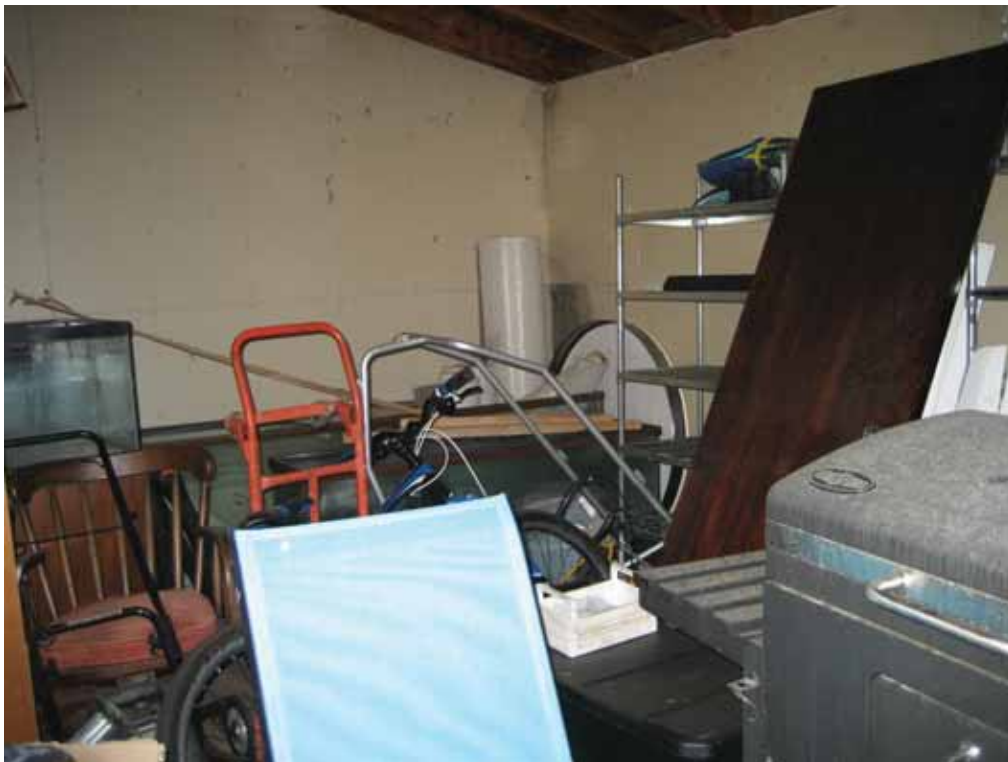
**Photo 4:** Interior view of the storage building associated with the dwelling located in the western portion of the subject site.

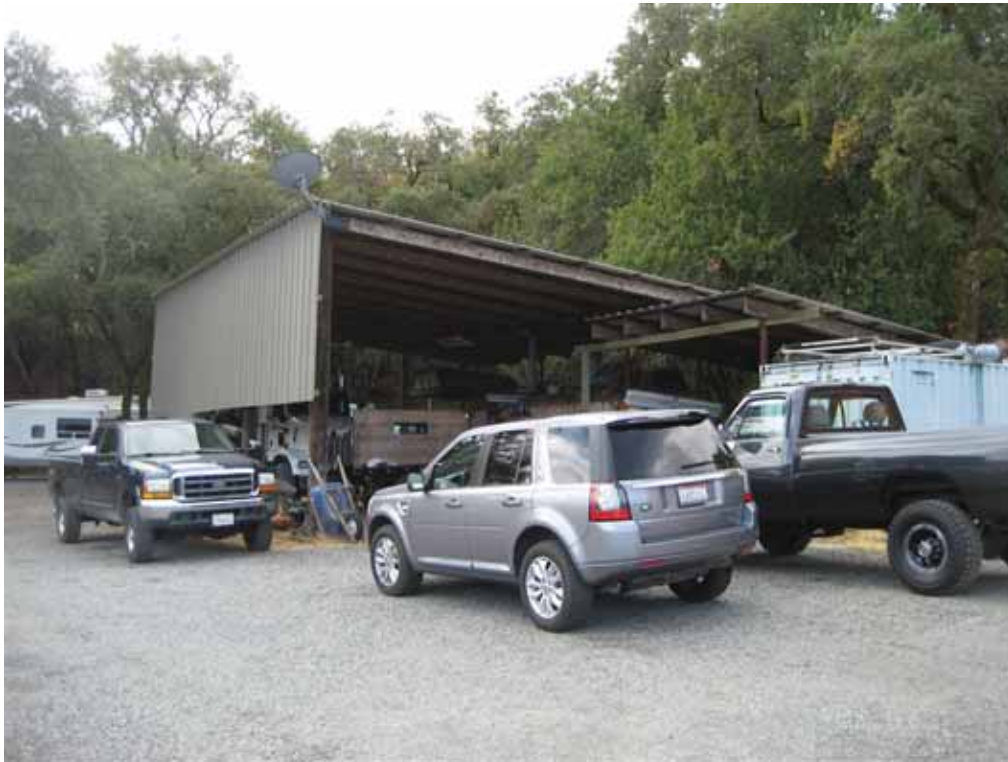
**Photo 5:** Southern-facing view of the shop canopy structure located in the western portion of the subject site.

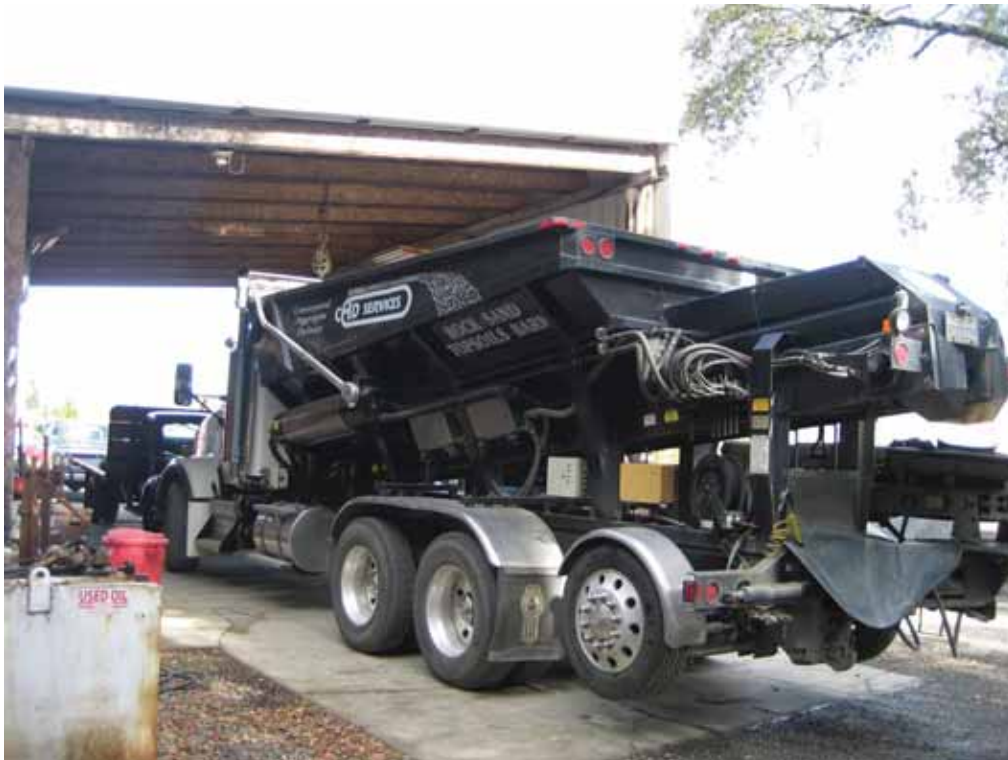
**Photo 6:** Northeastern-facing view of the area beneath the shop canopy structure located in the western portion of the subject site.

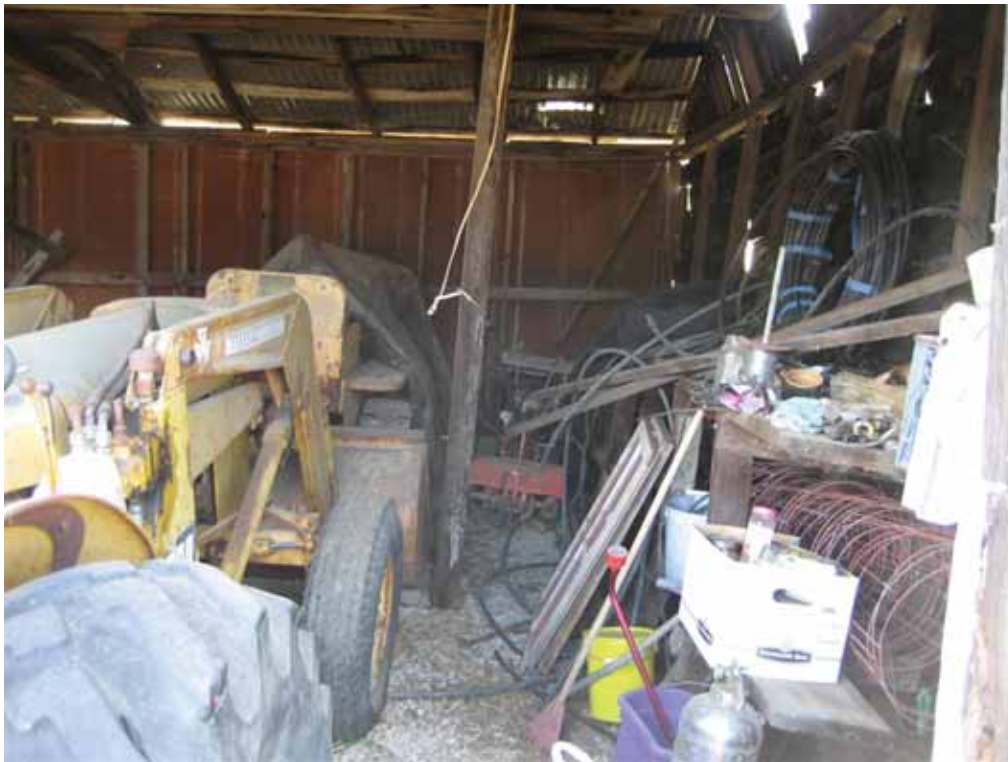
**Photo 8:** Interior view of the northern end of the tractor storage shed located in the central southern portion of the subject site.

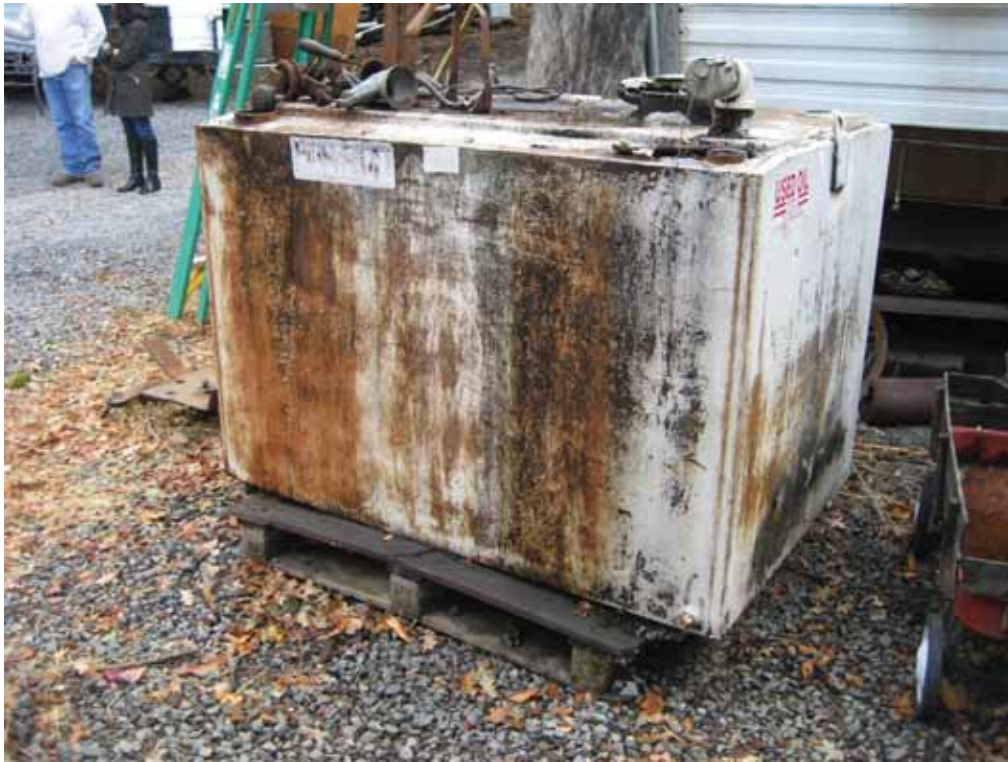
- Hazardous materials and hazardous wastes were observed in association with the shop structure, including compressed welding gases, three 30-gallon drums of gear oil/grease, an approximately 125-gallon waste oil AST, and small quantity containers (one gallon or less) of a variety of common maintenance materials (See Photographs No. 13 – No. 15). The waste oil AST, noted to be resting on gravel-paved ground, appeared to be a double-walled tank; however, this could not be substantiated by observation. Additionally, small quantities of common maintenance materials were observed within a trailer located adjacent to the northwest of the shop canopy used for storage of personal property. Mr. Baumgardner stated that he recently sold his primary residence and was temporarily storing personal property in the trailers/shipping containers located on site. No odors, surface staining, stressed vegetation, or other evidence of a release of waste oil/fuel/hazardous materials was observed in association with the waste oil AST, the hazardous materials storage areas in and surrounding the shop canopy, or the areas surrounding the trailers and shipping containers in which personal property is being stored.

**Photo 13:** View of an approximately 125-gallon waste oil AST located at the shop in the central-eastern portion of the subject site.

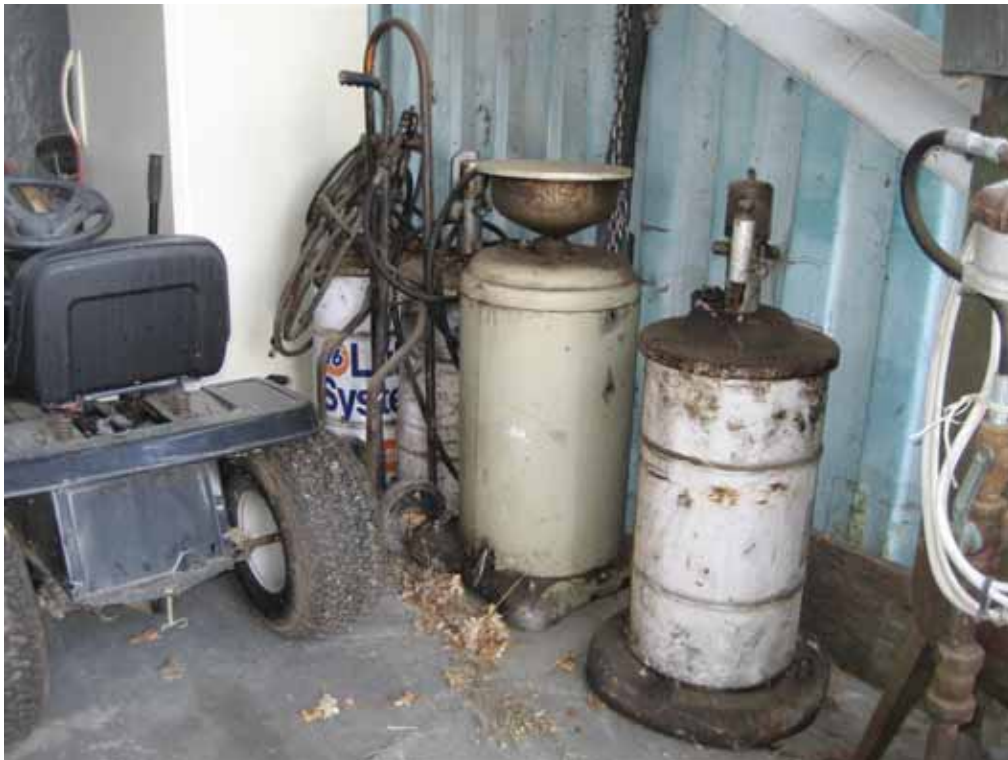
**Photo 14:** View of the grease/lubricant drums and waste oil receptacle located at the shop in the central-eastern portion of the subject site.

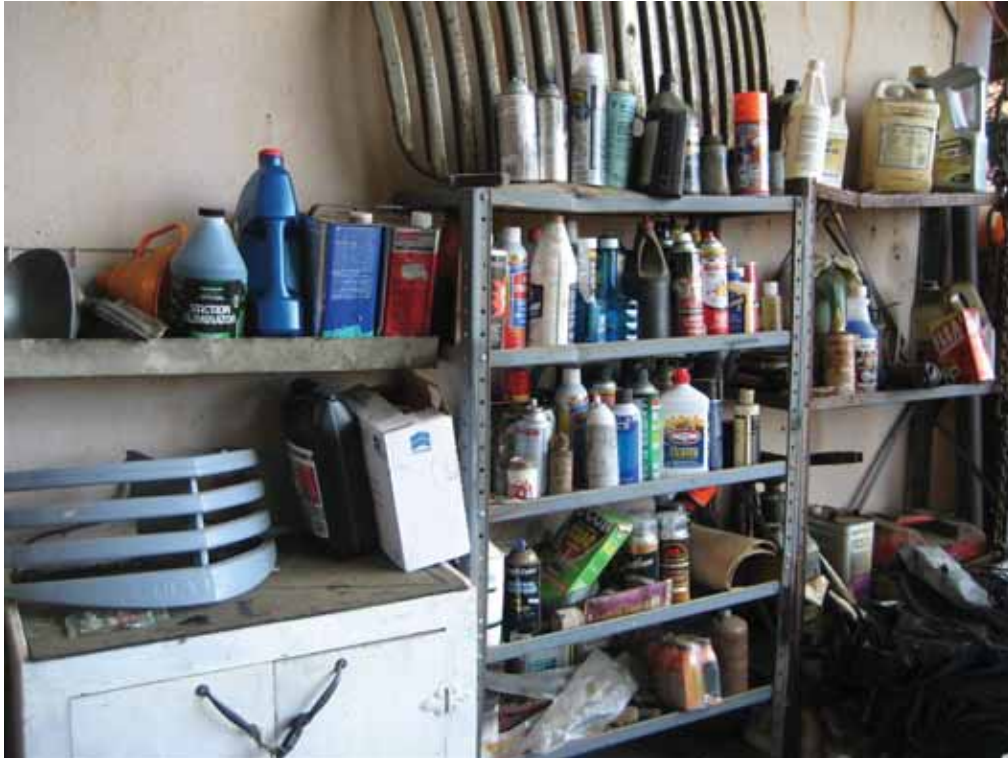
**Photo 15:** View of the common maintenance materials located at the shop in the central-eastern portion of the subject site.

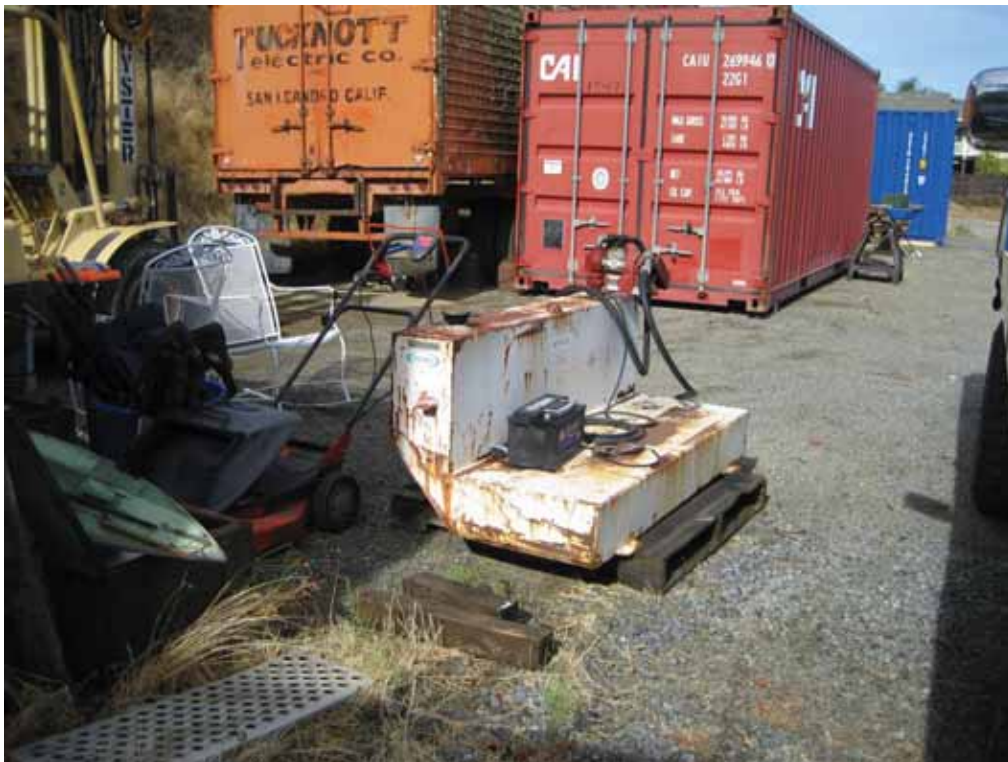
- Other than an empty truck-mounted fuel tank resting on the ground (See Photograph No. 16) and small plastic containers of gasoline/diesel fuel (5 gallons or smaller) observed in the shop area, fuel storage was not observed on the subject site. Mr. Baumgardner stated that an approximately 200-gallon fuel AST was located on site in the 1960s or 1970s; however, he indicated that no fuel ASTs have been located on the subject site in many years. Mr. Baumgardner stated that, to the best of his knowledge, no underground storage tanks have been located on the subject site.

**Photo 16:** View of an empty truck-mounted fuel tank located at the shop area in the central-eastern portion of the subject site.

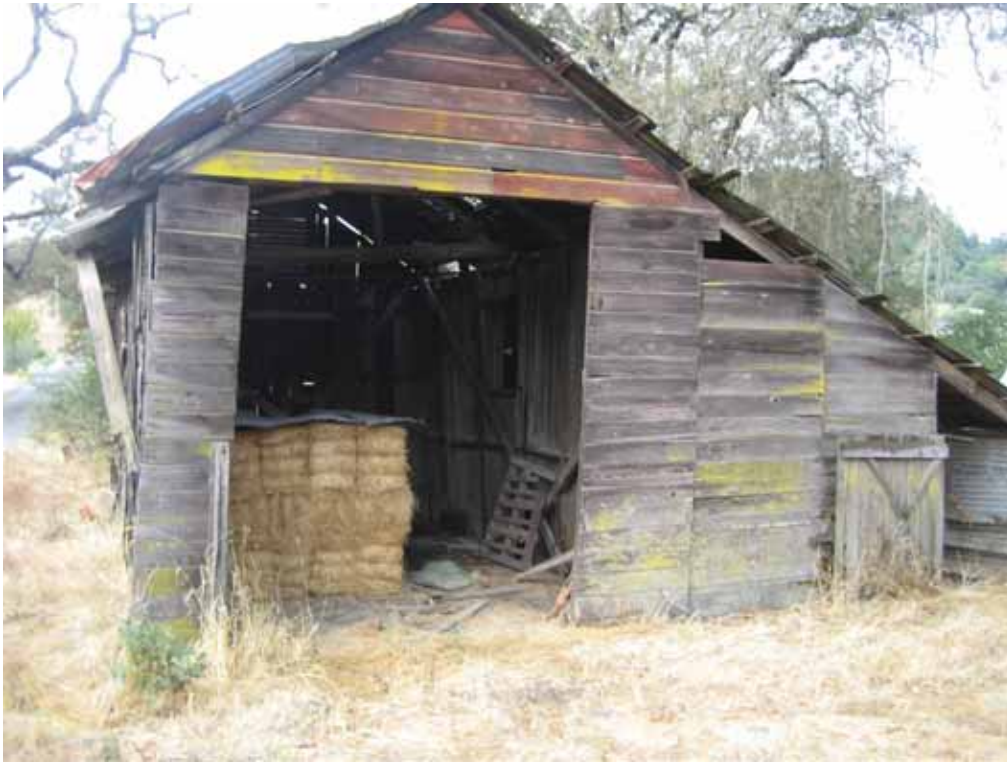
- A dilapidated storage barn containing several bales of hay, several tractors (some of which appeared to be non-functional), an all-terrain vehicle, and farm equipment was observed in the southeastern portion of the subject site (See Photograph No. 17 – No. 19). No evidence of fuel storage or of the presence of hazardous materials in containers greater than five-gallon capacity was observed in association with the dilapidated storage barn.

**Photo 17:** Southwestern-facing view of the storage barn located in the southeastern portion of the subject site.

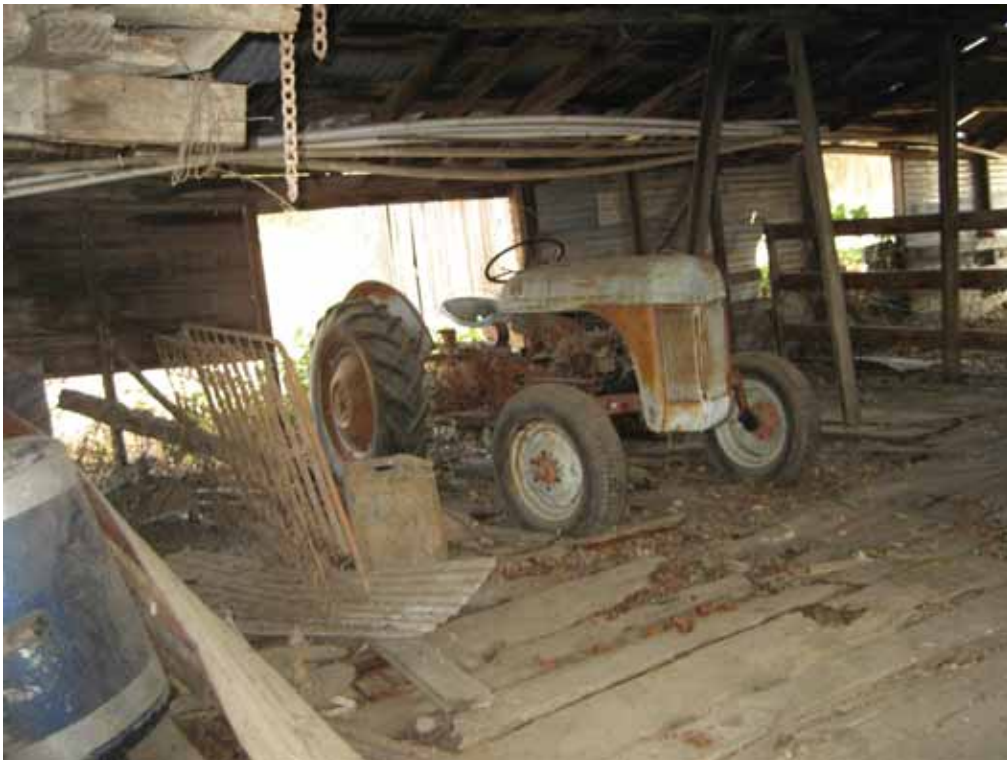
**Photo 18:** Interior view of the western portion of the storage barn located in the southeastern part of the subject site.

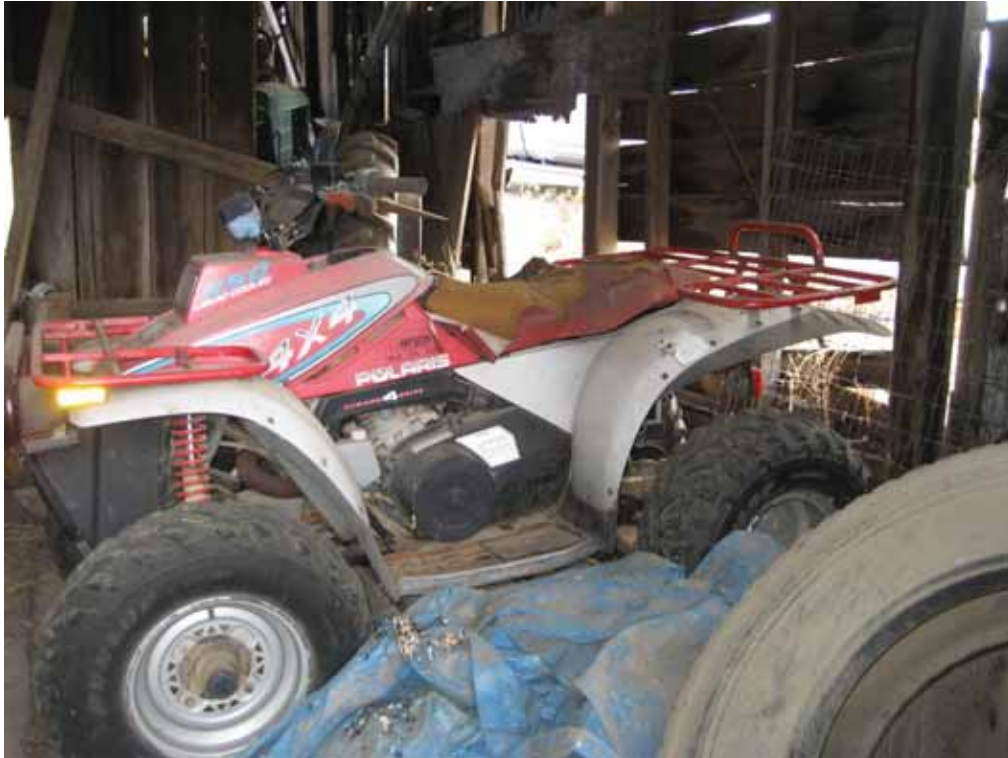
**Photo 19:** Interior view of the southern portion of the storage barn located in the southeastern part of the subject site.

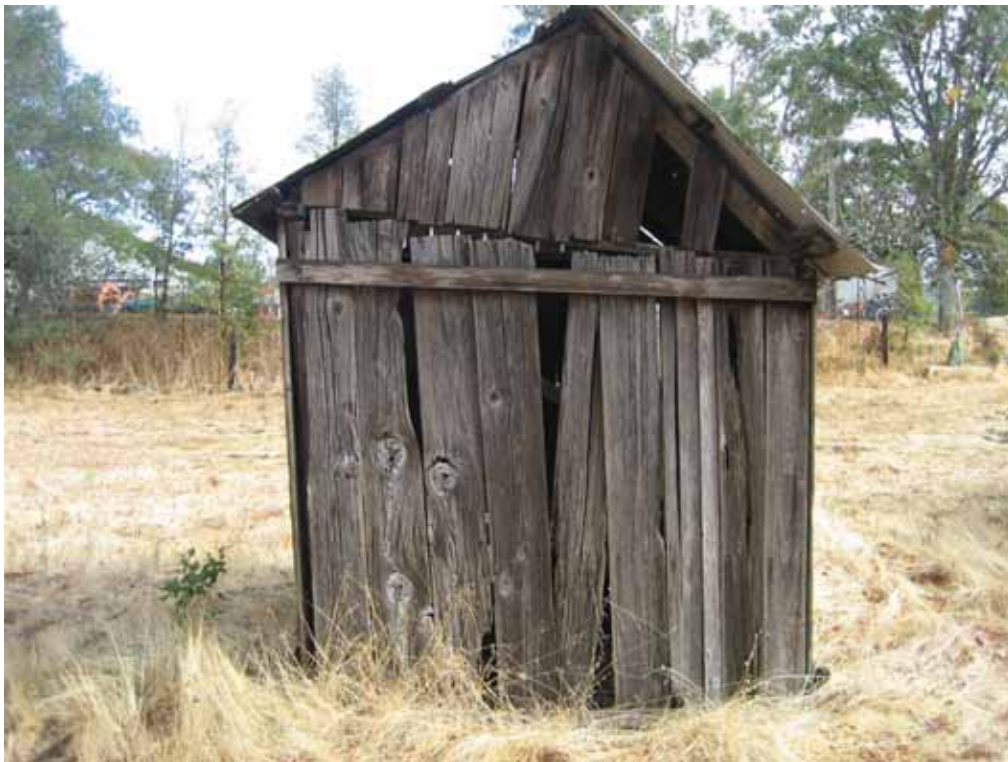
- A dilapidated water well house was observed adjacent to the northwest of the storage barn in the southeastern portion of the subject site (See Photograph No. 20). The well house was locked and inaccessible at the time of the site reconnaissance. Mr. Baumgardner stated that the water well had not been used in many years and, to the best of his knowledge, had always been electrically powered. The water well and associated pressure tank could only be viewed/photographed

**Photo 20:** Northeastern-facing view of the dilapidated well house located in the southeastern portion of the subject site.

During Krazan's site reconnaissance, a water well no longer in use was observed within an inaccessible well house located in the southeastern portion of the subject site adjacent to a storage barn. Mr. Baumgardner stated that the water well had not been used in many years and, to the best of his knowledge, had always been electrically powered. The water well and associated pressure tank could only be viewed through cracks in the structure; therefore, thorough observation relative to the former power source for this well was precluded. However, no storage tanks, surface staining, or other obvious evidence that the well had been powered by diesel fuel was observed. No information regarding analytical testing or construction specifications of the on-site well was found during the course of this assessment. If the on-site water well is not to be used in the planned redevelopment of the subject site, it should be properly destroyed in accordance with State and local guidelines.

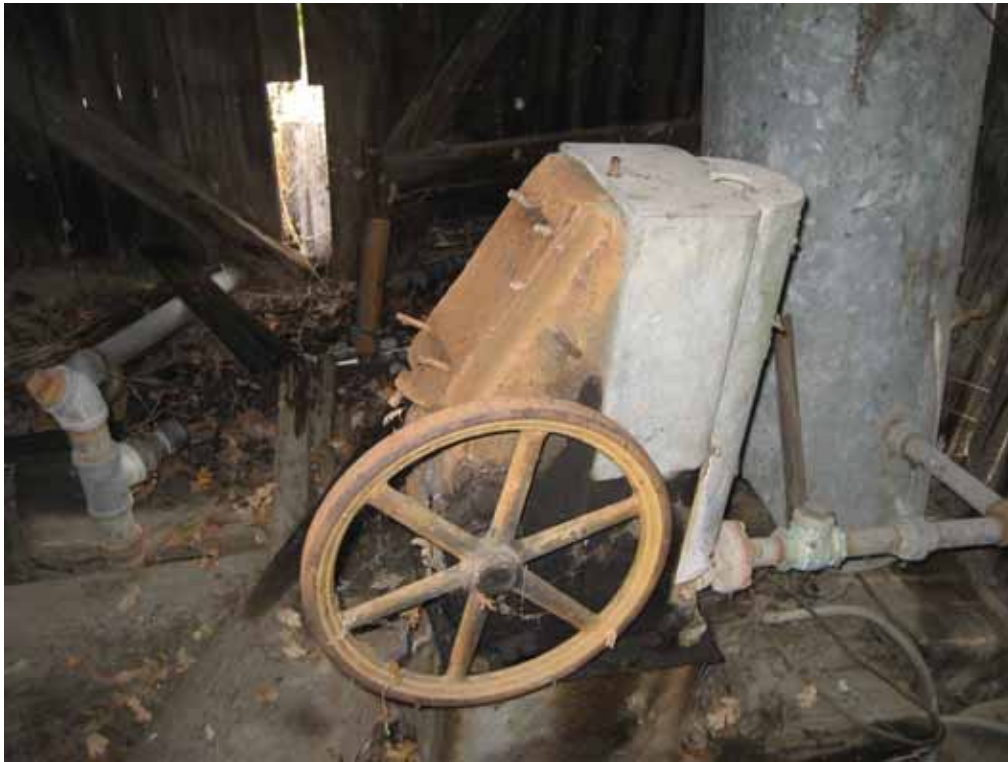
through cracks in the structure; therefore, thorough observation relative to the former power source for this well was precluded. However, no storage tanks, surface staining, or other obvious evidence that the well had been powered by diesel fuel was observed, although lubricant-related staining was present on the wellhead (See Photograph No. 21).

**Photo 21:** Interior view of the non-operational water well and pressure tank located in the dilapidated well house in the southeastern portion of the subject site.

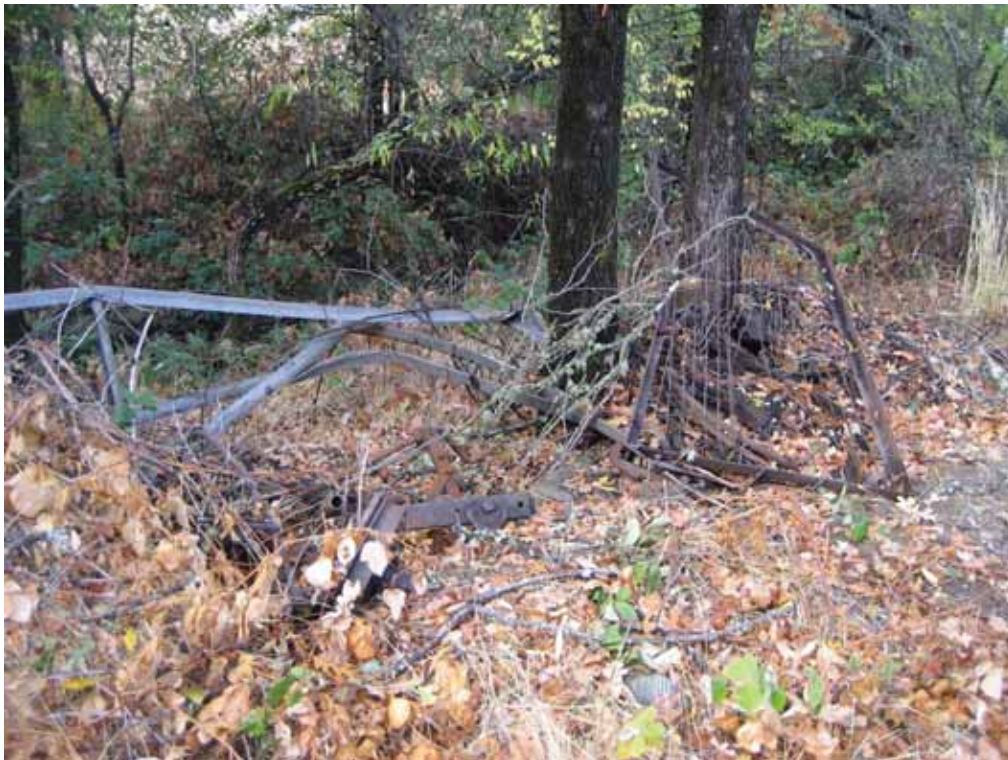
- Wood and metal debris which appeared to be associated with old farm equipment and household goods were observed in the southeastern portion of the subject site adjacent to a drainage channel (See Photograph No. 22). Mr. Baumgardner stated that the area had only been used for limited surface disposal of old farm equipment. Mr. Baumgardner stated that, to the best of his knowledge, no burn pits, subsurface waste disposal, or buried materials are located on the subject site.

**Photo 22:** Western-facing view of the discarded materials resting on the ground surface adjacent to the drainage channel in the southeastern portion of the subject site.

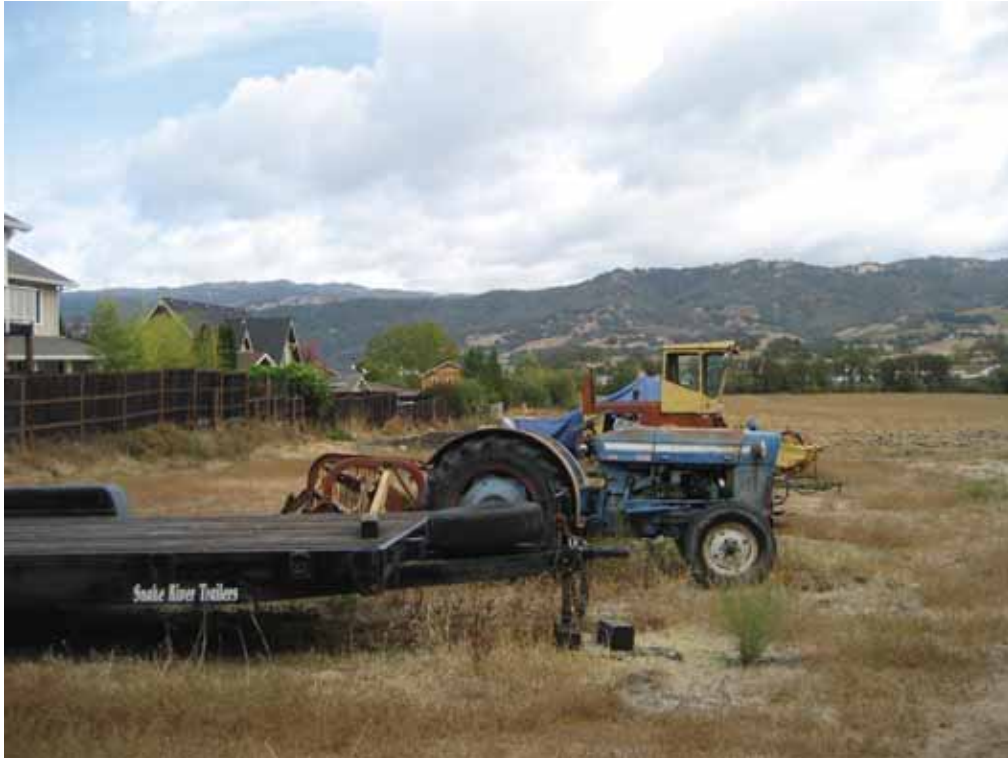
**Photo 23:** Northeastern-facing view of the farm equipment located in the central-northern portion of the subject site.

- Exterior areas were observed in the central and central-northern portions of the subject site in which a boat, functional and apparently non-functional vehicles/tractors/trailers, farm equipment, and/or maintenance materials were stored (See Photographs No. 23 – No. 26). Although the ground surface directly beneath the stored materials could not be inspected directly, no obvious evidence of a significant release of hazardous materials was observed immediately proximate to the stored materials. Relative to the removal of the vehicles/tractors/trailers, farm equipment, and/or maintenance materials, Ms. Daphne Peterson, a real estate agent associated with the pending property transaction present during the site reconnaissance, stated that the property is being sold “as is.” However, when questioned further, Ms. Peterson stated that the purchase/sale agreement states that all hazardous materials will be removed from the subject site prior to completion of the property purchase.

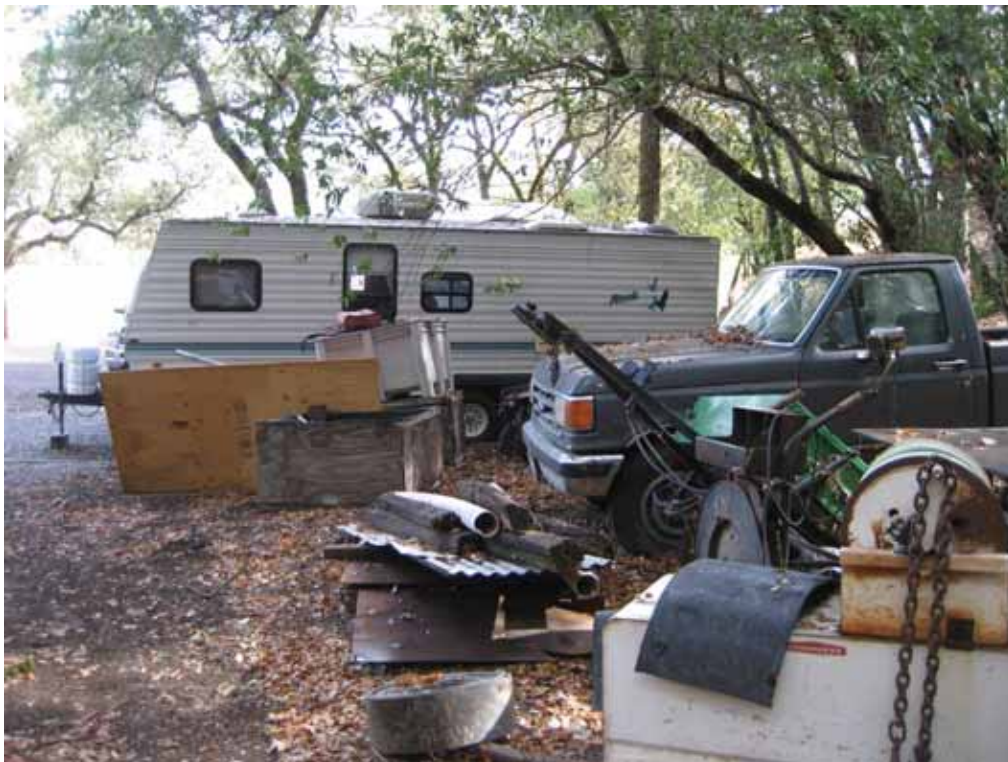
**Photo 24:** Southwestern-facing view of the vehicles and farm equipment/materials located adjacent to the west of the shop canopy in the central portion of the subject site.

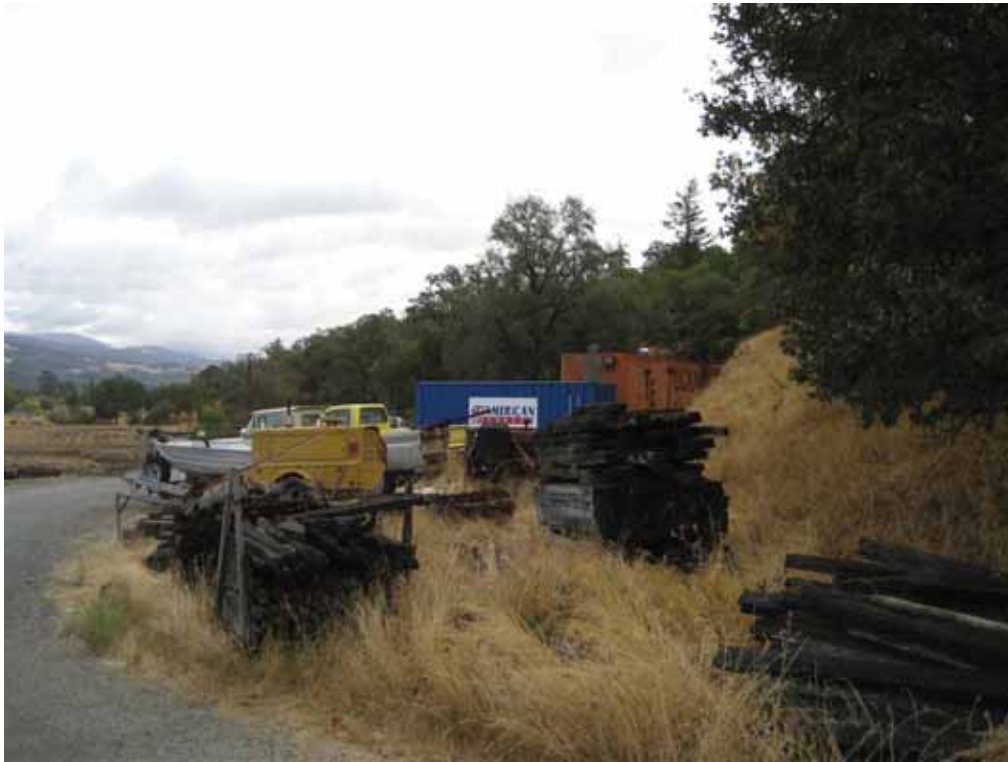
**Photo 25:** Southern-facing view of the fence materials, boat, truck, and farm equipment located in the central-northern portion of the subject site.

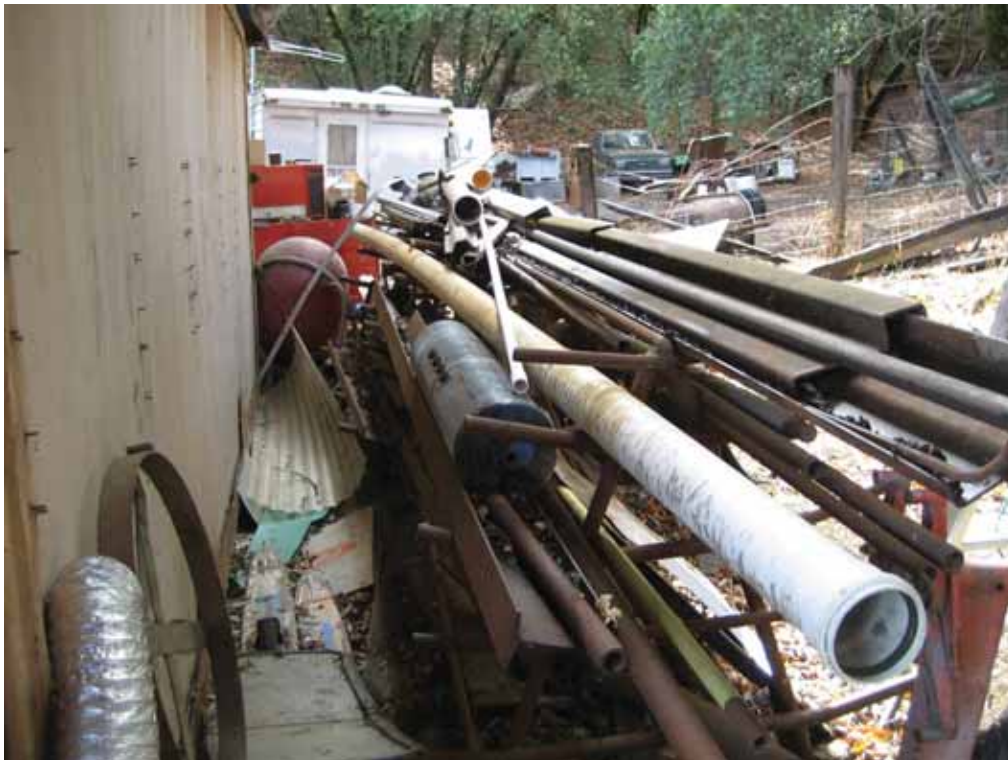
**Photo 26:** Southeastern-facing view of the pipe rack and maintenance materials located adjacent to the west of the shop canopy (central-western portion of the subject site).

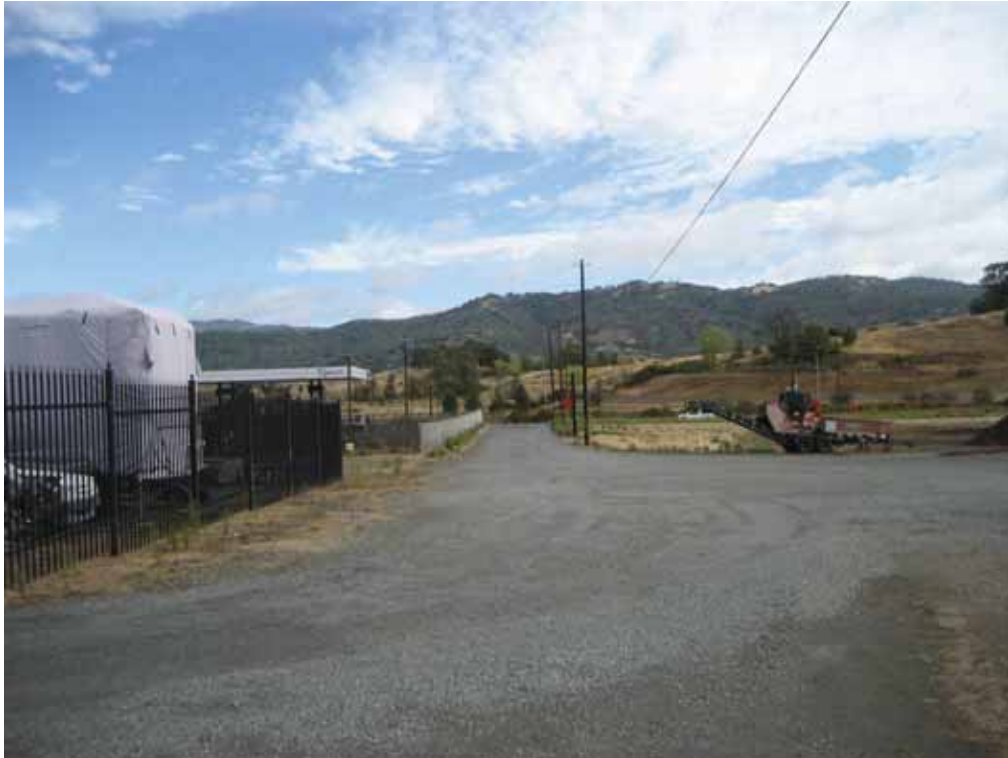
**Photo 27:** Northeastern-facing view of the access road which comprises the far-southeastern portion of the subject site.

- The remainder of the subject site not occupied by the previously referenced structures/features was observed to be occupied by an access road (See Photograph No. 27), a drainage channel (See Photograph No. 28), fallow agricultural land (See Photographs No. 29 and No. 31), unpaved and gravel-paved driveways (See Photograph No. 30), landscaped areas around the dwelling, and undeveloped forested land (See Photograph No. 32). No evidence of hazardous materials storage or hazardous waste was observed within these portions of the subject site except as previously noted.

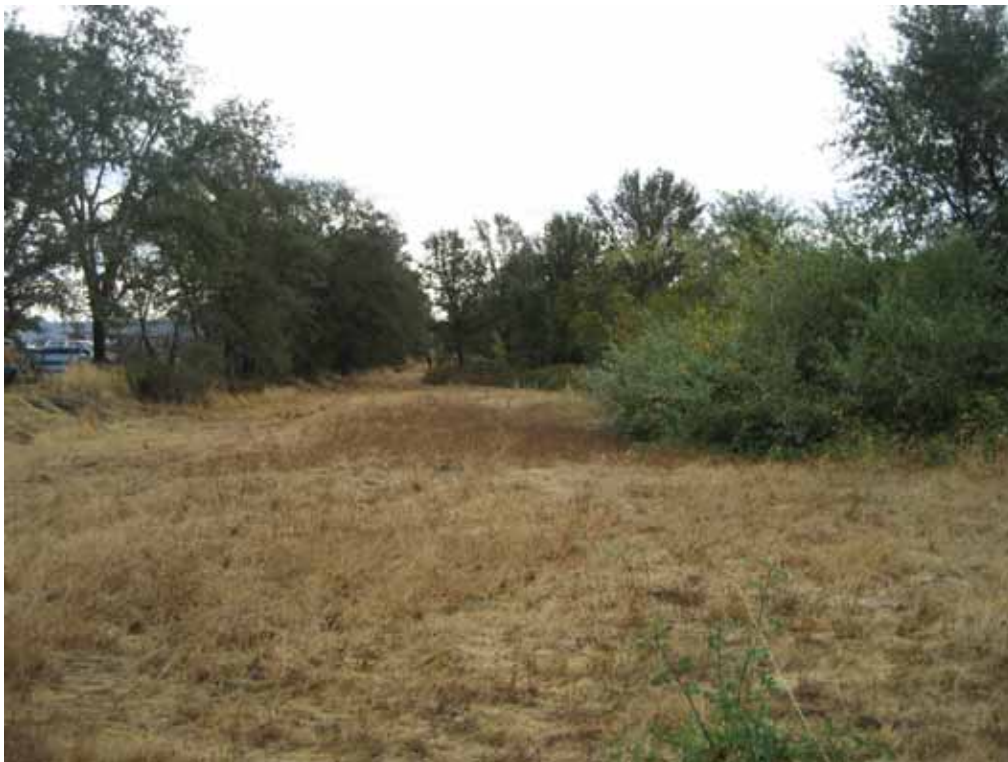
**Photo 28:** Southeastern-facing view of the northeastern portion of the subject site (on-site drainage channel is pictured on right side of photo).

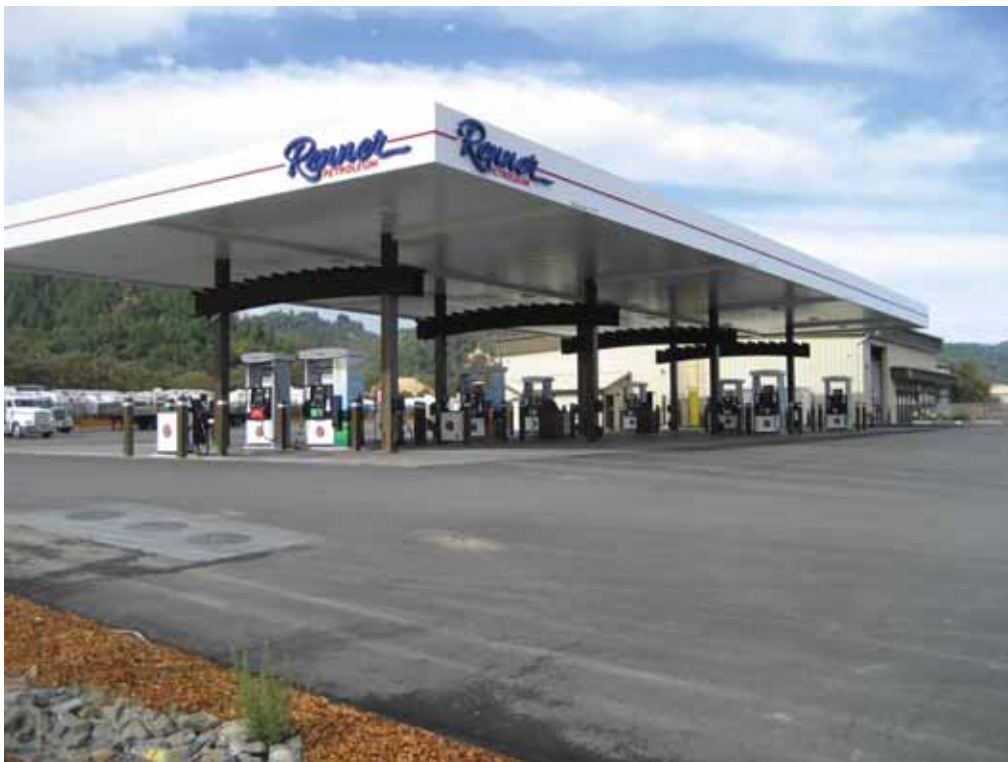
**Photo 38:** Western-facing view of the Renner Petroleum fueling facility located adjacent to the north of the access road comprising the far eastern portion of the subject site.
