Whiskey Slide Road over Jesus Maria Creek Bridge Replacement Project

Natural Environment Study

Whiskey Slide Road over Jesus Maria Creek
Calaveras County, California
Federal Aid Number BRLO 5930(064)

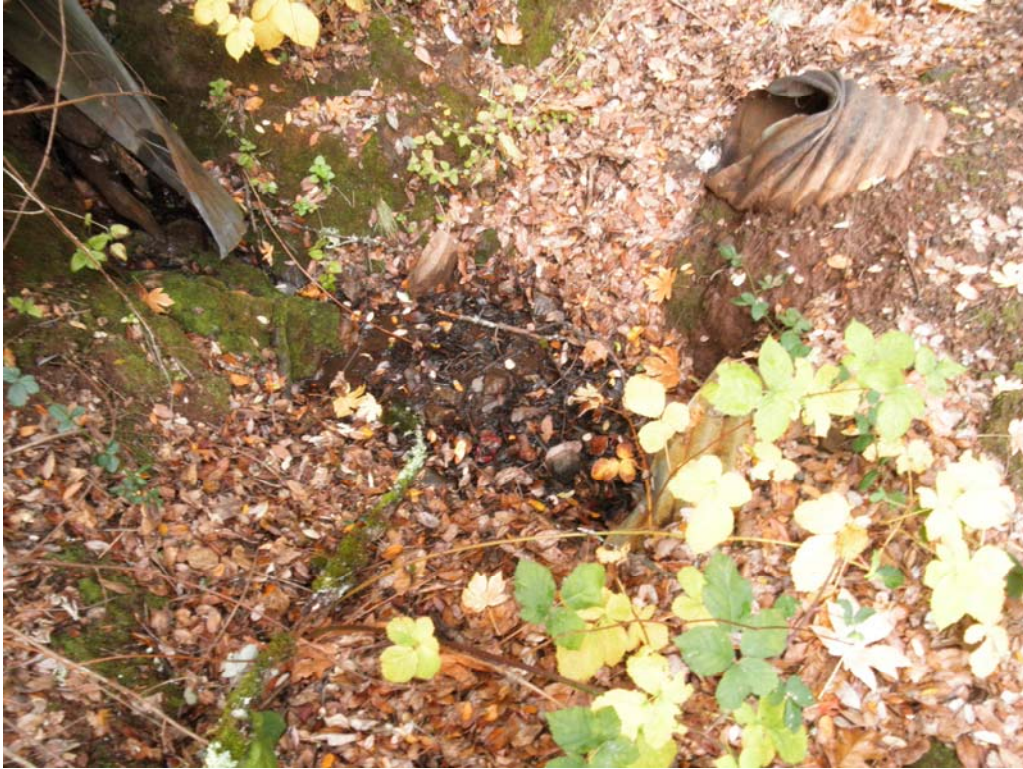
Photo 7. (Site 3) View of pool at culvert inlet from Whiskey Slide Road.

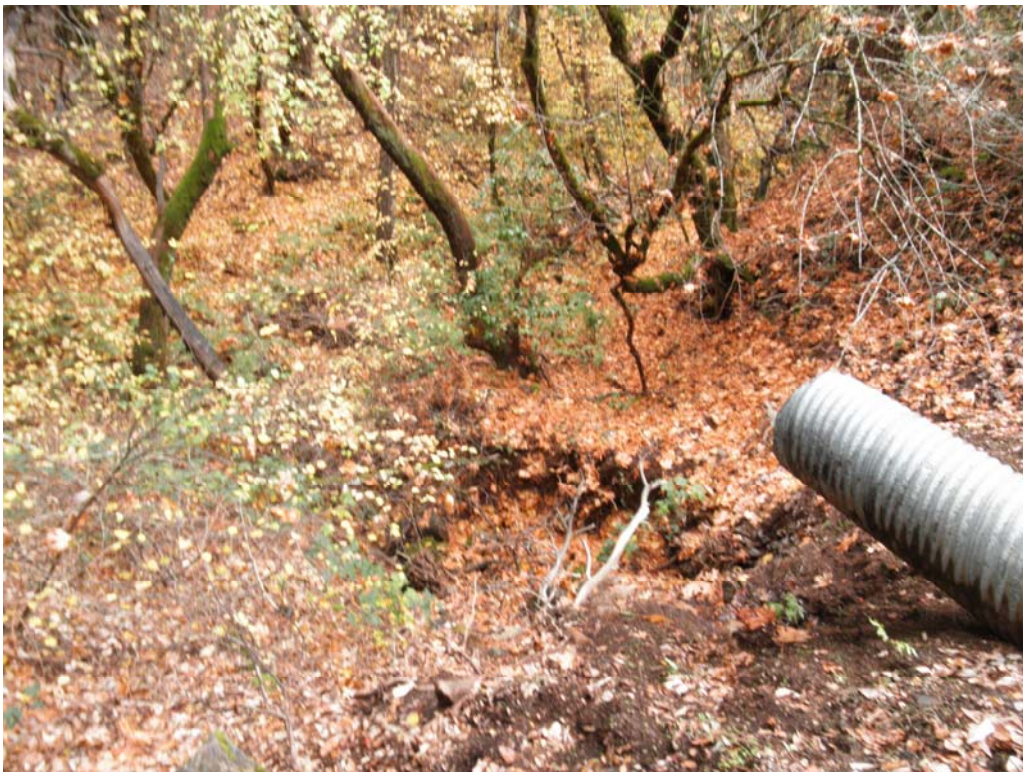
Photo 8. (Site 3) View of culvert outfall from Whiskey Slide Road.

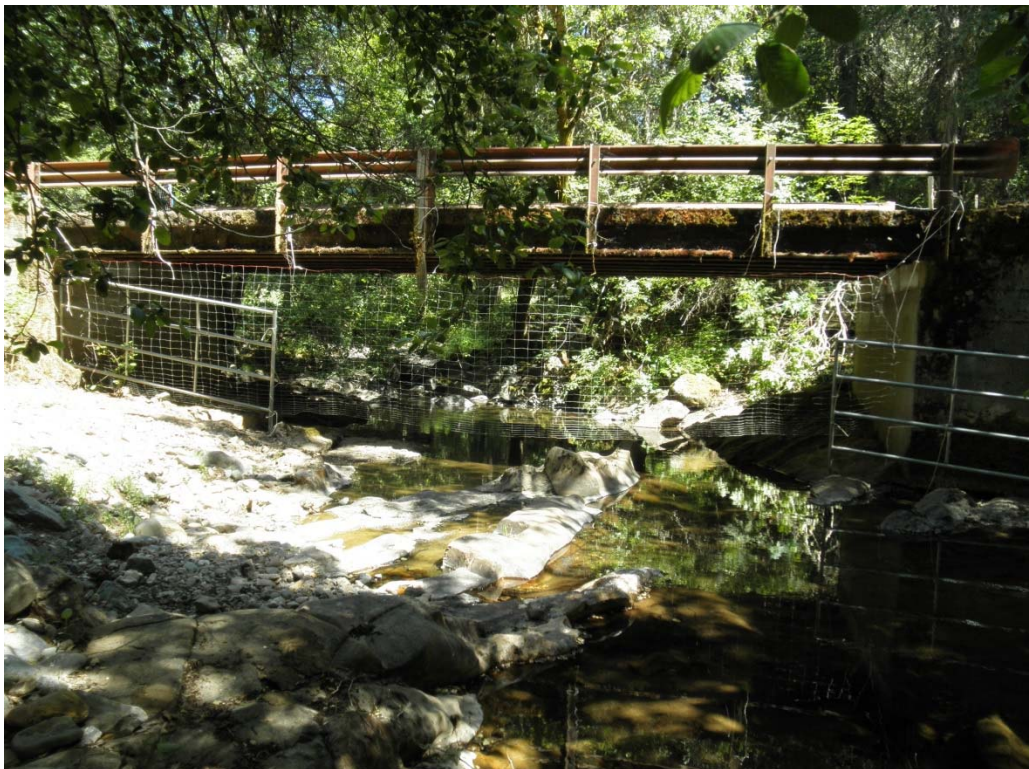
Photo 6a (pre-fire). View of bridge over Jesus Maria Creek, facing east from west of the bridge. Photo date: 5/23/2013

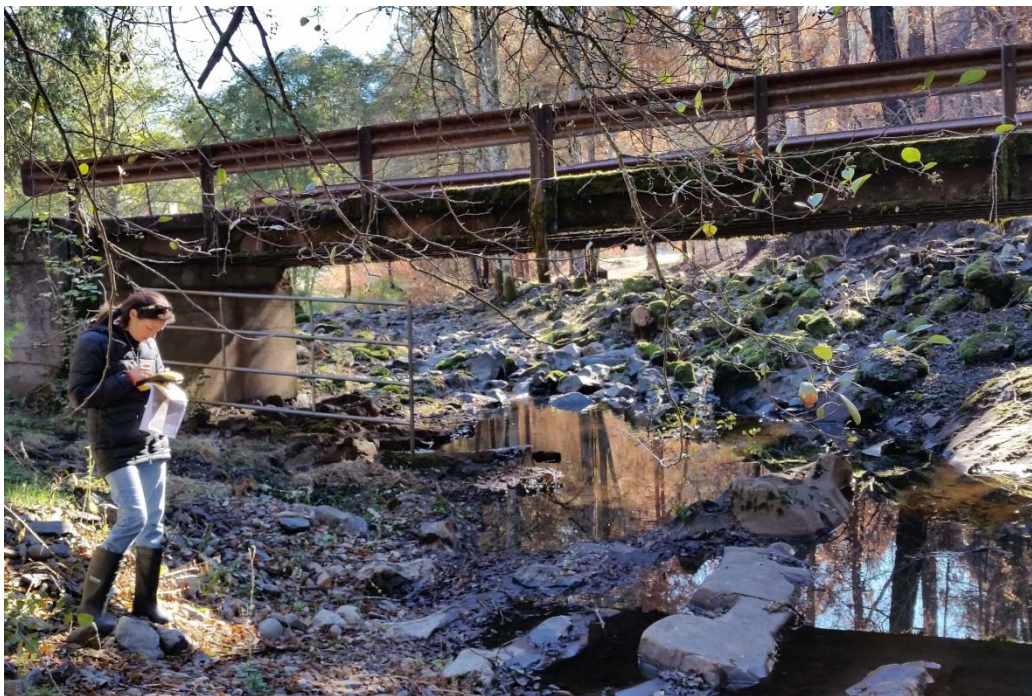
Photo 6b (post-fire). View of bridge over Jesus Maria Creek, facing southeast from west of the bridge. Photo date 11/11/2015

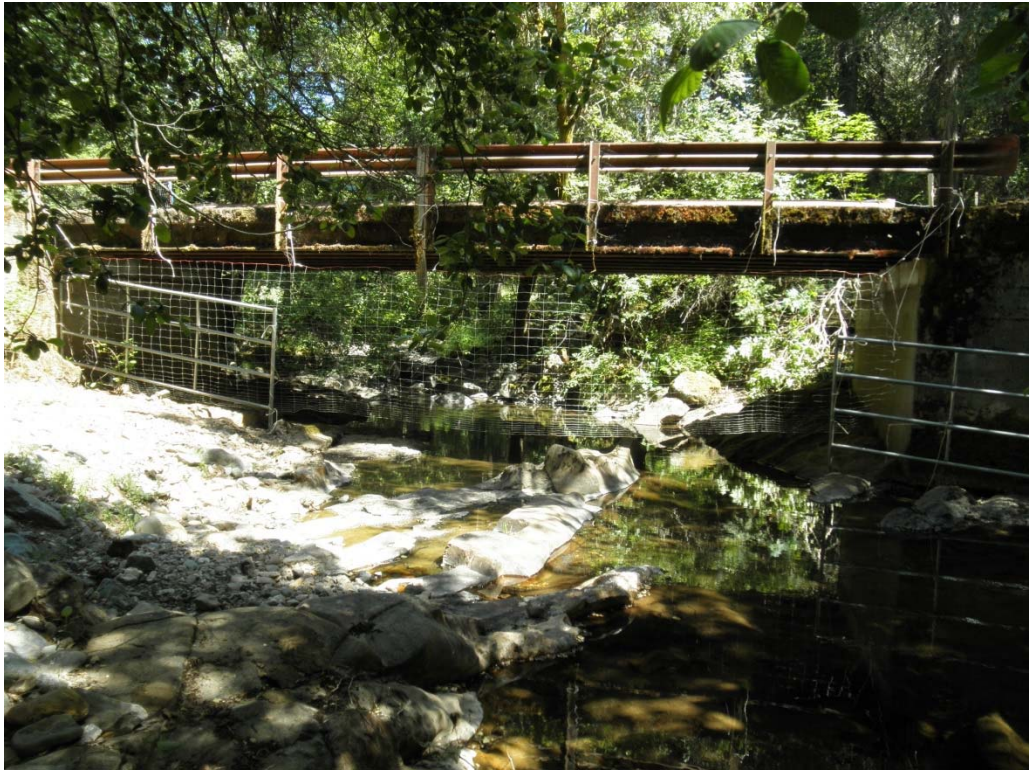
Photo 6 (pre-fire). View of bridge over Jesus Maria Creek, facing east from west of the bridge. Photo date: 5/23/2013

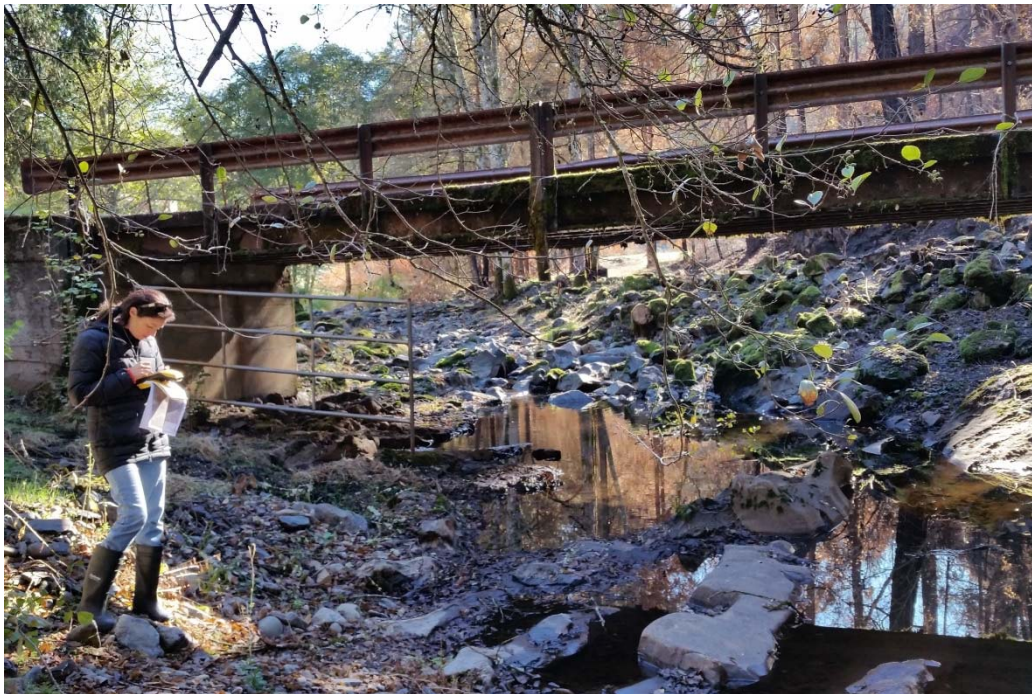
Photo 7a (post-fire). View of bridge over Jesus Maria Creek, facing southeast from west of the bridge. Photo date 11/11/2015

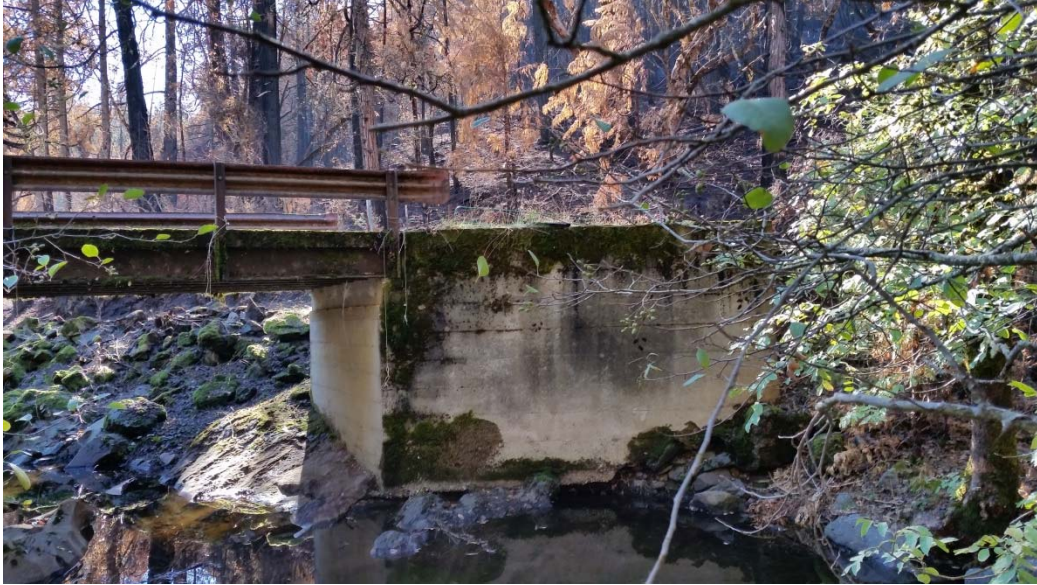
Photo 7b (post-fire). View of bridge over Jesus Maria Creek, facing southeast from west of the bridge. Photo date 11/11/2015

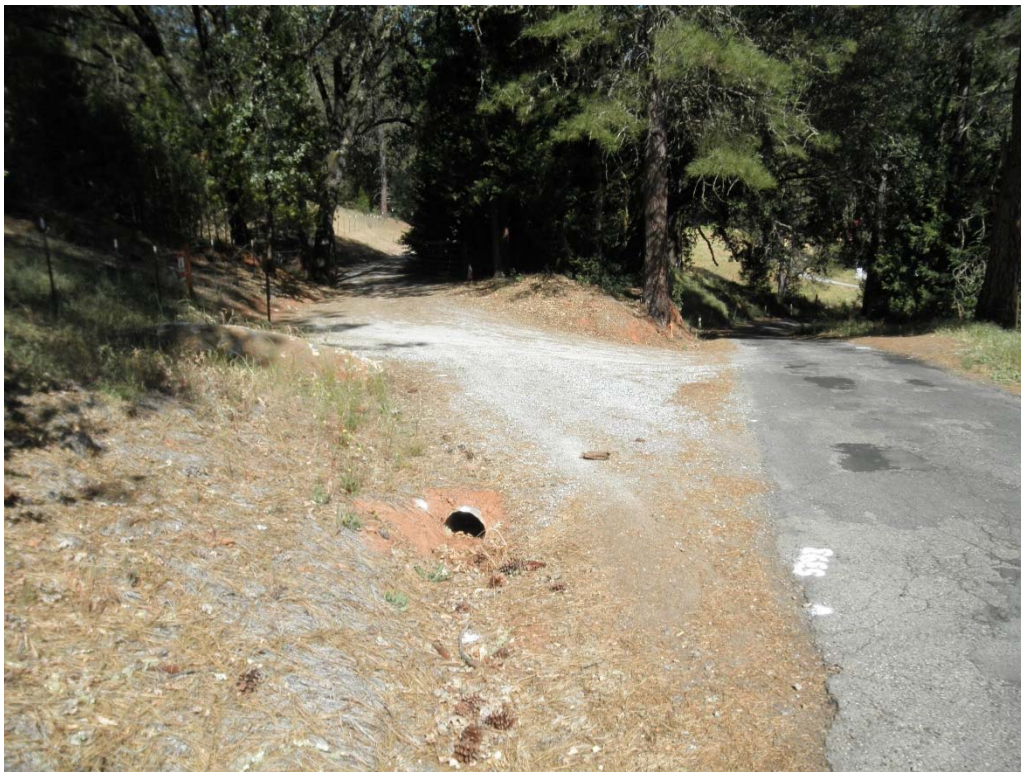
Photo 8 (pre-fire). View of culvert inlet under private drive along ditch north of Whiskey Slide Road. Photo date: 5/23/2013

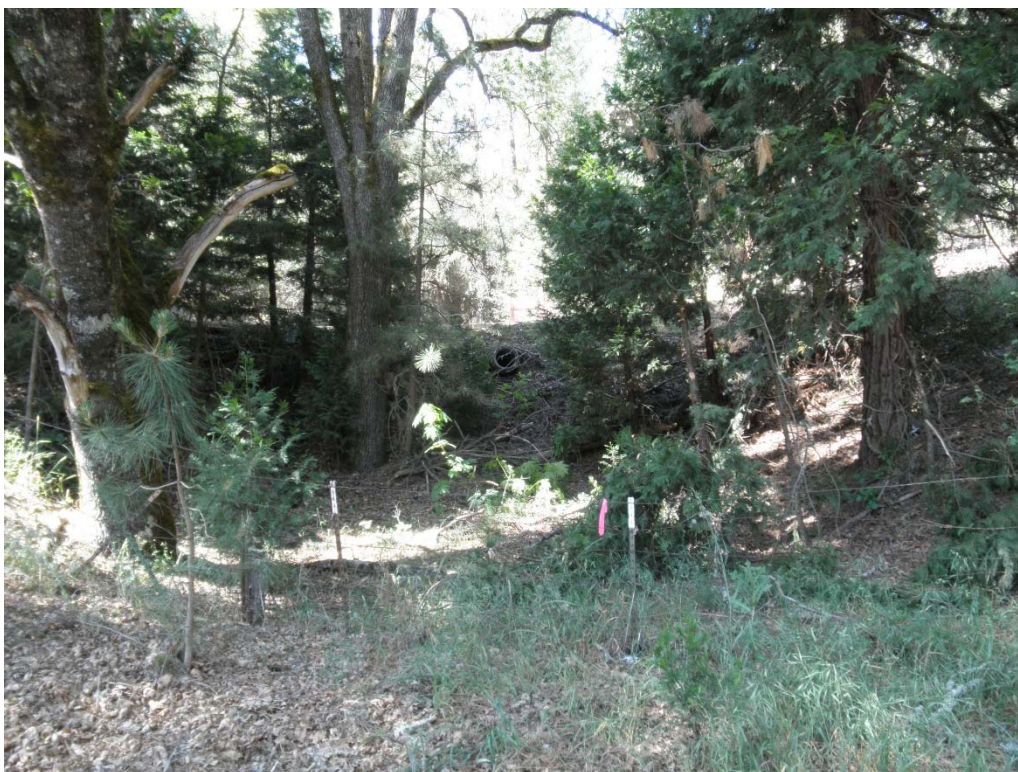
Photo 9a (pre-fire). View of culvert outlet and embankment north of the ditch north of Whiskey Slide Road. Photo date: 5/23/2013

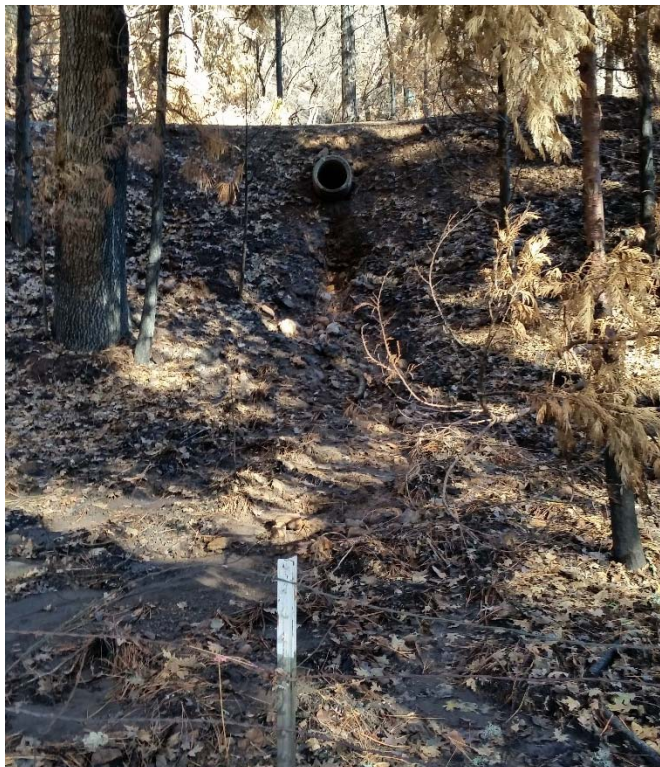
Photo 9b (post-fire). View of culvert outlet and embankment north of the ditch north of Whiskey Slide Road. Photo date: 11/11/2015

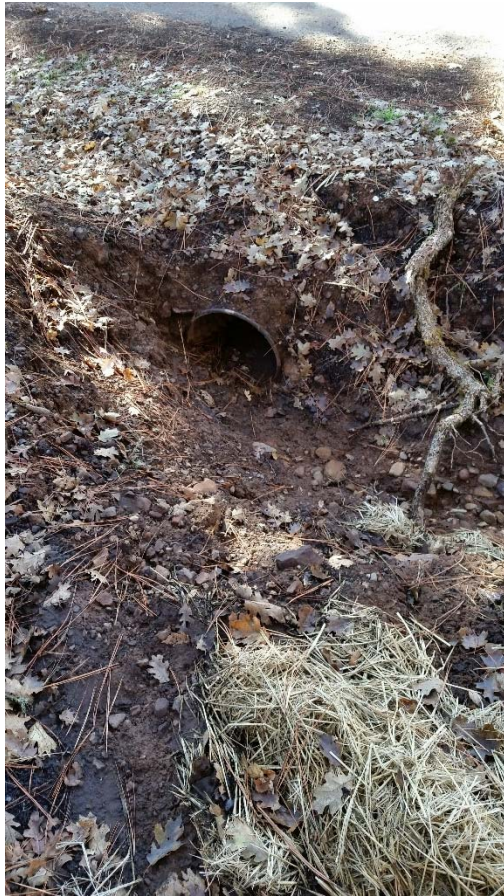
Photo 10 (post-fire). View of culvert outlet south of Whiskey Slide Road, near where the road turns southward. Photo date: 11/11/2015

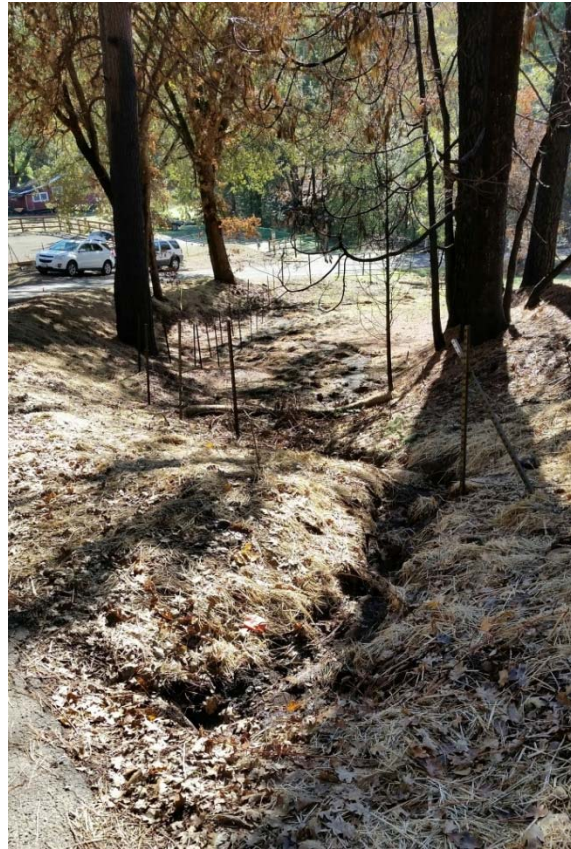
Photo 11 (post-fire). View of erosional feature south and west of Whiskey Slide Road from culvert outlet at Whiskey Slide Road. Photo date: 11/11/2015

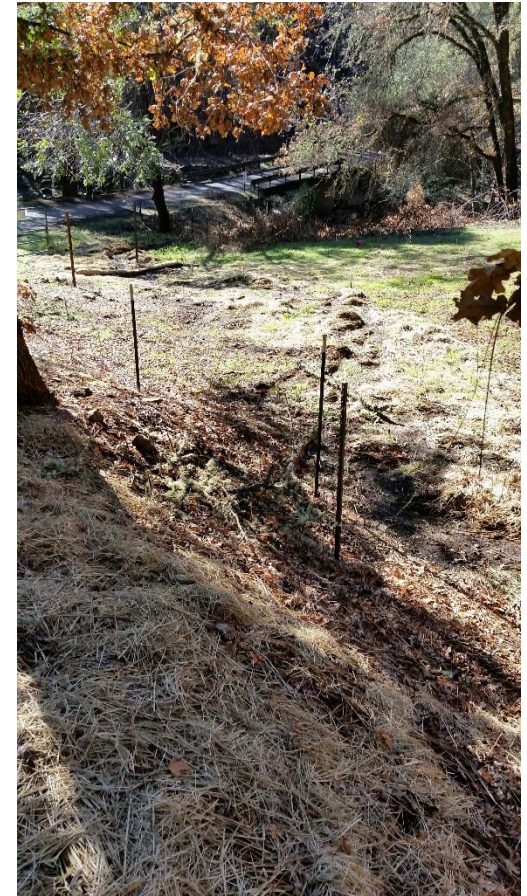
Photo 12 (post-fire). View of erosional feature south and west of Whiskey Slide Road from approximately halfway between culvert outlet and Jesus Maria Creek. Photo date: 11/11/2015
