Re: **EXECUTIVE SUMMARY** - Phase I Environmental Site Assessment

1330 West Pico Boulevard

Centec Project #0617040

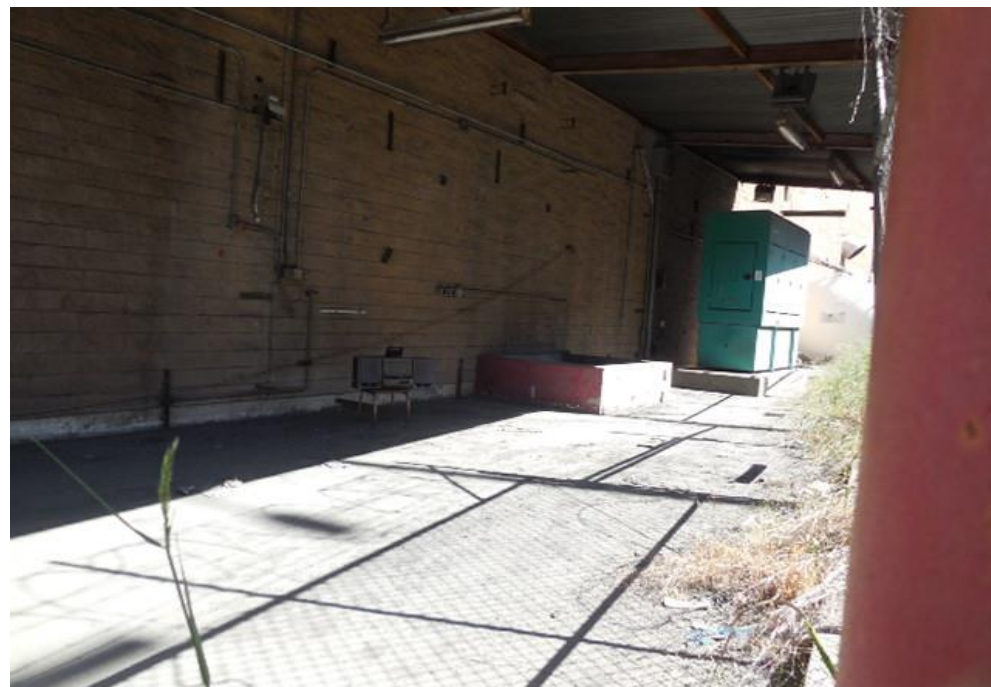
Looking north toward the "pit" and emergency generator under the parking ramp along the east side of the building.

clarifiers inside the building which appear to still contain water (and one has mosquitoes). There is an above-ground diesel tank and generator, as well as a "pit" that had contained wastes. It is recommended that the two clarifiers and the pit be removed and/or filled in, and the aboveground tank and unused diesel generator be removed from the subject property. A history of the subject property was ascertained through historical aerial photographs, historical USGS Maps, records at the City of Los Angeles Building and Fire Departments, and a previous report written about the subject property by LFR Levine-Fricke (LFR) in 2002. Sanborn Fire Insurance Maps were sought for the property, and a set of maps were included in LFR's report. LFR's research indicated the property was used for residential purposes, with "a few stores," from at least 1894 until the early 1960s, and was improved with the current 150,000 square-foot brick building in the late 1960s. A banknote production business occupied the two-story building from construction until the 1990s, and records and observations indicated "printing presses, inks, dyes and paper pressing operations were used," and the company "manufactured their own printing plates on site." Two clarifiers had been installed inside the building, a sump and floor drain system was in use, a pit for holding inks and dyes and an emergency generator were located outside the east wall of the building. The LFR report was written in 2002 because LAUSD was going to lease the building to use to train school police. LAUSD moved out of the building in 2015.

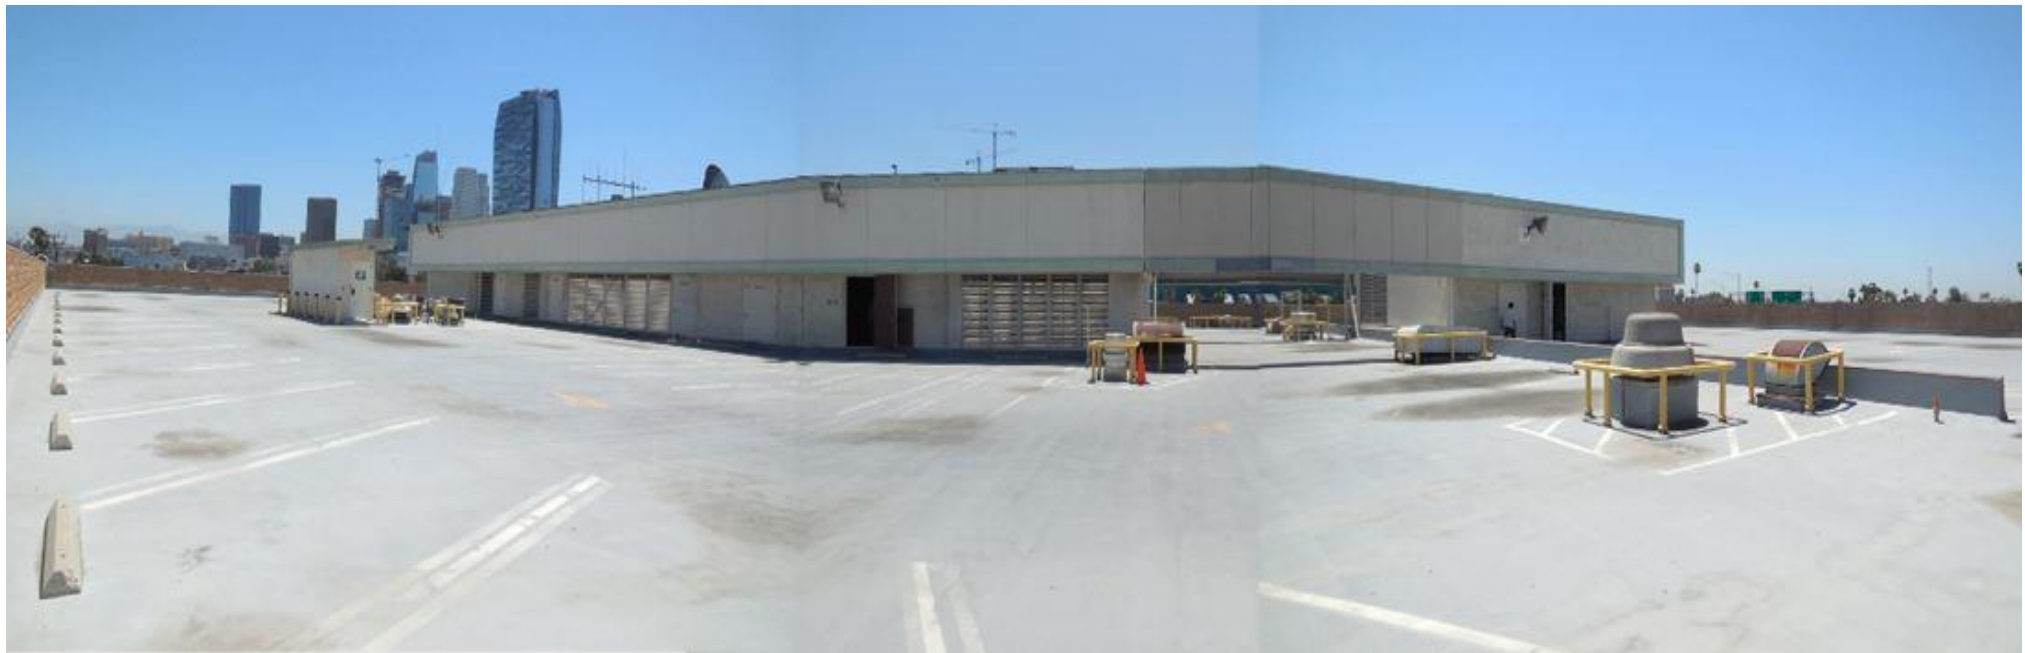
Looking north (at left) to east from the west side of the upper roof section. Mechanical systems are within the long structure.

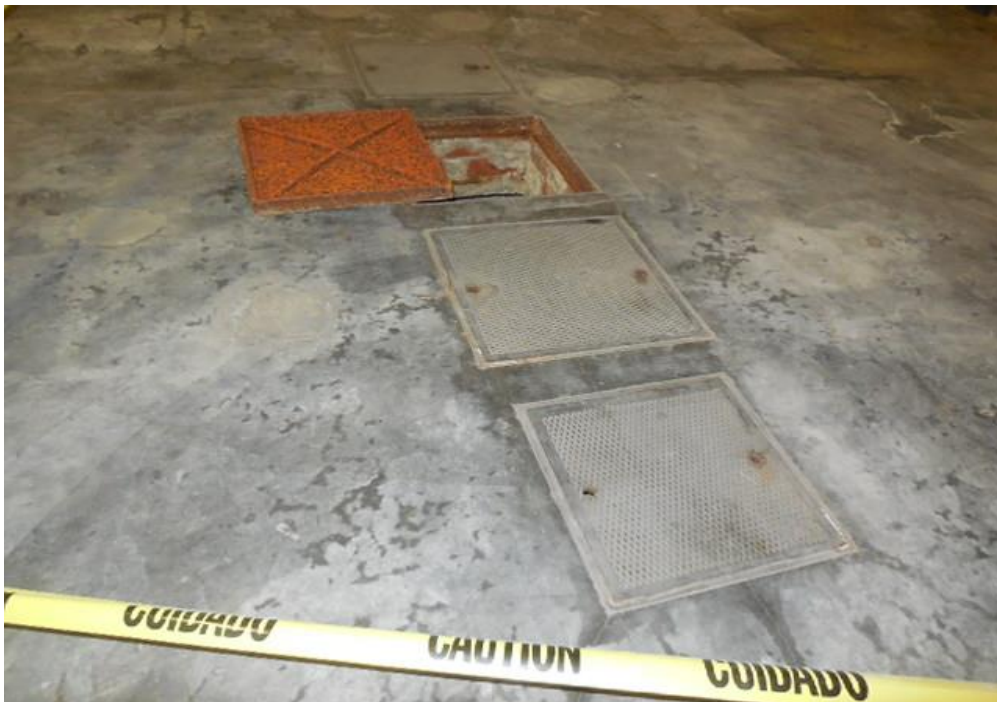
View of the clarifier in the northwest quadrant of the building.

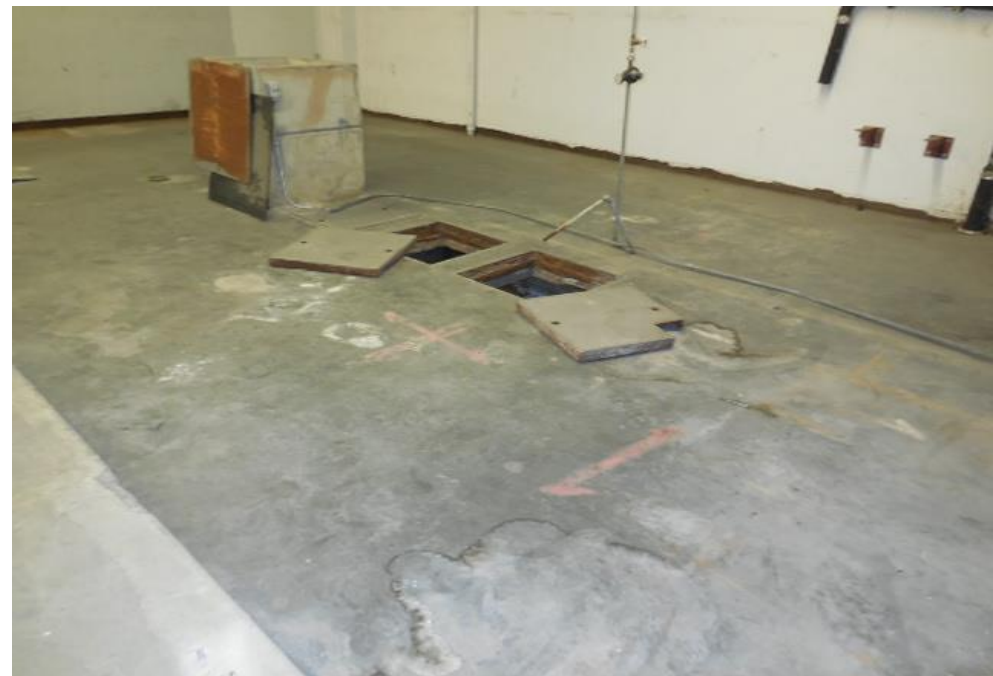
View of the clarifier in the large east room of the building.

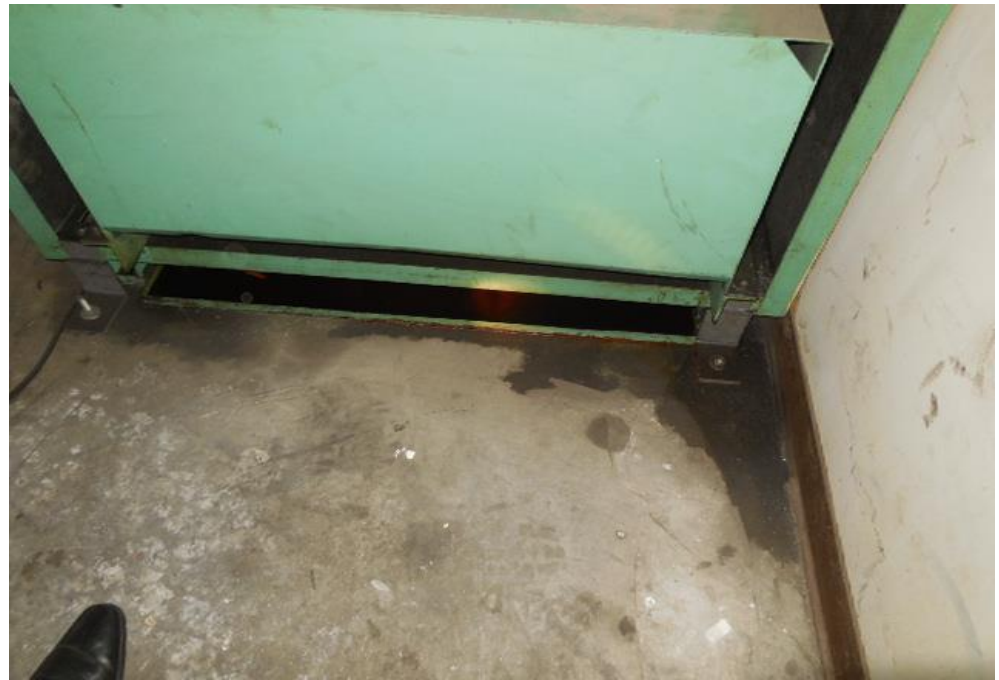
View of minor oil staining below the control equipment for the freight elevator.
