APPENDIX 4b

Re: Addendum to Historic Property Identification and Evaluation Report
Weldon Regional Water System Improvement Project
Weldon Area, Kern County, California
CRM TECH Project No. 3238B

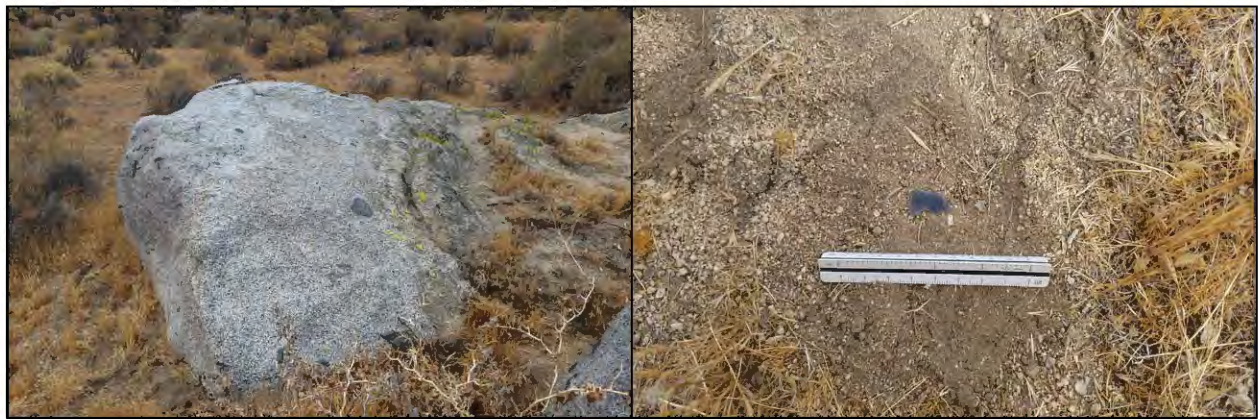
Figure 3. Prehistoric cultural remains at Locus 3 of Site 15-019606. *Left*: bedrock milling feature (Feature 42); *right*: obsidian flake. (Photographs taken on November 20, 2018)

As a result of this study, additional bedrock milling features and surface artifacts were observed within the portion of the APE associated with Alternative 1, across the lower reach of the proposed access route (Figure 2). These newly recorded features and artifacts, located across some 50 meters of disturbed land to the southwest of the previously established perimeter of 15-019606 (see Appendix), was subsequently designed Locus 3 of the site. Among them are 22 granitic bedrock boulders with a total of 42 grinding slicks and 7 visible mortars, 14 obsidian flakes, and 1 possible groundstone fragment (Figure 3; see Appendix for further details).

Measuring approximately 133x80 meters, Locus 3 is the largest among the three known loci, and there are indications of possible subsurface cultural deposits around some of the bedrock milling features, such as midden soil. Altogether, Site 15-019606 now contains 52 bedrock milling features with 90 slicks and 46 mortars, along with 15 obsidian flakes, 1 obsidian point fragment, 1 shell fragment, and 1 possible groundstone fragment.

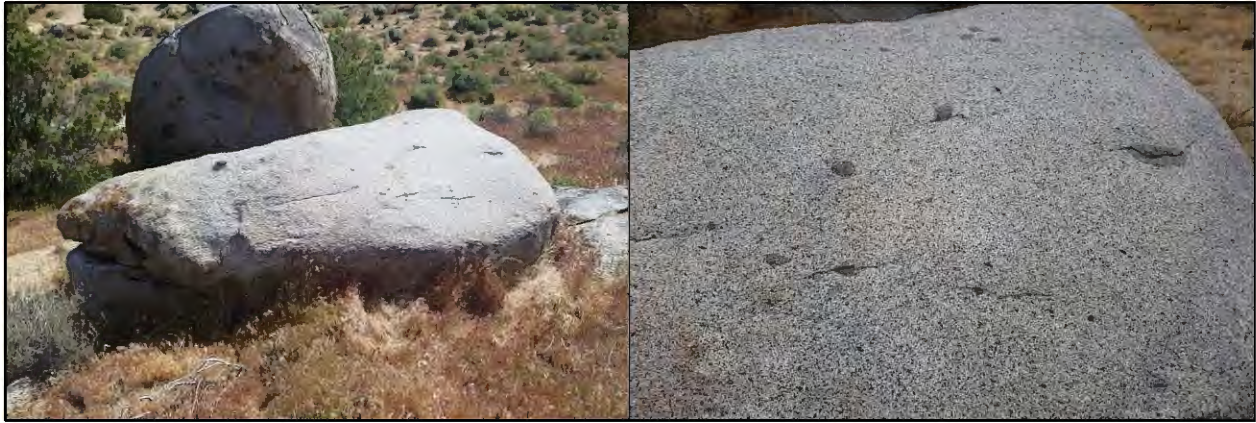
Figure 4. Site 15-019893. *Left*: bedrock milling feature (Feature 1); *right*: grinding slick. (Photographs taken on April 15, 2019)

Sites 15-019892, 15-019893, and 15-019894, represent three previously unrecorded bedrock milling features identified during this study. The boulder at 15-019893 exhibits three grinding slicks (Figure 4), while the boulders at 15-019892 and 15-019894 each contain a single slick (see Appendix for further details). These isolated milling features were found at or near the top of the hill, at higher elevations than the clusters of milling features recorded at 15-019606. Among them, 15-019893 lies

within the APE for Alternative 2, while 15-019892 and 15-019894 are located between the two alternatives (Figure 2). No surface artifacts were observed around the milling features at these sites.

Site 15-019893 consists of a granitic boulder with three grinding slicks. Unlike the large, concentrated groups of milling features with deep mortars at Site 15-019606, isolated bedrock milling features with only lightly used slicks are generally indicative of temporary, opportunistic resource processing activities and may result from as few as one single use. They do not represent areas of long-term habitation or repeated visits by the native population, and subsurface excavations at similar sites in the past typically did not encounter a substantial subsurface component. As such, Site 15-019893 does not hold the promise for any new or important archaeological data and does not appear to qualify as a “historic property,” “historical resource,” or “tribal cultural resource.”

- If possible, the bedrock milling feature at Site 15-019893 should be moved to a location outside the construction footprint for the access road for preservation.

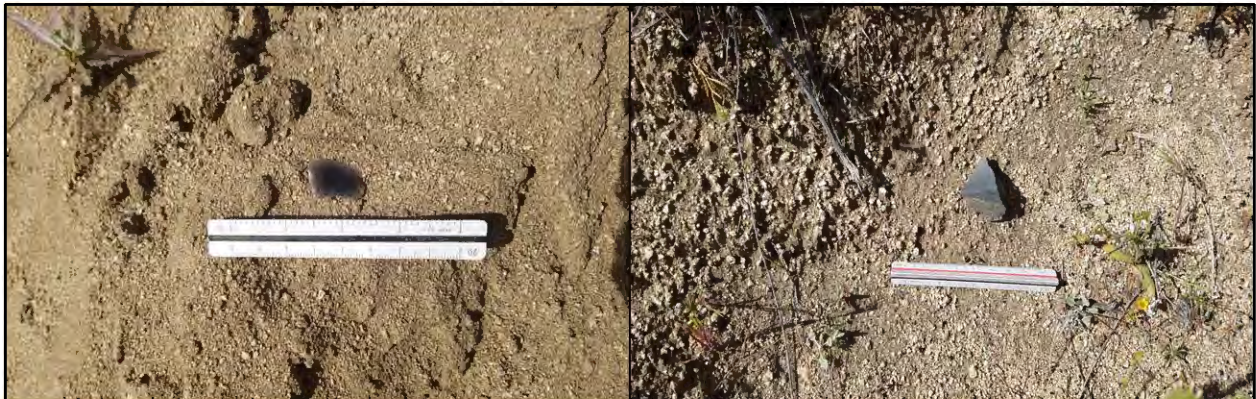
Figure 5. Prehistoric isolates found within Alternative 2. *Left*: 15-020013; *right*: 15-020014. (Photographs taken on April 15, 2019)

The two prehistoric isolates are both located in the portion of the APE for Alternative 2, along the proposed access route (Figure 2). 15-020013 represents a secondary obsidian flake, and 15-020014 is a gray metavolcanic core fragment (Figure 5; see Appendix for further details).

One of the newly recorded bedrock milling feature sites, 15-019893, and both of the isolates are located within the portion of the APE associated with the access route for Alternative 2 and will be impacted by the undertaking as currently proposed. None of these localities, however, appears to meet the definition of a “historic property,” “historical resource,” or “tribal cultural resource.” The isolates, by definition, do not qualify as archaeological sites due to the lack of contextual integrity. Therefore, they do not constitute potential “historic properties,” “historical resources,” or “tribal cultural resources,” and require no further study.

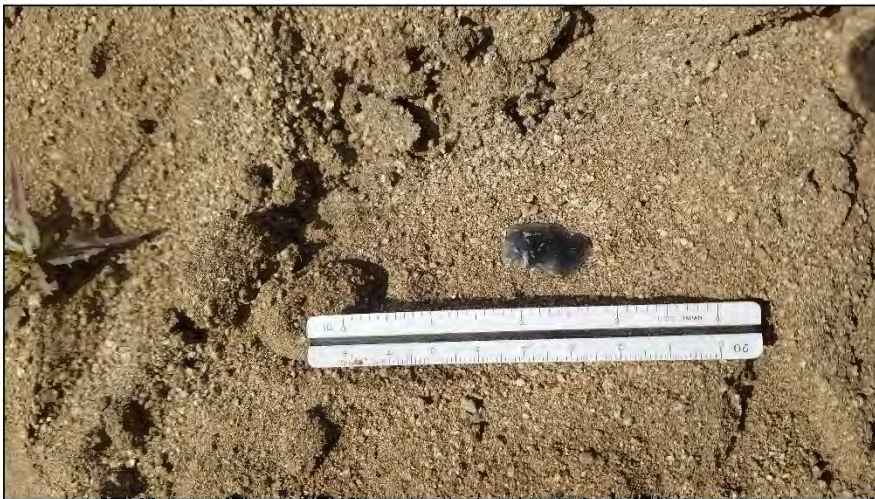
P5b. Description of Photo (view, date, accession #): April 15, 2019

*P3a. Description: (Describe resource and its major elements. Include design, materials, condition, alterations, size, setting, and boundaries) This prehistoric isolate consists of a secondary obsidian flake measuring approximately 2.5x1.6x0.2 cm in size.

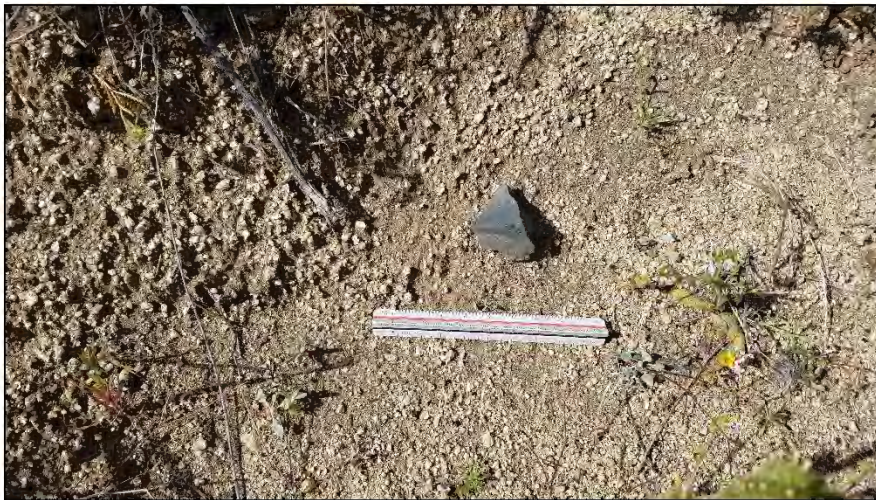
P5b. Description of Photo (view, date, accession #): April 15, 2019

*P3a. Description: (Describe resource and its major elements. Include design, materials, condition, alterations, size, setting, and boundaries) This prehistoric isolate consists of a gray metavolcanics core fragment measuring approximately 3.8x3.5x2.7 cm in size.
