**APPENDIX 4a**

**IDENTIFICATION AND EVALUATION OF HISTORIC PROPERTIES**  
**WELDON REGIONAL WATER SYSTEM IMPROVEMENT PROJECT**

**Weldon Area**  
**Kern County, California**

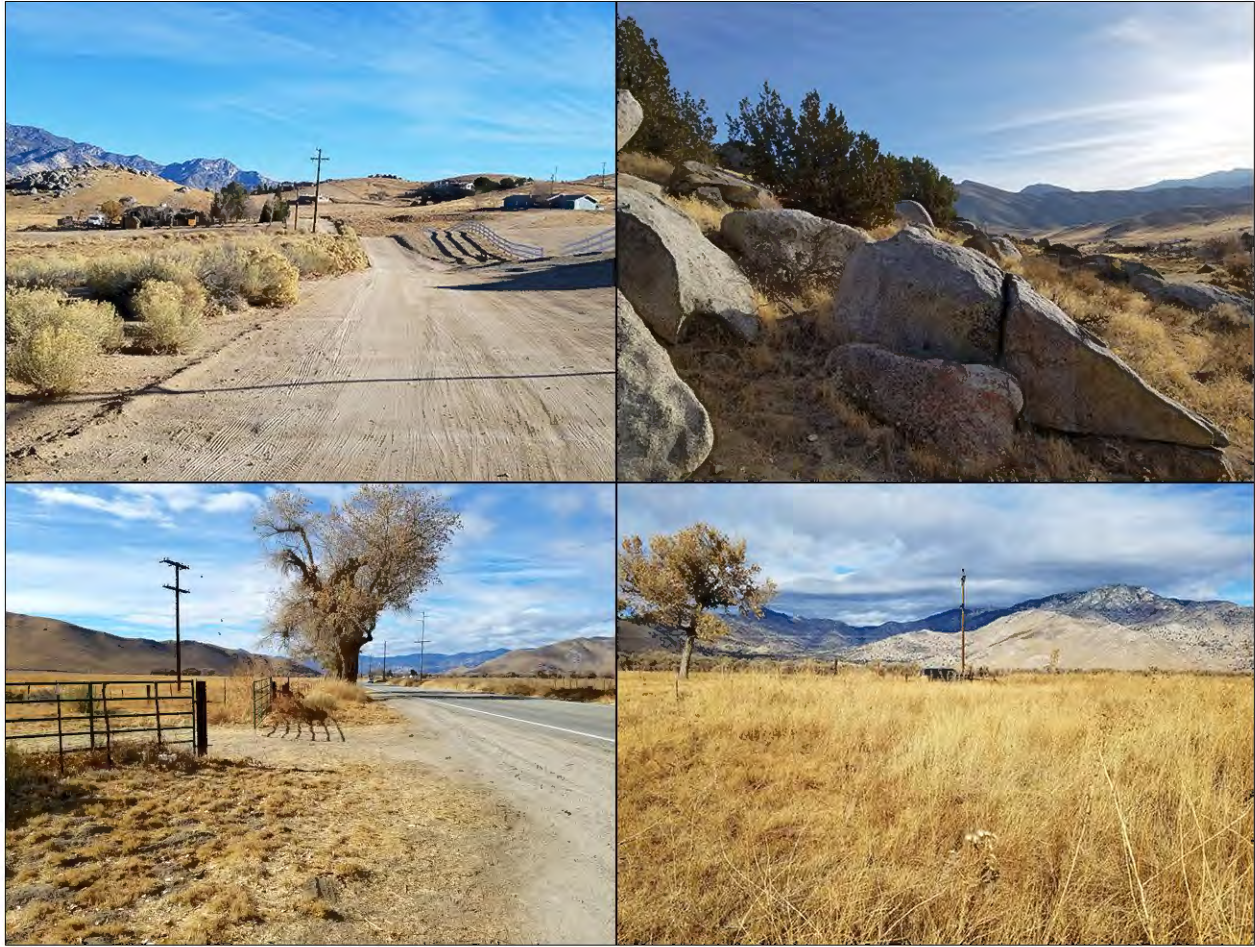
The proposed pipeline alignment is confined with the existing rights-of-way of various paved and unpaved roads, where the surface soils have been extensively disturbed in the past. Two of the three alternative sites for the office compound are located on residential streets in the community of Bella Vista, where the ground surface has been disturbed and, in fact, partially leveled. The other alternative site for the office compound, the two well sites, and the three alternatives for the Bella Vista Tank Site have evidently been disked in the past but retain more of the natural landscape and appear to be used for livestock grazing. Among the different portions of the APE, the Kelso Valley Tank Site, situated on the tip of a rugged hill that is covered with granitic bedrock outcrops, has clearly undergone the least ground disturbance in the past (Fig. 4).

Figure 4. Typical landscapes in and near the APE. *Clockwise from top left*: pipeline alignment along Maverick Avenue, view to the northeast from the intersection of Bella Vista Drive; Kelso Valley Tank Site, view to the south; Well Site No. 2, view to the north; pipeline route along the south side of SR 178, view to the west. (Photographs taken January 4-5, 2018)

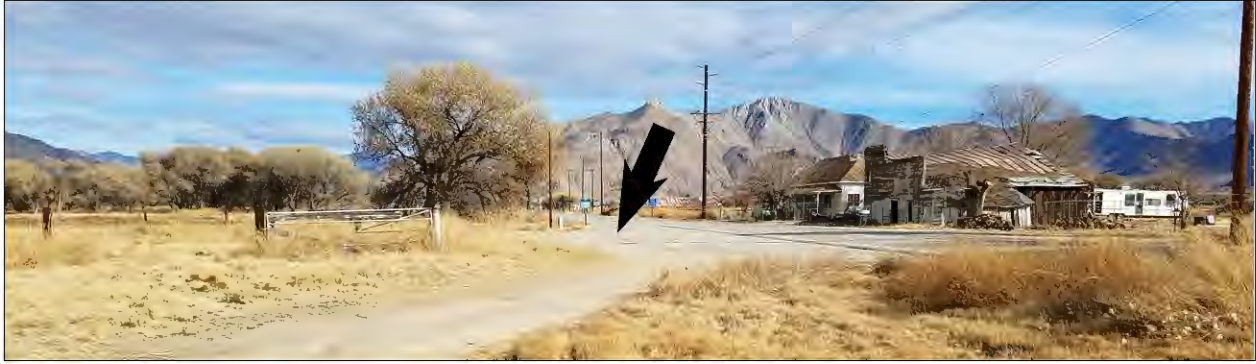
As recorded in 2006, Site 15-015989 consists primarily of eight buildings in the Andrew Brown Ranch complex, which range in age from the 1880s to the 1960s (see App. 4). These buildings include two residences, a former store, a slaughterhouse, a garage, a barn, a shop building, and a saddle shed, located on either side of SR 178 to the east of the intersection of Kelso Valley Road. The proposed pipeline alignment traverses across the area of Site 15-015989 within the northern shoulder of SR 178, and none of the buildings recorded as components of the site is situated within or immediately adjacent to the APE, nor is any other features or artifact deposits associated with the ranch complex (Fig. 6; see App. 3).

Figure 6. Nearest historic-period buildings at Site 15-015989 to the APE (indicated by arrow), view to the east. (Photograph taken on January 4, 2018)

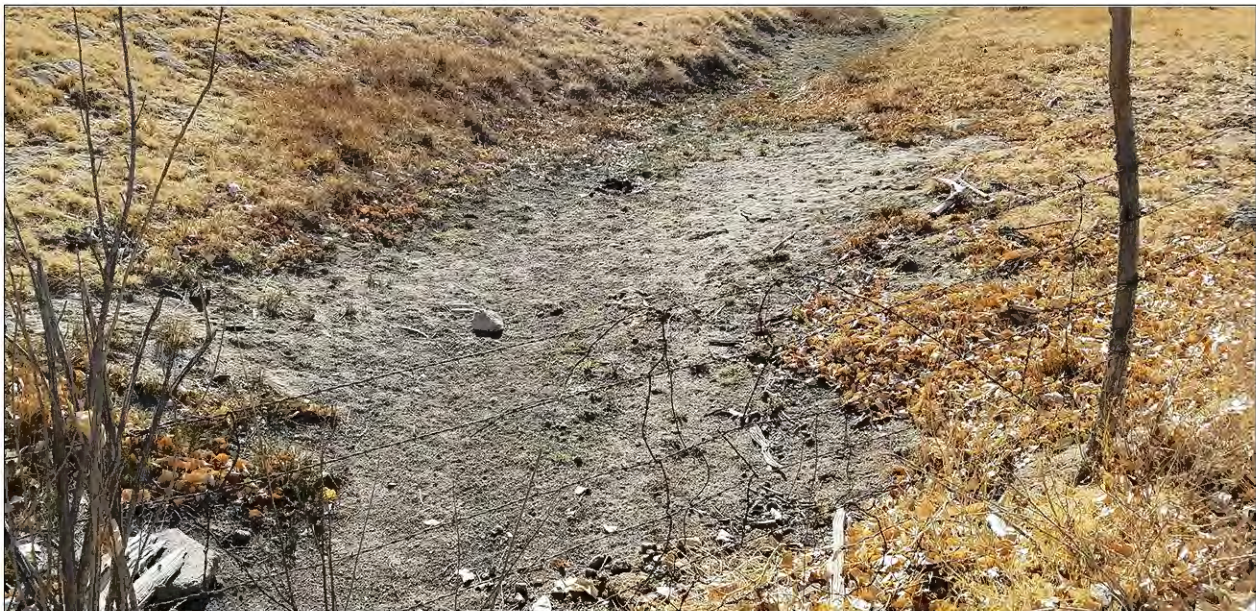
One of the two ditches, known as the Hillside Prince Ditch, extended to the south of SR 178, and crossed the proposed pipeline alignment twice on either side of the Kelso Valley Road intersection (see App. 3). A small segment of this ditch along the north side of the highway is known to have been present at least by 1874 (GLO 1875a). Where it crosses the APE, the ditch is conveyed under the SR 178 roadbed in corrugated metal culverts of relatively modern appearance, and the rest of the ditch remains an unlined open canal but is apparently no longer used for irrigation purposes (Fig. 7).

Figure 7. Hillside Prince Ditch at Site 15-018210, view to the northeast. (Photograph taken on January 4, 2018)

Site 15-018210, the Hillside Ditches, was evaluated when it was first recorded in 2014 and was found to be ineligible for the National Register of Historic Places due to the lack of research potential despite the fact that it retained historic integrity (Coleman 2014:2). The present study has found no new information to warrant a re-visit of that conclusion. Furthermore, the portions of the

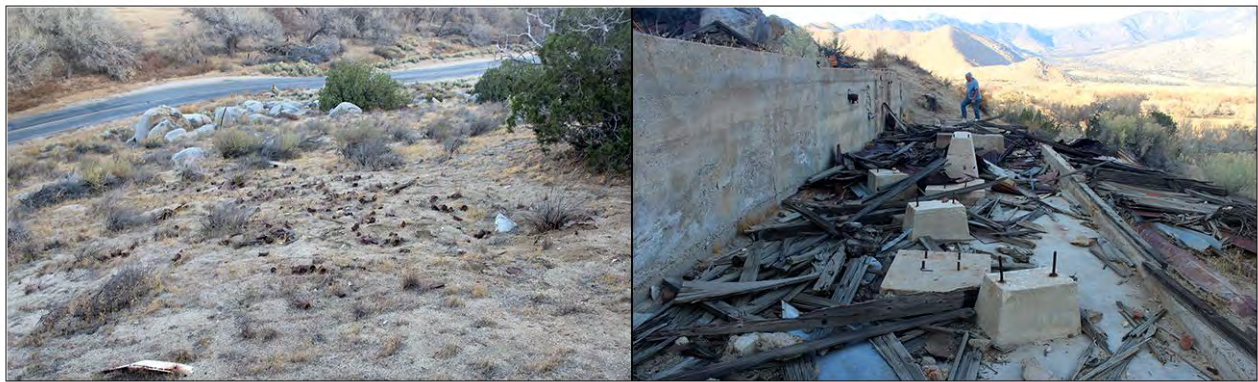
The primary components of the site include seven concrete pads/foundations, historic-period refuse and lumber scatters, and the remnants of three parallel wood-and-metal chutes, wooden stairs, and a small reservoir (Fig. 8). One of the concrete pads appears to be the foundation of a residence that was located at the mill. The main refuse scatter, located adjacent to the house foundation, contains approximately 300 rusted metal cans (including sanitary cans, beverage cans, meat cans, hole-in-top cans, and tobacco tin cans), glass fragments, metal wires, and lumber fragments. In addition to those noted at this location, lumber and lumber fragments are scattered throughout the portion of the site around the former mill, evidently representing the remnants of the various buildings.

Figure 8. Historic-period features and artifacts at Site 15-019603. *Left*: refuse scatter; *right*: concrete pads and lumber scatter. (Photographs taken on January 5, 2018)

If physical impact on these sites cannot be avoided, additional research procedures will be needed to evaluate their historic significance properly. For 15-019603, focused historical background research is recommended in order to ascertain whether the site is closely associated with any persons or events of recognized historic significance and whether it embodies any special merits in design, construction, engineering, or technology. For 15-019606, a systematic archaeological testing program is recommended to explore potential subsurface cultural deposits and to assess the archaeological data potential of the site. The scope of the testing program should include, at a minimum, detailed mapping of the milling features, surface collection of artifacts, excavation of archaeological test units, laboratory analysis of recovered artifacts, permanent curation of the artifact assemblage at an appropriate facility, and a final report to document the findings.

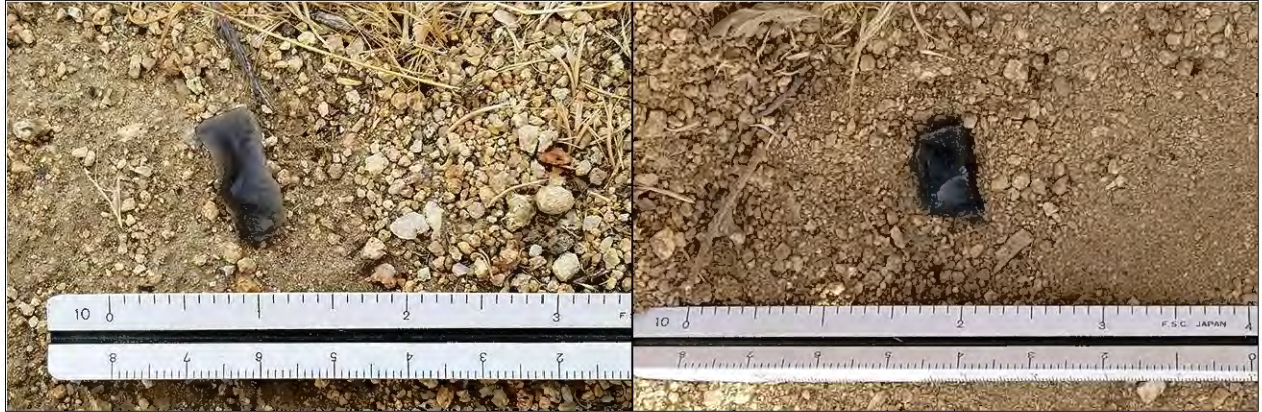
Found at the proposed Office Site Alternative 1 between SR 178 and the Bella Vista neighborhood, each of these prehistoric isolates consist of a single secondary obsidian flake (Fig. 9; see App. 3). The flake at 15-019604 measures roughly 2.6x1.0x0.2 centimeters in size, and the one at 15-019605 measures approximately 2.0x1.7x0.4 centimeters (see App. 4).

Figure 9. Prehistoric isolates found in the APE. *Left*: obsidian flake at 15-019604; *right*: obsidian flake at 15-019605. (Photographs taken on January 4, 2018)

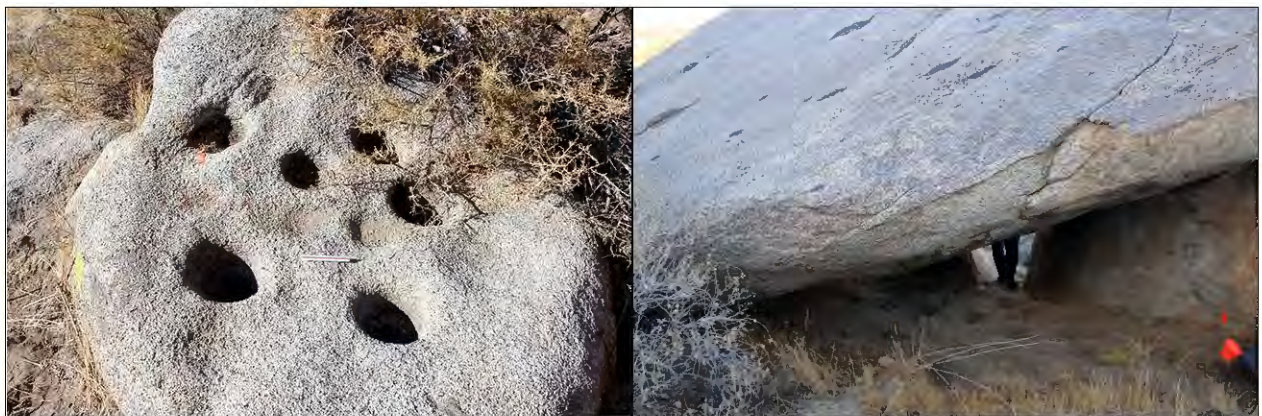
Site 15-019606 consists mainly of 30 granitic bedrock boulders with a total of 48 grinding slicks and 39 mortars, most of them concentrated in two loci in the eastern and western portions of the site (Fig. 10; see App. 4). Locus 1 contains 16 of the bedrock milling features with 19 slicks and 28 mortars, while Locus 2 contains 10 features with 23 grinding slicks and 4 mortars. Also noted at the site is a possible rock shelter, although no artifacts, midden soil, or human alterations were observed at the feature (Fig. 10). In addition to the features, two lithic artifacts were observed on the ground surface

within Locus 1, including a secondary obsidian flake measuring roughly 1.9x1.8x0.2 centimeters and an obsidian projectile point fragment measuring 4.1x1.8x1.8 centimeters, the latter apparently from a dart point.

The irregularly-shaped site measures approximately 275x130 meters in total dimension and is located on the northern tip of the hill at the proposed Kelso Valley Tank Site, partially overlapping Site 15-019603 (see App. 3). There are indications of subsurface cultural deposits around some of the bedrock milling features, as well as possible midden soil at Locus 1. Given the number of additional boulders on the hillside, it is likely that the site extends beyond APE boundaries.

Figure 10. Prehistoric cultural features at Site 15-019606. *Left*: bedrock mortars (Feature 1); *right*: possible rock shelter. (Photographs taken on January 5, 2018)

Site 15-019606 encompasses a large, concentrated group of bedrock milling features with not only the commonly found grinding slicks but also a total of 39 conical mortars. Also noted at the site were a possible rock shelter, two lithic artifacts, and indications of subsurface cultural deposits and possible midden soil. Unlike isolated or sparse milling feature sites consisting exclusively of shallow grinding slicks, which generally reflect occasional use during resource gathering excursions, a substantial milling station site like this represents the results of prolonged, repeated, and concentrated use, often associated with a long-term settlement nearby.

The other two resources in the APE, Site 15-019603 and Site 15-019606, are both located at the proposed Kelso Valley Tank Site, and both contain a large amount of cultural remains. The qualification of these sites as “historic properties,” “historical resources,” and/or “tribal cultural resources” cannot be determined without further historical and/or archaeological investigations. Based on these findings, CRM TECH recommends that the Kelso Valley Tank Site be relocated to avoid impacts on Sites 15-019603 and 15-019606, if feasible.

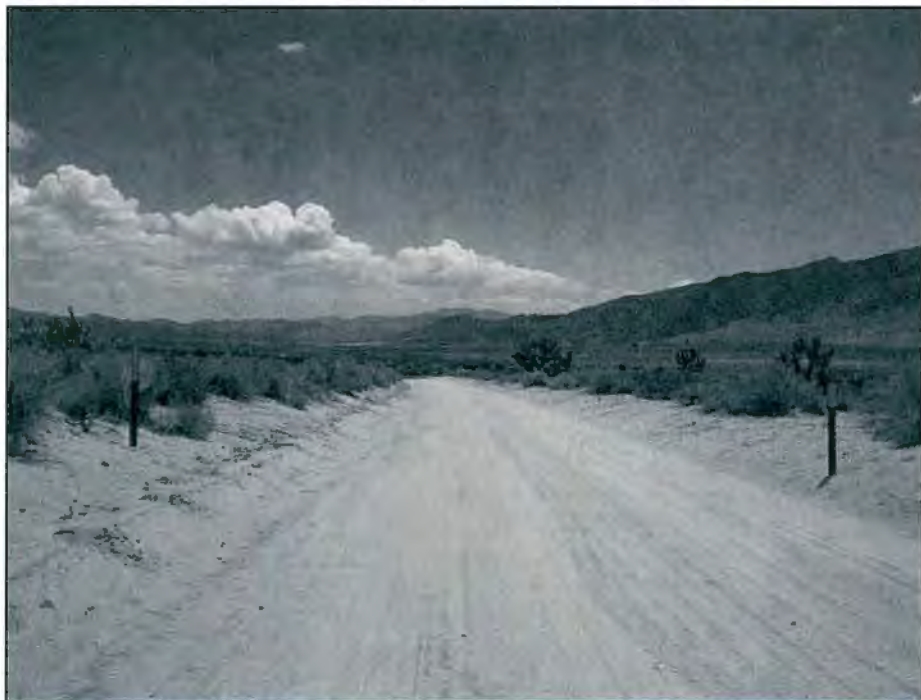
Historic Kelso Valley Road segment at north end. (View: 178 °)

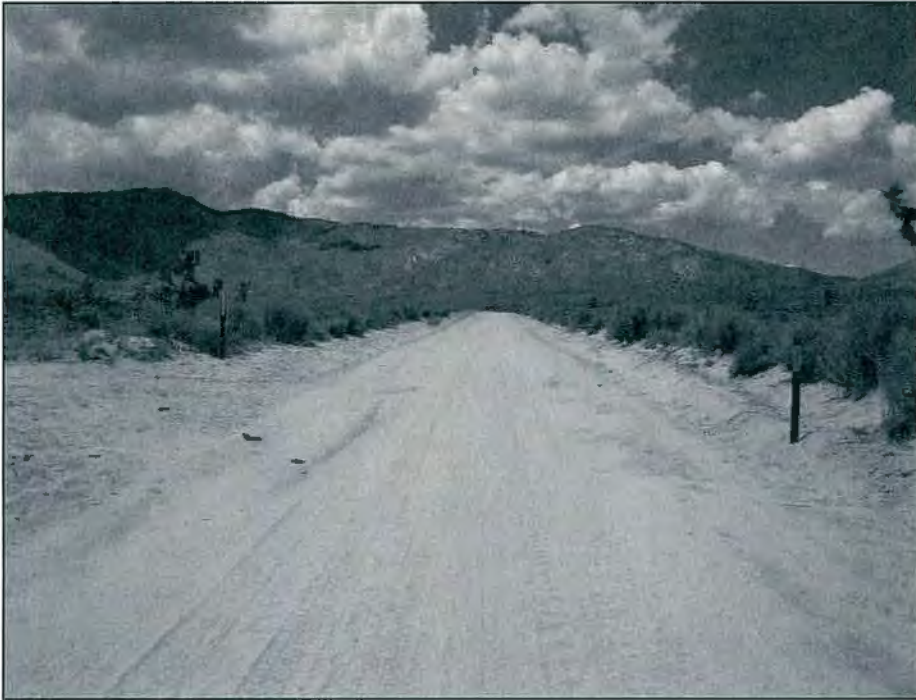
**L8b. Description of Photo/Map/Drawing:**  
Historic Kelso Valley Road segment at  
south end. (View: 334 deg)

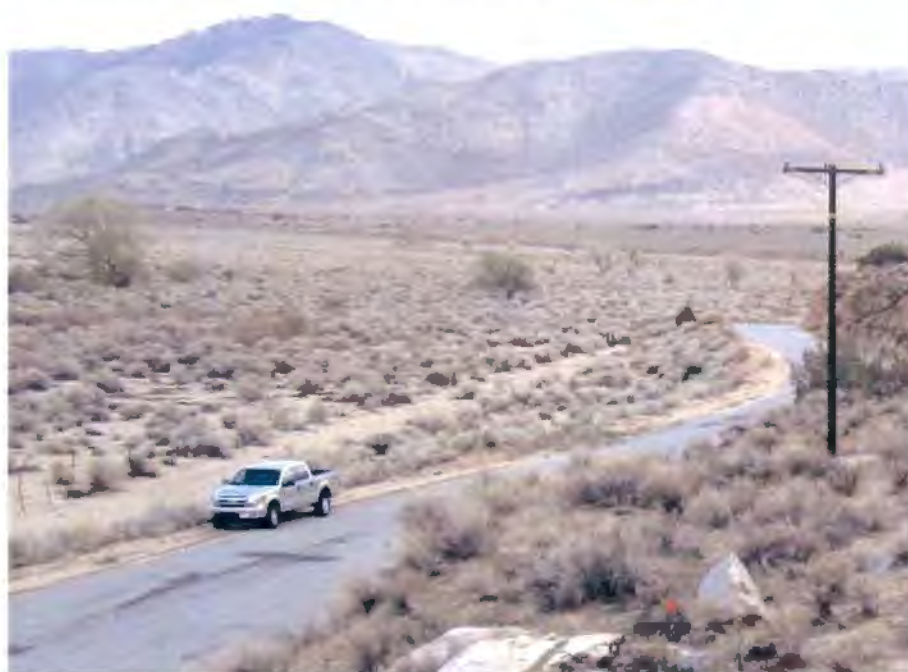
P5b. Description of Photo: LIS-010, View of Kelso Valley Road, view north/northeast. Photo #2013-058-135

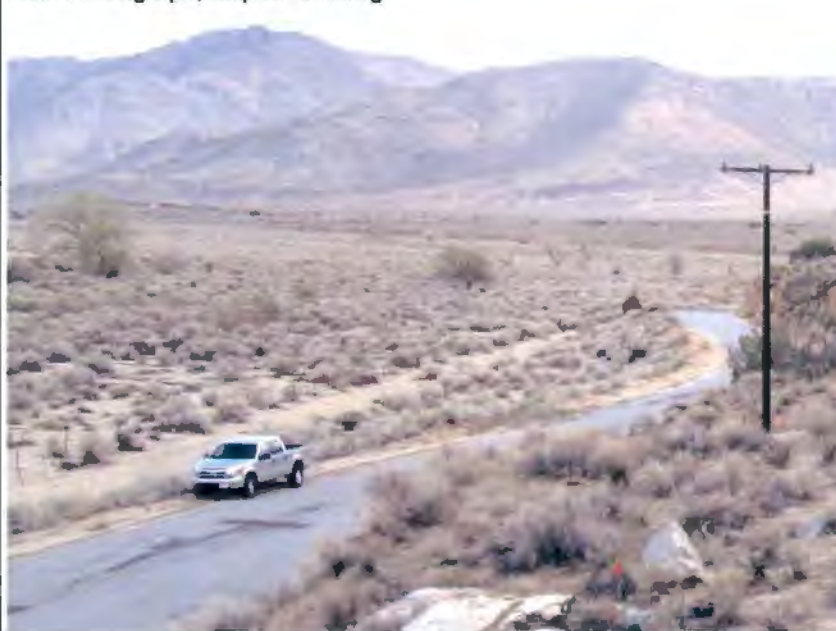
**L8a. Photograph, Map or Drawing**

**L9. Remarks:** this road appears on historic-period maps as the main route through Kelso Valley. As such, this road was likely used by John Kelso to move supplies from LA to Keyesville and may have served as a transportation route to and from the mining

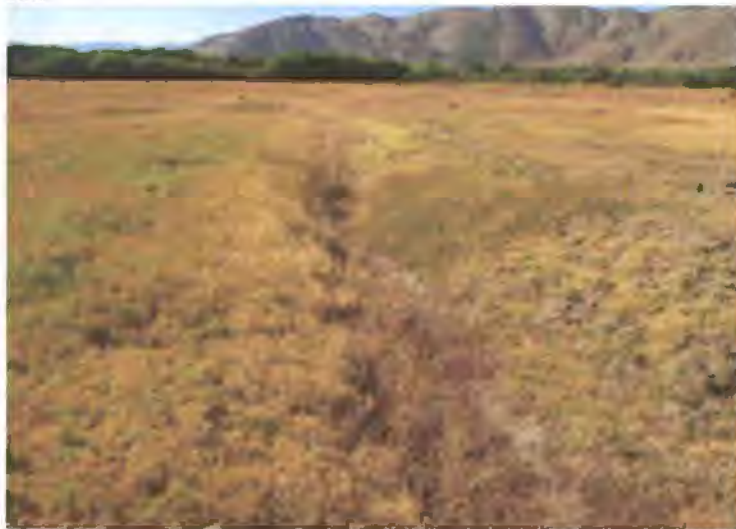
Audubon Hillside Ditch, facing west, October 13, 2014.
