Biological Technical Report for Trails at Carmel Mountain Ranch Project

New Urban West

AUGUST 2020

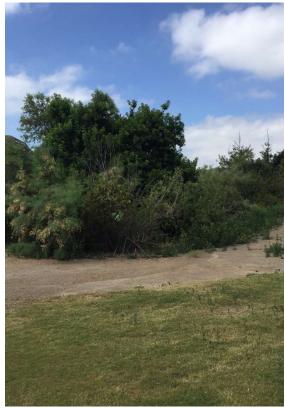
Photo 1: Southwest-facing view of side tributary to Chicarita Creek (Feature A).

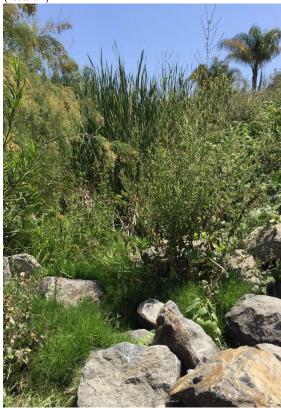
Photo 3: Northeast-facing view of Chicarita Creek (Feature A) from Data Station 3 (looking upstream)

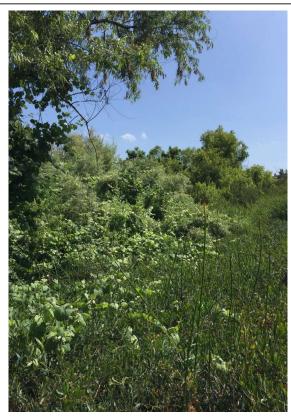
Photo 2: Interior view of vegetated tributary to Chicarita Creek (Feature A).

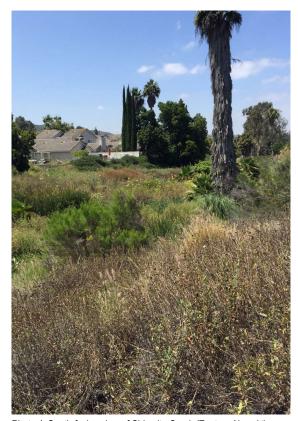
Photo 4: South-facing view of Chicarita Creek (Feature A) and the adjacent coastal sage scrub vegetation.

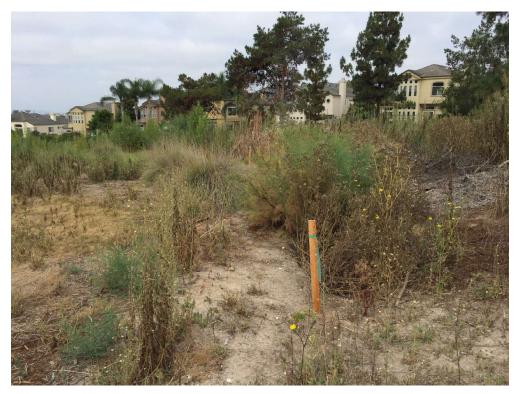
Photo 5: Disturbed southern willow scrub habitat associated with Feature E. The stake represents the northern terminus of the feature.

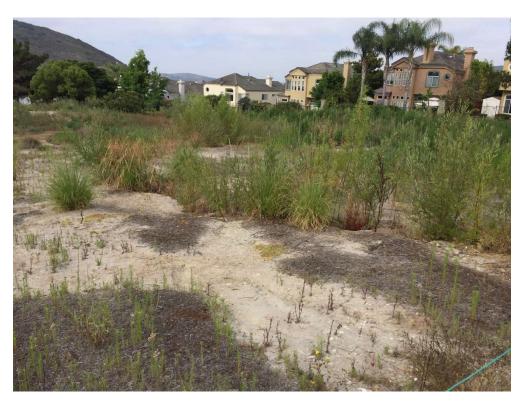
Photo 6: Additional photo of Feature E illustrating the disturbed nature of the channel and the narrowness of the feature.

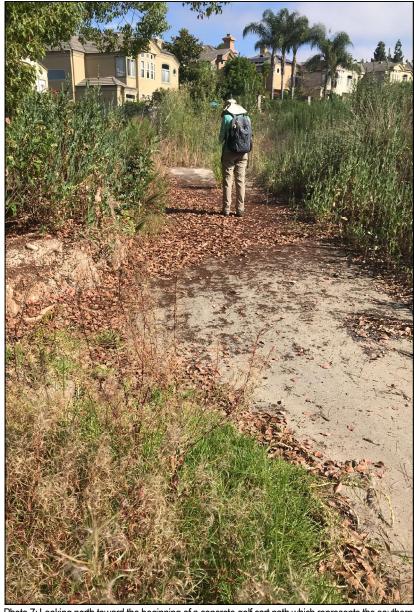
Photo 7: Looking north toward the beginning of a concrete golf cart path which represents the southern terminus of Feature E.

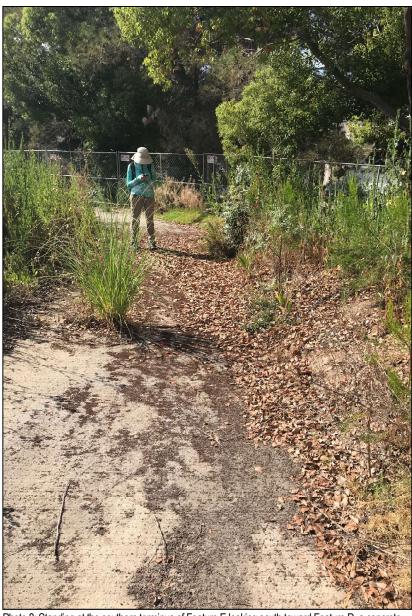
Photo 8: Standing at the southern terminus of Feature E looking south toward Feature D, a concrete-lined brow ditch overgrown with ornamental groundcover (not visible).

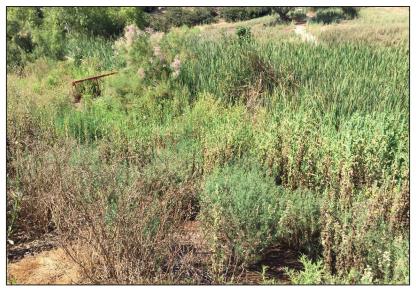
Photo 9: Freshwater emergent wetland associated with Feature I looking downstream (south) toward an existing golf cart bridge.

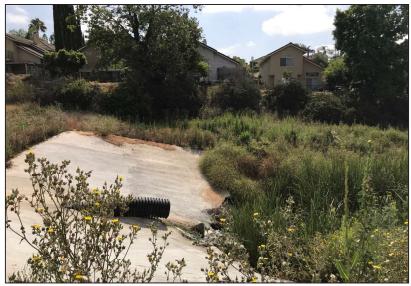
Photo 11: South-facing view of Feature J where flows that daylight from a closed pipe have created dense, impassable emergent wetland vegetation.

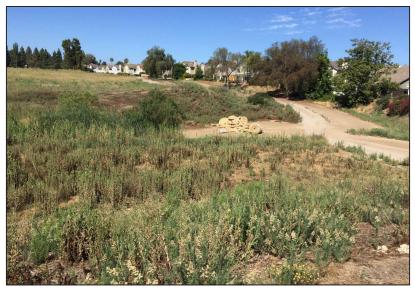
Photo 10: Northwest-facing view of the northern terminus of Feature I.

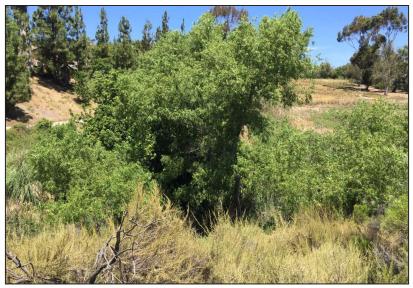
Photo 12: North-facing view of Feature R, a man-made earthen pond vegetated with mature, dense southern willow scrub vegetation.

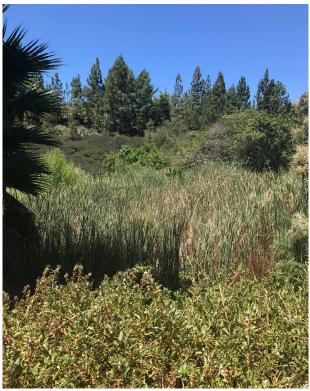
Photo 13: South-facing view of Feature Q, a man-made earthen pond that is overgrown with freshwater emergent wetlands and southern willow scrub vegetation.

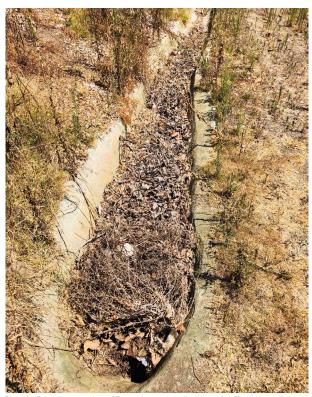
Photo 15: Downstream terminus of Feature L, a concrete-lined brow ditch filled with weeds, leaves, and debris. An open drain was observed that collects and conveys nuisance flow to the east where it ultimately sheet flows into the channel.

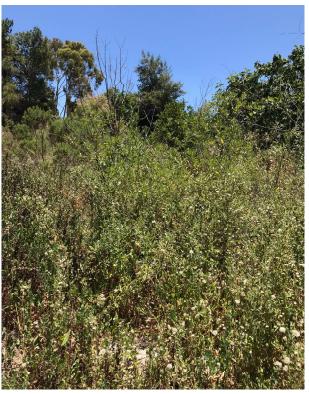
Photo 14: East-facing view of Feature C, a 3-foot-wide earthen swale that at one time collected and conveyed runoff from the golf course to a 30-inch pipe culvert to the west. Feature C is dominated by non-native uplands and omamental vegetation from the neighboring homes.

a closed, storm drain conveyance system. Feature C does not support hydrophytic vegetation nor were signs of hydrology observed. In light of the rock lining, hydric soils could not be evaluated.

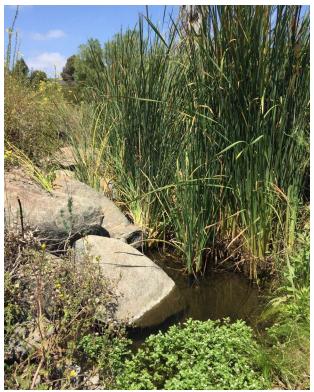
Photo 16: South-southwest facing view of Feature M, a freshwater emergent wetland at the daylight of a large culvert beneath an existing, abandoned golf cart path.
