HISTORICAL RESOURCES TECHNICAL REPORT FOR THE E RESERVOIR REPLACEMENT AND PUMP STATION PROJECT

Assessor's Parcel No. 174-240-33

VISTA IRRIGATION DISTRICT

MAY 2019

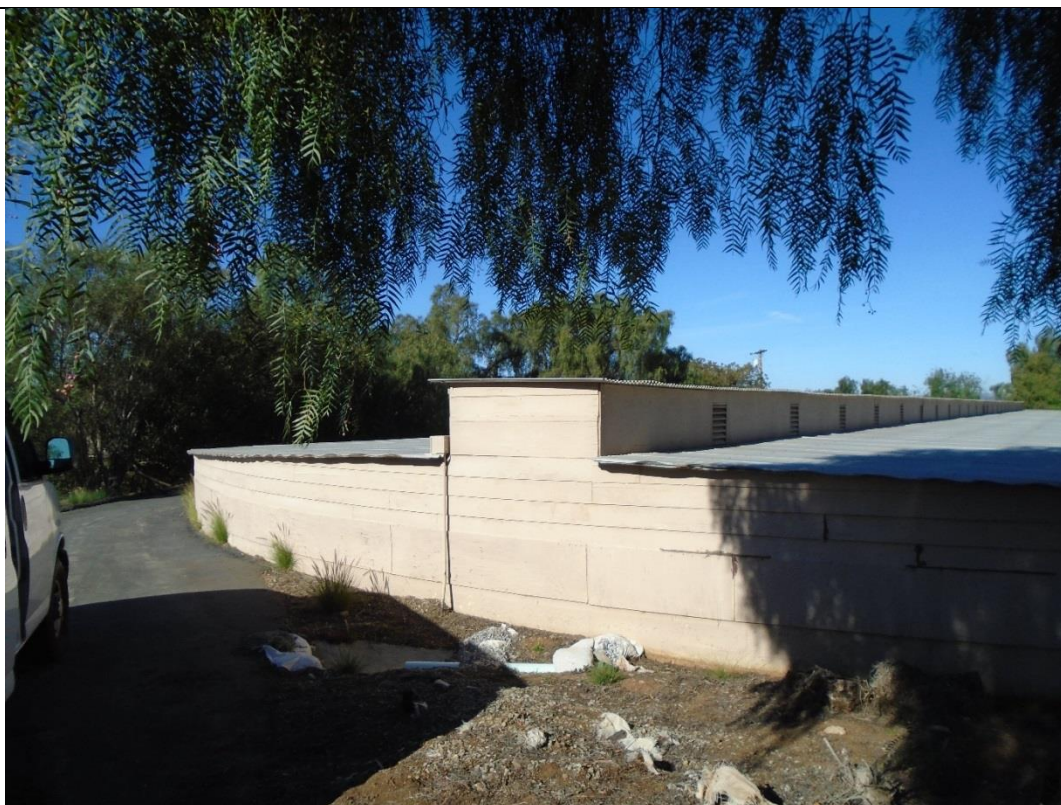
Figure 3 **Main elevation (southeast), view to north (DSC00820)**

The water storage reservoir is an industrial structure, oval in plan, initially built c. 1929 and subsequently altered. The most significant change to the structure is the replacement of the roof and the alteration of the exterior concrete (1952).

- Extension of concrete walls above ground level (1952)
- Replacement of original earthen roof with corrugated metal (1952)
- Replacement of original pump house (2009)
- Addition of horizontal plywood panels over what appears to be mesh screening (date unknown, observed)

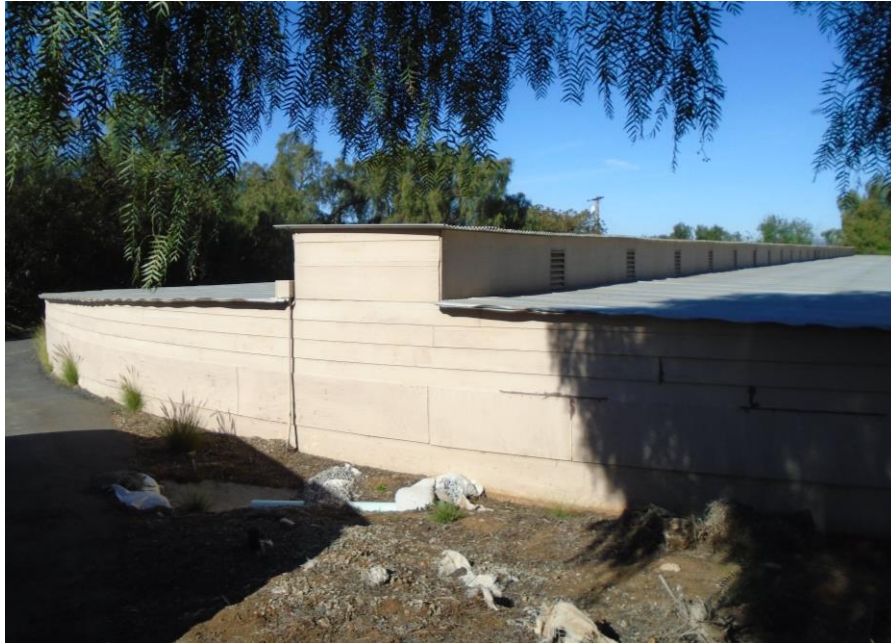
P5a. Photograph or Drawing (Photograph required for buildings, structures, and objects.)

The Reservoir Storage Tank is an industrial structure oval in plan, initially built c. 1929 and subsequently altered. The most significant change to the structure is the replacement of the roof and the alteration of the exterior concrete. The Reservoir is approached by an asphalt driveway that circles around the western elevations of the structure. The height of the main body of the structure is approximately four feet with a two-foot wide center raised section measuring six feet in total height. The exterior walls are poured-in-place running the circumference of the reservoir and along the raised center section. **See Continuation Sheet.**

P5b. Description of Photo: (view, date, accession #) View looking north, 01/24/2019, DSC00820
