**BIOLOGICAL RESOURCES ASSESSMENT**  
**for**  
**VESTING TENTATIVE PARCEL MAP CO 15-0071**  
**(APN 041-031-005 and -013)**  
**Templeton, San Luis Obispo County, California**

*August 10, 2017*

**VTPM CO 15-0071 (MBS, 2017)**

Figure 1: Annotated Preliminary Site Plan

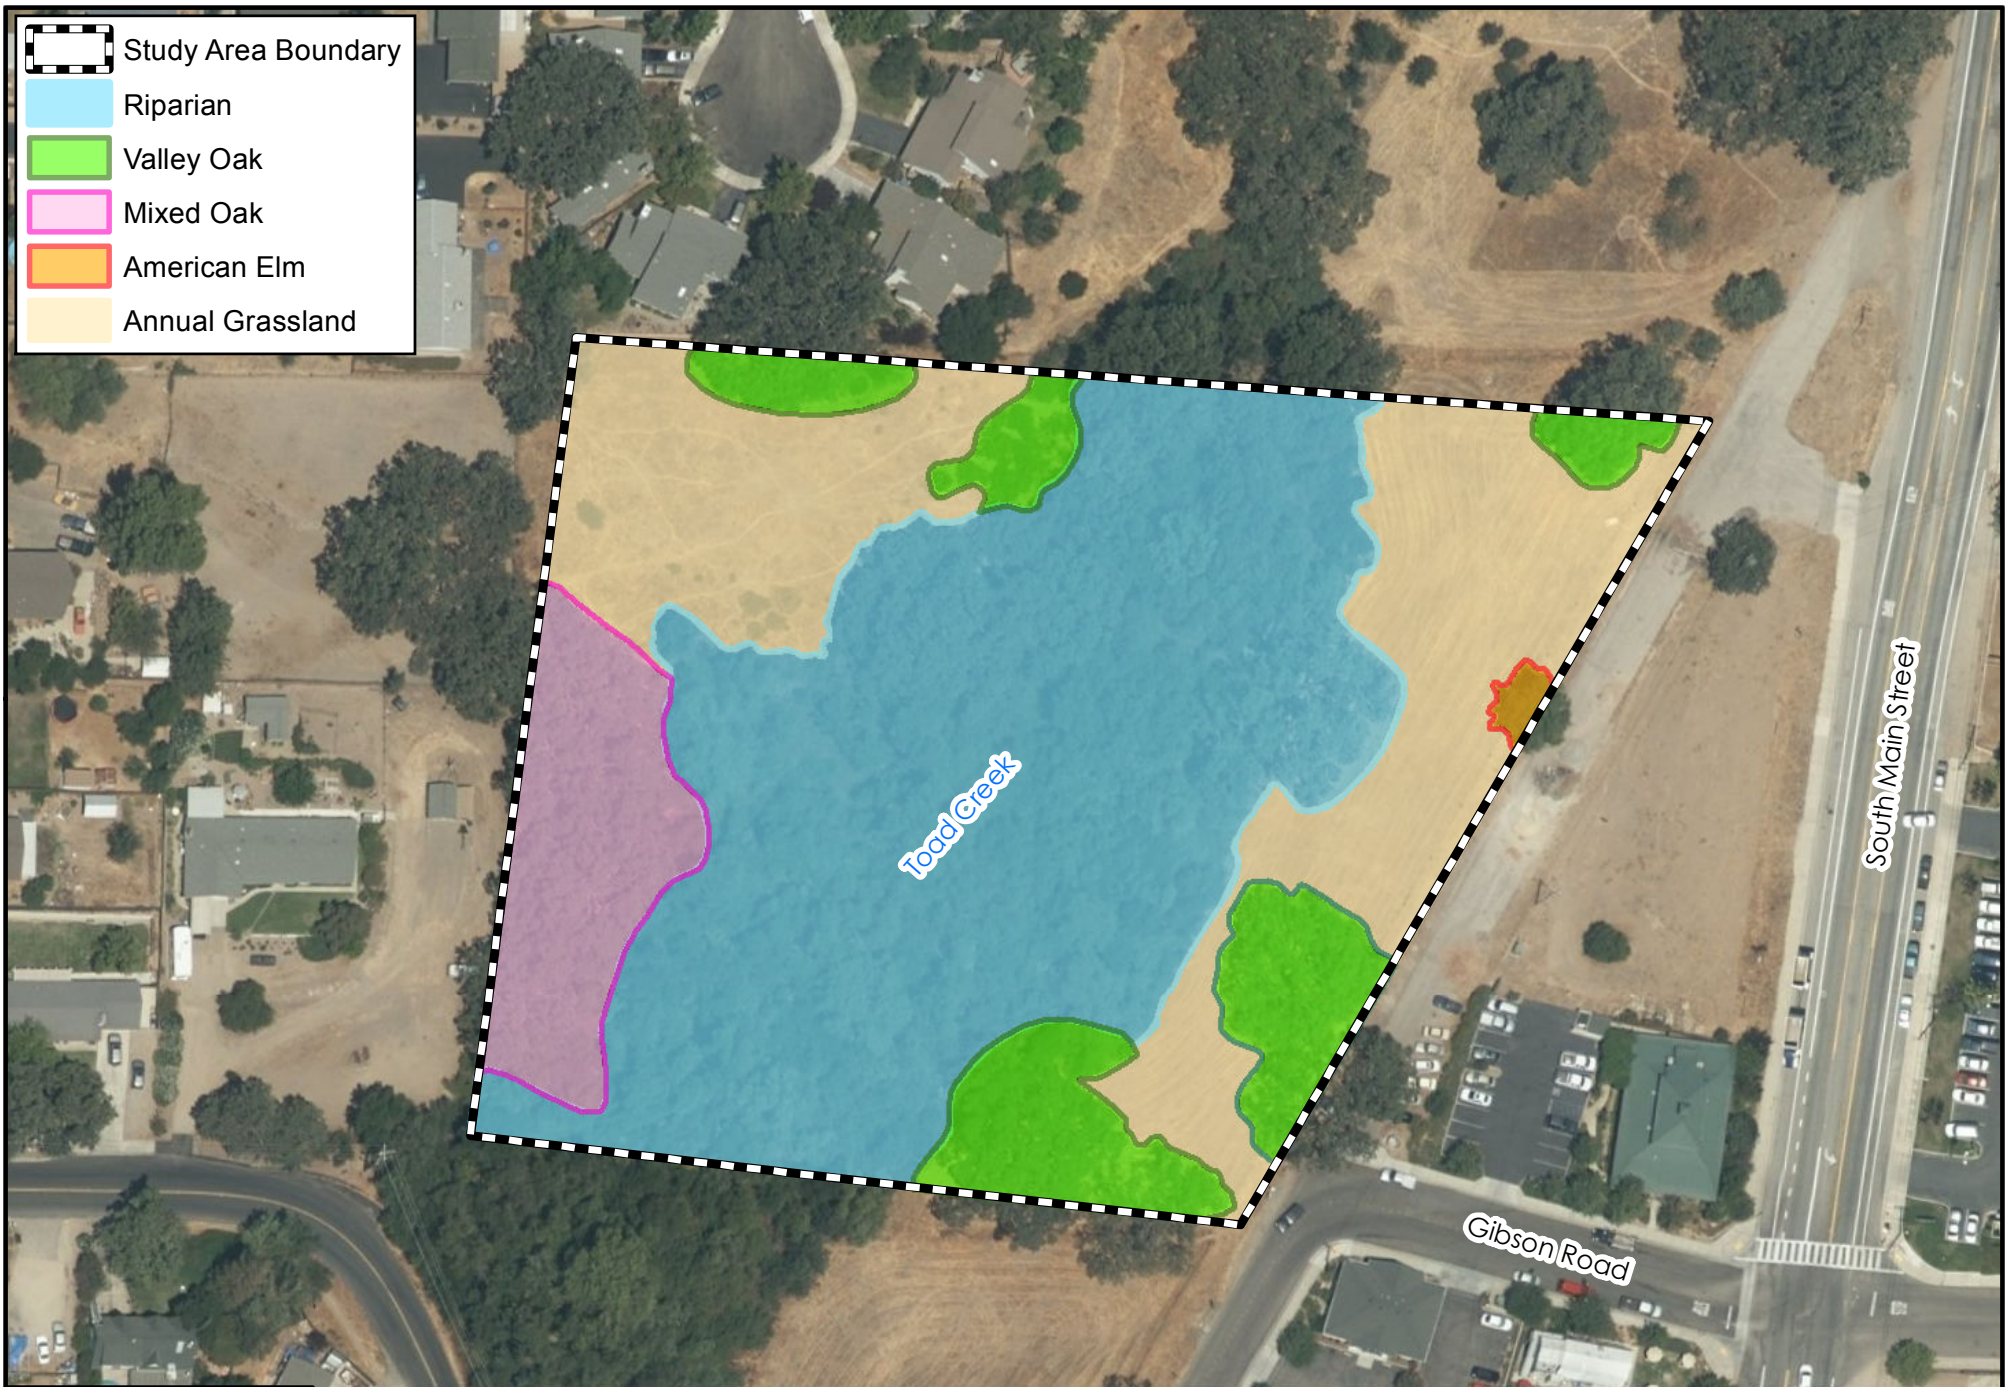
1 in = 100 ft

Annual grass dominated habitat was observed along Old County Road and the eastern slope leading down towards the Toad Creek corridor. Grassland dominated habitat was also observed in the western portion of the site to the north of the ephemeral tributary drainage. Species observed in this habitat type included soft chess (*Bromus hordeaceus*), ripgut brome (*Bromus diandrus*), wild oats (*Avena barbata*), and fiddle dock (*Rumex pulcher*). A small occurrence (approximately 10'x15')

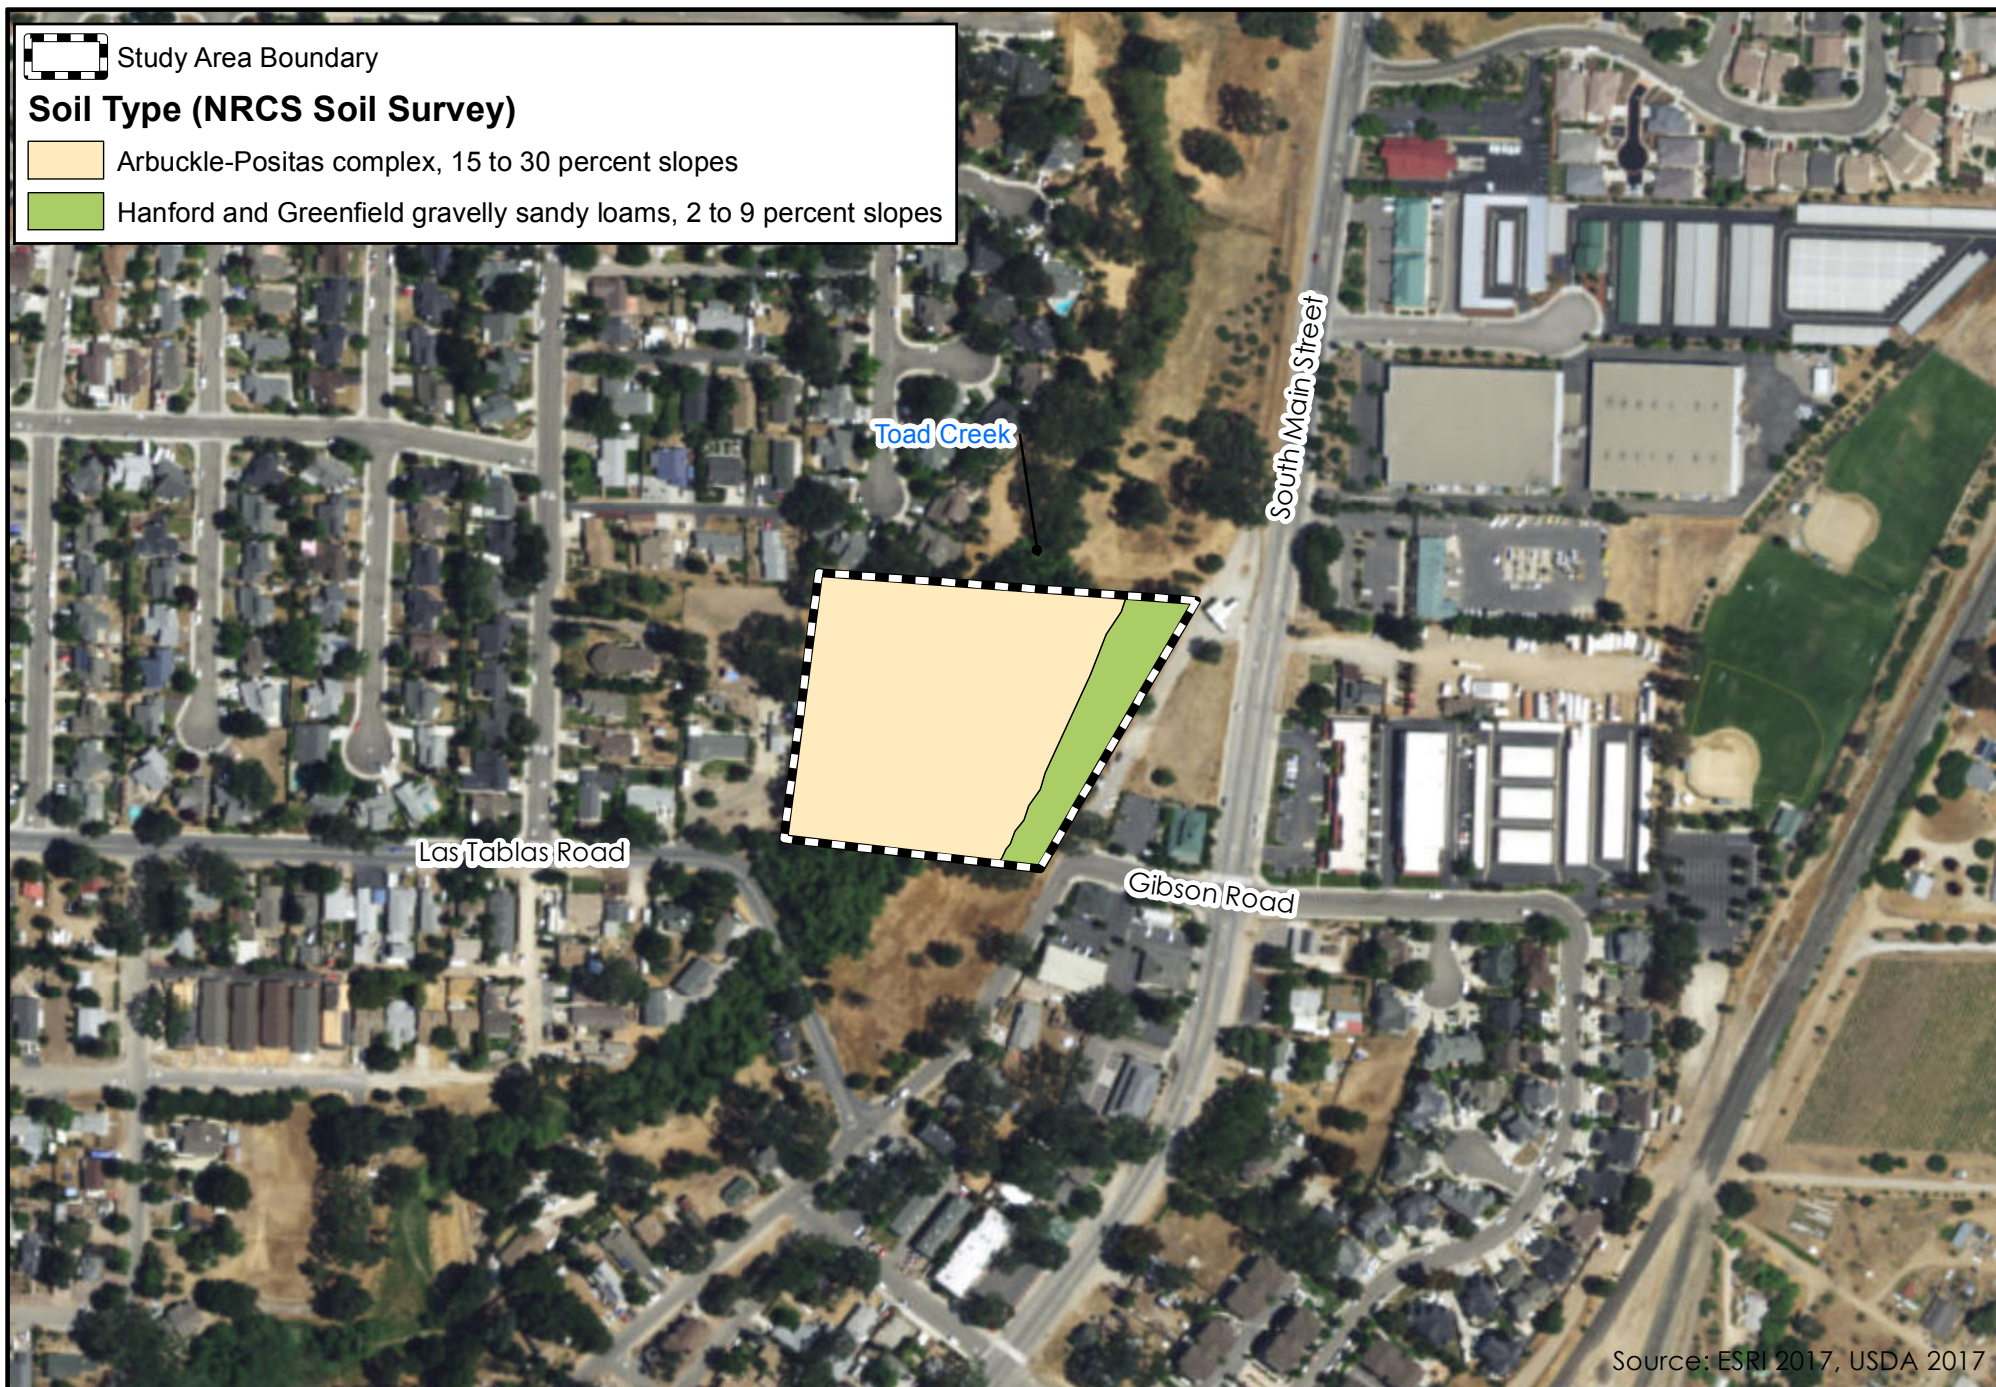
Source: ESRI 2017, USDA 2017

Hanford and Greenfield gravelly sandy loams, 2 to 9 percent slopes

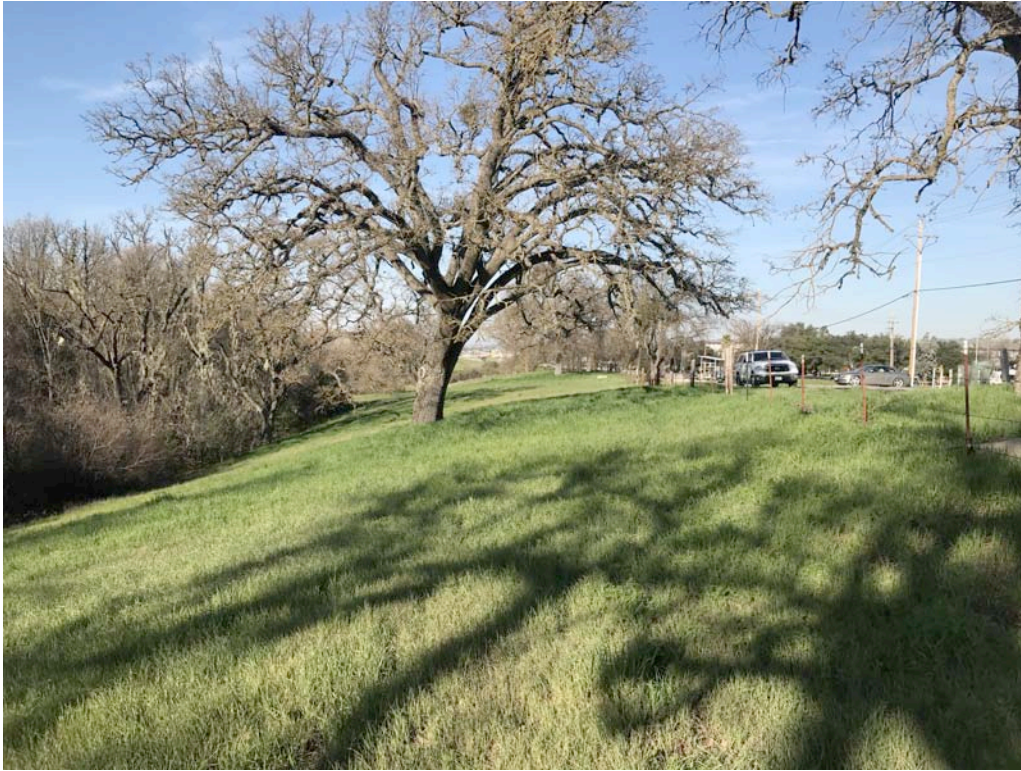
**Photo 1.** Northerly view of the site in March 2017 with Old County Road visible to the right. Proposed development envelopes are sited in annual grassland habitat to avoid oak trees and riparian habitat.

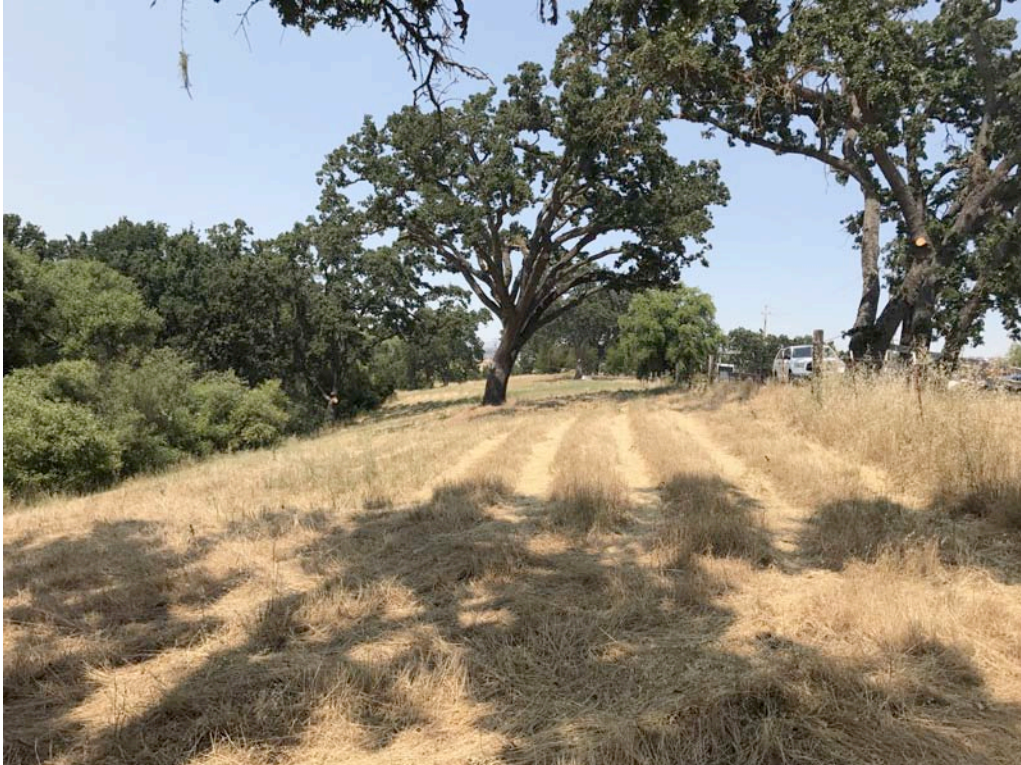
**Photo 2.** Northerly view of site in May 2017 showing managed (mowed) annual grassland. Oak trees in the right of photo and American elm in the distance along Old County Road were removed as part of a separate tree removal permit after photo was taken.

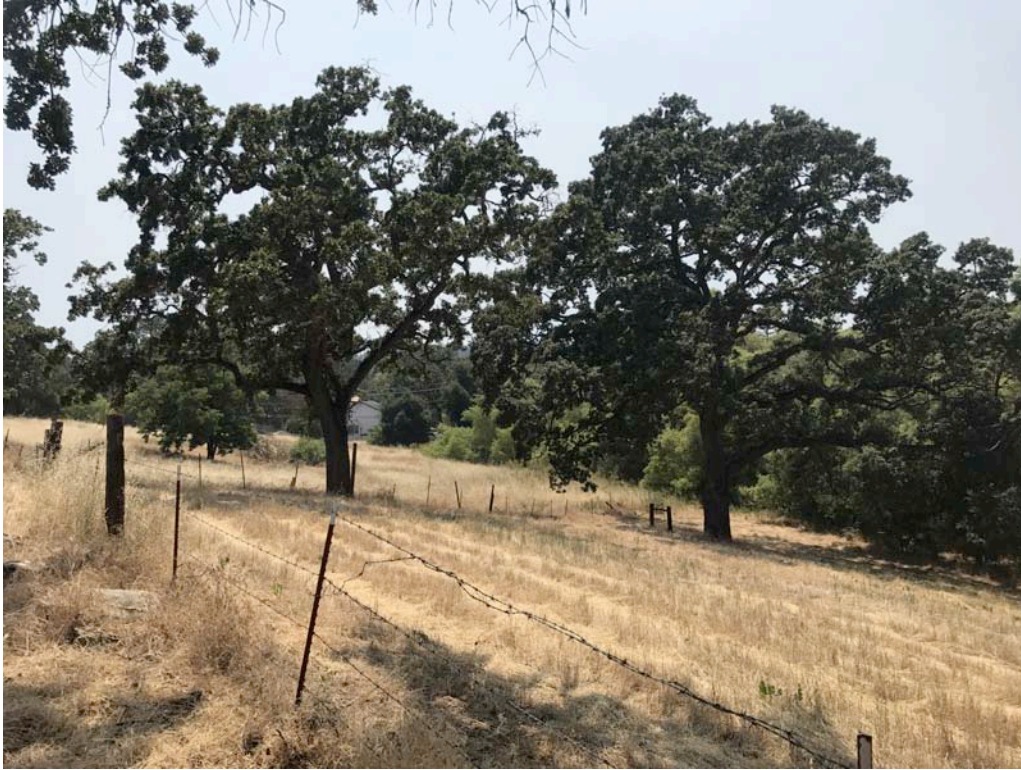
**Photo 3.** Southwesterly view of the southern property line with two oaks along the barbed wire fence and Toad Creek riparian corridor visible in the right side of photo.

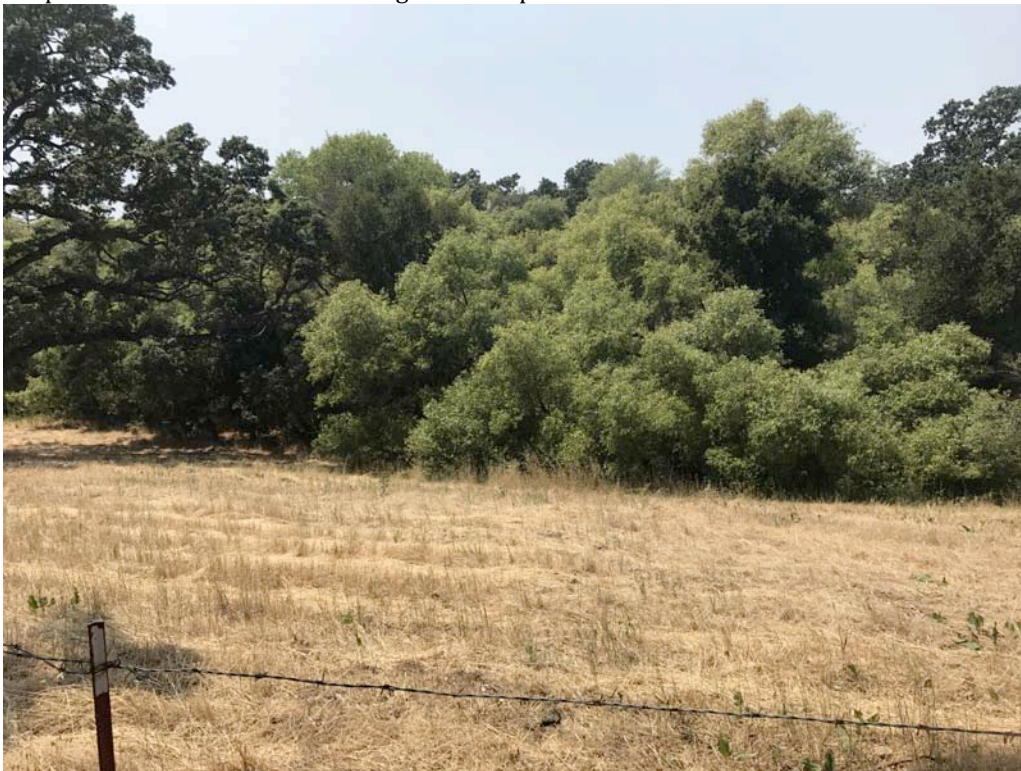
**Photo 4.** Westerly view of the annual grassland interface with valley oak and willow riparian habitat along Toad Creek.

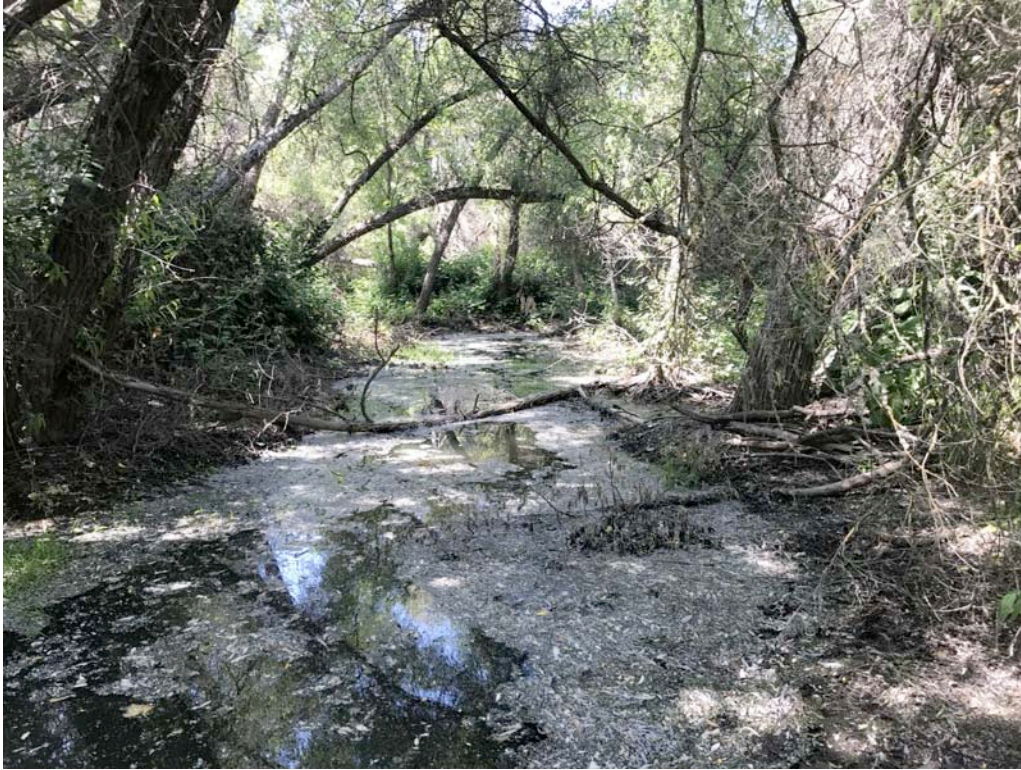
**Photo 5.** Northerly view of Toad Creek channel with dense riparian habitat. Channel depth ranges from approximately 4 to 6 inches deep with occasional 12 to 18-inch deep pools present.

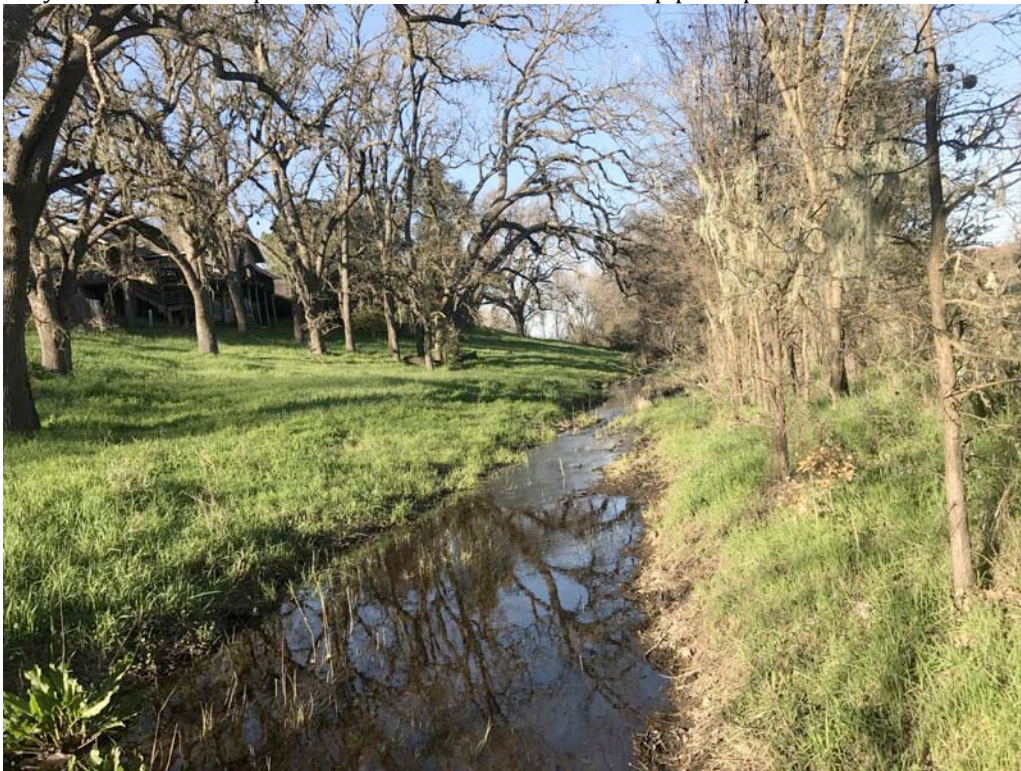
**Photo 6.** Northerly view of Toad Creek just downstream from northern property line. Creek appears channelized with no riparian habitat covering the active channel.

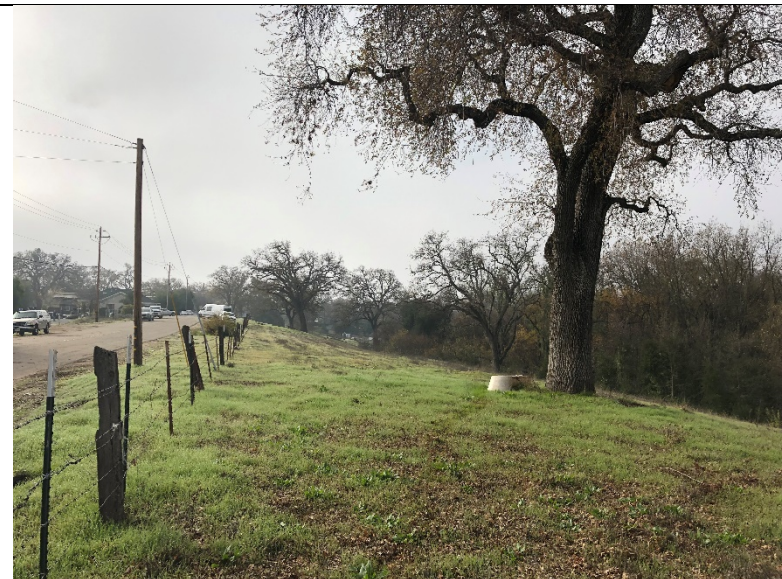
**Photo 1:** View looking south from northeast property corner at proposed 44" DBH valley oak removal (existing Tree #5).

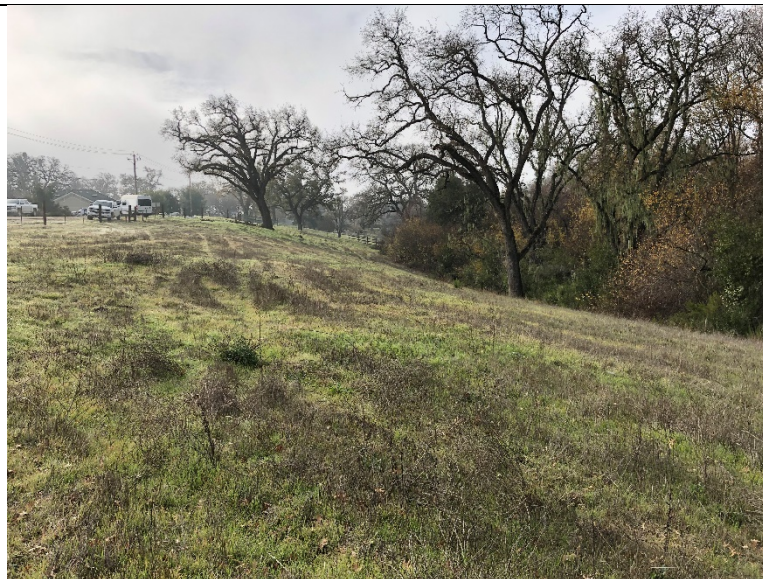
**Photo 2:** View south from northeast property corner at 38.8" DBH valley oak encroachment adjacent to Creek (no Tree Tag visible) & approximate sewer connection location. 44" DBH valley oak in center of photo is proposed for removal (Tree #5).

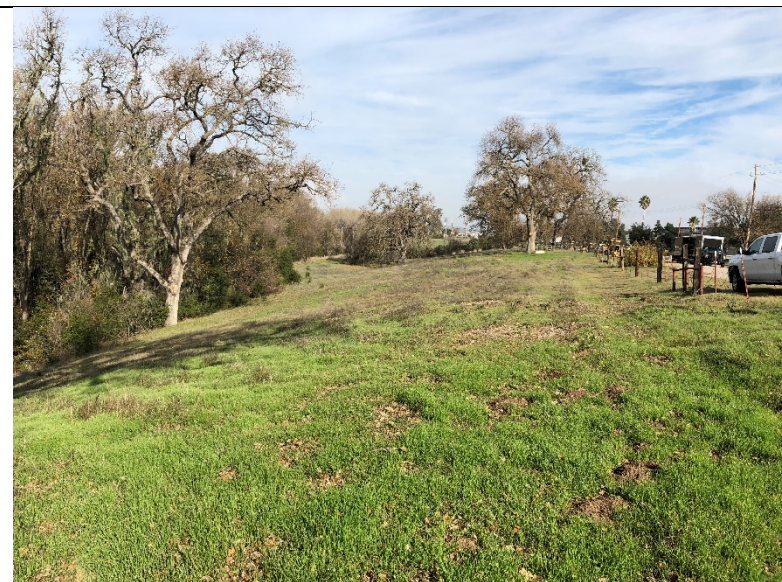
**Photo 3:** View north from approximate sewer line connection at riparian edge towards 38.8" DBH valley oak encroachment adjacent to Toad Creek (no Tree Tag visible). 45.8" DBH valley oak (existing Tree #1) at top right of photo is proposed for removal.

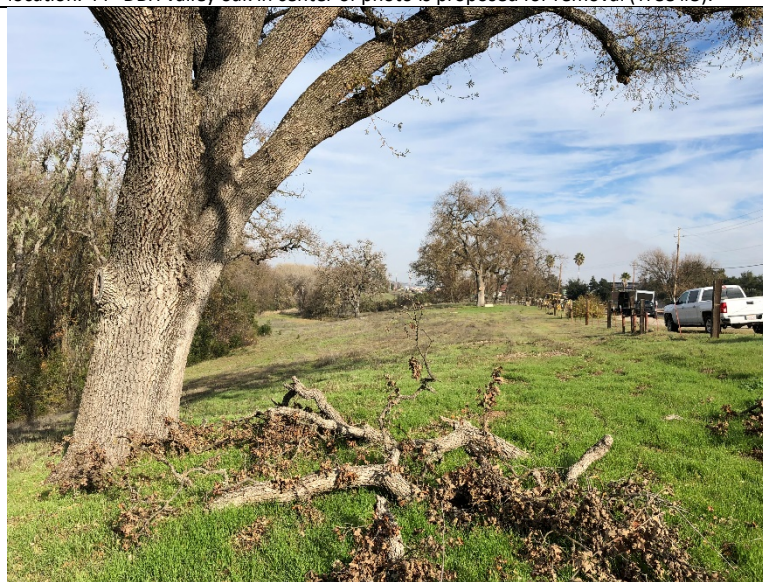
**Photo 4:** View looking north from proposed 44" (existing Tree #5) DBH valley oak removal. 45.8" DBH valley oak (existing Tree #1) at top right of photo is also proposed for removal.
