Architectural Evaluation for 1144 Chorro Street, San Luis Obispo, San Luis Obispo County, California

APRIL 2020

ARCHITECTURAL EVALUATION FOR 1144 CHORRO STREET, SAN LUIS OBISPO, SAN LUIS OBISPO COUNTY, CALIFORNIA

SWCA Project No. 27640.15

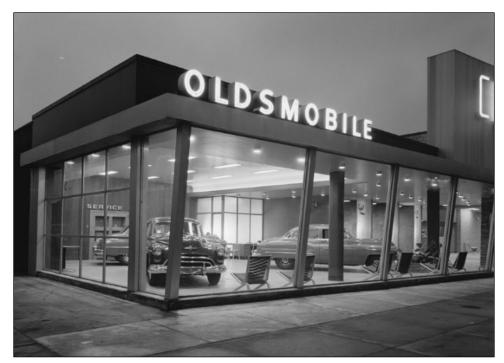
Figure 2. Crystal Motors, Brooklyn, New York, designed by famed Mid-Century architect Morris Lapidus in 1950 (Class Haus 2019).

Figures 2 through 6, below, document high-style commercial architectural designs that clearly demonstrate the major architectural elements diagnostic of the Mid-Century commercial style, as discussed by Jackson and Longstreth. Figures 2 and 3 are views of Morris Lapidus's 1950 design for an automobile showroom, and Figures 4 and 5 are the work of Welton Becket and Associates, "responsible for a stunning array of iconic modern structures that literally defined post-war Los Angeles" (Emerton 2003:3). Through an array of architectural and popular magazines, trade journals and catalogues, newspapers, and advertisements, the Mid-Century style was made known to the American public. Figures 6 through 8 present more modest examples of the Mid-Century commercial style, which nonetheless incorporate important diagnostic elements. Other examples are depicted in Appendix A (Dyson 2008).

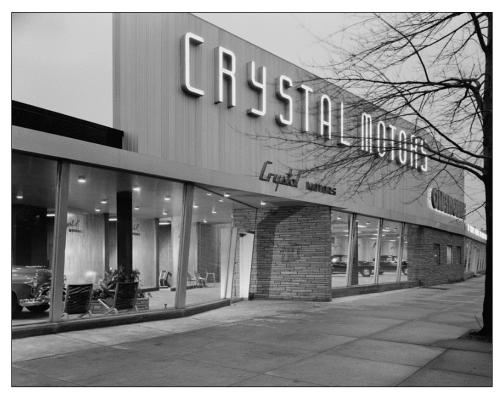
Figure 3. Crystal Motors, Brooklyn, New York, designed by Morris Lapidus in 1950 (Class Haus 2019).

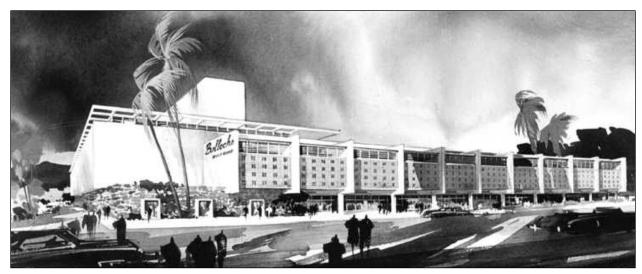
Figure 4. Architectural rendering for Bullock's Westwood (PatricksMercy 2010).

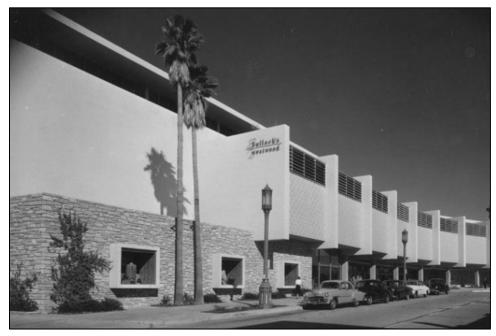
Figure 5. Becket's Bullock's Westwood opened in 1951 (Los Angeles Public Library Photo Collection c1953).

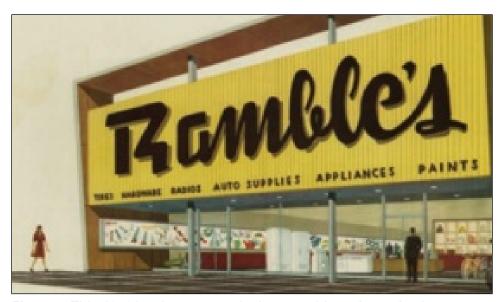
Figure 7. This 1946 hardware store design "combines dramatic signage with linear display boxes that run from the exterior plywood and aluminum frame through the open front and on into the store" (Dyson 2017:6).

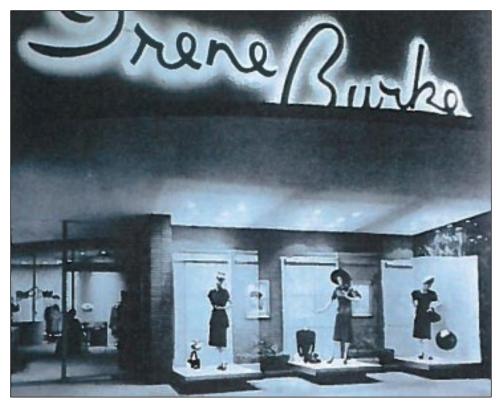
Figure 8. Floating display windows "deconstructed the front plane of retail windows," Irene Burke dress shop, Long Beach, 1948 (Dyson 2015:164).

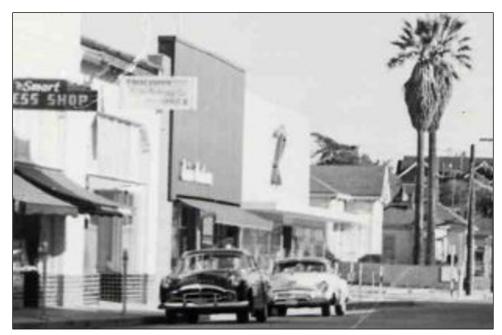
Figure 25. The first unit of Rileys Department Store, with the Union Hardware store that occupied the building next door between 1955 and 1960 (History Center of San Luis Obispo County).

An artist's rendering of the completed store building (Figure 24), which extended down Chorro Street only as far as the palm tree, shows good correspondence with the 1955 photograph (Figure 25). Canopies are shown extending outward above the projecting display windows on Chorro Street and cantilevered out over the flush-mounted display windows on the Marsh Street elevation. The prominent central entryway on Marsh Street is easy to spot just beyond the display windows.

Overlapping with construction of the Rileys store, the new Union Hardware building had been under construction next door at 1126 Chorro Street (see Figure 25). The *San Luis Obispo Telegram-Tribune* (1955b:2) reported that the hardware store occupied the "former site of frame store buildings razed for the new project:"

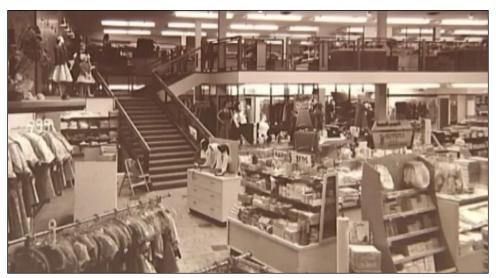
Figure 31. Interior view of store, including mezzanine and staircase, c1958 (KSBY 2018).

Photographs of the department store interior, probably taken not long after the opening, reveal some of interior designer Lee B. Kuhn's design aesthetic, as well as his incorporation of store fixtures manufactured by the L.A. Darling Company (Figures 30–32). The company's manufacturing plant was (and still is) located in Arkansas, and Kuhn was their West Coast representative at the time of his contract with Landeck and Humphrey.

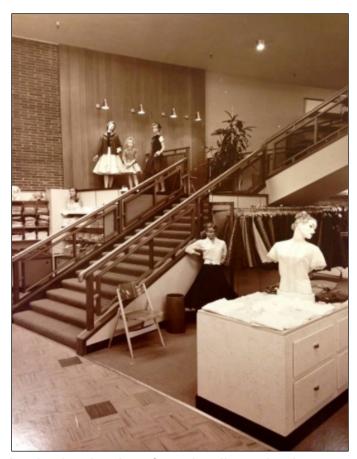
Figure 32. Another interior view of merchandise and stairway to mezzanine, taken on same day as Figure 31, c1958 (Pinterest 2019b).

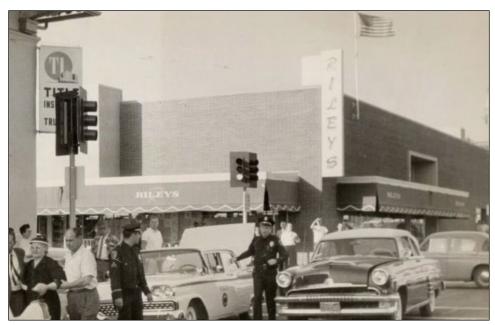
Figure 34. View of Rileys vertical sign and flagpole at the corner of Chorro and Marsh, c1959 (History Center of San Luis Obispo County).

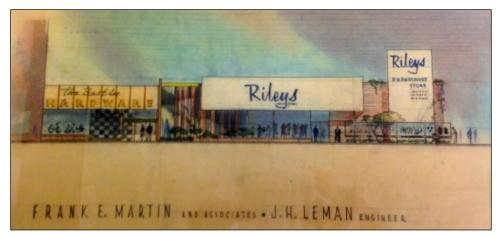
Figure 35. Artist's rendering, probably c1955, of what may have been a proposed Rileys Department Store exterior design; note the hardware store at the left (Pinterest 2019a).

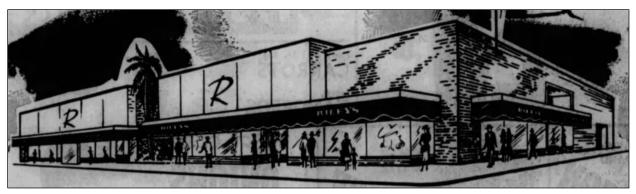
Figure 36. An advertisement published in 1962 featured the entire artist's rendering of the Chorro Street elevation (cf. Figure 17, above) (*Santa Maria Times* 1962b:6).

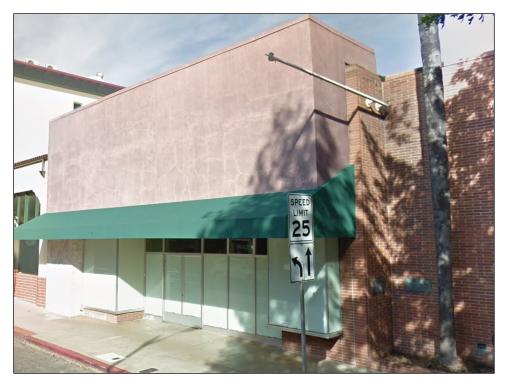
Figure 42. Former Union Hardware store building incorporated into Rileys in 1960, camera facing north (Google, November 2018).

The parcel is occupied by a rectangular commercial building made up of two adjoining buildings with a slight recessed area between them on the Chorro Street frontage. The building is one story high, with an interior mezzanine. City records (City Building Department, address file for 1144 Chorro Street) state that the building is Type III construction. The main structural support depends on a grid of columns and beams, with infilled exterior wall areas of Roman brick interspersed with anodized aluminum-framed plate-glass door and display-window assemblies. The west end of the Chorro Street elevation was built as the Union Hardware building in 1955 and incorporated into the main Rileys Department Store building in 1960. The façade of this portion is characterized by a tall, boxy, plain stuccoed wall that rises above a canvas awning running the width of the façade; the awning turns the corner to intersect with the brick wall in the recessed area (Figures 42 and 43).

Below the awning, the storefront configuration is different from the rest, reflecting its different origin as the hardware store, as well as later modifications. On the left side of the display windows, the wall is clad with marble slabs (Figures 44 and 45). The display windows on either side of the doorway are rectangular, rather than angled in toward the entrance. On the left side of the door, the display case is supported by a low bulkhead of Roman brick laid in a common bond pattern. On the right side of the door a smaller display window projects from the brick wall, with no supporting bulkhead; bricks below the window are laid in common bond, and to the right (at the edge of the recessed area) are laid in stacked bond. Both display windows and door assembly have plate glass framed in anodized aluminum (Figures 46 through 48).

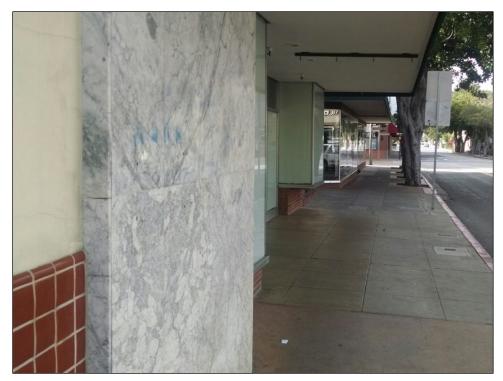
Figure 43. Overview down Chorro Street, camera facing east (Google, November 2018).

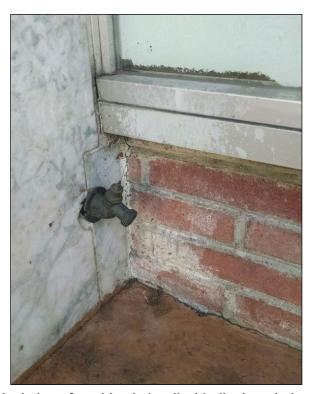
Figure 44. View down Chorro Street elevation, camera facing southeast (SWCA, May 5, 2019).

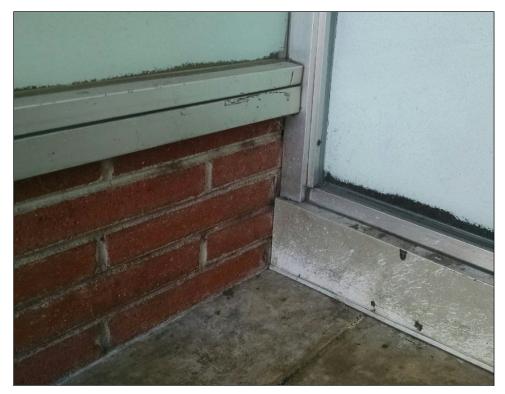
Figure 46. Articulation of rectangular storefront window, brick bulkhead, and door assembly on former Union Hardware building, camera facing north (SWCA, May 5, 2019).

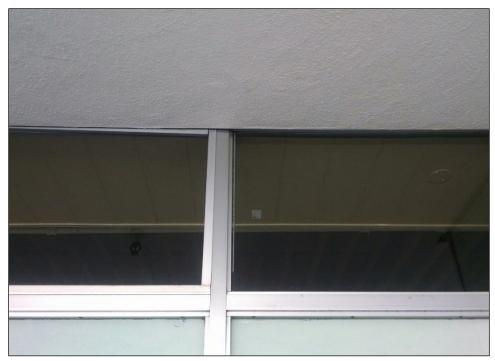
Figure 47. Door assembly, including transom and wall surface below awning, former Union Hardware building, camera facing northeast (SWCA, May 5, 2019).

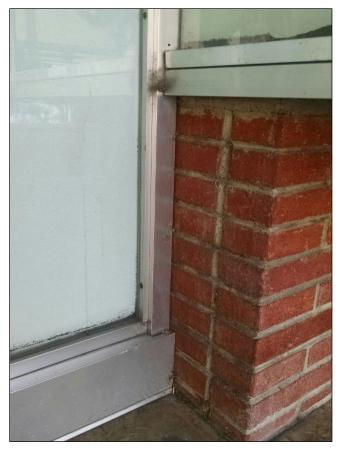
Figure 48. Articulation of door assembly with brick wall and projecting display window, camera facing east (SWCA, May 5, 2019).

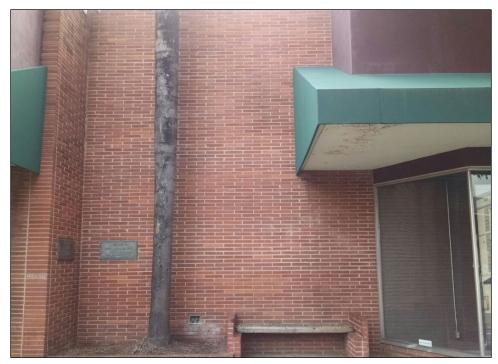
Figure 49. Approved plan for Copeland Sports project, 1992 (City of San Luis Obispo microfiche, 1144 Chorro Street). The red arrow shows the limits of the former Union Hardware building; the yellow arrow shows the location of the recessed area.

The recessed area that marks the transition between the former Union Hardware building and the original portion of the Rileys building is trapezoidal in plan (see Figure 49). This area is characterized by four prominent features: a tall Roman brick wall, laid in a common bond pattern; a pair of inset bronze memorial plaques to Herbert A. Landeck, Sr., and Coy C. Humphrey (co-owners and developers of the property in 1955); a tall palm tree in a low brick planter; and a brick and concrete bench (Figures 50–53). The bench is a more recent addition to this area; made of a mixture of brick types it is adjacent to the back wall but not tied into it (see Figure 50). The blocky upper wall and awning-covered canopy of the adjacent Rileys building project into the recessed area, intersecting the tall brick wall at different heights and angles. Additional exterior and interior photos are included as Figures 54 through

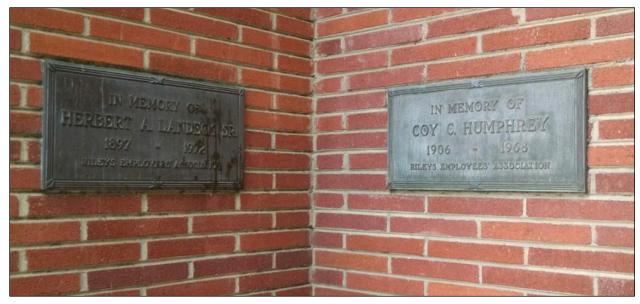
Figure 50. Recessed area on Chorro Street with Roman brick wall, memorial plaques, palm tree, and bench, camera facing northeast (SWCA, May 5, 2019).

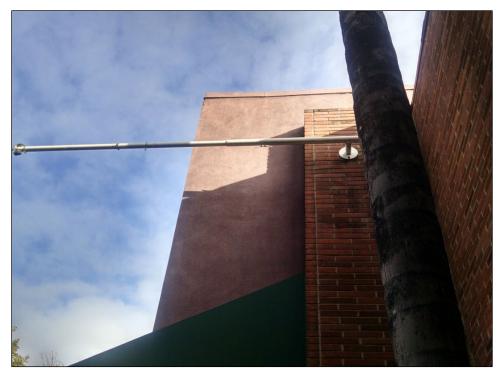
Figure 52. Articulation of brick masonry wall and concrete wall at recessed area, with palm tree and horizontal flagpole, camera facing northwest (SWCA May 5, 2019).

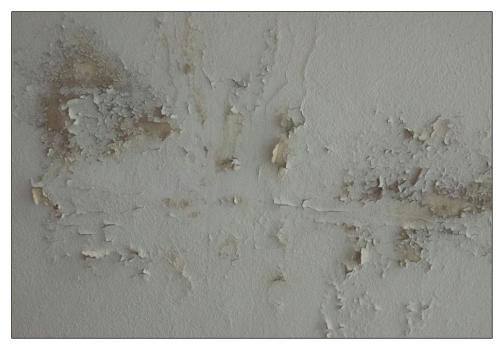
Figure 54. Underside of stuccoed canopy over Chorro Street sidewalk (SWCA, May 5, 2019).

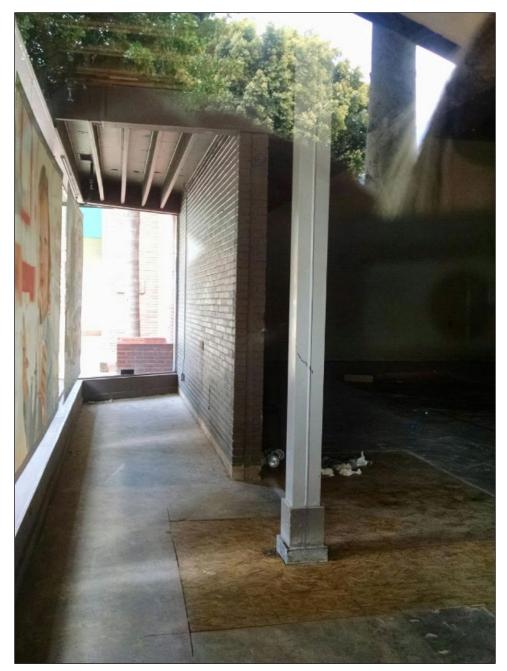
Figure 56. View of interior and recessed area beyond, through display windows, camera facing northwest (SWCA, May 5, 2019). The exterior brick wall extends into the enclosed space; the structural support for the canopy is also visible.

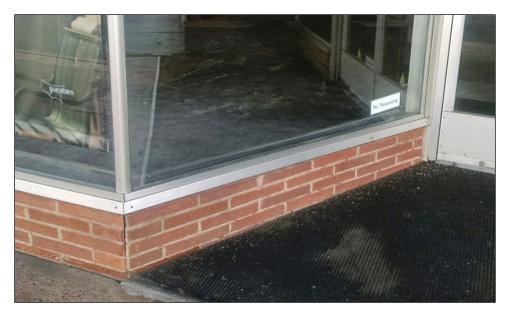
Figure 57. Angled display window at left side of main Chorro Street entrance, camera facing north (SWCA, May 5, 2019). Note gap in brick masonry at exterior corner of bulkhead.

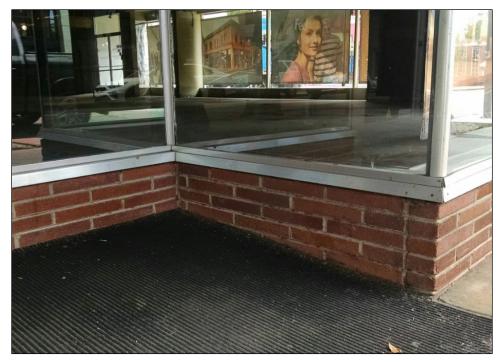
Figure 58. Right-angled corner of display window at right side of main Chorro Street entrance, camera facing east (SWCA, May 5, 2019). Inner corner of bulkhead brick masonry is not integrated into wall plane.

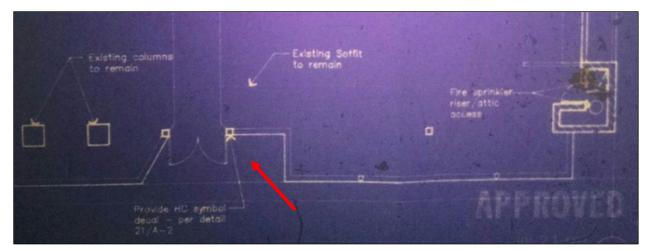
Figure 59. Approved plan for Copeland Sports project, 1992 (City of San Luis Obispo microfiche, 1144 Chorro Street). The red arrow indicates the trapezoidal shape of the main Chorro Street entrance.

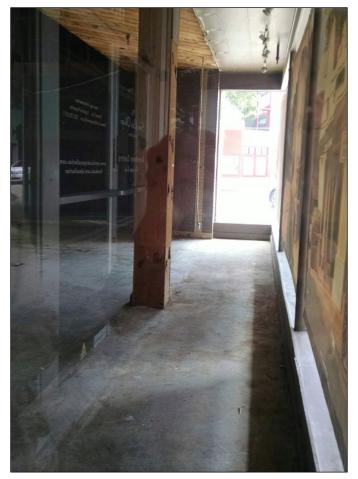
Figure 60. View through display window to Marsh Street corner, camera facing southeast (SWCA, May 5, 2019). Display window cases have been removed.

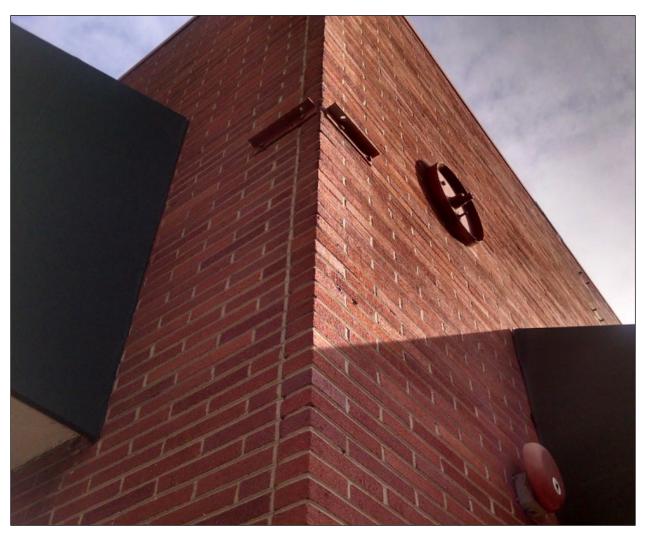
Figure 62. Articulation of Roman brick masonry walls at the corner of Chorro Street and Marsh Street, with brackets that formerly held the vertical Rileys sign and flagpole, camera facing north (SWCA, May 5, 2019).

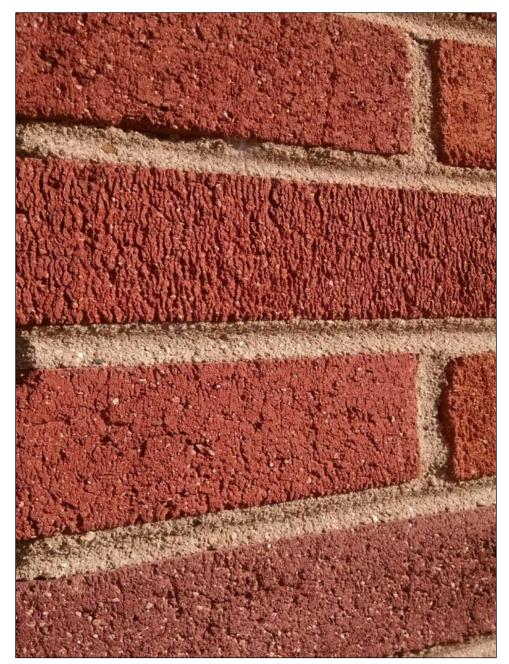
Figure 63. Detail of brick texture and inclusions in clay body; note well-executed concave mortar tooling (SWCA, May 5, 2019).

Most of the original Roman brick masonry is extant and still in excellent condition. The concave-tooled mortar also appears to be original, with no repointing or painting. Plate glass windows are still in place, and the aluminum frames are intact, though dinged and bent at street level in some locations. With the exception of the new black-framed doorway on Marsh Street (which constitutes a new and visually prominent material), the aluminum door assemblies are also original. New materials that have been added include the discordant application of marble slabs at the west end of the building, a canvas awning with a metal mesh screen attached to the bottom frame, and the concrete-topped bench.

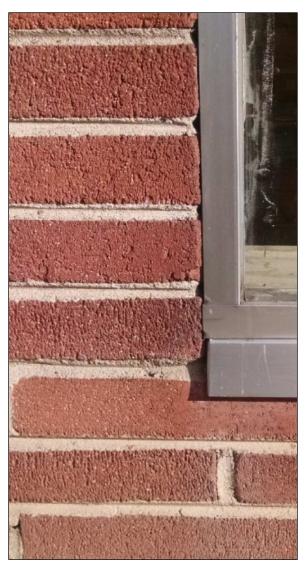
Figure 67. At west end of display window, aluminum frame is flush-mounted in brick wall, Marsh Street elevation, camera facing northwest (SWCA photograph, May 8, 2019).

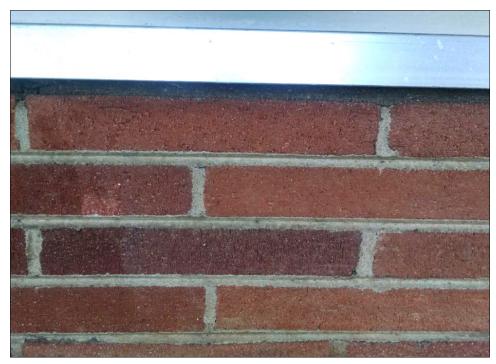
Figure 68. Roman brick masonry bulkhead on Marsh Street elevation, camera facing northwest (SWCA, May 5, 2019).

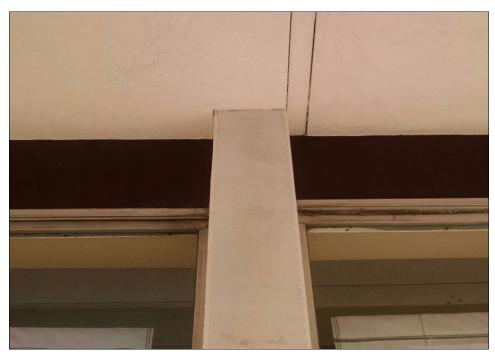
Figure 69. Upper wall surface, underside of canopy, and left concrete pillar of doorway portal, Marsh Street elevation, camera facing northwest (SWCA, May 5, 2019).

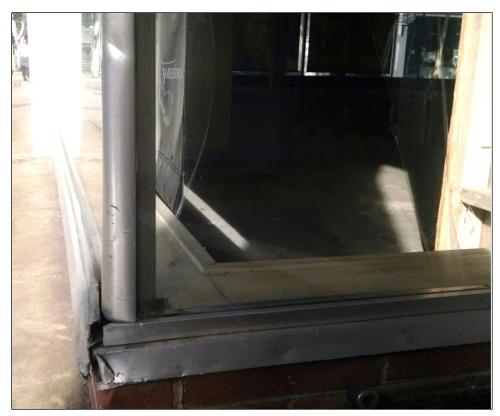
Figure 70. At east end of display window, aluminum frame flares out on top of brick masonry, Marsh Street elevation, camera facing west (SWCA, May 5, 2019).

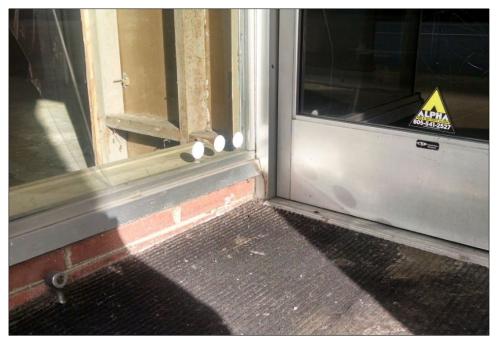
Figure 71. Articulation of brick masonry bulkhead, display window assembly, and door assembly, Marsh Street elevation, camera facing west (SWCA, May 5, 2019).

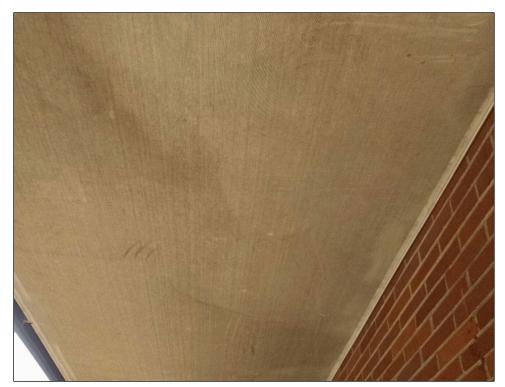
Figure 74. Metal mesh screening on underside of canvas awning, Marsh Street elevation, camera facing southwest (SWCA, May 5, 2019).

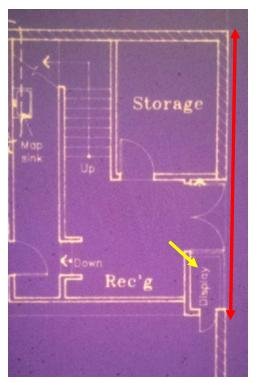
Figure 76. Approved plan for Copeland Sports project, 1992 (City of San Luis Obispo microfiche, 1144 Chorro Street). The red arrow indicates the area shown in Figures 69-73, below; the yellow area indicates a display case removed to accommodate the replacement door.

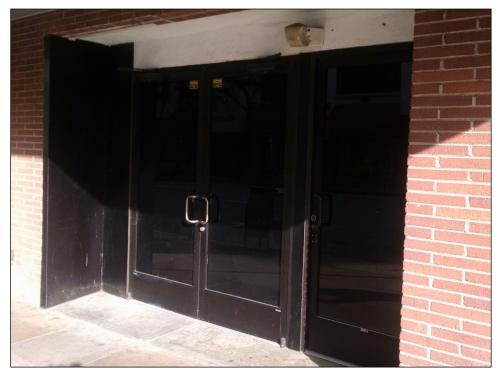
Figure 77. Replacement door assembly near alleyway on Marsh Street elevation, camera facing west (SWCA, May 5, 2019).

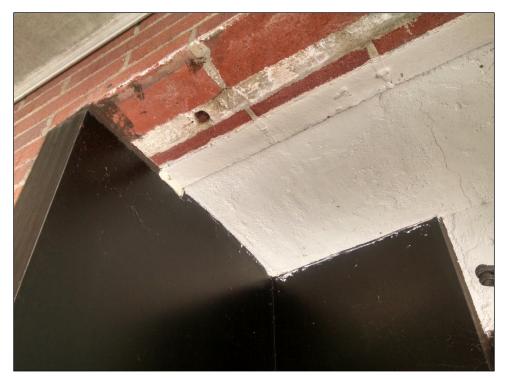
Figure 80. Upper corner of Marsh Street entrance near alleyway, showing where display window was formerly located, camera facing west (SWCA, May 5, 2019).

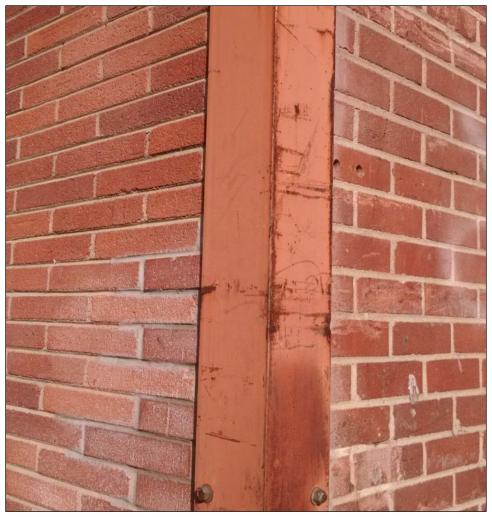
Figure 81. Steel angle bar protecting brick masonry at corner of Marsh Street alleyway behind Rileys building (SWCA, May 5, 2019). Note difference in brick type and dimensions, and in depth of mortar tooling, camera facing west.

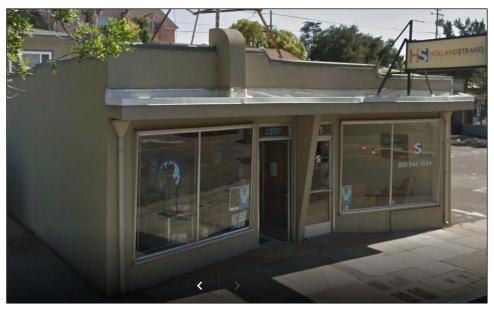
Figure 82. Modest example of early Mid-Century style, 1335–1337 Monterey Street (Google, November 2018).

By way of contrast, one modest example of the dawning use of Mid-Century elements in San Luis Obispo is the small two-unit commercial building at 1335–1337 Monterey Street (Figure 82), built in 1949, which includes a vertical element above the roof canopy, a jutting triangular wall feature between the two units, angled wall planes fronting on Monterey Street, and angled plate-glass windows that cant out slightly from the upper edge but are flush mounted at the lower edge. This is not meant to suggest superior workmanship or style, but to demonstrate that diagnostic elements of the Mid-Century design vocabulary were already being adopted in downtown San Luis Obispo in the late 1940s.

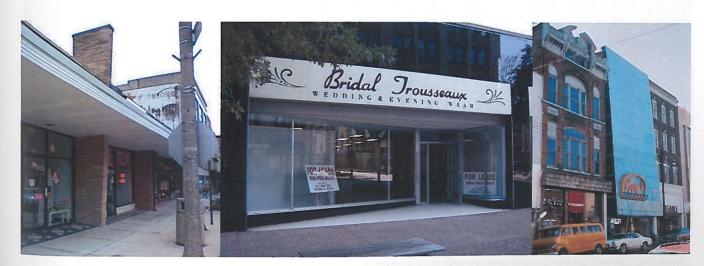
Figure 4: Left, a Freeport, Illinois, angled stone pylon. Center, a Moline, Illinois example of the common post-war angled open storefront, shown here in structural glass. Right, a much more unusual design angles the entire porcelain enamel facade out from top to base. Left photo: author, center and right photos: IHPA archives

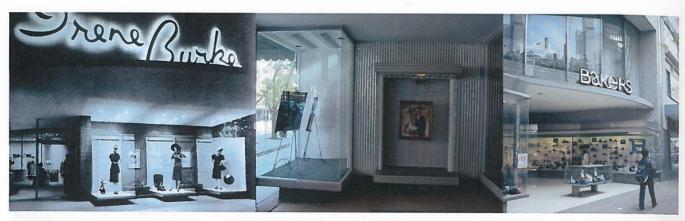
Figure 5: Cantilevered display cases in outdoor lobbies deconstructed the front plane of retail buildings. Left, a design in Long Beach, California, from Design for Modern Merchandizing, April 1948, p. 126. Center, similar displays in Bloomington, Illinois. Right, the former Bakers Shoes in Chicago, Illinois, had a free-standing display table, well lit cantilevered display cases and a curved open front display window on the second floor, photo: author. Center photo: IHPA archives.

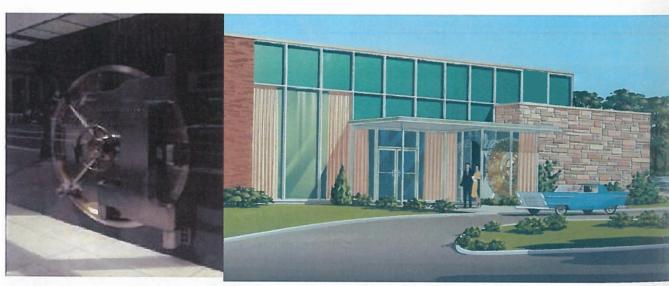
Figure 6: Right, the University Bank of Carbondale, by the Bloomsdale Bank Building & Equipment Co., c. 1960, combines a white metal curtain wall and projecting canopy with stone and brick. Between the customers and car, the modern bank vault door is visible through the open front. This bank was clearly influenced by the widespread publicity about Manufacturers Hanover Trust Branch Bank in New York. Left, a photo of the New York bank's vault door visible through the open front glazing, photo: author.

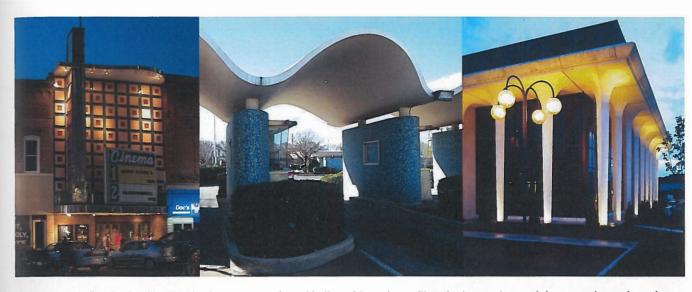
Figure 7: Left, a Taylorville, Illinois cinema was refaced in the mid-century with polychromed porcelain enamel panels and a swooping stainless steel and aluminum canopy, roof and dramatic pylon, photo: IHPA archives. Middle, the elegant Oklahoma City, Oklahoma, Central Motor Bank drive-up, built in 1959, combines a thin-shell concrete roof with bright blue mosaic tile encased piers, photo: Ann V. Swallow. Right, precast concrete columns surround a dark curtain wall on this Moline, Illinois, bank, designed by John Van Scheltema of the Illinois Bank Building Corporation in the 1970s, photo: John Van Scheltema.

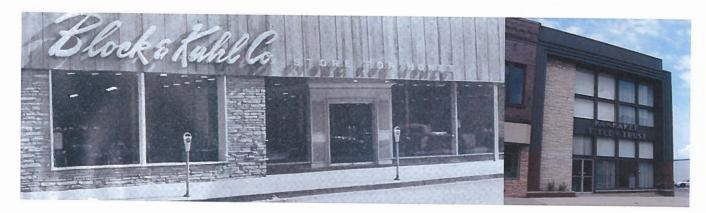
Figure 9: Left, Block & Kuhl's "California style" remodeling by Raymond Loewy Associates in Danville Illinois. From the National Magazine of the Home Furnishings, August 1948, 43. Right, the Kankakee Title and Trust in Kankakee, IL, also combines wood, stone and asymmetry in its elegant facade. Photo: IHPA archives.
