Stratford Kings River Bridge Replacement

Natural Environment Study

State Route 41 in Kings County, CA

February 2020

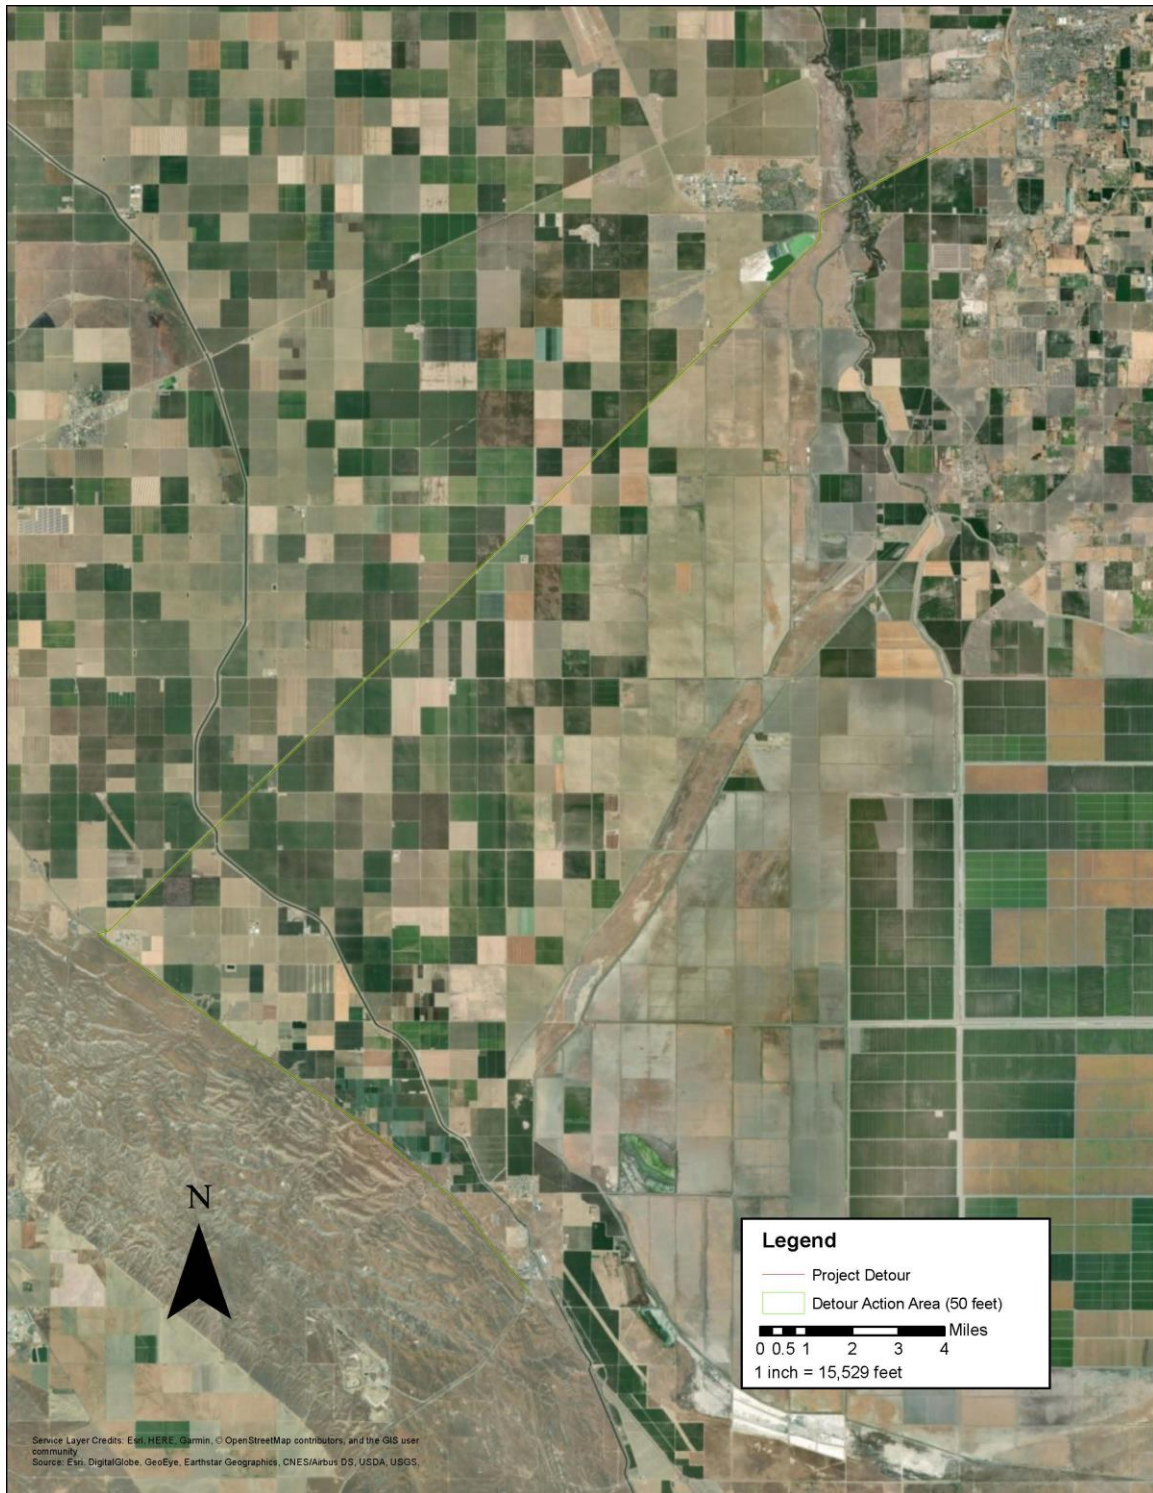
Figure 4: Detour Action Area

The 32-mile detour action area consists of Caltrans right-of-way which contains ruderal and invasive species. The action area also includes the Avenal Kings River bridge and its banks, and the California Aqueduct. Most of the lands in the action area preceding south on Avenal Cutoff Rd that do not fall within Caltrans right-of-way are agricultural, including fallow or grazed lots, row crops, and fields of dry grain crops. The action area phases into valley salt scrub and valley grassland west of I-5 and borders I-5 to the west all the way to the Kettleman City exit. Continuing north on SR 41 through Kettleman City, the action area consists of ruderal and invasive species bordered by agricultural fields just outside the Caltrans right-of-way.

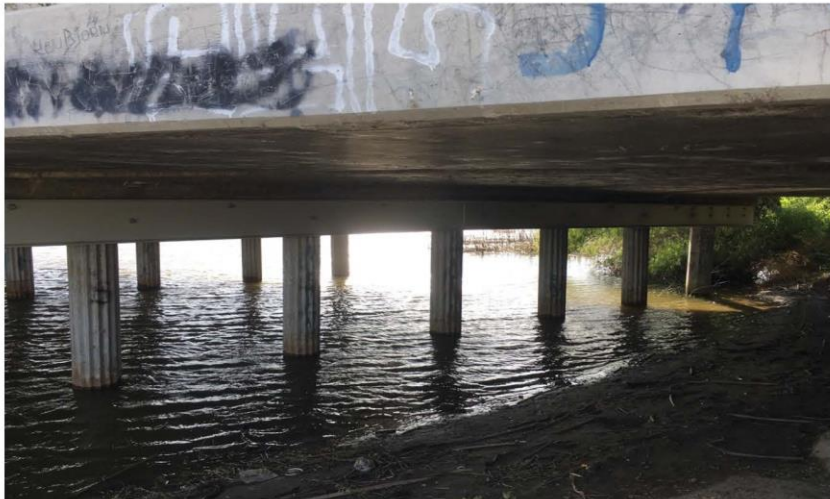
May 24, 2018. View of the underside of the bridge looking northwest from the eastern side of the bridge.

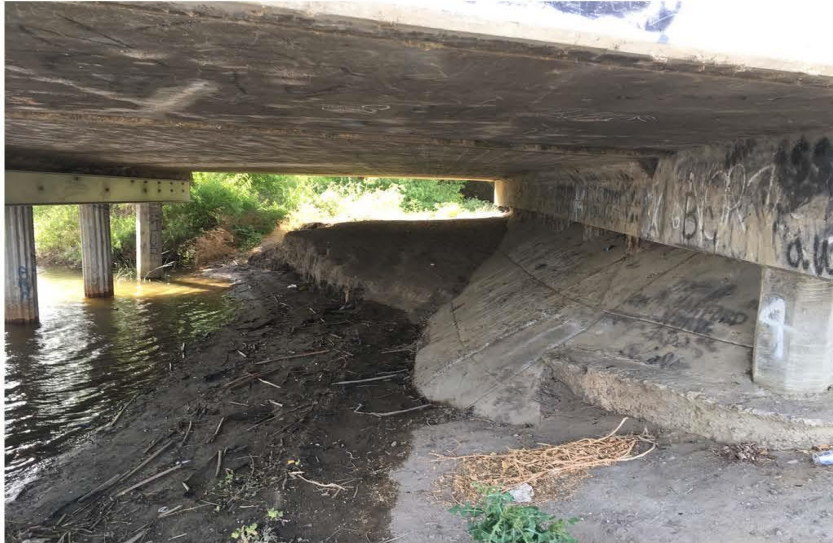
May 24, 2018. View of the eastern bridge abutment.

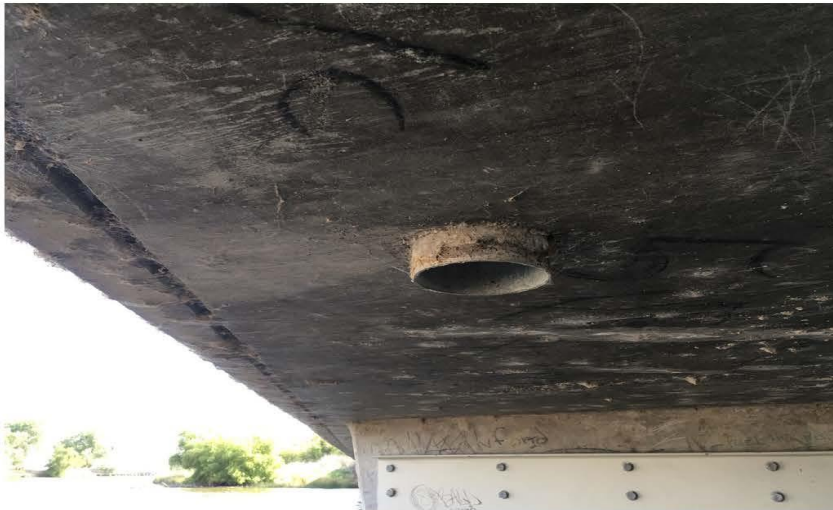
May 24, 2018. Weep hole extending through the deck of the bridge.

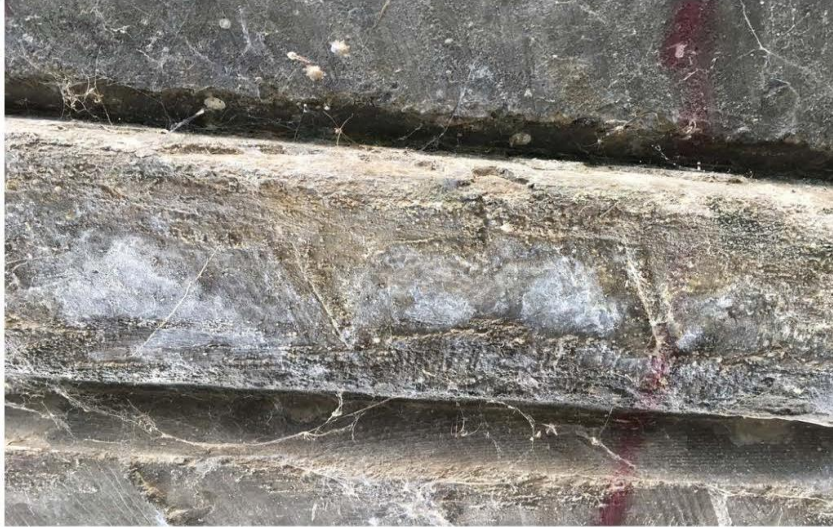
May 24, 2018. Groove extending the length of the underside of the bridge.

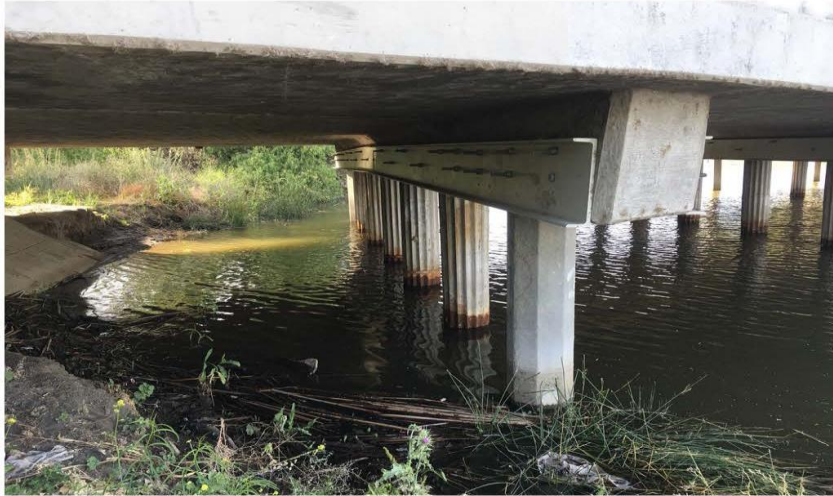
May 24, 2018. View of underside of bridge from western abutment.

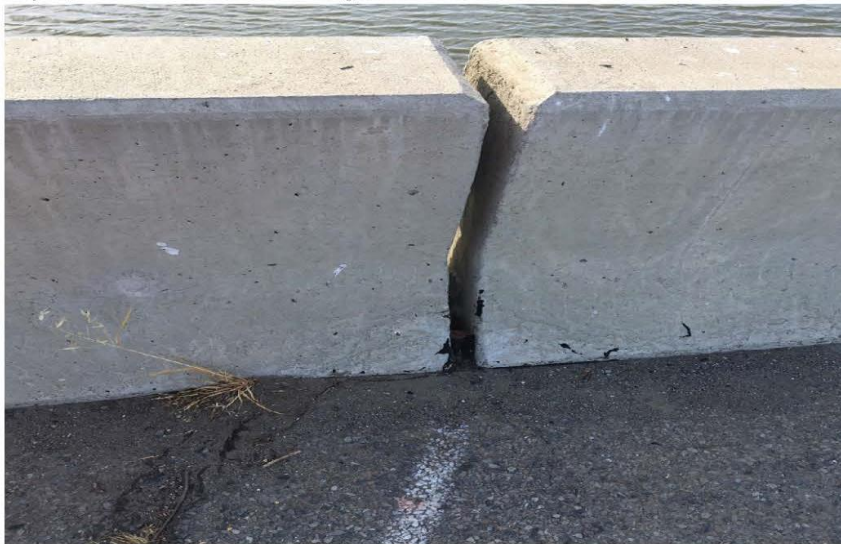
May 24, 2018. View of joint from the top of the bridge. The joint extends through the bridge from the top of the bridge and creates a 1.5" to 2" gap across the underside of the bridge.

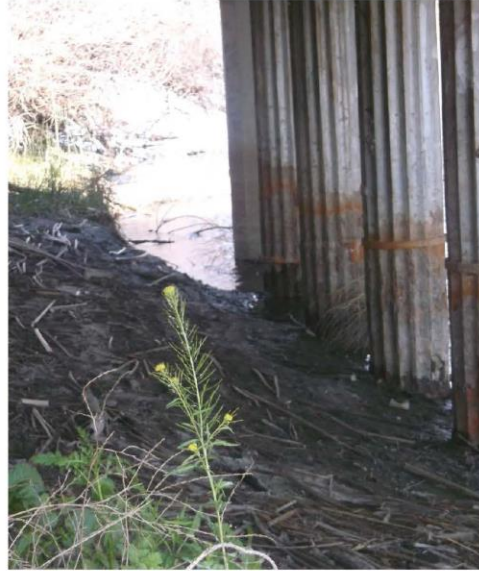
Representative Photo 2: Kings River Bridge with water-stained columns and wrackline of debris, facing north.
