ARCHIVES
&
ARCHITECTURE

RE: Historical Evaluation Update – 3585 El Camino Real, Palo Alto, CA
APN# 132-40-058

Summary of Findings

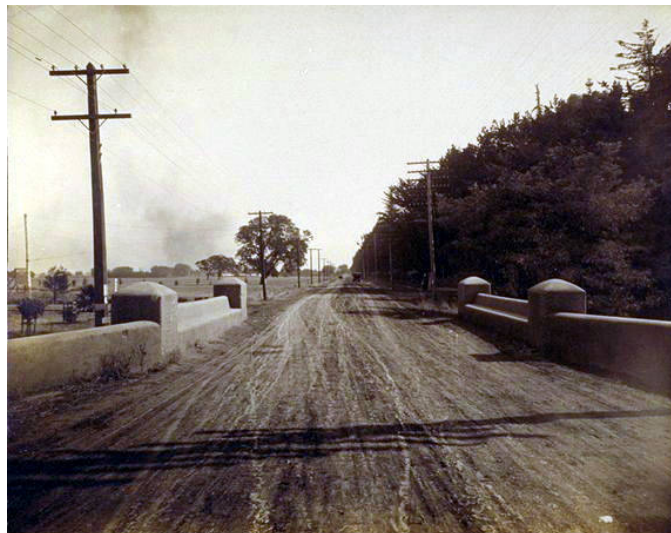
"View of El Camino Real looking south from Mayfield" Image from Palo Alto Historical Association, Guy Miller Archives <http://archives.pahistory.org/u/?PAHA.77>. The subject property is to the left, past the Matadero Creek Bridge. Unknown date, but "automobiles are visible"

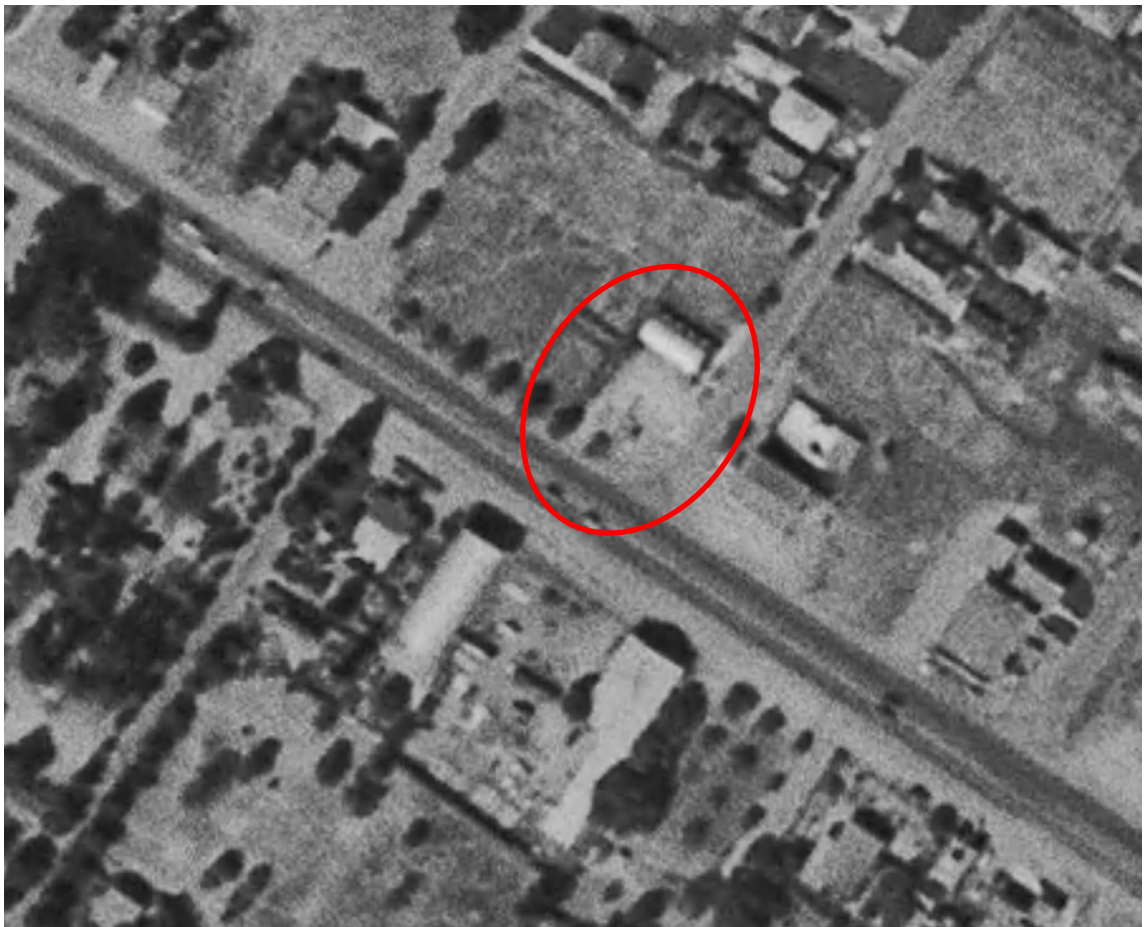
1948 Aerial View, showing building on property and sparse surrounding development. Note the building to the southeast, the previous repair shop operated by F.G. Simonini.

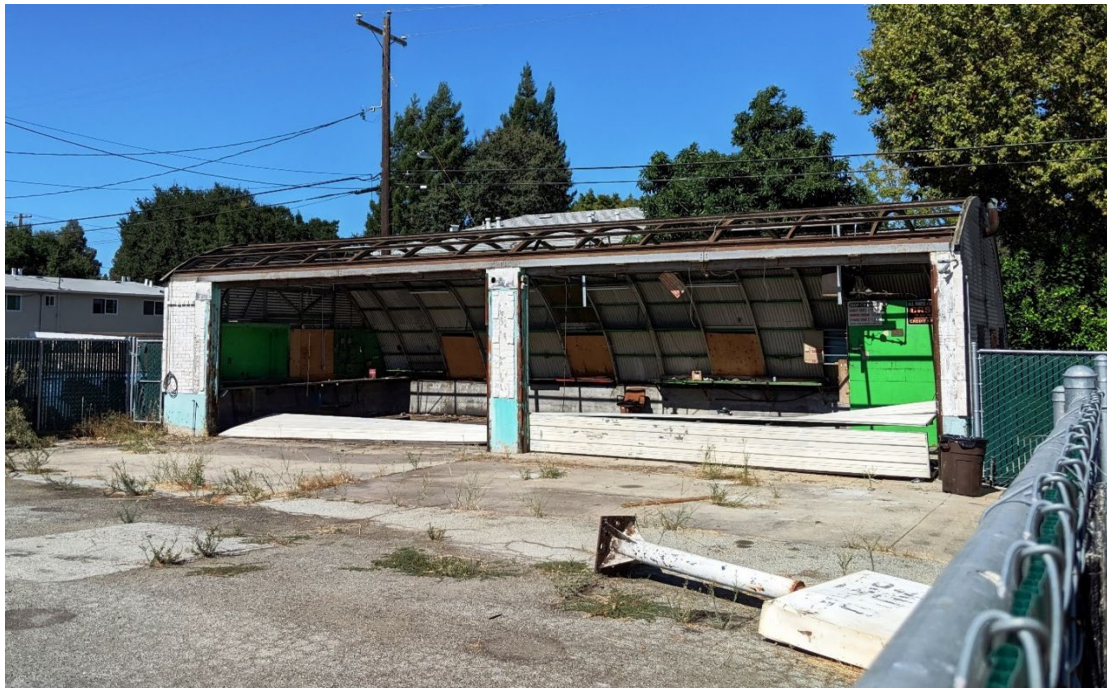
The west façade features two wide garage openings. County Assessor records indicates that the original design of the building included three smaller overhead doors and one window. The northernmost of the three remaining narrow wall segments, at the corner, is clad with decorative brick veneer above the concrete pony wall. It features a recessed brick panel laid in a Dutch bond, with a pattern of projecting bricks (tooths) at the top of the panel, suggesting a pilaster capital. The sides of the wall segment are outlined with a running bond of bricks. The central wall segment consists of a pair of vertical brick lines with regularly spaced toothes; the material of the relatively smooth central panel could not be confirmed. The southern wall segment is no longer clad, but a portion of vertical running bond remains at the outer corner. All of the brickwork has been painted. The aluminum overhead garage doors, currently in disrepair, were permitted for replacement in 1976 (Palo Alto City Building Permits).

*Front (nominally west) Façade of 3585 El Camino Real, viewed facing north, September 2019
Photo by Leslie Dill (See also additional photographs at end of report)*

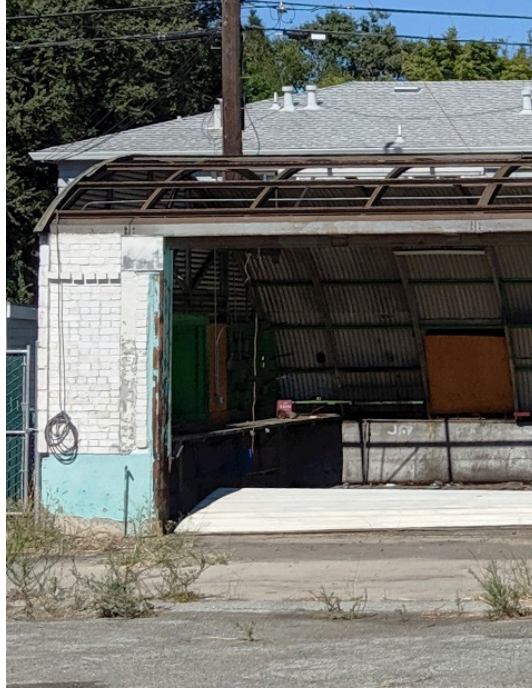
*Front (nominally west) Elevation Detail facing north.
Illustrates brickwork at northwest corner and loss of roofing.*

Workmanship: The essence of a Quonset hut is in its prefabricated materials and construction techniques, rather than with artisanship or human construction skills; this aspect of integrity is not fully applicable to the relocated Quonset hut. The brickwork that is evident on the front façade,

apparently an original alteration, has been lost after the remodeling of the garage openings. The pylon sign does not have forms, details, or materials that represent artisanship of high quality. The limited workmanship of the site does not retain historic integrity.

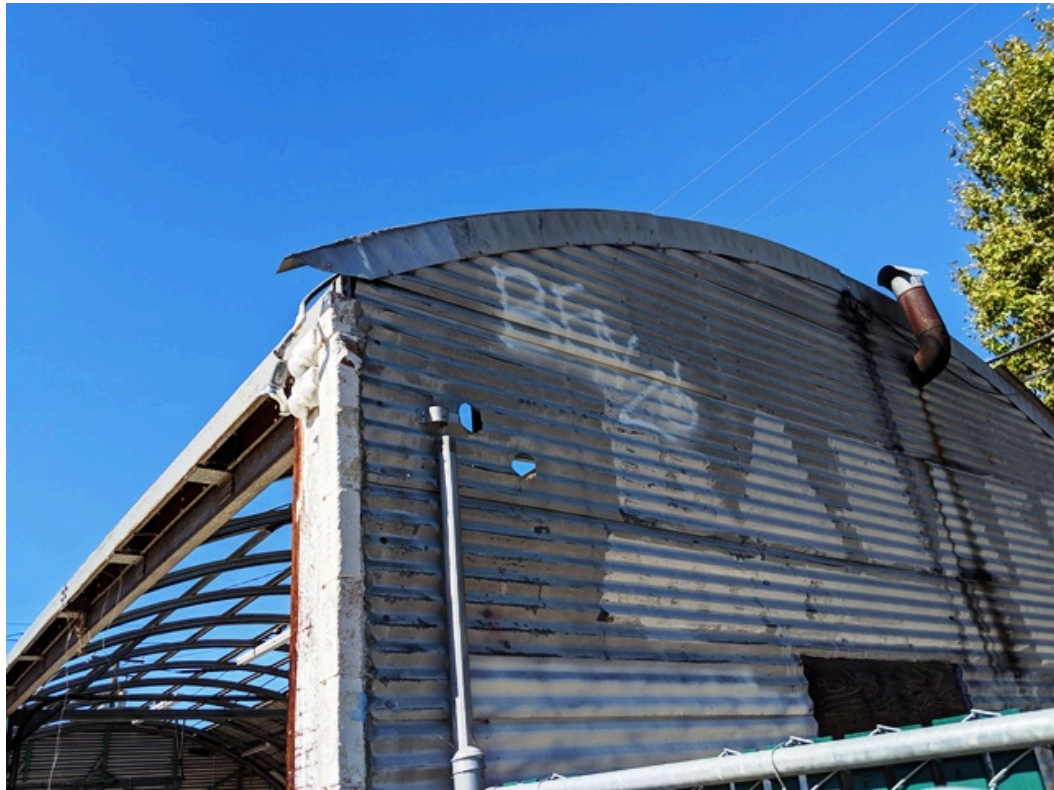
*Detail of nominally southwest corner, viewed facing north.
Illustrates original corrugated siding, original structural members, missing roofing, and loss of brickwork at corner.*

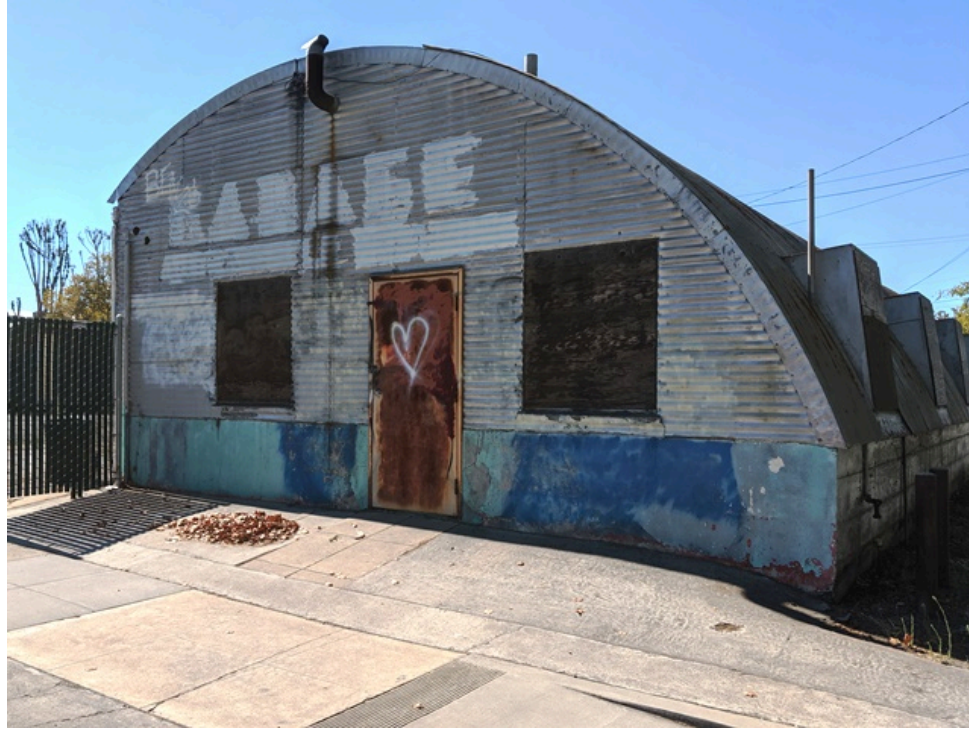
The south façade is 3/4 of an arch with an offset entry doorway and two boarded-up windows that asymmetrically flank it. The Assessor computation indicates that there was only one window on this façade in the mid-1940s, so the current composition is not original to the relocation. The rear façade features four dormer windows with sheet-metal side walls and almost-flat sheet-metal roofs. Beneath the windows are flat or slightly curved panels of unknown material, once painted red. The rear window openings are boarded up, inside and out, but the County assessor referred to them as “wired windows” and “steel frame sash.” The north façade mirrors the south façade in shape. It includes two closely spaced, slightly offset windows, currently boarded up. No windows are indicated on the original plan.

*South Side Elevation facing northwest.
Illustrates original roof form with truncated front wall, added windows and door, and roof trim following arched end.*

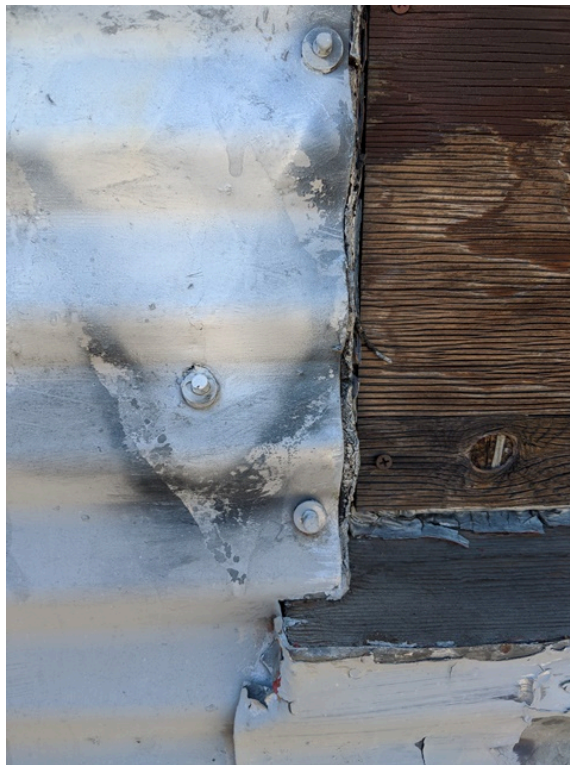
*Detail of South Elevation from the south.
Illustrates the materials and connectors.*

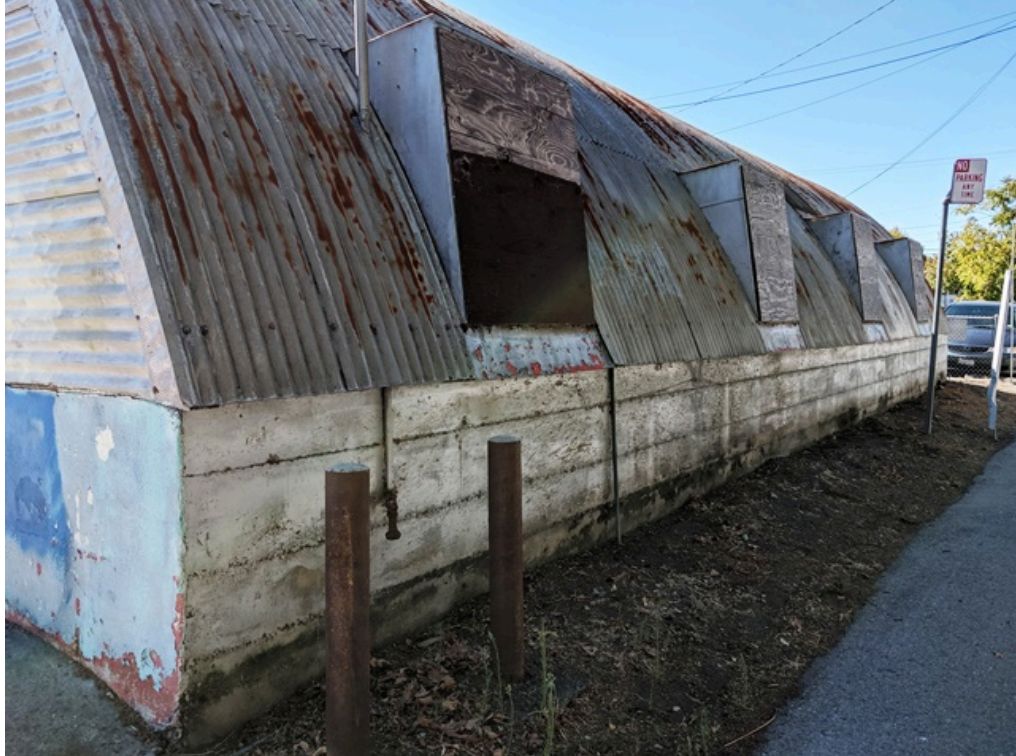
*Rear (east) elevation from south.
Illustrates concrete pony wall, dormer form of windows, and unplanted rear setback strip.*

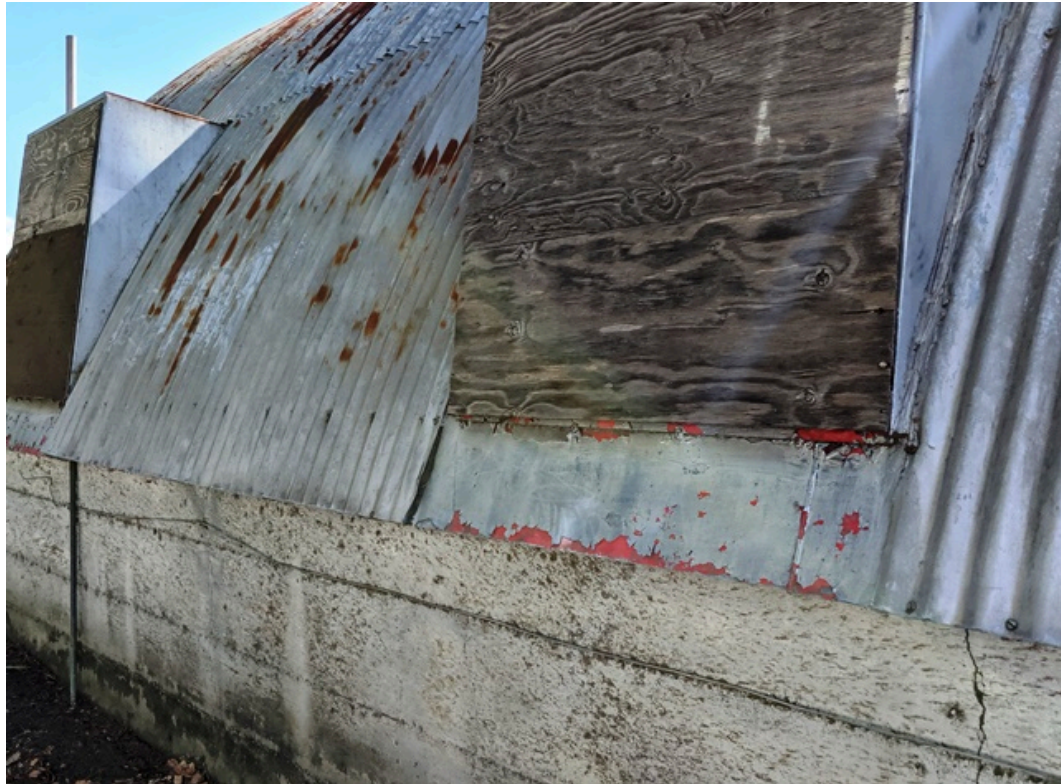
*Detail of East Elevation from the north.
Illustrates concrete pony wall, boarded-up windows, and smooth panel beneath the window.*

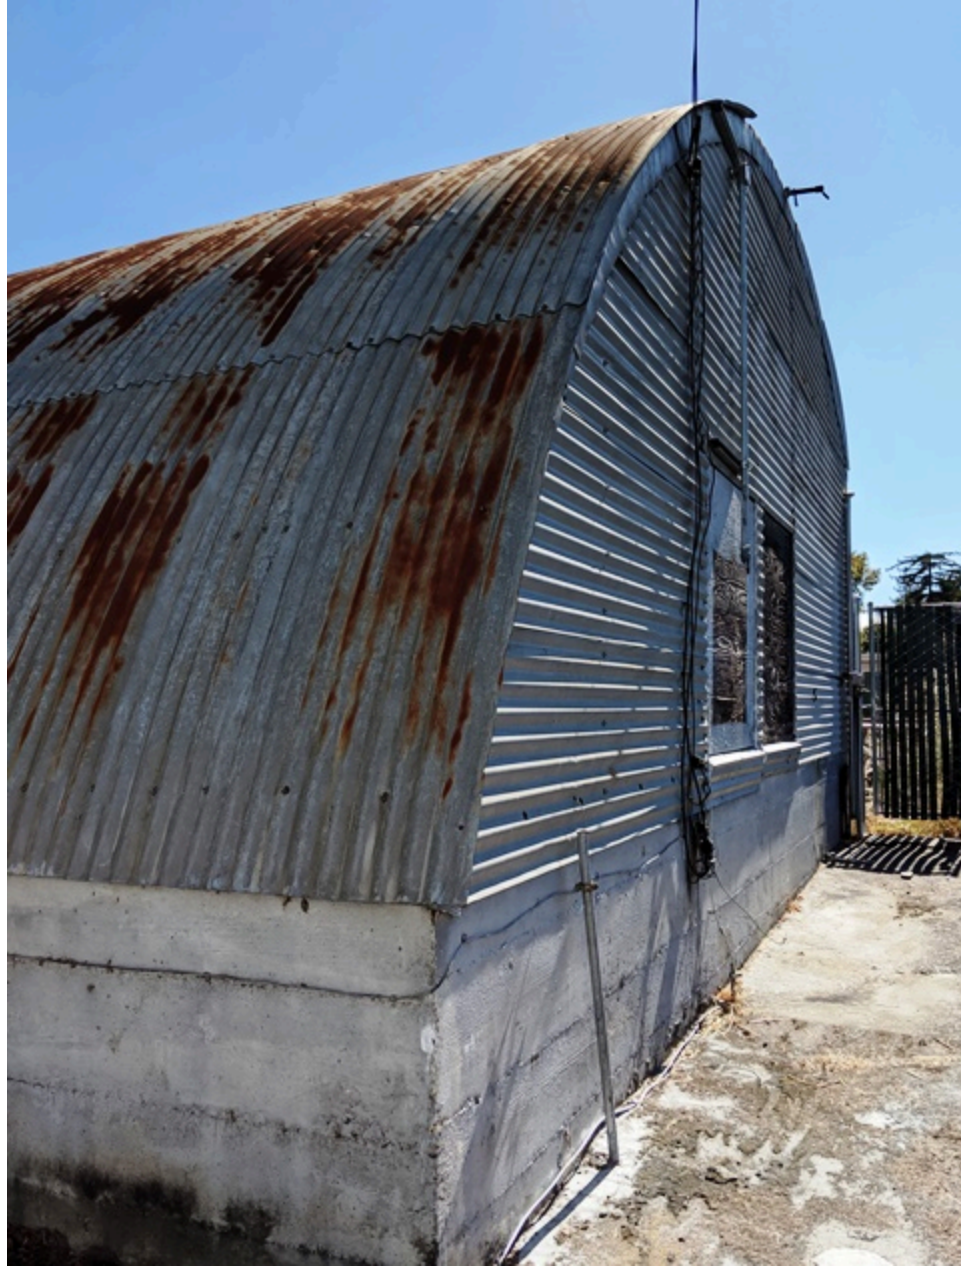
*North Side Elevation, viewed facing southwest.
Illustrates arched form, concrete pony wall, added windows, and concrete setback paving.*
