# San Tomas Aquino Creek Trail Project (Reaches 1 & 2)

## **Initial Study**

Public Draft
June 2020
City of Campbell

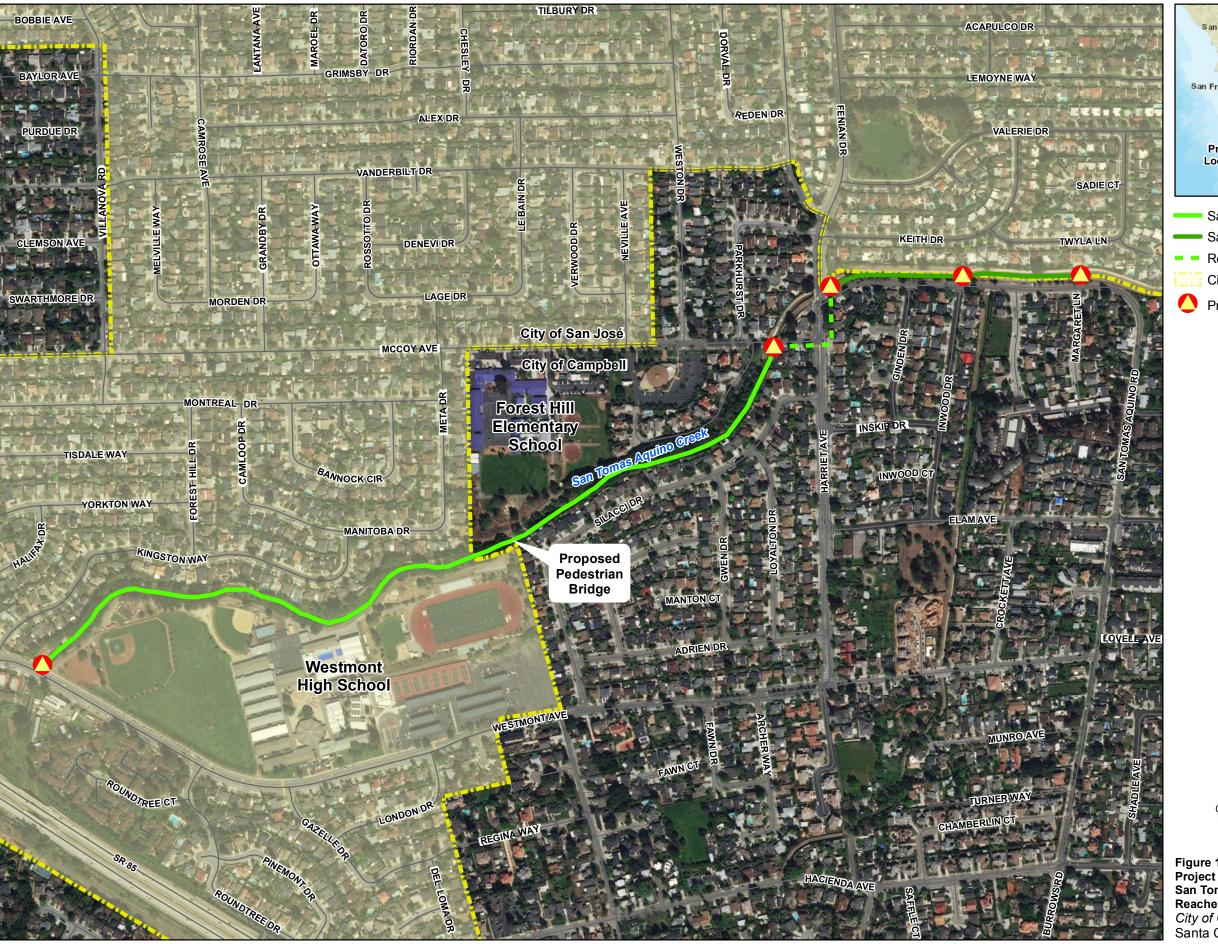
Figure 1
Project Location
San Tomas Aquino Creek Trail
Reaches 1 & 2 Project
City of Campbell
Santa Clara County, California

- San Tomas Aquino Creek Trail (Reach 1)
- San Tomas Aquino Creek Trail (Reach 2)
- Reaches 1 & 2 Connection
  - City of Campbell/City of José Boundary
- Proposed Trailhead
