**CULTURAL RESOURCES
STUDY FOR THE COUNTY ROAD
AND EAST END AVENUE PROJECT**

**CITY OF CHINO,
SAN BERNARDINO COUNTY, CALIFORNIA**

October 25, 2019

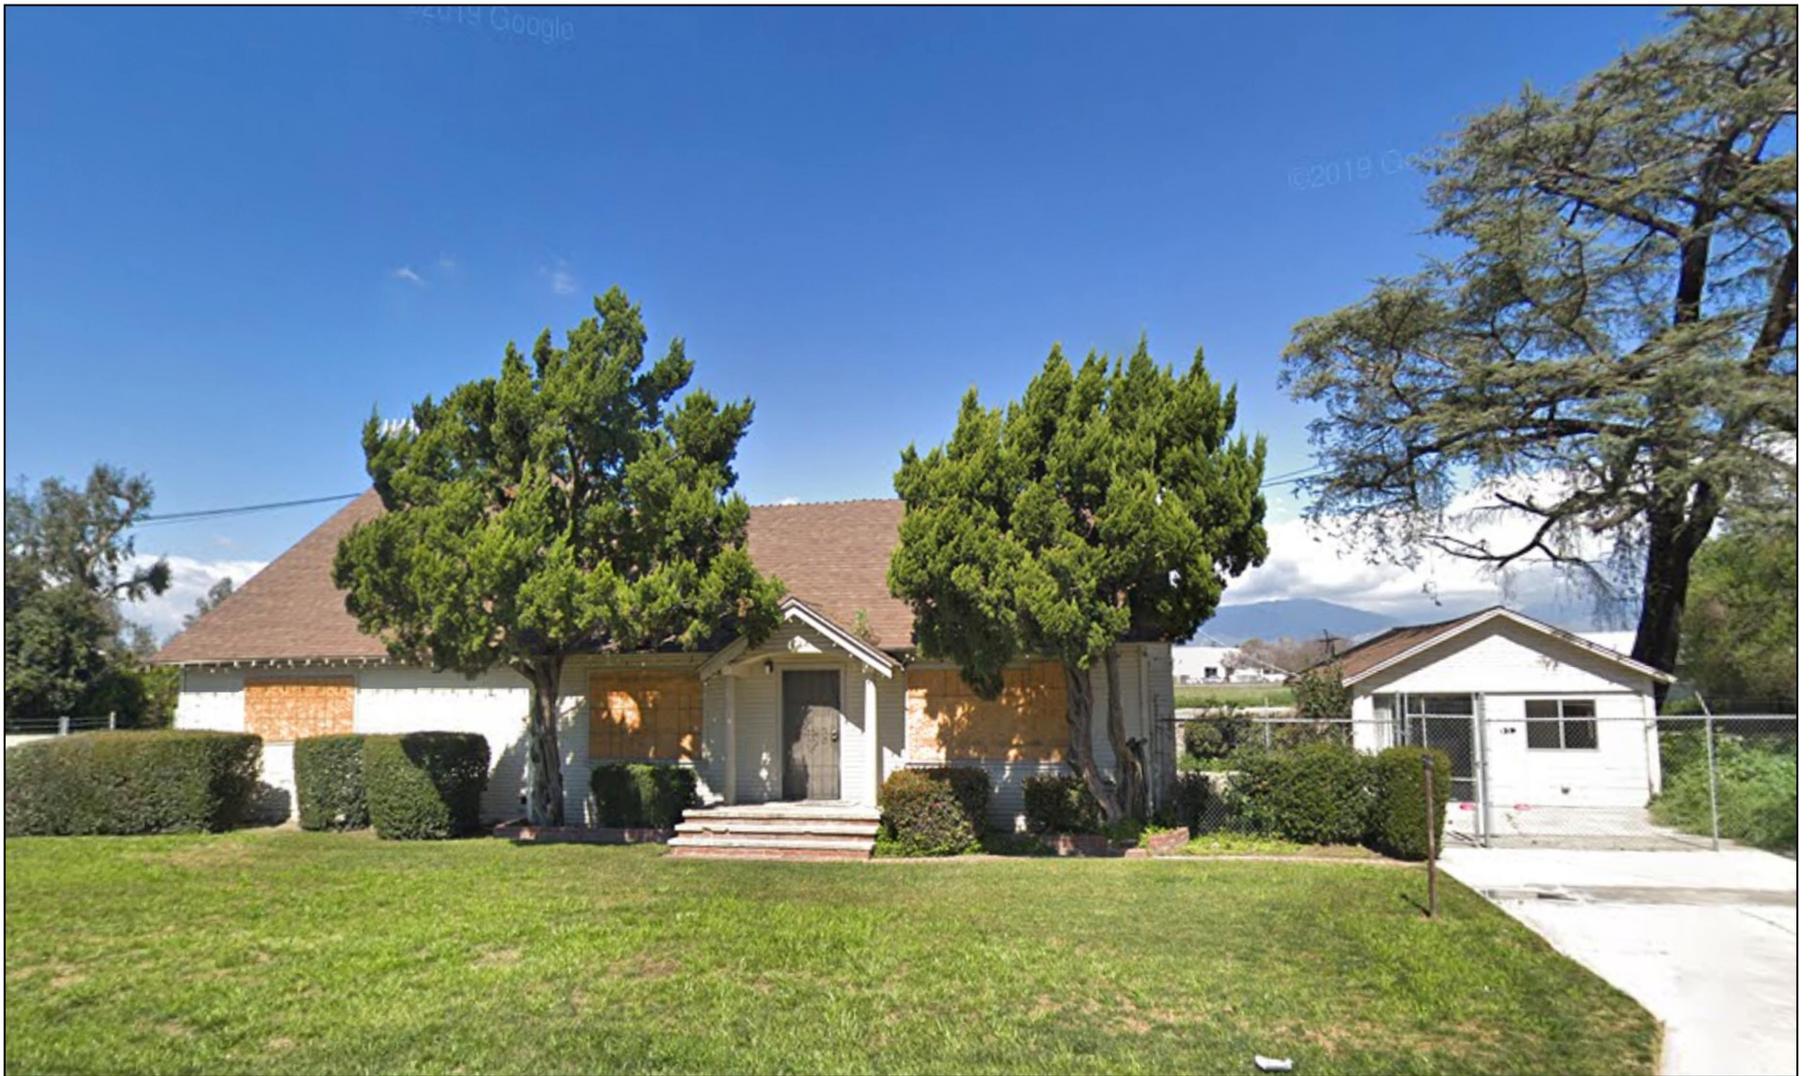
Plate 3.2-5

**2019 View of the South Façades of the Residence (Left) and
Detached Garage (Right) at 3592 County Road, Facing North**

The roof of the building is moderately pitched and possesses a moderate eave overhang with exposed rafter tails and is covered in composite shingles (see Plate 3.2–5). The residence was built using standard frame construction on a concrete foundation with floor joists and a subfloor. The building features horizontal clapboard siding and originally possessed wood-framed, double-hung windows. A brick chimney is located on the east façade toward the front of the house (Plate 3.3–11). Toward the rear of the east façade of the side-gabled portion of the building is a small porch that is recessed beneath the second floor (Plate 3.3–12).

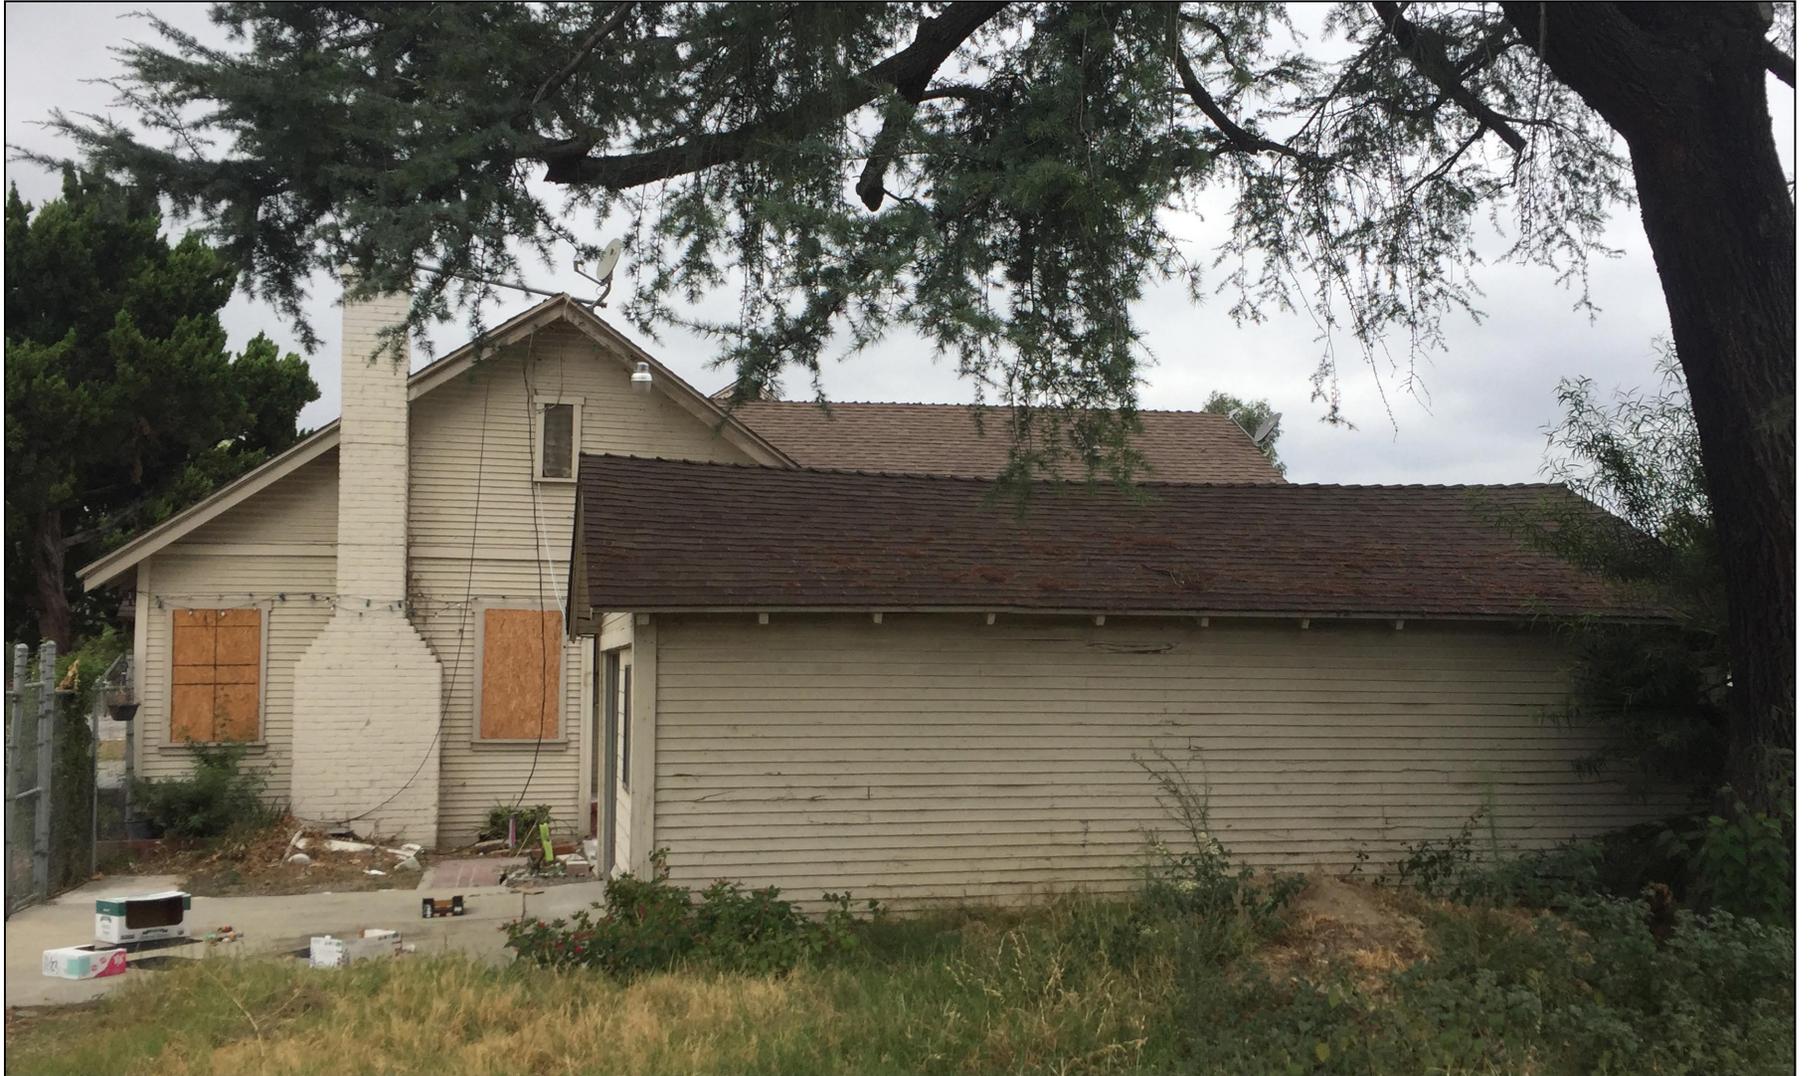
Plate 3.3-11

**View of the East Façades of the Residence (Behind) and
Detached Garage (Front) at 3592 County Road, Facing West**

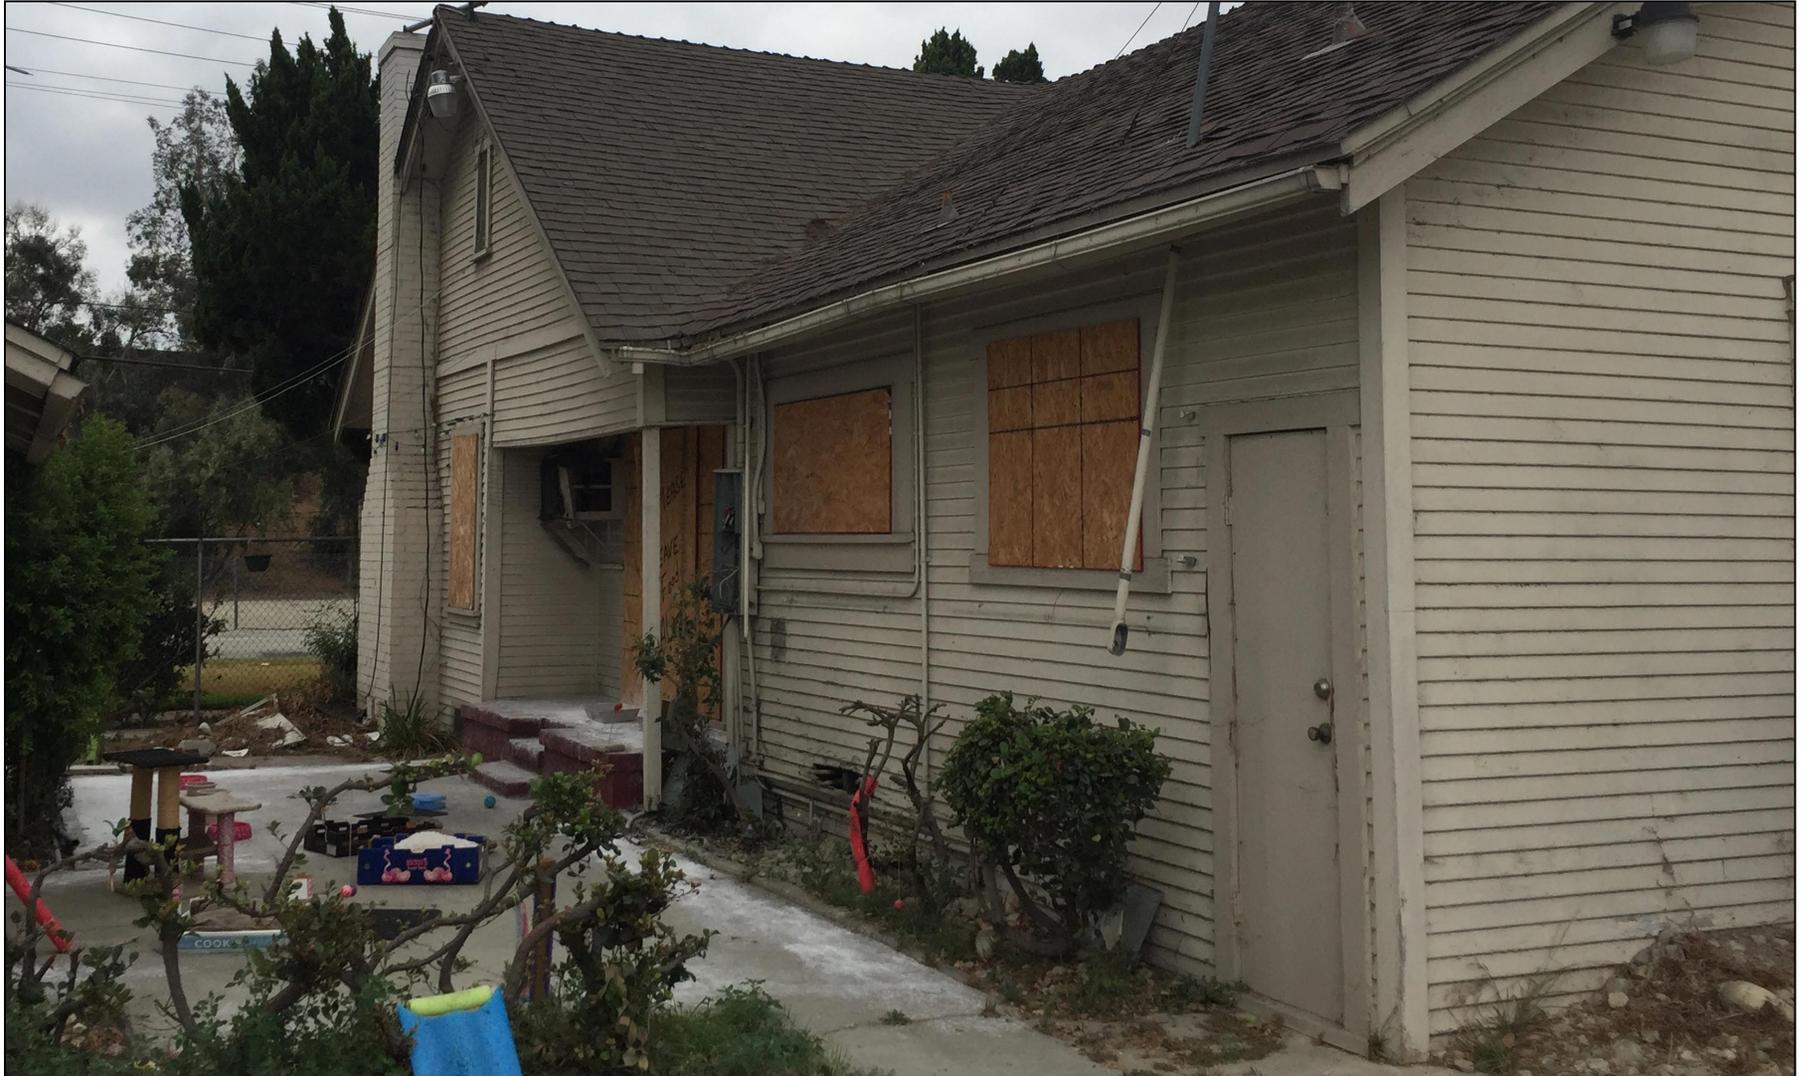
Plate 3.3-12

**View of the East (Left) and North (Right) Façades of the
Residence at 3592 County Road, Facing Southwest**

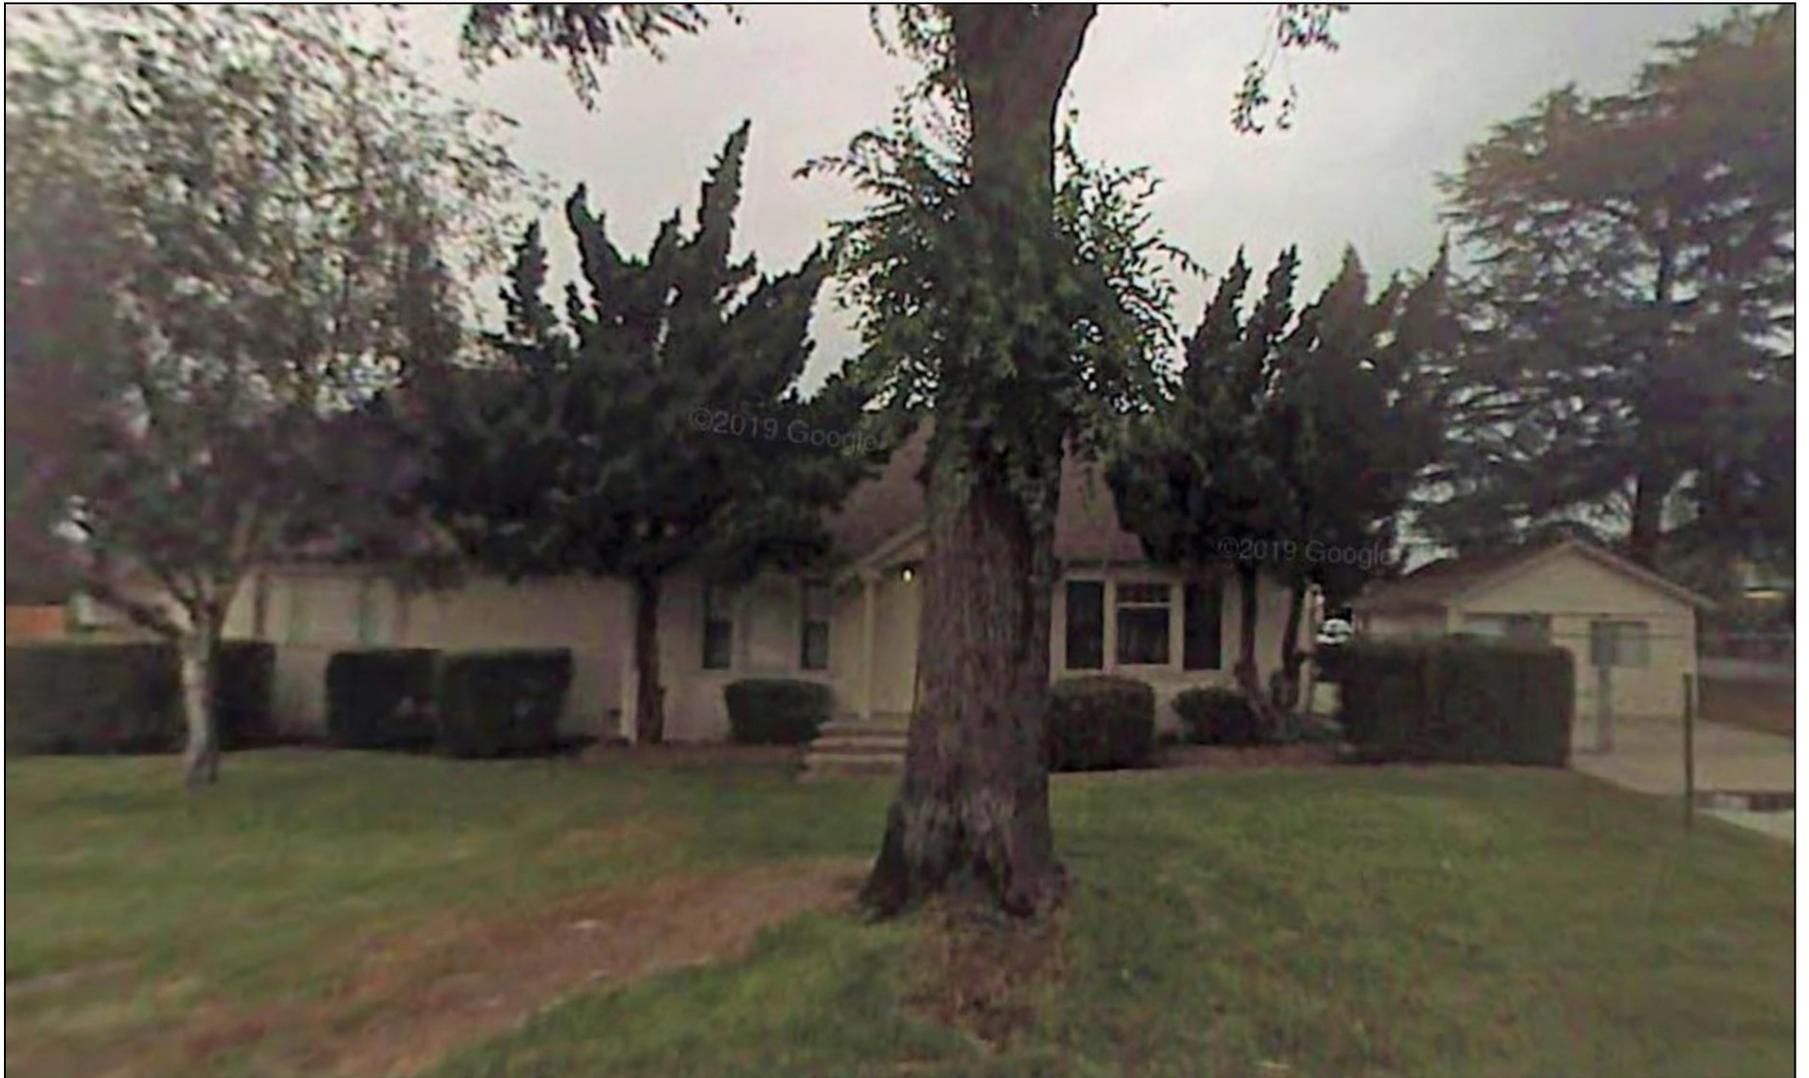
Plate 3.3-16
2007 View of the South Façade of the Residence at 3592 County Road, Facing North
The County Road and East End Avenue Project
(Image courtesy of Google Street View)

Although all windows on the building are currently boarded over, they are visible in 2007 (see Plate 3.3–16) and 2018 (Plate 3.3–17). Fenestration appears the same in both years, but the 2018 imagery is of better quality. In the images, the windows on the south façade of the original portion of the residence include two multi-lite, fixed windows on either side of the front door, which are flanked by two double-hung windows. The double-hung windows, however, appear to be metal-framed, which indicates that the original, wood-framed sashes were replaced prior to 2007. On the east façade, original, double-hung, wood-framed windows are visible flanking the chimney in Plate 3.3–16 and Plate 3.3–17. At an unknown date, a window on the north façade of the 1897 to 1927 addition was replaced (see Plate 3.3–13). The addition likely housed the kitchen, as the window that was added was an aluminum-framed, bump-out window, which is a style typically added in kitchens near or above the sink.

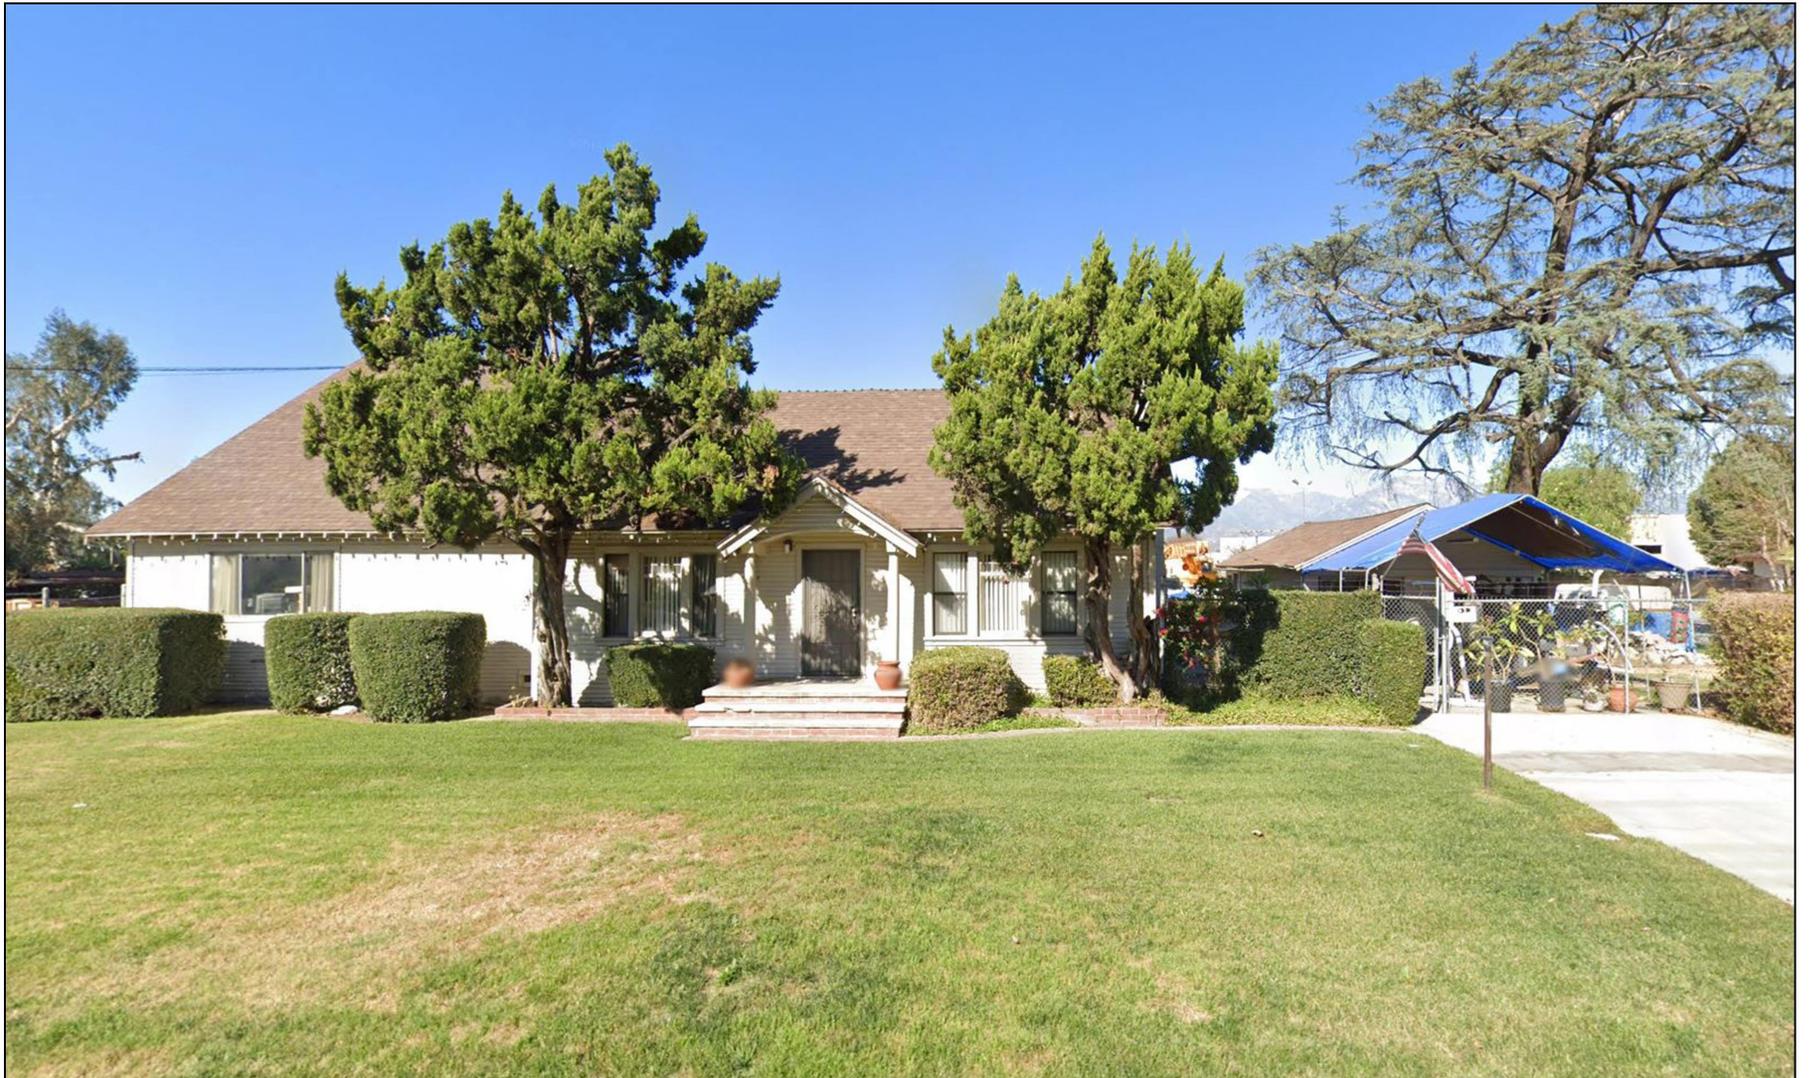
Plate 3.3-17
2018 View of the South Façade of the Residence at 3592 County Road, Facing North

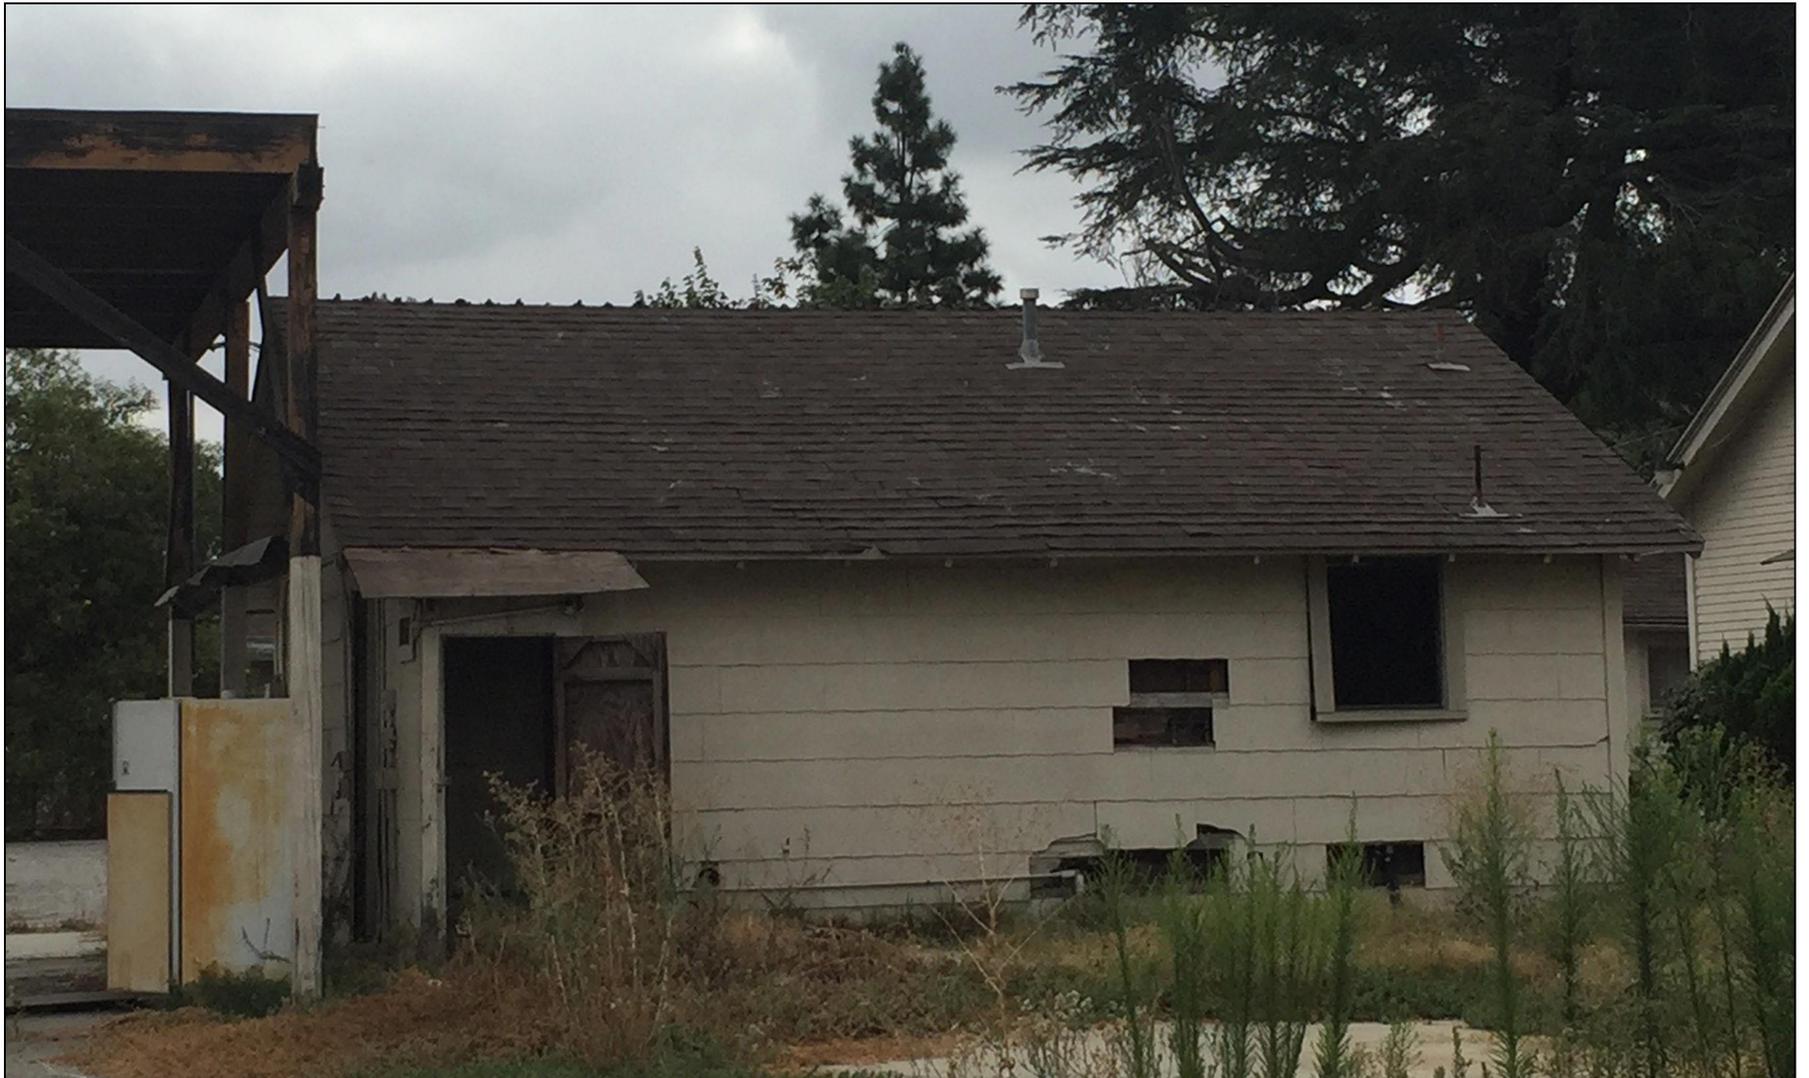
Plate 3.3-20

The outbuilding that is currently immediately north of the residence has a similar roof form as the residence and detached garage (moderately-pitched, front-gabled, with open eaves and exposed rafter tails), but exhibits wide-board, horizontal wood siding rather than the narrow clapboard siding on the other two buildings (Plate 3.3–19). All windows and doors appear to have been replaced fairly recently and it is unclear what the original materials were (Plate 3.3–20).

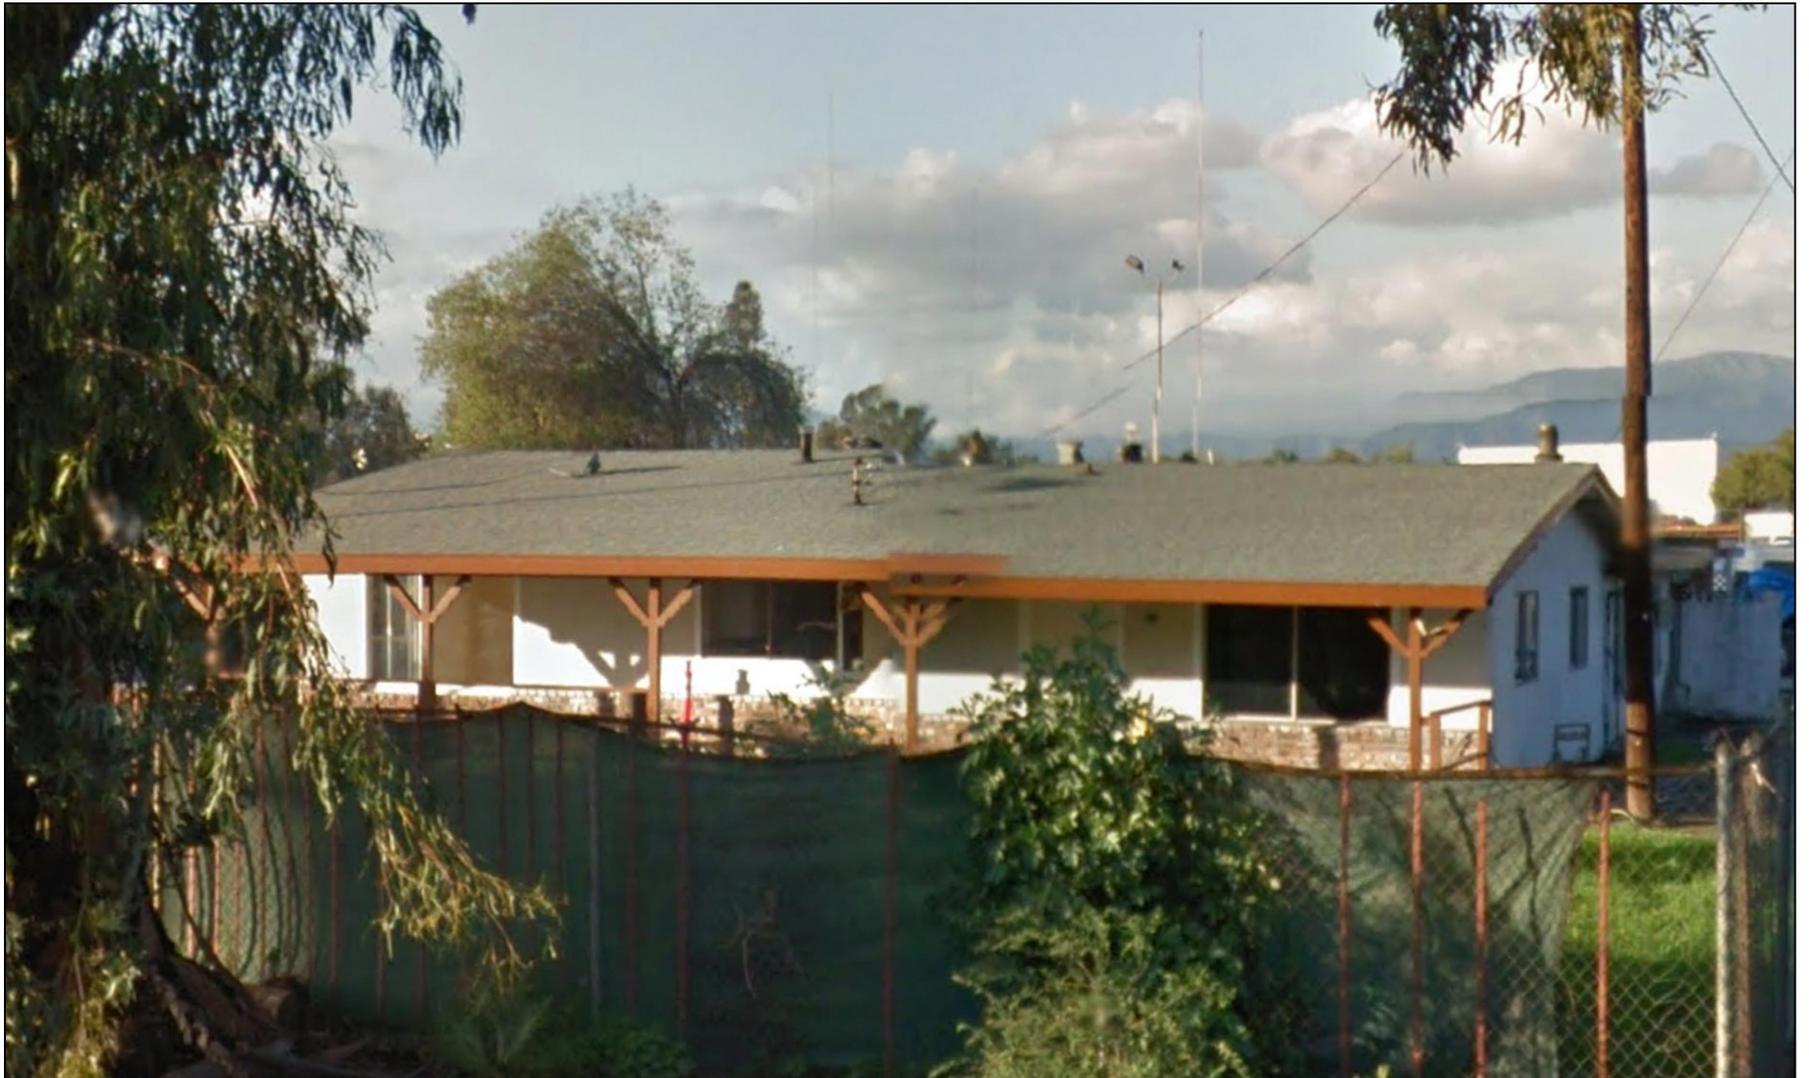
Plate 3.3-26
2014 View of the South Façade of the Residence at 3624 County Road, Facing Northwest

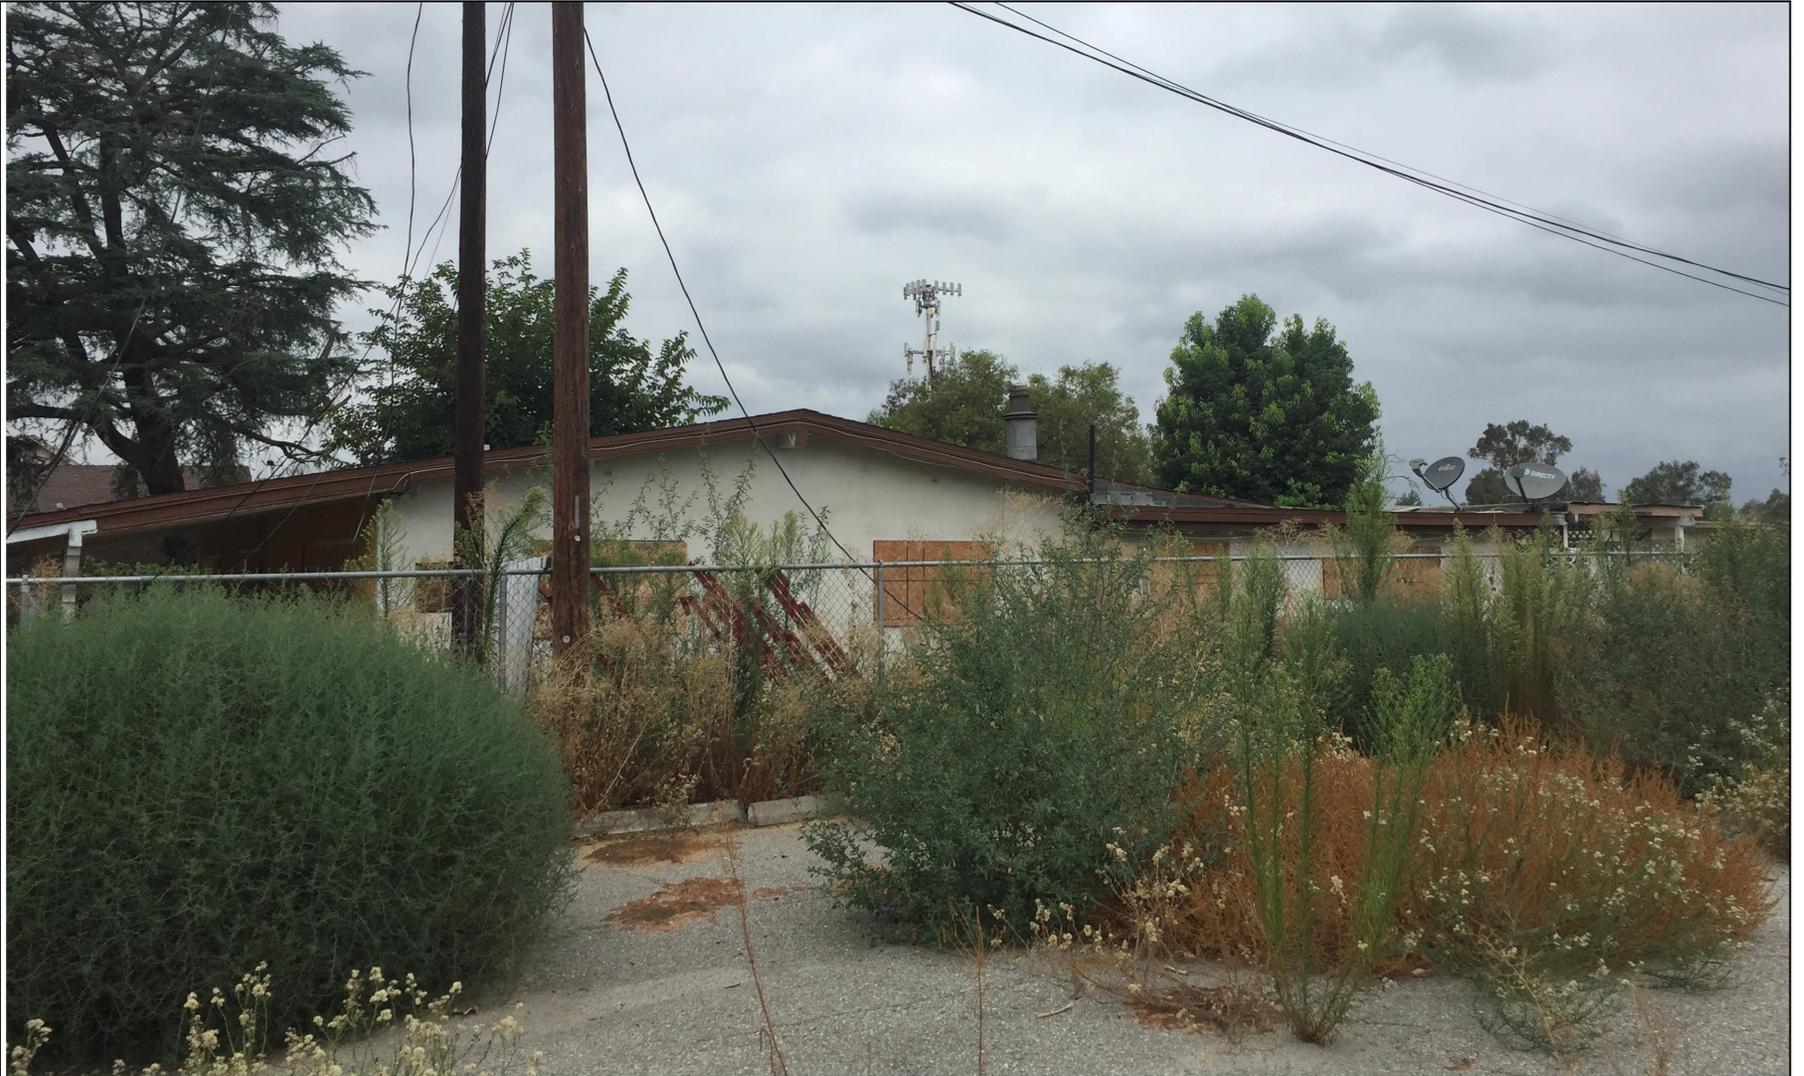
Plate 3.3-27

The building record indicates that in 1973, the 1959 rear patio was replaced with another addition (Plate 3.3–27). The 1973 addition extended the flat-roofed portion of the building to the east, filling in the “ell” created by the original building and the 1959 addition.

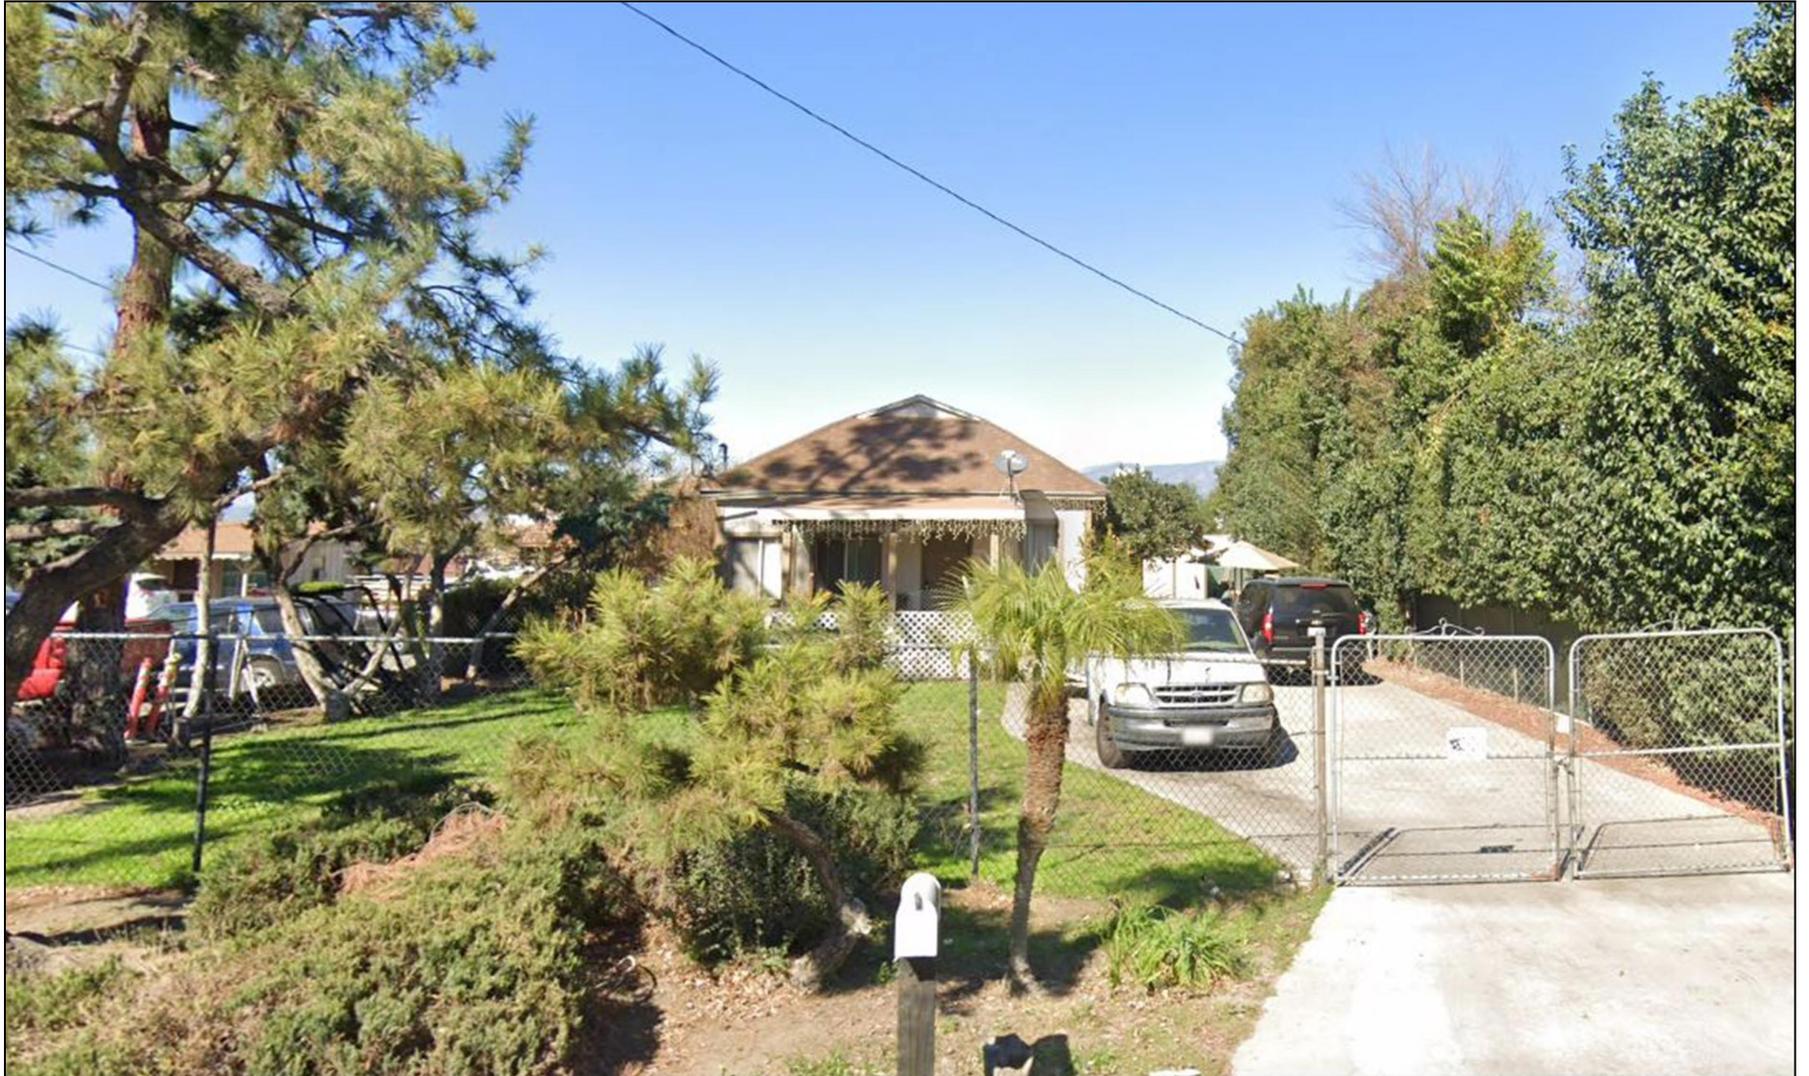
Plate 3.3-31
2018 View of the South Façade of the Residence at 3634 County Road, Facing North

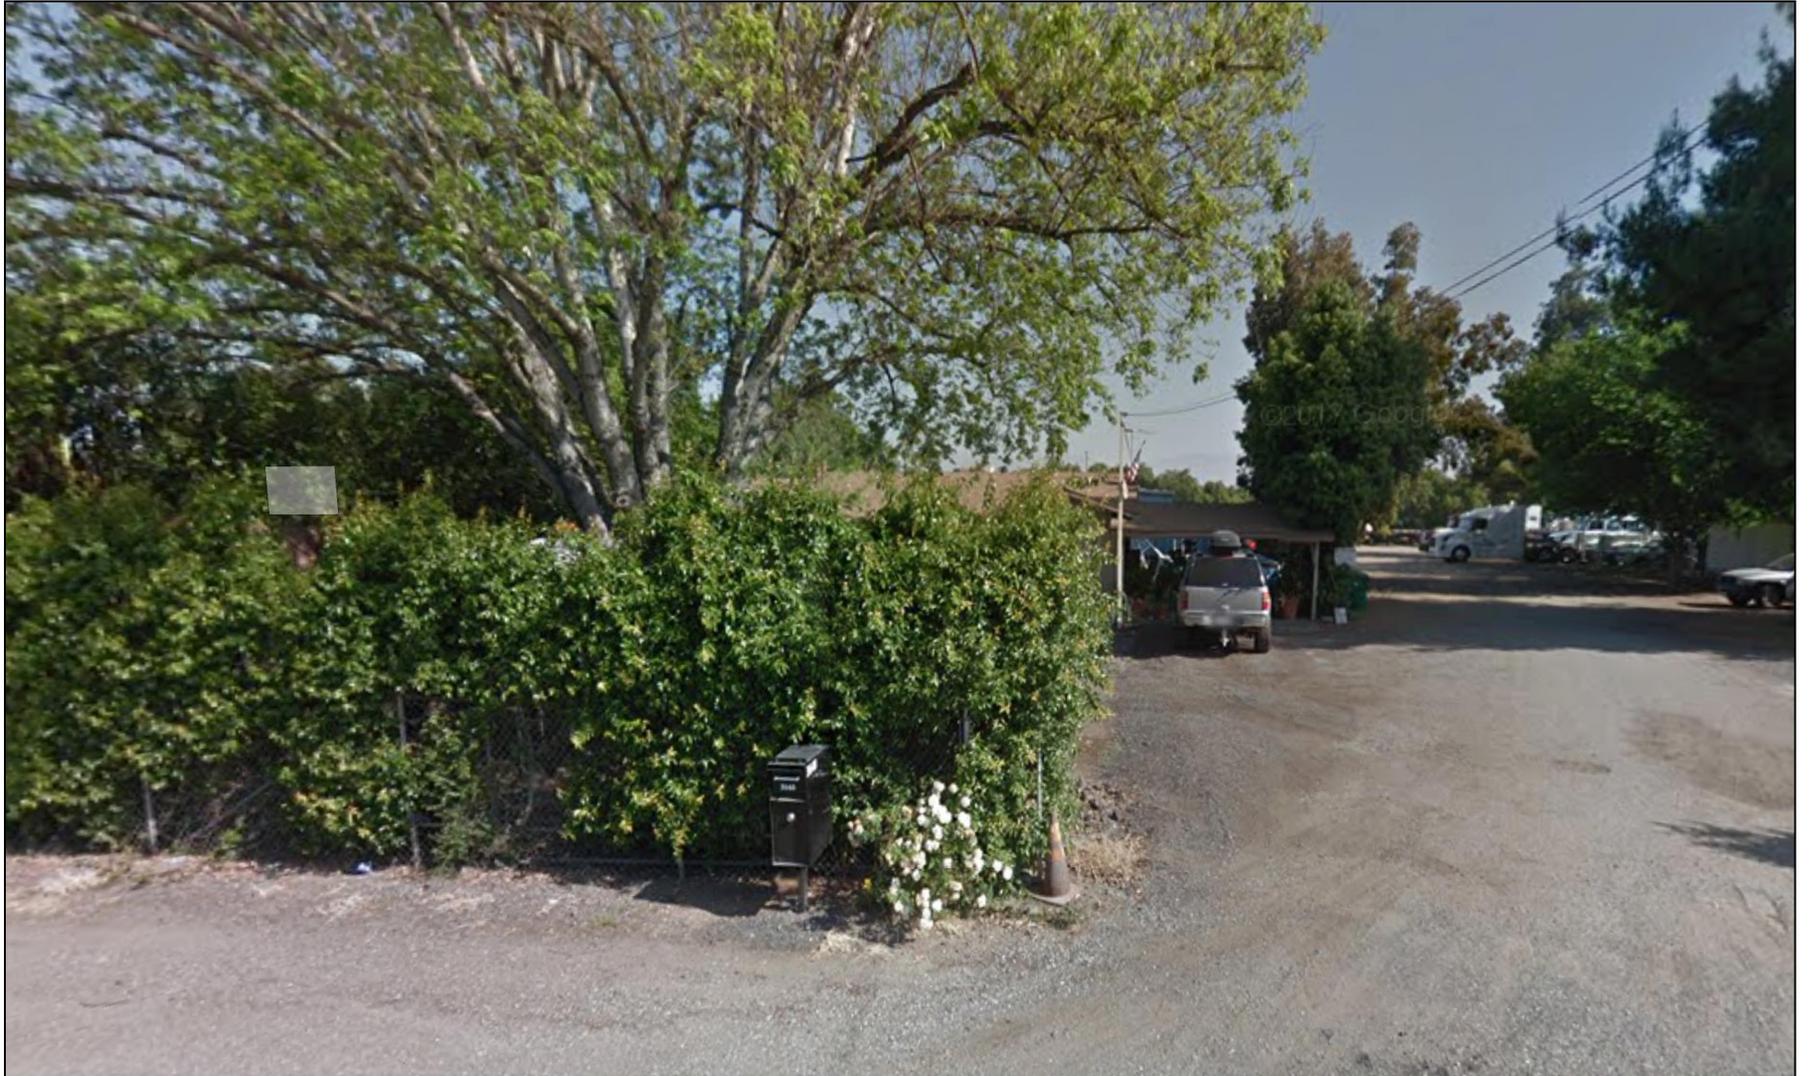
Plate 3.3-36
2012 View of the South Façade of the Residence at 3648 County Road, Facing North
The County Road and East End Avenue Project

The building record indicates that a carport was added to the property in 1964 and the original garage, which was located on the west façade of the building, was replaced with a larger, front-gabled addition in 1965. Both the carport and west façade addition are visible on the 1965 aerial photograph (see Plate 3.3–6). Between 2012 (Plate 3.3–36) and 2014 (Plate 3.3–37), however, the carport was converted into a garage.

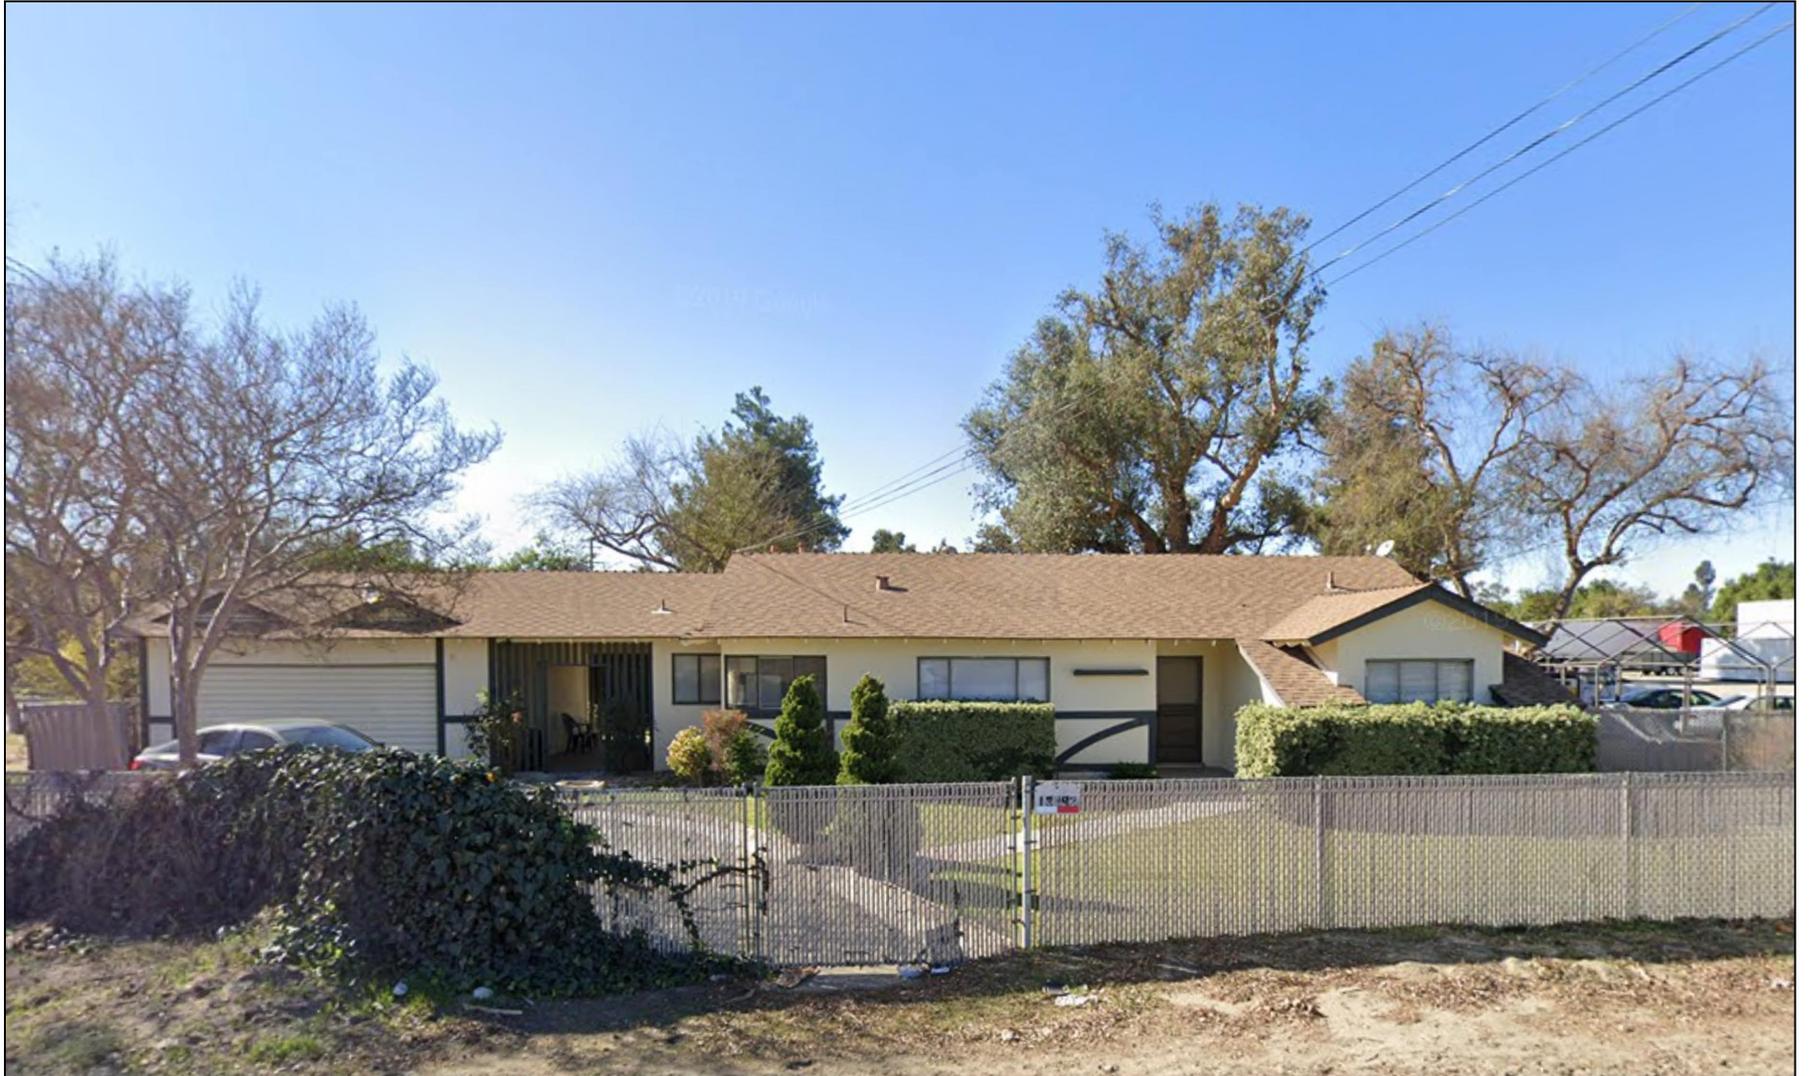
Plate 3.3-38

The Residential Building Record indicates that the 12482 East End Avenue building and garage were constructed in 1956 on APN 101-628-104 using standard frame construction on a concrete foundation in the Ranch architectural style (see Plate 3.2–10). The roof of the building is side-gabled with a wide eave overhang and exposed rafter tails. A front-gabled projection is located on the north end of the east façade. The exterior of the building is clad in stucco and fenestration is recorded on the building record as steel sash casement windows. Although the windows are currently boarded over, 2018 Google Street View imagery indicates that at that time, windows were still steel sash casement (Plate 3.3–38).
