**CULTURAL RESOURCES
STUDY FOR THE COUNTY ROAD
AND EAST END AVENUE PROJECT**

**CITY OF CHINO,
SAN BERNARDINO COUNTY, CALIFORNIA**

October 25, 2019

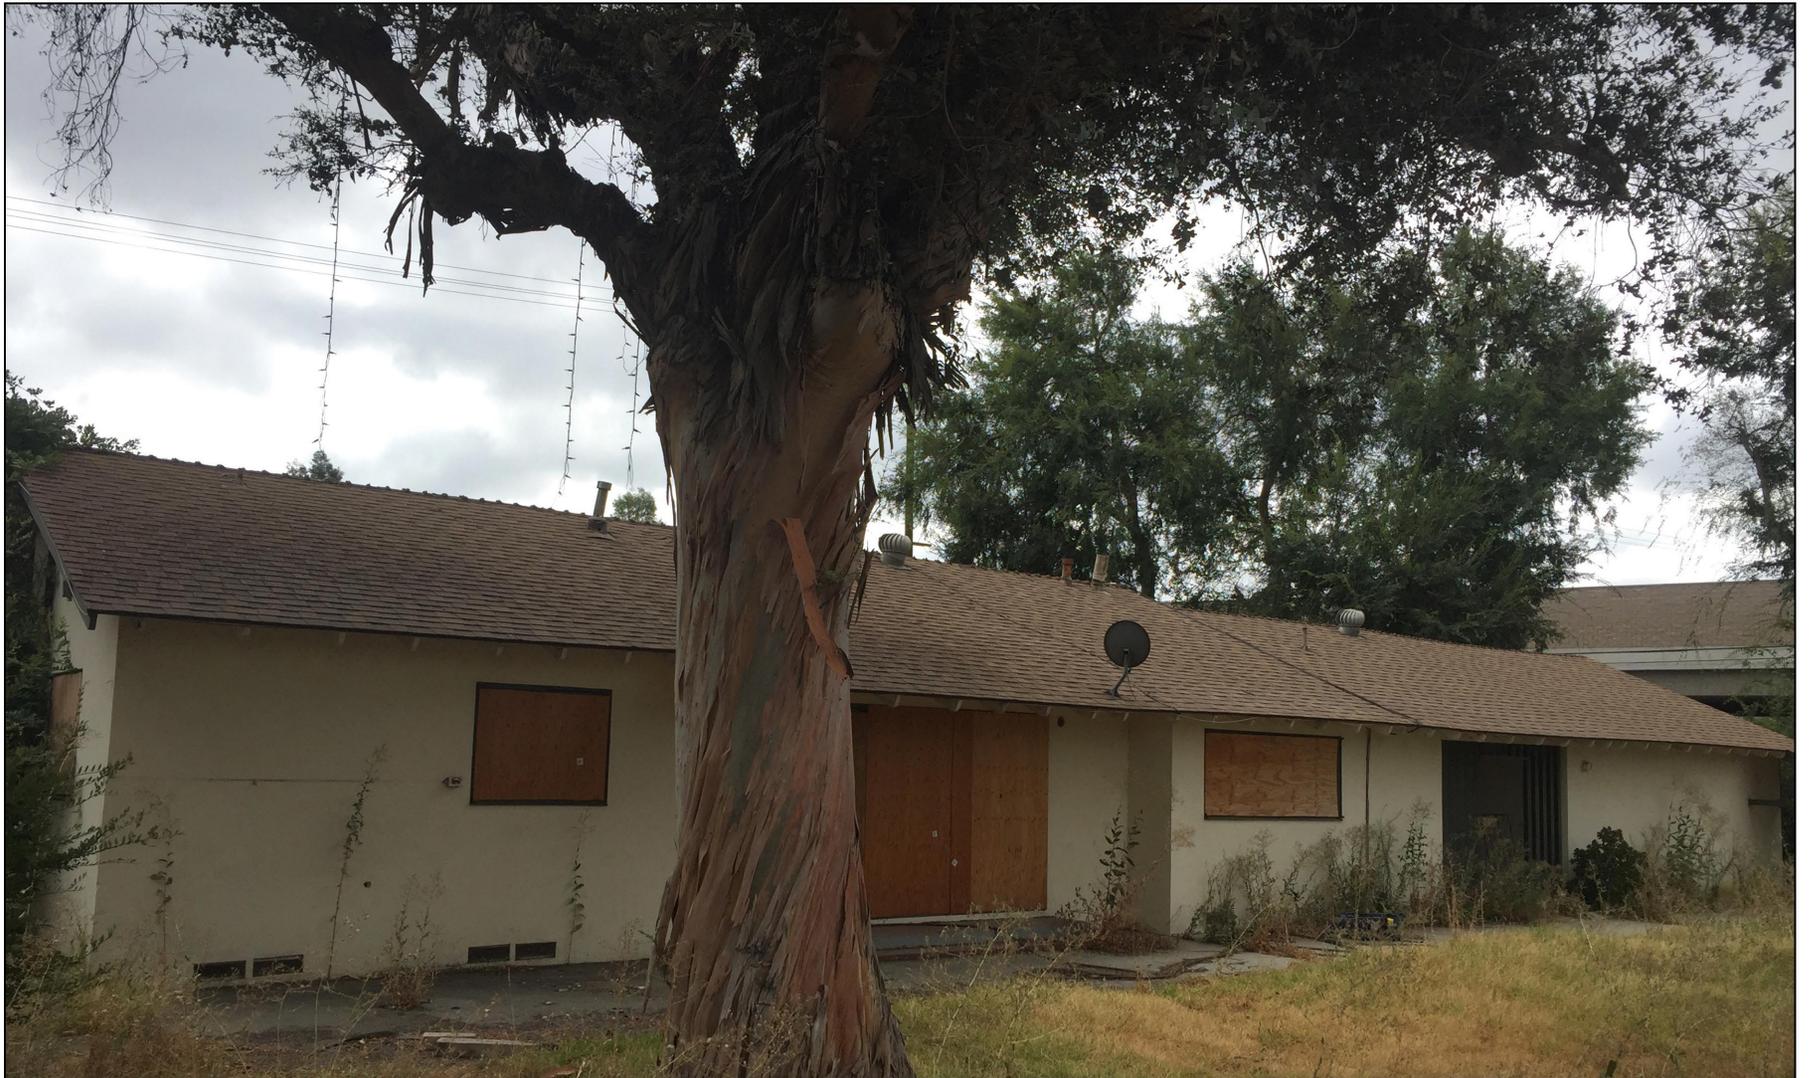
Plate 3.3-39

The residence and garage are connected via a breezeway (Plate 3.3–39). The current aluminum, roll-up-style garage door is likely not original. Visual inspection of the building and its presence on the 1959 aerial photograph (see Plate 3.3–5) revealed that the breezeway *is* likely original. Both aerial imagery and the building record indicate that no structural modifications have been made to the 12482 East End Avenue building since its initial construction, except for potentially the replacement of the garage door.
