Appendix A Carbon Canyon Channel Pipeline Avenue to Peyton Drive Alternatives Analysis

CARBON CANYON CHANNEL PIPELINE AVENUE TO PEYTON DRIVE ALTERNATIVE ANALYSIS

**Carbon Canyon Channel
Habitat Assessment
Chino Hills, San Bernardino County, California**

Carbon Canyon Channel Wetland Condition Analysis and Jurisdictional Waters Chino Hills, San Bernardino County, California

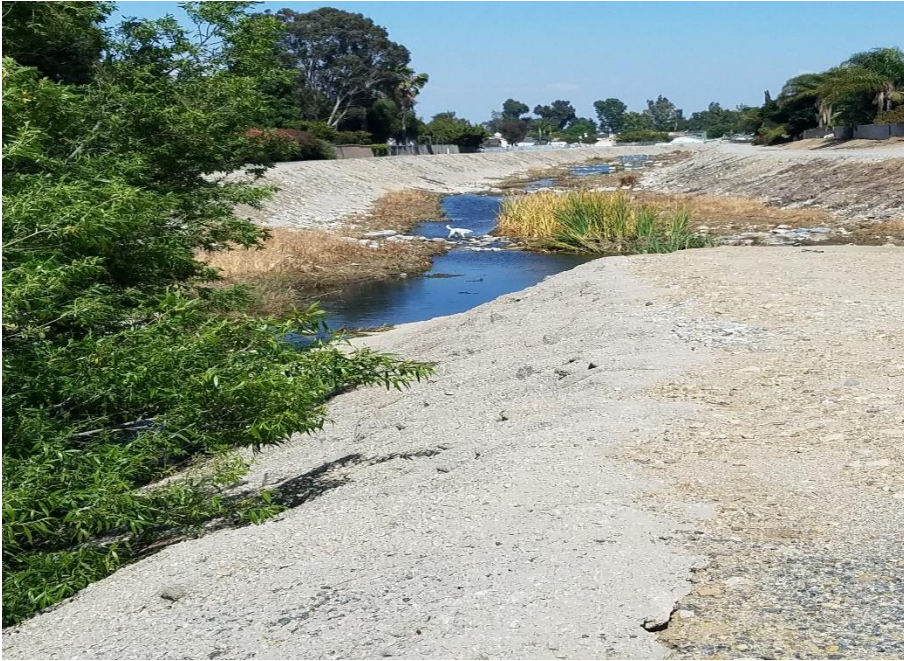
Photo 1. Western Extent of Project at Confluence, Facing East

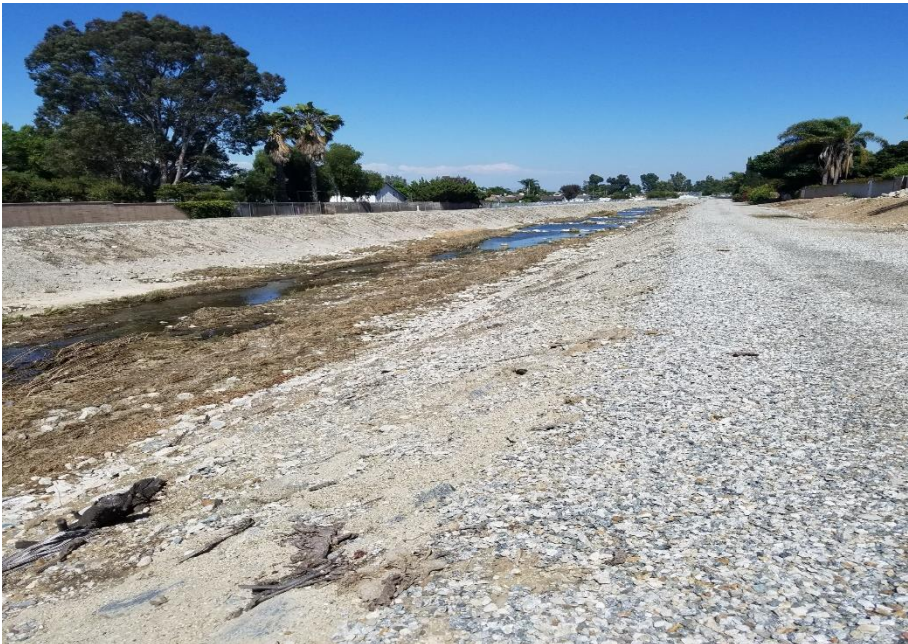
Photo 2. Typical vegetation of Project, Eastern Extent of Project, Facing East

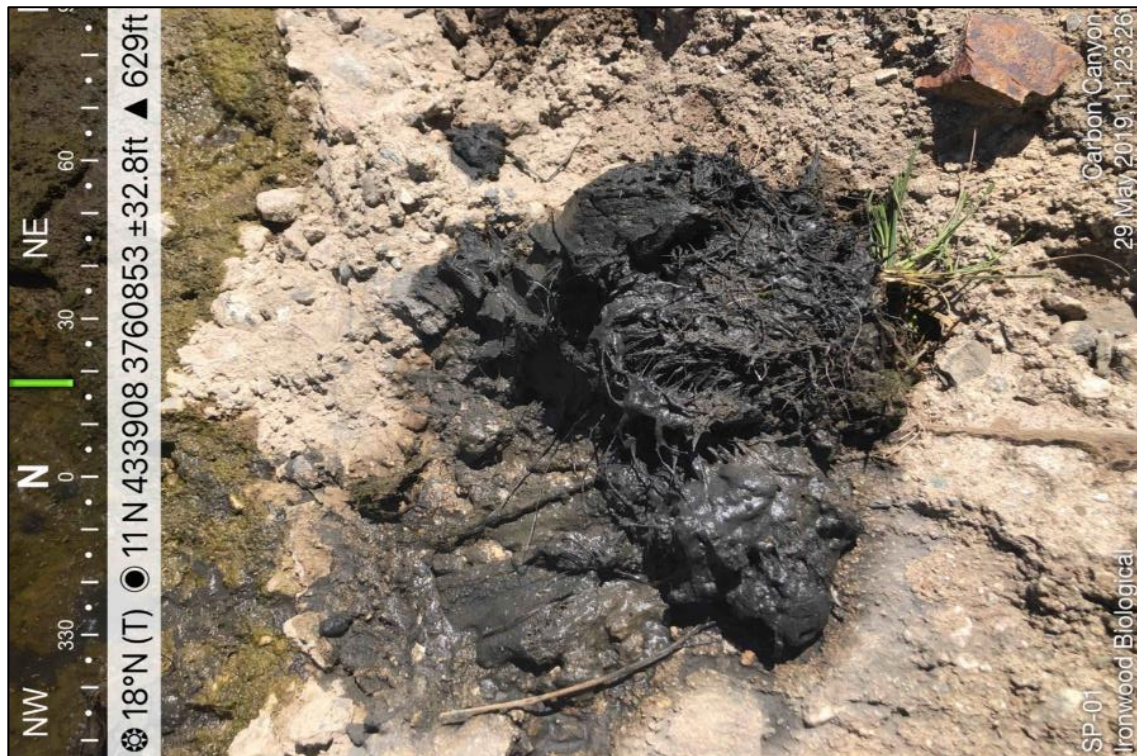
Photo 7. Loamy mucky mineral soils at SP-01

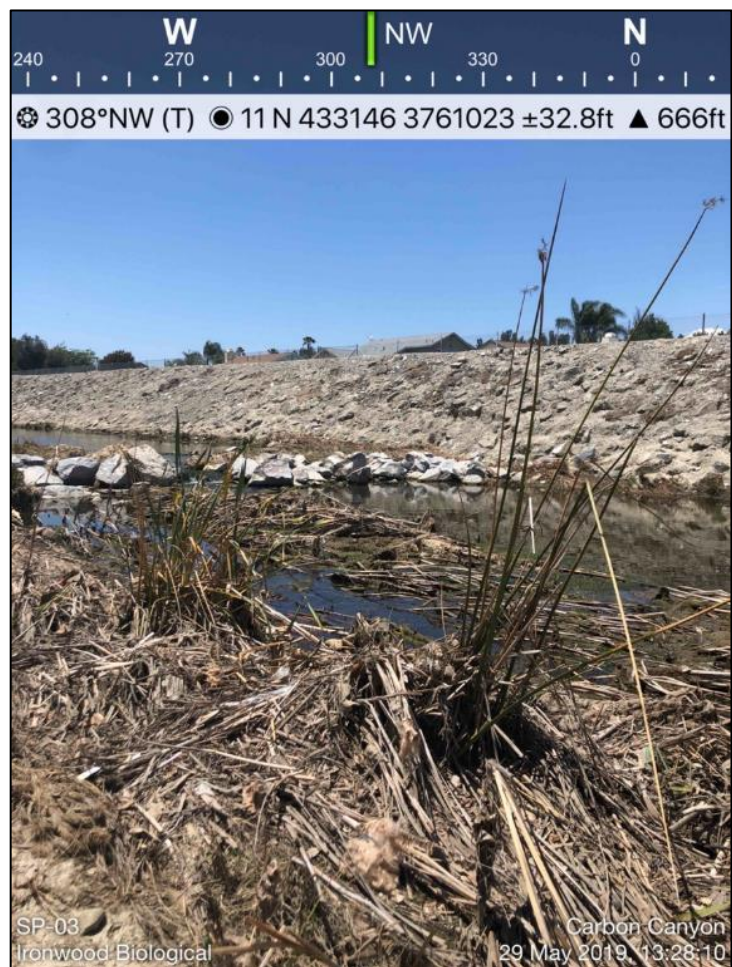
Photo 8. SP-03 with wetland vegetation and standing water

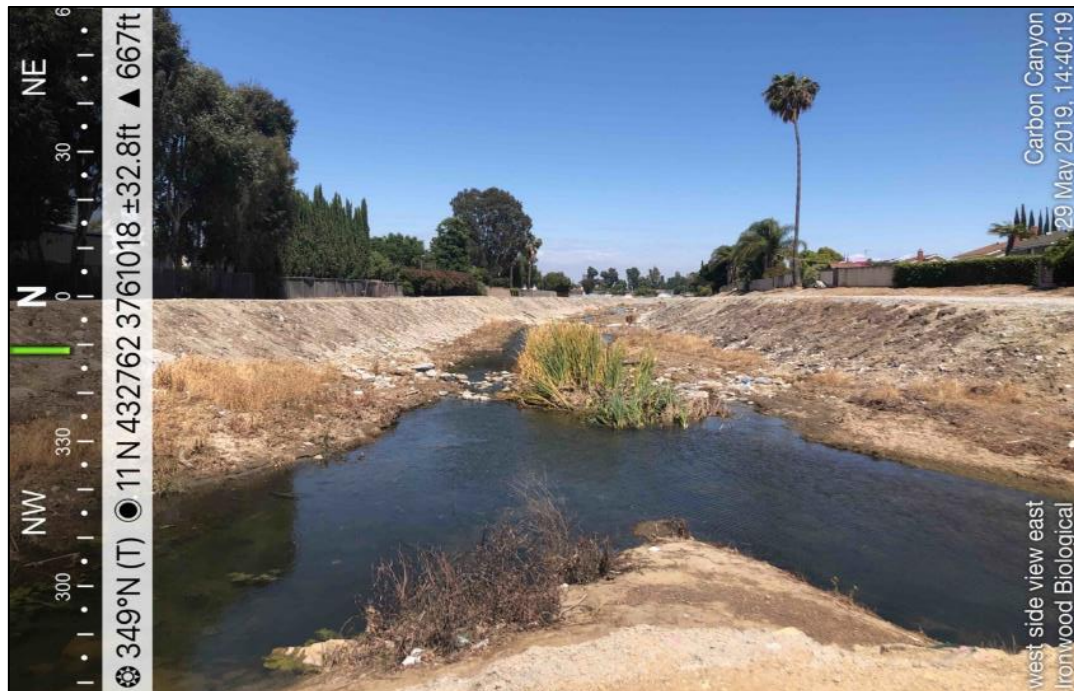
Photo 10. Looking east at wetland W-12, where SP-05 was collected

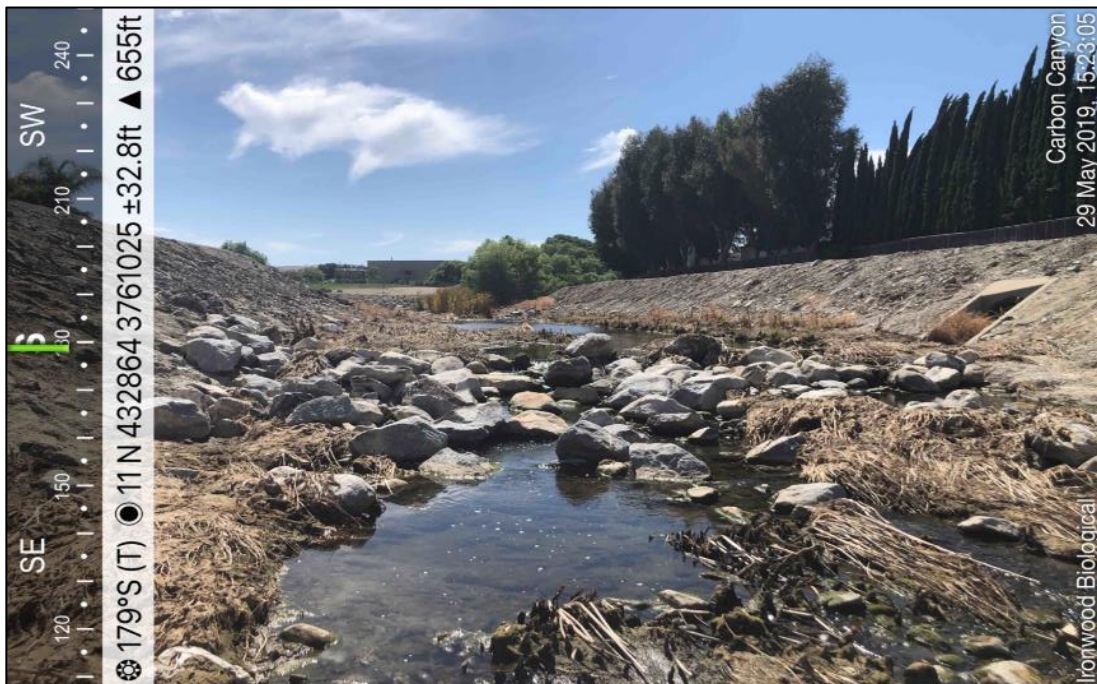
Photo 11. Representative wetland with characteristics of SP-03 and surrounding uplands (SP-02, SP-04)
