**246 BENNETT WAY, TEMPLETON,  
SAN LUIS OBISPO COUNTY, CALIFORNIA**

**BIOLOGICAL RESOURCES  
AND WETLANDS ASSESSMENT**

*July 30, 2019*

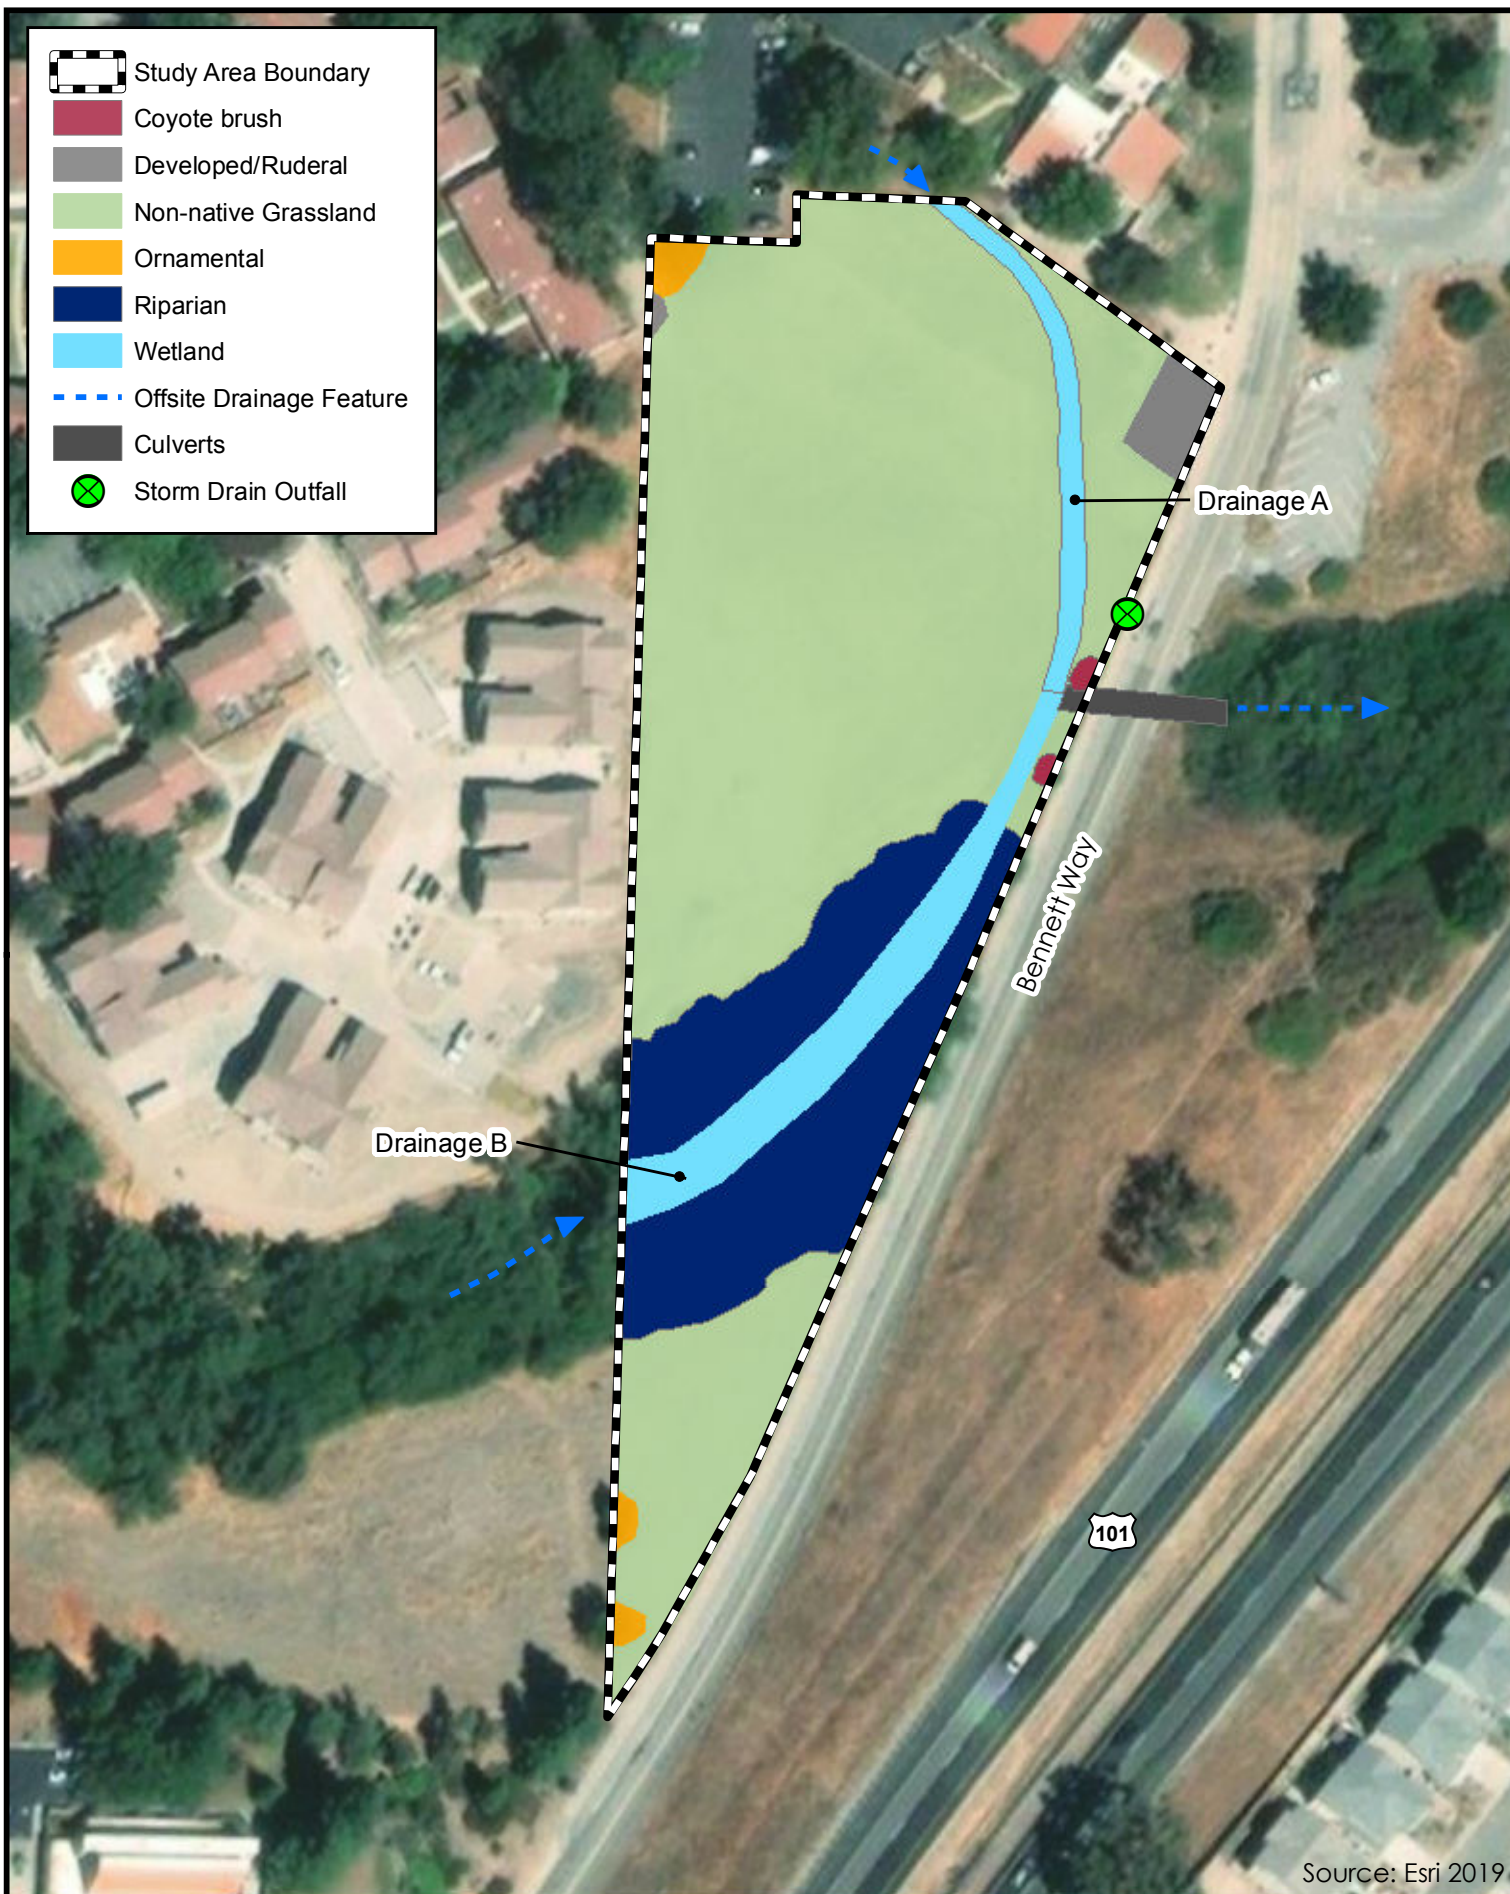
**Figure 3**

The property contains only one soil type, Lockwood-Concepcion complex (2 to 9 percent slopes) (NRCS 2019a). These soils are alluvium derived from sedimentary rock, and form on toeslopes. The upper 26 inches are composed of channery loam (NRCS 2019a). Channery is thin, flat fragments of shale. Soils observed during the wetland assessment were shale clay loam, with a higher percentage of rocks in the upland areas.

Soil Map

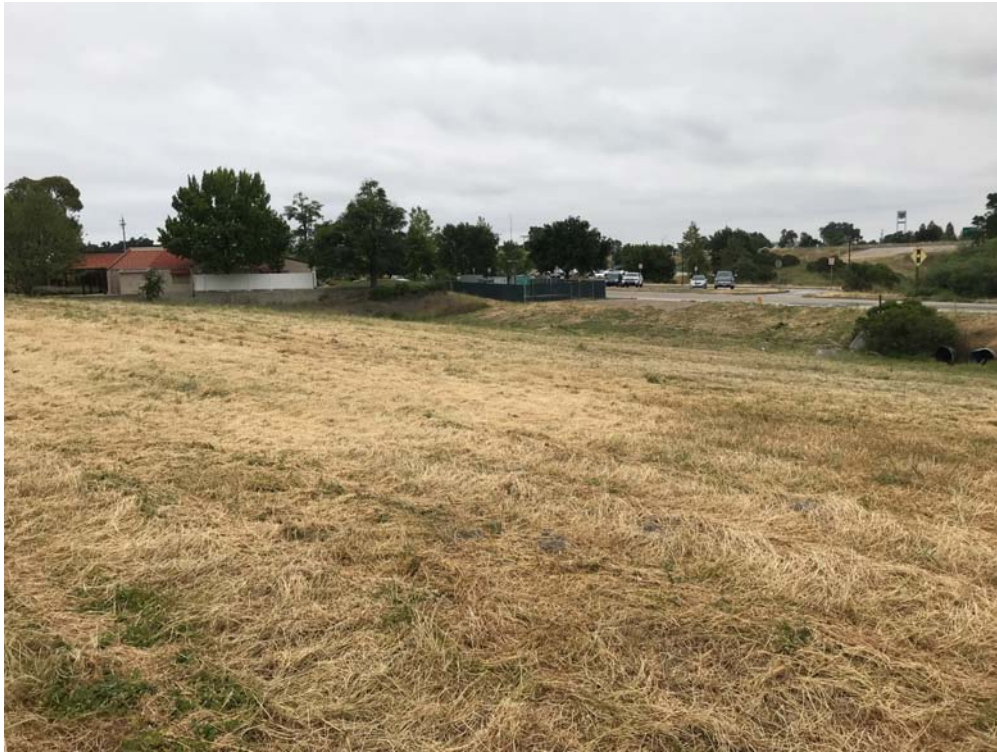
**Photo 1.** View from the central western edge of the property looking northeast across Non-native Grassland habitat that has been frequently disturbed. Drainage A is in the distance and the culverts under Bennett way can be seen in the far right.

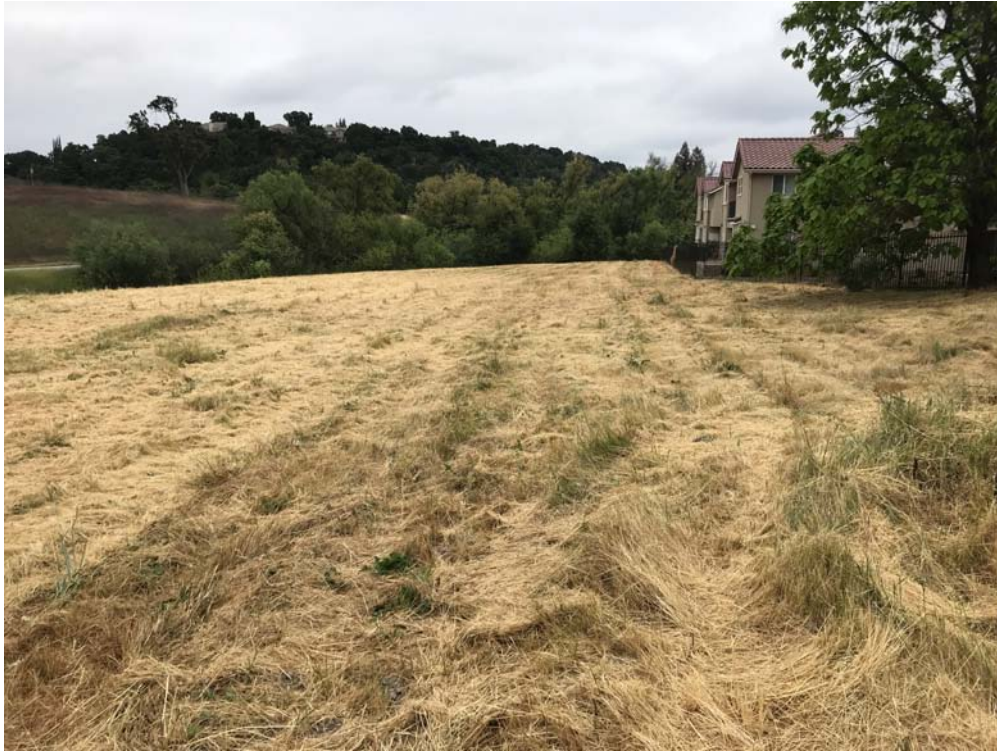
**Photo 3.** View from the western central edge of the property looking south. The Riparian habitat along Drainage B can be seen in the background.

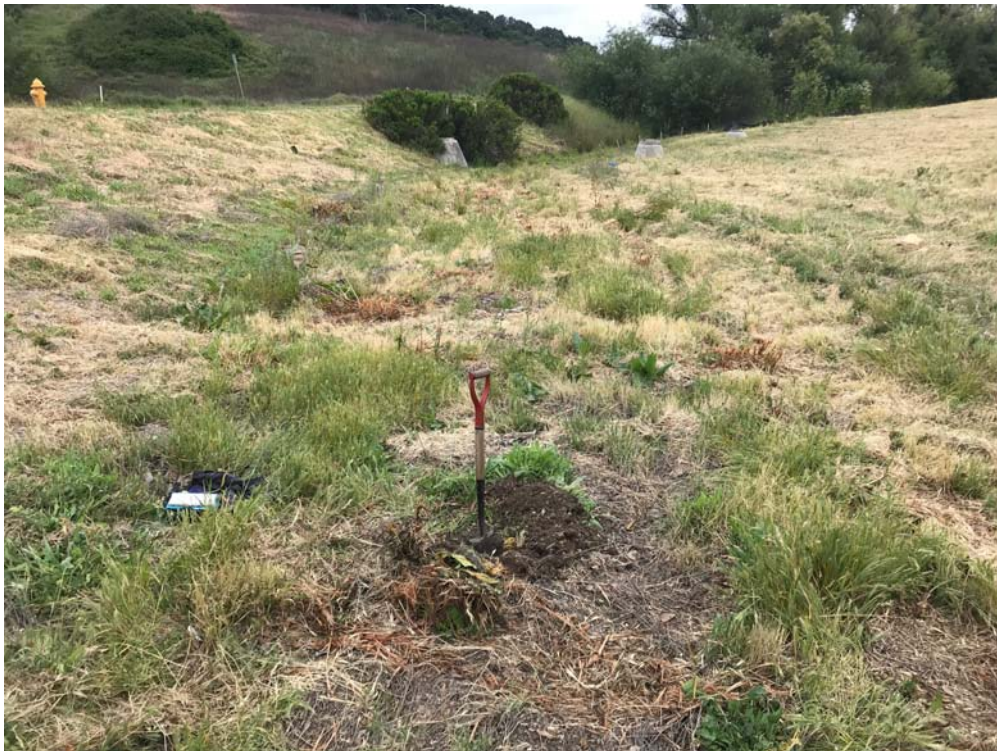
**Photo 4.** View from the central portion of Drainage A looking south. Wetland habitat is present in the gentle swale and has been mowed. The shovel marks the location of the wetland assessment Data Point 1. This area was determined to be Non-wetland Other Waters of the U.S. due to lack of hydric soils. Jurisdictional width is approximately 10 feet.

**Data Point 1** — Characterizes the bottom of the seasonally moist swale identified as Drainage A. This area had a small narrow defined channel of approximately three (3) feet wide, and consisted of an approximately 10-foot wide soft swale, that likely had channel morphology altered by frequent mowing. The portion of this channel upstream from the mowed area offsite had a defined channel with scour pools, since the channel morphology had not been altered as it had on the subject property. The dominant vegetation at this data point was Mediterranean barley and meadow barley, which indicated the presence of hydrophytic vegetation. The soil was shaly clay loam and had a color of 10YR3/2. No redoximorphic features or hydric soil indicators were observed, and hydric soils were not present. Secondary indicators of hydrology were observed, including drift deposits and drainage patterns. These consisted of leaves and trash that were accumulated on the upstream side of obstructions in the channel bottom, which showed evidence of flowing water. Because only two of the three wetland indicators were present, Drainage A was likely to be considered to be Non-wetland Other Waters of the U.S. This area would also be under the jurisdiction of CDFW and RWQCB.

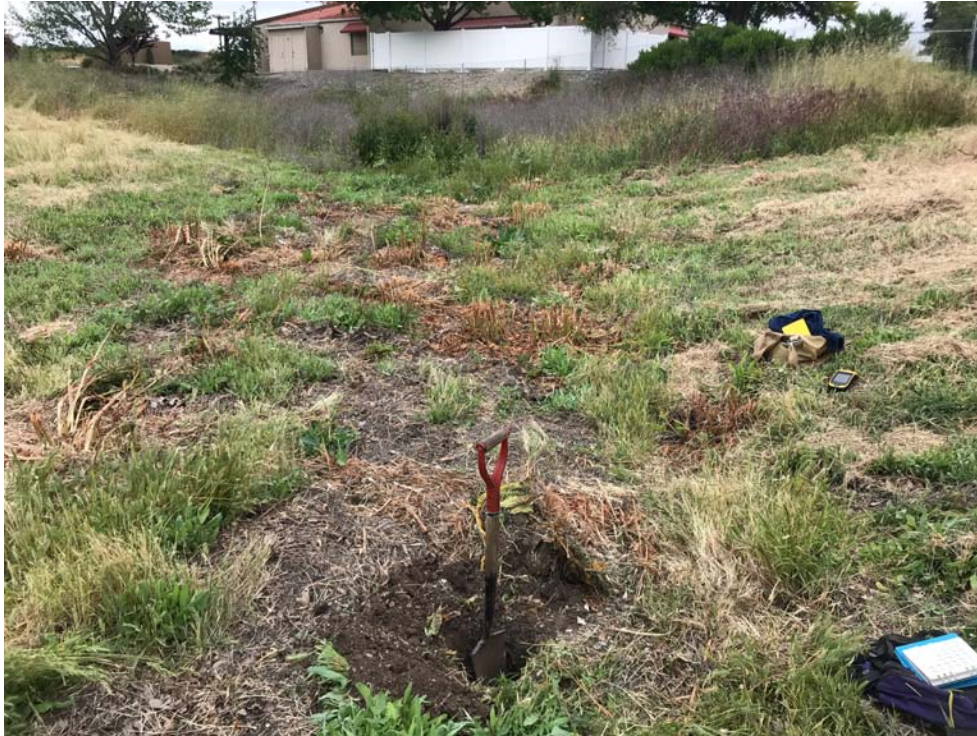
**Photo 5.** View from the central portion of Drainage A and Data Point 1 looking north. An unmowed portion of the drainage is offsite and in the background. Wetland habitat corresponds to Meadow Barley Patches (Sawyer et al. 2009).

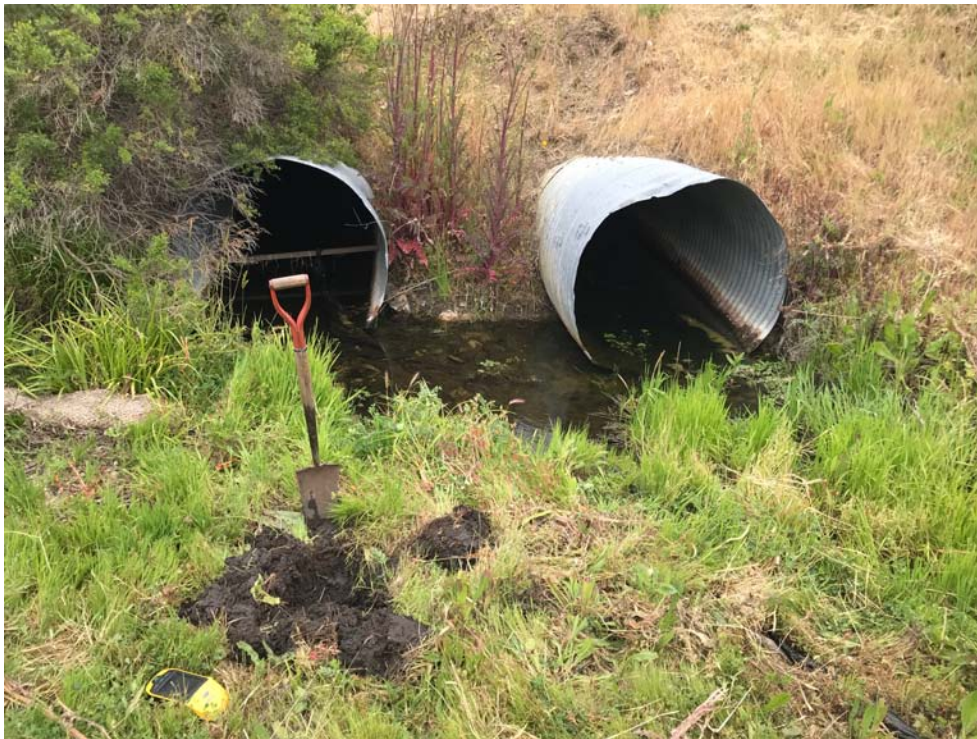
**Photo 6.** The location of the shovel indicates Data Point 3, which was determined to be Wetland Waters of the U.S. This point marks the confluence of Drainages A and B, which drain into these culverts under Bennett Way to the east. Flowing water was present in Drainage B.

**Data Point 3** — Located in the channel in front of the two 36-inch culverts that convey flow under Bennett Way, and at the confluence of Drainages A and B. The soil pit was located within the channel but outside of standing water. Vegetation consisted entirely of herb stratum, and dominant species were 100% wetland species, including meadow barley, rabbitsfoot grass, and tall flatsedge. An obligate species, watercress (*Nasturtium officinale*) also was present along the channel. The species composition indicated that hydrophytic vegetation was present. The soil had a color of

10YR2/1, with redox features of 5YR4/6 and oxidized rhizospheres. These features indicated that hydric soils were present. There was open water in the soil pit below eight (8) inches and soil saturation from the surface to eight (8) inches down. Within the wetted portion of the channel, there were northern Pacific treefrog (*Pseudacris regilla*) tadpoles, gilled snails (Gastropoda), water striders (Gerridae), and water fleas (*Daphnia* sp.). Therefore, wetland hydrology also was present. With the three criteria being met, the area was considered potentially a Wetland Waters of the U.S. and was approximately 10 feet wide. This area would also be under the jurisdiction of CDFW and RWQCB.

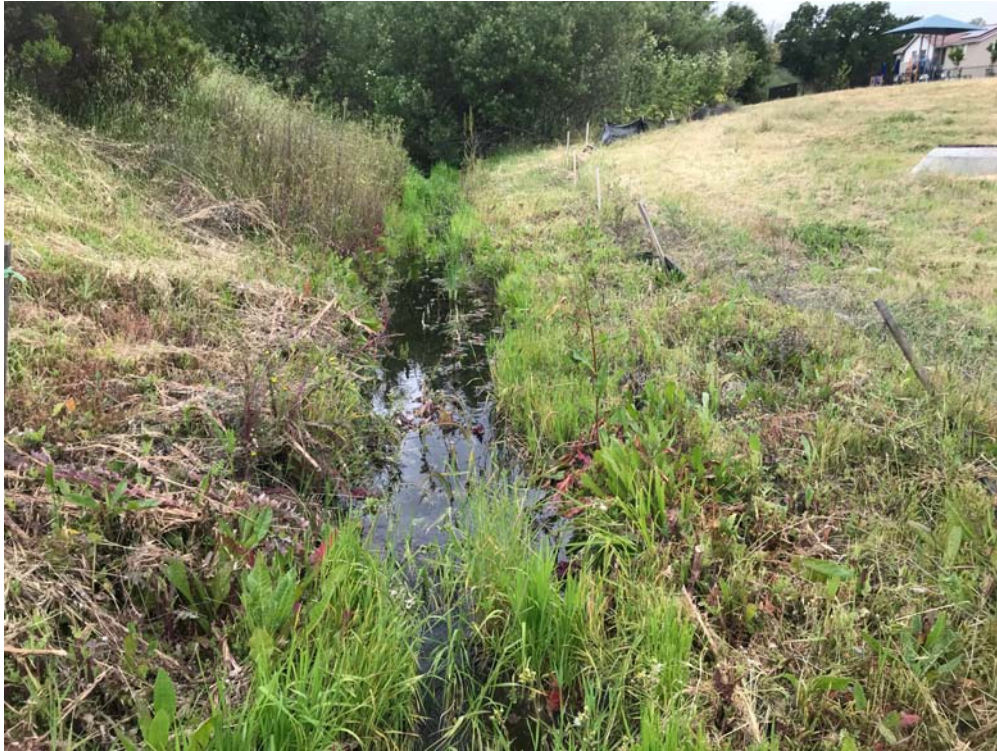
**Photo 7.** Drainage B between the culvert under Bennett Way and the Riparian habitat, seen in the distance, looking southwest. This area was determined to be Wetland Waters of the U.S. and jurisdictional width is approximately 10 feet wide.

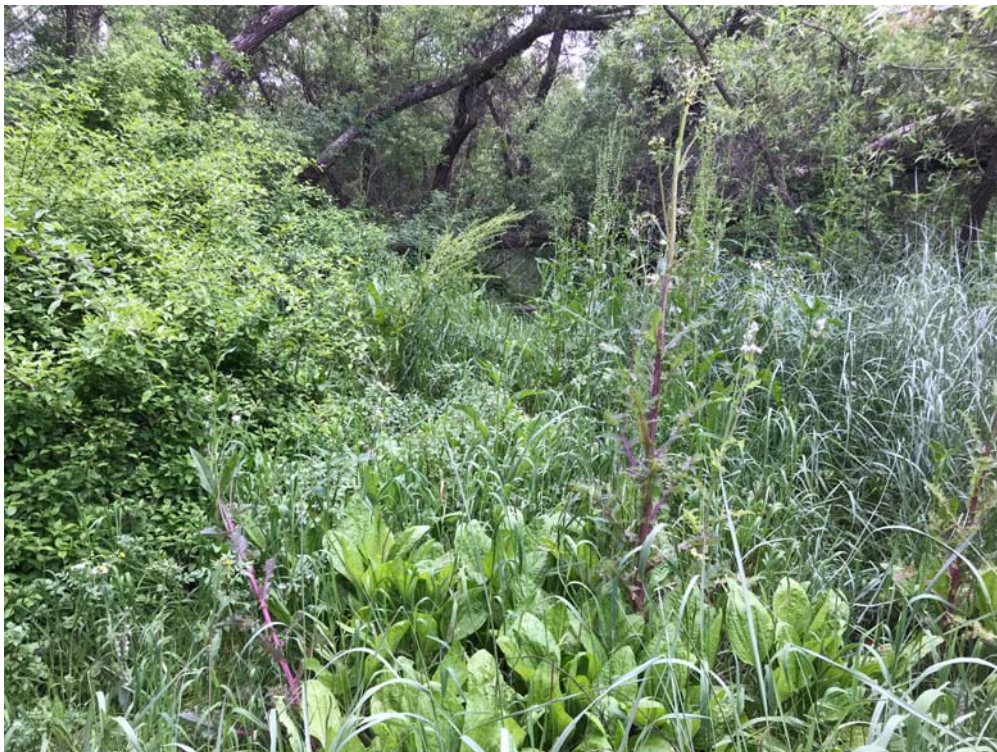
**Photo 8.** Wetland habitat along the Drainage B channel within the Riparian habitat. This community corresponds to the *Leymus triticoides* alliance (Sawyer et al. 2009), and was determined to be Wetland Waters of the U.S.

Wetland habitat in Drainage B within the riparian habitat corresponds to the *Leymus triticoides* alliance (Sawyer et al. 2009) with other characteristic species also present.

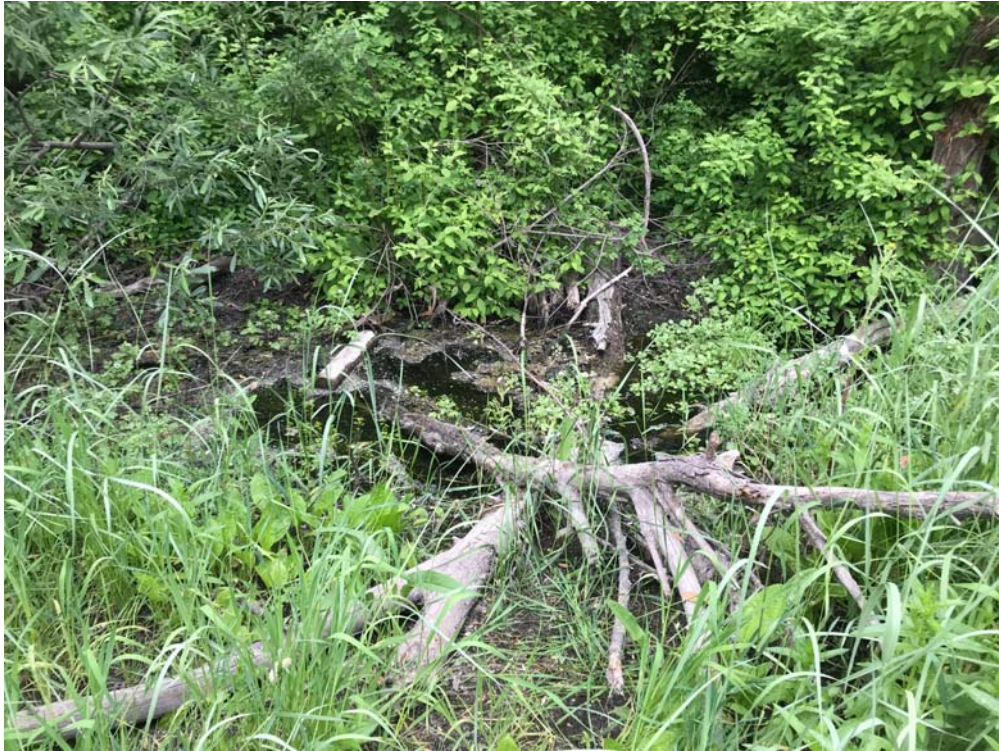
**Photo 9.** Wetland habitat within the Drainage B channel in the Riparian habitat at the location of Data Point 4. This area was determined to be Wetland Waters of the U.S. and the jurisdictional width was approximately 25 feet.

**Data Point 4** — Characterizes the Drainage B channel within the riparian forest. Flowing water that was approximately 10-feet wide had abutting/adjacent wetland vegetation. This area had a tree stratum in which red willow was dominant; a sapling/shrub stratum in which American dogwood and arroyo willow were dominant; and, an herb stratum in which beardless wild rye, common plantain, and watercress were dominant. In addition, an obligate species, water starwort, also was present in the wetted channel. Under the dominance test, 100% of the dominant plant species were hydrophytic. A soil pit was not used because hydric soils were presumed present based on flowing water, soil saturation and presence of hydrophytes. Evidence of hydrology included the presence of surface water and soil saturation, aquatic invertebrates, water marks, sediment deposits, and drift deposits. Potential Wetland Waters of the U.S. in this area were approximately 25 feet wide. This area would also be under the jurisdiction of CDFW and RWQCB.

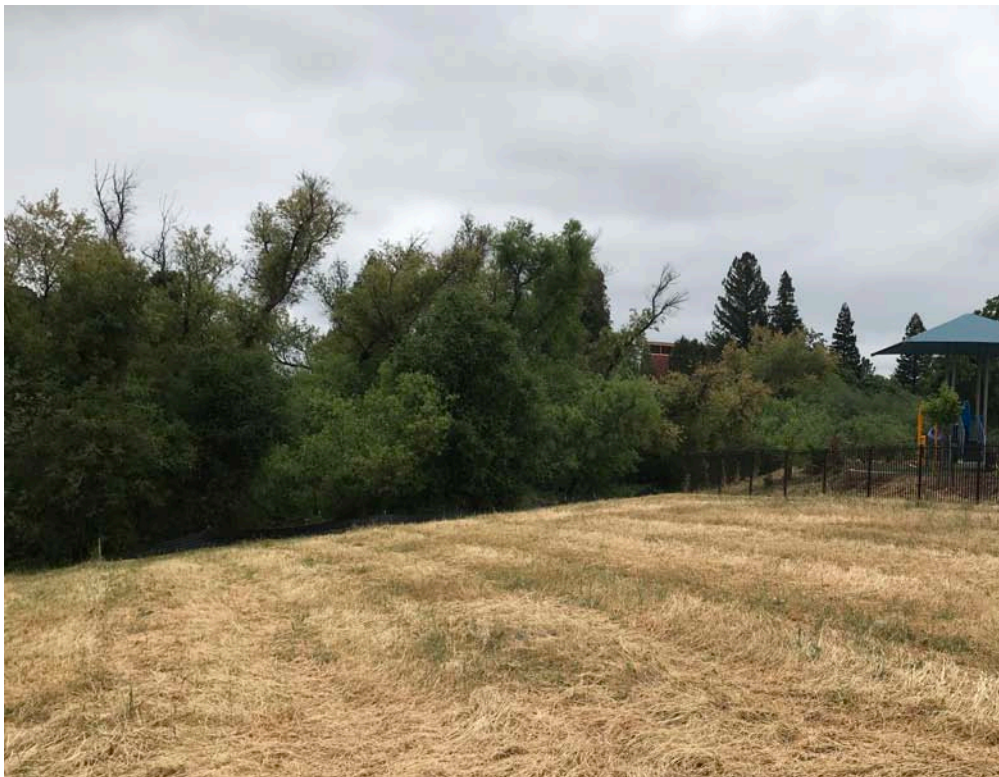
**Photo 10.** Riparian habitat along Drainage B consisted of dense willow scrub/forest along a channel with flowing water.

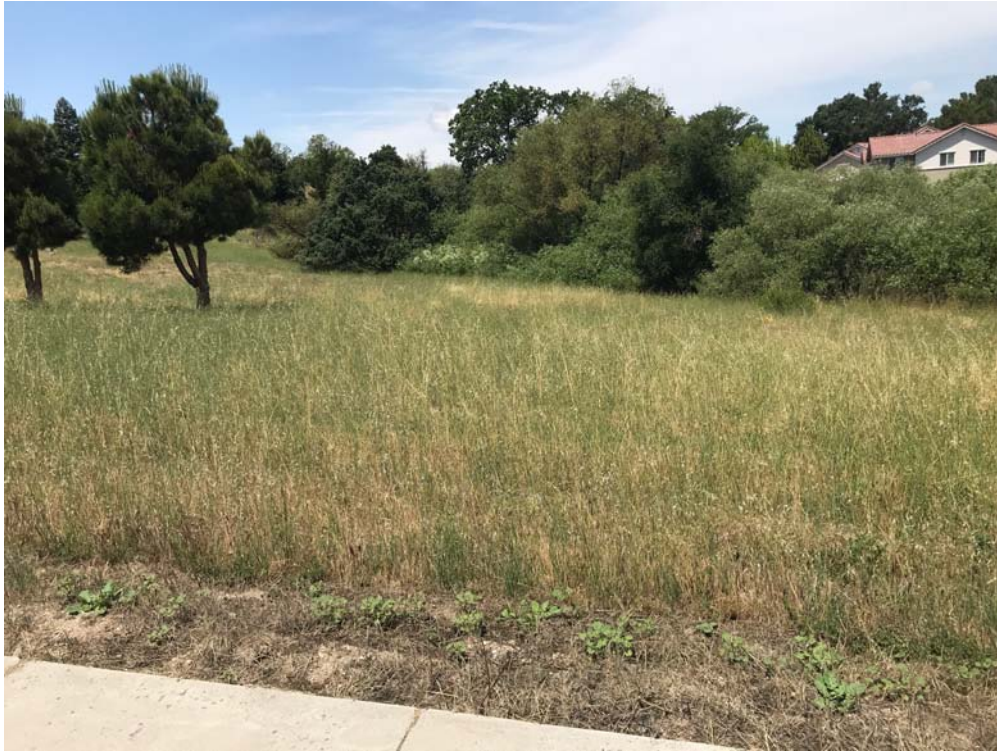
**Photo 11.** View from the Ruderal/Developed sidewalk along Bennett Way looking west across the southern tip of the property. Shown is Non-native Grassland habitat, with two Ornamental pine (*Pinus* sp.) trees, and the Riparian habitat along Drainage B in the distance.

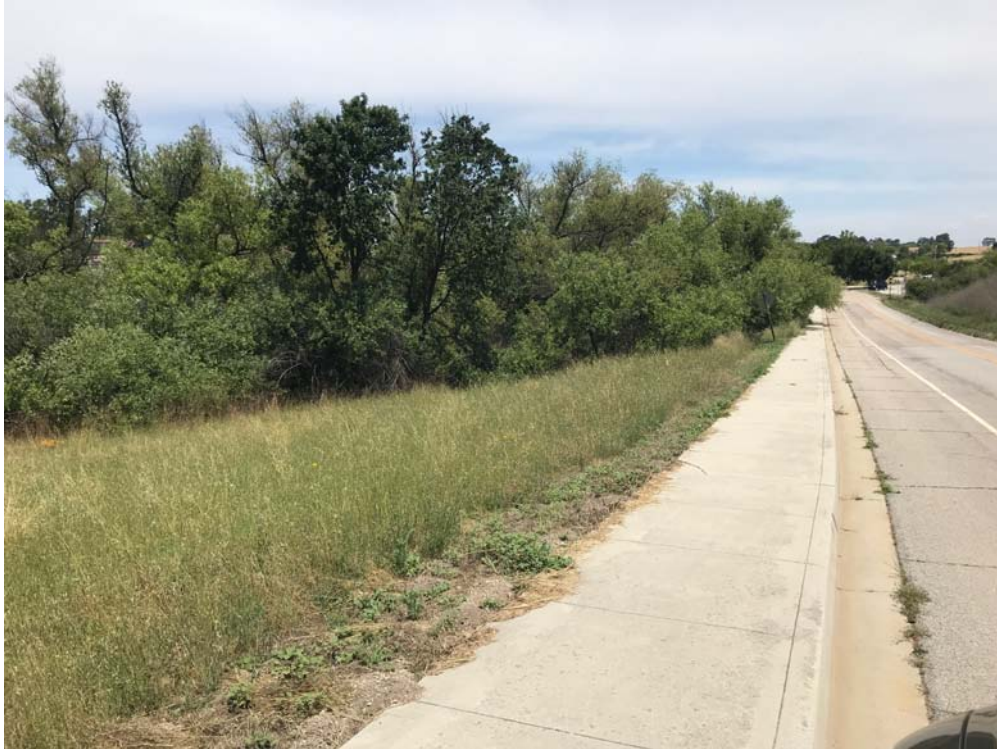
**Photo 12.** Northerly view of site abutting Bennett Way. Riparian habitat along Drainage B is overhanging the sidewalk.
