PHASE I ENVIRONMENTAL SITE ASSESSMENT

Former Stauffer Chemical Company Facility
2112 East 223rd Street
Carson, California 90745

November 22, 2019

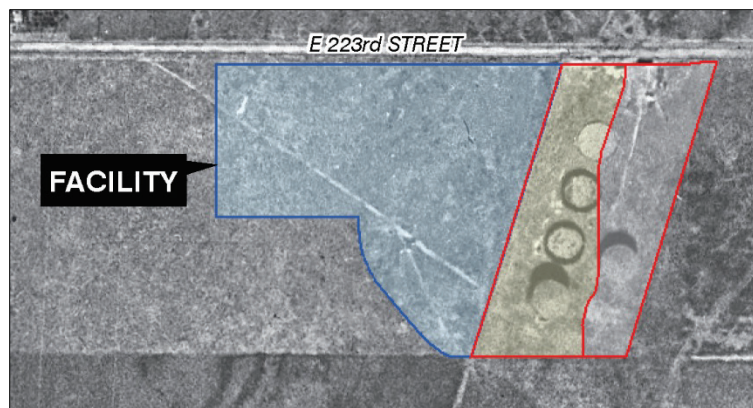
An aerial photograph taken in 1927 (Figure G-1 and below) shows that the subject SMC property was vacant and undeveloped, as was much of the surrounding area. The 1927 photograph also shows that East 223rd Street had been constructed and that the former Coon Trust property had been developed with at least two large (~120-foot-diameter) ASTs, one of which was within the boundary of the Carson Industrial LLC property. The two ASTs appeared to have had fixed roofs and, based on the shadows they cast, may have been on the order of 40 to 50 feet high. Three other circular features within the subject site boundary do not cast shadows in the 1927 photograph and may have been foundation pads for additional ASTs or ASTs under construction. The purpose of the ASTs is not discernible from the aerial photograph, although it is noted that oil had been discovered nearby in or around 1921. EDR's City Directory Abstract (Appendix I), which is based on records dating back to 1920, does not include any information for street addresses in the vicinity in the 1920s. Moreover, it is not clear how the tank contents were received

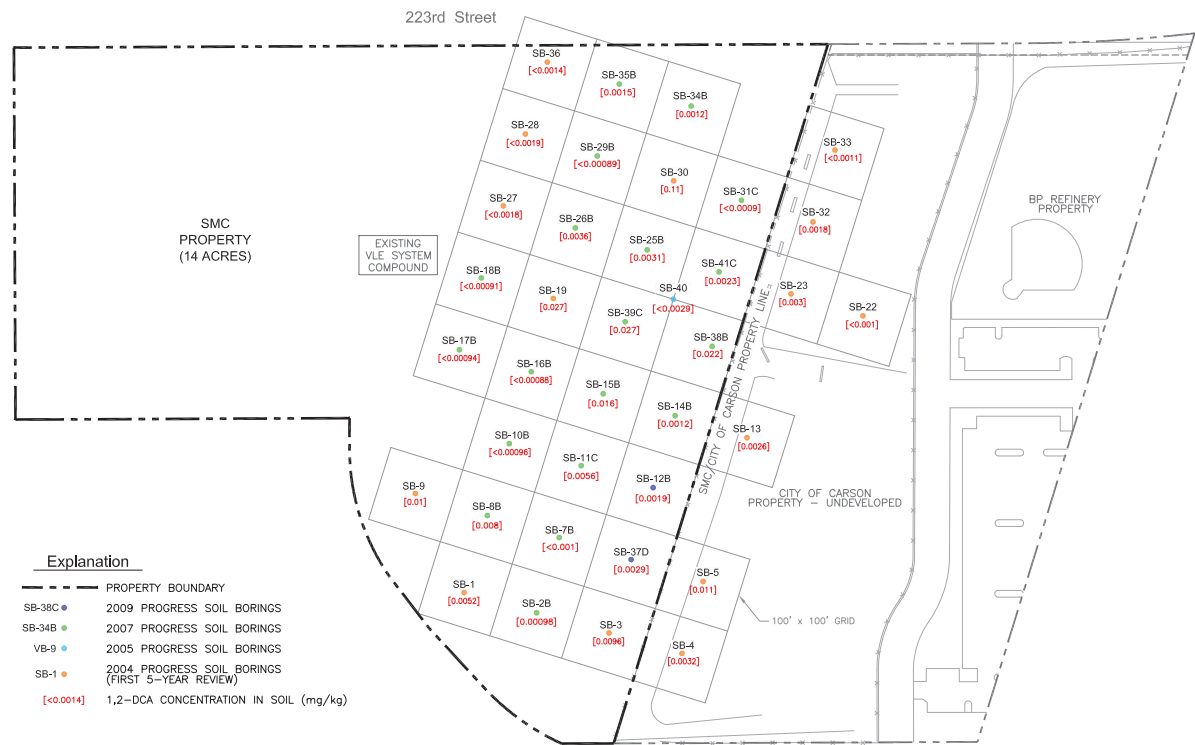
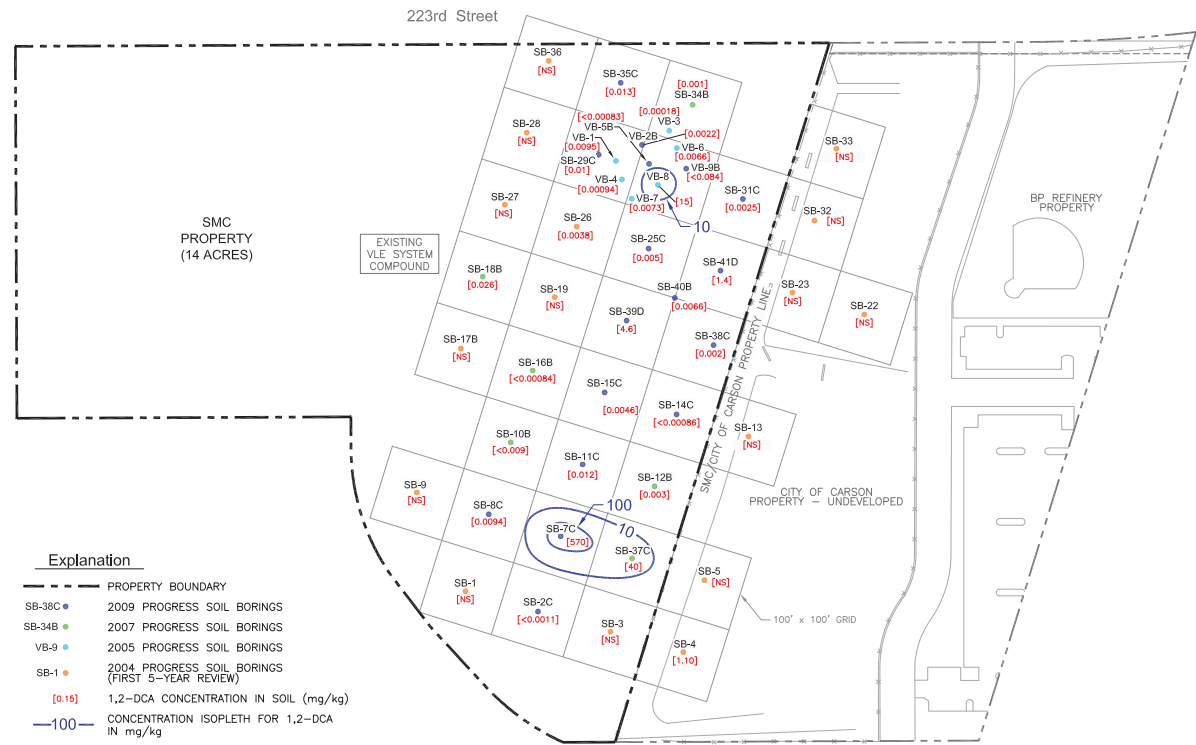
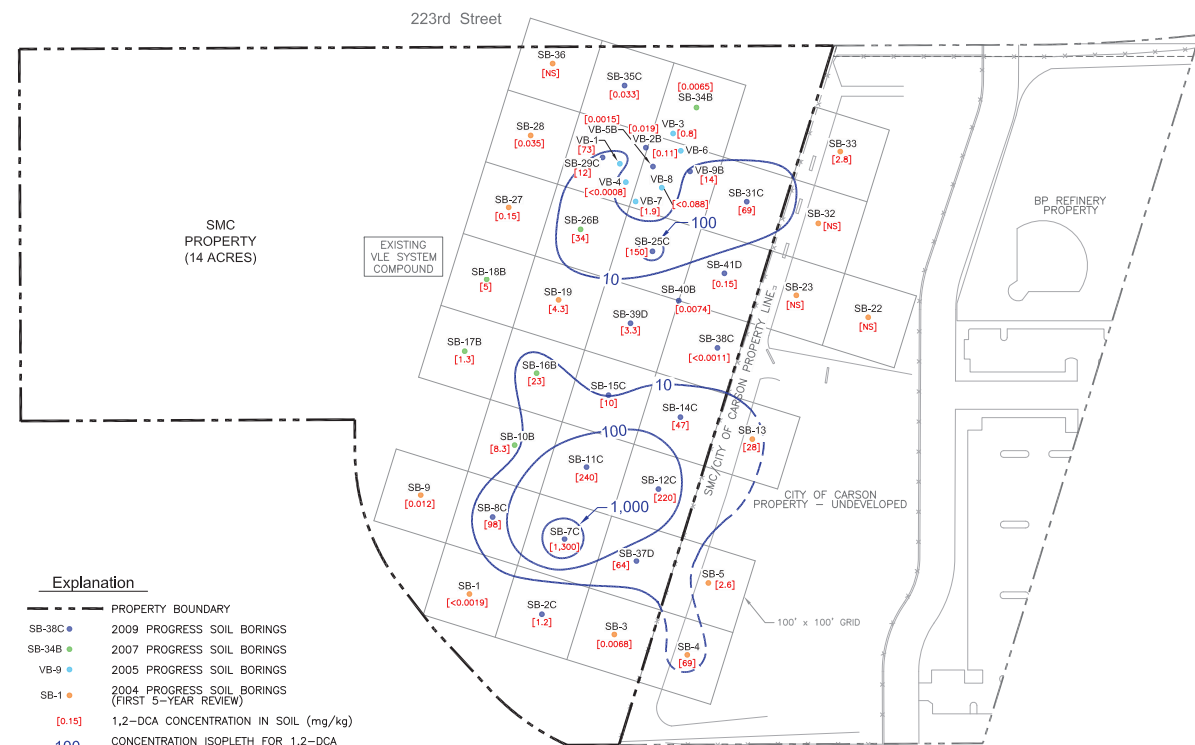
FIGURE 5
RESIDUAL 1,2-DCA IN SOIL
FORMER STAUFFER FACILITY
CARSON, CALIFORNIA
PREPARED FOR
PANATTONI DEVELOPMENT COMPANY, INC.
DENVER, COLORADO

It is noted that the RBCs were based on “estimated lifetime cancer risk” (ELCR) with a risk threshold of 1×10^{-5} . It is further noted that the RBCs for “shallow” soil were based on dermal contact, ingestion, and inhalation exposure pathways, whereas the RBCs for “deep” soil were based on exposure via inhalation only. Smaller numbers of verification borings were drilled and sampled in 2005, 2007, and 2009 at locations where residual VOC concentrations exceeded the RBCs. Verification boring locations are shown in Figures 5 and 6.
