**Jurisdictional Wetlands/Waters
Delineation Report**

Harvard Avenue and Michelson Drive
Intersection Improvement Project

September 25, 2019

Stantec Consulting Services Inc.
290 Conejo Ridge Avenue
Thousand Oaks, CA 91361

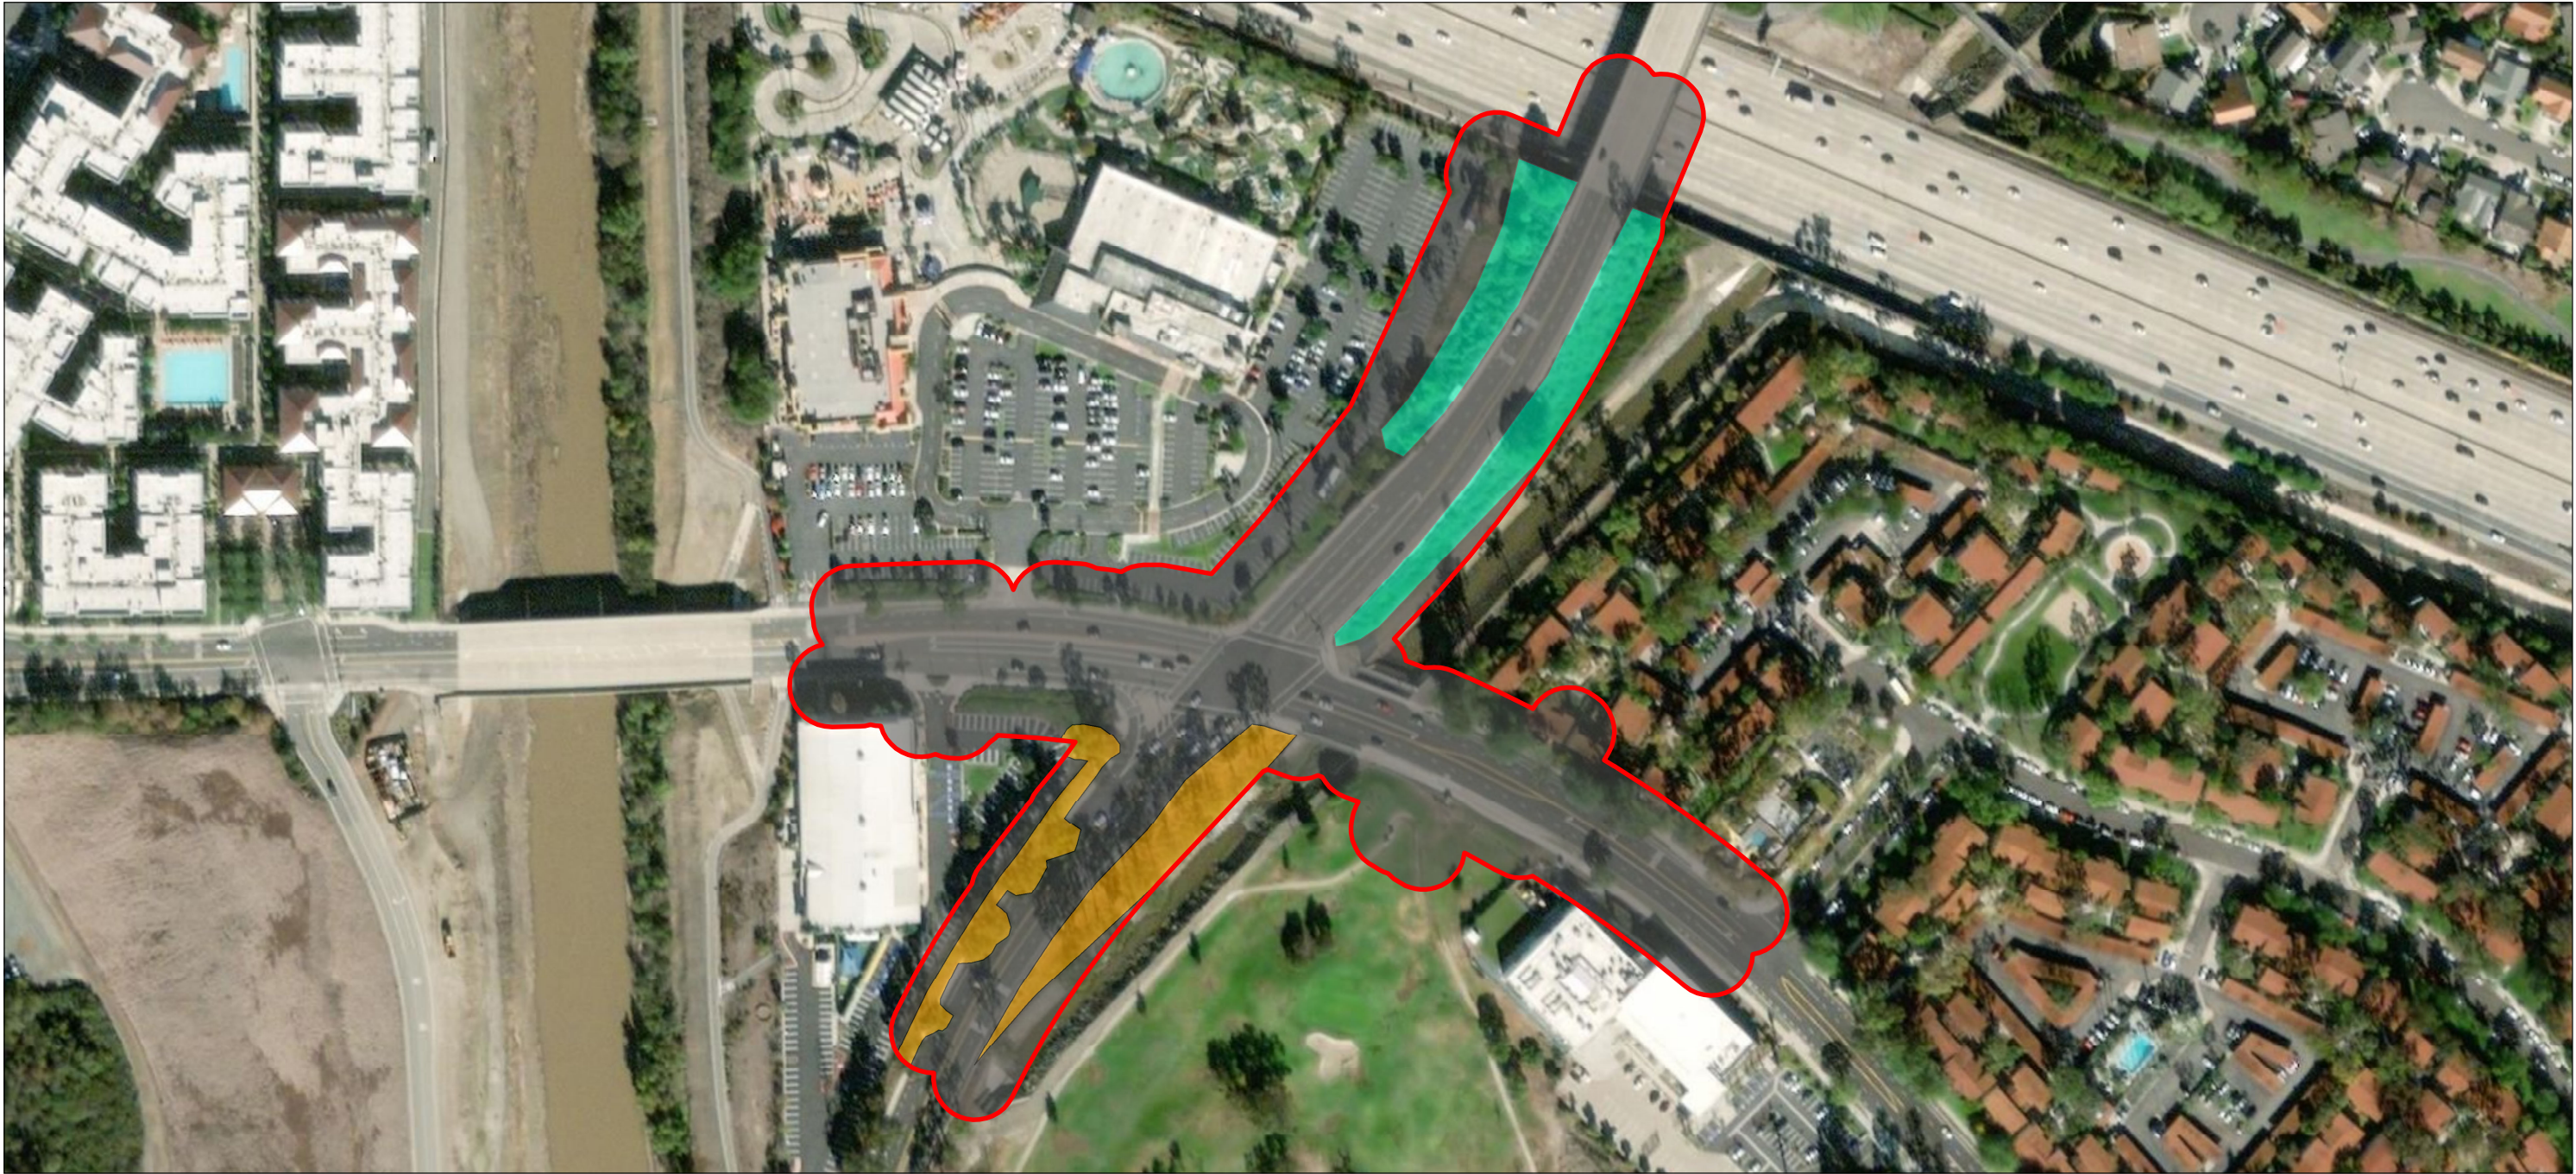
Figure No.
2
Title
**Vegetation Communities & Land Cover
Types**

- Biological Study Area
- Vegetation Communities & Land Cover Types**
- Disturbed/Developed
 - Eucalyptus* spp. Woodland Semi-Natural Alliance
 - Ornamental (*Acacia myrtifolia*)

Generally, mapping and description of plant communities follows the classification system described in the second edition of A Manual of California Vegetation (MCVII) (Sawyer et al., 2009). Species scientific and common names correspond to those described in the second edition of The Jepson Manual (Baldwin et al., 2012). Vegetation communities and land uses are described below and depicted in Figure 2 in Appendix A.

In the northern portion of the BSA, on either side of Harvard Avenue, approximately 1.13 acres of sloped land built up to create the I-405 overcrossing are populated by a near monoculture of myrtle wattle (*Acacia myrtifolia*). The myrtle wattle shrubs form a contiguous canopy across the slopes that does not allow for the growth of other shrub or herb species, though a few ornamental trees to punctuate these areas.

To the south of the Harvard/Michelson intersection, approximately 0.87 acre of this habitat type occurs in the landscaped medians on either side of Harvard Avenue. They are dominated by lemon-scented gum trees (*Corymbia citriodora*) with an understory of pittosporum shrubs (*Pittosporum* spp.) along the east side of the road and St. Augustine grass (*Stenotaphrum secundatum*) on the west side.

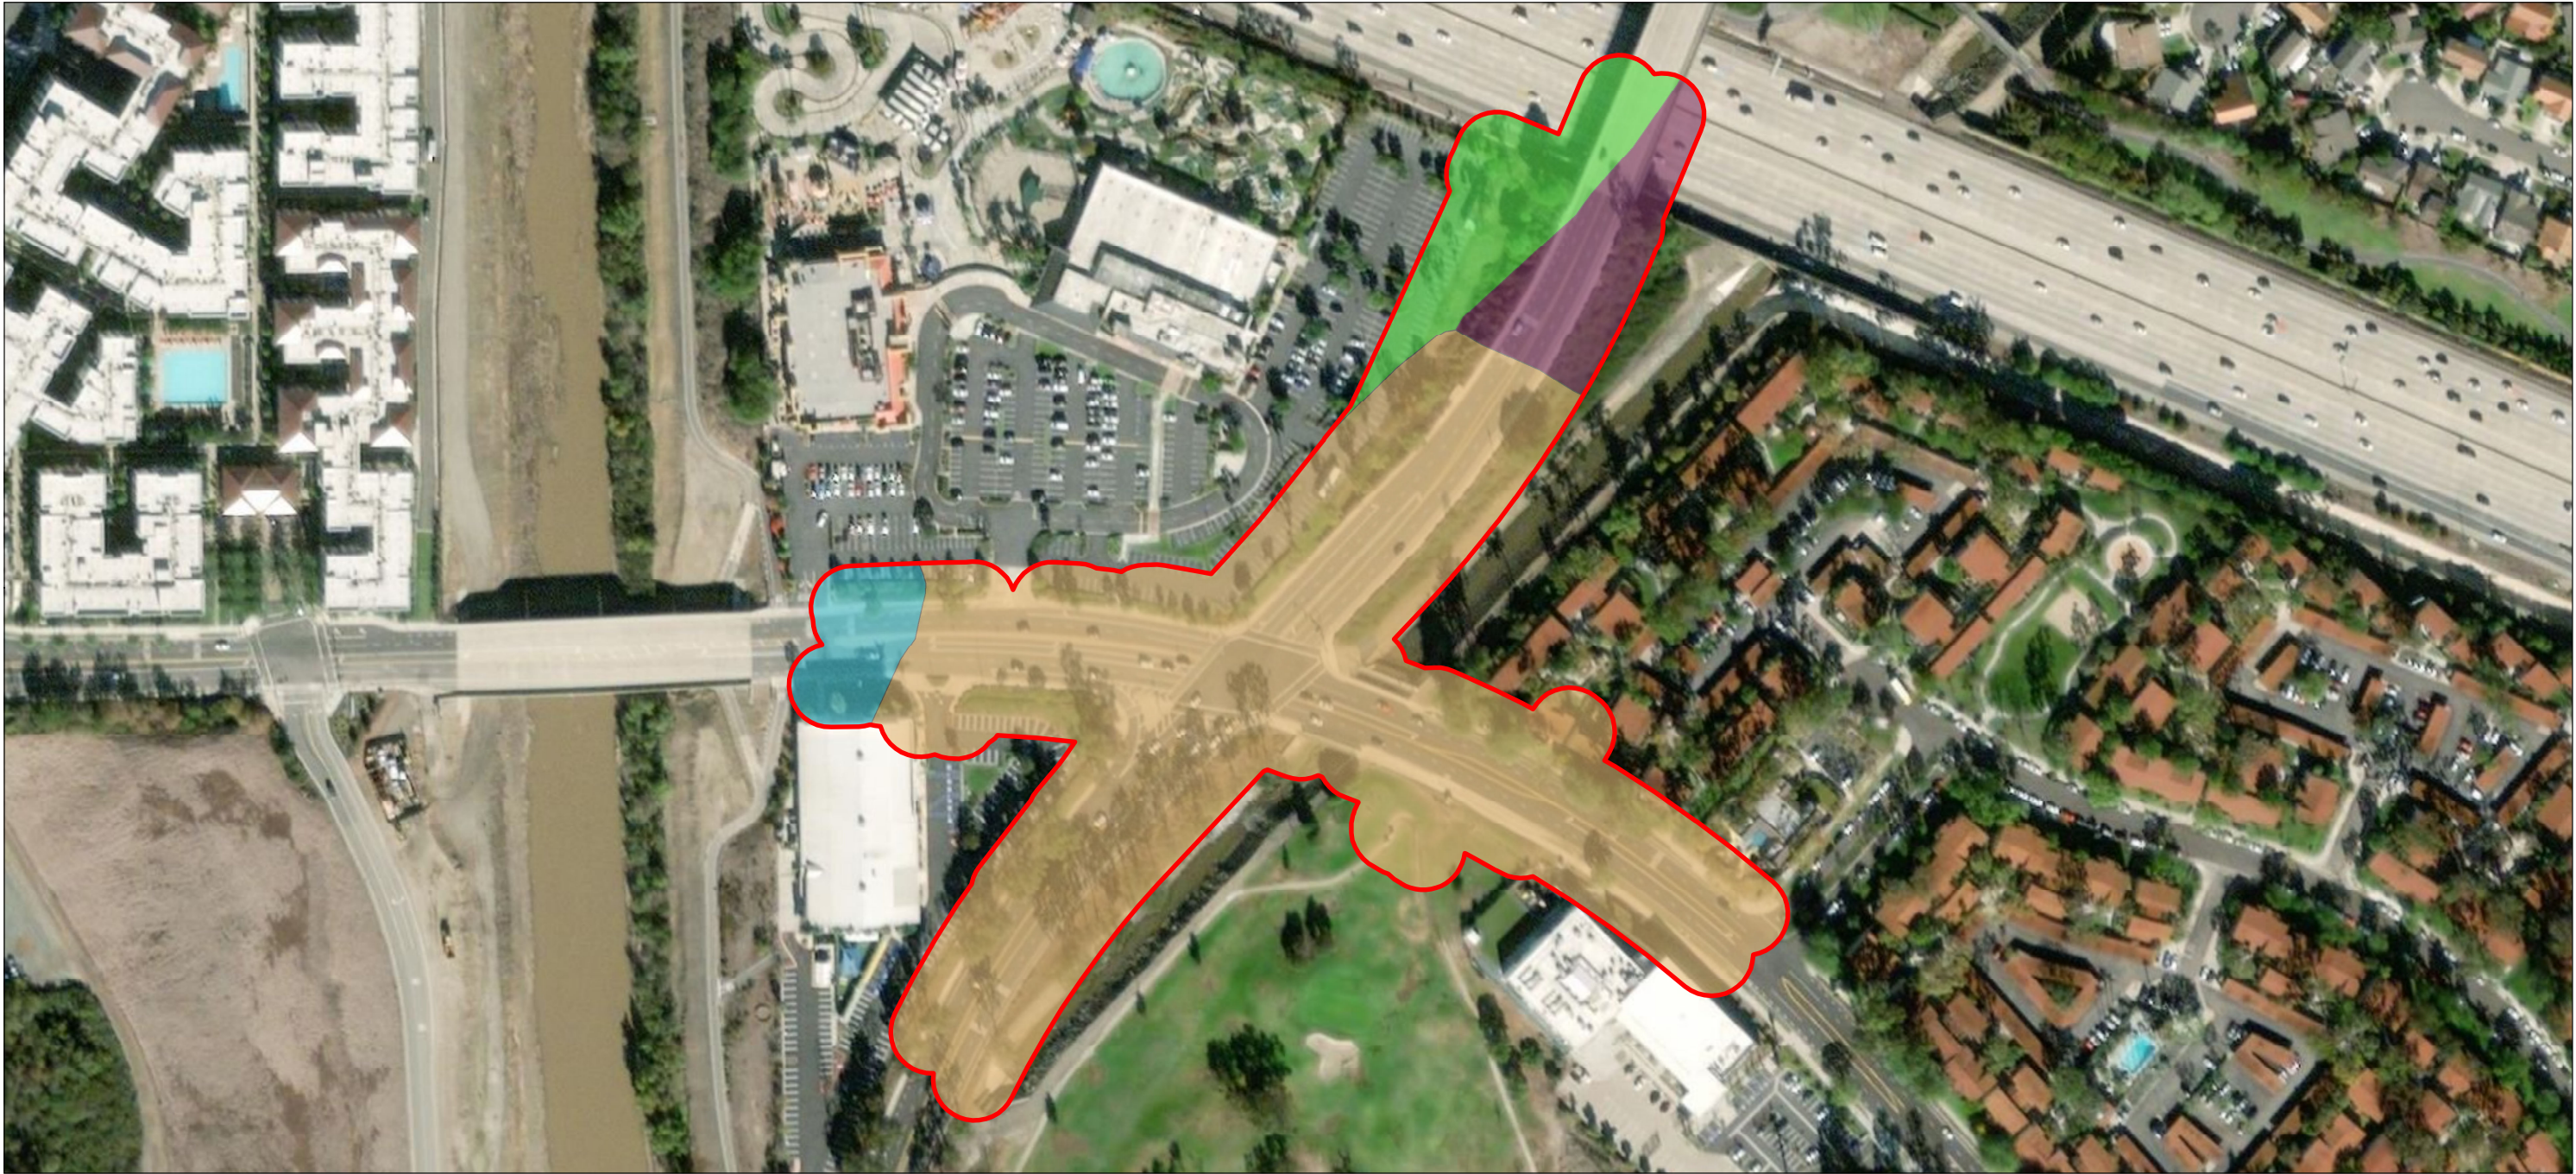
Historical Soil Types

Map Unit Symbol

Prior to conducting the delineation, historic soils data from the Natural Resources Conservation Service (NRCS) was used to determine potential soil types that may occur within the BSA, including where hydric soils have historically occurred (refer to Appendix A, Figure 3). Table 1 identifies the soils historically known to occur within the BSA and characteristics of these soils are summarized in Appendix C. Only one of the soils listed in Table 1 appears on the NRCS hydric soils list: Omni clay, drained.

Soils data from the NRCS are referenced to determine if hydric soils have been previously documented and/or historically occurred in or near the BSA (Appendix A, Figure 3). Based on this review, one hydric soil type (Omni clay, drained) was expected to occur, having been mapped throughout the majority of the BSA. However, based on the extensive development in the region, the historic characteristics of the soils are likely significantly compromised. Tables 6 and 7 in Appendix E include a complete list of hydric soils indicators.

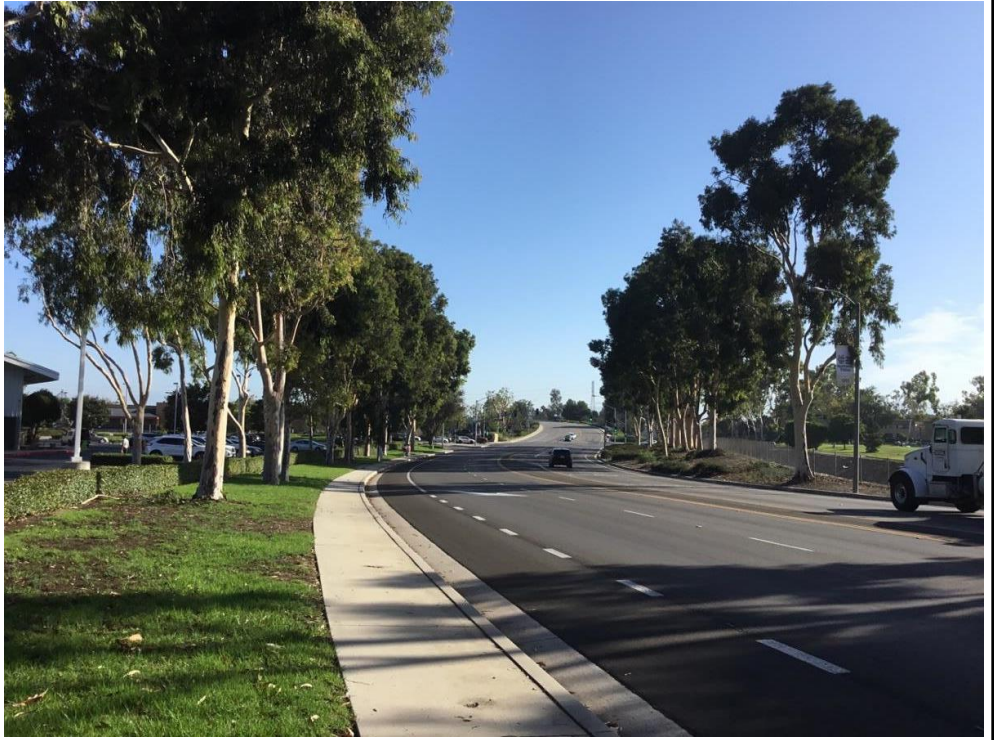
Client:	City of Irvine	Project:	Harvard Avenue and Michelson Drive Road Widening Project
Site Name:	Harvard Avenue/Michelson Drive	Site Location:	Irvine, California
Photograph ID: 1

Direction: Northeast			
Survey Date: 9/6/2019			
Comments: Looking down Harvard Avenue toward the Harvard Avenue/Michelson Drive intersection from the southern end of the BSA. San Joaquin Wash is beyond the eucalyptus trees on the right side of the photograph.			
Photograph ID: 2

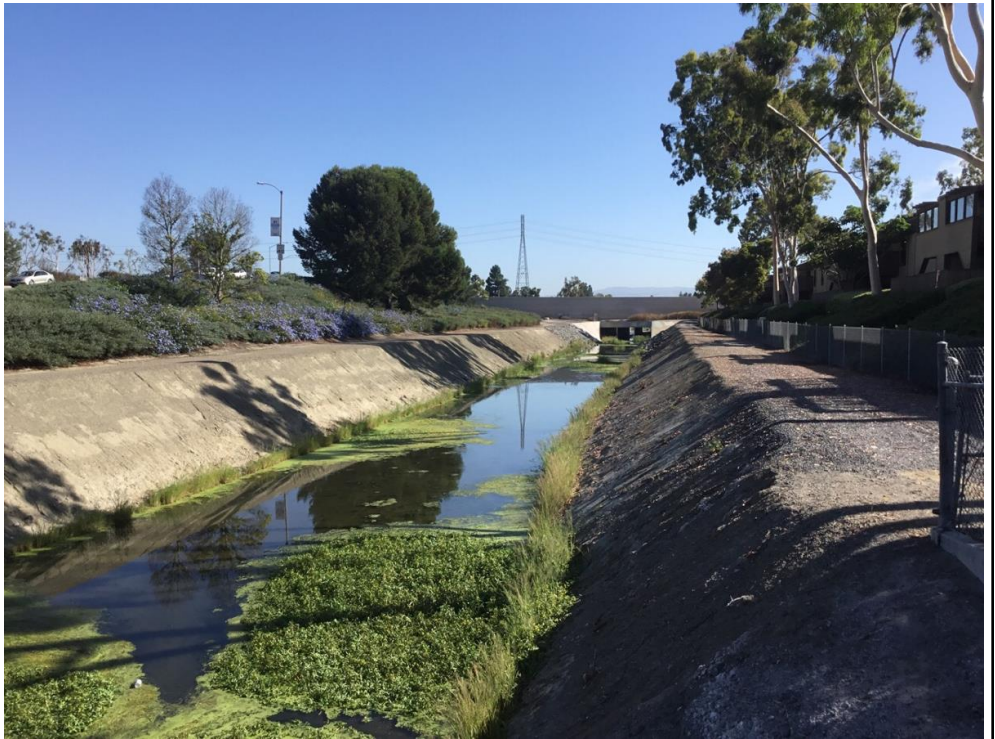
Direction: Northeast			
Survey Date: 9/6/2019			
Comments: San Joaquin Wash - looking upstream from Michelson Drive crossing.

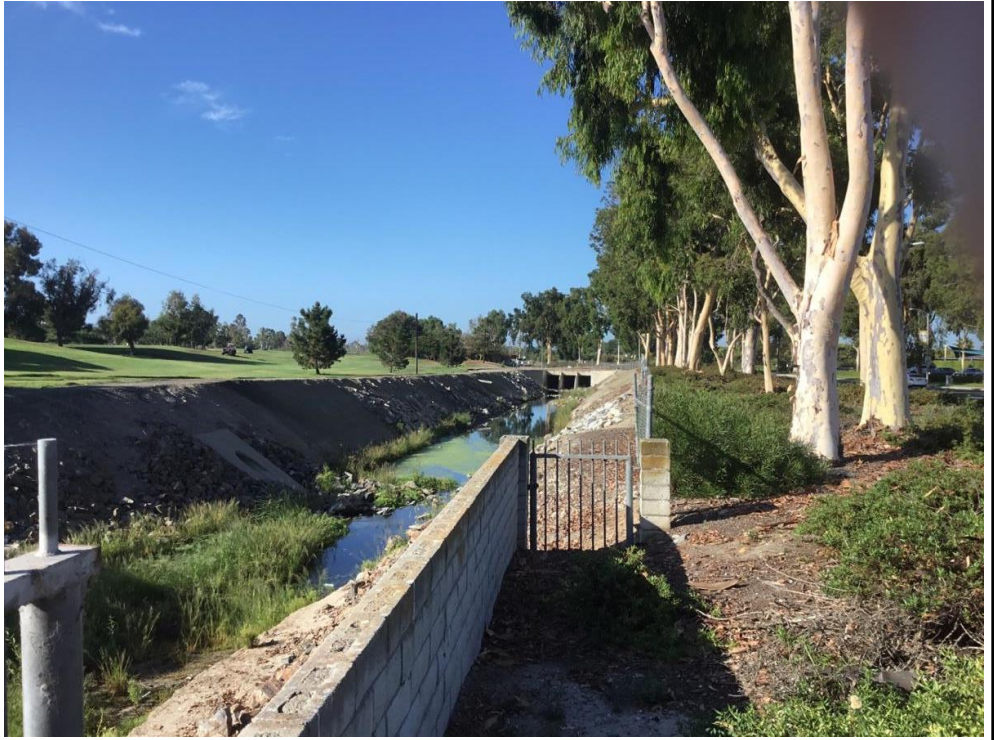
Client:	City of Irvine	Project:	Harvard Avenue and Michelson Drive Road Widening Project
Site Name:	Harvard Avenue/Michelson Drive	Site Location:	Irvine, California
Photograph ID: 3

Direction: Southwest			
Survey Date: 9/6/2019			
Comments: San Joaquin Wash - looking downstream from Michelson Drive crossing.			
Photograph ID: 4

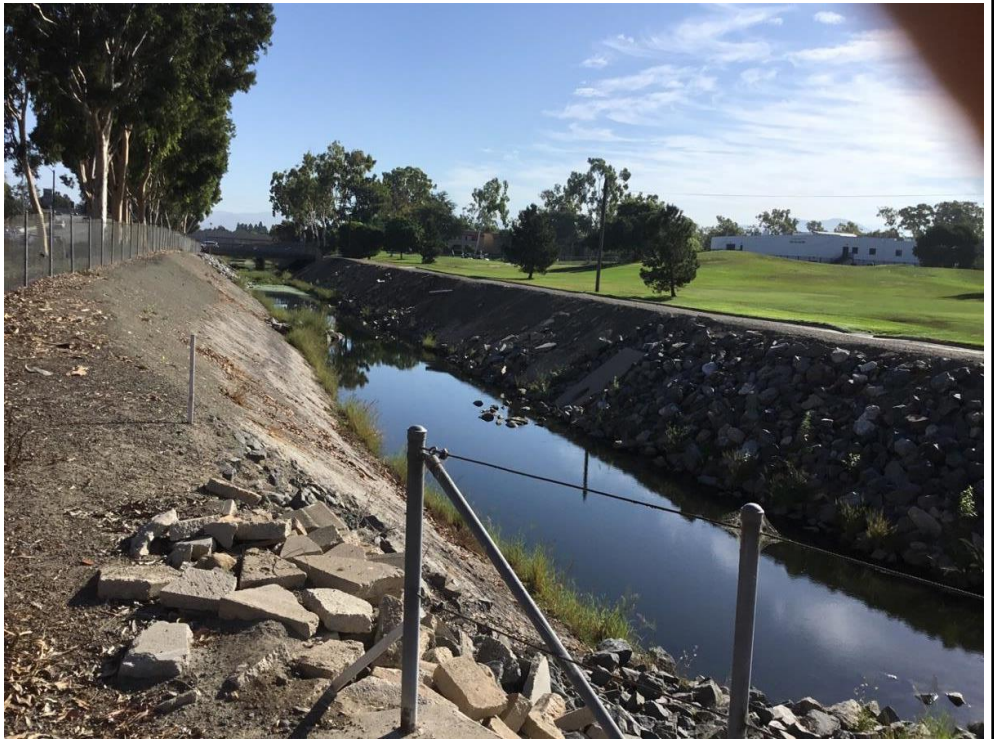
Direction: Northeast			
Survey Date: 9/6/2019			
Comments: San Joaquin Wash - looking upstream from southern end of BSA.
