**PINE CREEK MINE HYDROELECTRIC PROJECT
INYO COUNTY**

FERC PROJECT No. 12532-002

**FINDING OF EFFECT
(*No Adverse Effect*)**

October 14, 2015

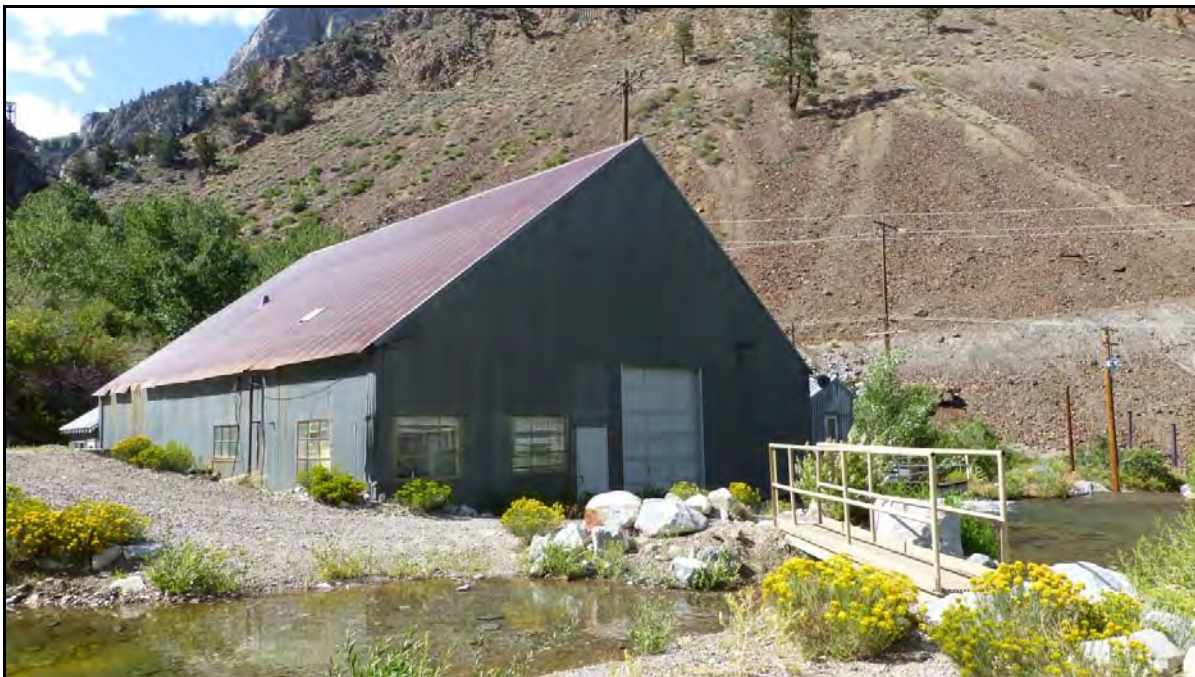
Figure 4: Building No. 12 – Metals Lab (built 1941), Pond 5 (P5) and Pond 6 (P6) (built 2005); facing north, August 12, 2014.

The Metals Lab, also known as Building No. 12, was constructed in 1941, has a rectangular footprint and a steeply pitched gable roof with a slight eave. An addition on the north has a hipped roof with exposed rafter ends and is covered by corrugated metal sheeting. The building is clad in corrugated metal sheeting. On the south side are two 9-light fixed pane windows, a single entry door, and an oversized roll-up door. On the west side is another 9-light fixed pane window and a 6-light fixed pane window. The addition has a single entry door with fixed glass and a two-sash horizontal sliding window. The north side has five smaller two-sash windows, and on the east side is a two-sash horizontal sliding window. Adjacent to the building is a concrete support for a penstock. See **Figures 4 and 5**.

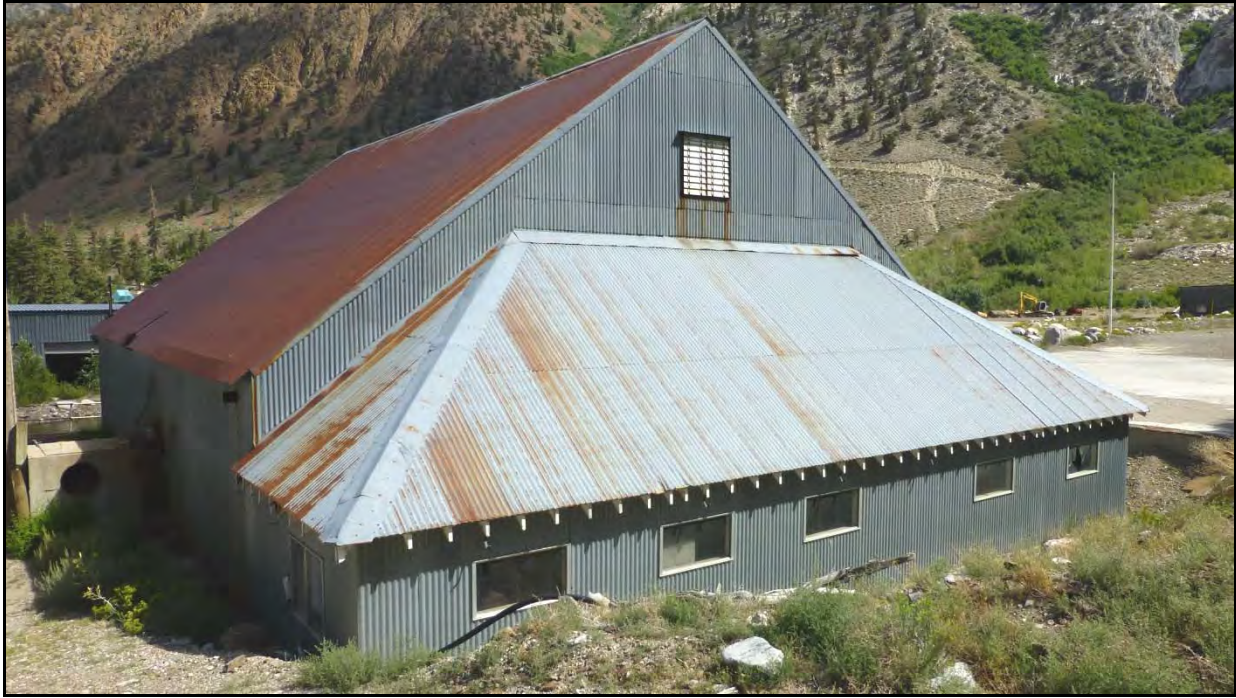
Figure 5: No. 12 – Metals Lab (built 1941); facing south, August 12, 2014.

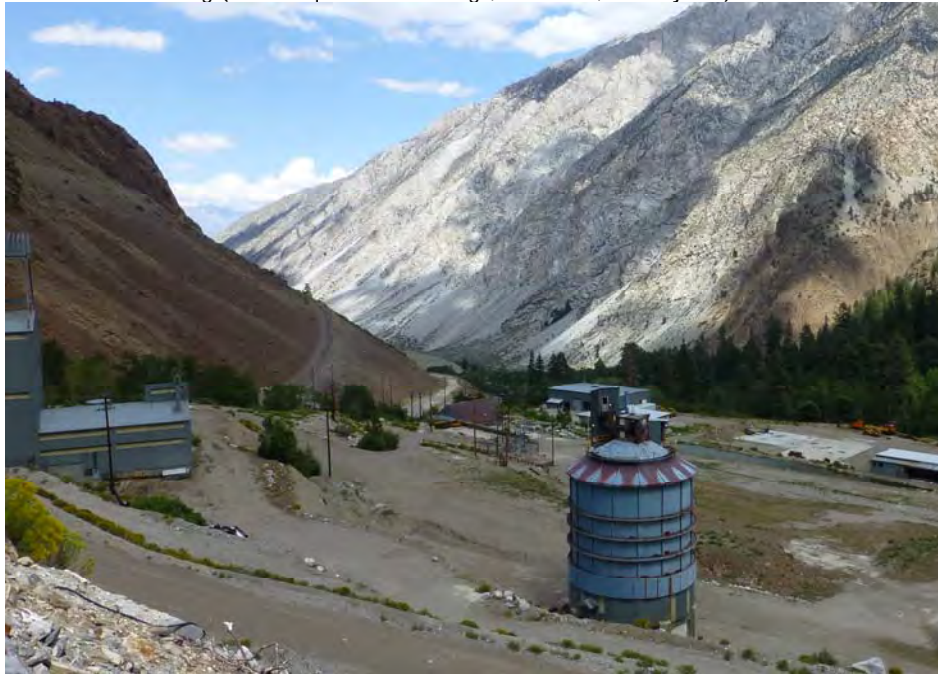
Photograph 1. Facing East, August 12, 2014

Pine Creek Mine was first established in 1916 at an elevation of 11,600 feet. The sites associated with the early history of Pine Creek Mine have been demolished. These included buildings and structures near Lake Morgan. Most of the Aerial Tramway except three lower towers, visible from the mill site, have also been demolished. Additionally, the upper adits have been sealed (See APE map attached to HRIER and **Figure 15**) (Belec Interview, August 12, 2014). The site recorded on this DPR form dates between 1941 and 2005 and includes existing improvements consisting of mine buildings, roads and bridges, ponds, utility poles and substations located at the old mill site and Easy Go adit (**Photograph 1; Site Map and List**). (See Continuation Sheet.)

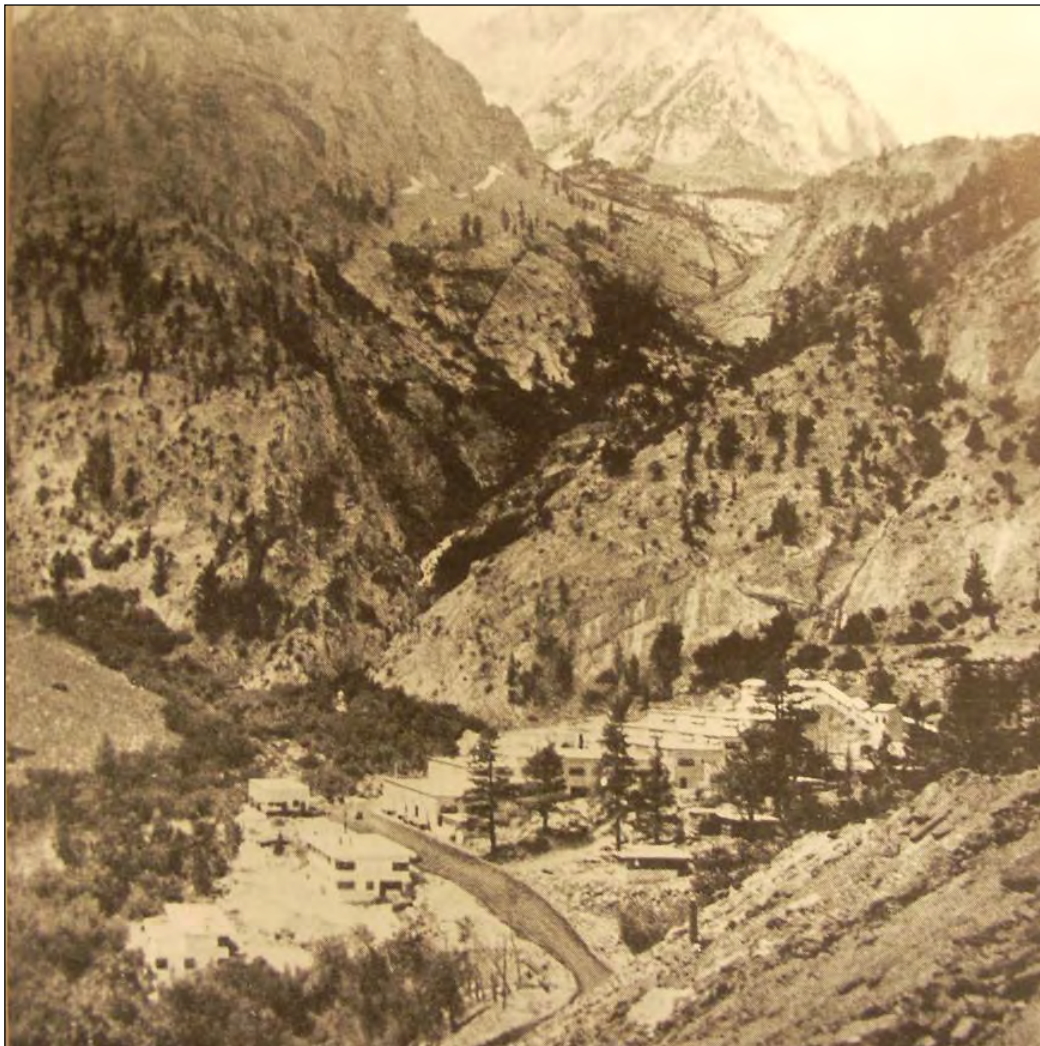
Figure 2. Concentrating and chemical treatment plant of U.S. Vanadium Corp. at junction of Pine and Morgan Creeks, elevation 7,700 ft. (Photograph from *Engineering and Mining Journal*, November 1941: 72.) This photograph, looking southwest, was taken from Morgan Creek Road leading to the upper mining area.

Ore is hauled by a 5-ton electric storage-battery locomotive, in 10-car trains, using 3-ton Granby-type side-dump cars, to a crushing plant at the mine portal consisting of a 20-in. gyratory crusher set to crush to 4-in. size at rate of 160 tons per hour. Crushed ore is conveyed by a ... tramway ... with a capacity of 100 tons an hour, to the new mill ... The buckets from the tramway discharge into a lower tramway bin, where the ore was fed by a pan feeder to a Symons 5½ ft. short-head crusher set to a ¼ inch opening. This crushed ore is conveyed to four 1,200-ton circular steel storage bins over a Merrick weightometer for recording tonnage. The mill had four sections, and “in each section the ore was fed to a 6x5-ft. March ball mill of the open-end type, in closed circuit with a 60-in. Akins classifier. The ore was ground to approximately 90 percent minus 60 mesh, and went to flotation machines at a pulp density of 25 percent solid (*EMJ*, November 1941:72).

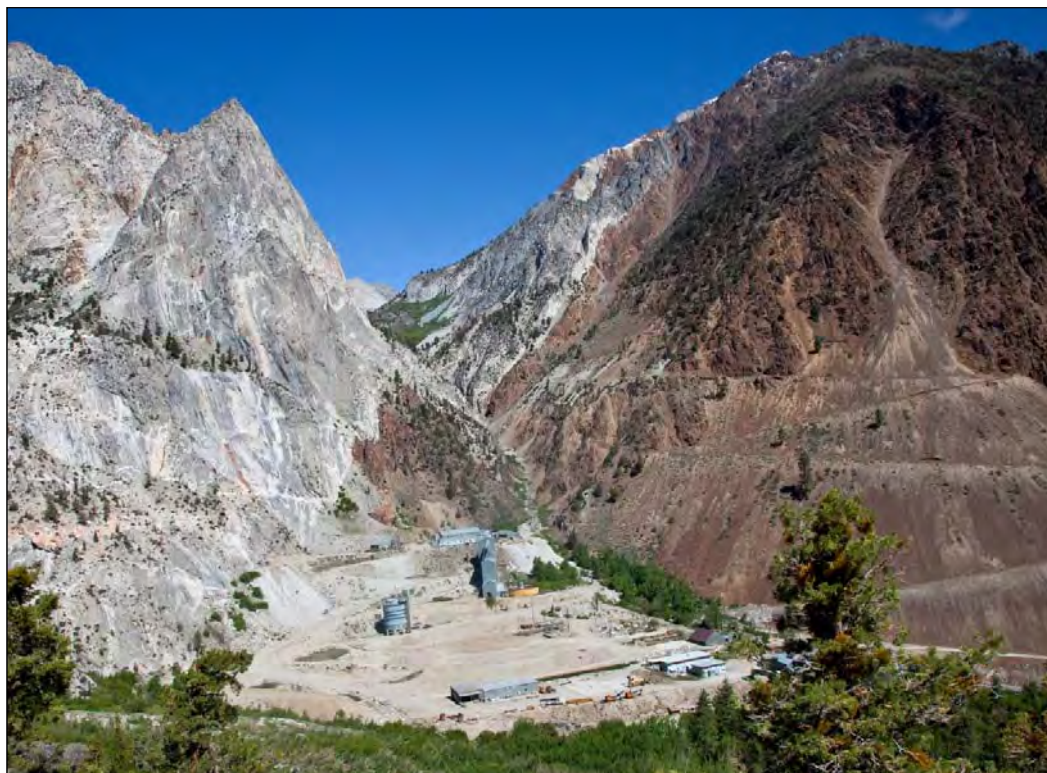
Figure 11. Pine Creek Mine facing northwest (Photograph provided by Brian Schmalz May 27, 2012, <http://calitrails.files.wordpress.com/2012/05/pinecreek-mine.jpg>). The Easy Go adit is near the crusher building (built 1970) in the center of this image.

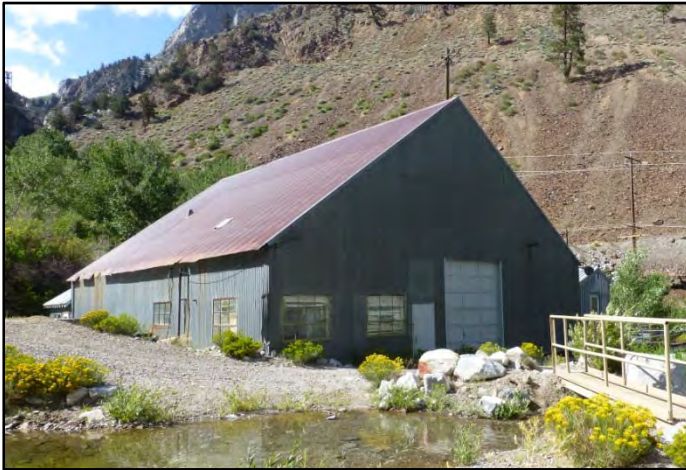
Photograph 2. Building 12 – Metals Lab; facing north; August 12, 2014.

integrity. The addition is in the back, and does not protrude above the building or significantly alter its size and massing. The personal door on the south facing side does not significantly alter the appearance of the front of the building. Integrity of setting and association have been affected by the removal of buildings once located at this mine site. However, these changes do not affect the buildings ability to convey its significance (See **Photograph 2**; **Photograph 3**).

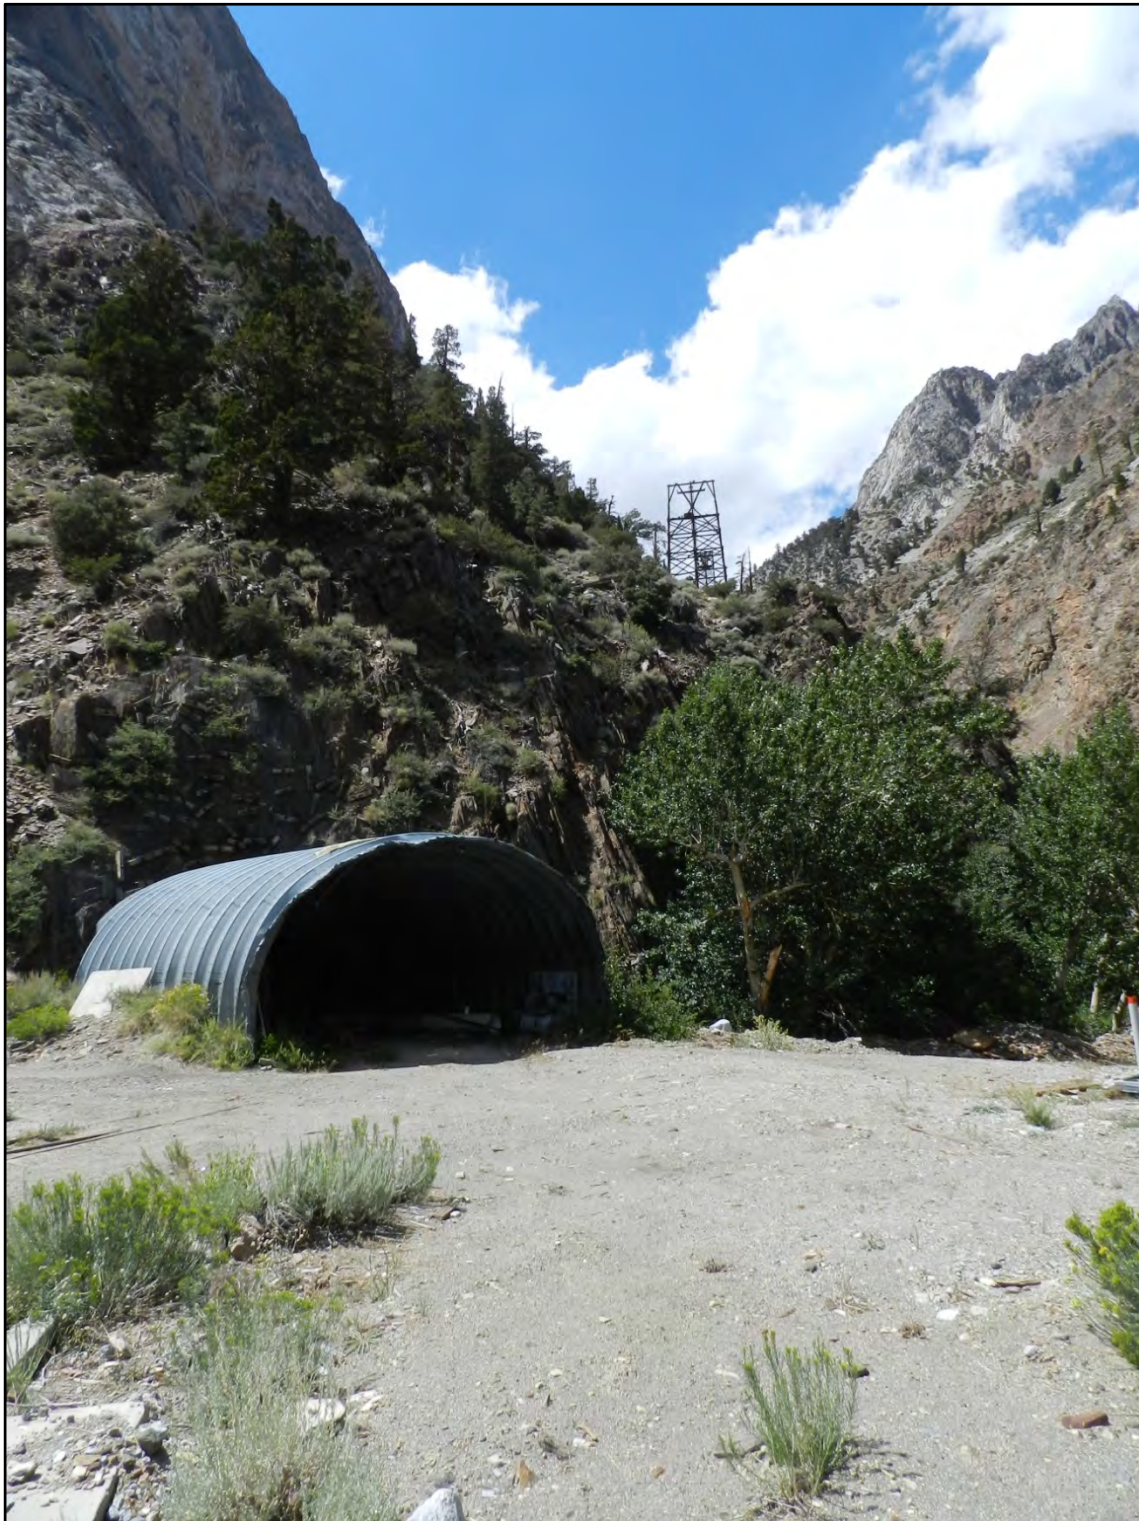
Photograph 4: No. A - Easy Go Adit (built 1970) and Structure 19 – Tramway Towers tramway towers (built 1941); facing north, August 12, 2014.

The Easy Go Adit is a mine portal constructed in 1970 extending approximately two miles into the mountain. At the entrance is a locked metal gate closing off the mine. Water pipes come out of the mine carrying water that runs into the ponds and down into Morgan Creek. An arched corrugated metal structure covers the entrance to the mine and once completely enclosed the train tracks that run from the mine into the crusher building. The metal enclosure was partially destroyed by an avalanche ca. 2001, and the damaged portion was removed shortly after (**Photograph 4**).

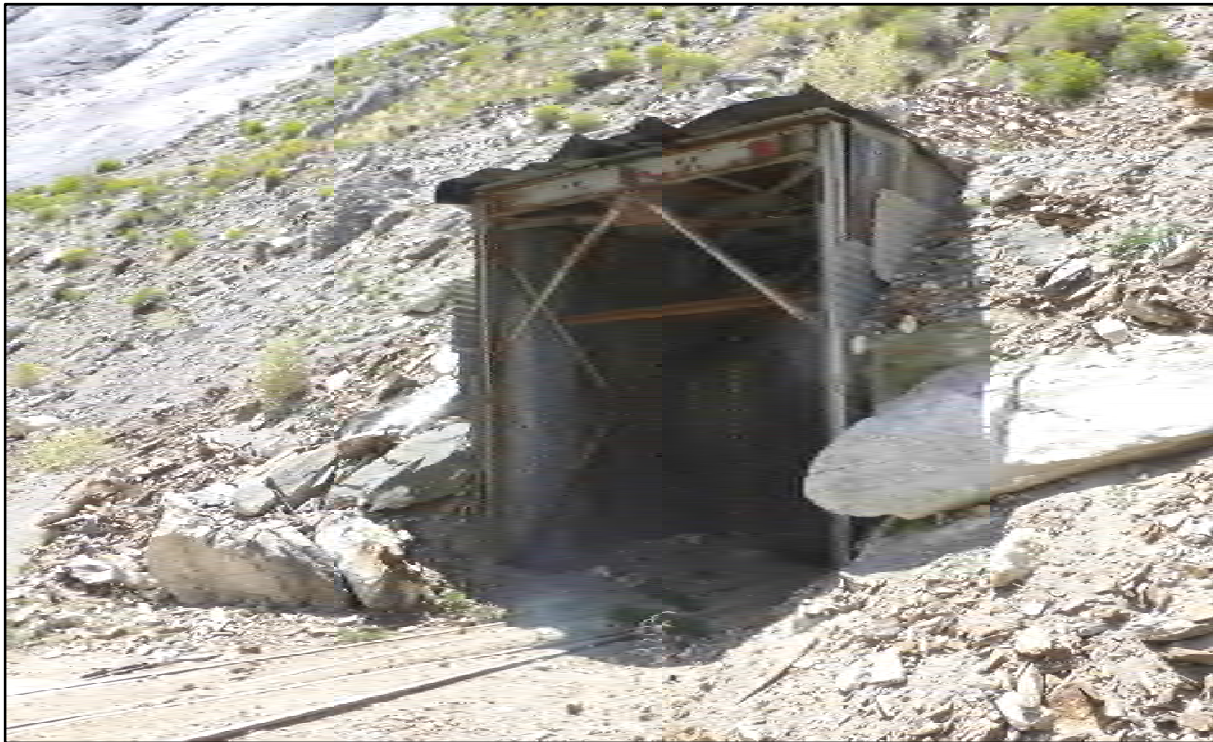
Photograph 5: No. B – Easy Go Maintenance Portal (built 1970); facing northwest, August 12, 2014.

The Easy Go Maintenance Portal, constructed in 1970, is to the west of the Main Adit. It is a smaller tunnel into the mountain with a locked metal gate closing off the entrance to the mine. A cross braced metal structure shelters the entrance and train tracks extending from the mine portal. The structure is covered with scraps of corrugated metal sheeting. The mine tunnel appears to be braced by wood beyond the gate (**Photograph 5**).

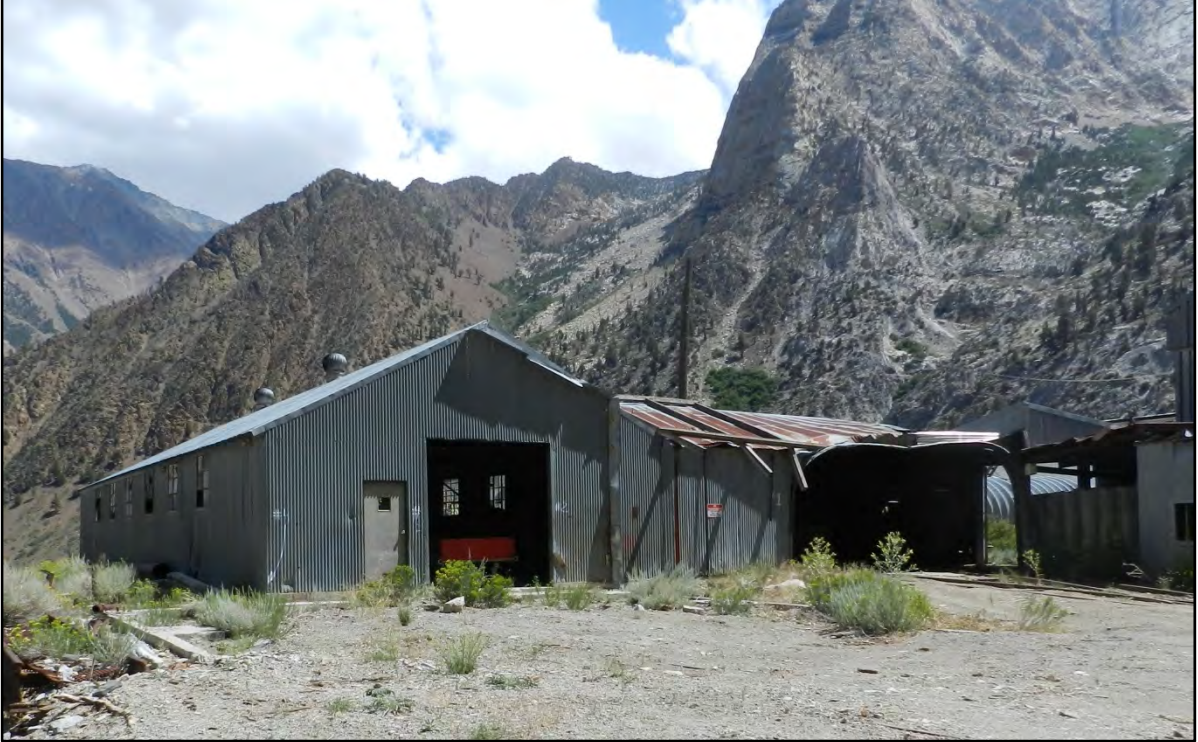
Photograph 7: No. 1 – Bit Sharpener Building (built 1970); facing south, August 12, 2014.

The Bit Sharpener Building, constructed in 1970, has an L shaped footprint and a concrete slab foundation. It is a manufactured building with a cross gabled roof covered with corrugated metal sheeting and little or no eave. On the north side of the building is a large opening for vehicles and a single entry door with a small glass window. The windows are multi-paned industrial windows, and some have broken or missing panes. There is another single entry door on the south side, and the building is clad in corrugated metal siding. It is connected to the covered mine train tracks going into the crusher building (**Photograph 7**).

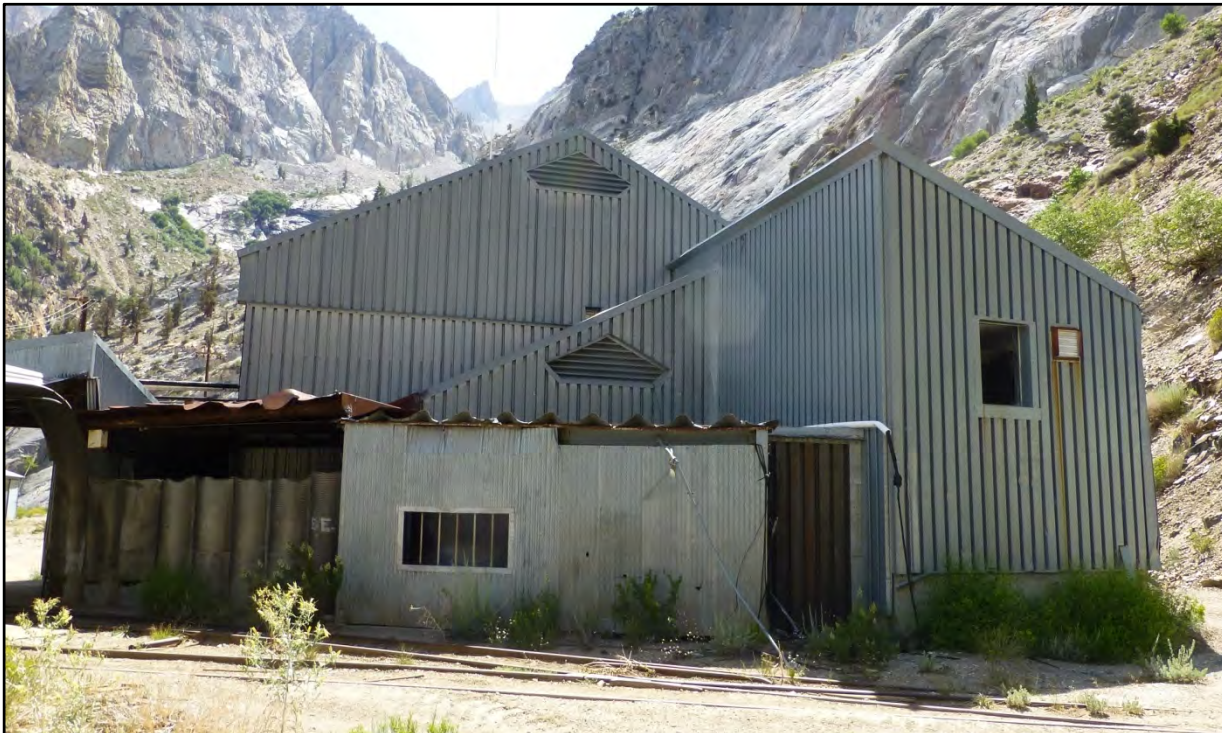
Photograph 9: No. 2 – Mine Engineering Building (built 1970); facing west, August 12, 2014.

The Mine Engineering Building, constructed in 1970, has a generally rectangular footprint with the main section of the building covered by a gable roof. It has a concrete foundation. The west end has a two-story smooth concrete attachment with a corrugated metal gable roof at the northwest and a one-story shed roof addition to the southwest with a roll up garage door. The building is clad in metal siding with some galvanized Kaiser Steel on the edges. The windows are two-part hinged with metal sash. On the south side, there are two entrances on the first floor, and one entrance on the second floor with a small landing and stairs going to the ground. The stairway has an open railing with round metal handrails. A cantilevered metal awning covers the stoop of the two first floor entrances (**Photograph 8**). On the north side, there are two groups of evenly spaced windows (**Photograph 12**). The east side has irregular roofline covered with corrugated metal. There are louvered vents at the top of two sections and a window opening on the northwest side. There is a covered area attached to the southeast corner of the building (**Photograph 9**).

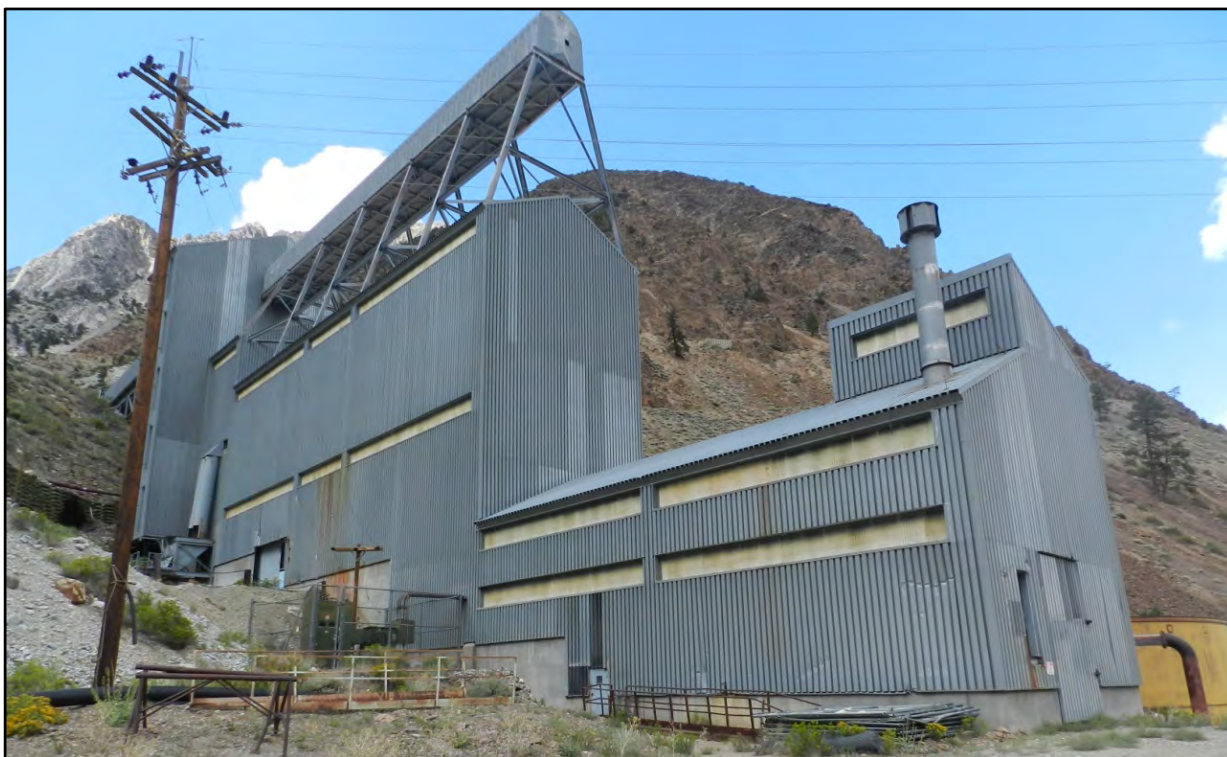
Photograph 10: No. 3 – Crusher/Dumper Building (built 1970); facing north, August 12, 2014.

The Crusher/Dumper Building, built in 1970, is an irregular shape and built into the side of the mountain with a concrete foundation (**Photograph 10**). The train tracks covered by a sheltered metal structure lead to the ore dump and extend past the dump station about the length of ten ore cars to allow movement of emptied cars. The sections of track covered by the arched shelter are supported by steel cross bracing. The building steps down the mountain side. The building has five gable roof sections covered by corrugated metal. The building is clad in corrugated metal sheeting. There are long rectangular window openings covered with fiberglass sheets. There are two single entry doors on the west side, and one on the south side. The crusher building has a section that extends to a clarification tank on the east side (**Photograph 11**). There is a

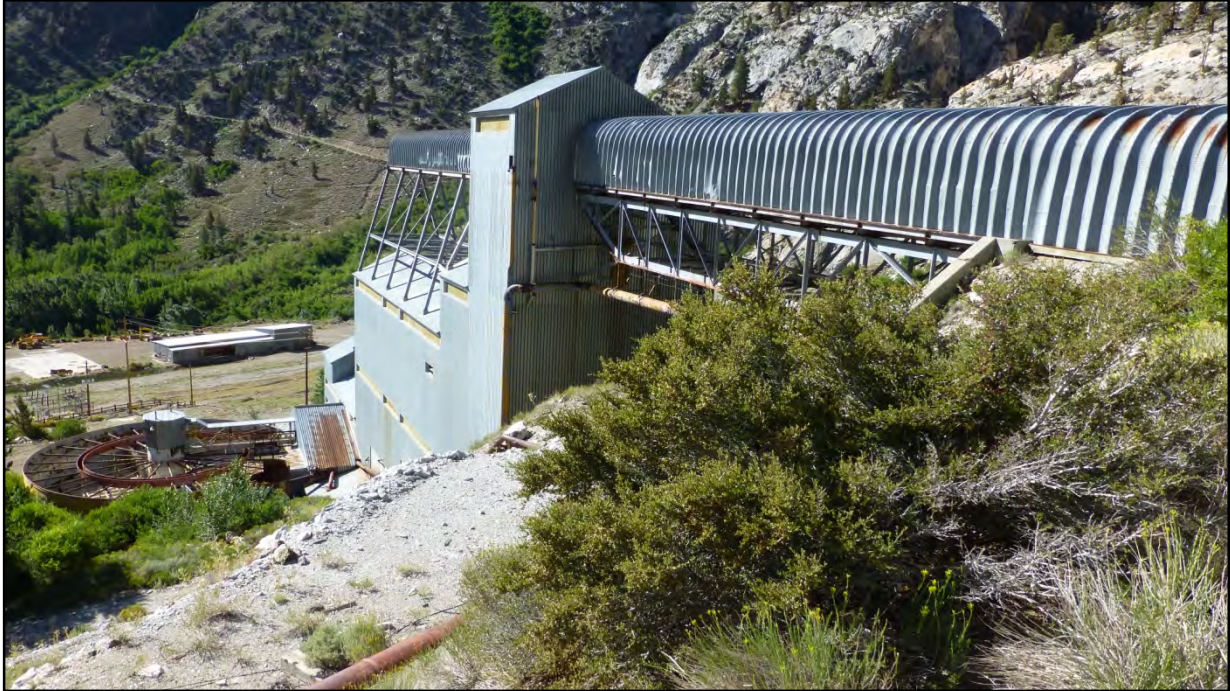
Photograph 11: No. 3 – Crusher/Dumper Building (built 1970) and Building 7, Clarifier Tank (built 1970); facing southwest, August 13, 2014.

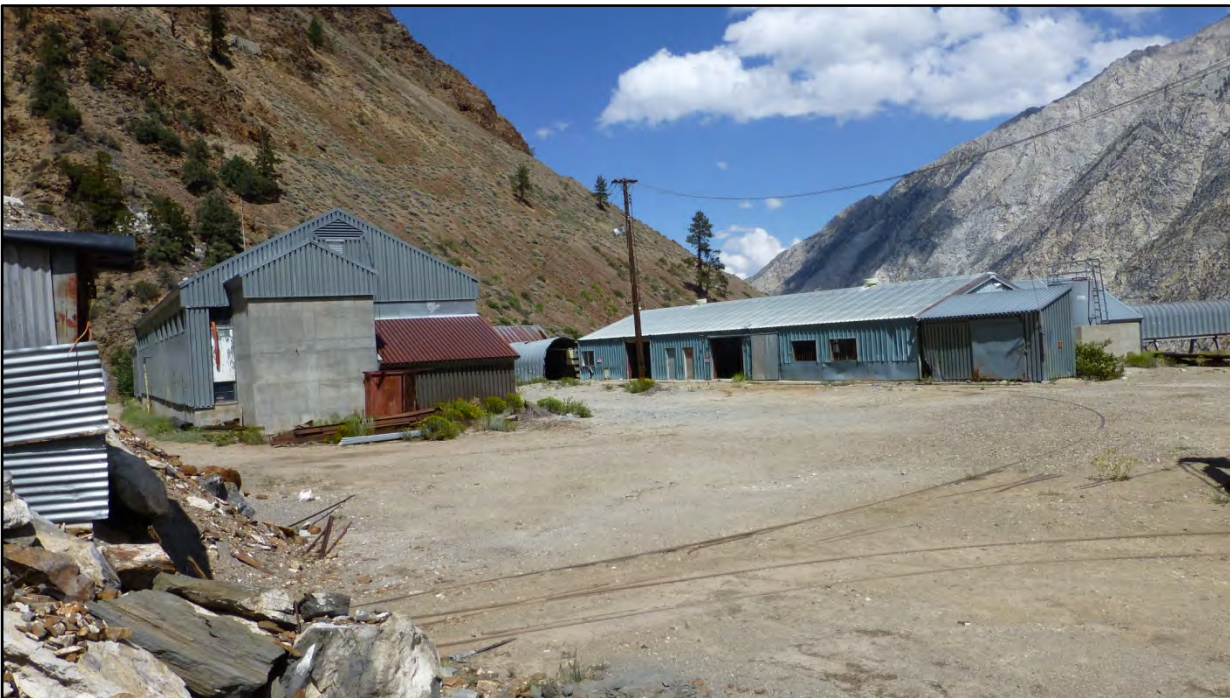
Photograph 12: No. 2 – Mine Engineering Building (built 1970), No. 4 – Carpenter/Warehouse Building (built 1970), E2 – Locomotive Railway Line (built 1970); facing east, August 12, 2014.

The Carpenter Building/Warehouse, constructed in 1970, is a Butler building attached to the covered train tracks going into Building No. 3 (**Photograph 12**). It has a generally rectangular footprint covered by a gable roof. There is an addition to the west side of the building with a shed roof. The building has a concrete foundation, and is clad in corrugated metal siding. There are two single entry doors on the north side, two barn door entrances, and a third large entrance with no door. There are three windows on the north side that are two part with aluminum sash. On the west side, there is a barn door entrance next to a two-story circular tank with a ladder and concrete containment wall. On the south side, there are six two-part aluminum sash windows with bars on the interior (**Photograph 13**).

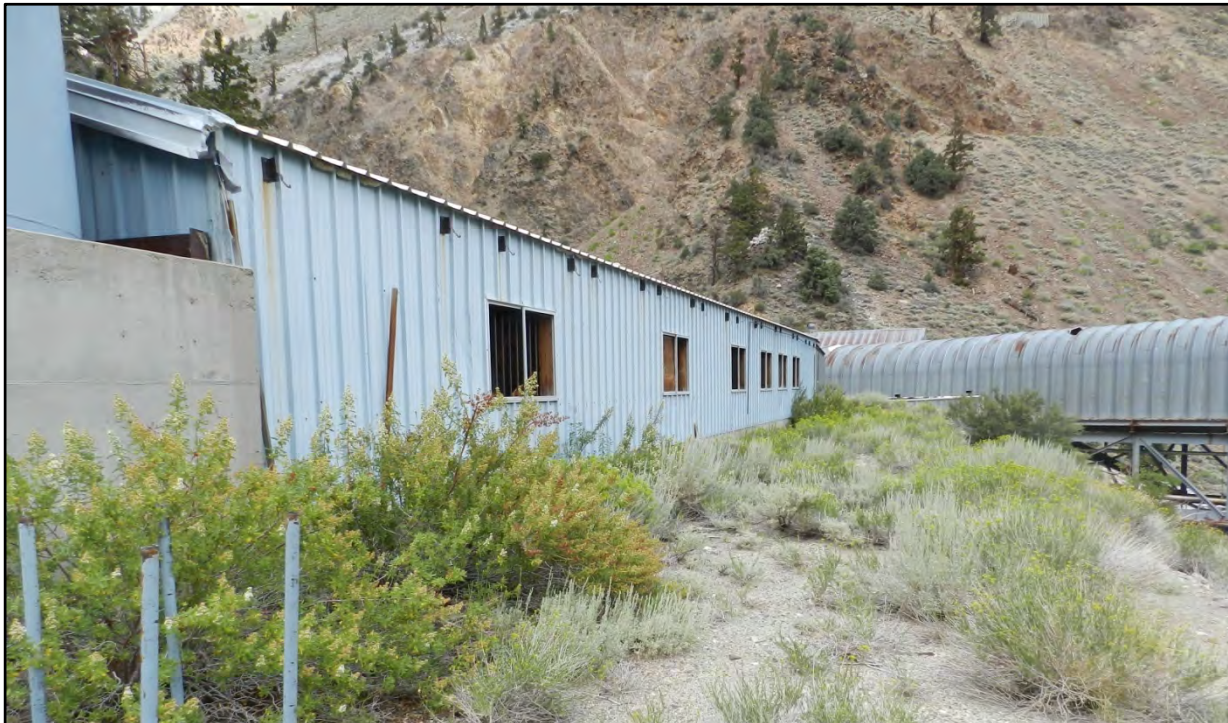
Photograph 13: No. 4 – Carpenter/Warehouse Building and covered tracks to No. 3 (built 1970); facing north, August 12, 2014.

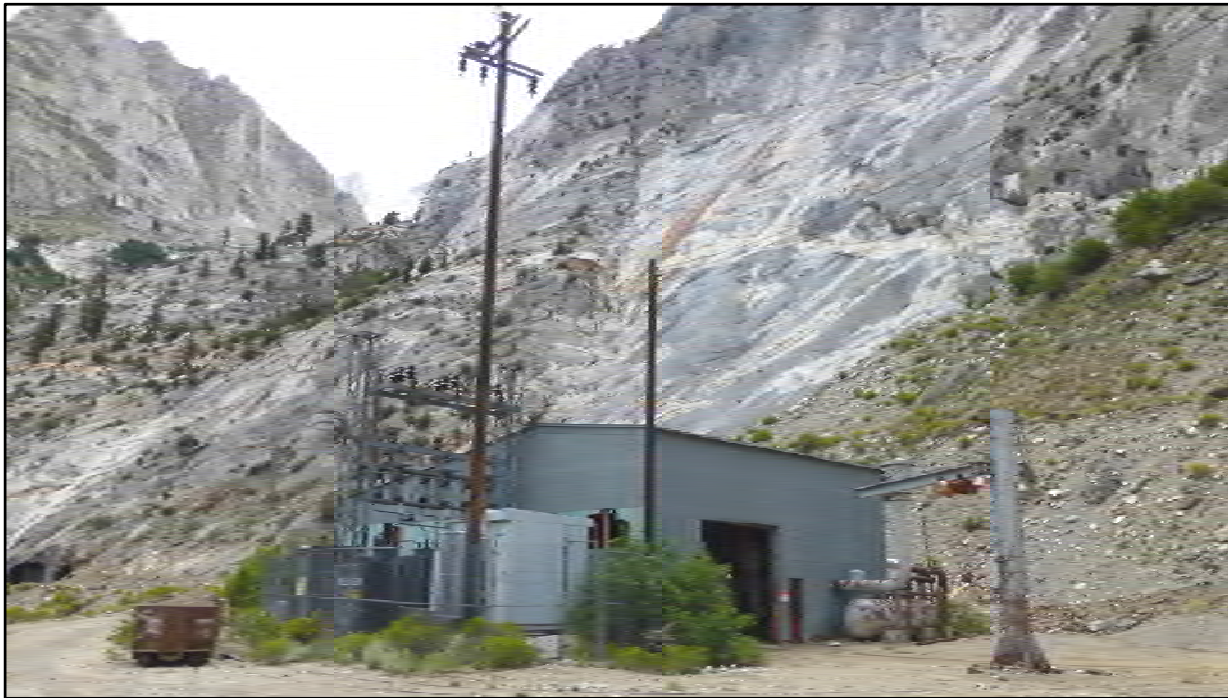
Photograph 15: No. 5 – Locomotive/Substation Building (built 1970), E1 - Ore Carts, E4 – Crane (1970), E5 – Mine Compressor (1970), and E6 – Power Pole and Lines; facing west, August 12, 2014.

Locomotive and Substation Building, constructed in 1970, has a rectangular footprint. It is a tall one-story building on a concrete slab. It has a low pitched salt box roof covered with metal. The building is clad in corrugated metal sheeting. Part of the sheeting is missing on the north side exposing the iron structure beams (**Photograph 14**). There are two large vehicle sized openings, one each on the east and west sides. The compressor tank and several pipes coming out of the building are on the northeast corner. At the north side of the building is located a service crane (see below, E4). On the south side is a substation with transformers, wooden electrical poles, and wire (**Photograph 15**).

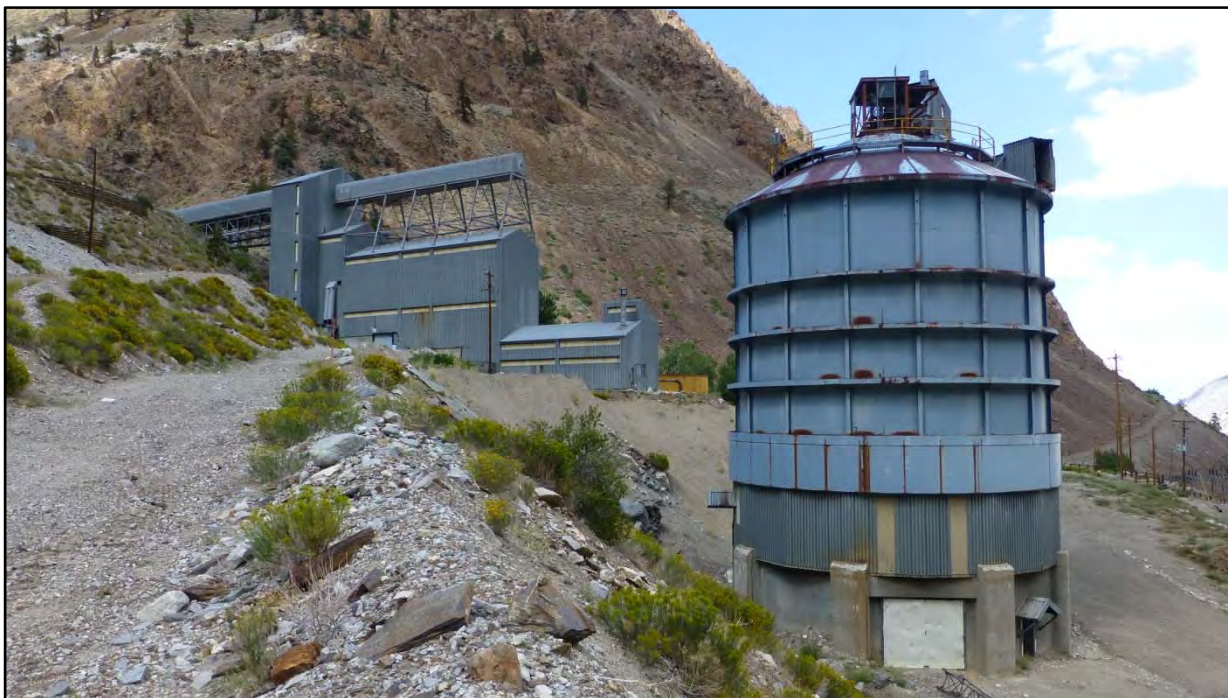
Photograph 16: No. 6 – Ore Bin with Elevator and No. 3 – Crusher/Dumper Building (built 1970); facing east, August 12, 2014.

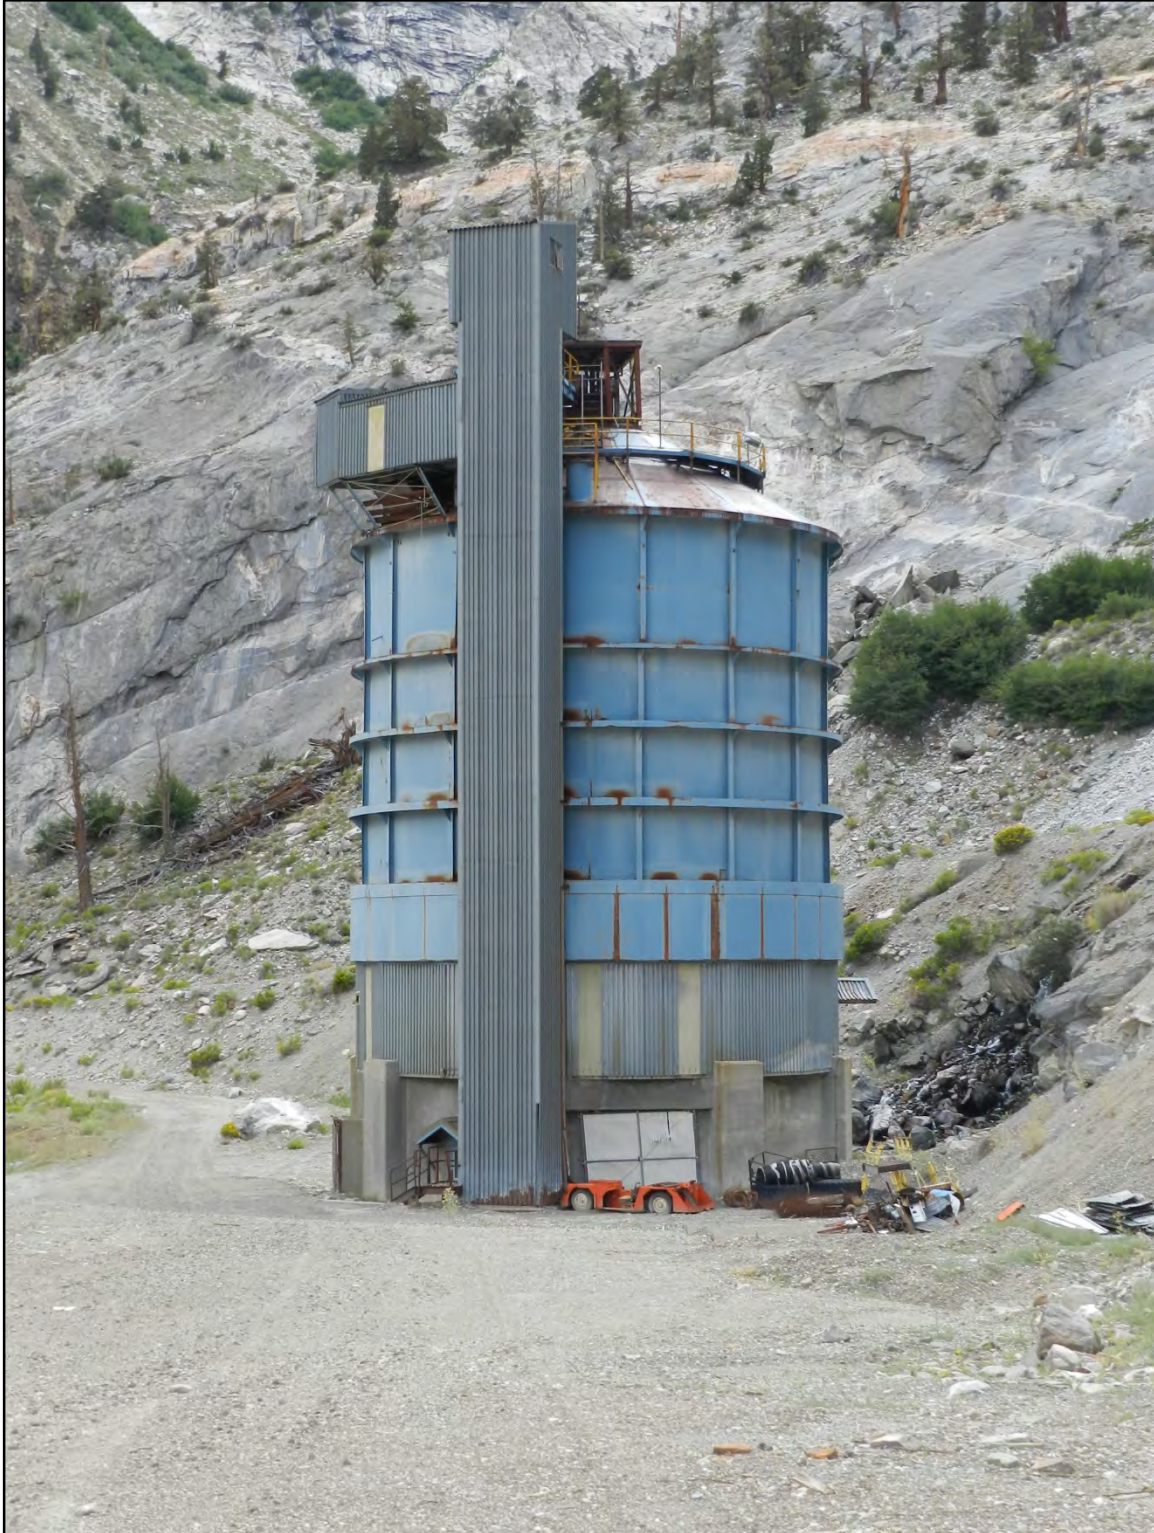
Photograph 17: No. 6 – Ore Bin with Elevator (built 1970); facing west, August 12, 2014.

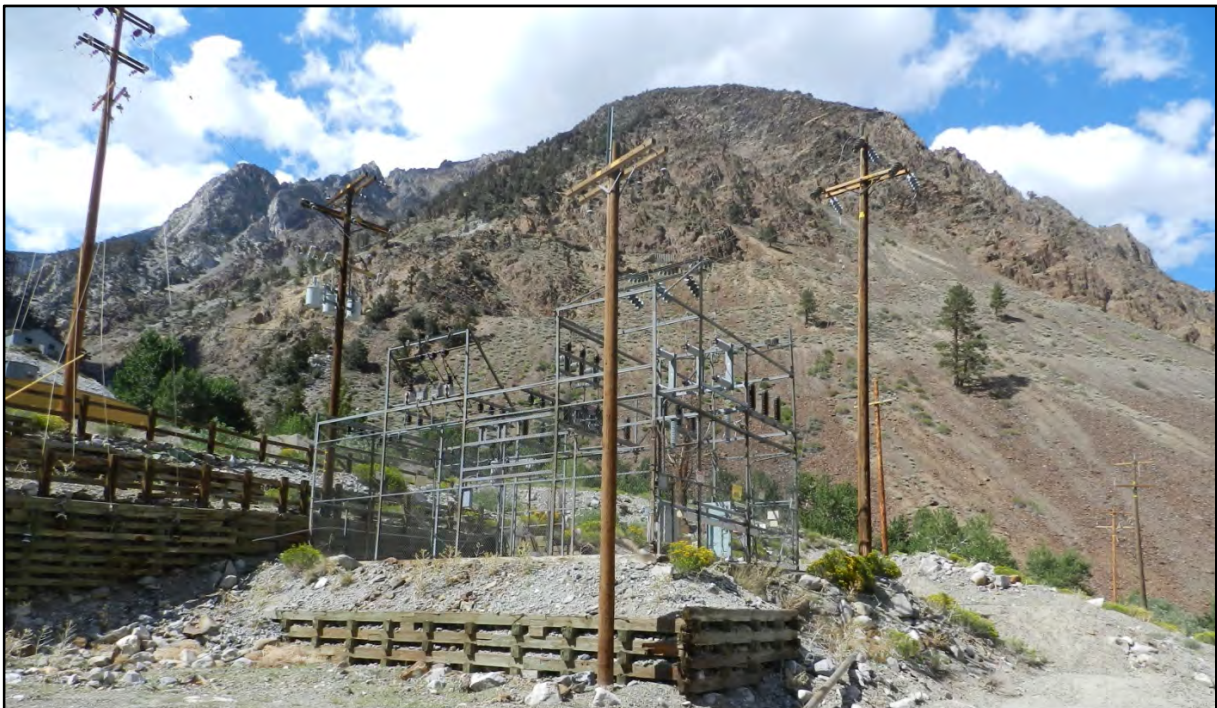
Photograph 19: No. 8 – Electrical Substation (built 1984), SCE and No's 9a (built 1970) and 9b (built 1941) behind; facing southwest, August 12, 2014.

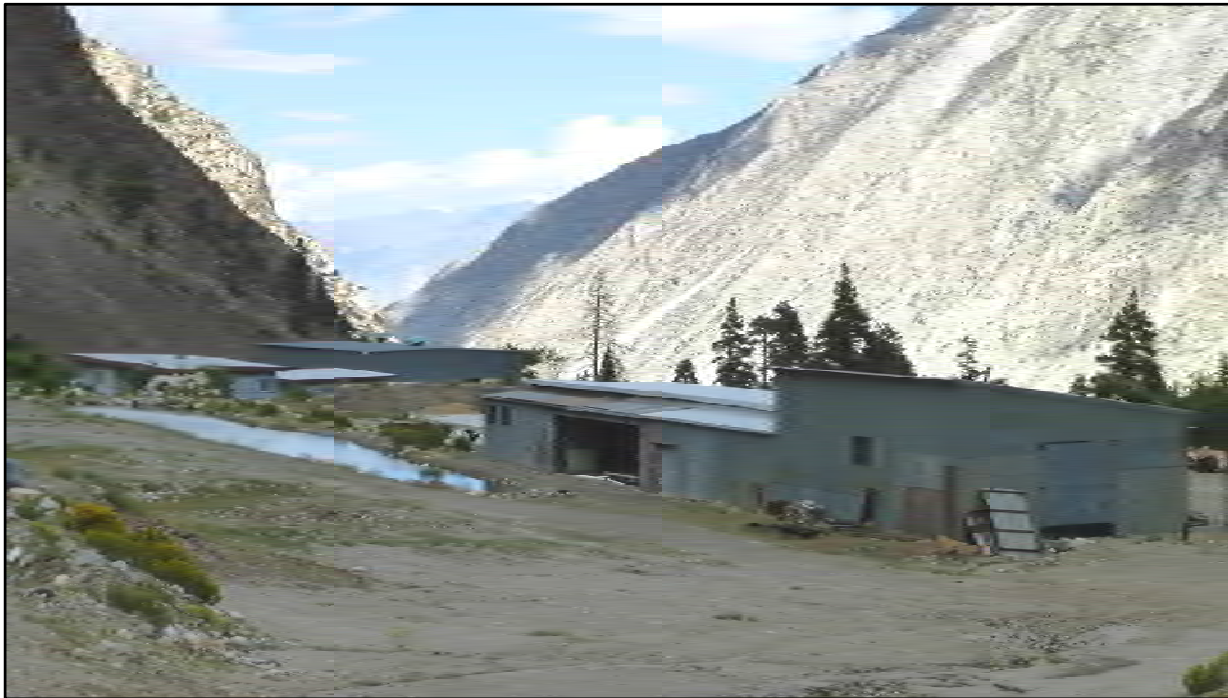
Photograph 20: No. 9a – Avalanche Warehouse (built 1970), No. 9b – Old Warehouse (built 1941), Pond 4 (P4) (built 2005); facing east, August 12, 2014.

window space. There is single entrance door opening to a small wood platform with four stairs. On the east side, there are two windows and a single entry wood door. One window is a two-sash horizontal sliding replacement window. The other window is six-light, two sash wooden frame that slides horizontally (**Photograph 21**). There is an addition to the north side with a shed roof that has a slight overhanging eave. There is a metal entry door with a fixed pane on the east side. On the north, there are two six-light fixed windows and a large opening approximately 12 feet across adjacent to a single entry door (**Photograph 20**).

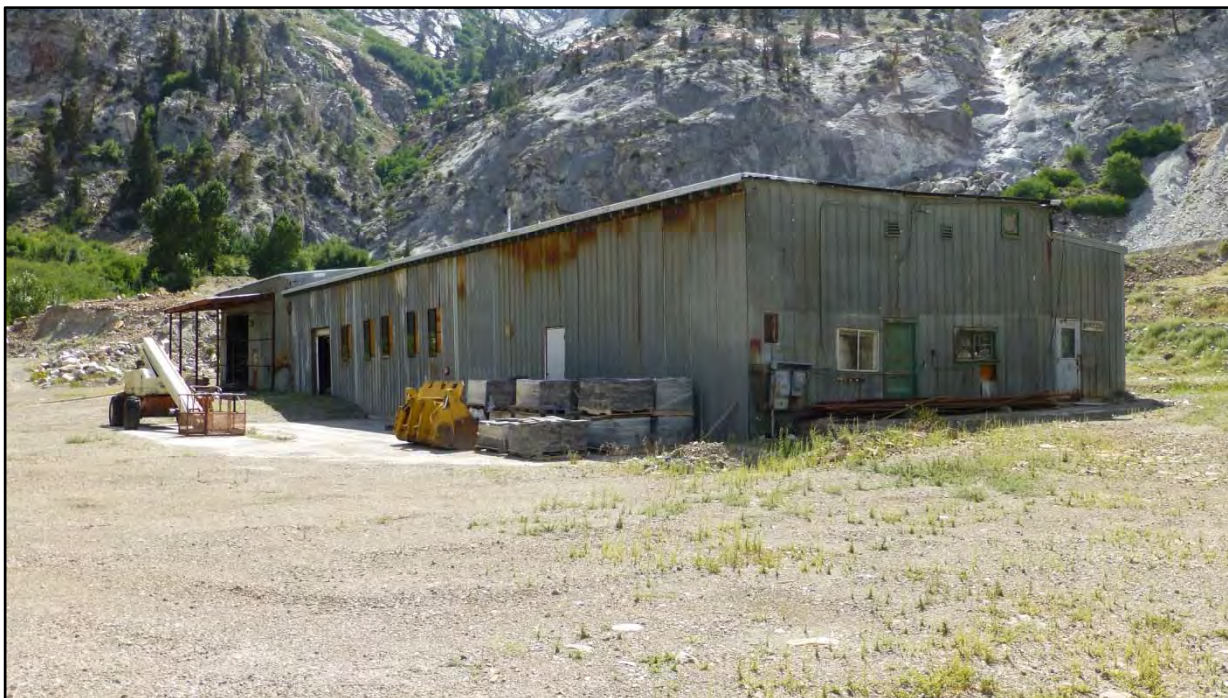
Photograph 21: No. 9b – Old Warehouse (built 1941), No. 9a – Avalanche Warehouse (built 1970); facing west, August 12, 2014.

The Avalanche Warehouse, constructed in 1970, has a square footprint and a concrete foundation. It is a tall one-story building with a shed roof covered with corrugated metal sheeting. The building has a steel frame clad in corrugated metal sheeting. On the north side, there is a small fixed six-pane window (**Photograph 20**). There is a concrete ramp leading to a vehicle entrance and a single entry metal door with a fixed single pane window adjacent to the vehicle entrance on the south side. Both are covered by a steel framed metal awning. There is another oversized entrance on the west side. The building is attached to No. 9b on the east side (**Photograph 21**).
