**PINE CREEK MINE HYDROELECTRIC PROJECT
INYO COUNTY**

FERC PROJECT No. 12532-002

**FINDING OF EFFECT
(*No Adverse Effect*)**

October 14, 2015

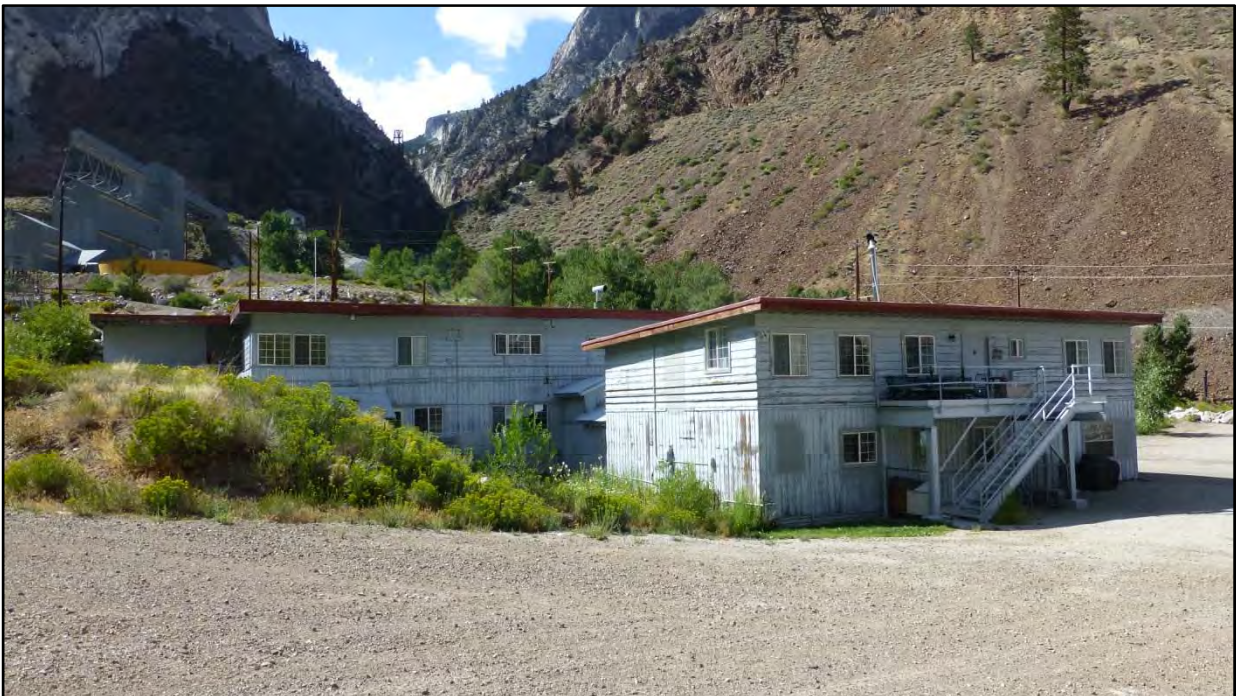
Photograph 23: No. 11 – Residential/Former Infirmary (built 1941), No. 10 – Residential/Former Office (built 1941); facing north, August 12, 2014.

The Residential/Former Office building, constructed in 1941, has a primarily rectangular footprint with a section extending on the west side (**Photograph 23**). The roof is slightly pitched shed with wide eaves and exposed rafters. The building is two story clad in horizontal shiplap on the second-story and vertical board on the first-story. The windows are double-pane two-sash replacements with faux muntins. There are windows wrapping around the first and second stories southwest corner. A concrete stair and stoop lead to a single entry door with eight-light window covered by a cantilevered awning on the west side (**Photograph 22**). On the southwest side, there is a deck enclosed with chain link fence adjacent to utility equipment covered by a shed roof and also enclosed by chain link fence. The north side of the building is against the hillside. On this side, the second story has several groupings of double-pane replacement windows with hinged windows above. There are two entry doors with full length glass opening to a concrete patio (**Photograph 24**). The building is attached to No. 11 by an enclosed hallway with a two part gable roof covered with corrugated metal sheeting. There is a single entrance door on the west and east sides of the hallway (**Photograph 25**).

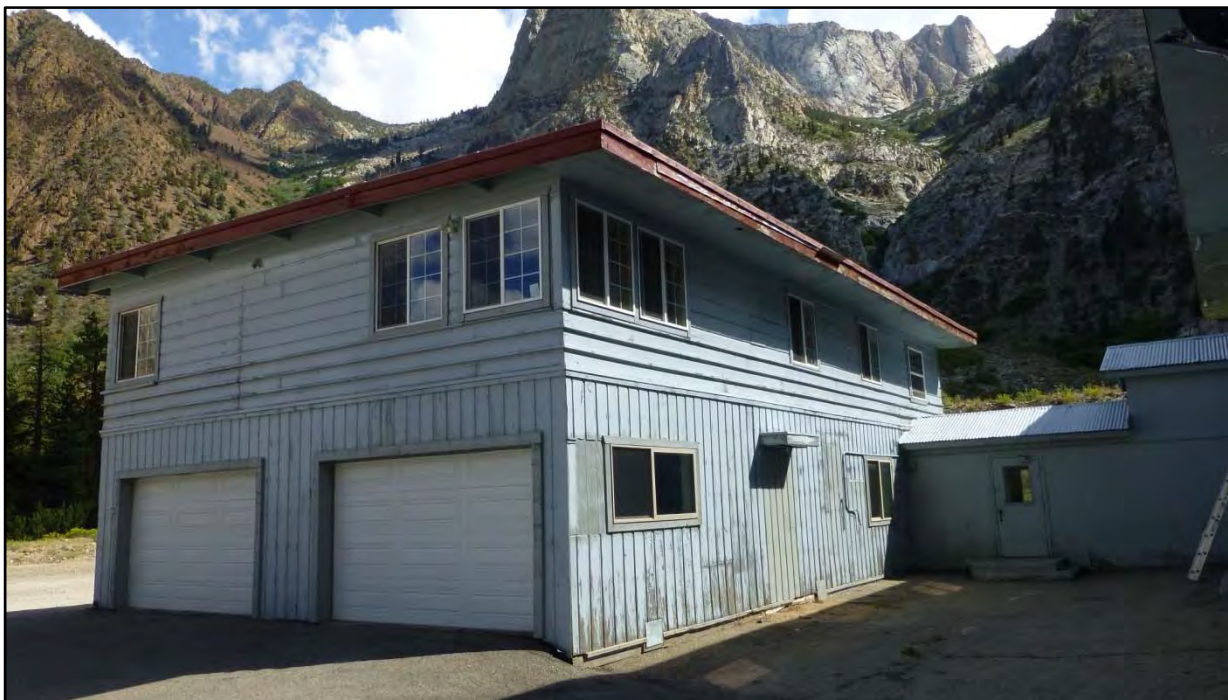
Photograph 25: No. 11 – Residential/Former Infirmary (built 1941) and connecting hallway moved to this site the 1960s; facing southwest, August 13, 2014.

The Residential/Former Infirmary building, constructed in 1941, has a rectangular footprint, and slight pitched shed roof with wide eaves and exposed rafters except on the north where they are boxed. The building is two story clad in horizontal shiplap on the second-story and vertical board on the first-story. The windows are double-pane two-sash replacement with faux muntins. On the south side, there is a raised deck on the second-story with metal railings and steel staircase (**Photograph 22**). There are two garage doors on the east side. On the north side, there is a two-sash horizontal sliding window adjacent to a cantilevered awning indicating an entry door was removed (**Photograph 25**). It was moved to this location ca. 1960s (Interview, Belec and Haeinni).

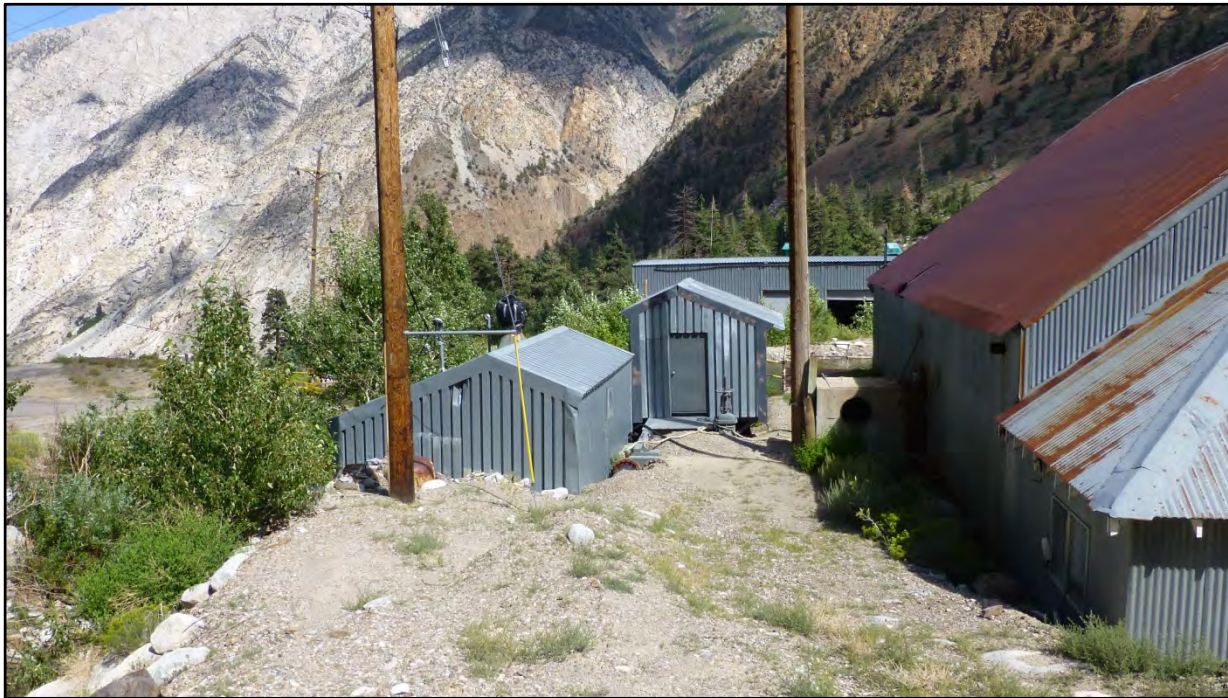
Photograph 28: No. 13 – Exempt Hydro P-13163 (installed 1980-82) and No. 14 – Mine Water Discharge (Steel Surge Chamber, installed 2005); facing southeast, August 12, 2014.

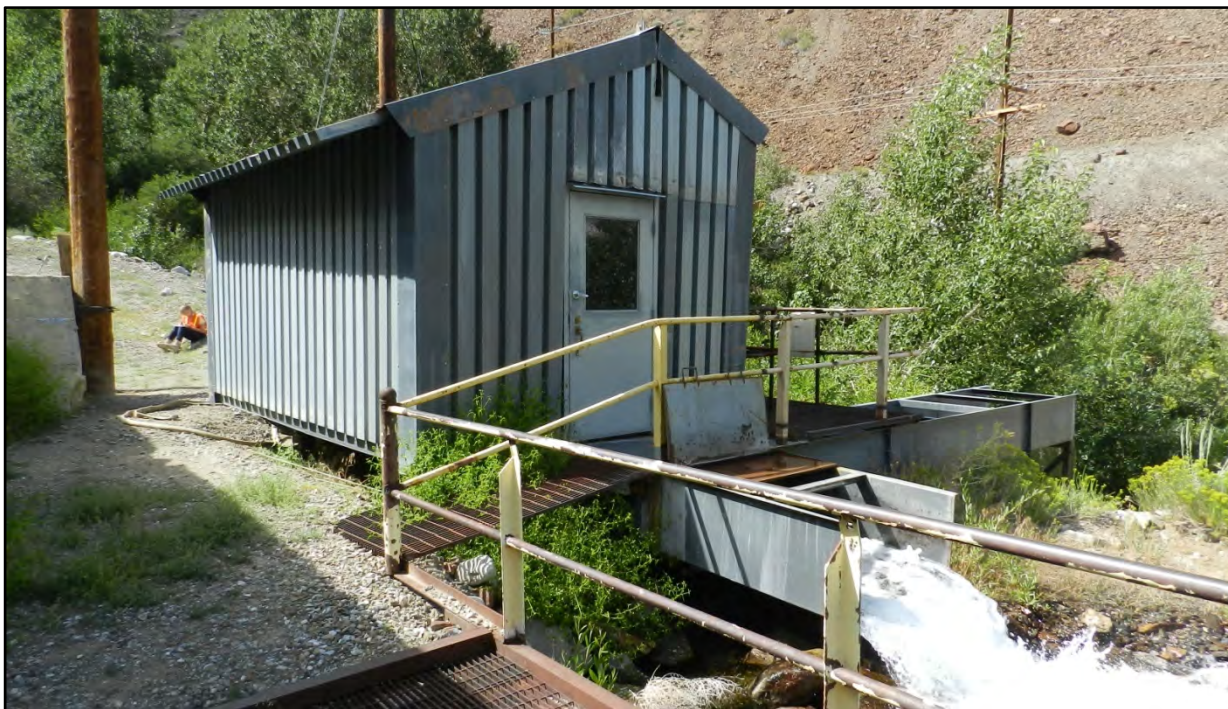
Photograph 29: No. 13 – Exempt Hydro P-13163(built 1980-82); facing north, August 12, 2014.

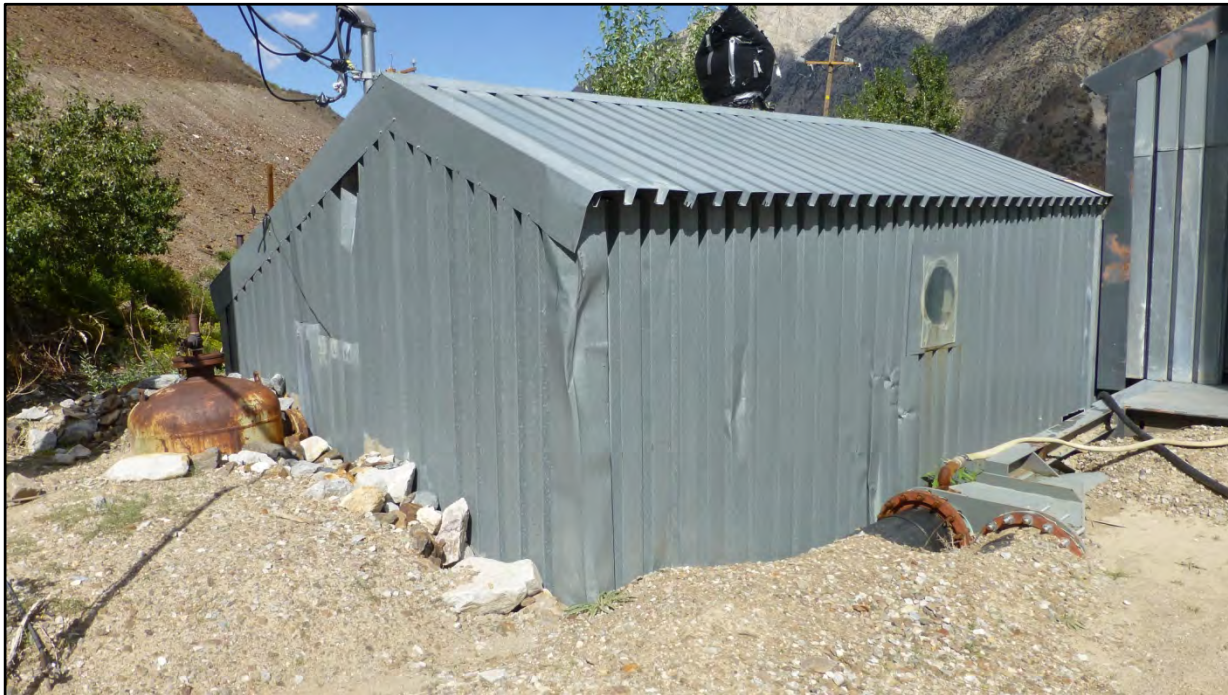
Photograph 30: No. 13 – Exempt Hydro P-13163(built 1980-82) and No. 14 – Mine Water Discharge (Steel Surge Chamber, installed 2005); facing east, August 12, 2014.

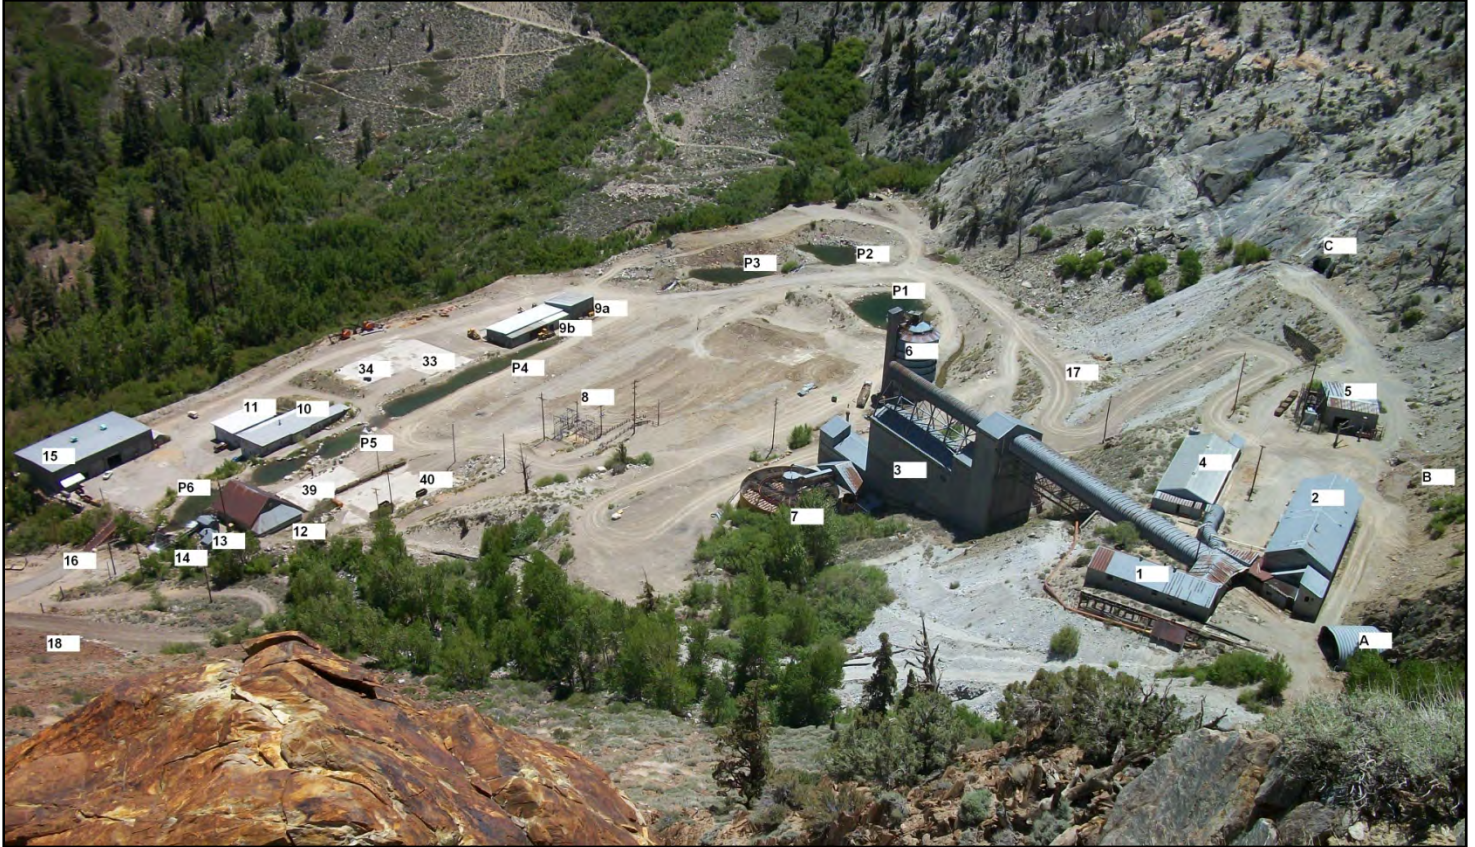
Figure 12. Existing Improvements at Pine Creek taken from Morgan Creek Road, provided by Jeff Francis, Pacifica Development Inc.

For construction dates of existing improvements please refer to Figure 14. Building 11 (Residential/Former Infirmary) was moved ca. 1960 to its current location from where Building 15 (Maintenance Building) is located. Most demolition was done ca. 2000.

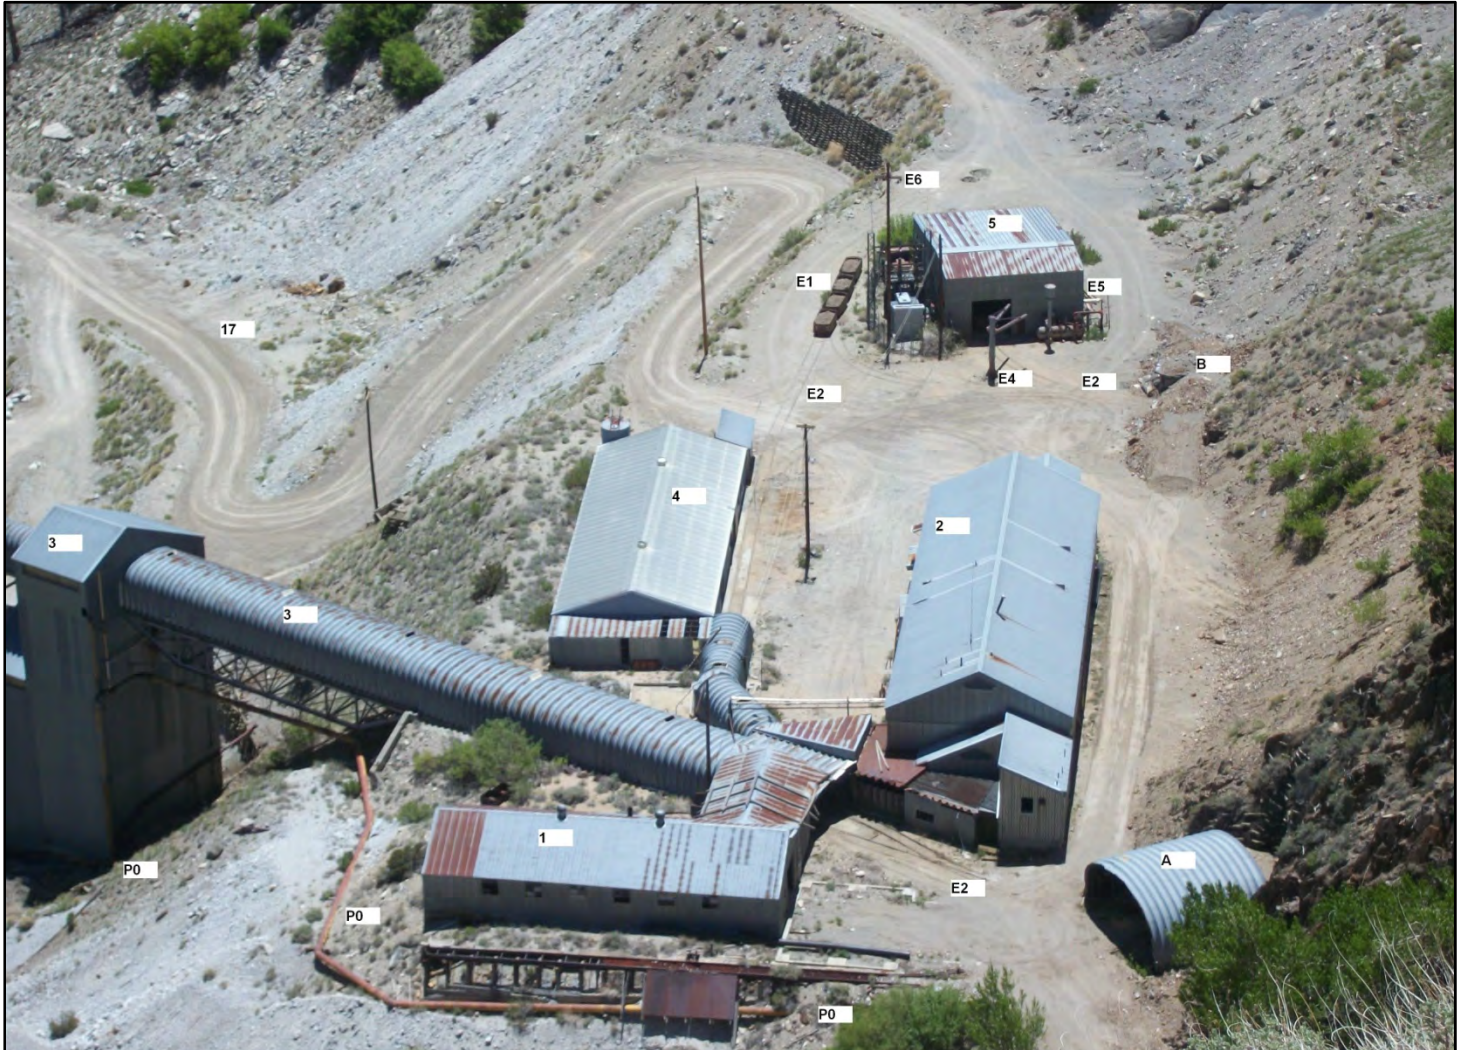
Figure 13. Existing Improvements at Pine Creek, provided by Jeff Francis, Pacifica Development Inc. The area between Adit A, Building 1 and Building 2 was enclosed until 2002.
