# **Crestview Apartments**

## Update Geotechnical Evaluation

### Proposed Crestview Apartment Complex Sycamore Canyon Boulevard and Central Avenue, Riverside, California

NOVA Project 3020003  
September 18, 2020

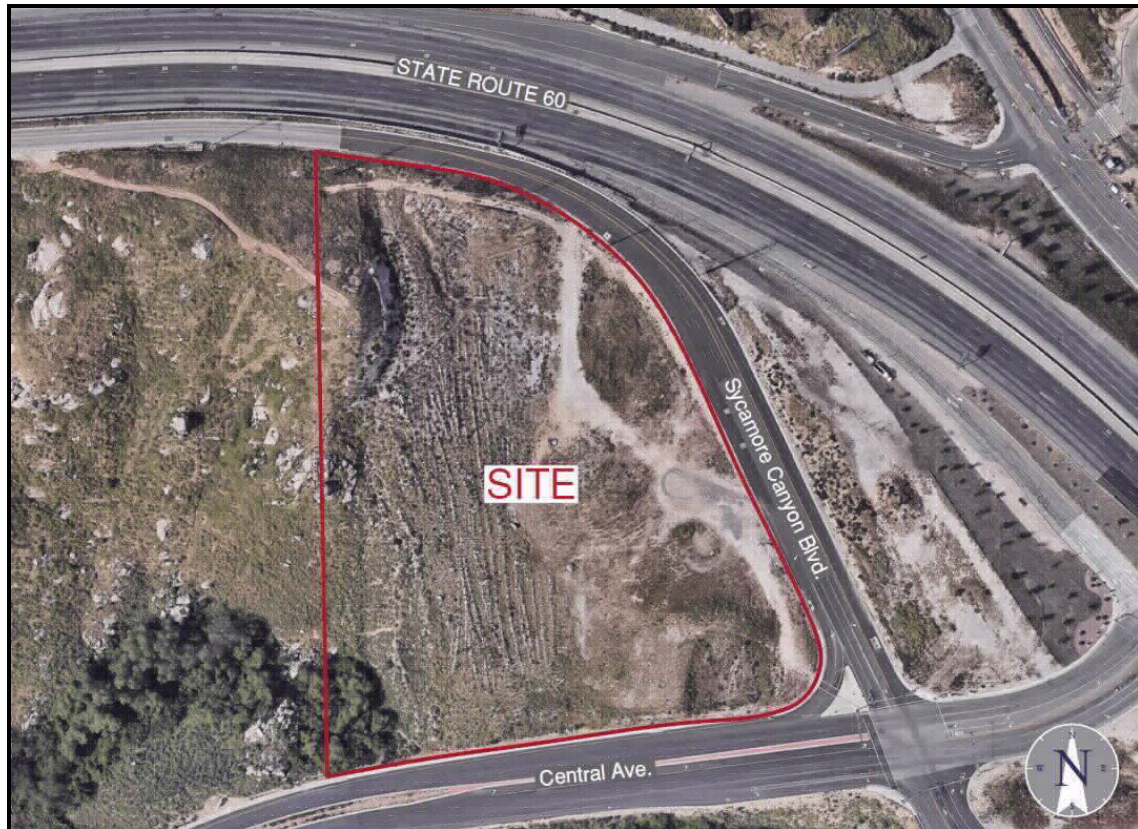
Figure 2-1. Site Limits and Location

The Crestview Apartments site is located on the northwest corner of Sycamore Canyon Boulevard and Central Avenue, Riverside, California. Figure 2-1 depicts the location and approximate limits of the site on a recent aerial image.

As may be seen by review of Figure 2-1, the site is lightly vegetated, with areas of bare soil and windrows of rocks and boulders. An approximately 38-foot high cut slope exposing granitic bedrock is located in the northwest corner of the property.

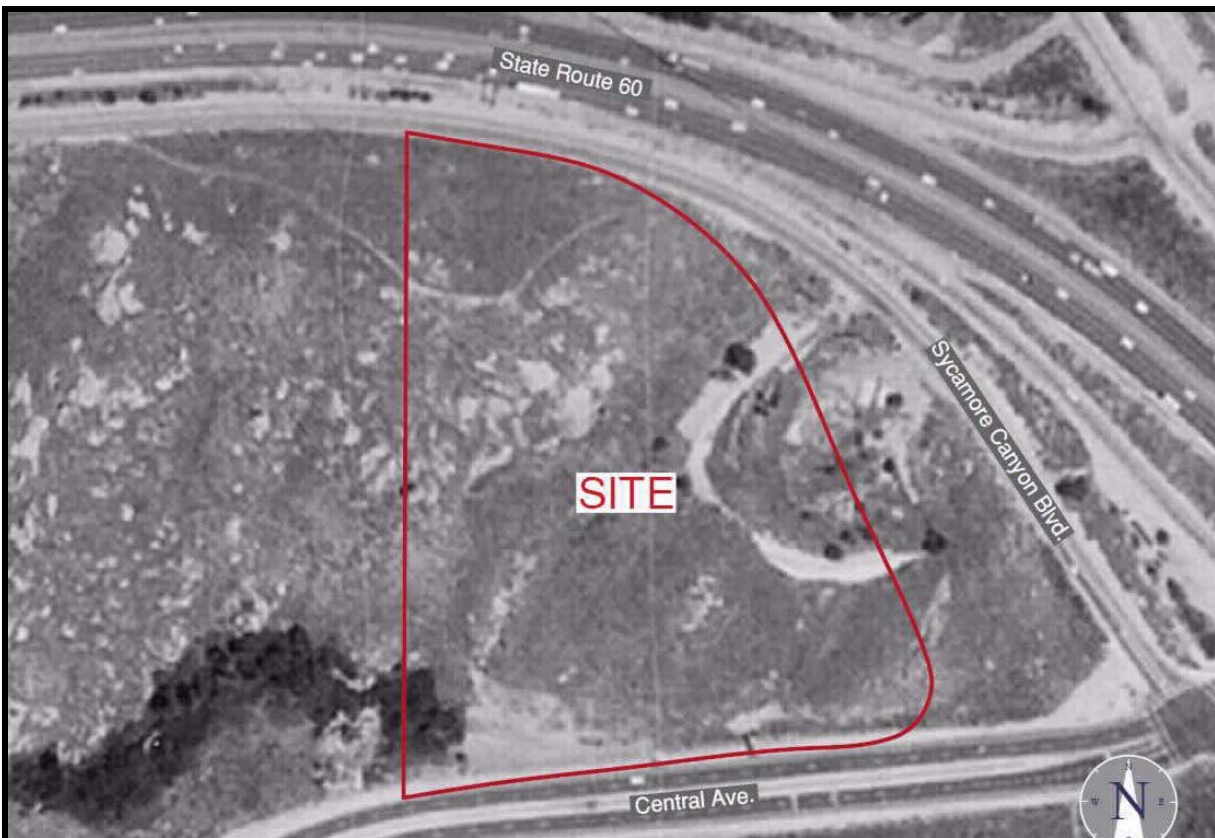
Figure 2-2. Site Area, May 1994

Review of aerial photography indicates that the site was utilized for construction staging operations and grading in 2005 through 2006, accommodating the realignment of Sycamore Canyon Boulevard. Previous to this time, the site was a hilltop cut by two southwest-trending drainage features.

Figure 2-2 depicts the site area in 1994 prior to this realignment. Figure 2-3 (following page) shows the site area in 2005, during realignment of Sycamore Canyon Boulevard.

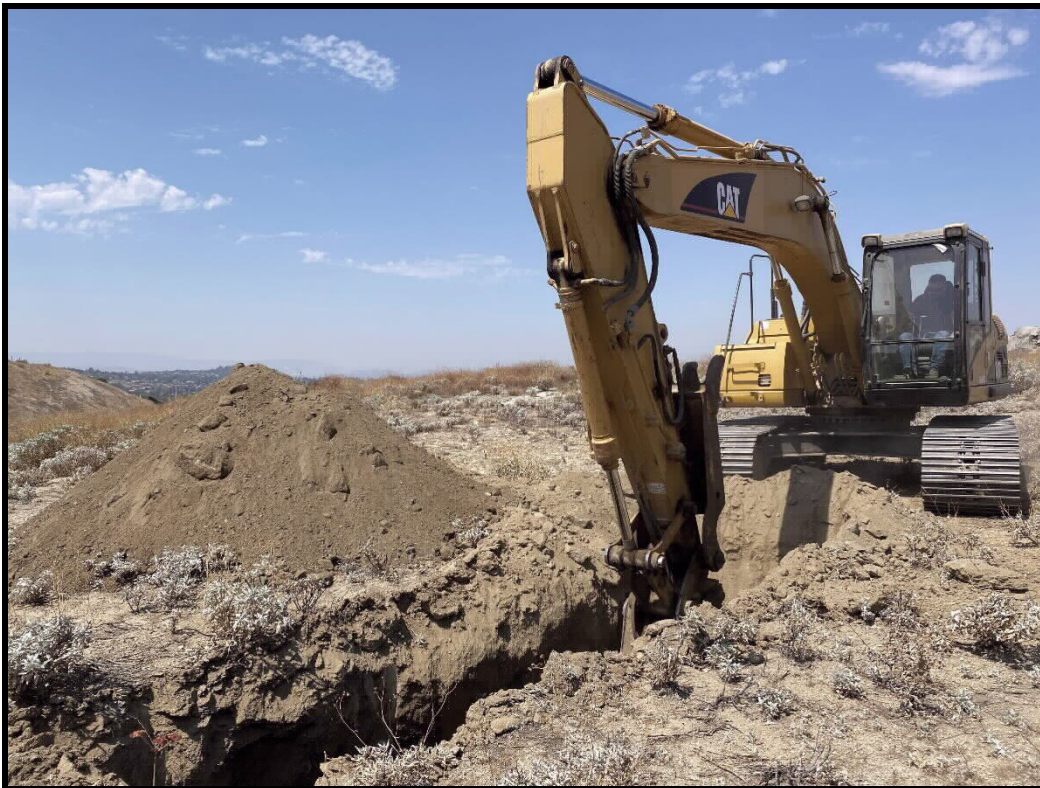
Figure 3-1. Task 1, Exploratory Test Pits, July 2020

Figure 3-1 and Figure 3-2 depict the field work.

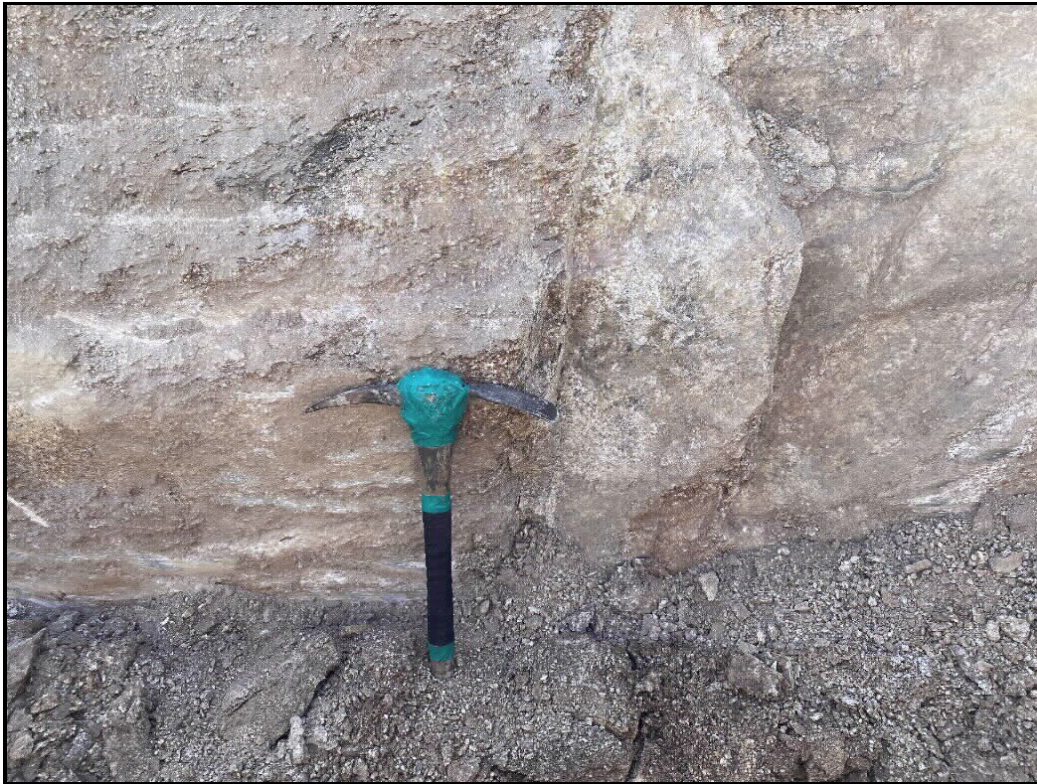
**Figure 3-4. Test Pit, TP-1, Exposing Val Verde Tonalite**

The exploratory test pits were completed utilizing a CAT 320 backhoe. The test pits were excavated to depths as great as 15 feet bgs and logged and sampled by the NOVA geologist.

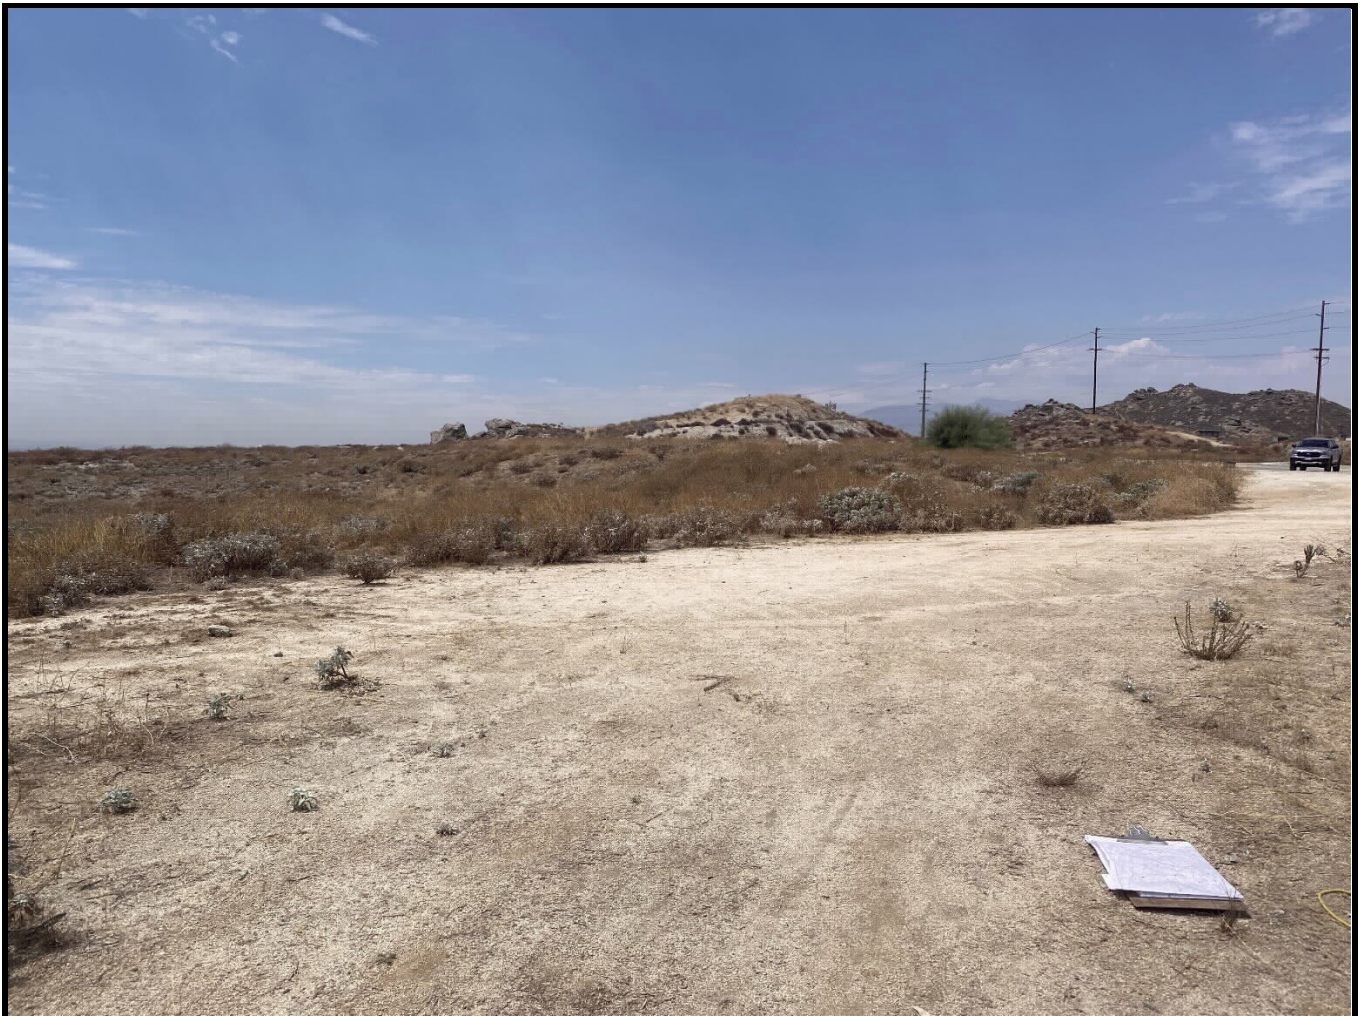
Figure 5-2 depicts current surface conditions.

**Figure 5-2. Surface Conditions, Looking NW Near Sycamore Canyon Boulevard and Central Avenue Intersection**

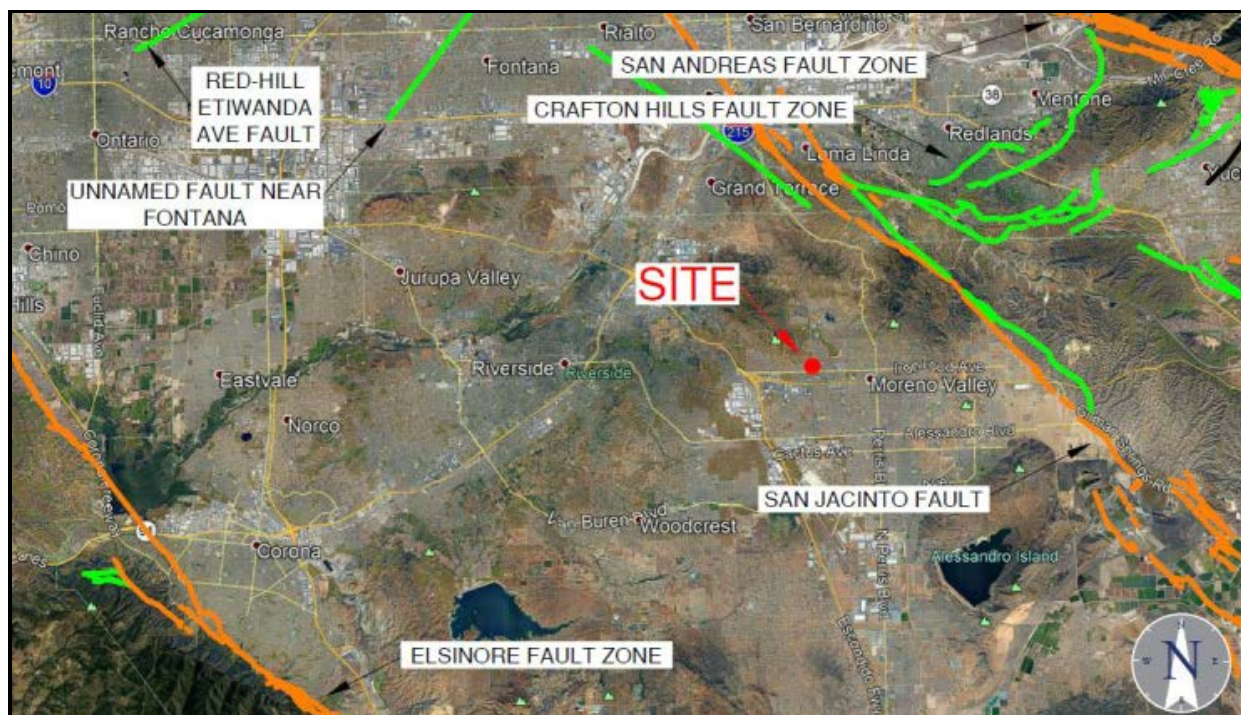
Figure 6-1. Faulting in the Site Vicinity (CGS 2010)

Figure 6-1 and Figure 6-2 (following page) depict regional fault maps off the site vicinity.

addition, the site is not located within a fault zone as designated by the County of Riverside (County of Riverside 2017). The possibility of damage due to ground rupture is considered low since no active faults are known to cross the site. The closest known active faults are associated with the San Bernardino Valley section of the San Jacinto Fault, located approximately 5.8 miles northeast of the subject site, and the Glen Ivy section of the Elsinore Fault Zone, located approximately 16.3 miles southwest of the subject site. The site is located approximately 0.19 miles west of an unnamed fault in the San Jacinto Fault Zone. The fault is not mapped by the State of California (CGS 2010) but it designated as a fault by Riverside County (Riverside County 2017).

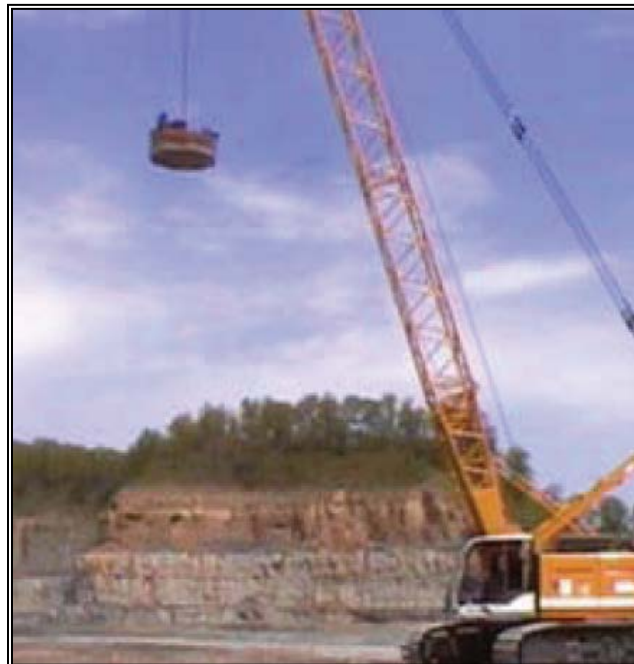
**Figure 7-1. Crane Lifting the Tamper**

DDC utilizes a heavy tamper (or ‘pounder’) that is repeatedly raised and dropped with a single cable from varying heights to impact the ground. The mass of the tampers generally ranges from 5 to 20 tons, while drop heights range from 30 feet to 80 feet. While specialty equipment can be developed for larger sites in order to effect higher drops of greater weights, the usual project employs a tracked crane to lift and drop the tamper. Figure 7-1 shows a typical operation.

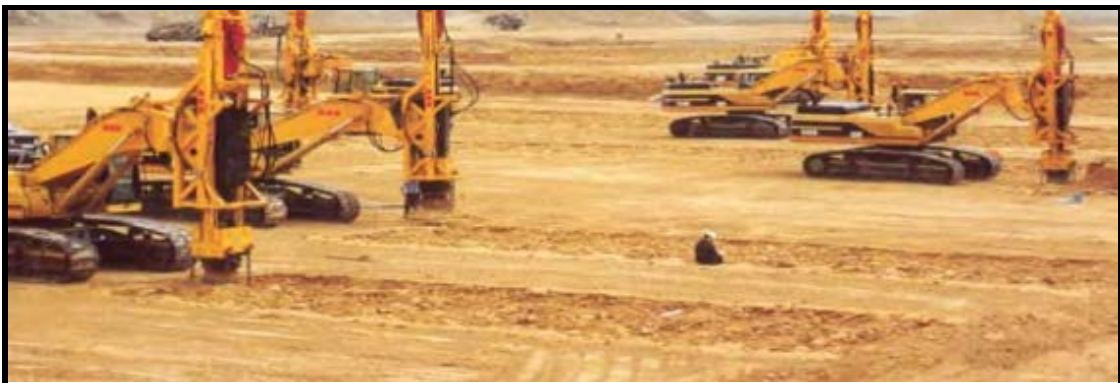
**Figure 7-2. Large-Scale Application of Rapid Impact Compaction**

Developed in the early 1990's by the British Military, "rapid impact compaction" (RIC) is a form of dynamic compaction, utilizing a hydraulic hammer to lift and drop a 7.5-ton weight from a controlled height of about 1 m (3 feet). The pounding rate is high, typically 40 to 60 blows per minute. Designed for use in granular deposits, benefits have also been noted in random fills and mine wastes. Figure 7-2 depicts a larger scale application of this procedure.

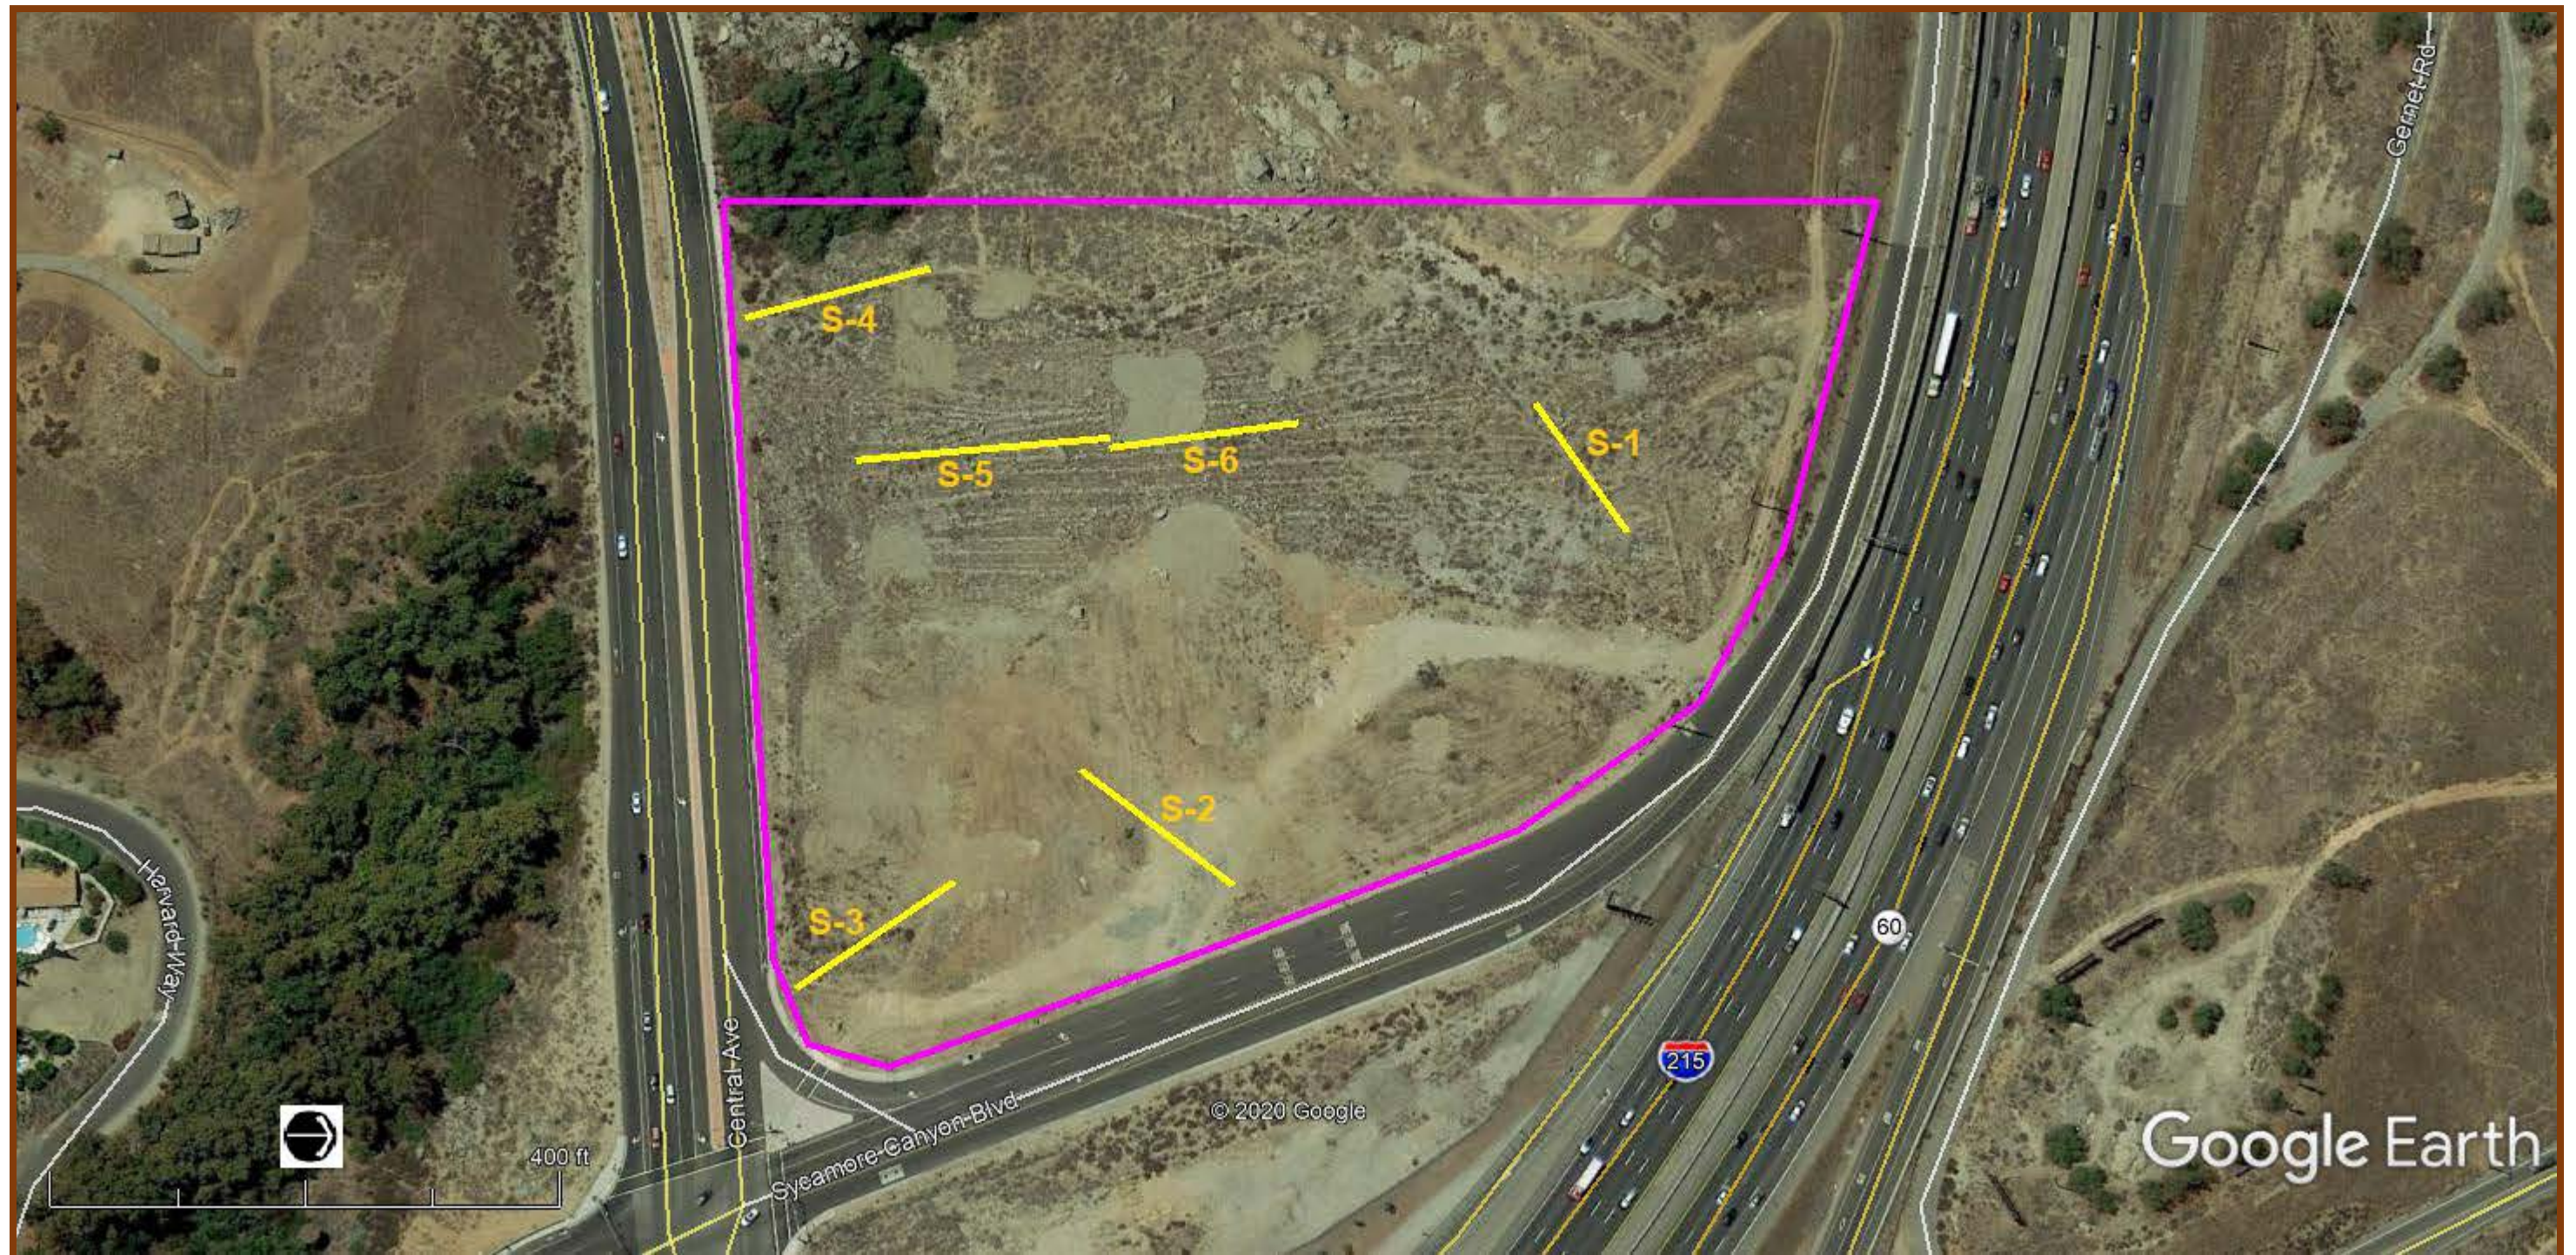
# SEISMIC LINE LOCATION MAP

Base Map: Google™ Earth imagery (2020); Seismic traverses shown as yellow lines.

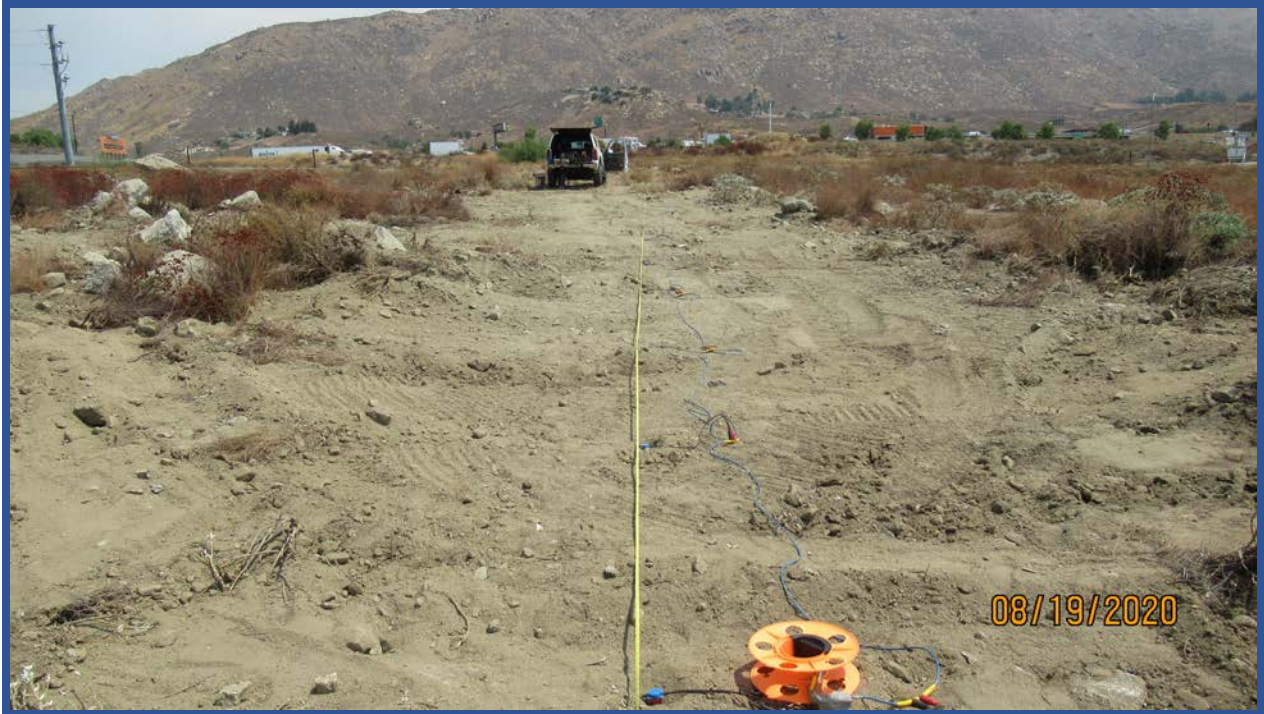
View looking northeasterly along Seismic Line SW-1.

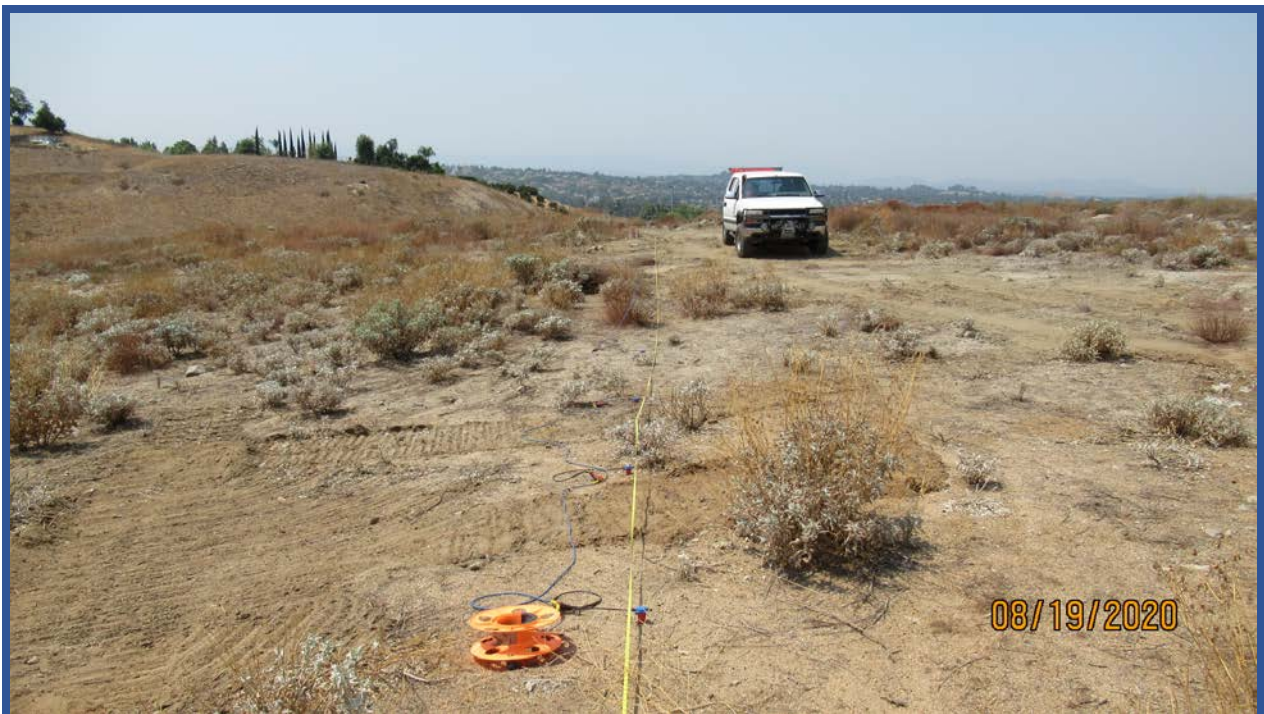
View looking southwesterly along Seismic Line SW-1.

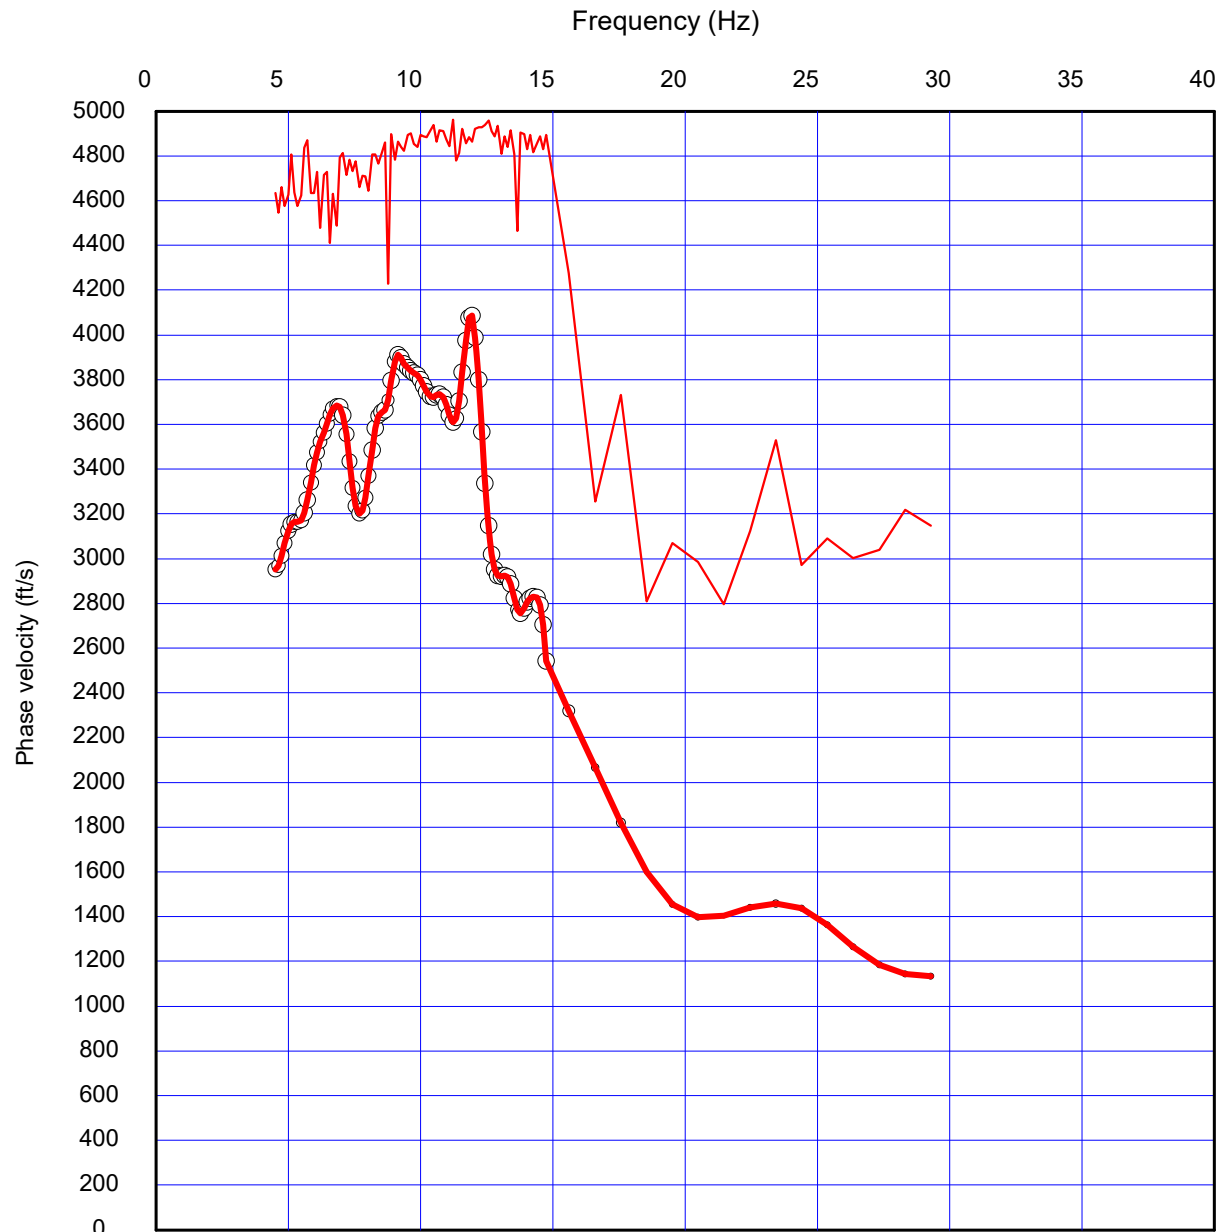
# SHEAR-WAVE MODEL SW-1

Dispersion curve : Combined.rst

## COMBINED DISPERSION CURVE

The seismic survey of the subject site included one seismic shear wave survey line (SW-1), approximately 184 feet in length. The approximate location is shown on Figure 3-3 and Plate 1, the Geotechnical Map. A 24-channel Geometrics StrataVisor NZXP model signal-enhancement refraction seismograph was used in conjunction with 24 4.5-Hz geophones spaced at regular intervals. For the MASW survey, two seismic records were obtained by multiple hammer strikes of a 16-pound sledge hammer on steel plates positioned 25 feet from the end of each terminus of the seismic line. Vibrations were recorded using a one second record length at a sampling rate of 0.5 milliseconds. The MAM survey records vibrations from background and ambient noise. The ground vibrations were recorded using 32-second record length at 2-millisecond sampling rate with 30 separate records obtained for quality control purposes.
