**Northern Inactive Waste Site  
Remediation Project**

**Phillips 66 Santa Maria Refinery**

Biological Resources Technical Report

March 30, 2020

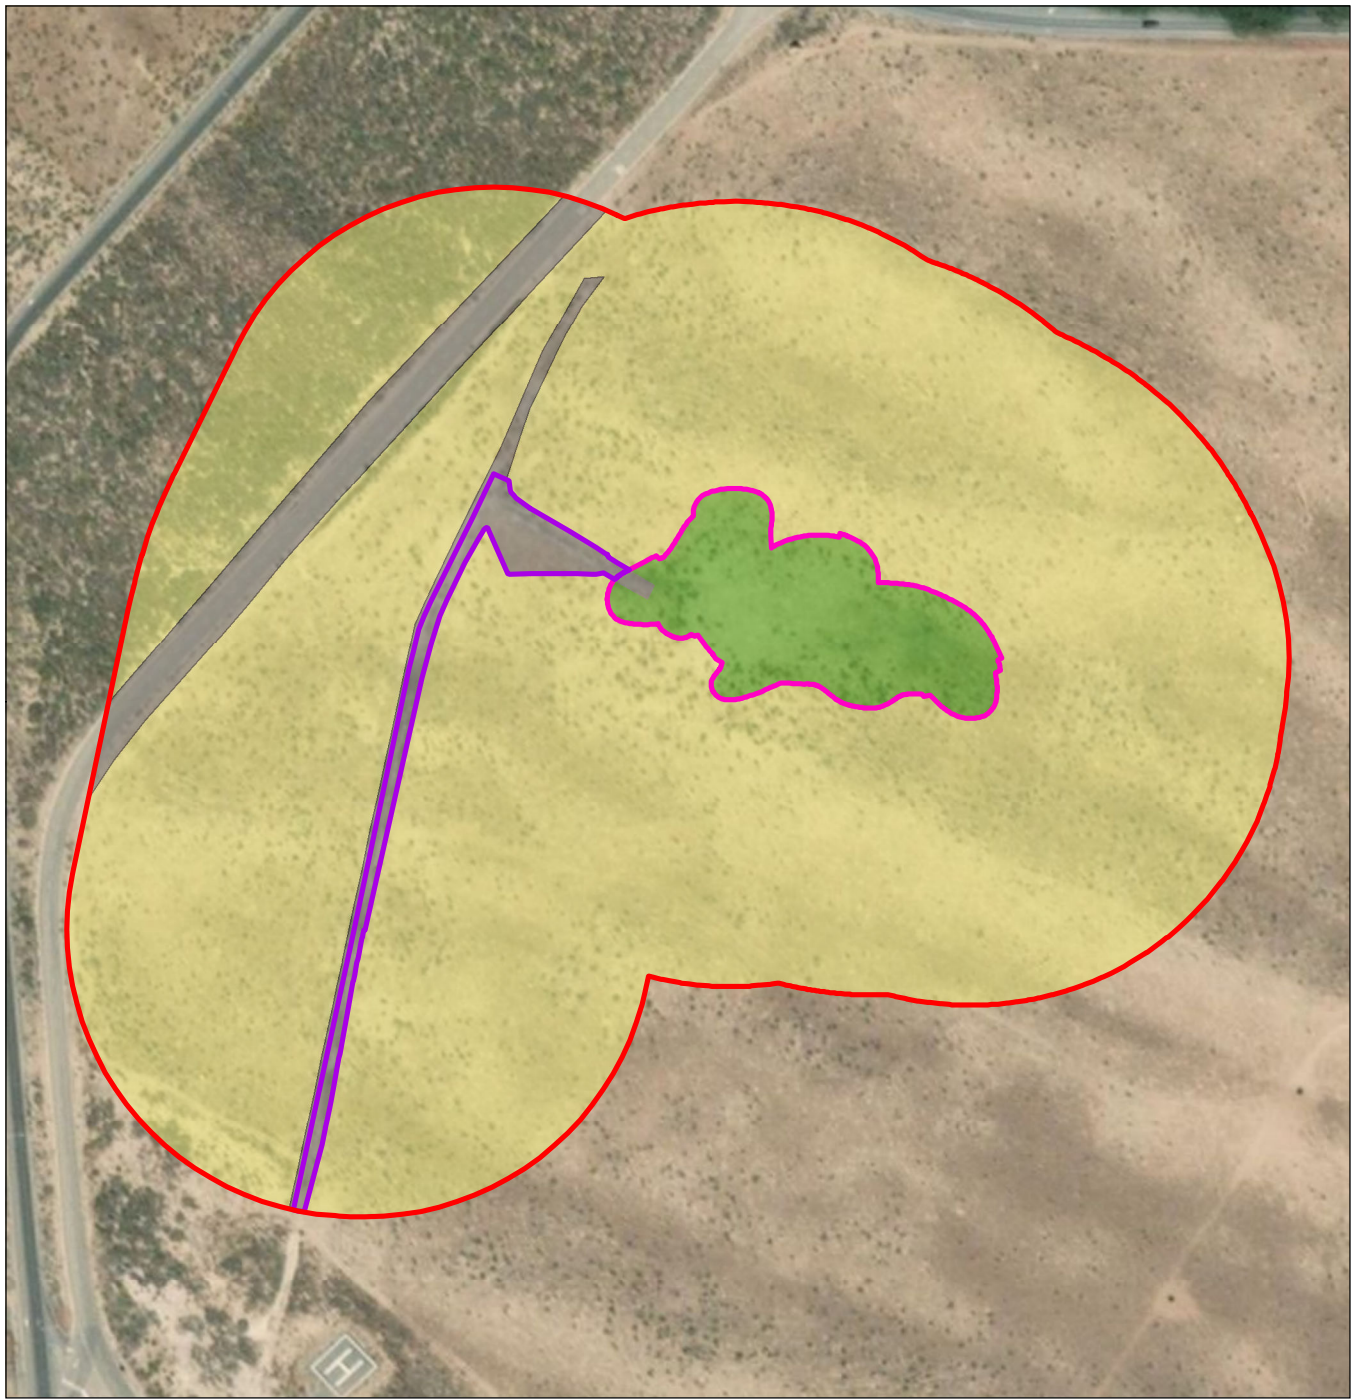
**Vegetation Communities & Land  
Cover Types**

Biological resources observed within the BSA during the field survey were comprised primarily of common plant species and vegetation communities characteristic of the coastal dunes of Central California. Habitat conditions within the BSA were noted to be of good quality, with well-established communities comprised primarily of native shrub and non-native grasslands. Within the BSA, Stantec biologists mapped one plant community defined by Sawyer et al. (2009), one undefined community, and one additional land cover type. These are described further in Section 4.2.1 below, summarized in Table 1, and depicted in Figure 2 in Appendix A.
