Appendix E4 Wetland Delineation Report

JURISDICTIONAL DELINEATION REPORT

Janus Solar Project Colusa County, California

February 11, 2021

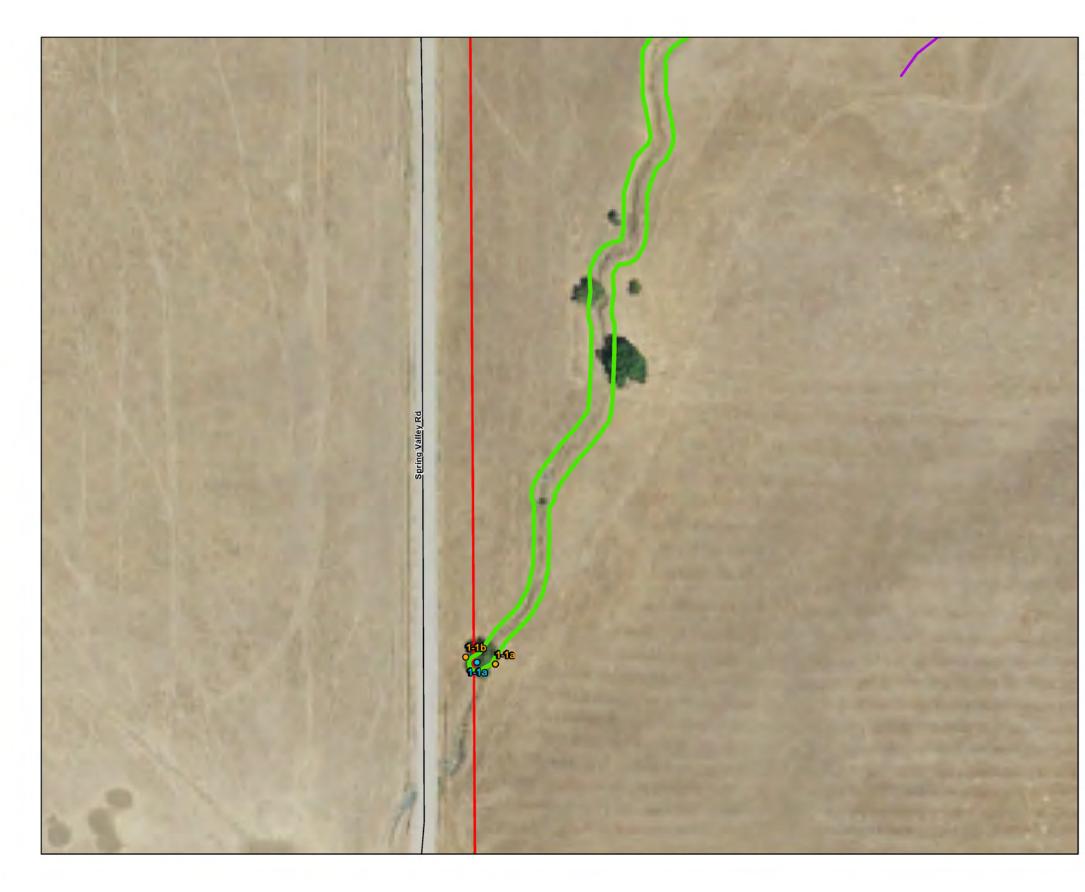
Colusa County, CA Figure 3: Wetland Delineation Overview | Sheet 1 Feature 1

Ten potential jurisdictional features were found within the Project site (Figure 2 and Figure 3 Sheets 1-5). All features within the Project site are disturbed by active cattle grazing or agriculture. Features 1 and 3 are ephemeral drainages that had a defined bed, bank, and channel. Feature 1 had standing water and riparian vegetation within the channel in some areas, which consisted of low cover of red willow (*Salix laevigata*), Fremont cottonwood (*Populus fremontii*), cattail (*Typha* sp.), and rush (*Juncus* sp.). Feature 3 did not have standing water but had a small area within the channel with low cover of Fremont cottonwood and rush. Portions of Features 1 and 3 are shown in the NWI database as riverine and portions are shown as freshwater forested/shrub wetland (USFWS 2021). These two features converge in the central portion of the Project site and may connect to Spring Creek offsite to the southeast. Feature 10 is a disturbed drainage that occurs within an active agricultural field and did not have a defined bed and bank. Low cover of red willow was found within this feature. Feature 10 is shown as a freshwater forested/shrub wetland in the NWI database (USFWS 2021). Feature 10 may connect to Salt Creek offsite to the north.

As shown in Table 1, six sample points within Feature 1 met all three criteria required to be a USACE Section 404 wetland. These sample points had low cover of vegetation that was dominated by hydrophytic plants and had standing water and/or saturated soils. The vegetation within this feature was disturbed by cattle grazing; without this disturbance, wetland plants and associated muck (highly decomposed plant matter) would likely be present in higher quantities. Additional hydrology indicators observed were water-stained leaves, hydrogen sulfide odor, and/or water marks. Hydric soil indicators that were found at these points were hydrogen sulfide, loamy gleyed matrix, loamy mucky mineral, redox dark surface, and/or redox depressions. These areas represented topographically low points in the drainage channel with a propensity to pool water.

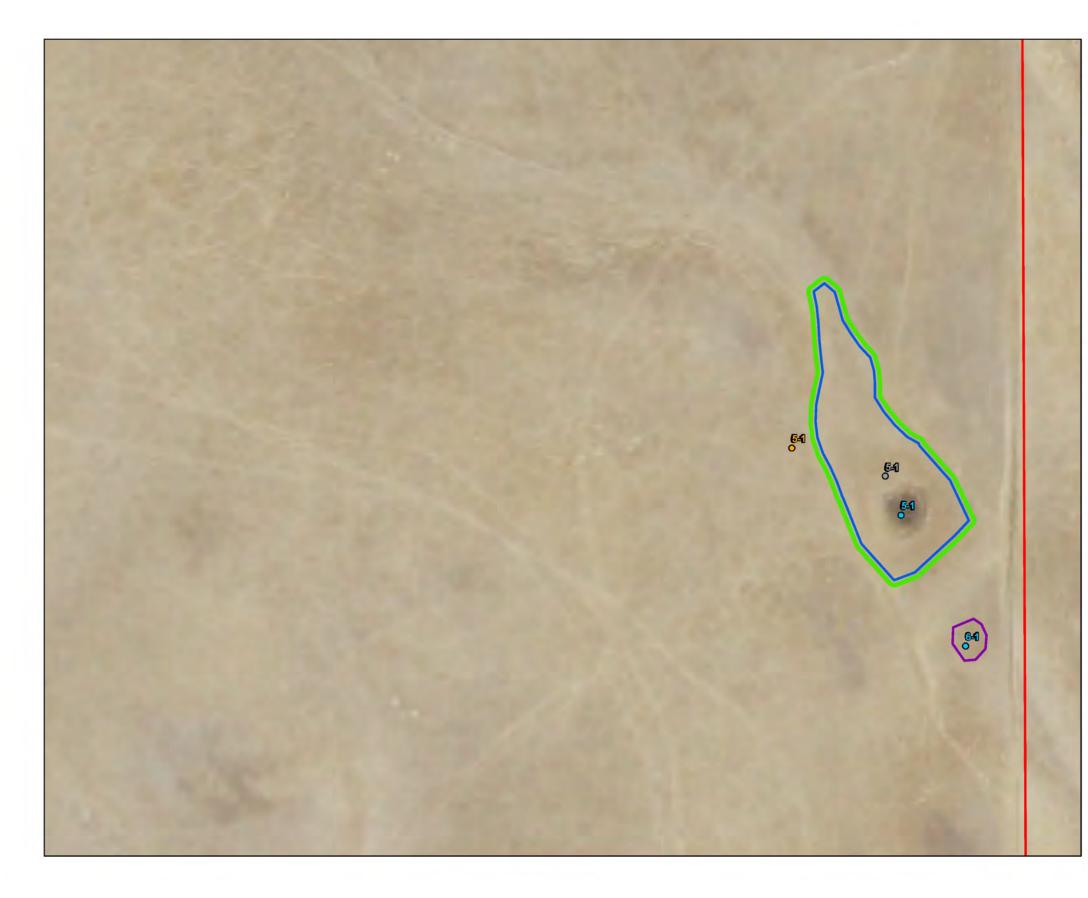
Colusa County, CA Figure 3: Wetland Delineation Overview | Sheet 4 Feature 5

Features 5 and 7 are depressional ponds where standing water was previously observed in 2019 (Tetra Tech 2020) and can be observed in aerial imagery. Feature 6 is a potential depressional area based on topography but water has not been observed in this area and it is not visible in aerial imagery. These

The sample points within Features 5 and 7 met all three criteria required to be a USACE Section 404 wetland (Table 1). Sample points 5-1 wet and 7-1 wet were located in the lowest areas of the depressions and had low cover of vegetation that was dominated by hydrophytic plants (Figure 3 Sheets 4 and 5). Sample points 5-1 trans and 7-1 trans were located in the transitional areas of the features between the low and upland areas and had moderate (Feature 5) or high (Feature 7) cover of vegetation that was dominated by hydrophytic plants. The redox depressions hydric soil indicator was found at all four of these sample points. While standing water was not observed at either of these features during the 2021 wetland delineation, it was observed during the initial survey in 2019 (Tetra Tech 2020). In addition, water marks, surface soil cracks, inundation visible on aerial imagery, saturation visible on aerial imagery, and/or drainage patterns (i.e., vegetation bent over at sample point 7-1 trans) were observed at these sample points. Based on the presence of large soil berms adjacent to Features 5 and 7, it is hypothesized that manmade flow blocks were previously created to stop flow and create ponding at these features for stock ponds or agricultural purposes. These features are not subject to ongoing operation and maintenance and have become a relatively permanent part of the natural landscape.
