# **Biological Report**

# **Guerra Ranch Agricultural Reservoir**

073-031-035 San Luis Obispo County

ALTHOUSE AND MEADE, INC. BIOLOGICAL AND ENVIRONMENTAL SERVICES 1602 Spring Street Paso Robles, CA 93446 (805) 237-9626

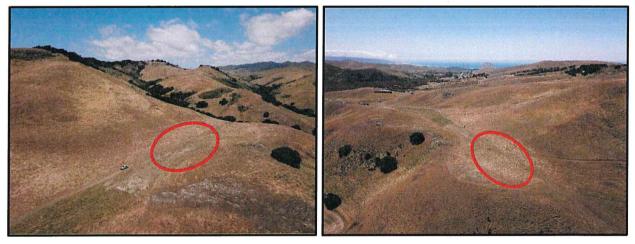
Photo 1. Aerial overview of Study Area. View northwest, May 28, 2019.

Photo 2. Aerial overview of Study Area. View southwest, May 28, 2019.

The Study Area occupies the head of a narrow draw which divides the principal grassland ridge bisecting Guerra Ranch property. A flattened terrace makes up the top of the draw, where the majority of the Study Area lies. Two unnamed seasonal streams border the grassland ridge, while no streams or drainages were present in the Study Area. Nonnative annual grassland characterizes the Study Area and much of the surrounding property, with coastal sage scrub occurring on sloping, shallow soils, and serpentine rock outcrop where soil is absent. Several species of rare plants occur within serpentine outcrop and coastal sage scrub, and at least one species occurs within annual grassland. Coast live oak trees occur on the north-facing slopes of the surrounding vicinity, with one oak tree partially entering the eastern boundary of the Study Area. Fill soil has been deposited in the draw since at least 2006 (aerial interpretation). Ruderal habitat occurs on this artificial fill, primarily on the eastern side of the dirt ranch road that provides access to the Study Area. Cattle actively graze the site and surrounding hillsides, and weeds typical of long-term heavy grazing are abundant.

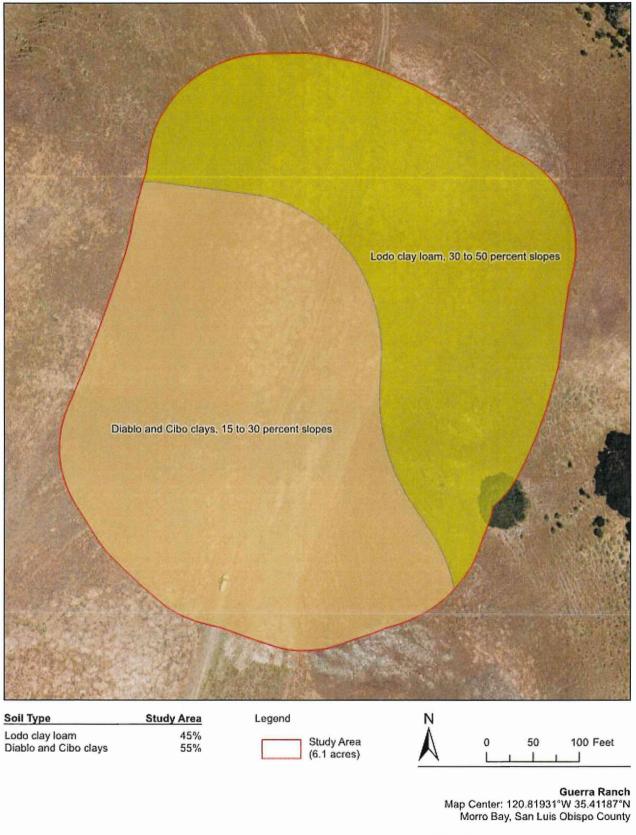
Map Updated: June 21, 2019 01:38 PM by JBB Figure 3. USDA Soil Survey

Soil Data Source: USDA NRCS Soil Survey Imagery Source: Althouse and Meade, Inc., May 2019

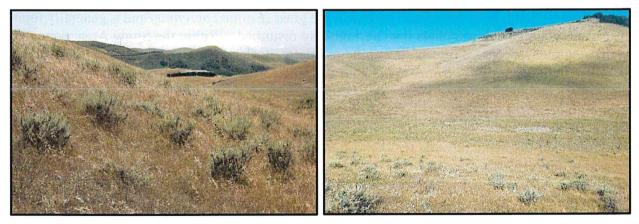
Photo 5. California sagebrush occurs with annual grasses in coastal sagescrub habitat. View southwest. May 28, 2019.

Photo 6. Low density coastal sage scrub habitat. View west. May 28, 2019.

Coastal sage scrub, described as Artemisia californica Shrubland Alliance (CNPS 2019), occupies approximately 0.9 acres of the Study Area. It has a State and Global rank of 5 (Secure). Presence of California sagebrush (Artemisia californica) is diagnostic of coastal sage scrub habitat and defines its boundaries. Within the Study Area, coastal sage scrub occurs as a low density shrubland on moderately sloped terrain in shallow soils, with bare serpentine bedrock occasionally exposed. Introduced annual grasses such as rattail grass (Festuca myuros), foxtail barley (Hordeum murinum), and wild oat (Avena barbata) make up the dominant herbaceous understory. Two rare plants species, club haired mariposa lily (Calochortus clavatus var. clavatus) and Blochman's dudleya (Dudleya blochmaniae subsp. blochmaniae), occur in the serpentine exposures within coastal sage scrub.

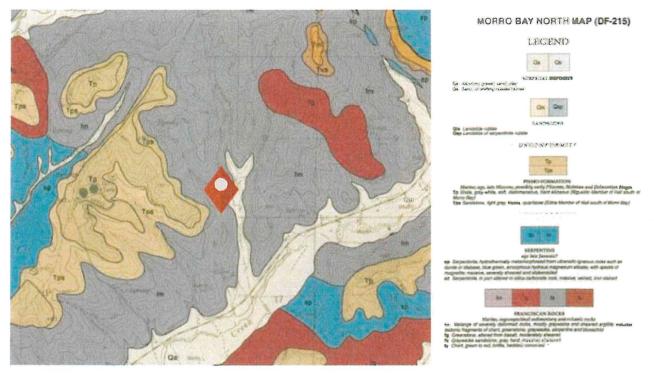
### Figure 4: Regional Geologic Map

Regional site geology was obtained from United States Geological Survey MapView internet application (USGS, 2013) which compiles existing geologic maps. Figure 4: Regional Geologic Map presents the geologic conditions in site vicinity as mapped on the *Geologic Map of the Morro Bay North Quadrangle* (Dibblee, 2006). The majority of all underlying weathered bedrock material at the Site was interpreted as Franciscan Rocks.

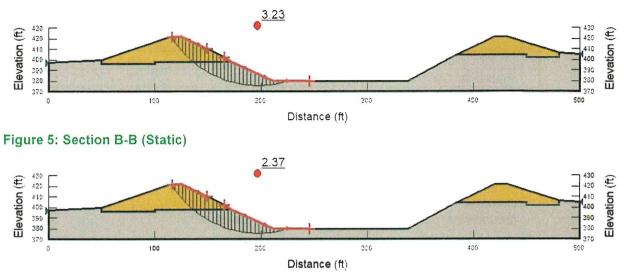
Figure 6: Section B-B (Pseudo-Static)

The pseudo-static (seismic) stability analyses performed for the slope configurations as illustrated in Section B-B. The minimum engineering standard for pseudo-static factors of safety is 1.1. Section B-B resulted in critical static factor of safety value above the minimum standard, indicating that they reflect stable conditions.
