RE: Submittal of Section 401 Water Quality Certification Application for the Huffman Access Road Improvement Project, Chimney Rock Road, San Luis Obispo County, California

a) Project Title: Huffman Access Road Improvement Project
b) Purpose/Goal: Installation of a primary paved driveway to a proposed single-family residence. The paved driveway includes widening an existing access road to meet San Luis Obispo County Department of Fire (CalFire) access requirements as well as relocating the driveway approach to a safer location along Chimney Rock Road.

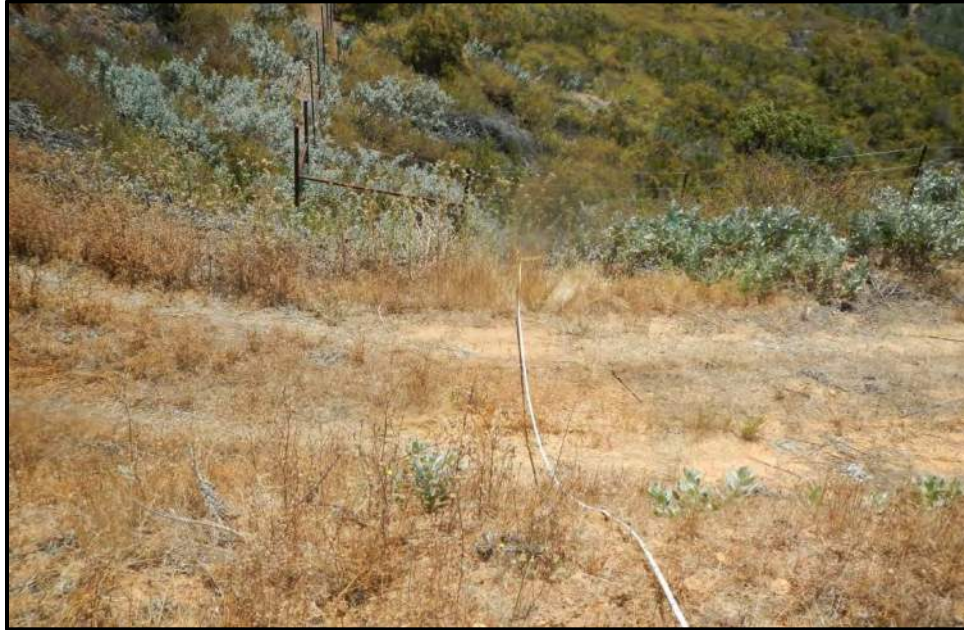
Photo 1. View southeast of Culvert 5 from northern side of existing road. Note dominance of upland chaparral species (June 14, 2017).

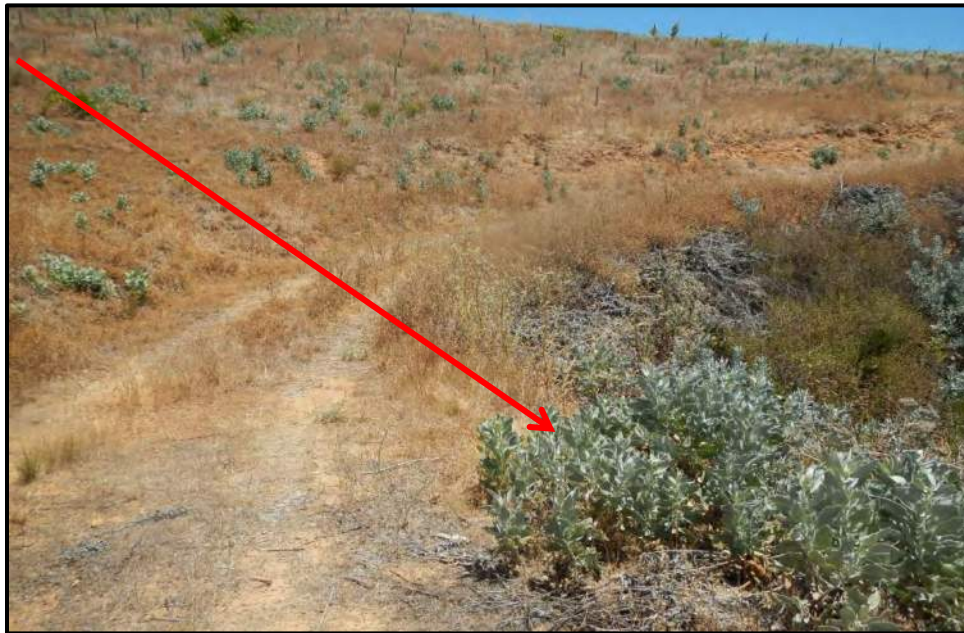
Photo 2. View of road and proposed outfall location of Culvert 5, aspect east. Note fallowed vineyard on north side of road (June 14, 2017).

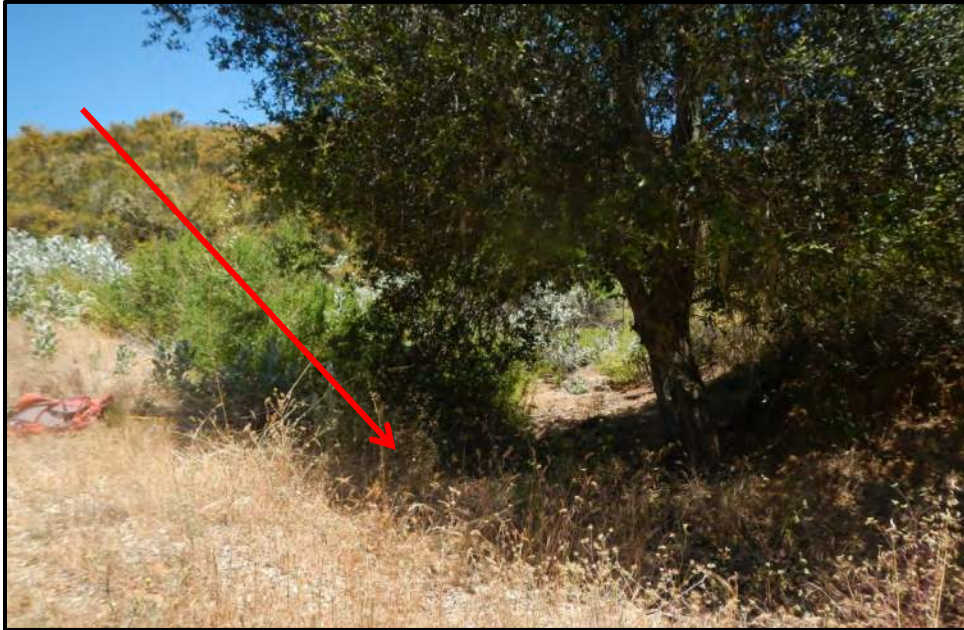
Photo 3. View northwest of Culvert 4 location (June 14, 2017).

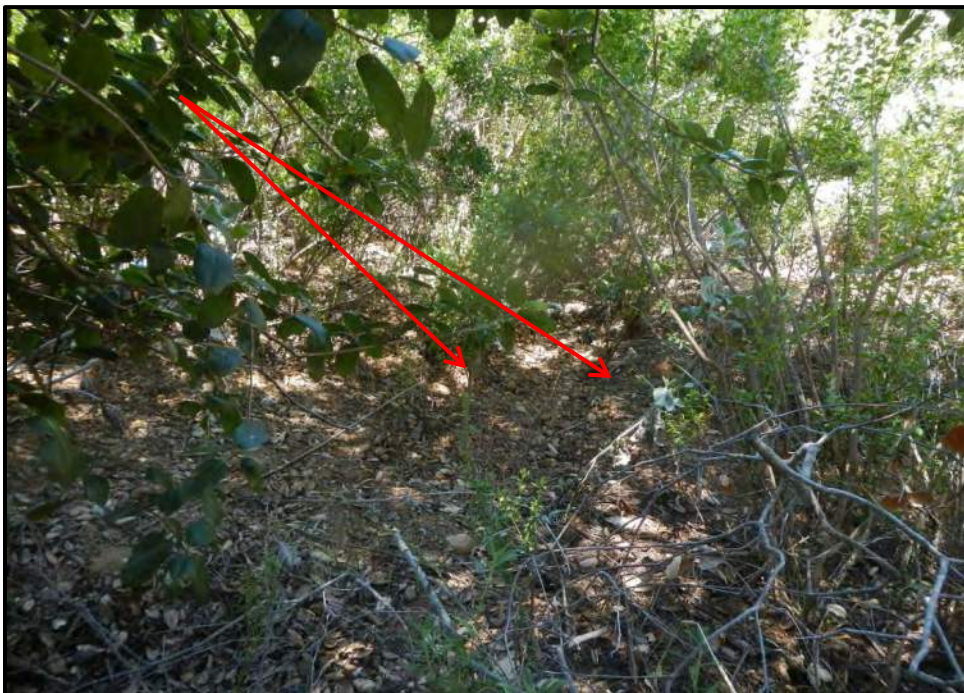
Photo 4. View north of drainage feature at Culvert 4 with marginal evidence of OHWM (June 14, 2017).

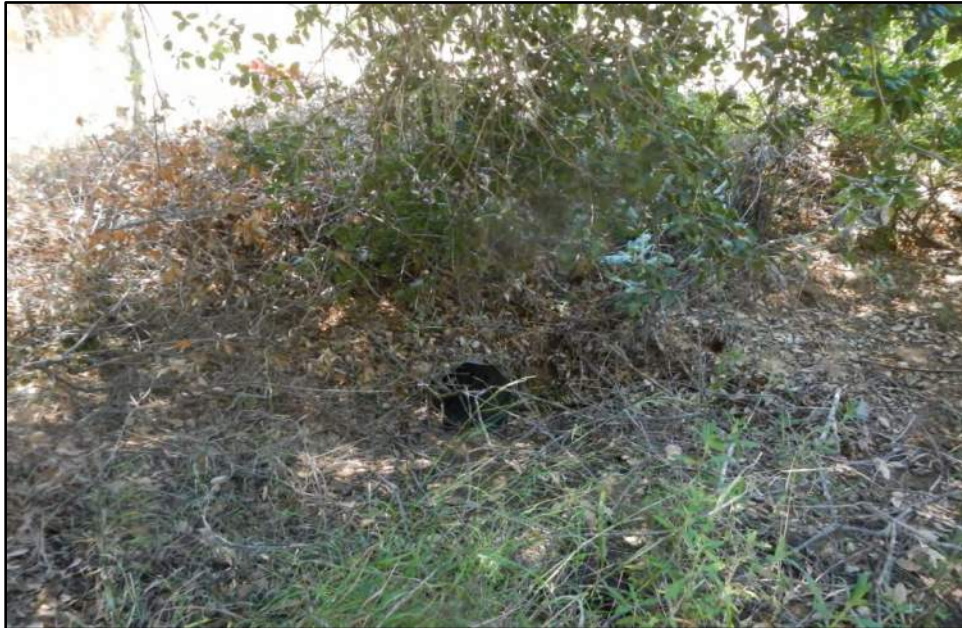
Photo 5. View of existing 12-inch culvert on north side of road at proposed Culvert 4 location. (June 14, 2017)

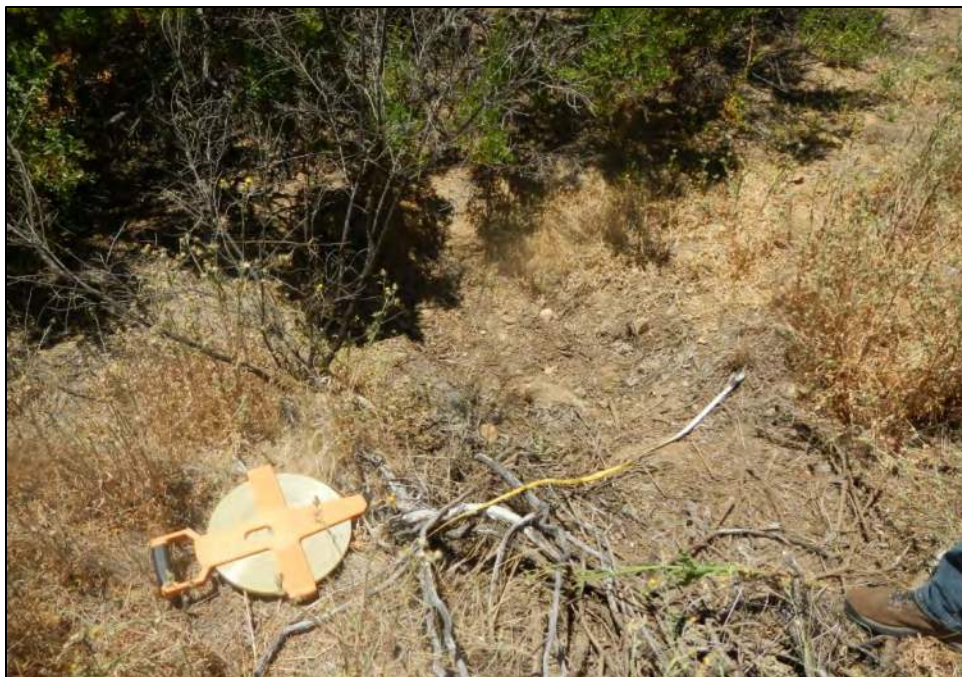
Photo 6. View of channel and evidence of debris wracking south of road at proposed Culvert 4 location (June 14, 2017).

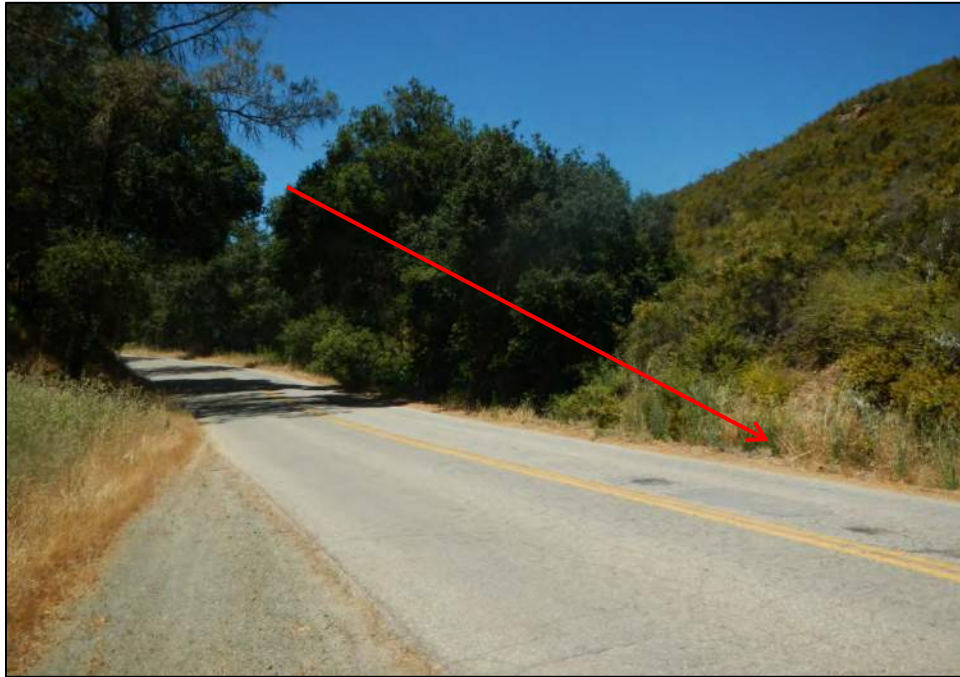
Photo 7. View west of roadside drainage ditch that hydrologically connects Culvert 4 to Dip Creek, which eventually connects to the Salinas River via Nacimiento River (June 14, 2017).

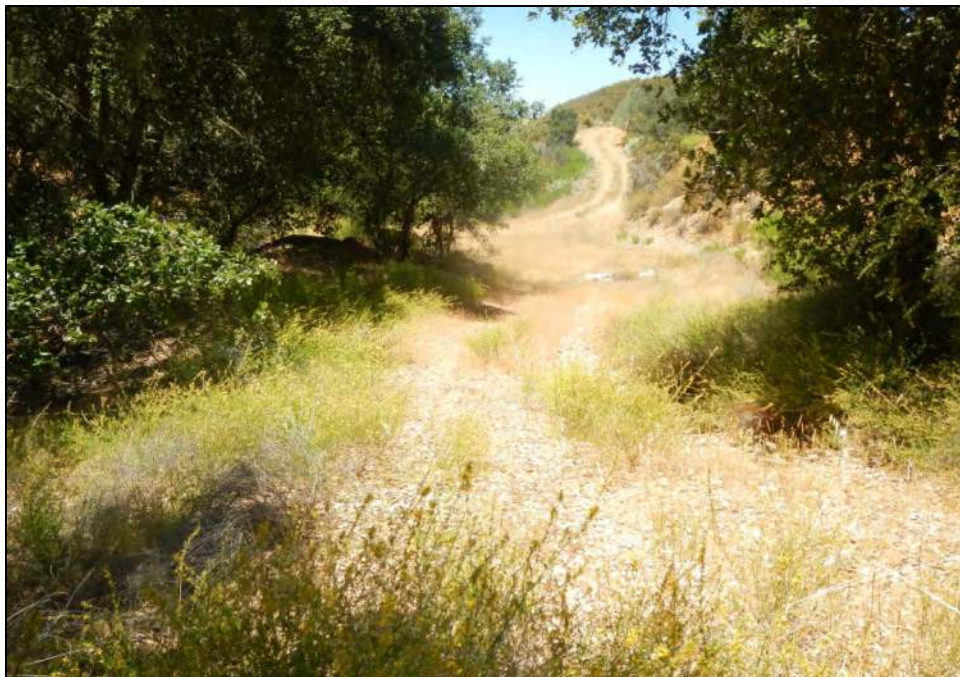
Photo 8. View east of road at proposed Culvert 3 location (June 14, 2017).

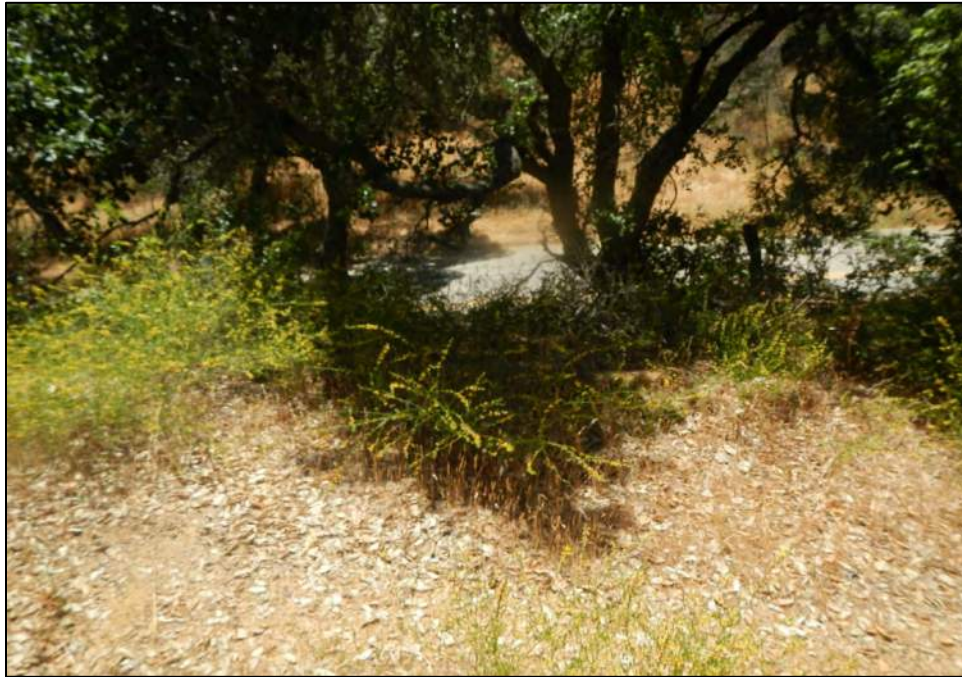
Photo 9. View south of proposed Culvert 3 location. Note no evidence of bed, bank, or OHWM (June 14, 2017).

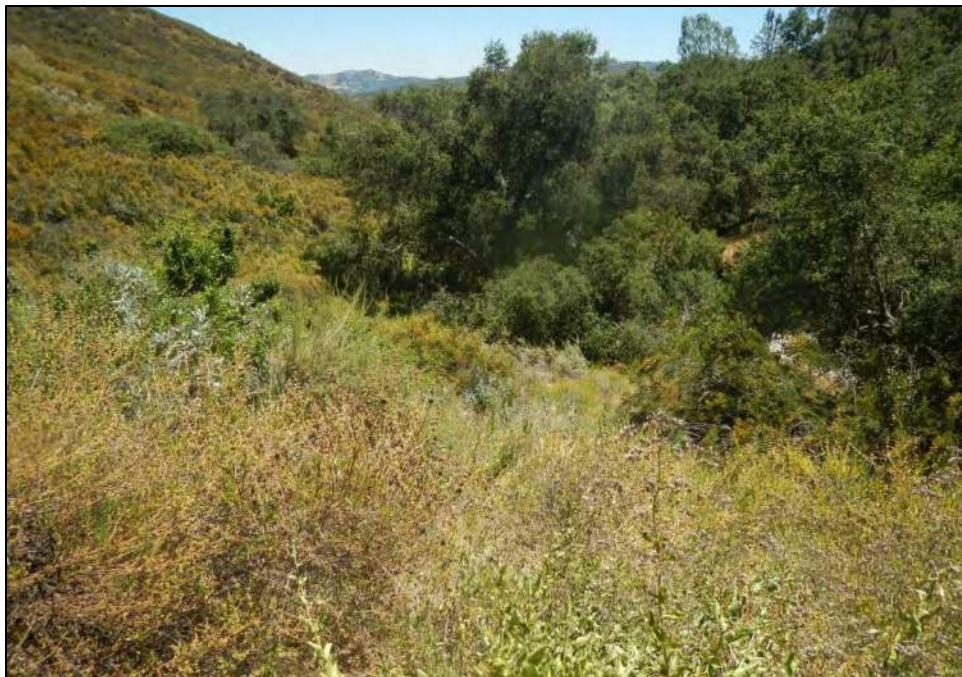
Photo 10. Overview east of proposed road and Culvert 2 location (June 14, 2017).

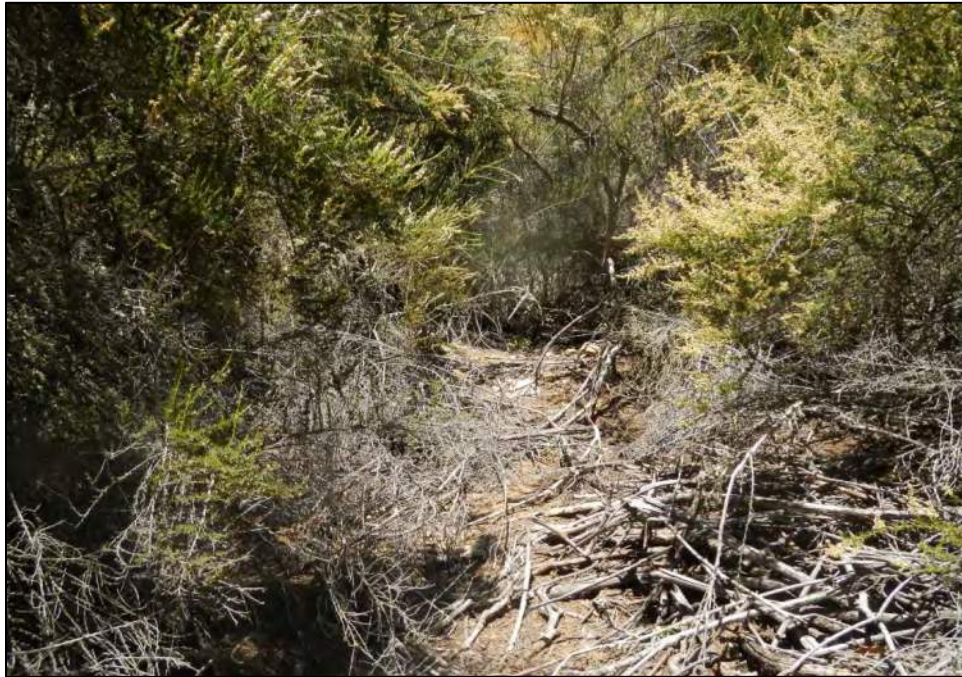
Photo 11. View north of channel with evidence of debris wracking and flow in proposed Culvert 2 drainage, aspect north. Note a lack of riparian vegetation (June 14, 2017).

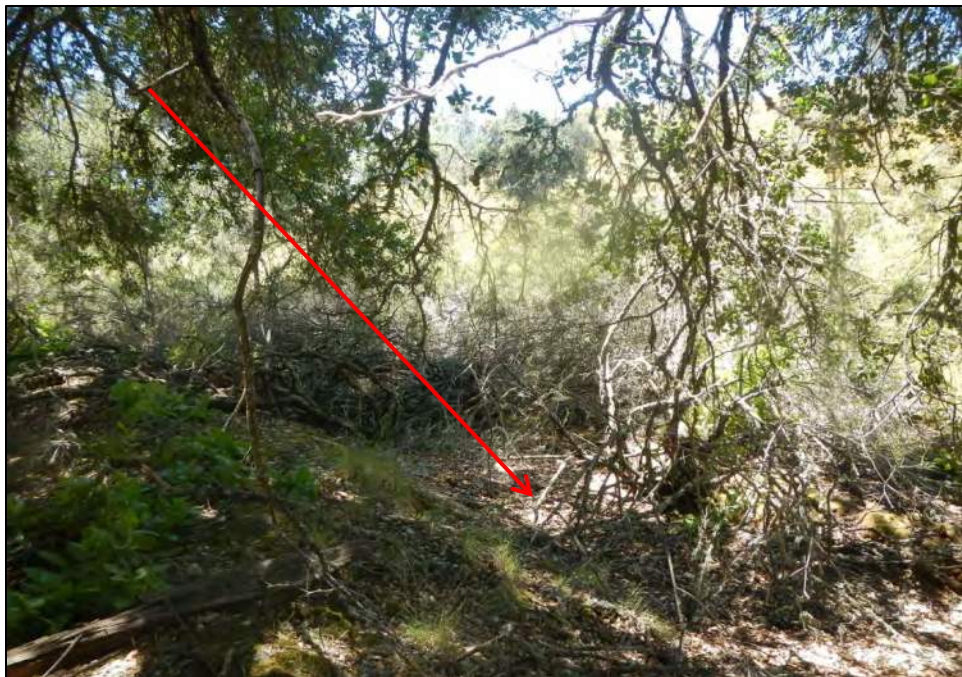
Photo 12. View north of swale feature that Culvert 2 drainage enters that lacked clear evidence of defined bed, bank, and recent flows (June 14, 2017).

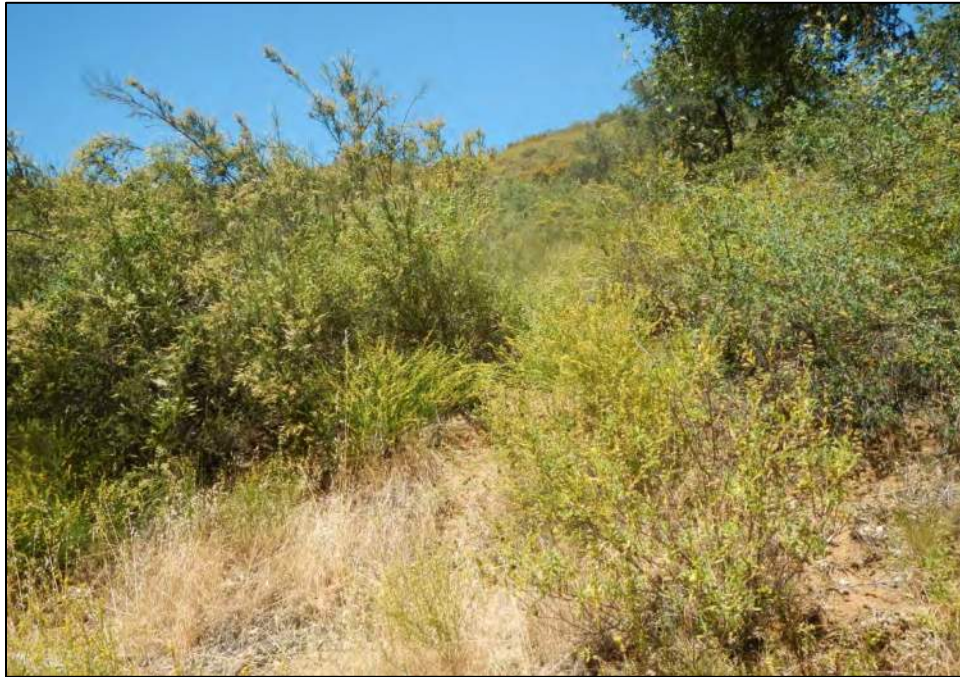
Photo 13. View north of proposed new driveway approach and Culvert 1 location. Note upland species dominating Culvert 1 location (June 14, 2017).

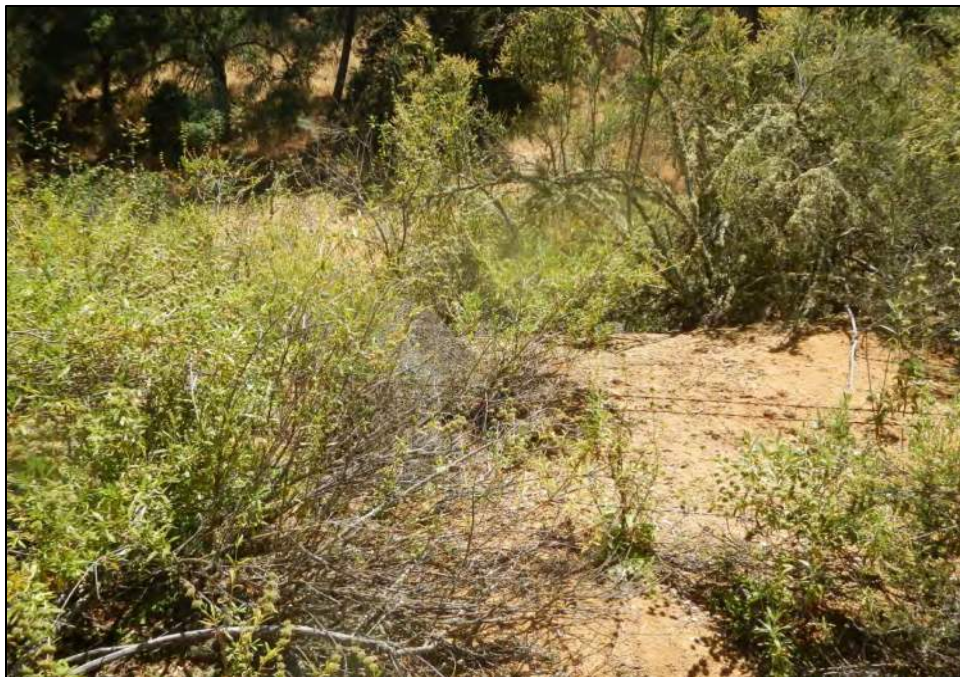
Photo 14. View of north of Culvert 1 location. Lacked evidence of a defined bed and bank, and OHWM (June 14, 2017).

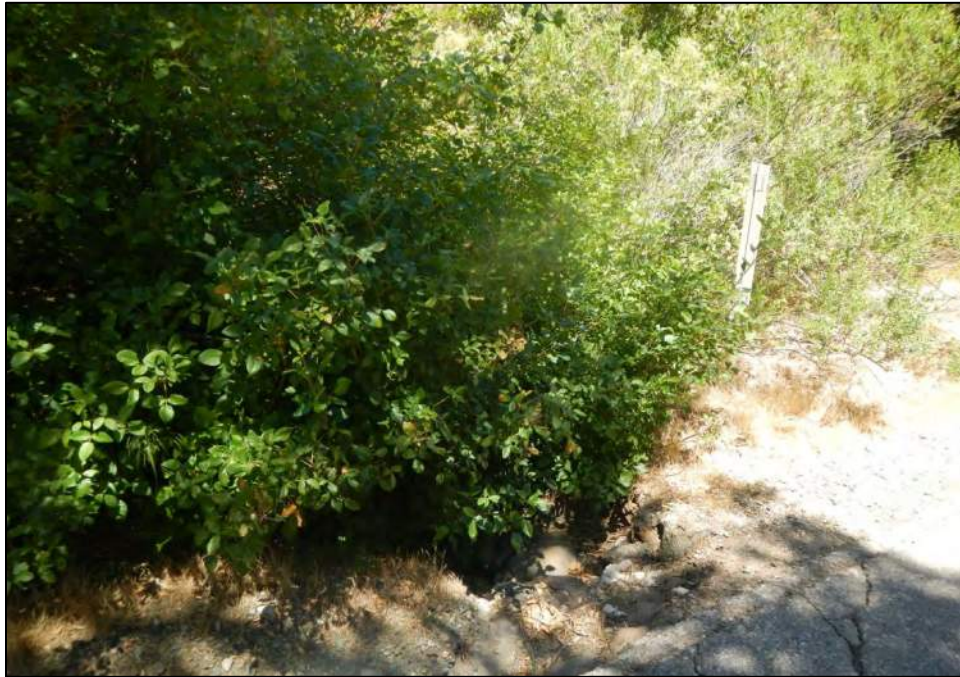
Photo 15. View of inlet to tributary to San Marcos Creek approximately 500 feet east of Culvert 1 location (June 14, 2017).

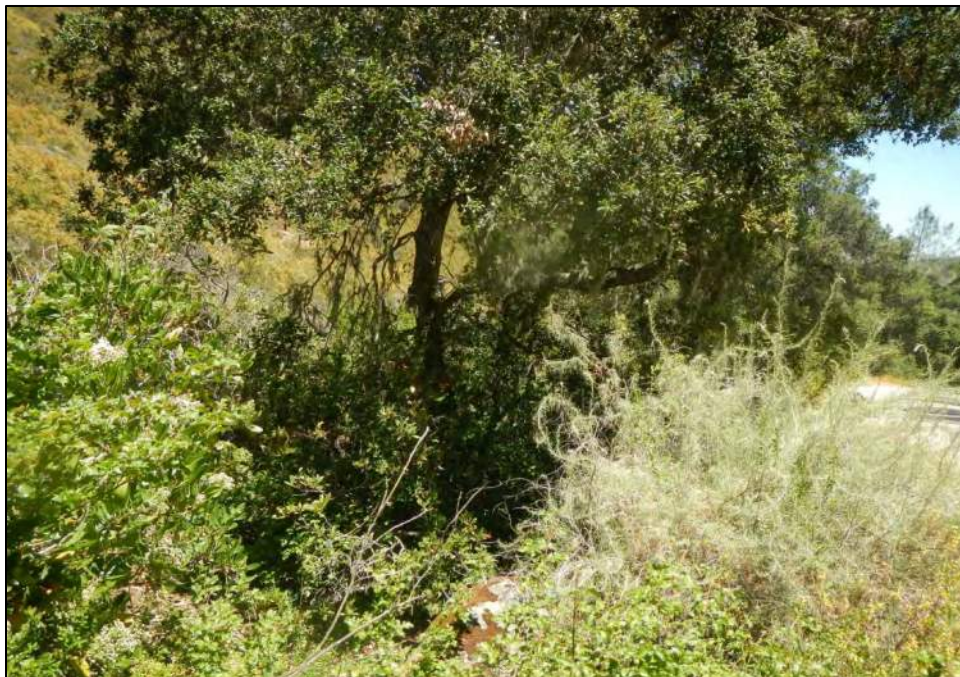
Photo 16. View east of tributary to San Marcos Creek, defined blue line feature that hydrologically connects to the Salinas River (June 14, 2017).
