PHASE I ENVIRONMENTAL SITE ASSESSMENT REPORT

Proposed Residential Development

West Avenue J & 40th Street West Lancaster, California 93536

Report Date: September 12, 2018 Partner Project No. 18-225080.1

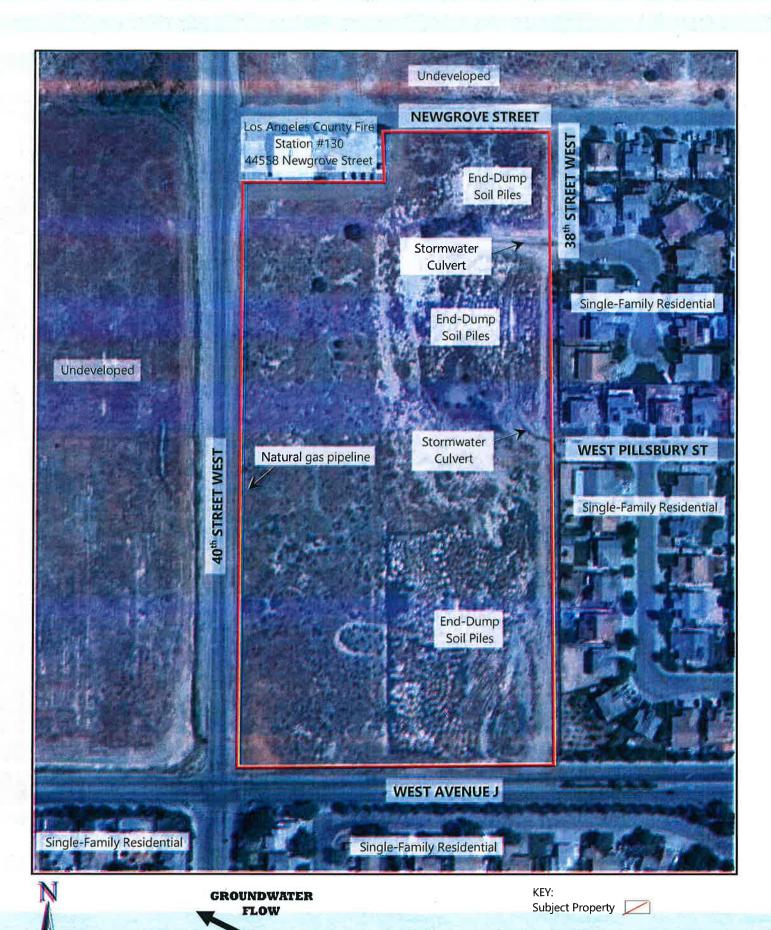
FIGURE 2: SITE PLAN Project No. 18-225080.1

The subject property is currently vacant land. No operations are currently performed on site. The eastern half of the subject property is occupied by numerous end-dump soil piles, and a subsurface natural gas pipeline easement appears to traverse north to south along the western subject property boundary.
