### **Fault Hazard Evaluation Report for the Proposed Camelia Residential Community**

Project No. 15805-10A

Subject: **Fault Hazard Evaluation Report for the Proposed Camelia Residential Community, Assessor's Parcel Number 380-220-003, Located North/East of the Transition of Palomar Street to Washington Avenue, City of Wildomar, Riverside County, California**

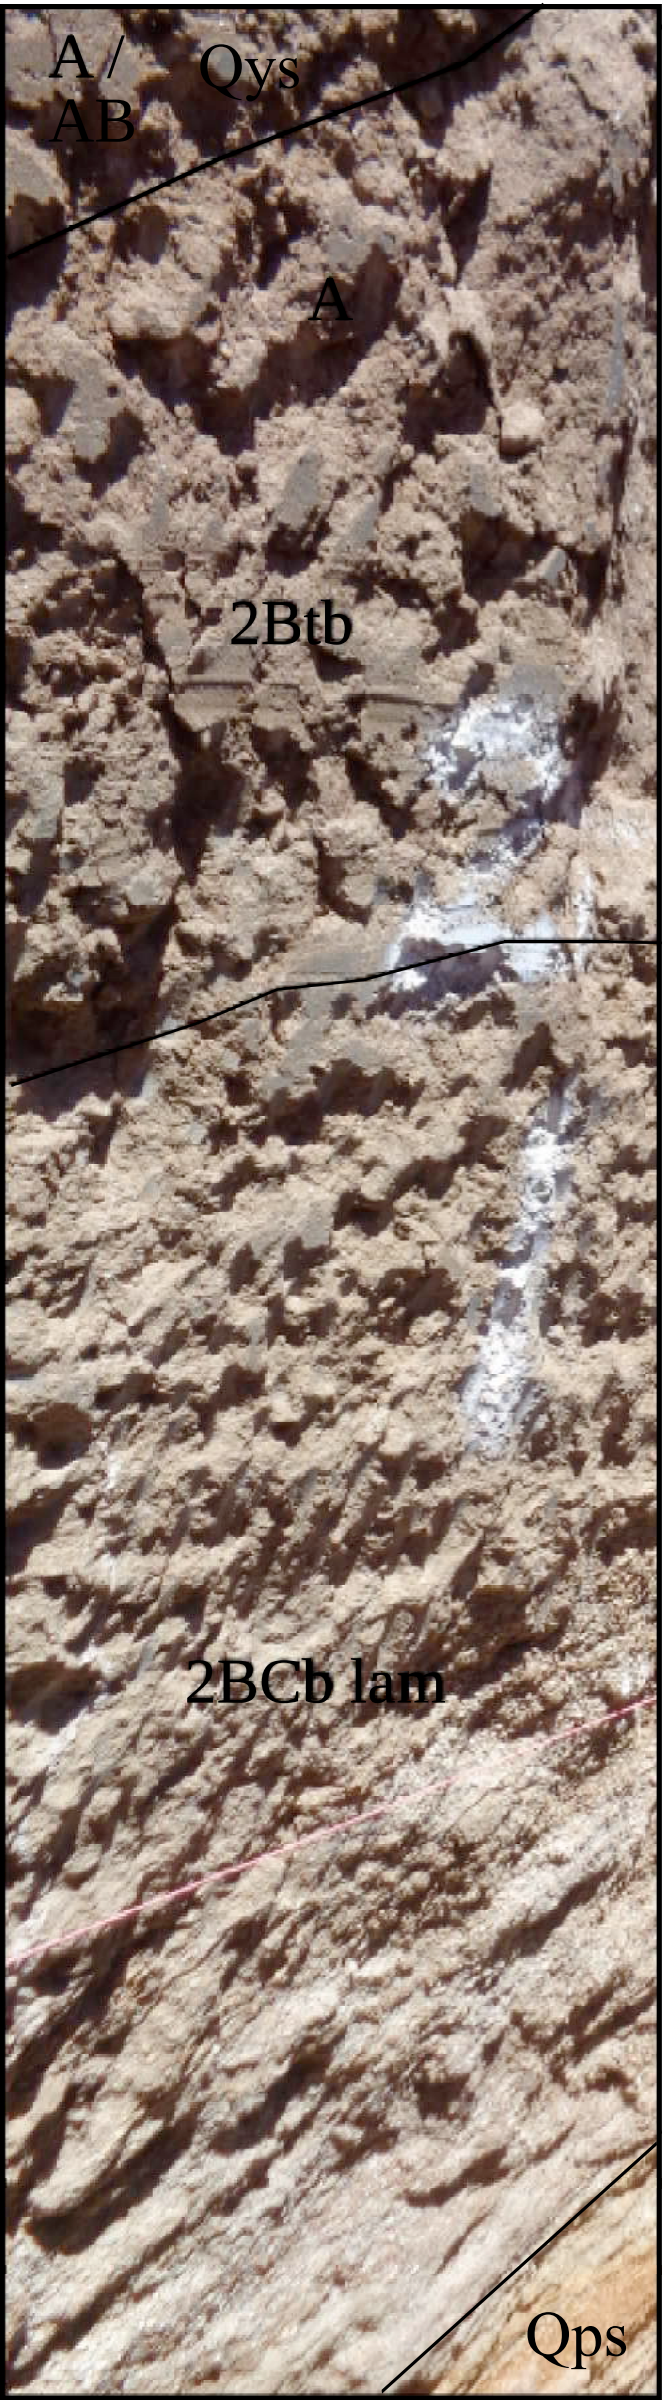
Soil Profile 2, Trench FT-1, Station 195 - 200 feet

Paleoxeralf  
Q<sup>oa</sup>

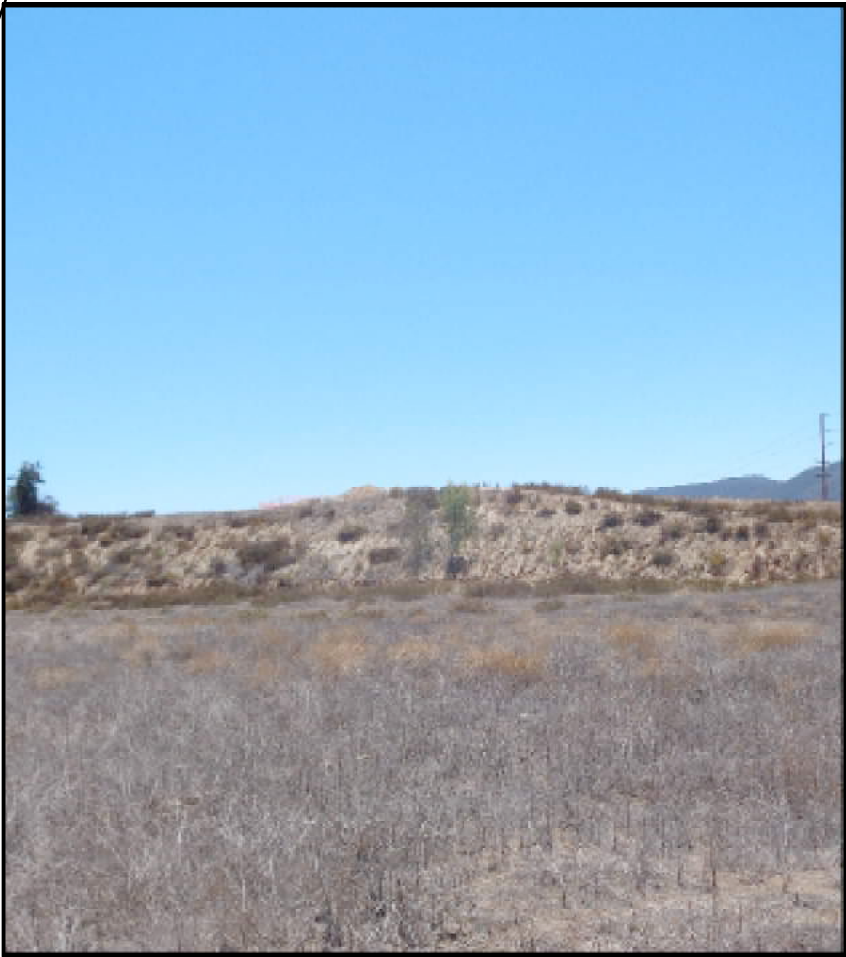
FIGURE 2. Soil Profile 2

View of FT-1 pediment surface from the inset FT-5 Alluvial Surface (Qyf).
