COUNTY OF SANTA BARBARA

Draft
Mitigated Negative Declaration
20NGD-00000-00008

Montecito Debris Nets
Maintenance Project

19DVP-00000-00036
September 2020

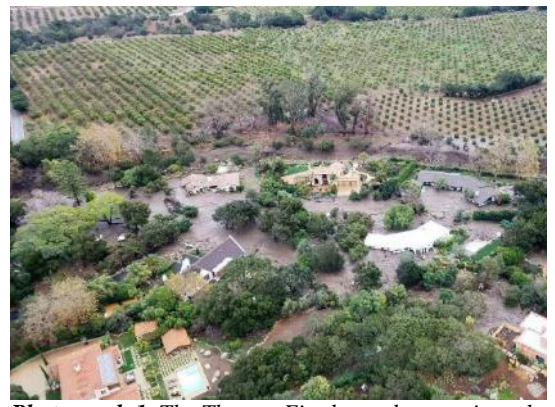
Photograph 1. The Thomas Fire burned approximately 281,893 acres resulting in large unvegetated areas with loose sediments that were mobilized by rainfall during the substantial debris flows on January 9, 2018.

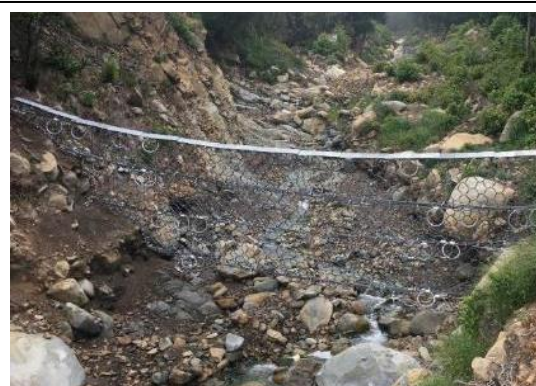
Photograph 2. Six Geobrugg flexible debris nets were installed within Cold Springs Canyon, San Ysidro Canyon, and Buena Vista Canyon. SY-18 (pictured above) was installed in San Ysidro Canyon in April 2019 under the original Emergency Permit issued by the County.

Per the conditions of the Emergency Permits and Development Plan the debris nets were installed at a minimum elevation ranging from 3 to 5 feet above the water surface within the low-flow channel of each creek to allow for the passage of water, fine sediment, and fish and wildlife. The Emergency Permits and Development Plan require that the space between the water surface and the bottom of the debris net be maintained at a minimum of 3 feet, such that debris does not restrict the low-flow channel, except during high stream flow or debris flow events. Depending on their location, the debris nets range in height from 10 to 20 feet. The bottom length of each debris net ranges from 14 to 98 feet wide, the middle length of each debris net ranges from 26 to 134 feet wide, and the top length of each debris net ranges from 37 to 150 feet wide. Engineering oversight was provided by DRS Engineering and Geo Solutions during the installation of the debris nets in April and September 2019. Additionally, consistent with the condition of the Emergency Permits and Development Plan, full-time biological monitoring was provided by Storrer Environmental Services (SES). Table 1 below provides a description of net type, retention capacity, and location of the six debris nets.

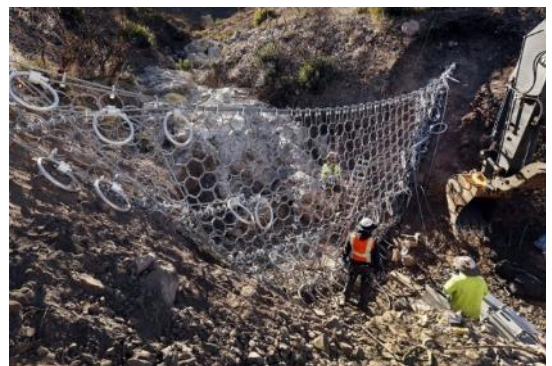
Photograph 3. Required maintenance activities would vary depending on the size and total volume of sediment or other debris captured by the debris nets. Minor debris accumulation maintenance would involve the use of hand tools (e.g., picks, shovels, and small hydraulic splitters). If major debris accumulation occurs, maintenance would require the use of heavy construction equipment.

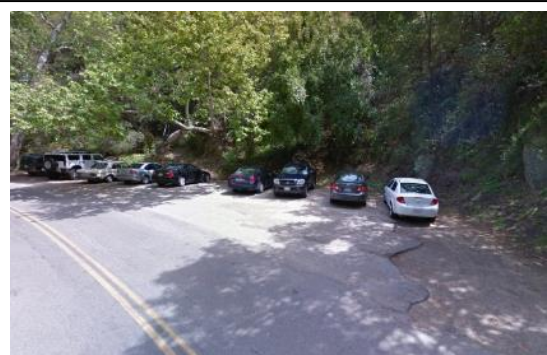
Photograph 4. Pursuant to the conditions of the original Emergency Permits and Development Plan, parking during construction, maintenance, and removal activities shall not occur at the existing trailheads. Maintenance crews and monitors shall be shuttled to each canyon and shall hike into each debris net location.

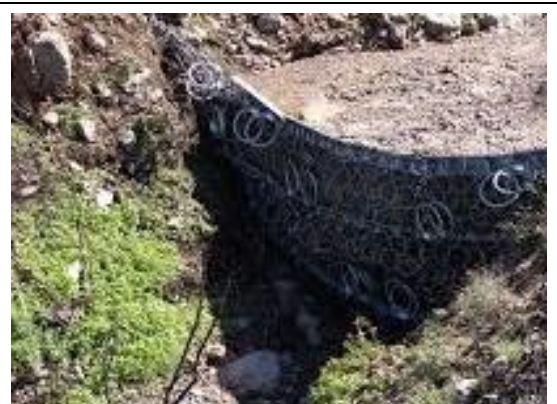
Photograph 5. In the event of major debris accumulation, heavy construction equipment would be required to remove the large boulders, rocks, tree trunks, branches, and other debris to restore capacity and function of the existing debris nets. (Photograph of captured debris within Camarillo Springs.)

Should the debris nets accumulate enough material to block the low-flow channel, heavy construction equipment would be airlifted to the debris net locations, after it is safe to do so. Light airlift activities would be accomplished using a MD-500 helicopter and heavy lift activities would be accomplished using a CH-47 helicopter. The contractor would use a Spyder excavator or a 10-ton class excavator to remove the debris from the low-flow channel depending on the specific characteristics of the debris flow. The crew size for these activities would average approximately four construction workers per debris net location.

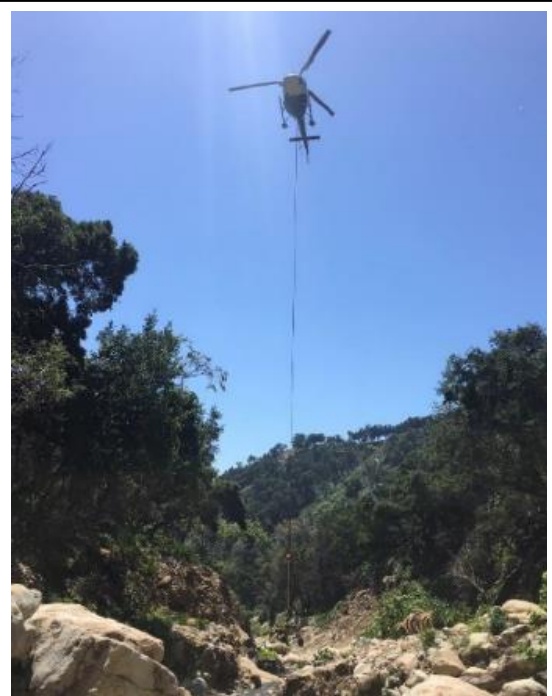
Photograph 6. Heavy construction equipment (e.g., Spyder excavator or 10-ton class excavator and conveyor belt system) would be airlifted to via helicopter for major maintenance activities.

To re-establish the low-flow channel during the wet season, the helicopter would place the excavator(s) on top of the accumulated debris (i.e., behind the debris net). The excavator would then clear a low-flow channel by excavating through the middle of the debris in the channel and side-casting material against the upstream banks. Restoring the low-flow channel to baseline elevation conditions would begin from the back of the debris flow working towards the debris net. During the excavation of the low-flow channel, a minimum of 3 feet of freeboard would be re-established to maintain terrestrial wildlife passage under the net through the duration of the wet season.

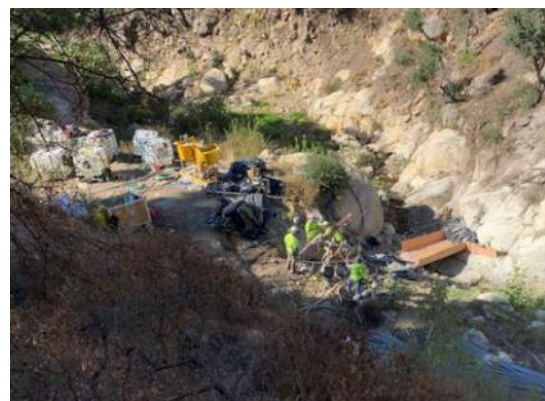
Photograph 7. During major maintenance activities, heavy construction equipment and materials would be airlifted to the debris net locations and staged in unvegetated disturbed areas, similar to the original installation activities (as pictured above at Buena Vista Creek).

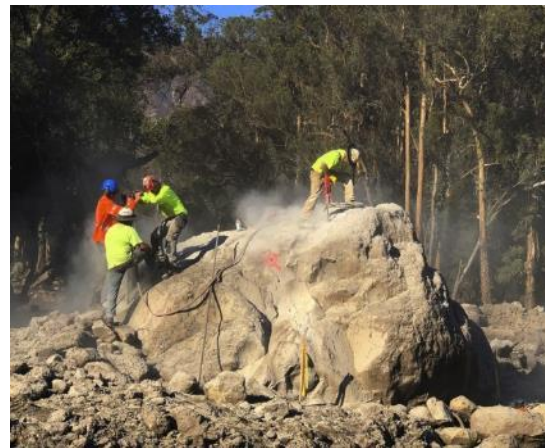
Photograph 8. Major maintenance events with major debris may require removal of large boulders using hydraulic splitters and excavators.

Immobile Material: Large boulders that cannot be lifted by the excavator would be broken in place using hydraulic splitters or a hydraulic excavator-mounted hammer to enable management with the excavator. The materials would then be placed according to size, or as otherwise directed by a qualified geomorphologist and a qualified biologist.

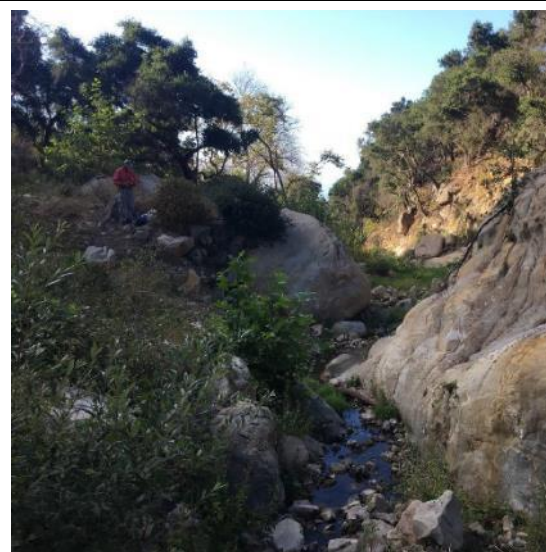
Photograph 11. The existing drainages, including Buena Vista Creek (pictures above) are perennial, with surface water generally flowing throughout the year.

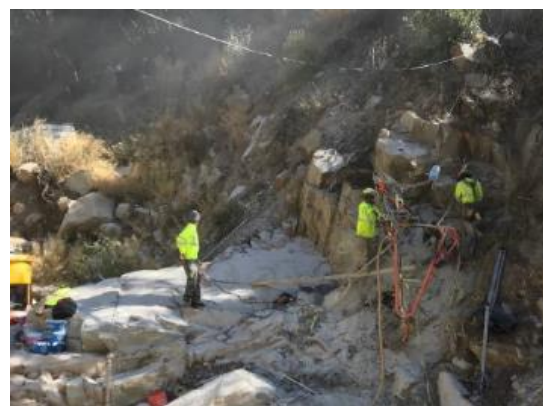
Photograph 13. Minor maintenance activities would involve a crew of between one and four personnel that would be visible for short periods along the trails paralleling the creek. These maintenance activities would look similar to the original installation activities pictured above.

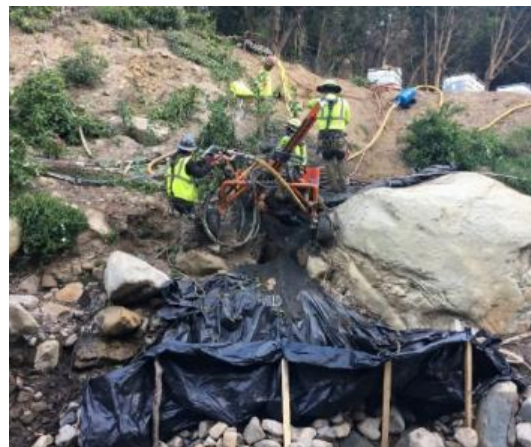
Photograph 18. During the initial installation of the debris nets, temporary secondary containment structures were successfully used to ensure that there were no accidental spills associated with heavy construction equipment. Similar BMPs would be installed during all maintenance activities involving the use of power tools or heavy construction equipment.

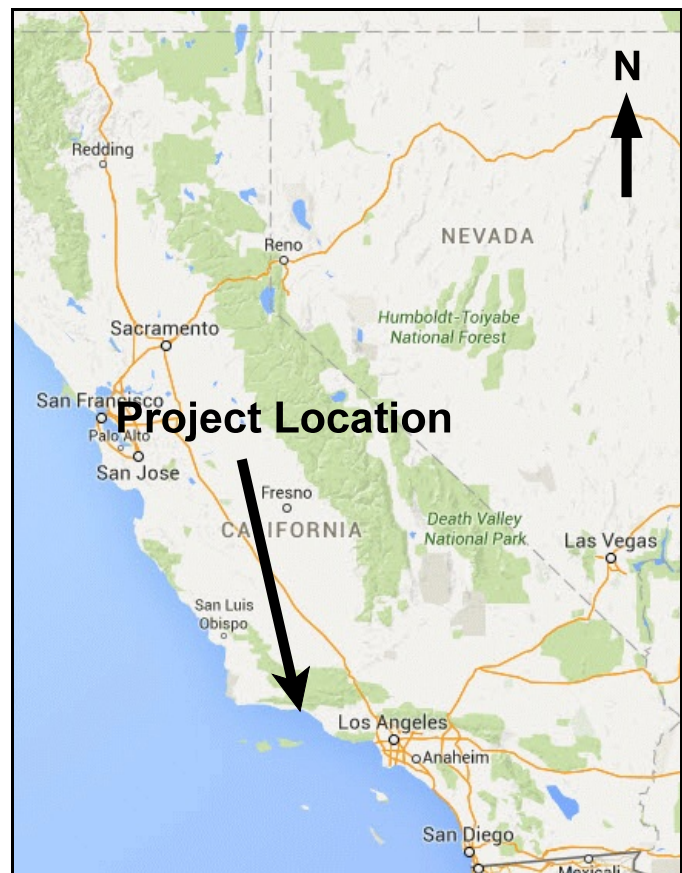
Figure 1. Project location in Santa Barbara County, California.

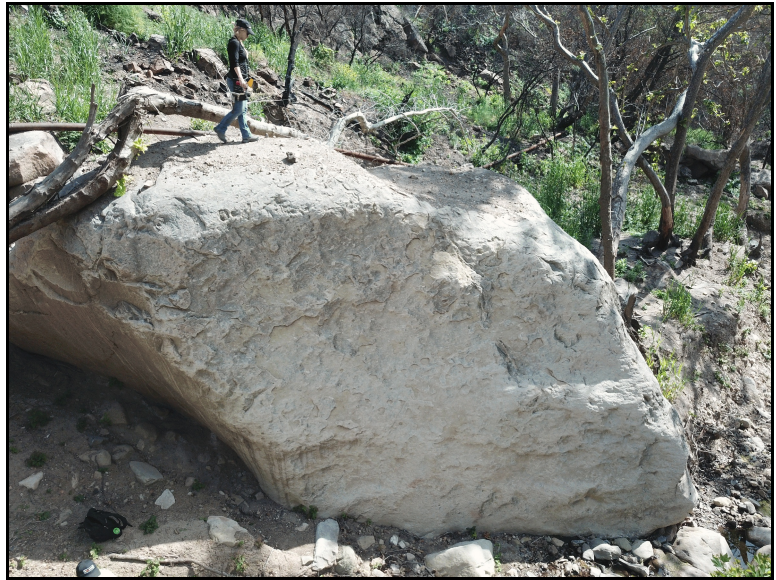
Figure 3. Massive boulder transported by a debris flow in Buena Vista Creek channel.

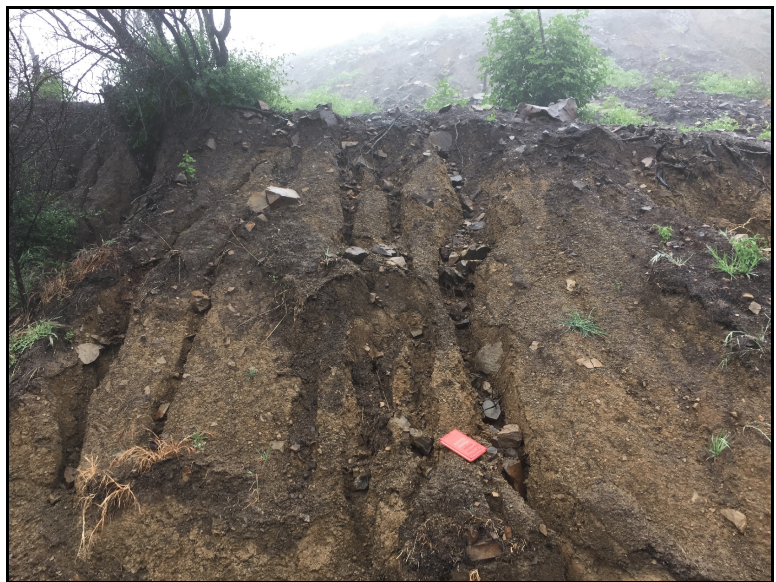
Figure 4. Rapid erosion on bare slope in Romero Canyon.

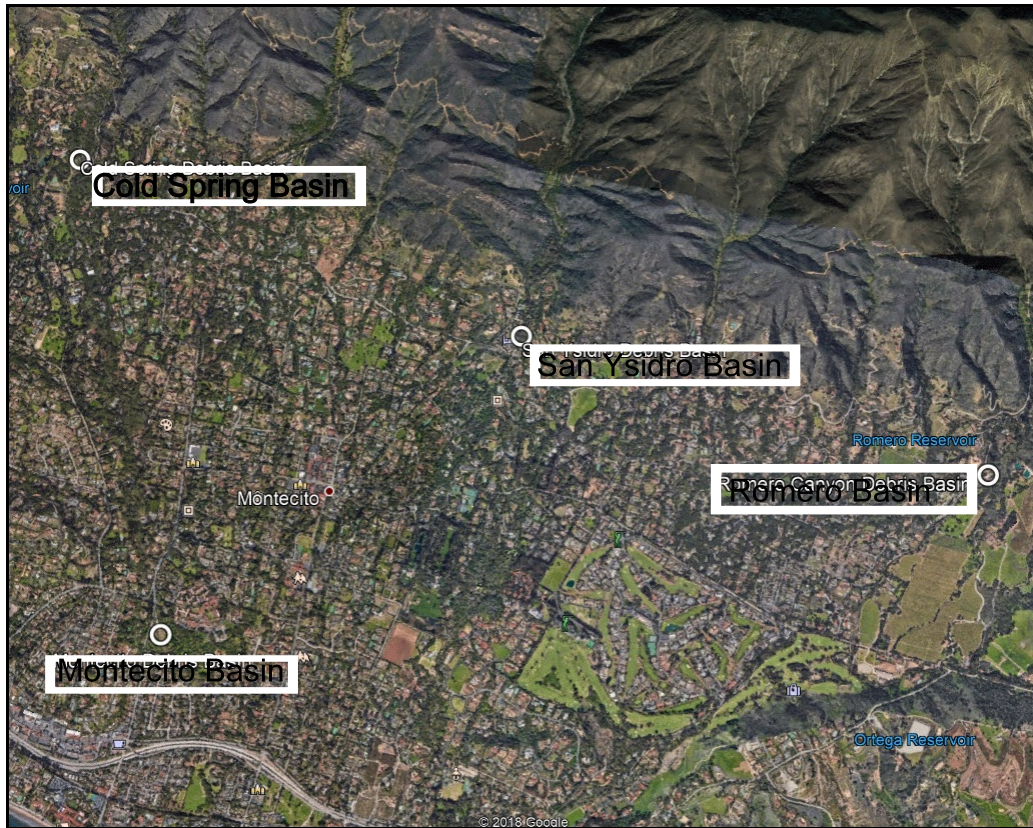
Figure 5. Debris basins located within the limits of Montecito, California.

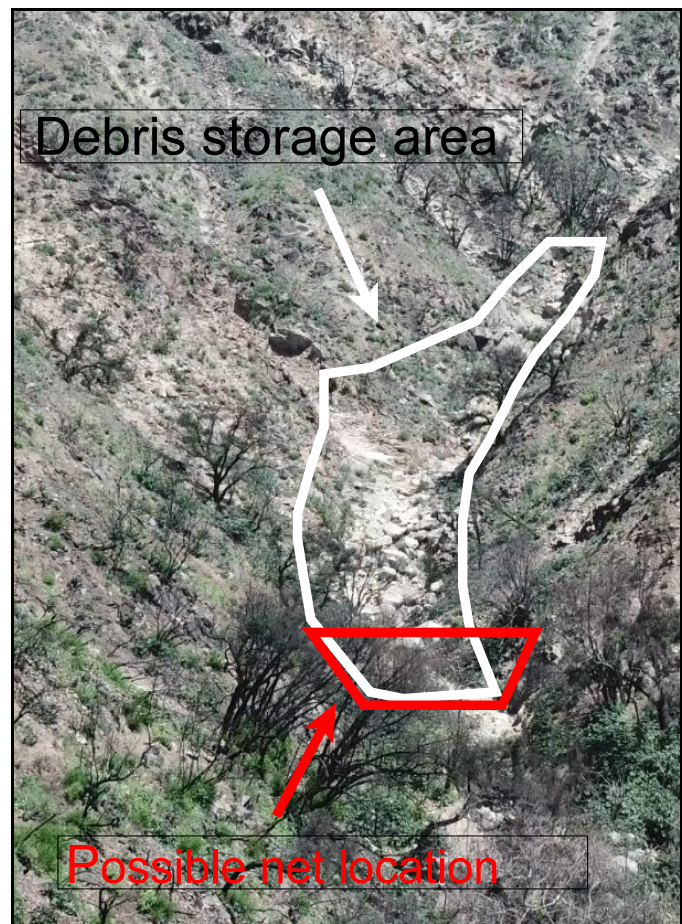
Figure 6. Choke-point in channel with upslope storage.

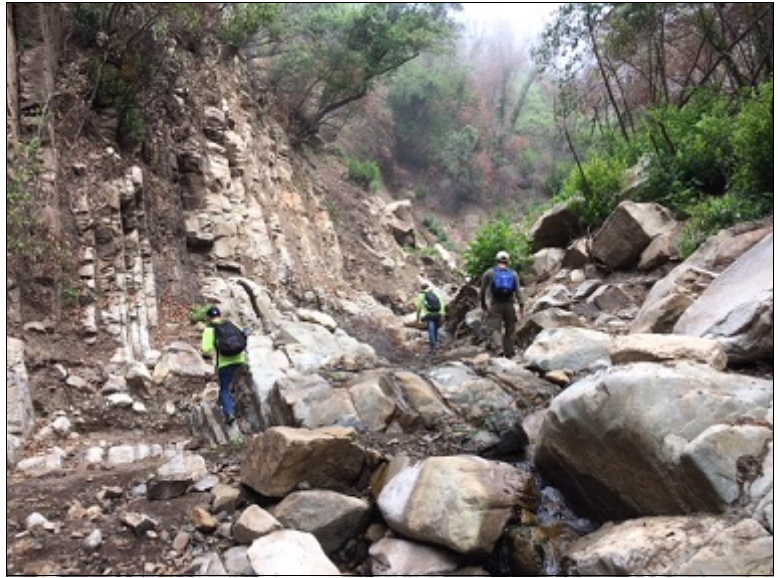
Figure 7. KANE GeoTech geologists and engineers hiking a canyon. Note the large boulders remaining in the channel.

videoed each area with use of the DJI Mavic Pro Drone, and marked the locations with a handheld Garmin GPS, Figures 7 and 8. A total of 71 net potential net locations were identified. All net numbers and GPS locations are provided in Appendix A. Please see Canyon-Specific Reports for images with net locations shown.

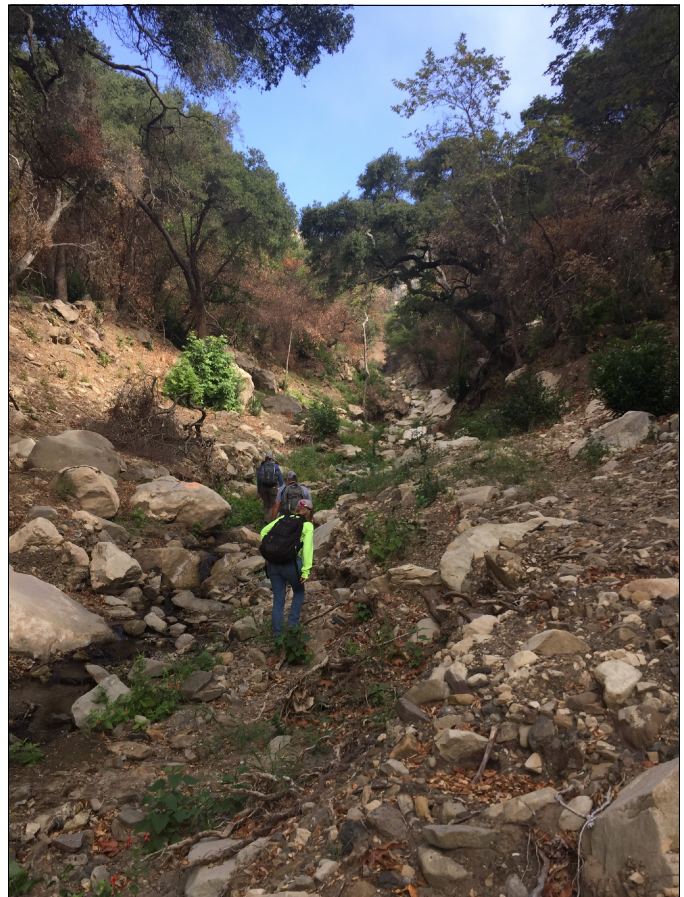
Figure 8. KANE GeoTech geologist in Romero Canyon channel. Note large amounts of fine to boulder debris in channel.

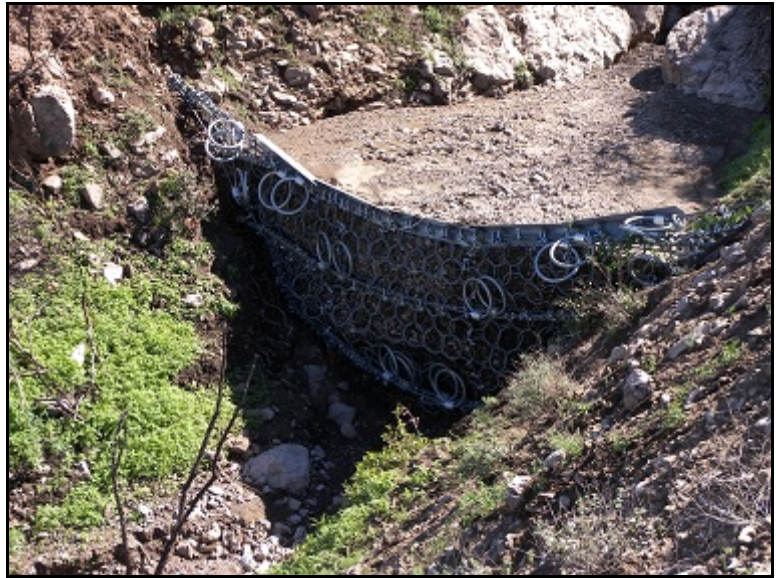
Figure 9. Geobrugg VX debris net protecting the community of Camarillo Springs, California. The net is easily cleaned after filling.

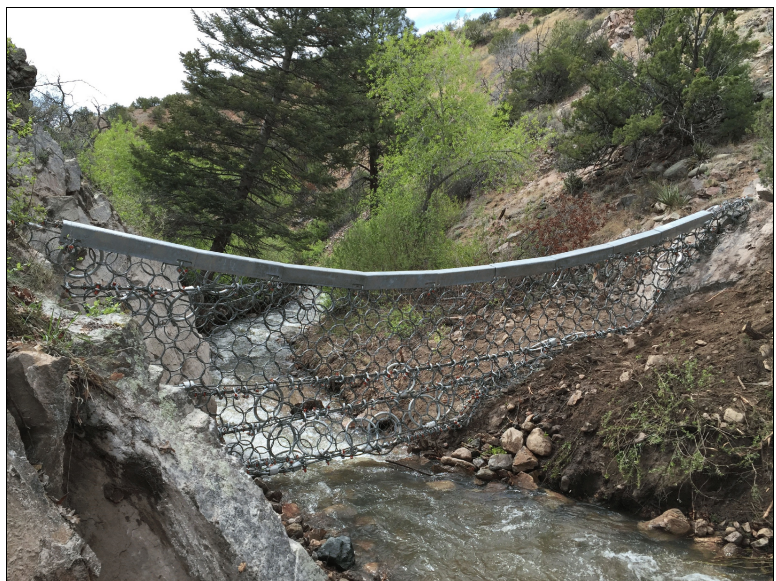
Figure 10. Post-fire VX net installed above running stream on the Nambé Pueblo, New Mexico. Note basal opening allowing water and fish passage beneath.

There are two basic versions of the Geobrugg debris net systems. The VX net which is intended for relatively narrow (up to 40-ft wide), Figure 10. The UX net is installed in wider channels (up to 90-ft wide) and has posts to keep the top net support rope from sagging. In wide channels where foundations cannot be constructed, such as in the Montecito canyons, a “Super VX” net can be installed, Figure 11. It is essentially a VX net with additional and stronger top net support ropes. Due to the environmental conditions in the Canyons above Montecito, Super VX nets will be constructed, rather than UX nets, to eliminate the need for foundations in the channel beds.

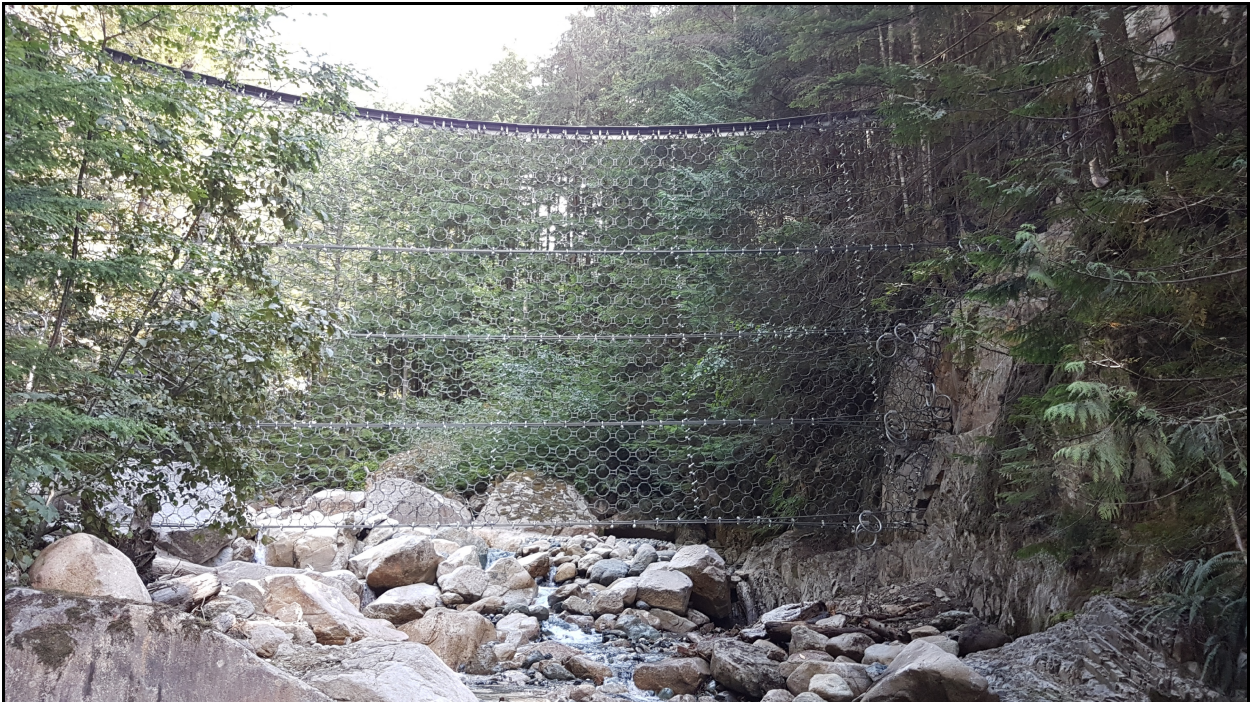
Figure 11. "Super VX" debris net installed in British Columbia, Canada. Note freeboard beneath net to allow stream flow and animal traffic. Basal opening freeboard is adjustable to eliminate construction excavation in stream channel.

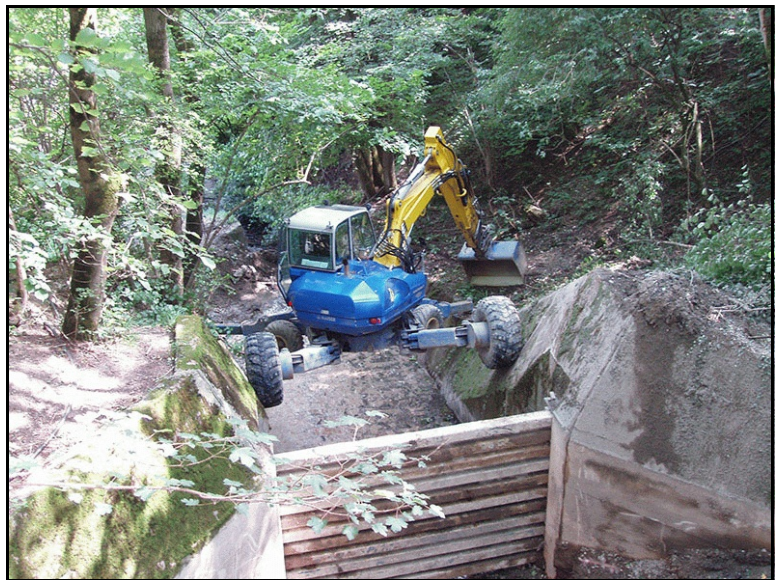
Figure 14. The Kaiser Spyder S2 Walking Excavator. It is specialized, low-environmental-impact drilling equipment from Access Limited. The machine recently was used to install anchors for debris nets Camarillo, California. Note that machine is supported on sides of channel and does not disturb the channel itself. Pictured here with an excavator bucket. The machine can be configured with a drill for anchor installation or a bucket for net clean-out.

While fabrication is in progress, the Contractor will begin drilling anchors using approved equipment per permit, Figure 14. All anchors will be installed in the channel sides. KANE GeoTech will be on-site to ensure conformance with its plans and to address any engineering issues immediately that may occur. Anchor installation requires the most time in the installation process. It takes a crew of three about one week to drill anchors and install a net.

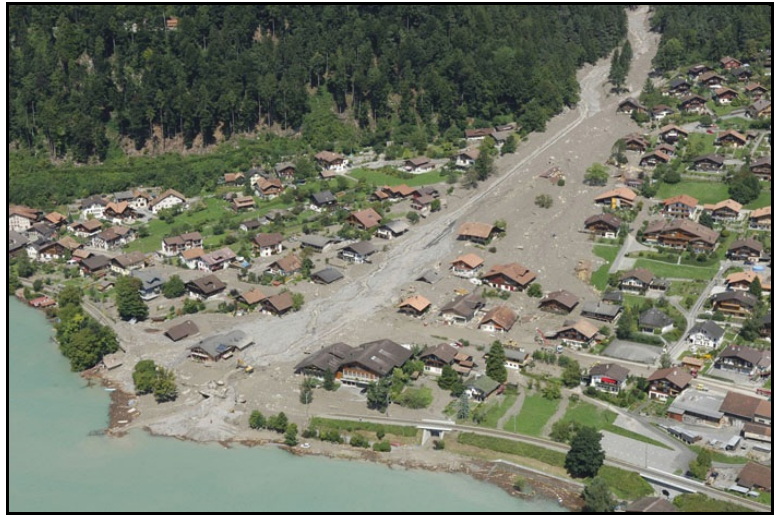
Figure 16. Catastrophic damage to the town of Brienz, Switzerland in summer 2005 was similar to that experienced by Montecito after the January 9, 2018 debris flows.

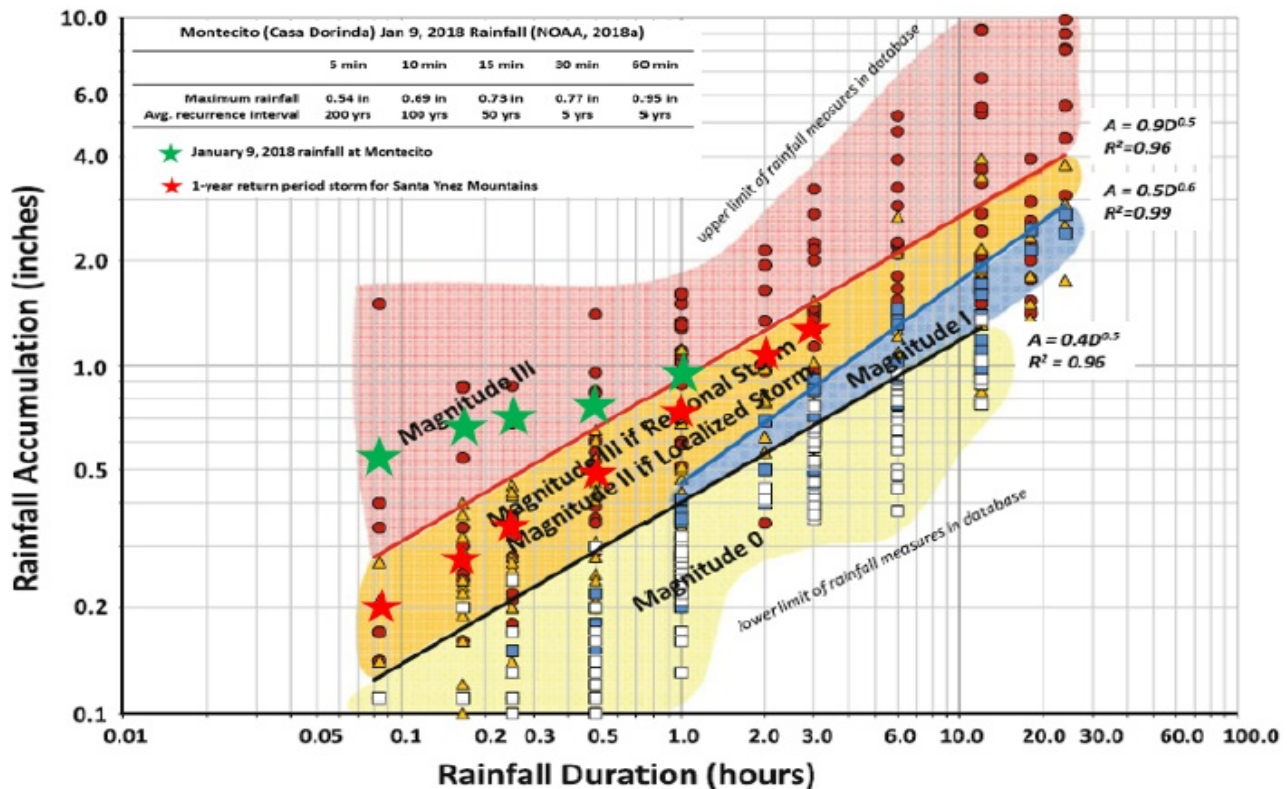
Figure 1. Adapted from Fig. 3 of Cannon et al. 2011. Within-storm rainfall accumulations for storms that triggered debris flows and floods. Open squares are storms with negligible response; blue squares are magnitude I events (small flows, houses damaged, but few large buildings threatened); orange triangles are magnitude II events (moderate flows, damage to houses and infrastructure); red circles are magnitude III events (large flows, buildings and infrastructure may be destroyed); green stars are rainfall reported at Montecito on January 9, 2018 by NOAA (2018a); red stars are rainfall for a 1-year return period in the Santa Ynez Mountains above Montecito (NOAA 2018b)

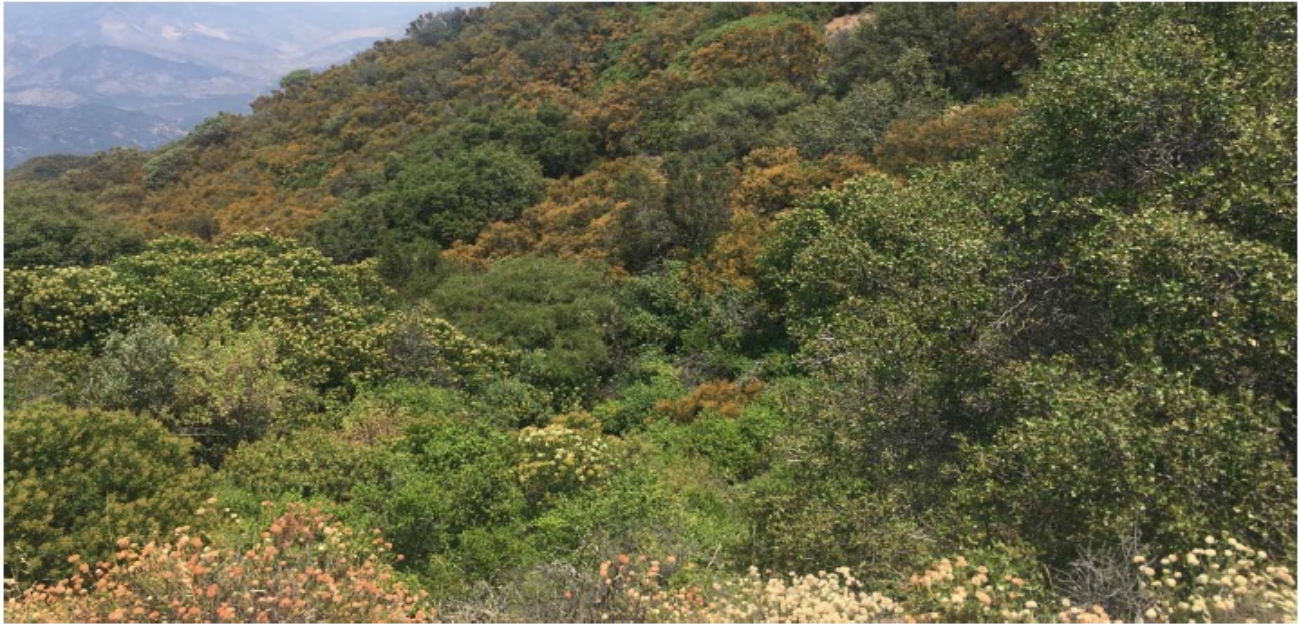
Figure 2. Typical chaparral shrubland in a watershed that has not recently burned. This watershed is located immediately north of San Ysidro Creek watershed, adjacent to the Thomas Fire burn area. BGC photo, July 2018, looking north from Camino Cielo Road.

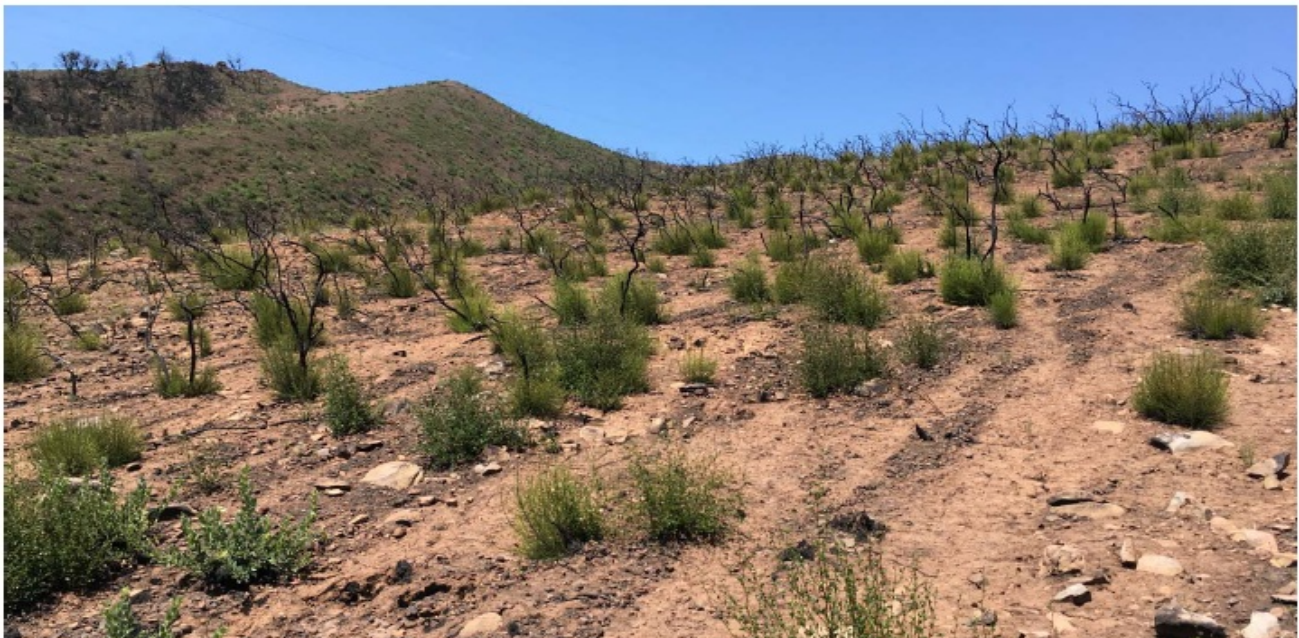
Figure 3. Typical watershed slope following the Thomas Fire. Note lack of vegetation and lack of organic duff layer, and loose soil directly exposed to rainfall. Pioneer vegetation has developed since the Thomas Fire. BGC photo, July 2018, looking northwest from lower Buena Vista Creek watershed.

3. The Thomas Fire burned most vegetation in the Montecito Watersheds (Figure 3), although the burn severity appears to be somewhat less in Romero watershed compared to the other Montecito Watersheds (Figure 4, Figure 5). The Montecito fire department (K. Kellogg, pers. comm.) reports that the watersheds burned between December 13 and 16, 2017.

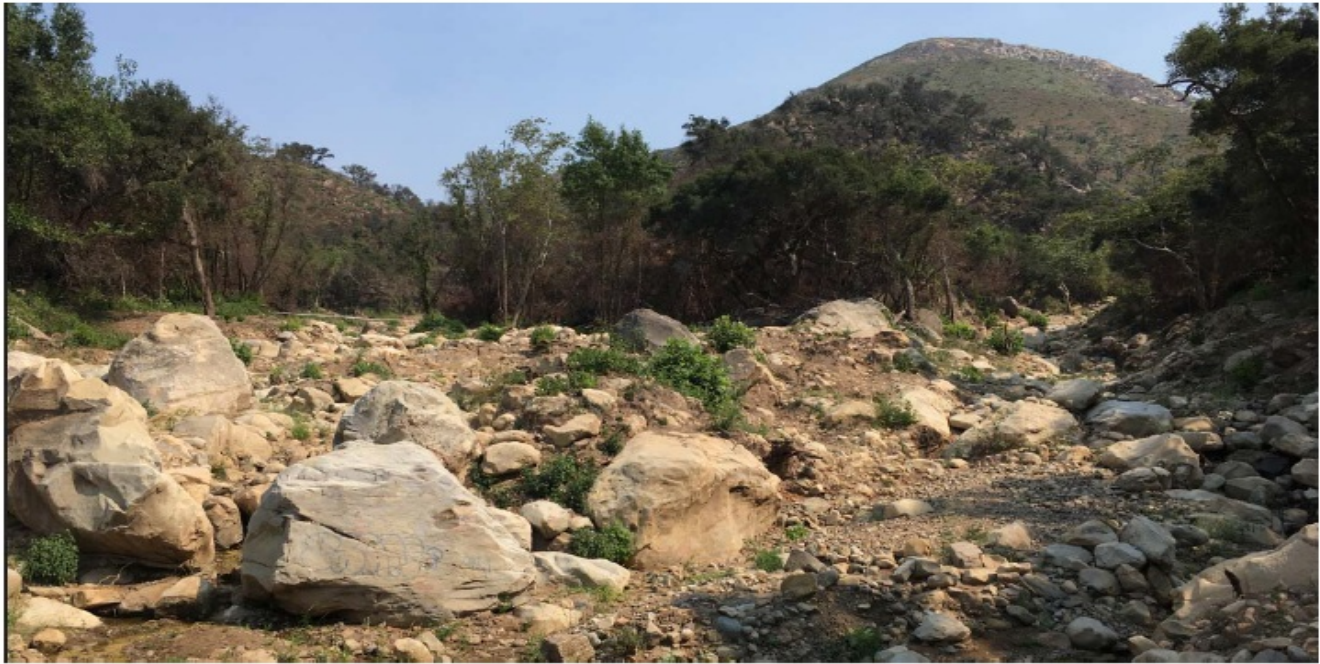
Figure 6. Sediment and boulders in Cold Spring Canyon approximately 400 m upstream from the development interface. Boulders up to 1.5 m diameter in foreground. BGC photo, July 2018, looking north.

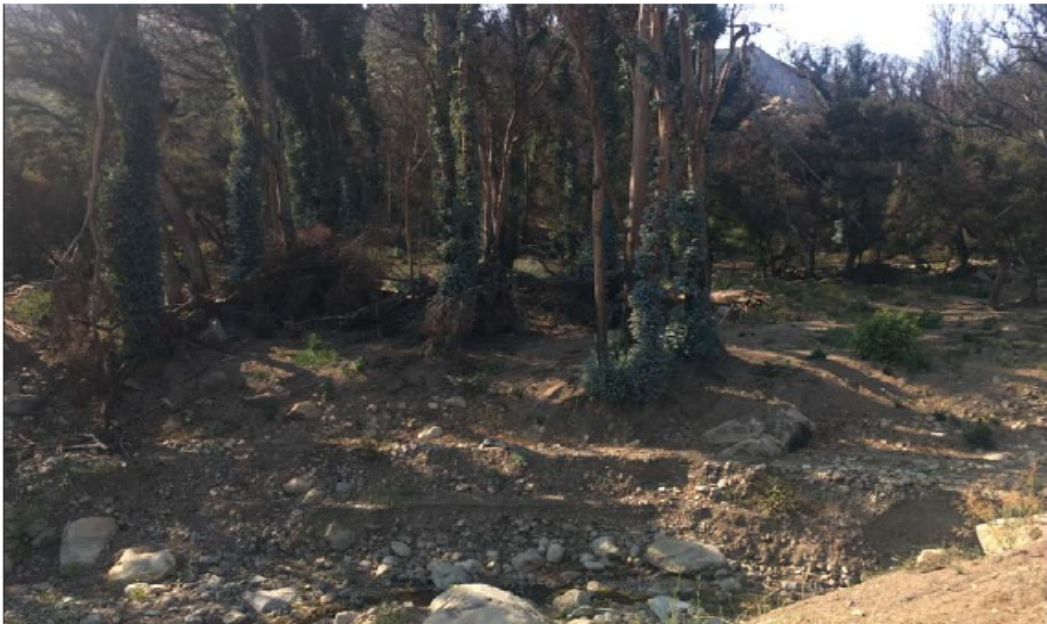
Figure 7. Woody debris and erodible channel banks in San Ysidro Canyon approximately 200 m upstream from the development interface. BGC photo, July 2018, looking west.

4. Large quantities of fine-grained sediment, boulders, and woody debris are still available to be entrained in flows. This material is located on the watershed slopes, within creek channels in the canyons, and in the scoured banks of the January 2018 debris flow channel (Figure 6, Figure 7).

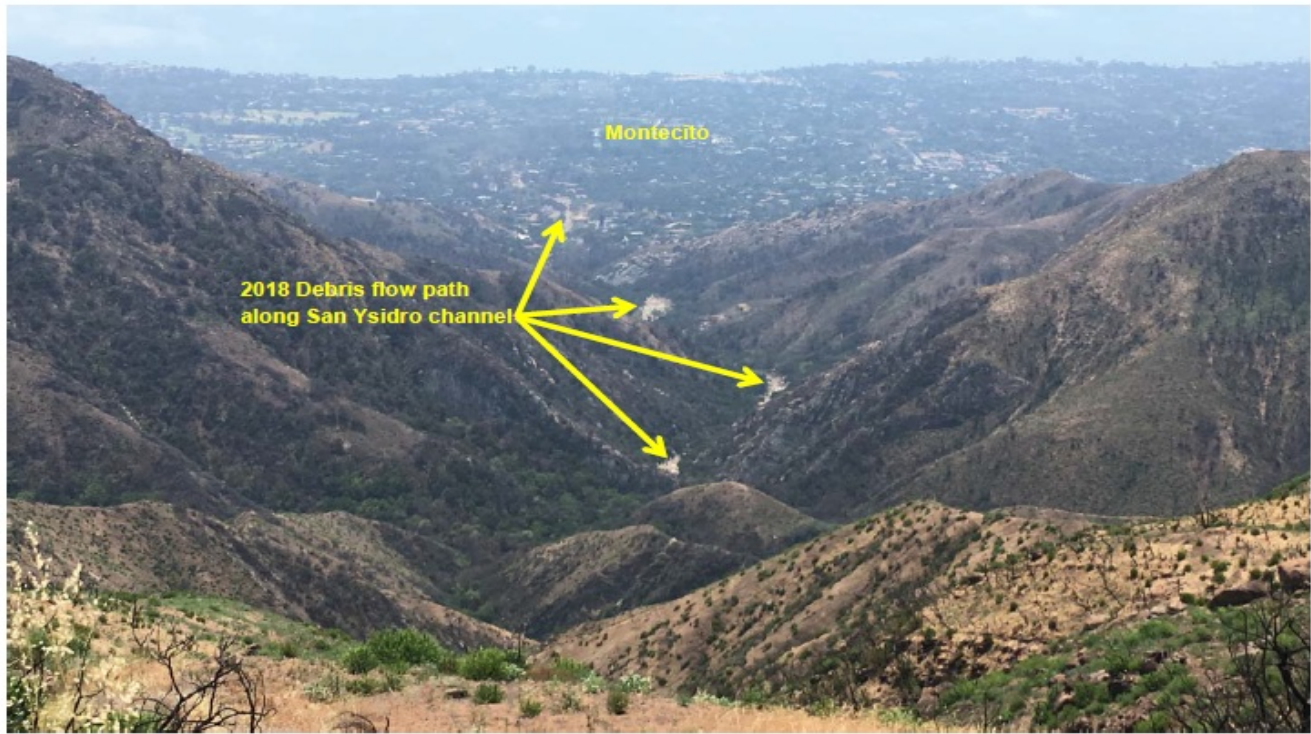
Figure 4. San Ysidro Creek watershed following the Thomas fire. BGC photo, July 2018, looking south from Camino Cielo Road.

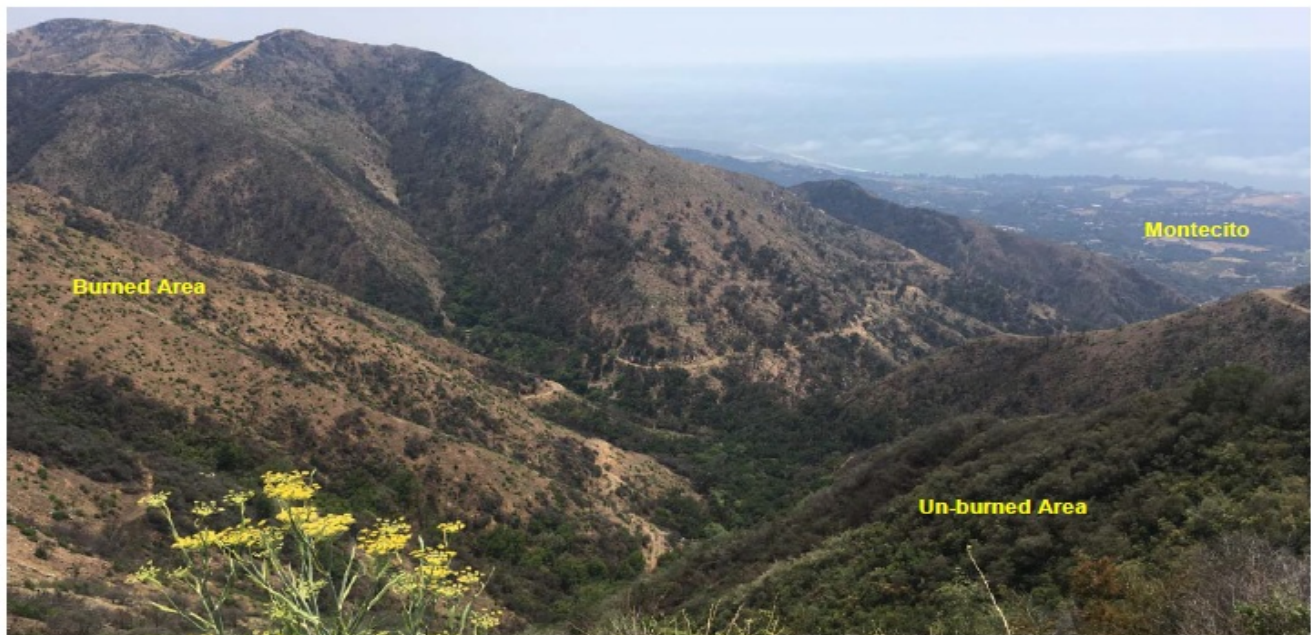
Figure 5. Romero Creek watershed showing a mixture of un-burned and burned areas from the Thomas fire. BGC photo, July 2018, looking south from Camino Cielo Road.

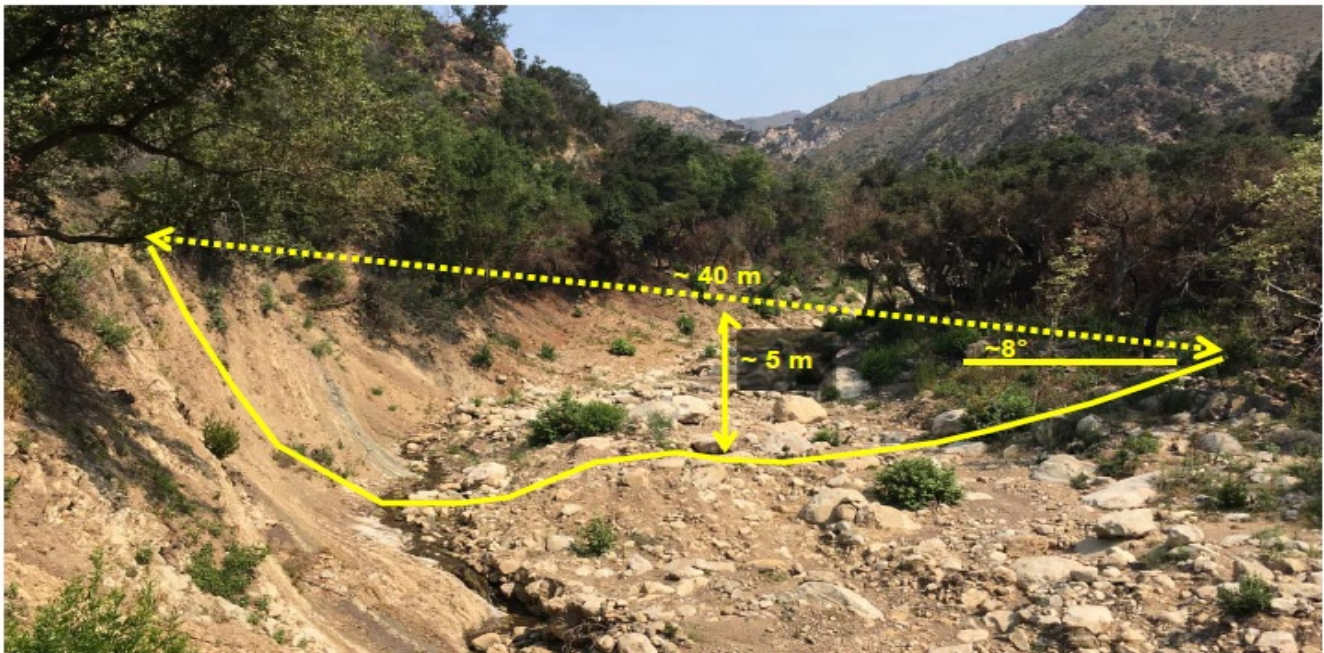
Figure 8. Superelevation of January 2018 flow indicated by mud lines in Cold Spring Canyon approximately 300 m upstream from the development interface. BGC photo, July 2018, looking north.

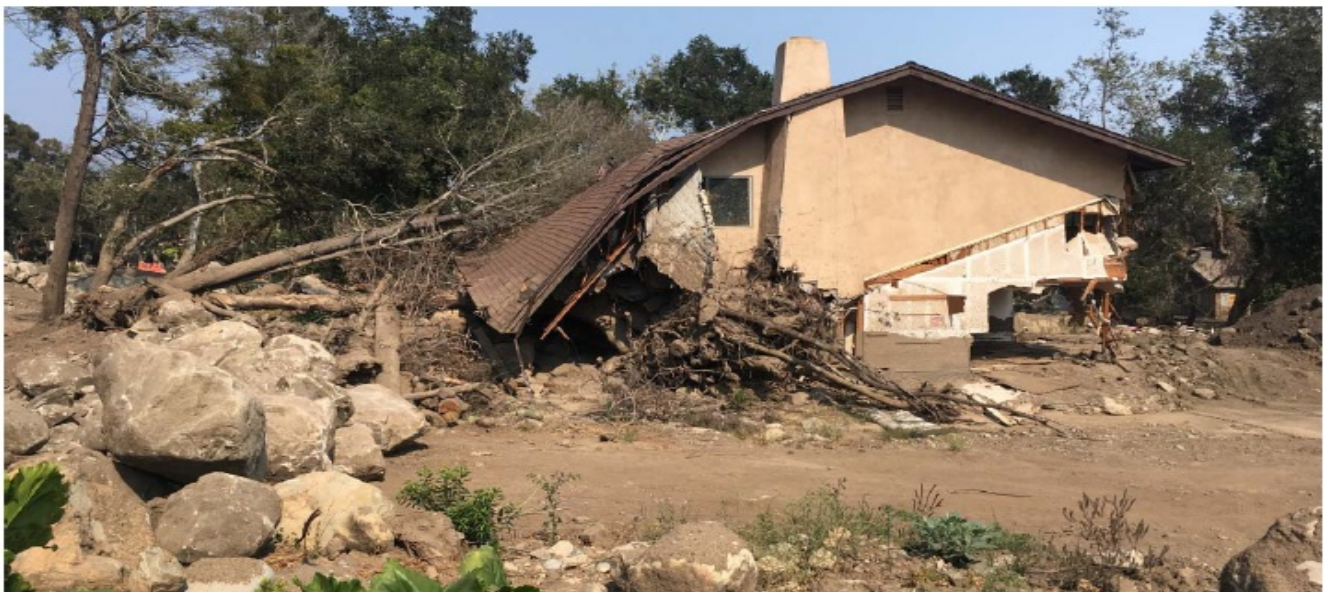
Figure 9. Destroyed home on San Ysidro Creek, located approximately 1 km from the fan apex. BGC photo, July 2018, looking east.

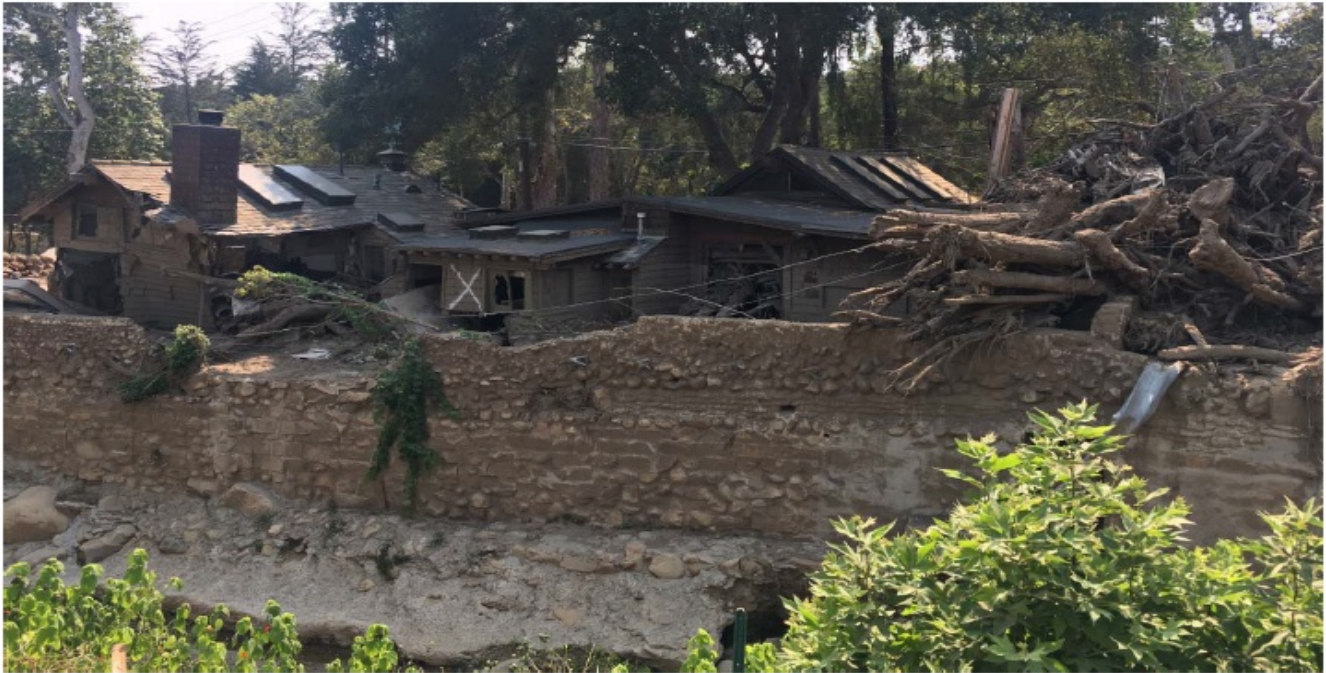
Figure 10. Woody debris immediately upstream of a destroyed home on Montecito Creek located approximately 2 km from the fan apex. BGC photo, July 2018, looking west.

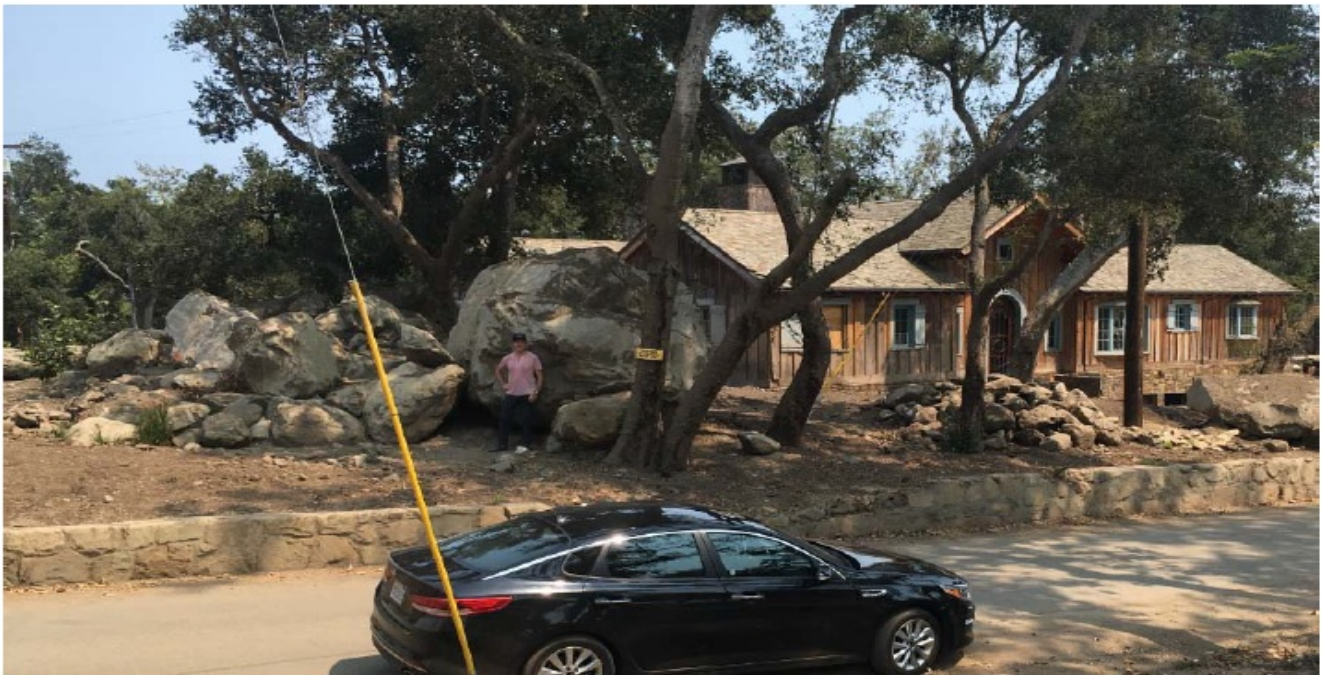
Figure 11. Boulders, up to 4 m diameter, transported by San Ysidro Creek debris flow more than 1 km from the fan apex. BGC photo, July 2018, looking east.
