COUNTY OF SANTA BARBARA

Draft
Mitigated Negative Declaration
20NGD-00000-00008

Montecito Debris Nets
Maintenance Project

19DVP-00000-00036
September 2020

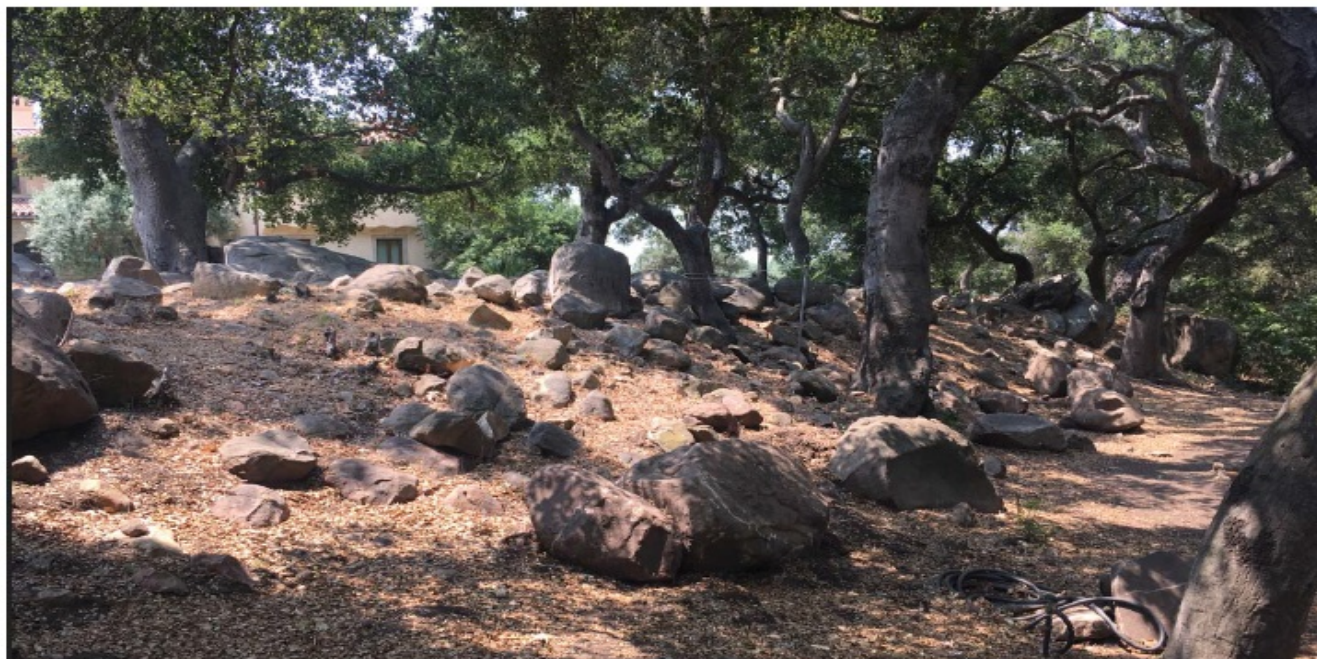
Figure 12. A landform interpreted to be a debris flow levee from an event that pre-dates construction of the home in the background, located 500 m from the Hot Spring Creek fan apex. Boulders up to 1 m diameter in foreground. BGC photo, July 2018, looking south.

7. Evidence of previous debris flows has been reported and observed, including an anecdote of a swimming pool that filled with mud near San Ysidro creek several times in the previous decades, and landforms on the upper fan area interpreted to be debris flow levees (Figure 12).

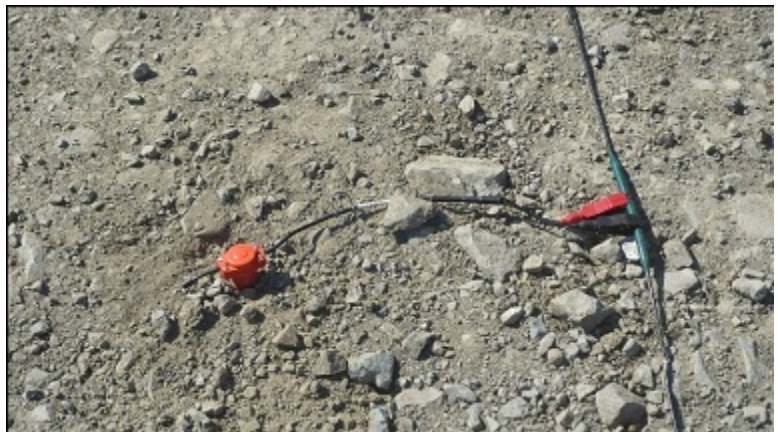
Figure C.1. Geophone installed in subsurface.

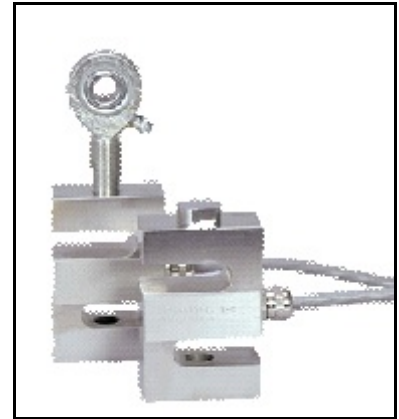
Figure C.2. Tension load cell.

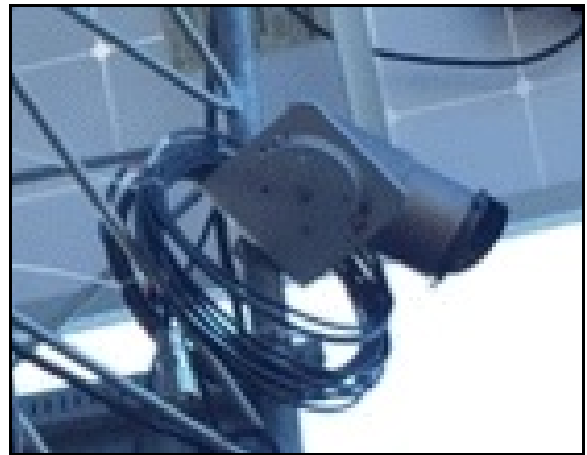
Figure C.3. Infrared video camera.

each net. When geophones and rain gauges exceed a threshold, the video cameras, Figure C.3, will be triggered to power on and record the debris flow as it impacts the nets.

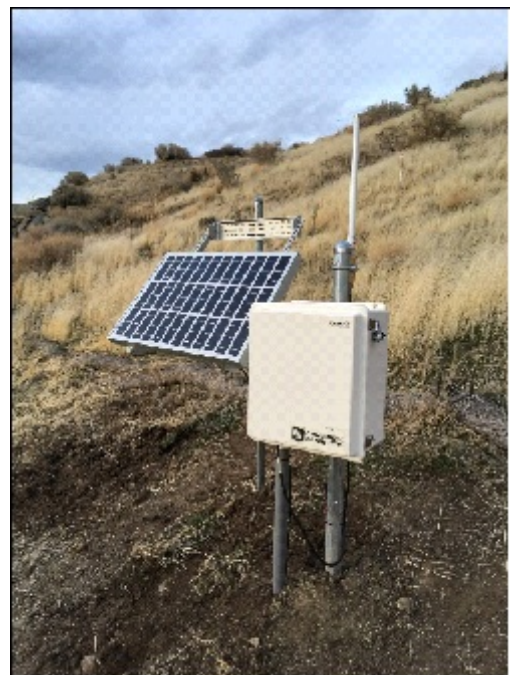
Figure C.4. Automated Data Acquisition System (ADAS) similar to the systems to be installed in Montecito.

The monitoring system is also capable of sending out text message and/or email alerts as debris flows progress. Alerts can be customized according to a user's preference. All data can be uploaded to a public web page from the automated data acquisition system (ADAS). In addition the video feed and data will be sent to a central emergency facility for real time monitoring of debris activity in the canyons. Figure C.4 shows a typical ADAS similar to the systems to be installed for the debris nets.

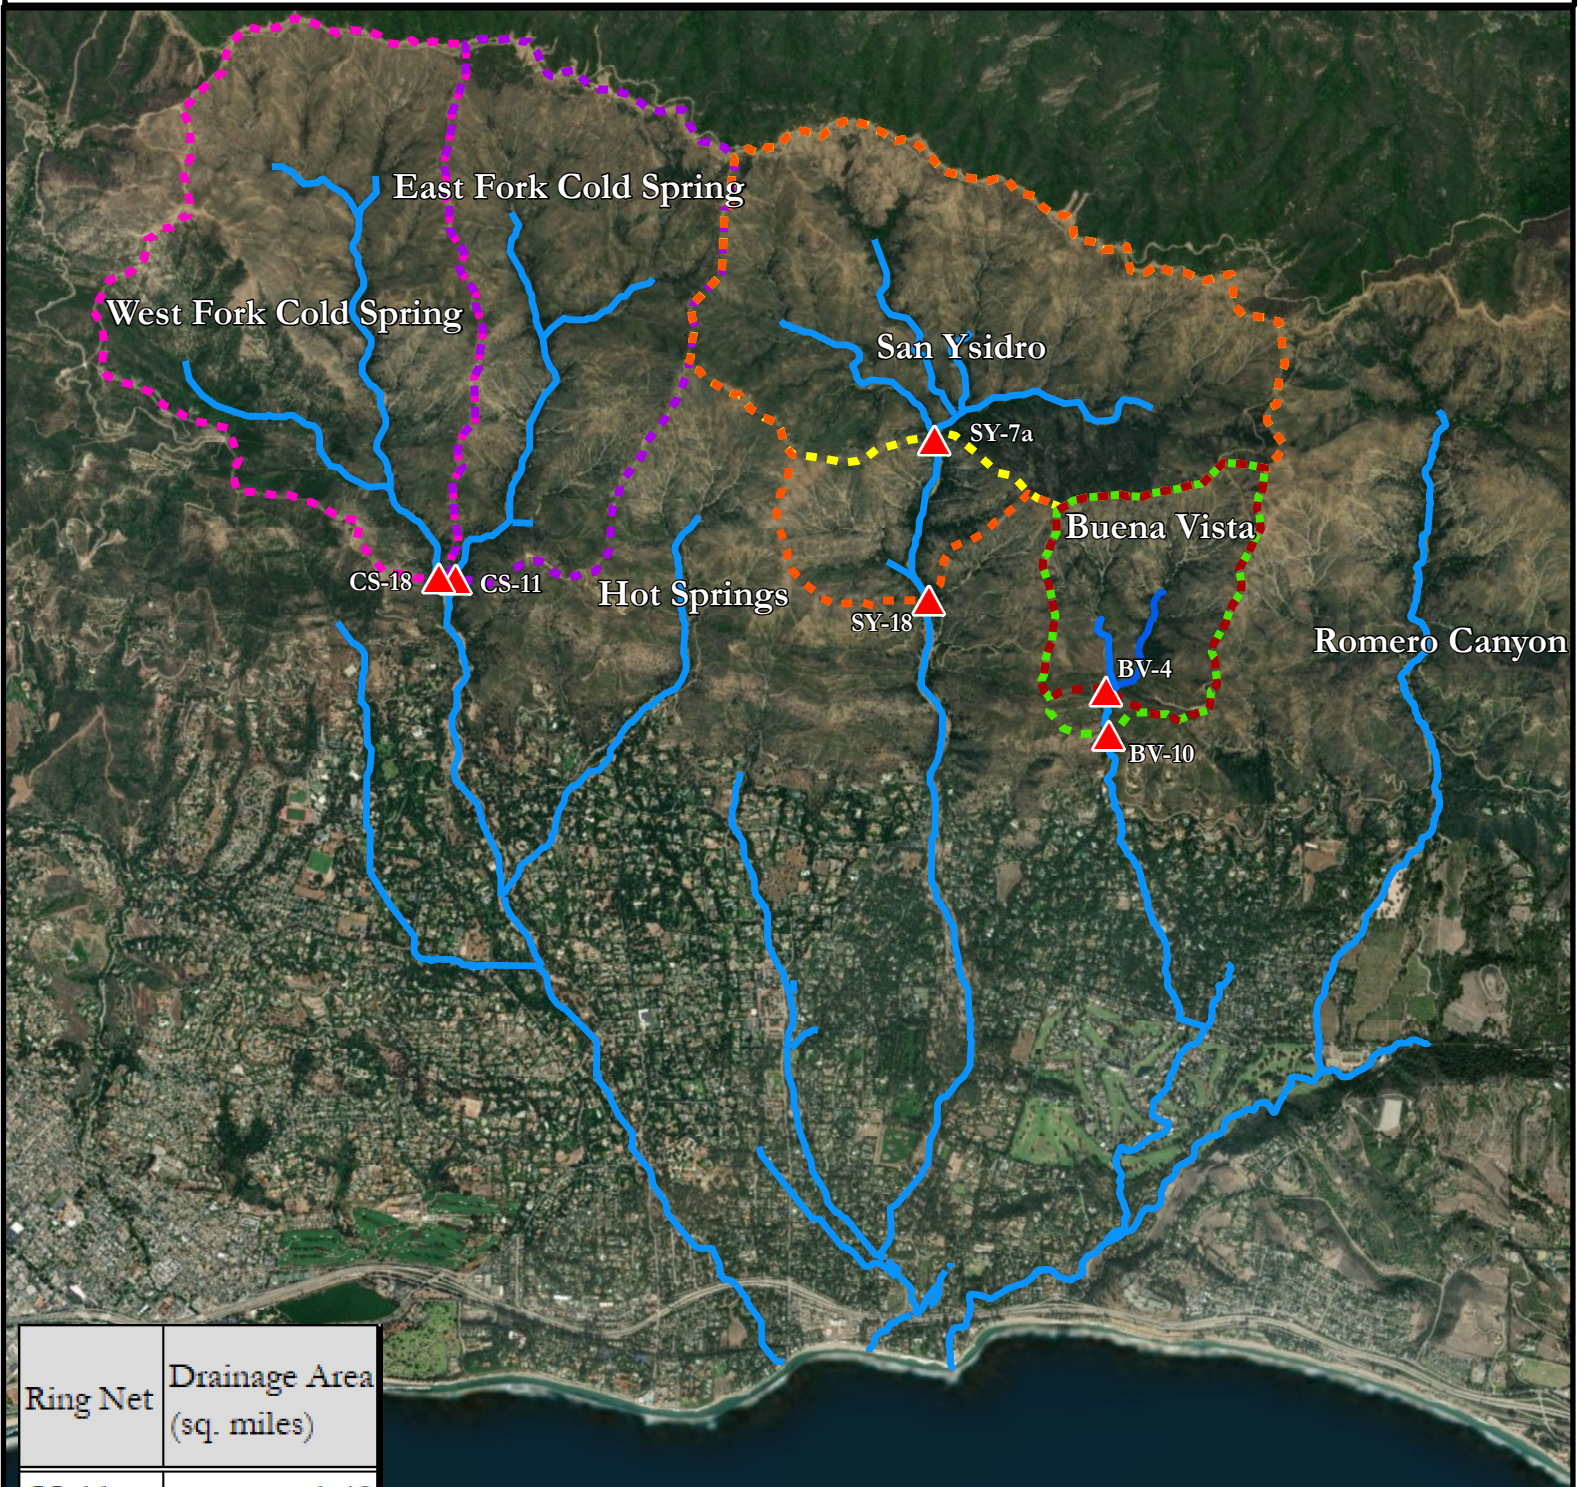
Net Locations and Drainages

Ring Net	Drainage Area (sq. miles)
CS-11	1.49
CS-18	1.94
SY-7a	2.02
SY-18	2.41
BV-10	0.58
BV-4	0.54

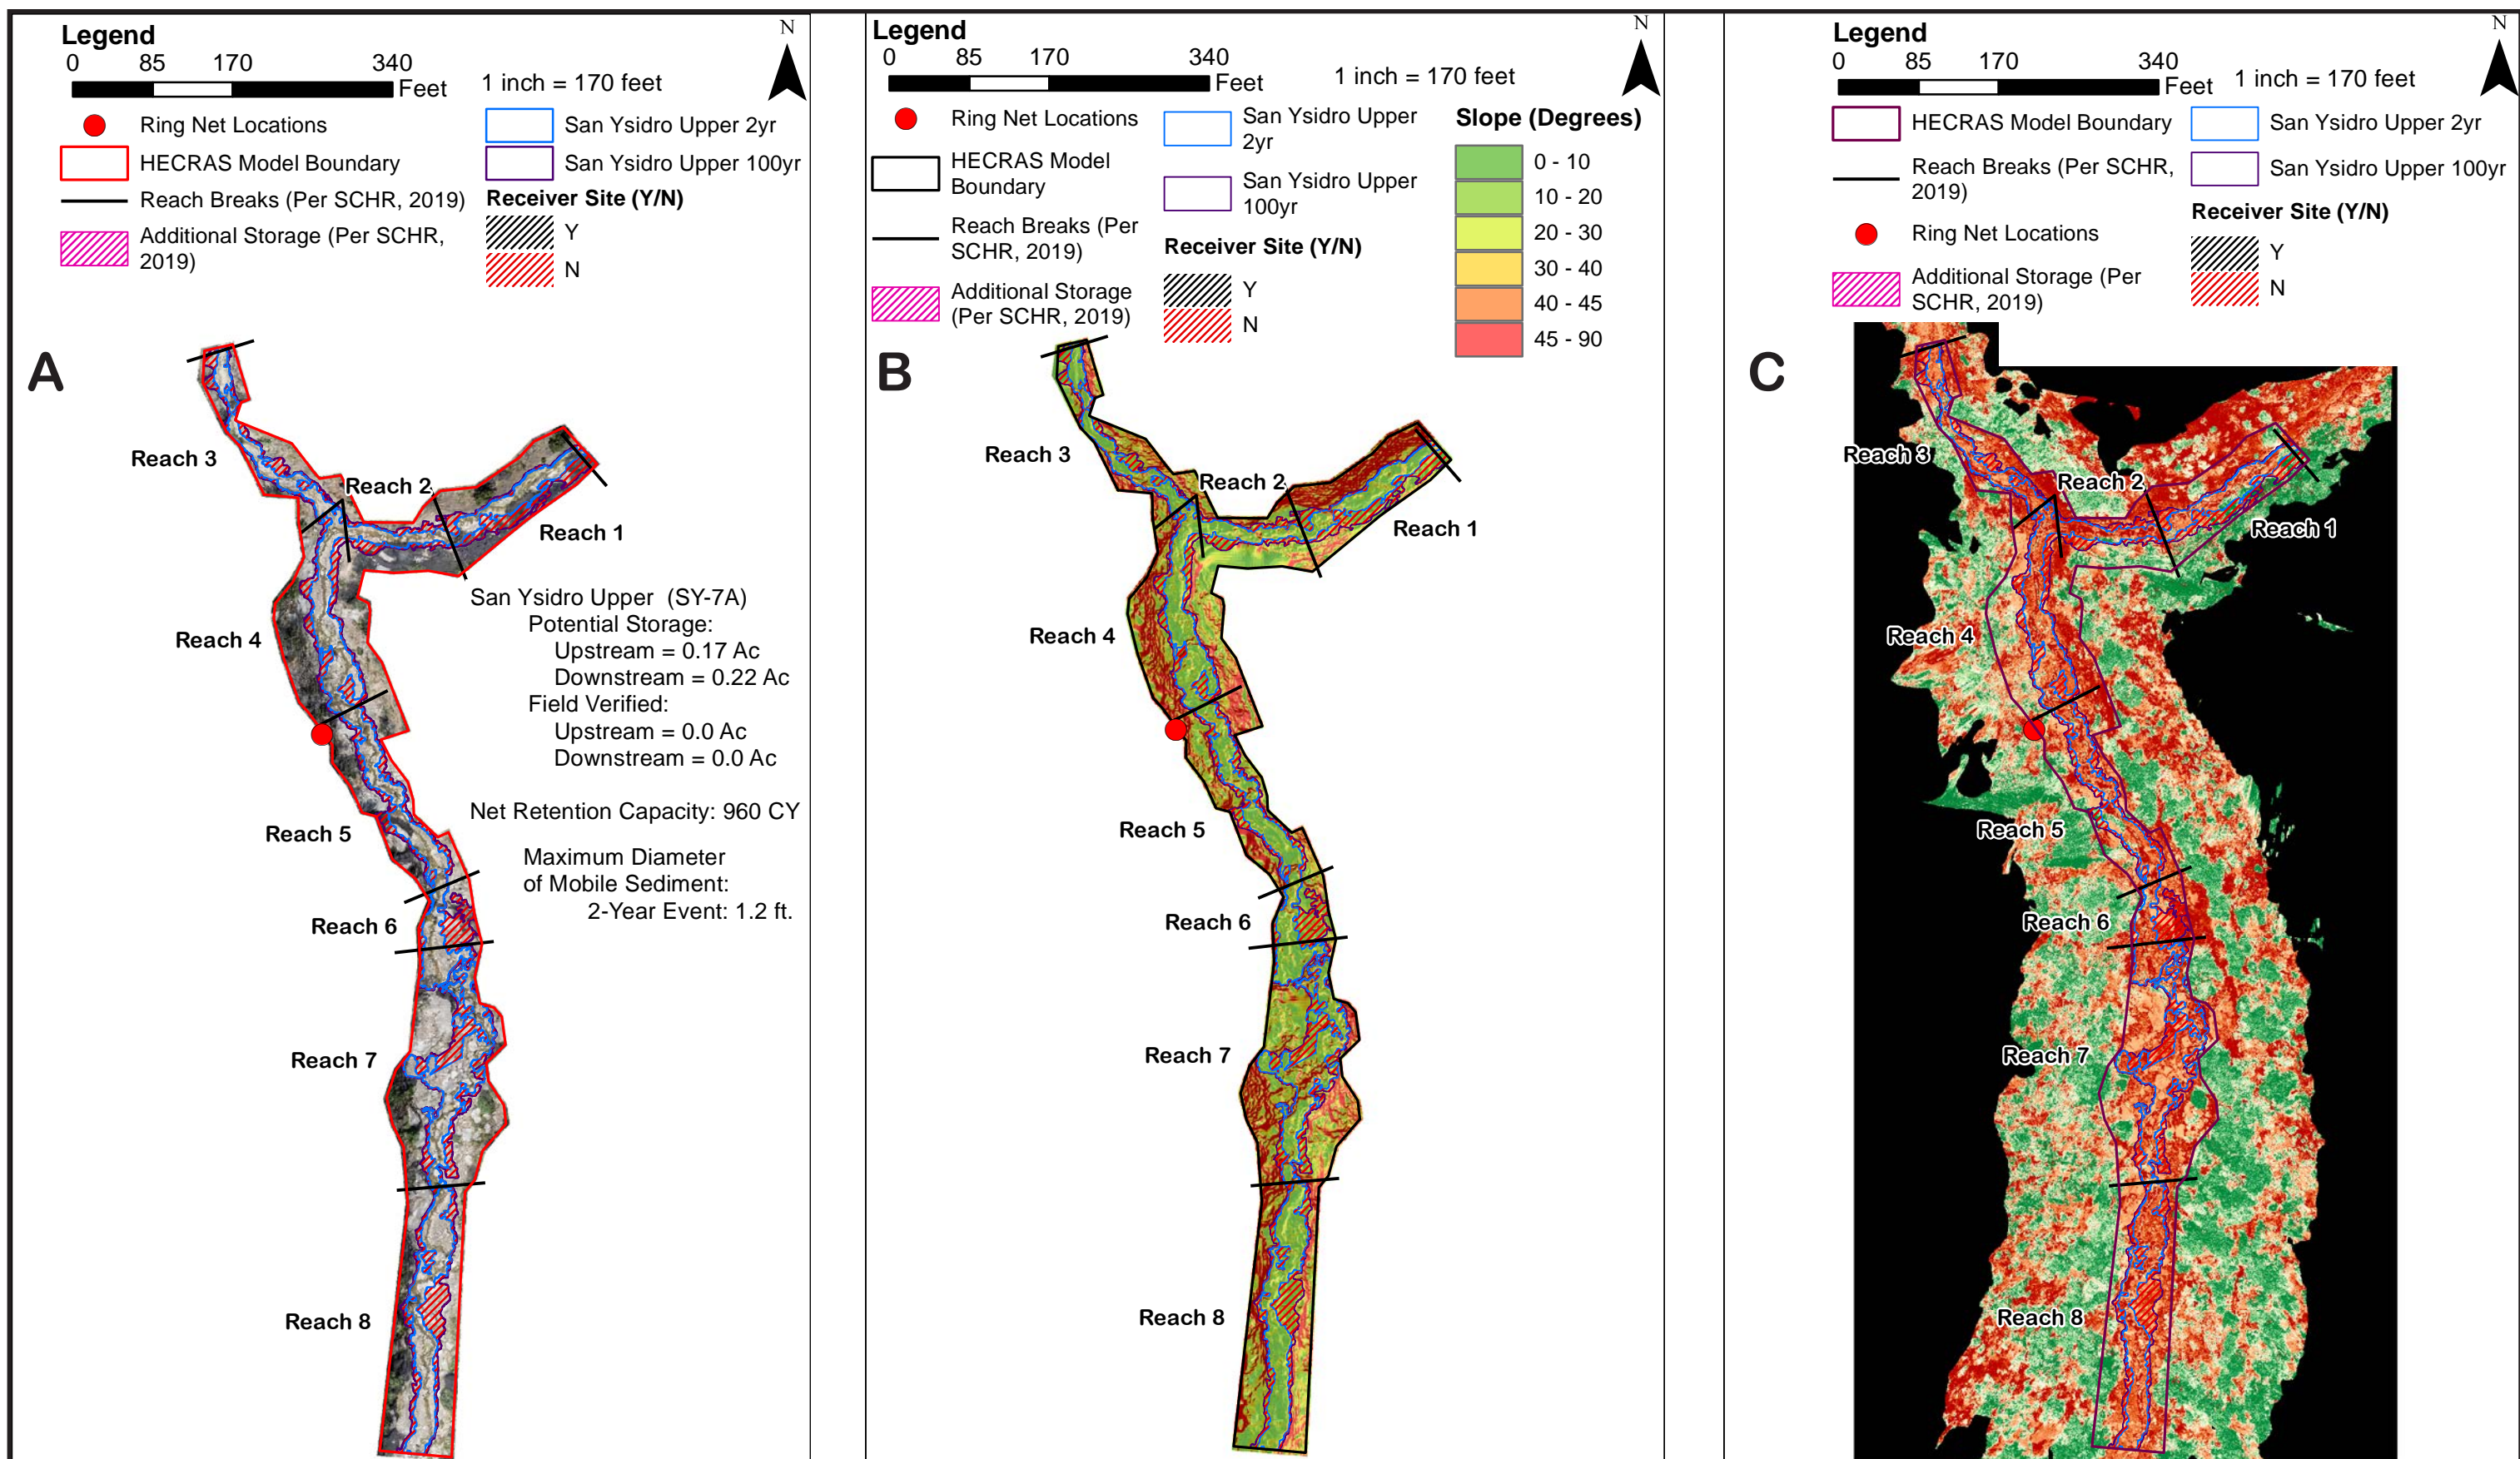
SY-7a (San Ysidro Upper)
 A: Aerial; B: Slope Raster; C: Normalized Difference Vegetation Index (NDVI)

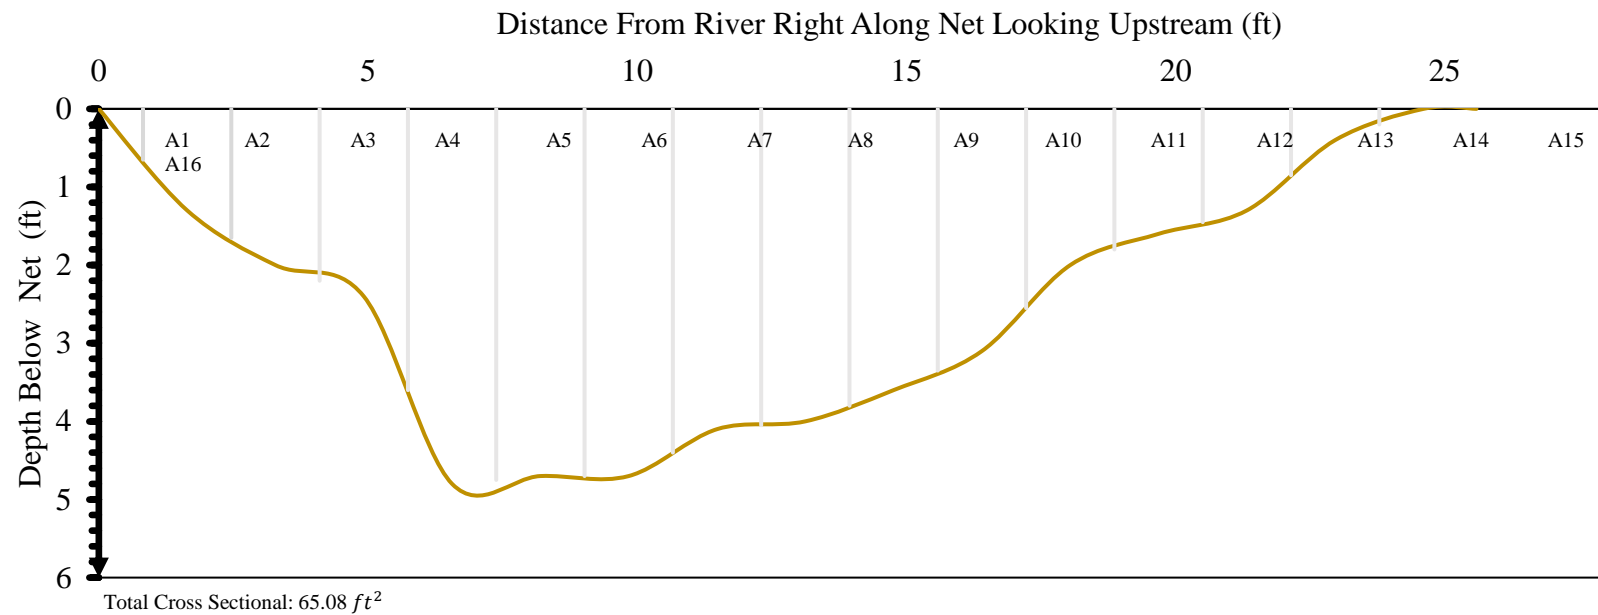
Figure 8 - Lower San Ysidro (SY-18); Cross Sectional Freeboard Profile

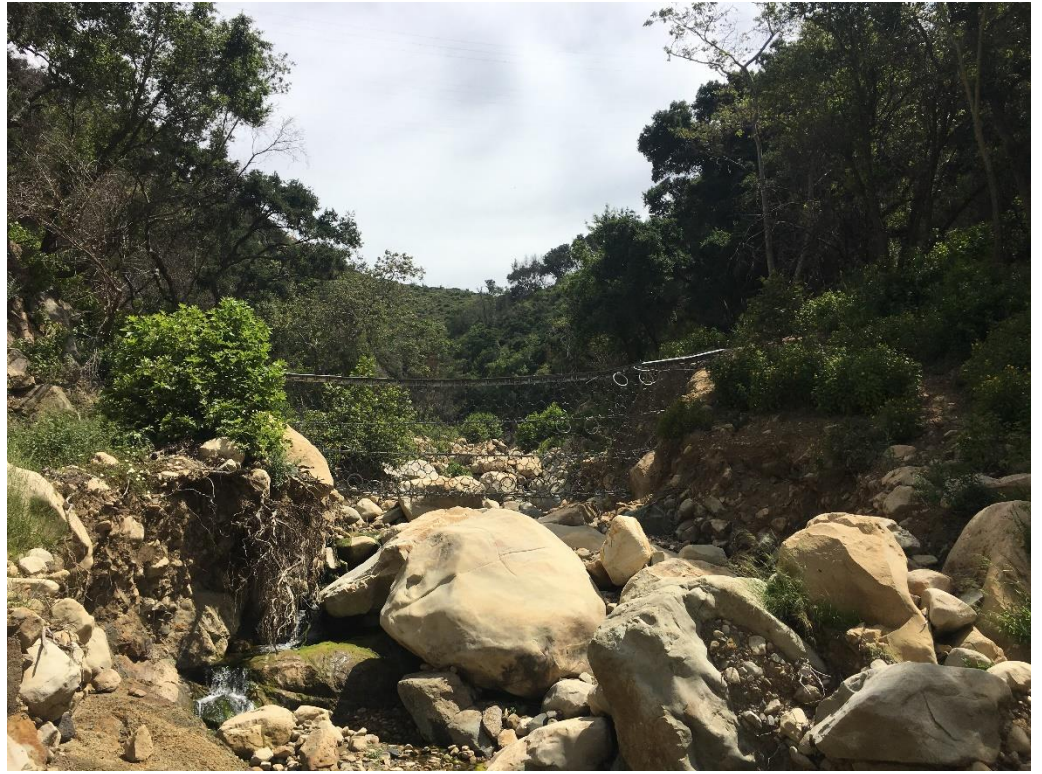
View looking upstream at
CS-11 net following
construction.

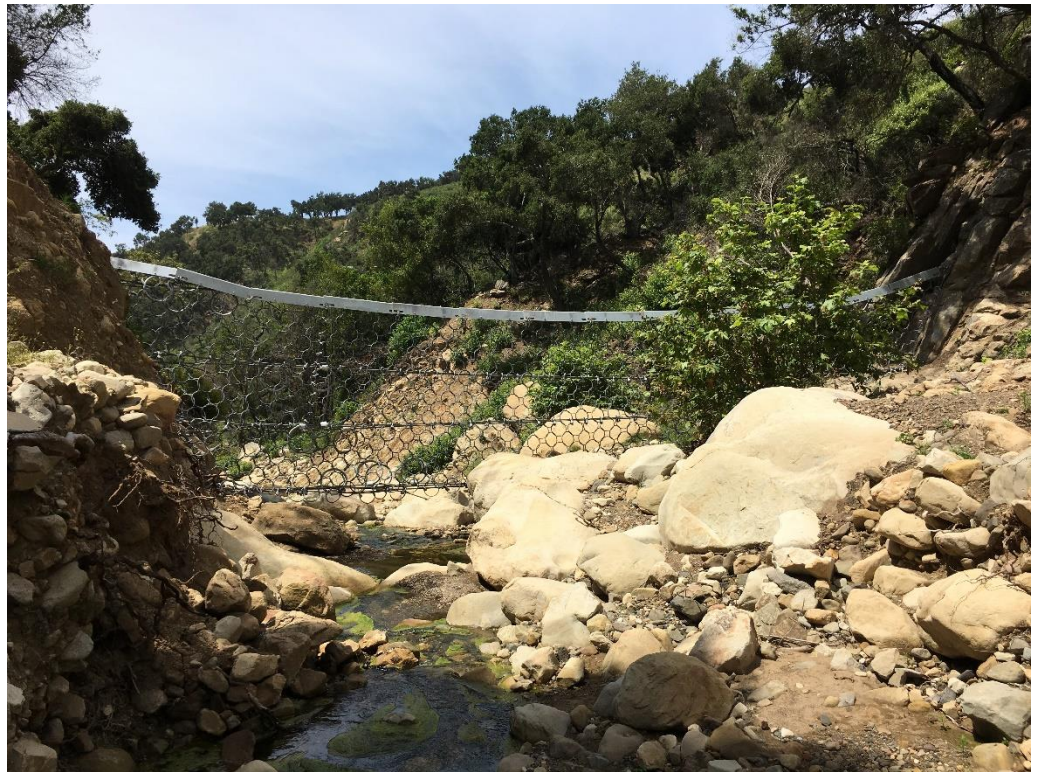
**Net
Location:**
CS-11

View looking downstream at
CS-11 net following
construction.

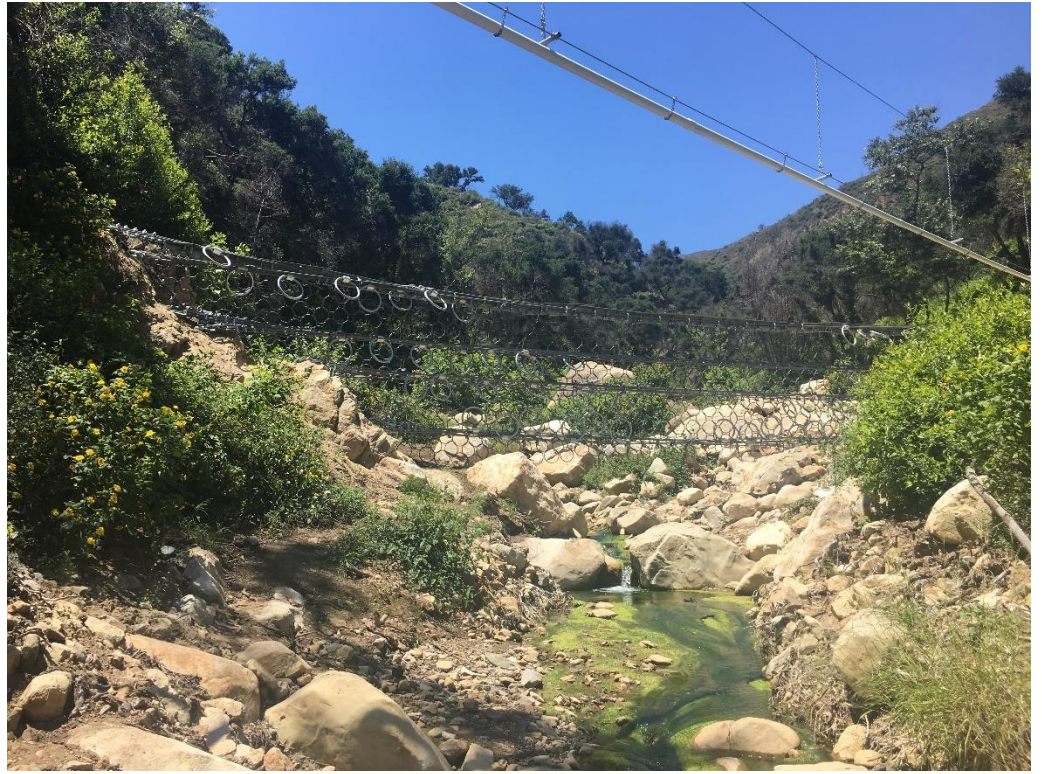
View looking upstream at CS-18 net following construction.

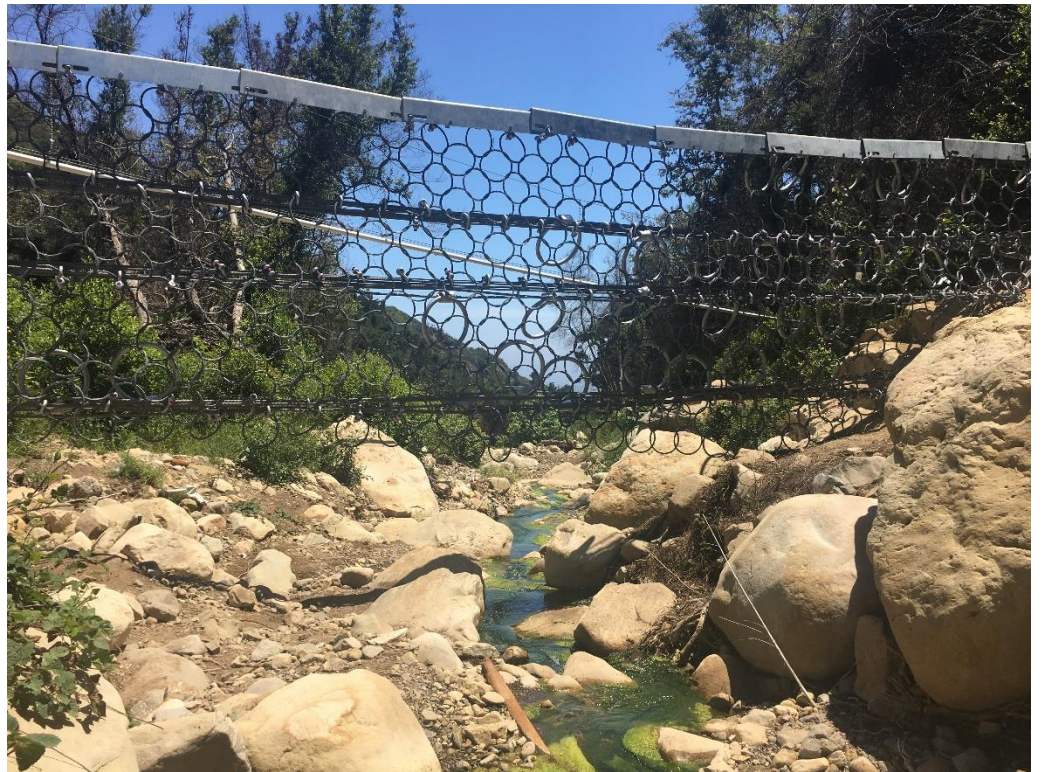
**Net
Location:**
CS-18

View looking downstream at CS-18 following construction.

Height of the net at CS-18 ranges from 36 to 57 inches above the creek channel.

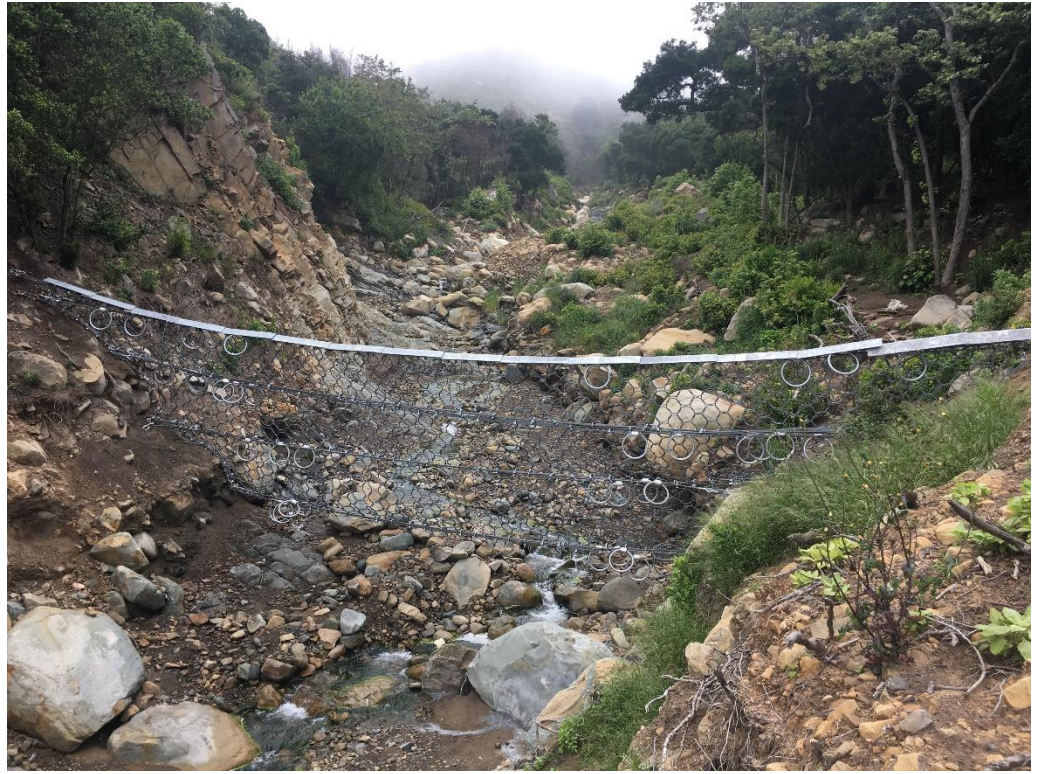
View looking upstream at SY-18 following net construction.

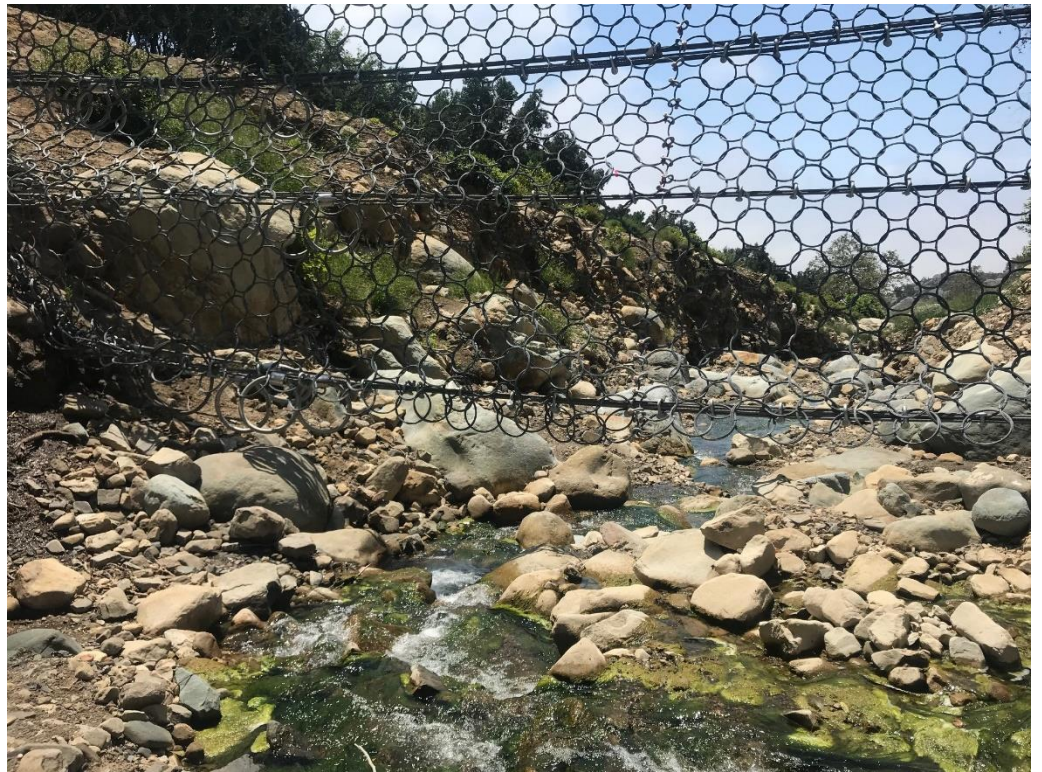
**Net
Location:**
SY-18

View looking downstream at freeboard under SY-18 after net construction.

Height of the net at SY-18 ranges from 20 to 50 inches above the creek channel.

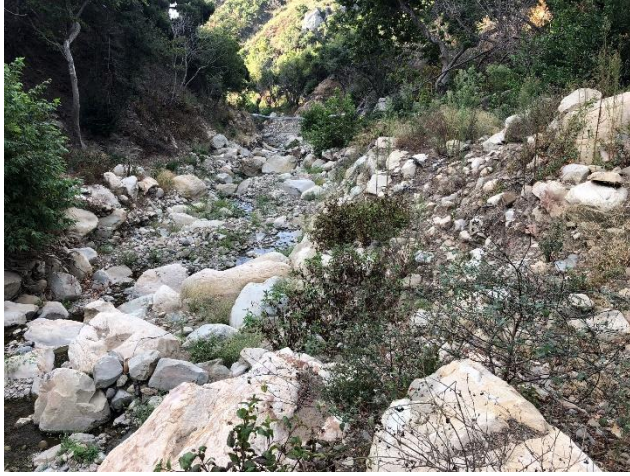
Cold Spring – Reach 2

Receiver Site Likelihood:	Plausible
Side-cast Site Likelihood:	Likely
Equipment Access Notes:	Equipment likely to be mobile within this reach is event of debris accumulation
Other Notes & Considerations:	Newly identified zone is the same reach 1 high flow channel, however, it is closer in elevation to main channel within this reach.
Photos

<p>Abandoned high flow channel comes closer to grade in this reach (Aspect: South, looking downstream)</p>

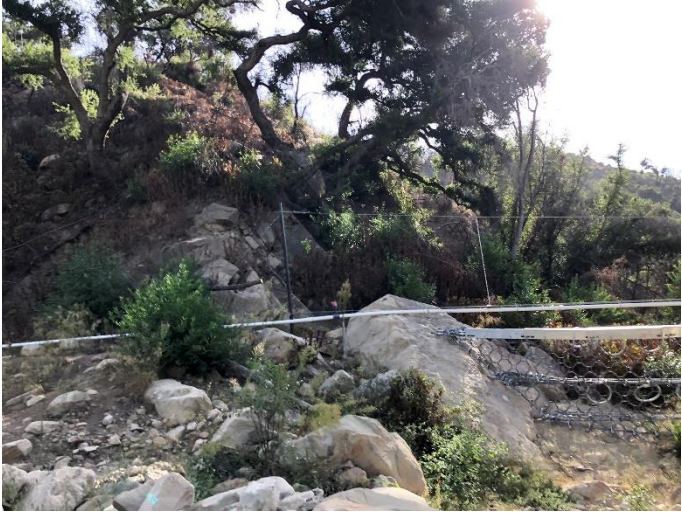
Cold Spring – Reach 5

Receiver Site Likelihood:	Unlikely
Side-cast Site Likelihood:	Likely
Equipment Access Notes:	Equipment likely to be mobile within this reach
Other Notes & Considerations:	A water pipe is adjacent to the stream on the left stream bank before crossing over and downstream the net to right canyon wall where it stay visible before going sub-surface. Considerations at this site should be made when placing material adjacent to the water line.
Photos

<p>(Aspect: East, looking at left bank)</p>

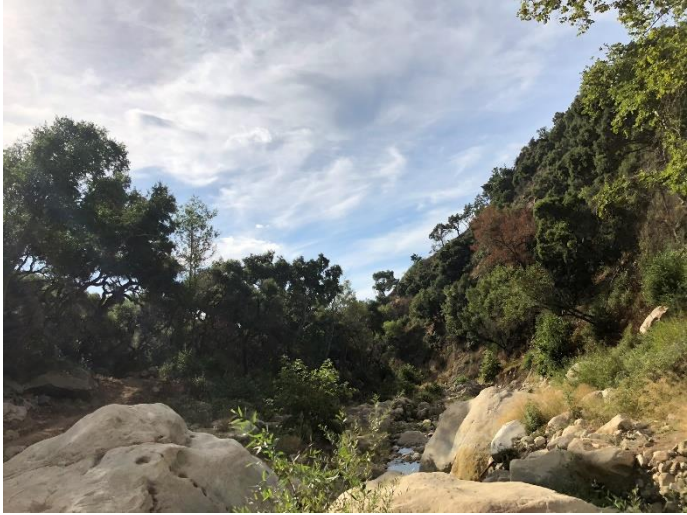
Cold Spring – Reach 8

Receiver Site Likelihood:	Plausible
Side-cast Site Likelihood:	Unlikely
Equipment Access Notes:	Equipment likely to be mobile within this reach, however, access from the nets will rely on mobility down a vertical drop near the confluence.
Other Notes & Considerations:	1 newly identified areas of storage potential within this reach. New area is a floodplain bench that is being protected from erosion by a 20ft+ diameter boulder. This is located just below the confluence and trail creek crossing.
Photos	<div data-bbox="599 707 1281 1218">

</div> <p>Newly identified areas is located on river right.</p>

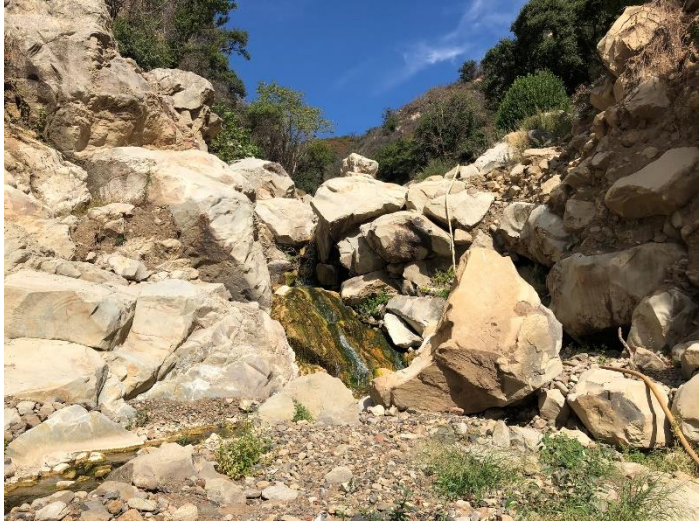
San Ysidro – Reach 6

Receiver Site Likelihood:	Unlikely
Side-cast Site Likelihood:	Unlikely
Equipment Access Notes:	Equipment unlikely to be mobile within this reach. Multiple big vertical drops (as many as 3 30ft+ drops).
Other Notes & Considerations:	Steep channel gradient, big drops, no equipment mobility
Photos	<div data-bbox="592 676 1286 1194">

</div> <p>One of many representative channel gradient impediments (Aspect: North, looking upstream)</p>

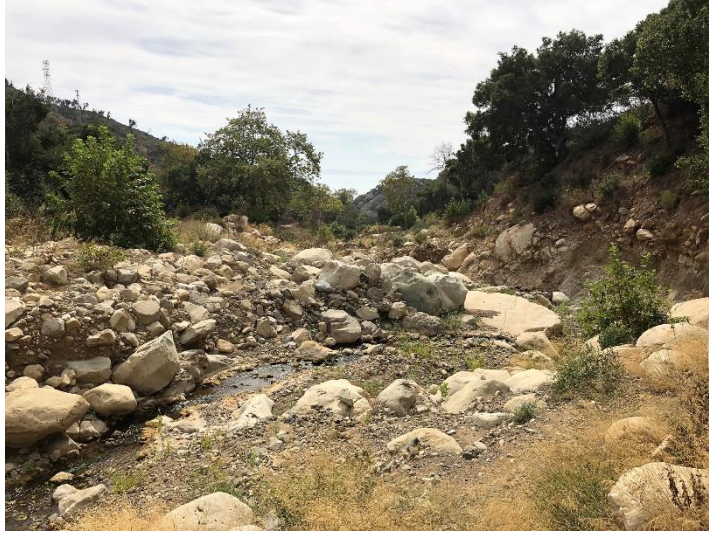
San Ysidro – Reach 12

Receiver Site Likelihood:	Plausible
Side-cast Site Likelihood:	Likely
Equipment Access Notes:	Equipment likely to be mobile within this reach
Other Notes & Considerations:	Bedrock channel with relatively flat grade
Photos

<p>Bedrock channel located just around the river bend (Aspect: South, looking downstream)</p>

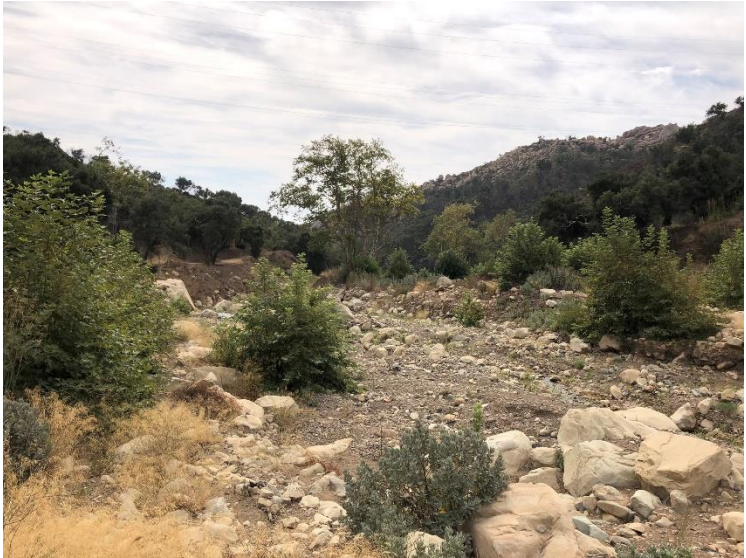
San Ysidro – Reach 14

Receiver Site Likelihood:	Likely
Side-cast Site Likelihood:	Unlikely
Equipment Access Notes:	Equipment likely to be mobile within this reach. Very close to net construction staging area.
Other Notes & Considerations:	One more additionally identified storage areas, creek fans out into wider portion of canyon; depositional zone, lots of area to work.
Photos

<p>(Aspect: South, from the Edison Catway staging area looking downstream)</p>

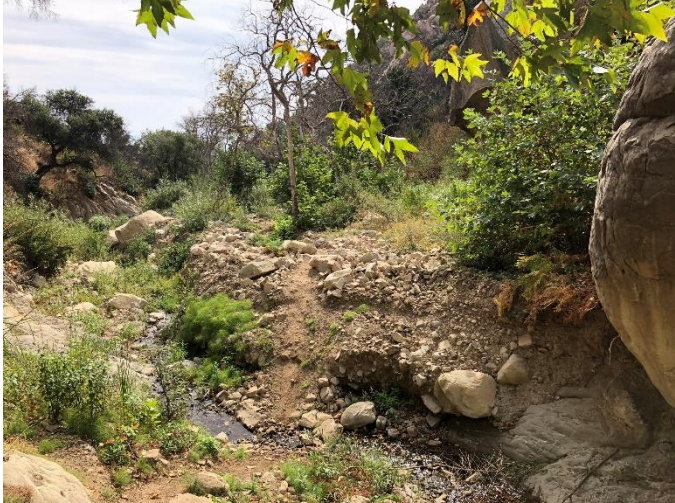
Buena Vista – Reach 5

Receiver Site Likelihood:	Plausible; need coordination with trails authority
Side-cast Site Likelihood:	Unlikely
Equipment Access Notes:	Equipment likely to be mobile within this reach with temporary access route installed from net along the current trail path to this zone.
Other Notes & Considerations:	From the net, Buena Vista Trail is located on River Left on terrace/potential abandoned roadcut until crossing the creek. The trail continues on a floodplain terrace on river right for several hundred more feet. This floodplain terrace is likely the best receiver site in close proximity to the BV-4. Also located on the terrace is large boulder (25-35ft high, with rock climbing bolts drilled into the rock and is potentially used for recreation purposes)
Photos

<p>Looking downstream at river right terrace with Buena Vista Trail bifurcating the terrace (Aspect: South). Rock climbing boulder in right foreground.</p>

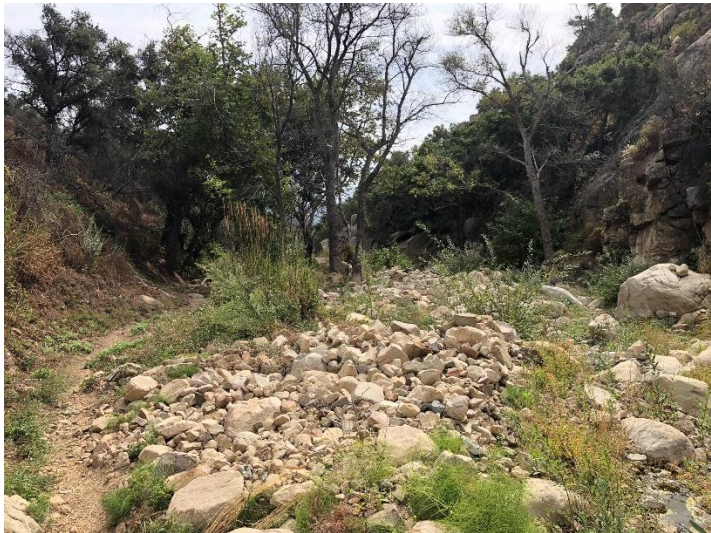
Buena Vista – Reach 6

Receiver Site Likelihood:	Plausible; need coordination with trails authority
Side-cast Site Likelihood:	Unlikely
Equipment Access Notes:	Equipment likely to be mobile within this reach using same trail path described above
Other Notes & Considerations:	Trail crosses creek again to the river left and continues along toe of canyon wall before migrating back on depositional river bar in middle of the canyon
Photos

<p>Aspect: South, looking downstream, trail on river left</p>

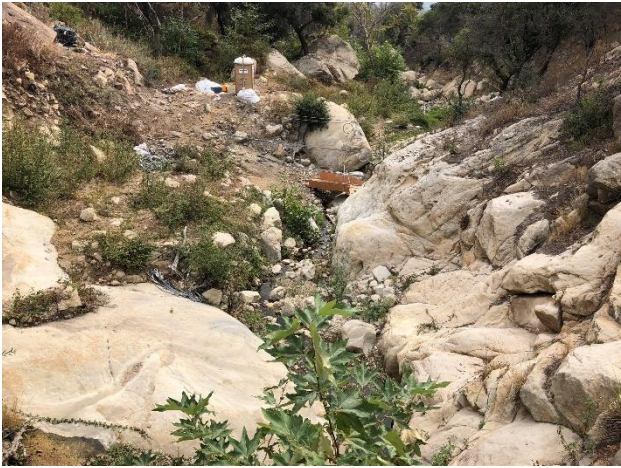
Buena Vista – Reach 8

Receiver Site Likelihood:	Unlikely
Side-cast Site Likelihood:	Likely, construction staging area likely a good location
Equipment Access Notes:	Equipment unlikely to be mobile beyond this reach
Other Notes & Considerations:	A bedrock chute partitions reach 7 from reach 8. It will likely remain impassable to equipment unless a very large debris accumulation event occur which provided access via the accumulated debris wedge
Photos

<p>Construction of BV-10 in progress (Aspect: South, looking downstream)</p>

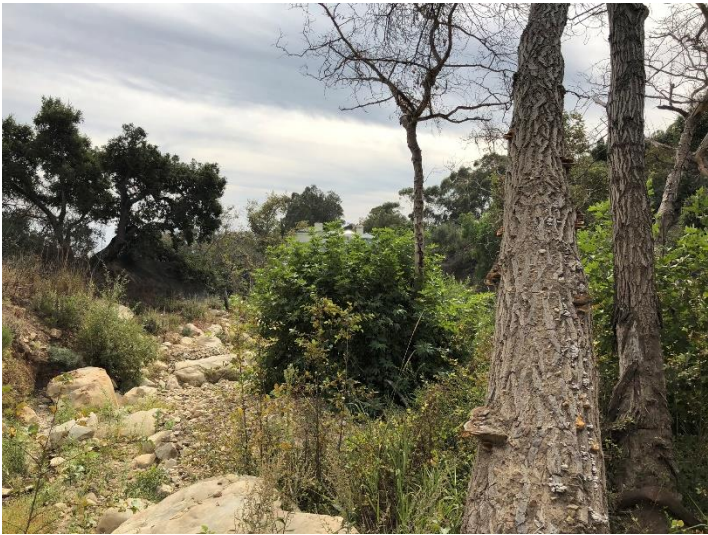
Buena Vista – Reach 11

Receiver Site Likelihood:	Plausible; relatively further downstream
Side-cast Site Likelihood:	Unlikely
Equipment Access Notes:	Equipment likely to be mobile within this reach
Other Notes & Considerations:	Decent vegetation cover; very flat floodplain terrace
Photos

<p>(Aspect: South, looking downstream)</p>
