COUNTY OF SANTA BARBARA

Draft
Mitigated Negative Declaration
20NGD-00000-00008

Montecito Debris Nets
Maintenance Project

19DVP-00000-00036
September 2020

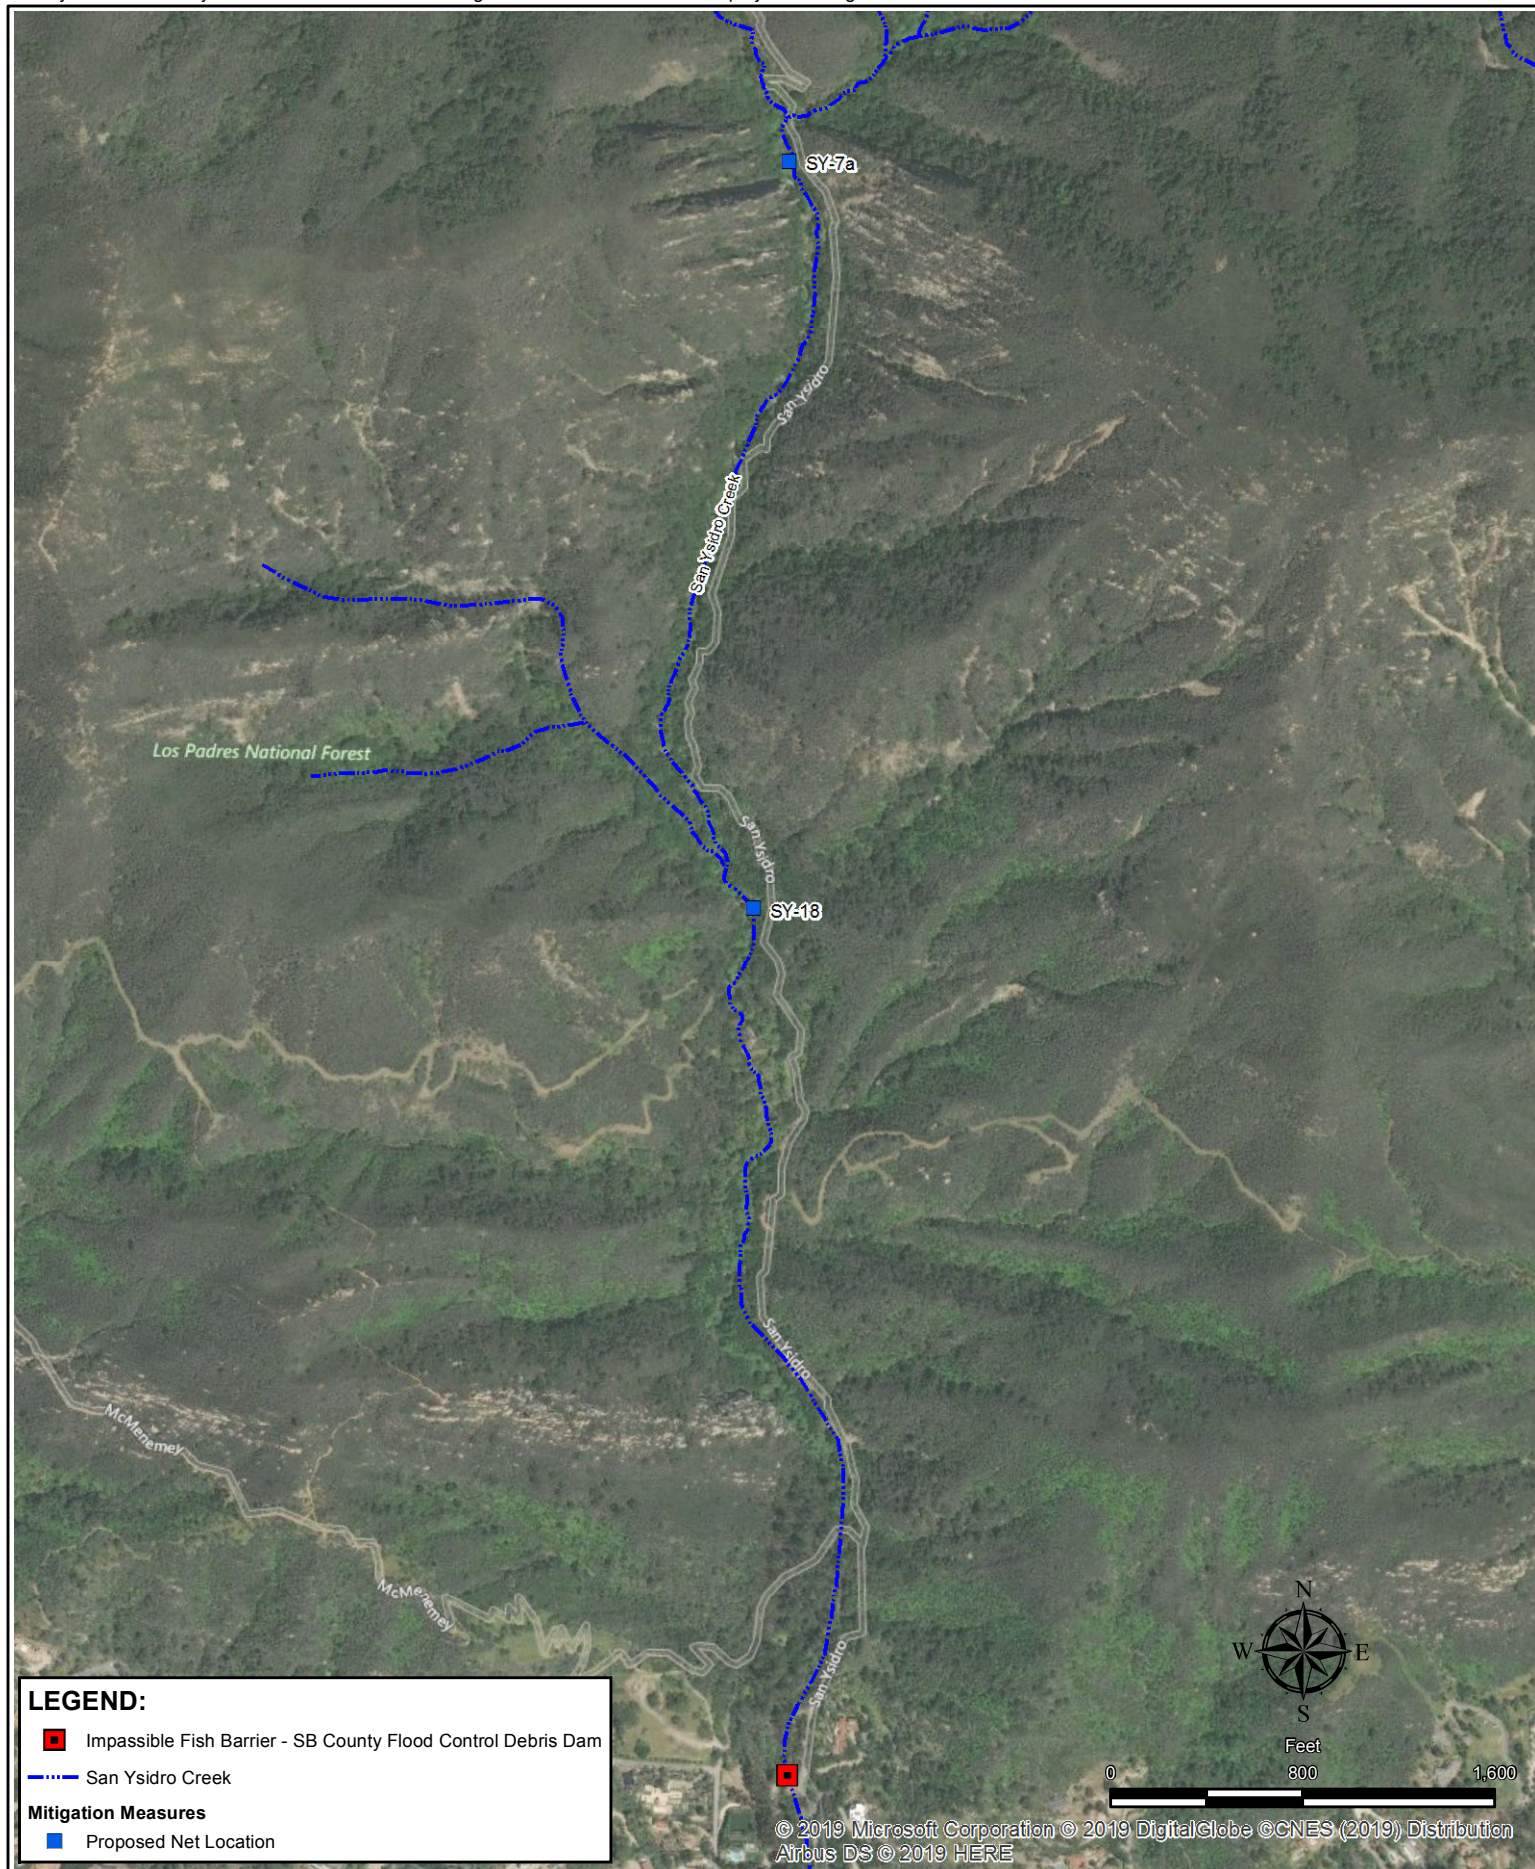
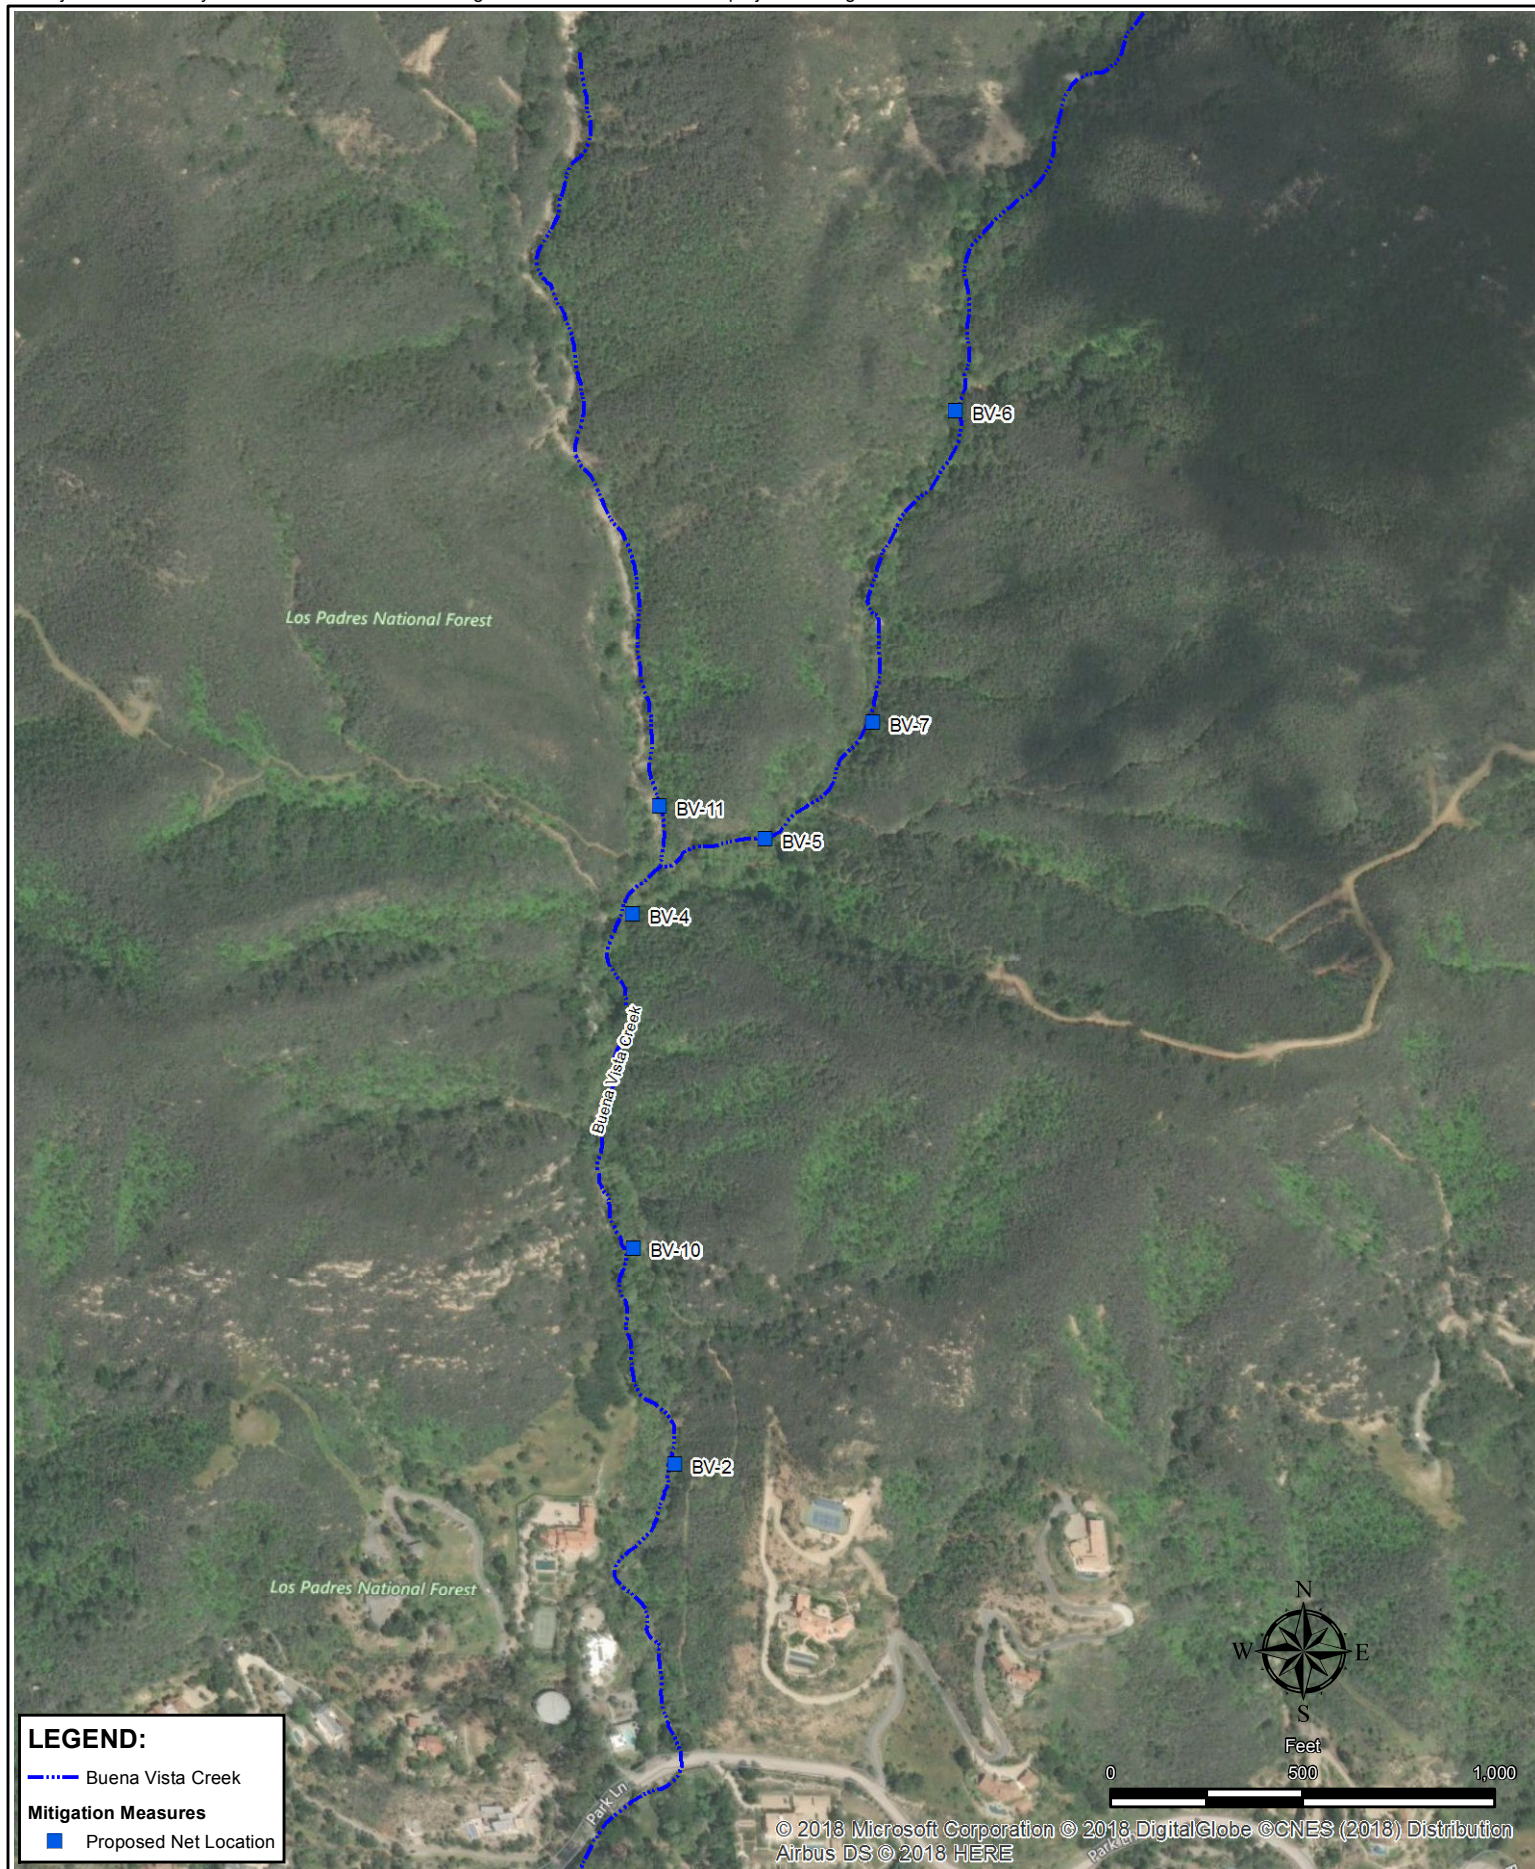
GEOBRUGG SVX180-H6 DEBRIS FLOW MITIGATION SYSTEM DIMENSIONAL SCHEDULE - 1								
LOCATION DESIGNATION	SYSTEM HEIGHT [H] (FT)	BOTTOM LENGTH [A] (FT)	LOWER MID LENGTH [B] (FT)	UPPER MID LENGTH [C] (FT)	TOP LENGTH [D] (FT)	SAG DISTANCE [S] (FT)	LEFT SIDE AVG. SLOPE INCLINATION [α] (DEG.)	RIGHT SIDE AVG. SLOPE INCLINATION [β] (DEG.)
BUENA VISTA BV-1	10	70	76	83	90	1.5	45	50
BUENA VISTA BV-4	17	45	54	69	77	1.5	55	66
BUENA VISTA BV-11	20	98	116	134	150	3	30	30
HOT SPRINGS HS-6	17	48	67	81	94	2	65	55
COLD SPRING CS-18	12	47	60	70	81	1.5	45	30
SAN YSIDRO SY-7	20	41	58	65	75	1.5	75	55
SAN YSIDRO SY-18	16	13	47	57	67	1.5	60	60
ROMERO RC-12	12	40	45	52	61	1	55	60

There are two basic versions of the Geobruigg debris net that are being proposed in the Subject Creeks. The VX net, which is intended for relatively narrow channels (up to 40 feet wide), and the Super VX, which is intended for wide channels where foundations cannot be installed. The Super VX (SVX) net is essentially a VX net with additional and stronger top net support ropes (KANE 2018a). Table 1 below provides a description net type, site dimensions, and location of each proposed net. Typical net cross-sectional views are depicted on Figures 3a – 3c.

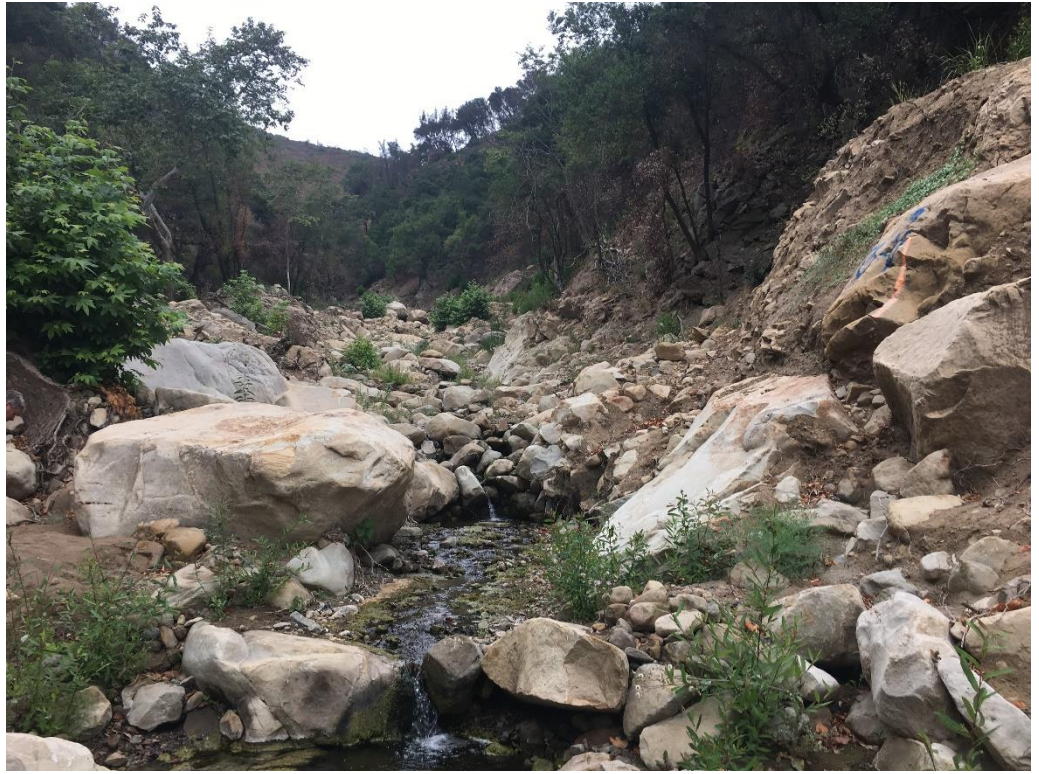
View looking upstream at the CS-11 net location.

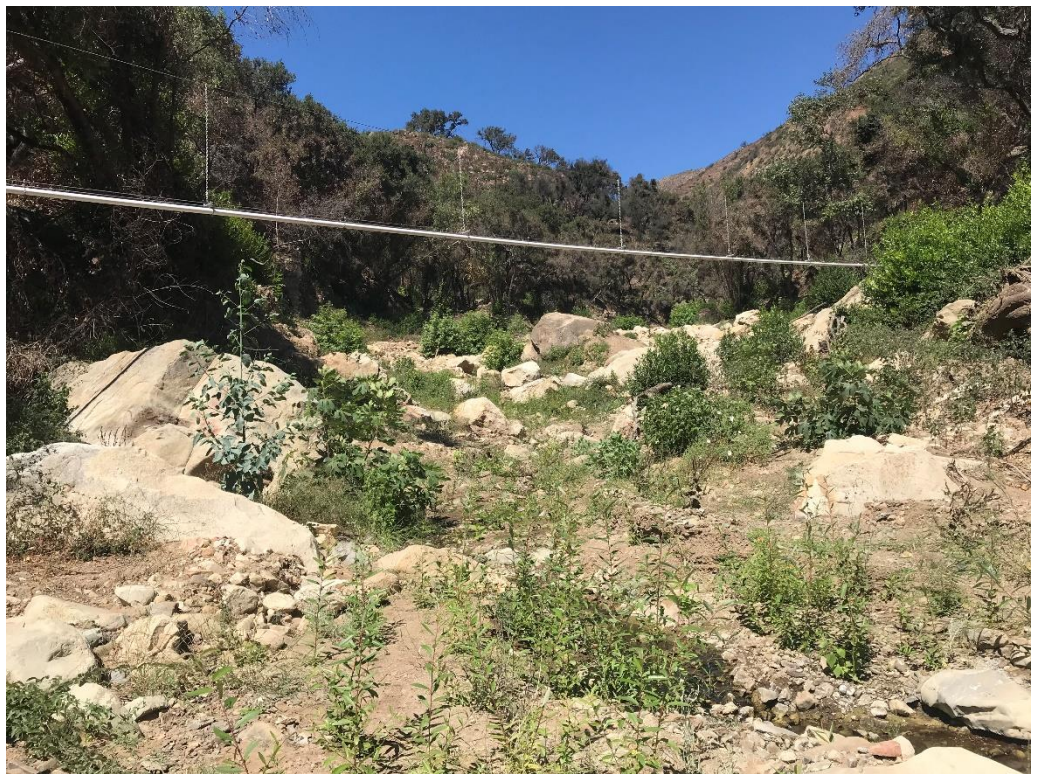
**Net
Location:**
CS-18

Net location is downstream of existing PVC waterline.

Four common fig (*Ficus carica*) saplings and tree tobacco (*Nicotiana glauca*) are becoming established in the channel.

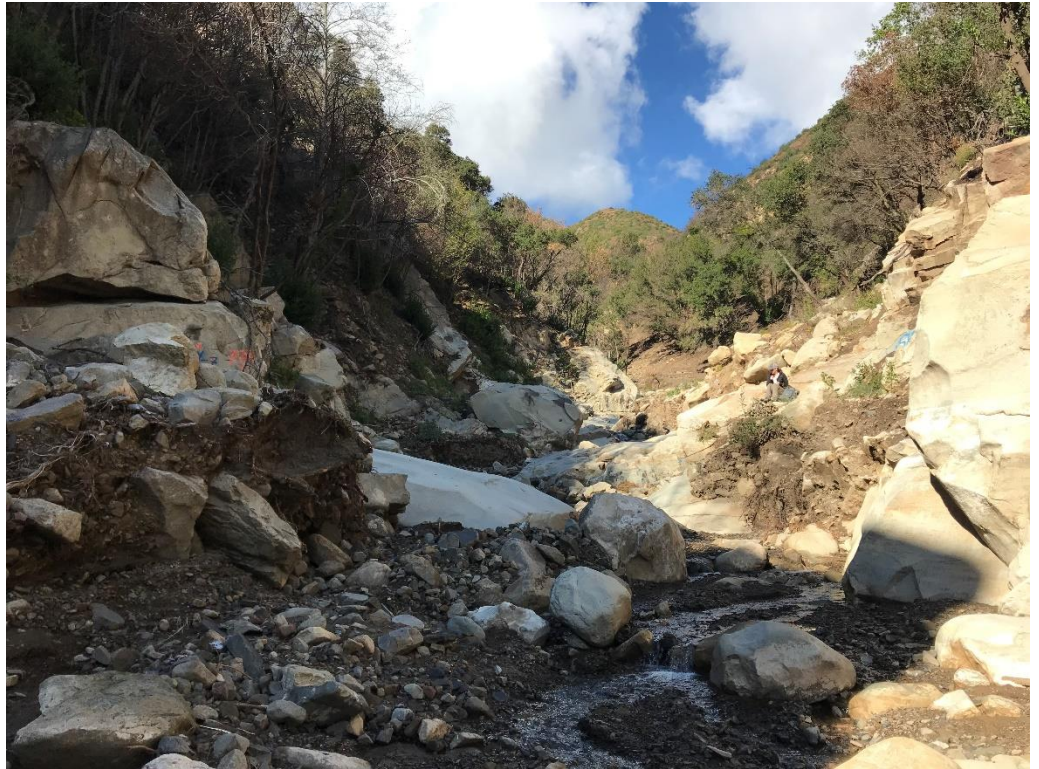
View looking upstream at the SY-7a net location.

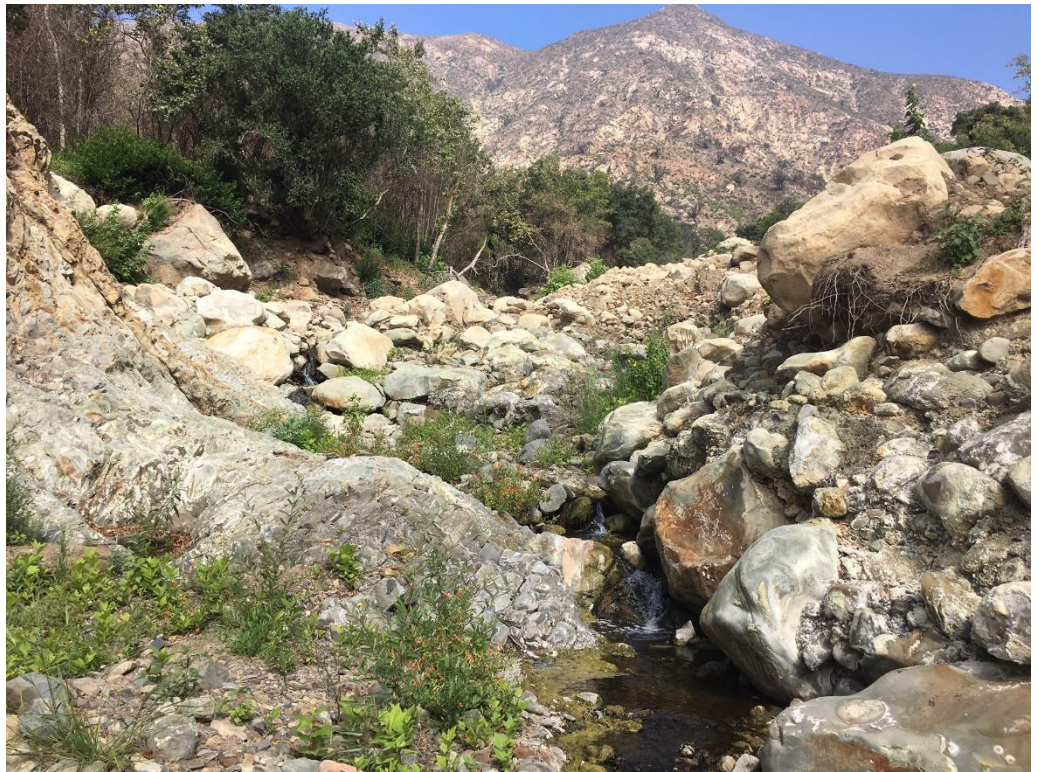
**Net
Location:**
SY-18

View looking upstream at the SY-18 net location.

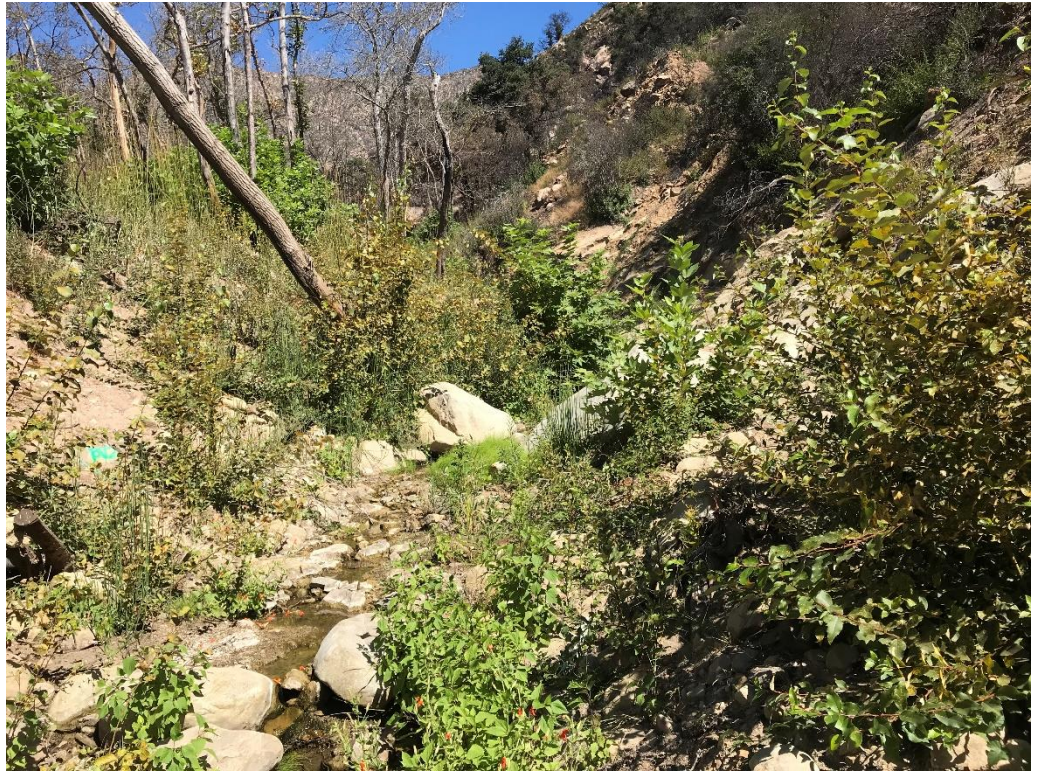
View looking upstream at the
BV-2 net location.

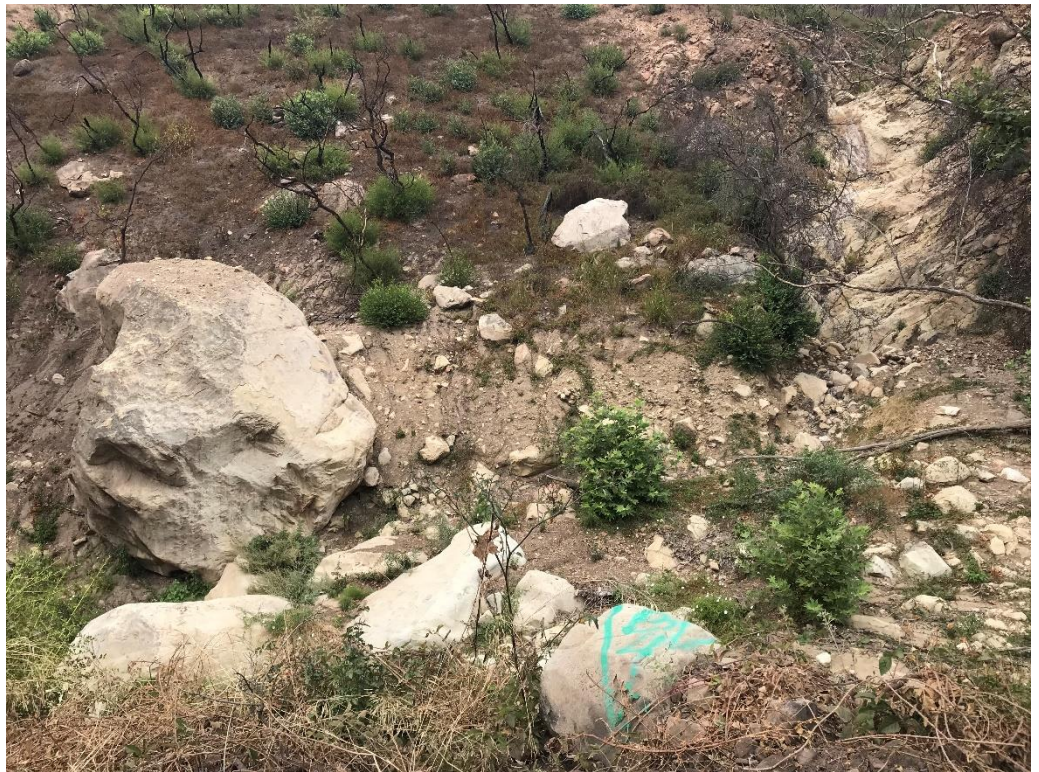
**Net
Location:**
BV-4

View looking down at the
BV-4 net location.

The two western sycamore
(*Platanus racemosa*) saplings
in the channel will be
trimmed for net installation.

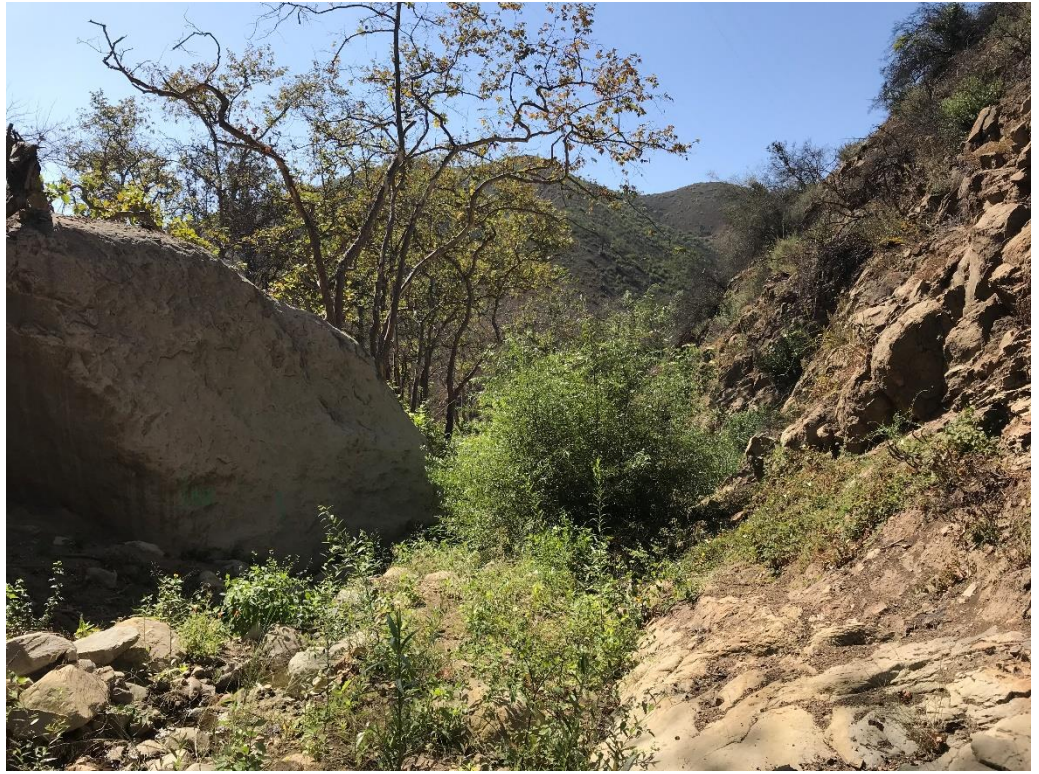
View looking downstream at the BV-5 net location.

The arroyo willow (*Salix lasiolepis*) in the middle of the channel will be trimmed for net installation.

Cape ivy was observed at three of the proposed net locations in Buena Vista Creek (BV-5, BV-6, and BV-7).

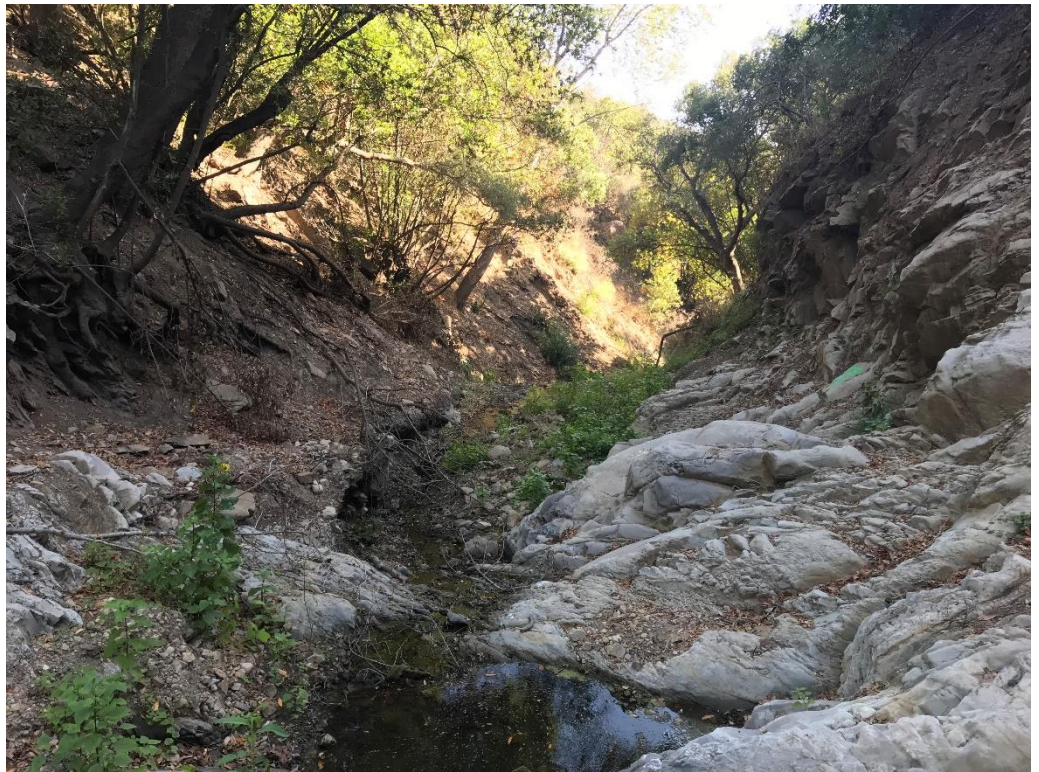
**Net
Location:**
BV-6

View looking upstream at the BV-6 net location.

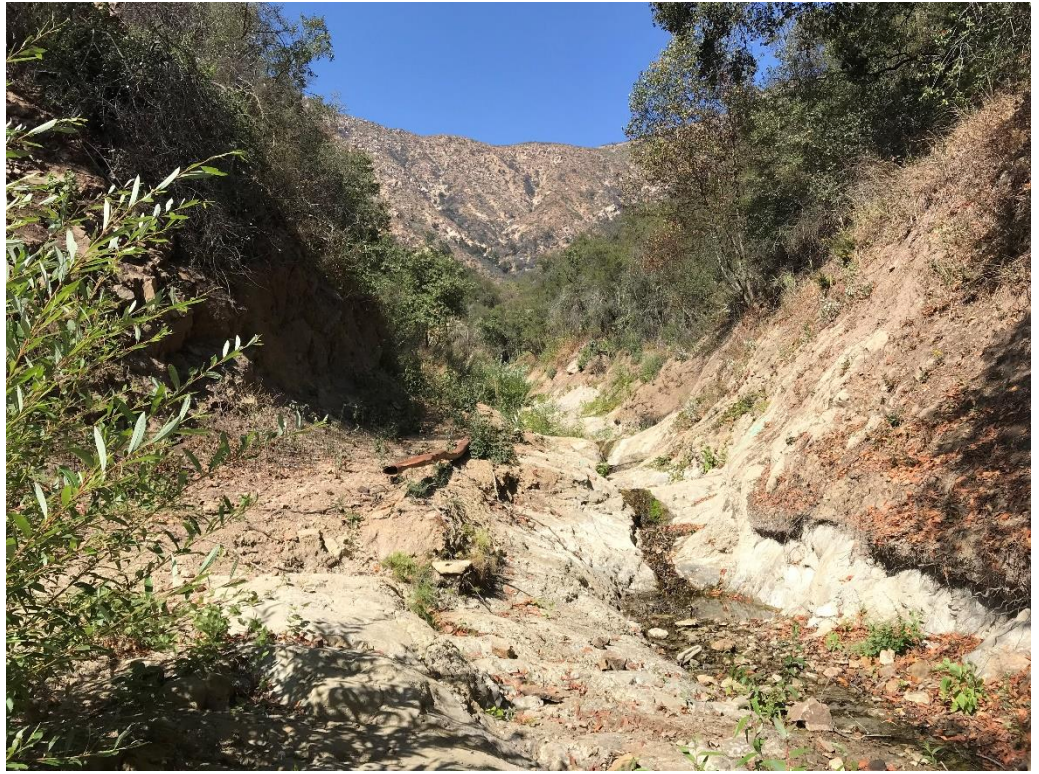
View looking upstream at the BV-7 net location.

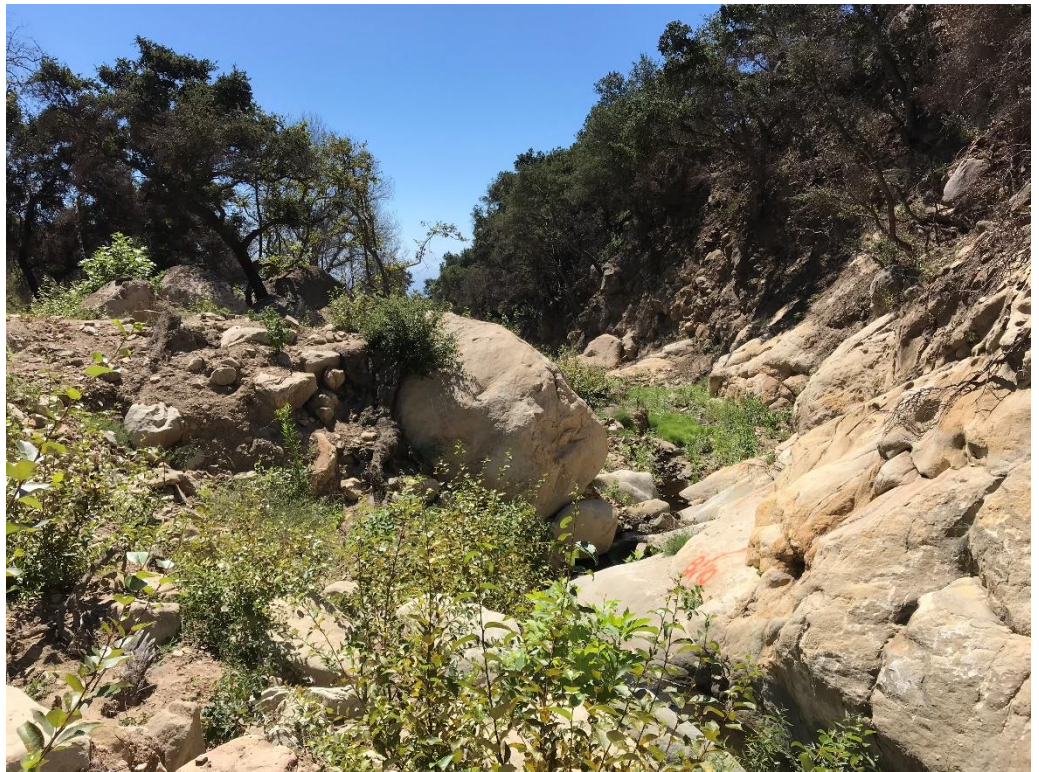
**Net
Location:**
BV-10

View looking downstream at the BV-10 net location.

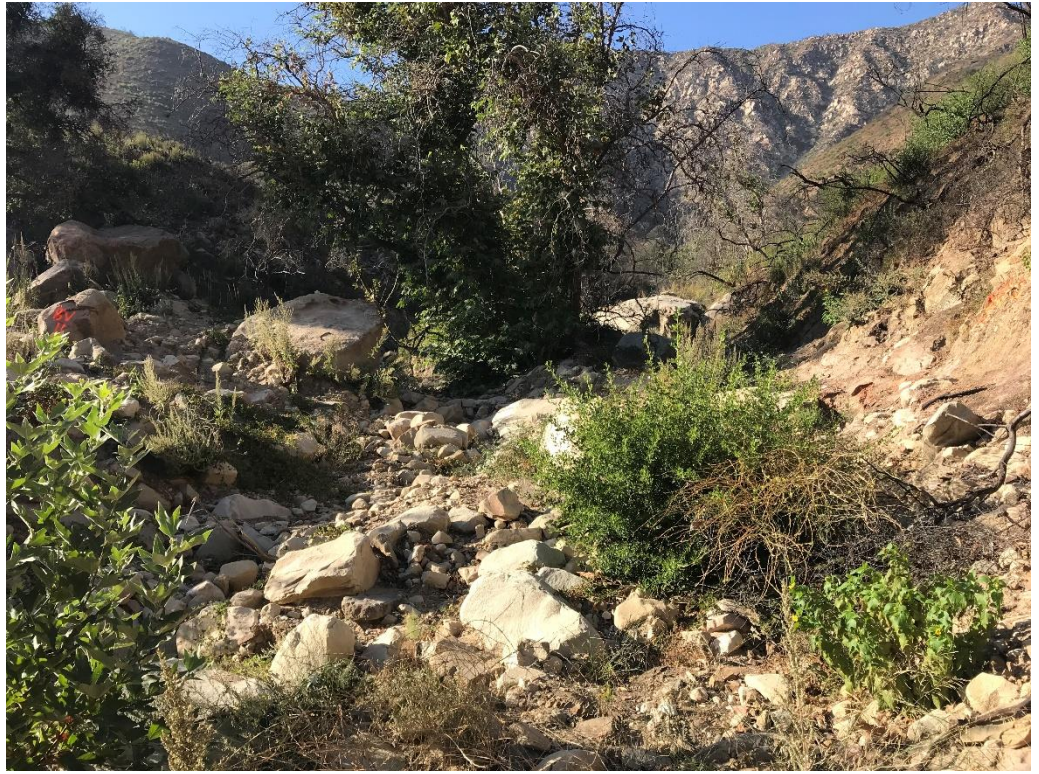
View looking upstream at the
BV-11 net location.

Net is located in a western
tributary to Buena Vista
Creek.

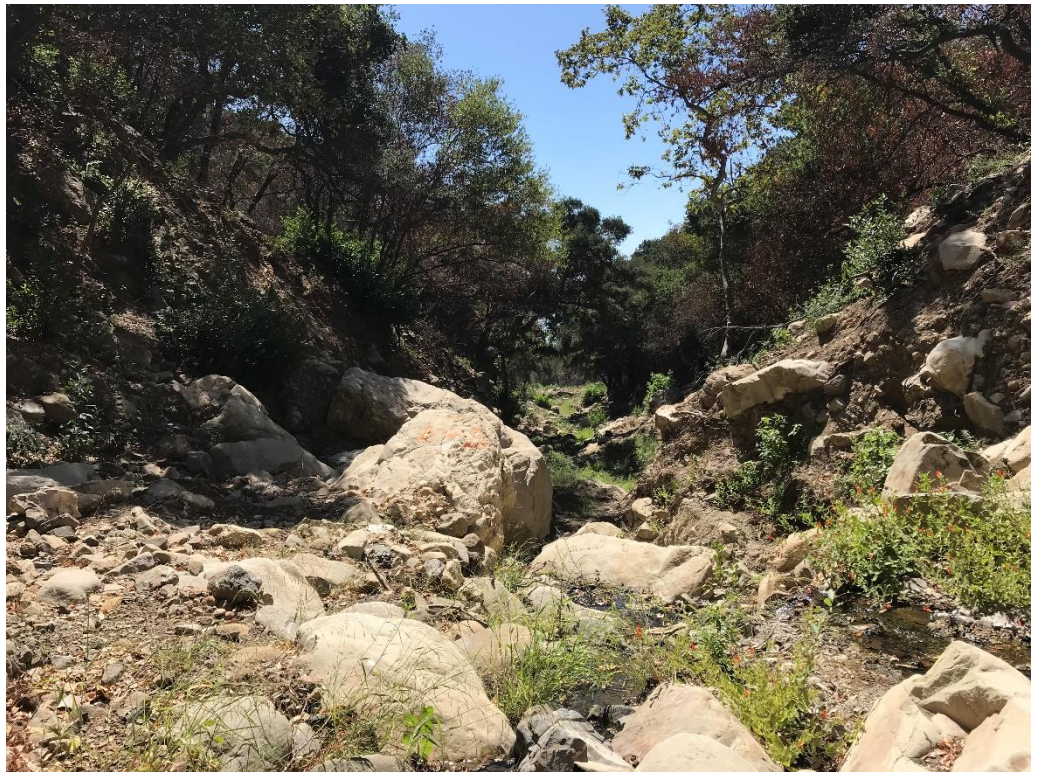
**Net
Location:**
RC-12

View looking downstream at
the RC-12 net location.

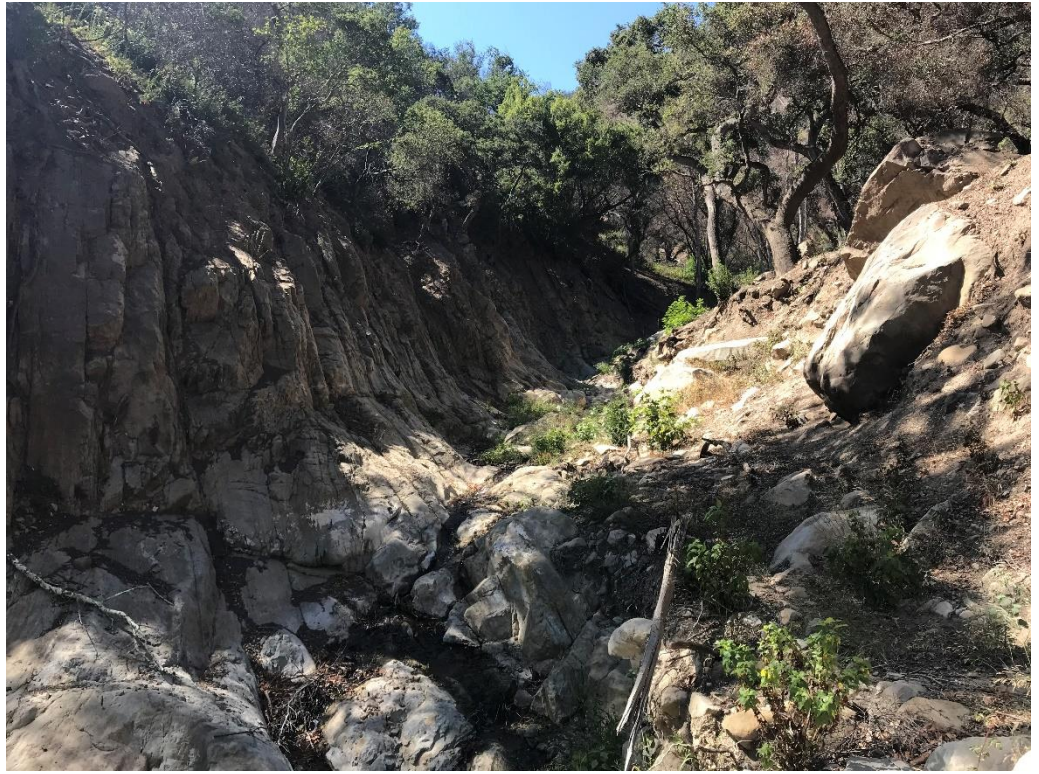
View looking upstream at the
RC-15 net location.
