Reassessment of the coast live oaks that may be removed or the drip-line infringed upon at a property at 6226 Ontario Dr., San Luis Obispo County with APNs of 076-241-016, 076-241-017 AND 076-114-052

July 12, 2018

BOTANICAL ASSESSMENT
OF APN 076-241-016, 076-241-017 AND 076-114-052
FOR
MR. ART WELDON
BY
GREG WILVERT
December 21, 2017

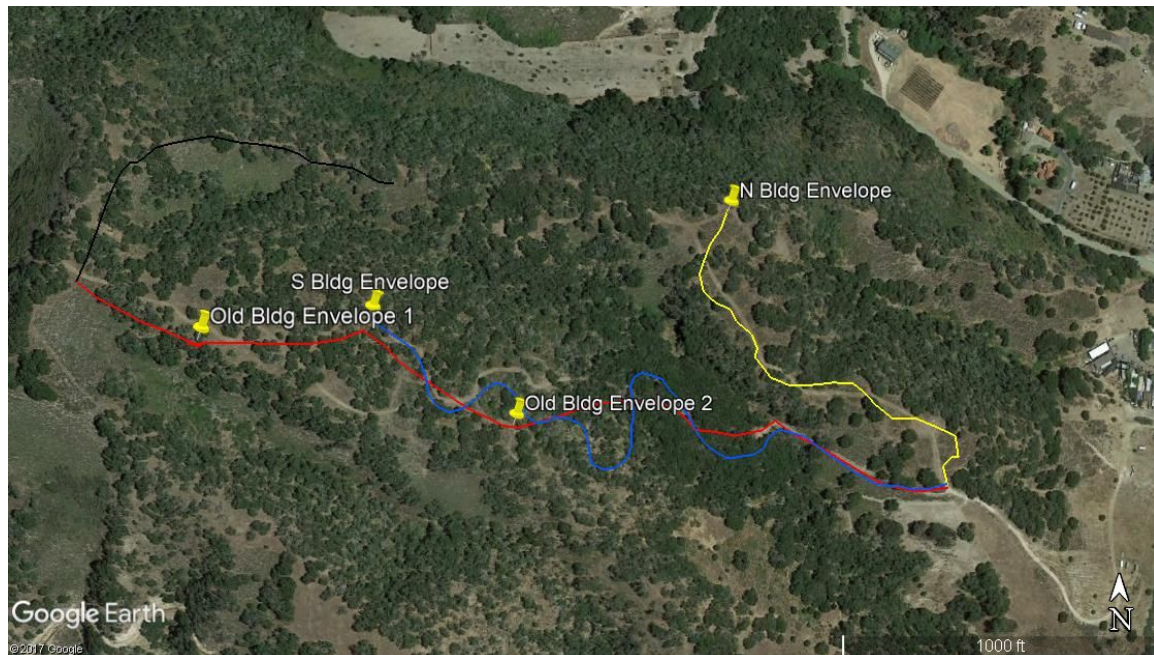
Figure 1. Satellite image of property. The original building envelopes of 2015 are marked as Old Bldg Envelope 1 and Old Bldg Envelope 2, as well as the possible roads accessing them (red for the southern route and black for the northern route). The new building envelopes as of 2017 are labeled S Bldg Envelope and N Bldg Envelope. The proposed road routes to access them are in blue and yellow. All locations are approximate.

The two building sites, and the roads to access them, that were proposed for the site in 2015 are shown in Fig. 1 (APN 076-241-016, 017; 076-114-052). Mr. Weldon wished to build homes at two sites, designated as Old Building Envelope 1 and Old Building Envelope 2 (Fig. 1). Presently, Mr. Weldon wishes to build only at the south building site (Fig. 1). This report addresses the botanical survey to assess the potential impact to coast live oaks along the presently proposed road routes.

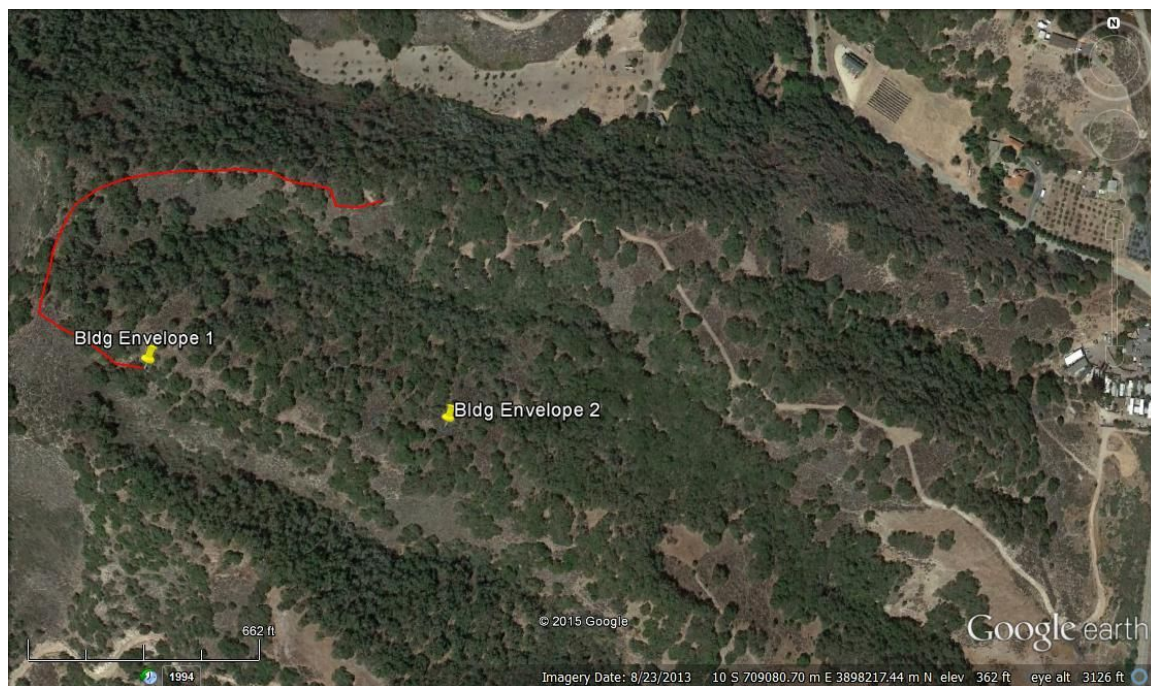
Figure 7. The route surveyed on March 27 and June 14, 2015. The route follows a ridge westward from the end of a dirt road that is drivable by four wheel drive. The route is approximate.

The first survey was spent focusing on the northern part of the proposed road route (Fig. 7). At the time, Mr. Weldon hoped to access a ridge, where he wanted to build two homes. After my visit, he learned that the slope was too steep in places on that route. The second survey thus focused on the southern route and Building Envelopes 1 and 2 (Fig. 8), as Mr. Weldon had decided that this was a more passable route with its mostly gentler slopes. On the third visit both routes were surveyed.

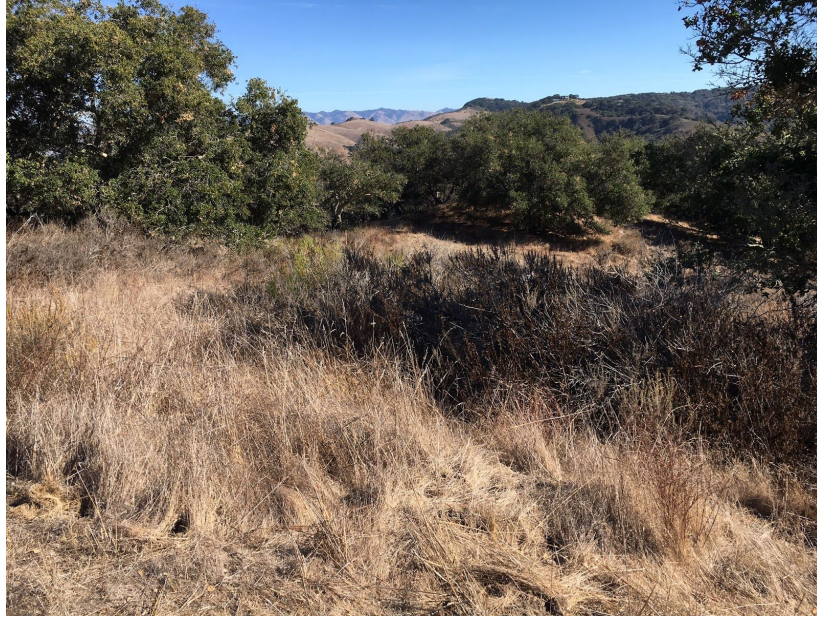
Figure 2. Proposed building envelope at the northern end of the northern proposed route. The approximate photo location is denoted by the circled number 1 and the arrow indicates the direction the photo was taken (Figure 1).

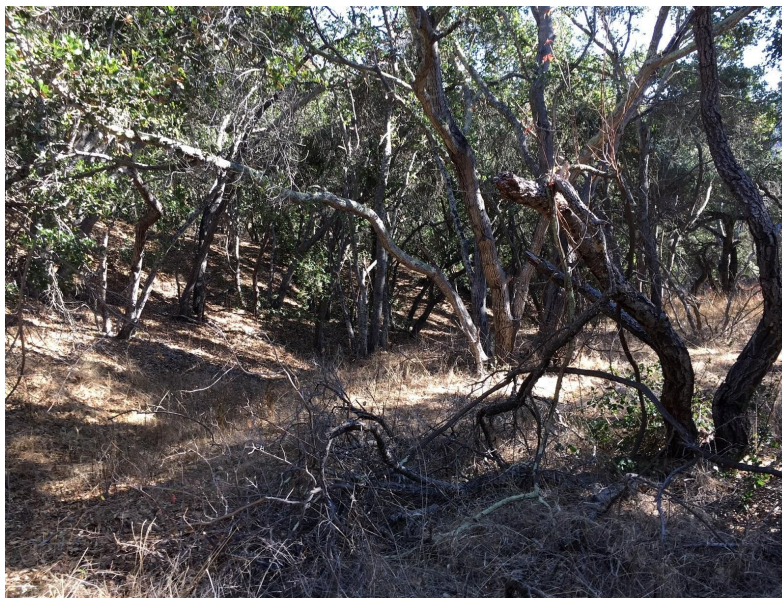
Figure 3. Photo taken along the proposed southern road route. The approximate photo location is denoted by the circled number 2 and the arrow indicates the direction the photo was taken.

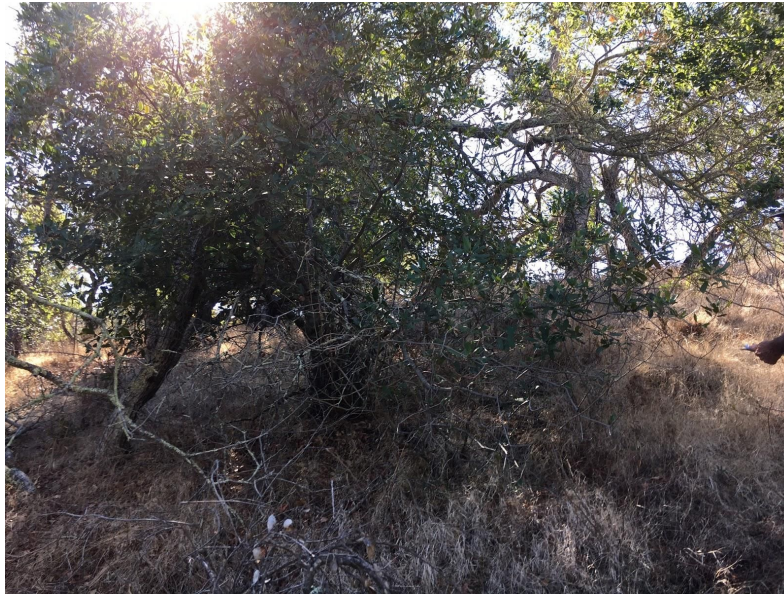
Figure 4. Photo taken along the proposed southern road route. The approximate photo location is denoted by the circled number 3 and the arrow indicates the direction the photo was taken.

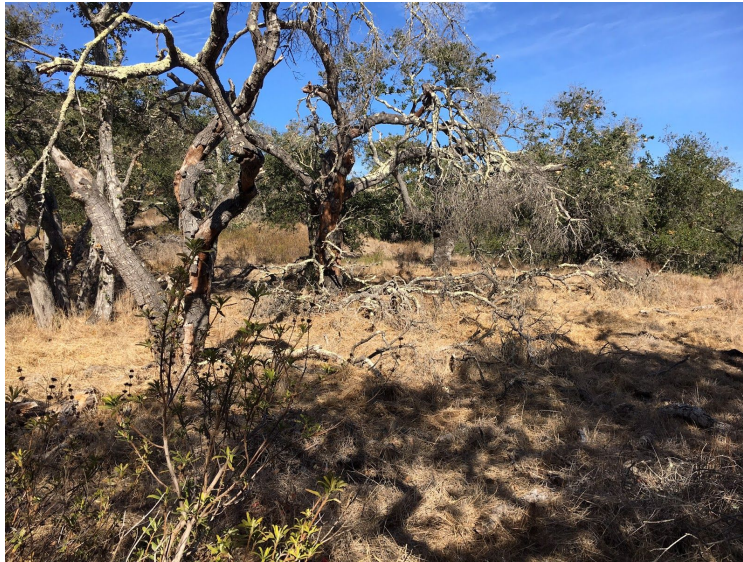
Figure 5. Photo taken along the proposed southern road route. The approximate photo location is denoted by the circled number 4 and the arrow indicates the direction the photo was taken.

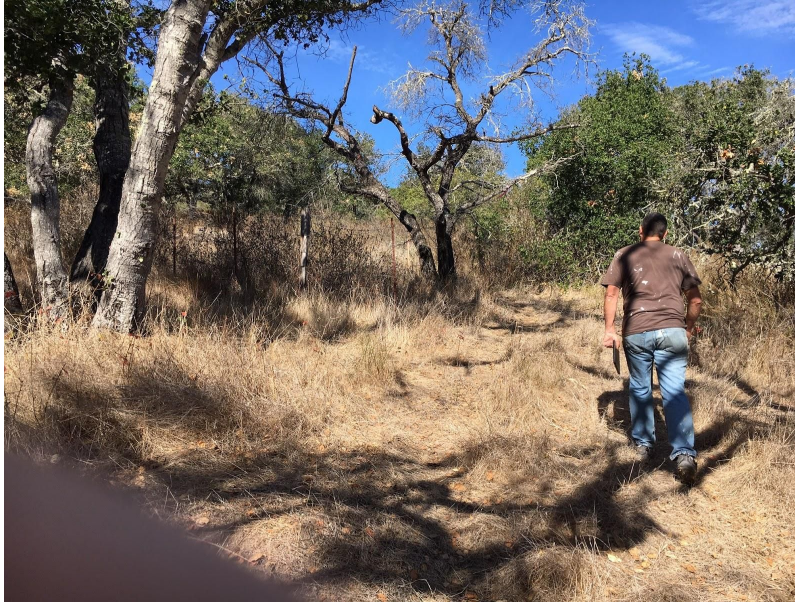
Figure 6. Photo taken along the proposed southern road route. The approximate photo location is denoted by the circled number 5 and the arrow indicates the direction the photo was taken.

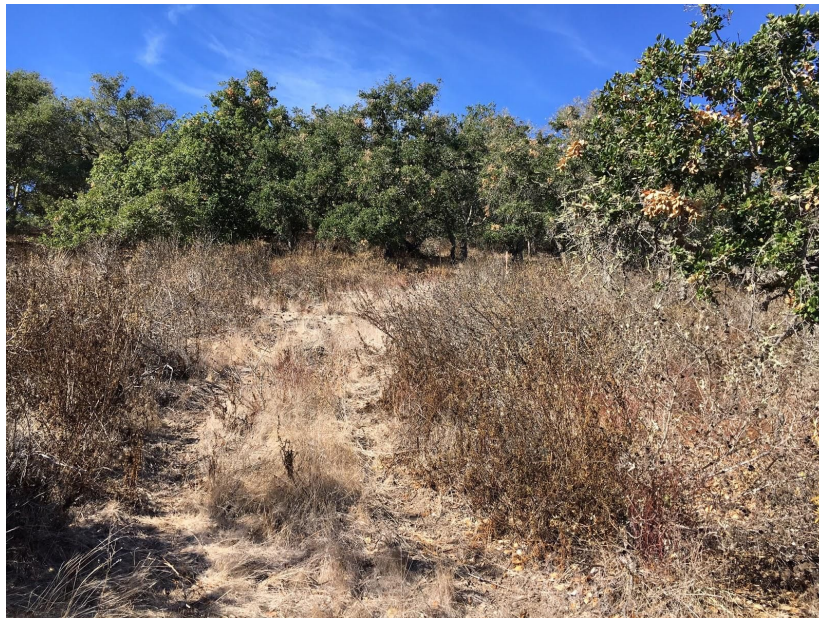
Figure 7. Proposed building site at the east end of the southern proposed road route. The approximate photo location is denoted by the circled number 6 and the arrow indicates the direction the photo was taken.
