**General Biological Assessment
The Shops at Jurupa
Jurupa Valley, California**

**Panorama Development, LLC
2005 Winston Court
Upland, CA 91784**

December 1, 2020

Project Number: PPI20-101

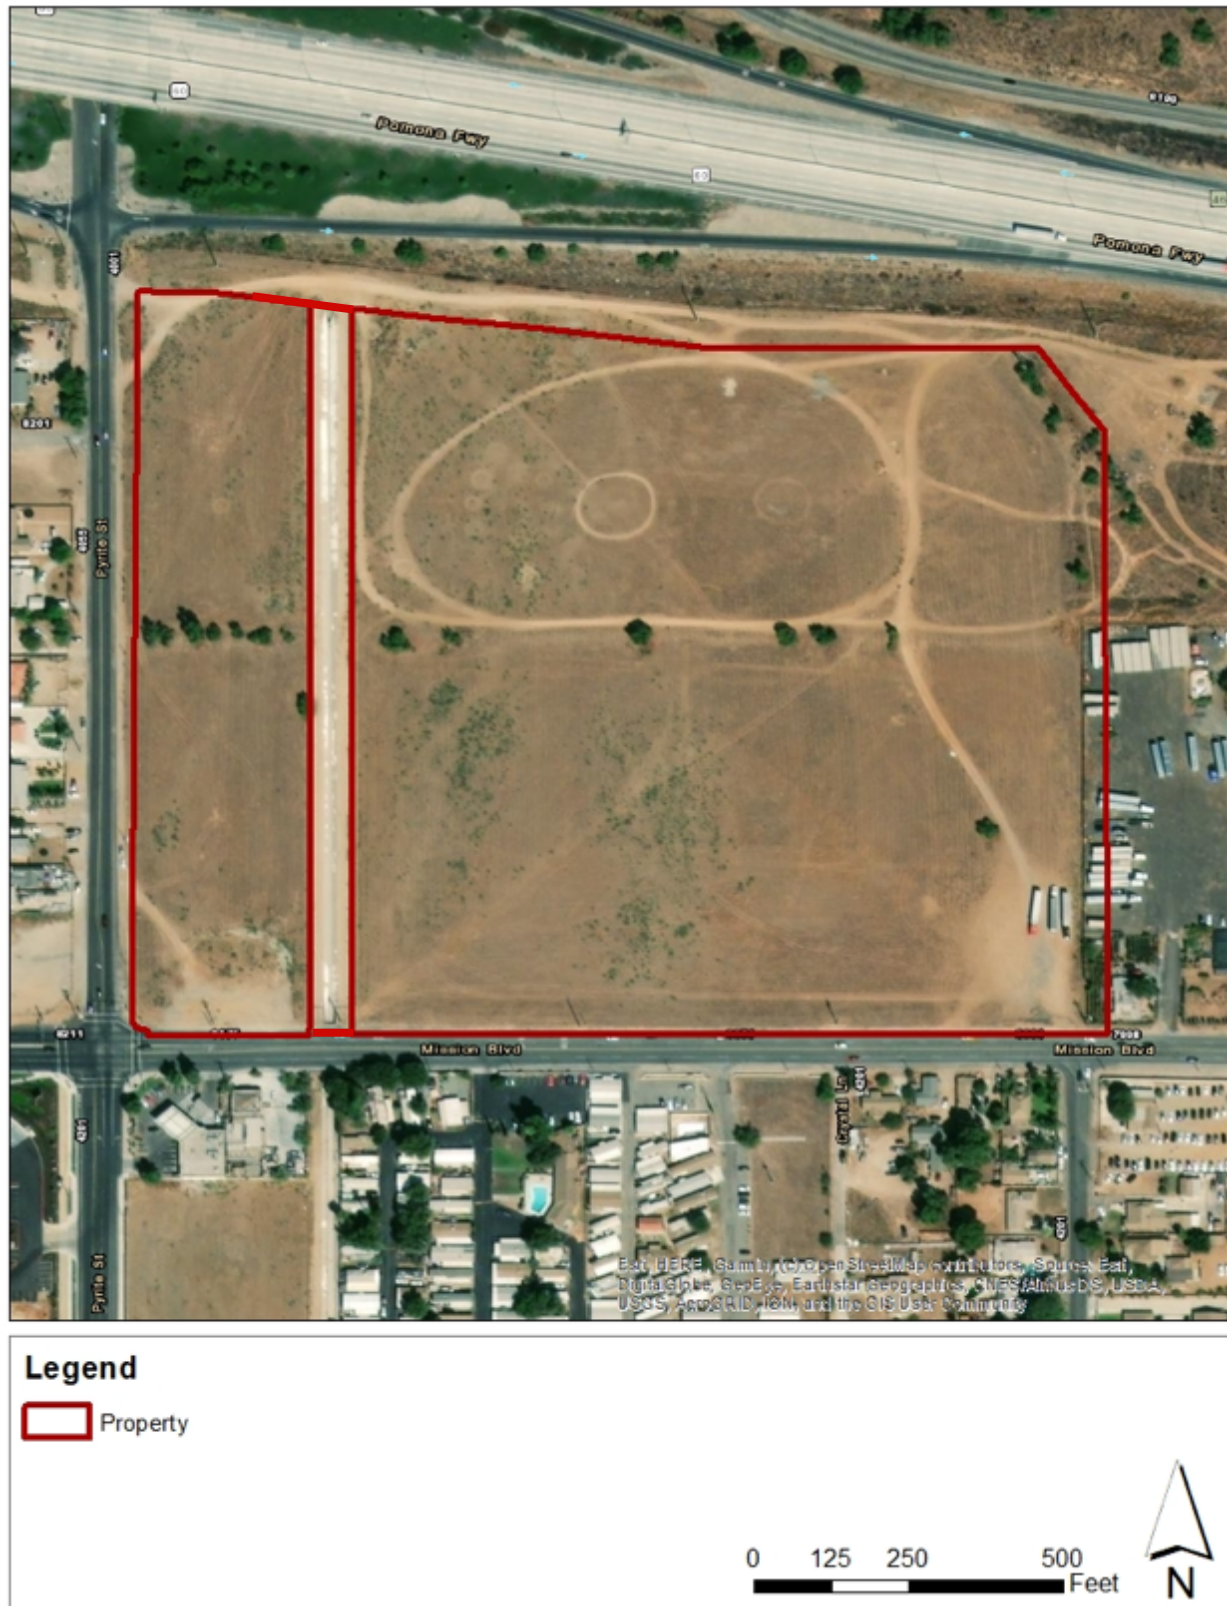
Figure 3. Aerial Showing the Condition of the Property. 2020.

The property has a flat topography (Figures 2 and 3).

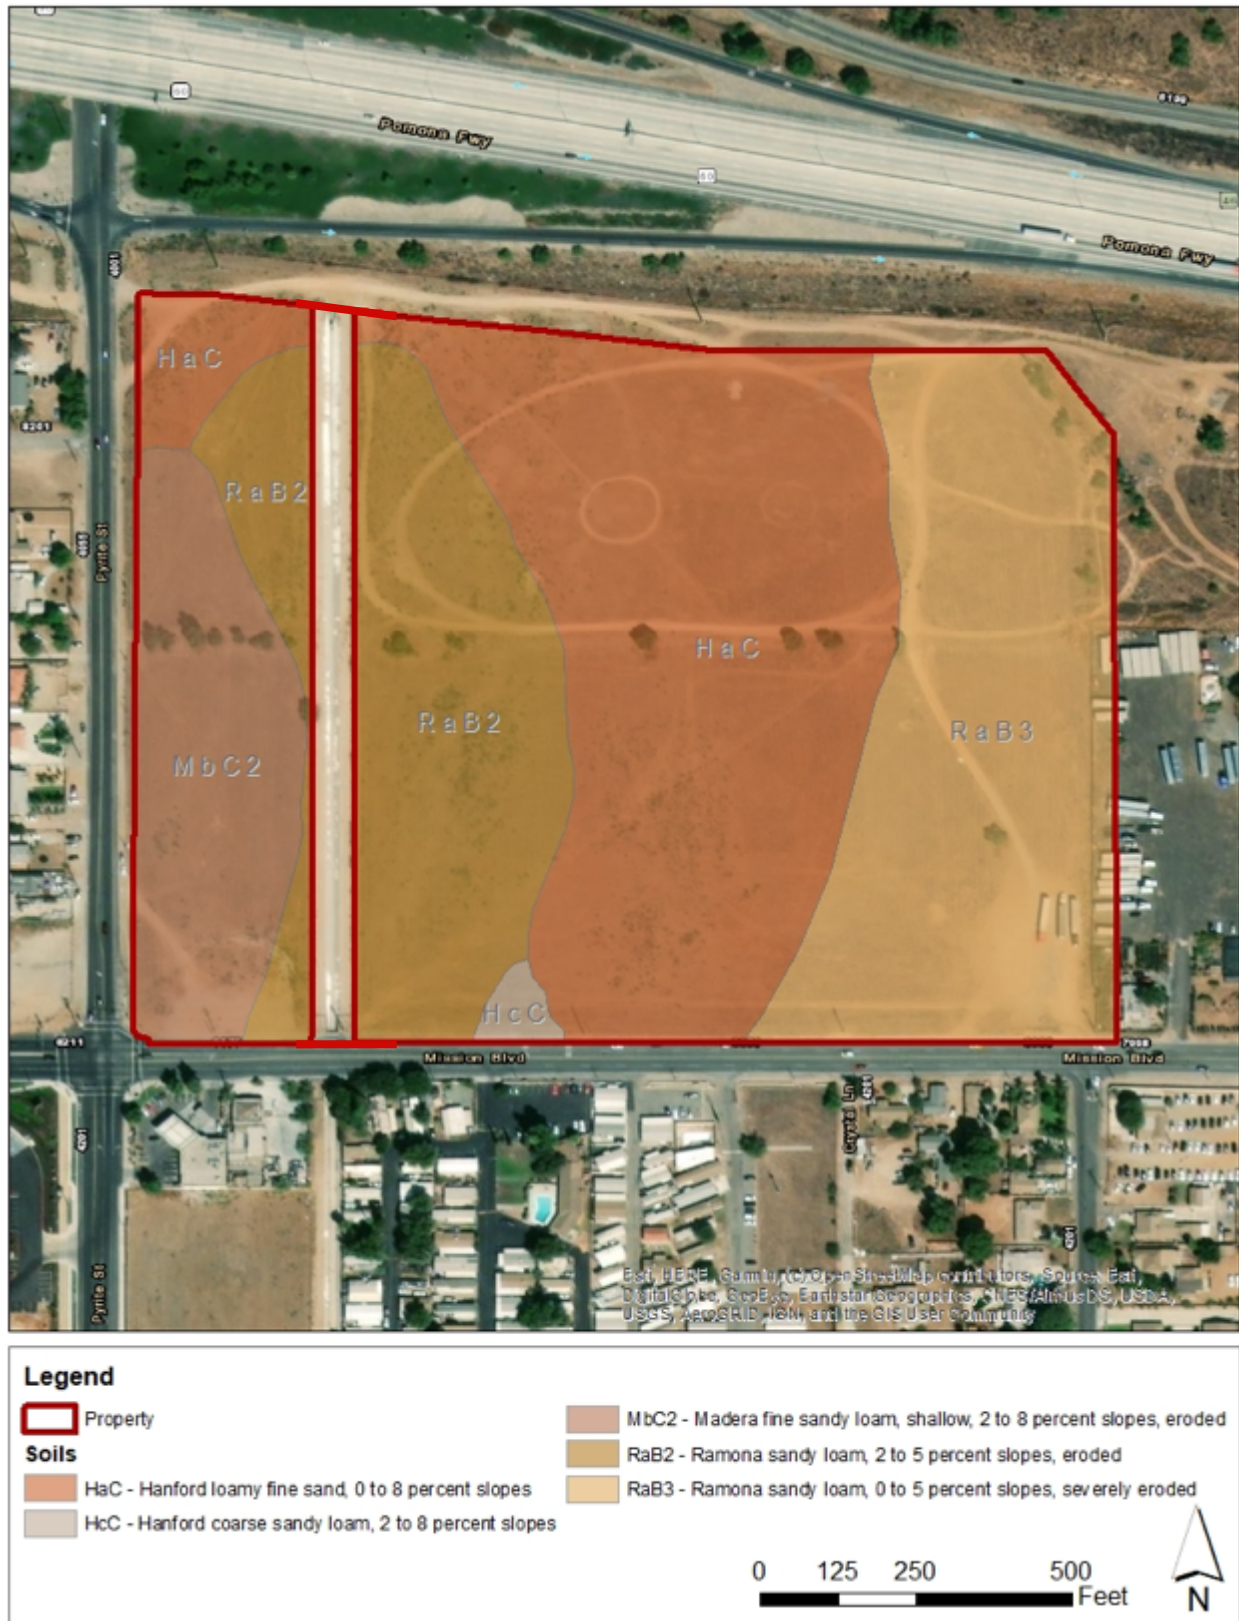
Figure 4. Soils.

Hanford loamy fine sand (HaC) is found on zero to eight percent slopes. This soil is developed from alluvium derived from granite and is found on alluvial fans. It is a well-drained non-hydric loamy fine sand that does not flood or pond.

Hanford coarse sandy loam (HcC) is found on two to eight percent slopes. This soil is developed from alluvium derived from granite and is found on alluvial fans. It is a well-drained non-hydric coarse sandy loam that does not flood or pond.

Madera fine sandy loam (MbC2) is found on two to eight percent slopes. It is an eroded soil with a shallow A horizon. Madera fine sandy loam is developed from alluvium derived from granite and is found on alluvial fans. It is a moderately well-drained hydric soil that does not flood or pond. Madera fine sandy loam is nonsaline to very slightly saline.

Ramona sandy loam (RaB2) is found on two to five percent slopes. It is an eroded sandy loam developed from alluvium derived from granite that occurs on alluvial fans and terraces. Ramona sandy loam is a non-hydric well-drained soil that does not flood or pond.

Ramona sandy loam (RaB3) is found on zero to five percent slopes. It is a severely eroded sandy loam formed from alluvium derived from granite that occurs on alluvial fans and terraces. Ramona sandy loam is a non-hydric well-drained soil that does not flood or pond.

All project soils have been impacted by disking for weeding and are mass compacted.

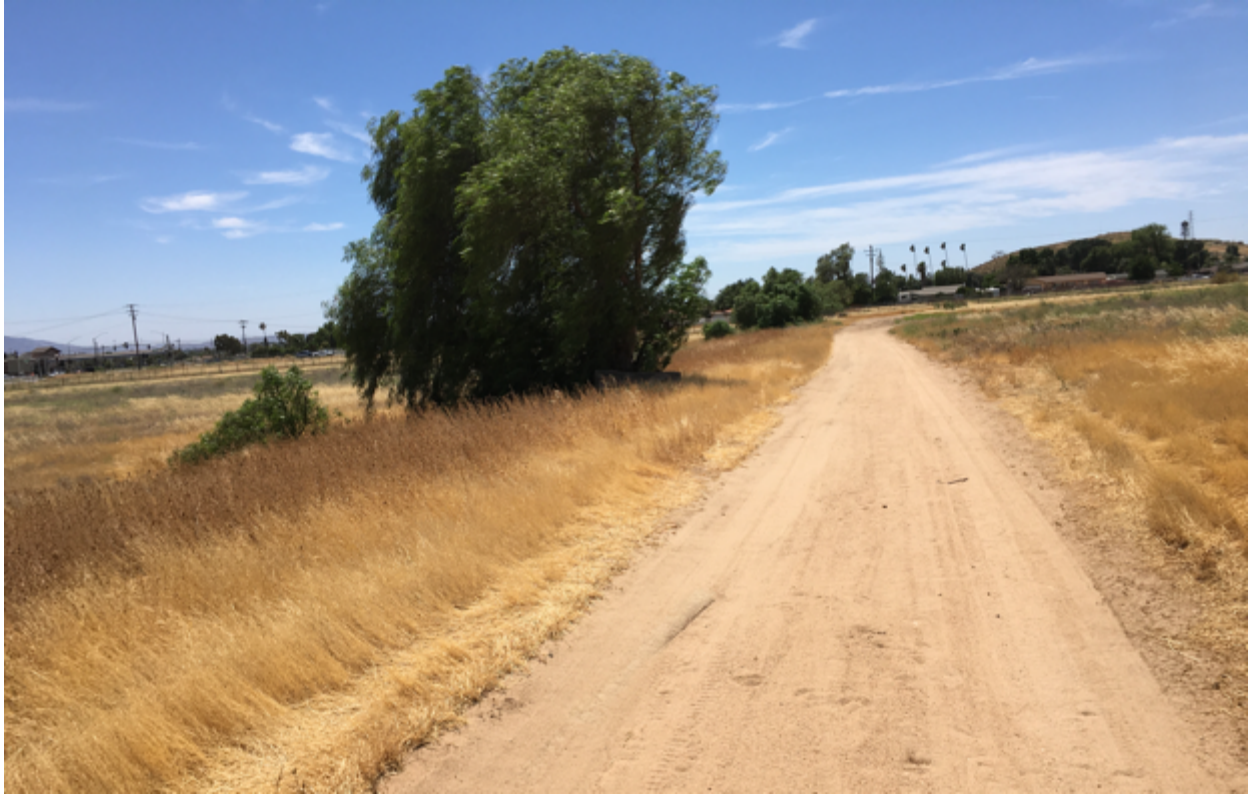
This condition is represented by mostly bare ground, dirt roads and pads (Photo 1).

Photo 1. East-west road bisecting the property. Looking west.

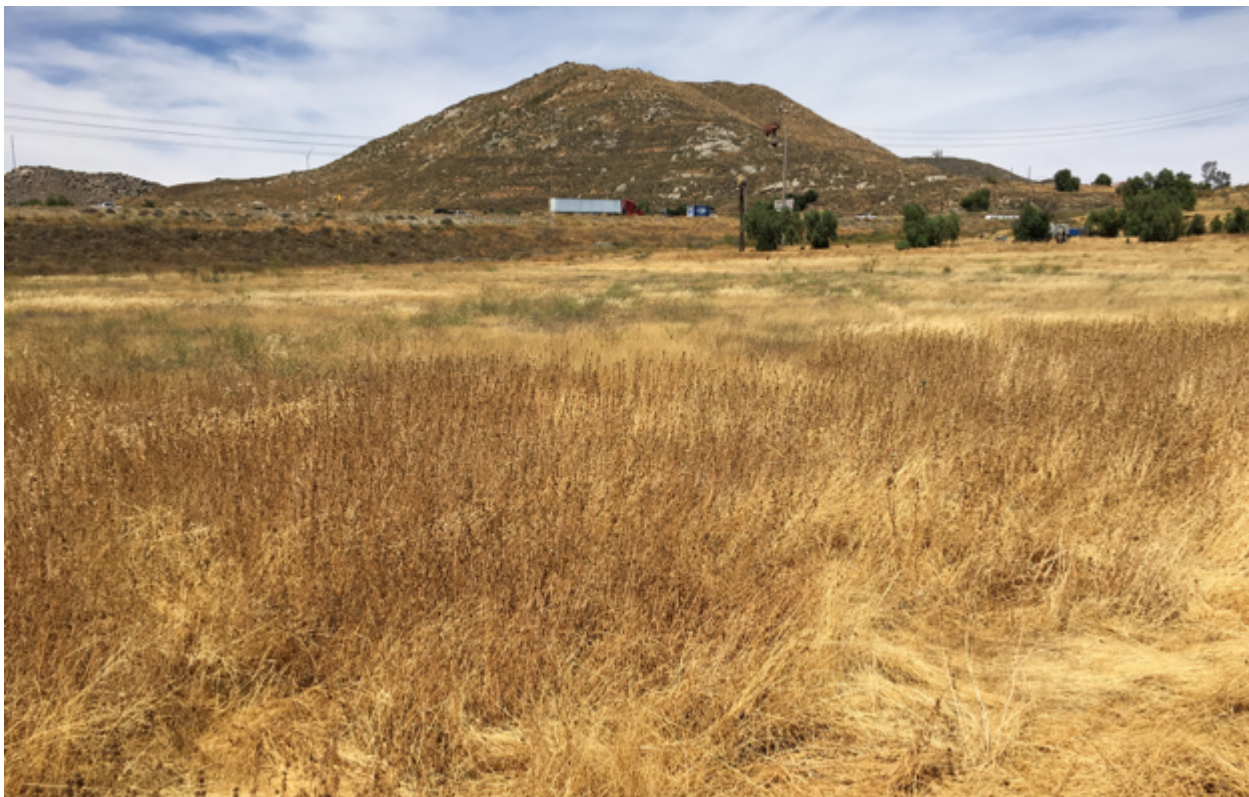
The ruderal plant community is found throughout the property except on the roads and pads (Photos 1 through 4). A list of all plant species observed is provided in Appendix A.

Photo 2. Ruderal grassland on the site. Looking north towards the Jurupa Mountains.

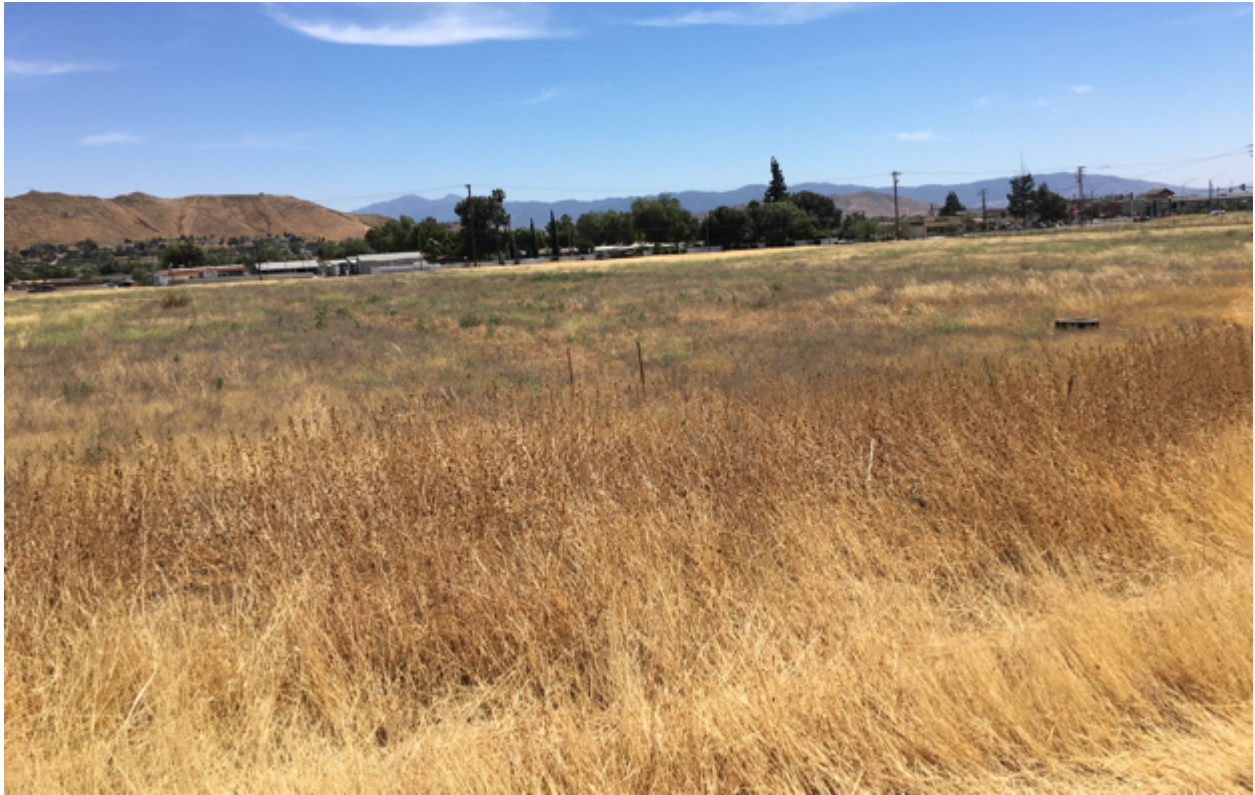
Photo 3. Ruderal vegetation. Looking south-southwest from the center of the property. Note the density of cover.

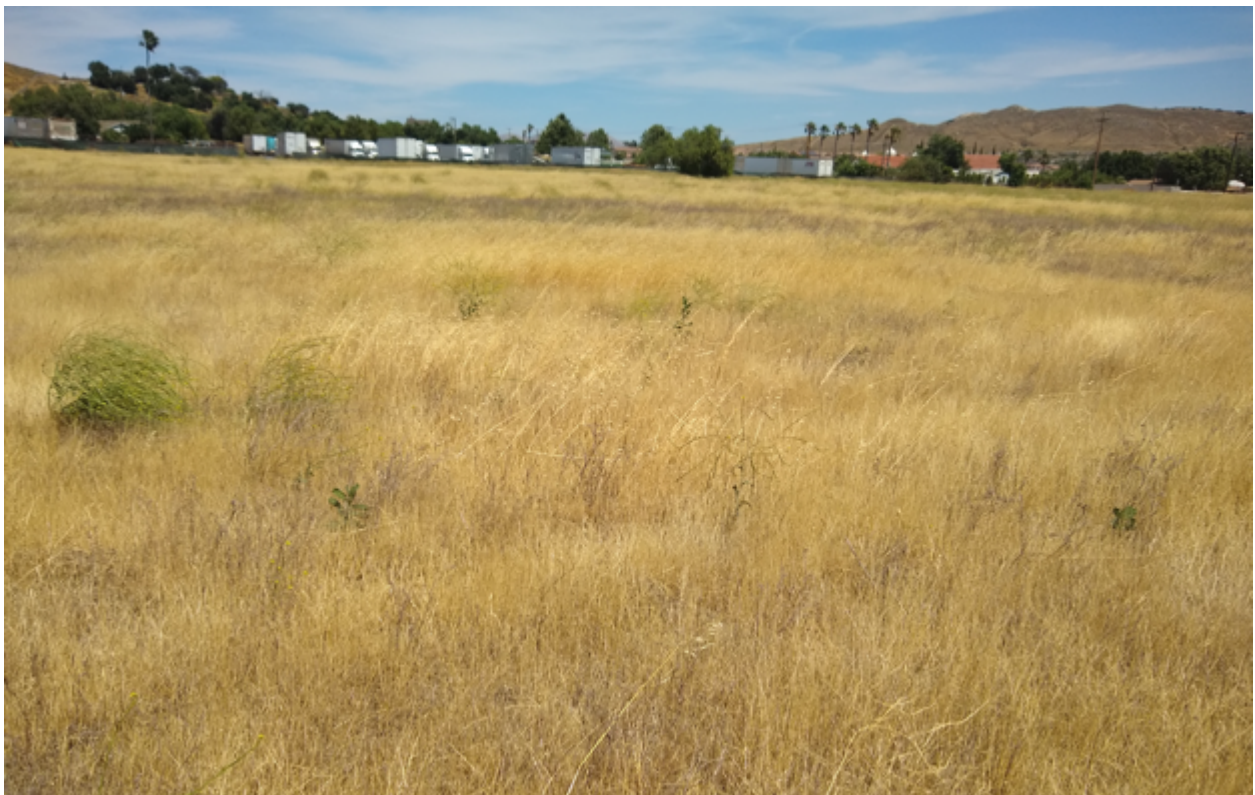
Photo 4. Ruderal vegetation in the eastern half of the property.

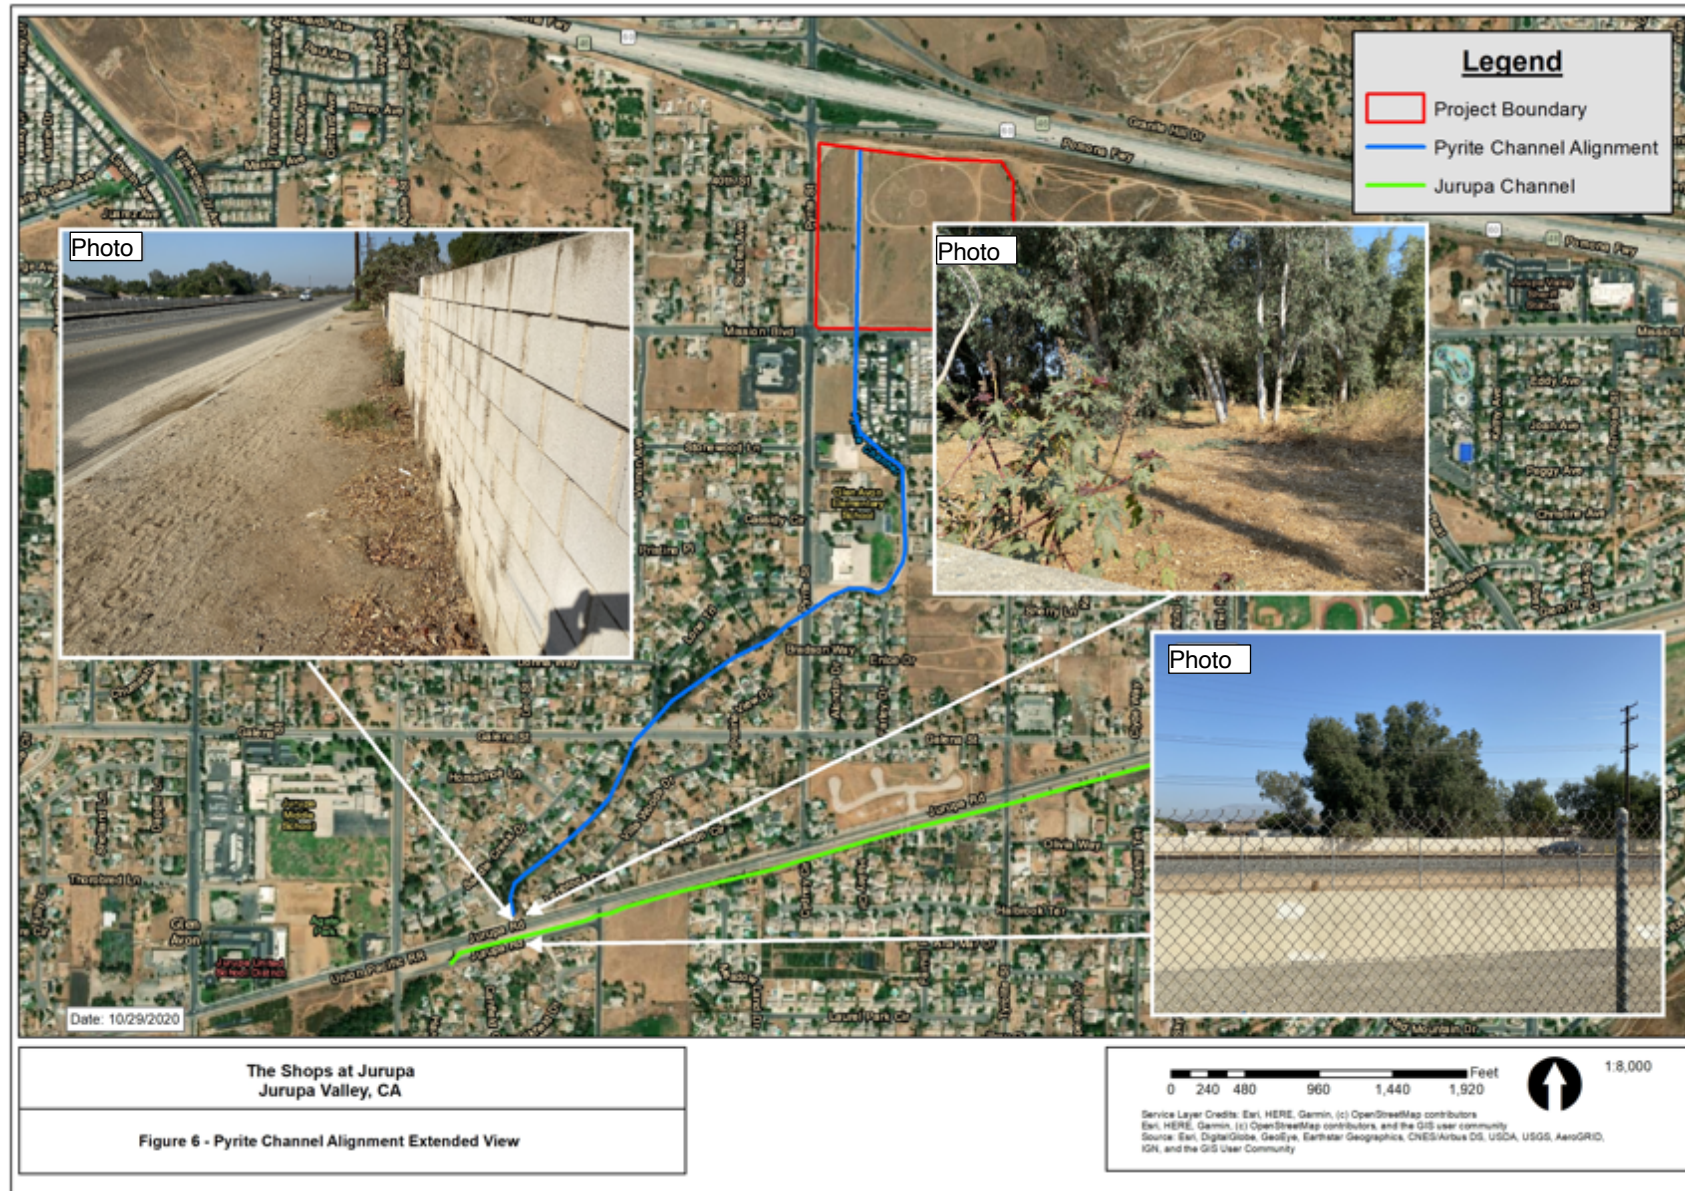
Figure 6. Pyrite Channel Alignment Extended View

The Pyrite Channel is a concrete lined trapezoidal channel which does not have any vegetation present onsite. Sheet flows that enter the channel flow south to the intersection of Pyrite Street and Lone Trail where the Pyrite Channel then converts to an underground facility and continues south to its terminus at the Jurupa Channel.

The Jurupa Channel then flows southwest until it undergrounds at the intersection of Jurupa Road and Agate Street, approximately 0.5 mile from the Pyrite Channel connection (Figure 6, Photos 5 – 7). Flows from the Jurupa Channel exit the underground portion and daylight onto a vacant portion of the adjacent parcel. Flows are then lost to sheet flow and various homeowner improvements, however, based on further analysis by the City of Jurupa Valley there remains a tenuous sheet flow connection to the Santa Ana River.

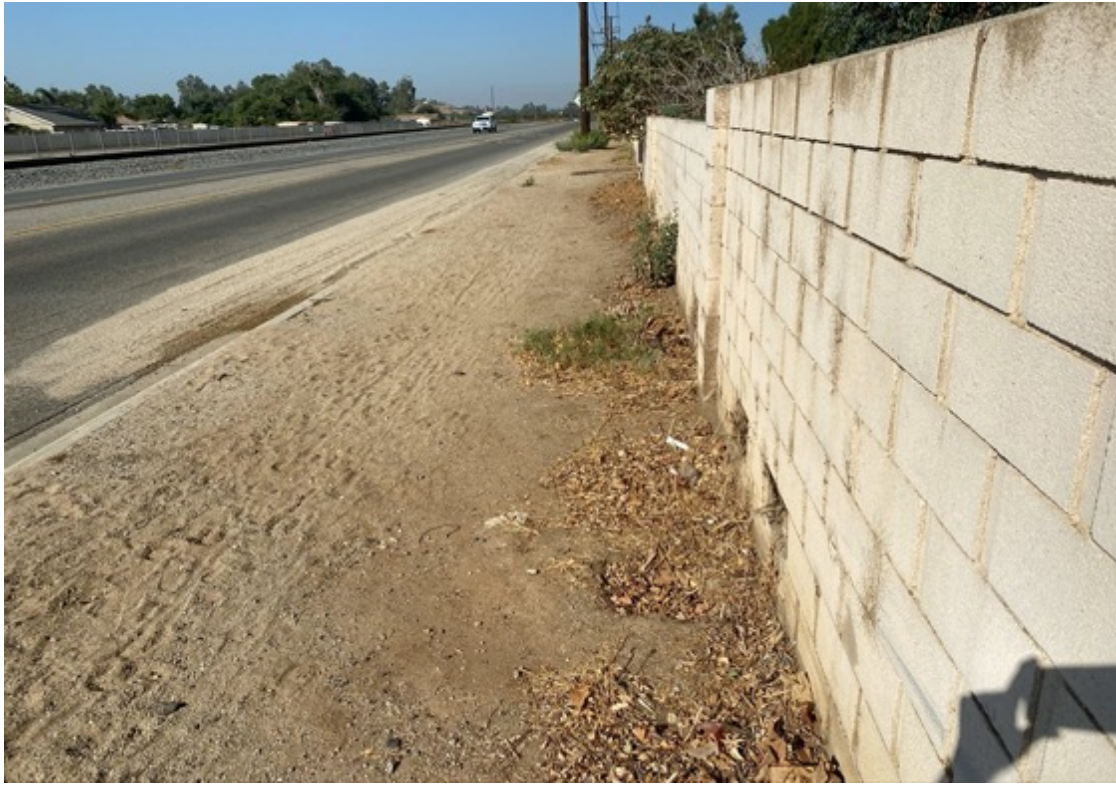
Photo 5. Facing east down Jurupa Rd at the terminus of the Pyrite Channel. Showing cinder block wall that stops flows of the Pyrite Channel.

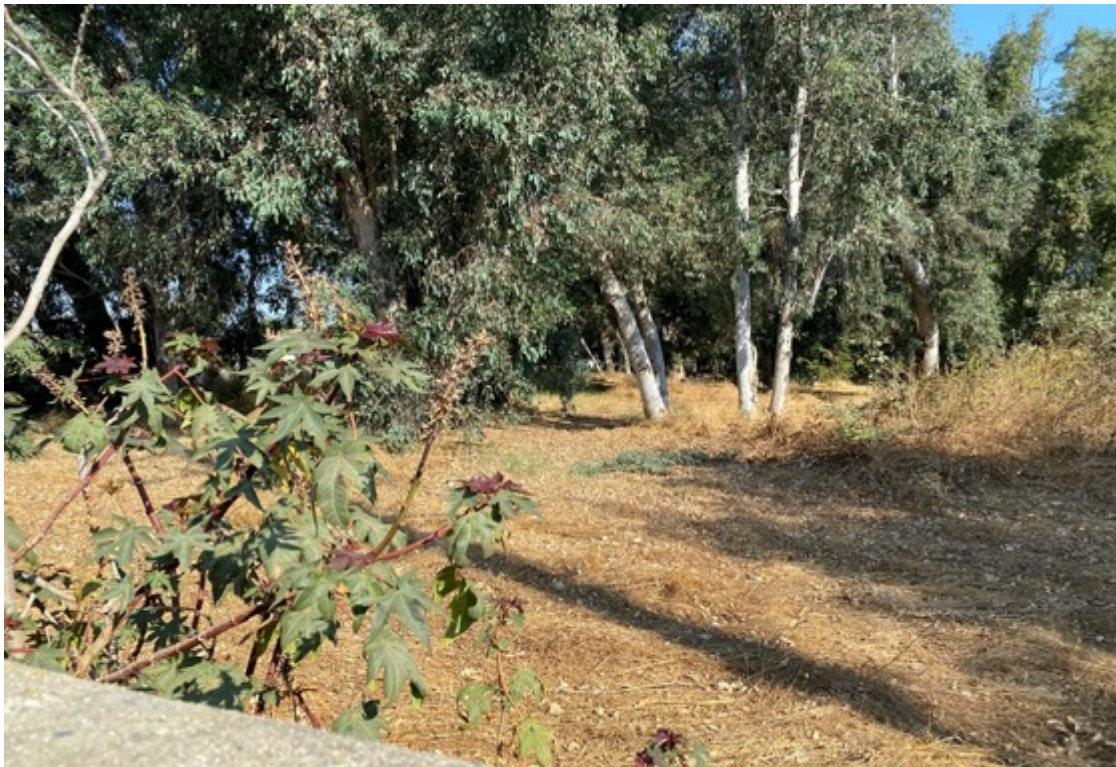
Photo 6. Facing north of the terminus of the Pyrite Channel, showing the lack of a defined channel on the north side of the cinder block wall.

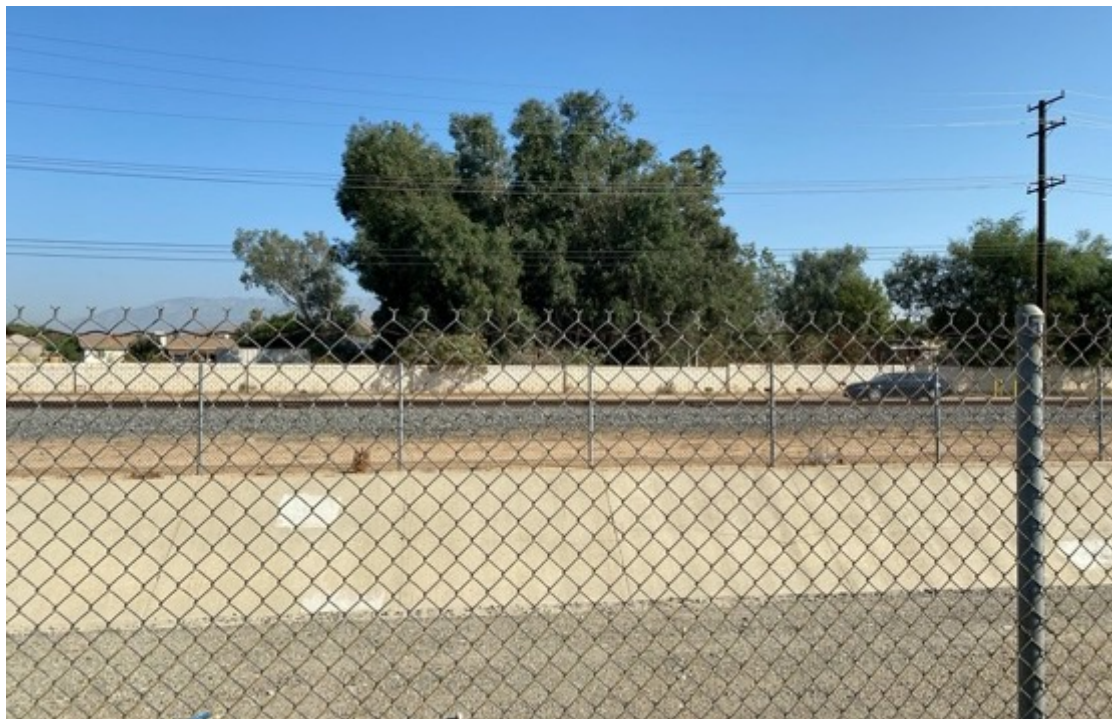
Photo 7. Facing north, showing the Jurupa Channel in the foreground and the terminus of Pyrite Channel in the background. There is no underground connection to the Jurupa Channel from the Pyrite Channel.
