Barry Building 11973-11975 West San Vicente Boulevard November 2021

HISTORICAL RESOURCES TECHNICAL REPORT

Barry Building 11973-11975 West San Vicente Boulevard

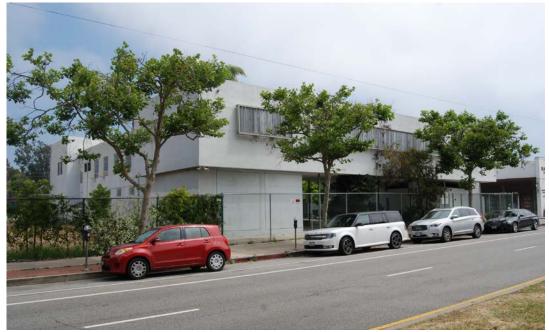
Photo 1: Barry Building, overall view northeast from San Vicente Boulevard. HRG

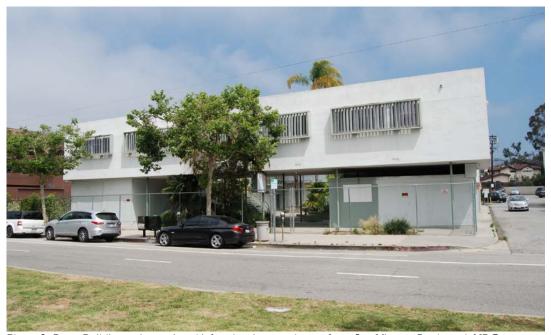
Photo 2: Barry Building, primary (south) façade, view northwest from San Vicente Boulevard. HRG

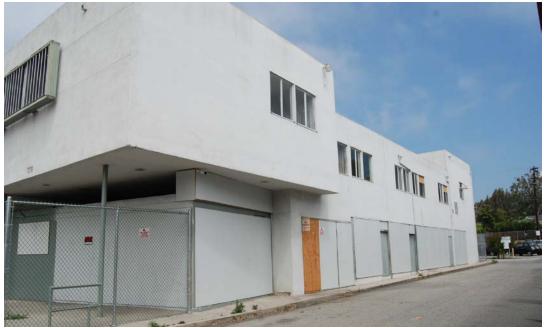
Photo 3: Barry Building, east façade and driveway, view northwest from San Vicente Boulevard. HRG

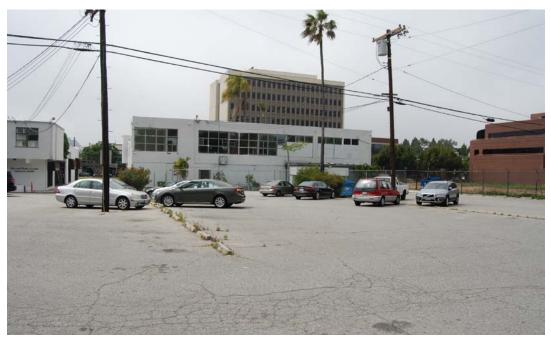
Photo 4: Barry Building, overall view southwest from parking lot. HRG

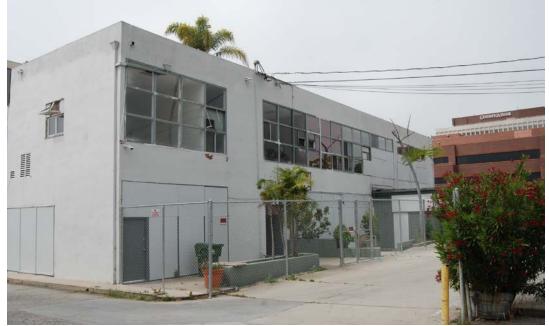
Photo 5: Barry Building, north façade, view southwest from parking lot. HRG

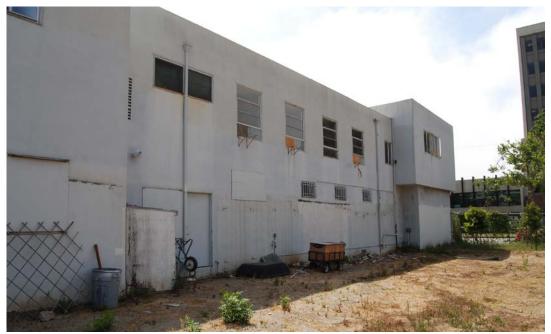
Photo 6: Barry Building, west façade, view southeast from adjacent parcel. HRG

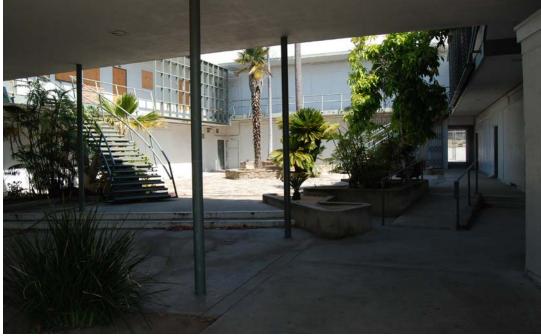
Photo 7: Barry Building, courtyard, view northwest from San Vicente Boulevard. HRG

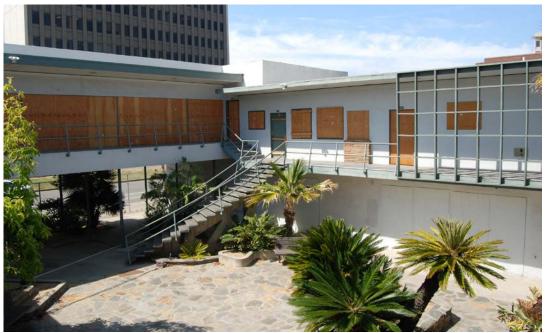
Photo 8: Barry Building, courtyard, view southwest from second floor balcony. HRG

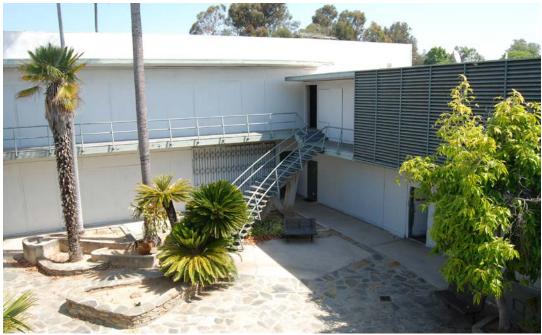
Photo 9: Barry Building, courtyard, view northeast from second floor balcony. HRG

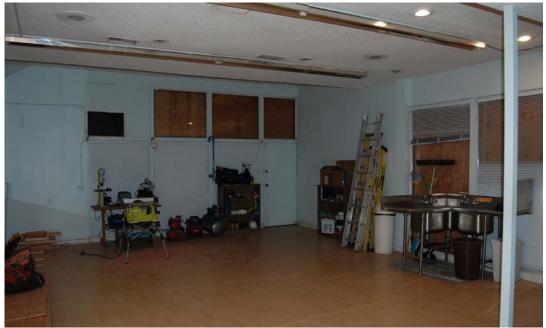
Photo 10: Barry Building, interior, typical first floor office suite, view northeast. HRG
