# RARE PLANT SURVEY RESULTS AND HABITAT ASSESSMENT FOR LOWER DEER CREEK, TRIBUTARY TO THE SACRAMENTO RIVER, TEHAMA COUNTY, CALIFORNIA

Prepared for: FlowWest

Prepared by: Sunny Loya

November 9, 2018

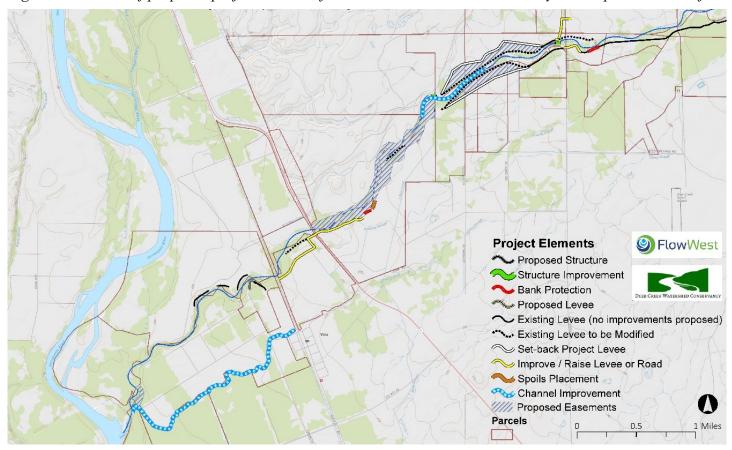
Figure 2. Location of proposed project elements for the Deer Creek Flood and Ecosystem Improvement Project.

The Deer Creek Flood and Ecosystem Improvement Project includes a variety of design measures, including levee setbacks, bank stabilization, flood easements, bridge improvements, diversion structure improvements, and levee improvements (Table 1, Figure 2). At the upstream end near river mile 6, improvements to Red Bridge would be coupled with levee setbacks and flood easements to convey higher flows and large wood through the bridge and allow some natural channel migration. Improvements to the Stanford-Vina Ranch Irrigation Company (SVRIC) Diversion Dam could improve sediment continuity and fish passage (Figure 2). Approximately 1.5 miles downstream, bank protection coupled with levee setbacks and improvements and flood easements could widen the floodway to allow greater flow conveyance, channel migration, and natural development of instream habitat (Figure 2). Additional elements include bank protection and levee improvements to protect valuable existing pasture and infrastructure (Figure 2).

Location on Deer Creek	Element	Objective
Upstream of Red Bridge	Modify existing levee on north bank	Remove existing levee to allow flooding on existing easement
Upstream of Red Bridge	Improve/raise road and levee	Coupled with levee modification above, raise Leininger Rd north of Red Bridge and construct new levee as needed along northern boundary of easement
Upstream of Red Bridge	Bank protection improvements	Improve bank protection and existing project levee to protect current ecological function and reduce future flooding risk to downstream landowners
Red Bridge	Improve Red Bridge	Raise and widen Red Bridge to reduce upstream backwater effects and excessive channel bed scour and bank erosion
Red Bridge to SVRIC Diversion Dam	Levee setbacks	Set back existing project levees on north and south banks to widen the floodway to allow for higher flood conveyance and encourage natural geomorphic function in this reach

Red Bridge to SVRIC Diversion Dam	Sediment removal and grading	Increase channel capacity by removing sediment deposits upstream of SVRIC  Diversion Dam and improve grade
SVRIC Diversion Dam	Improve diversion dam structure	Improve sediment routing and fish passage by modifying and/or improving the existing diversion dam
SVRIC Diversion Dam to Hwy 99	Floodway and migration easement	Provide compensation to north and south bank landowners in exchange for increased flood disturbance to allow natural channel migration, floodplain reconnection, and development of riparian vegetation

SVRIC Diversion Dam to Hwy 99	Remove existing non- project levee on south bank	Improve floodplain dynamics and sediment transport in the reach while streamlining the flood protection system
SVRIC Diversion Dam to Hwy 99	Bank protection improvements	Prevent channel migration into irrigated pasture using bioengineered bank stabilization techniques
Hwy 99 to Railroad Grade	Set back non-project levee on south bank	Increase channel capacity and floodway width between Hwy 99 and the railroad
Downstream of Railroad Grade	Ring levee	Prevent flooding of laundry facility at Monastery of New Clairvaux

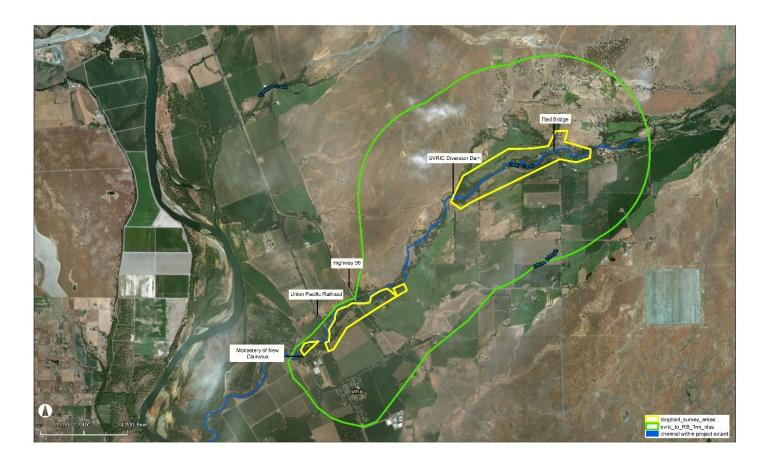
Figure 3. Location of Deer Creek Flood and Ecosystem Improvement Project, showing broad "scoping area" (green line) and targeted "survey areas" (yellow lines).

The proposed elements intend to protect the working landscape on Deer Creek while improving habitat conditions for salmonids. All proposed elements occur within four discrete "survey areas" (yellow lines in Figure 3) that collectively total approximately 350 acres. To determine the botanical resources that occur or have the potential to occur in the actual project footprint, a larger "scoping area" was defined (green line in Figure 3). The scoping area occurs on two USGS 7.5' quadrangles (Vina, Richardson Springs NW). Habitats within the scoping area were described to provide context for plants within an approximate one-mile radius of the project area (Figure 3). Soils within the scoping area were described per California Department of Fish and Wildlife plant survey protocols (CDFW 2018).

Field surveys occurred within the four survey areas shown in Figure 3. The actual extent of the spring and summer surveys was reduced due to landowner specifications. For example, the area between Red Bridge at the upstream end and SVRIC Diversion Dam at the

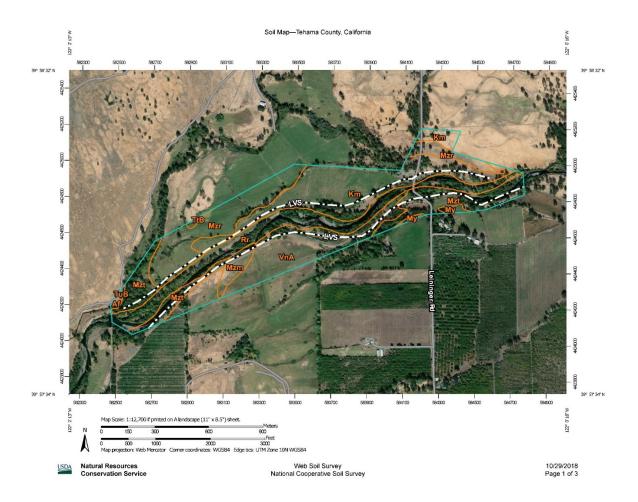
Figure 4. Soil map of upstream project area, showing levees (LVS) extending from the SVRIC Diversion Dam at the downstream end to above Leininger Road at the upstream end. Soil types are delineated in orange, and the approximate survey area is shown in teal. Riverwash (Rr) was the only soil type in the areas surveyed between the levees, except for a small area of moderately deep Keefers loam (Km) on the north side of the creek upstream of Red Bridge and beyond the levee.

Soils in the survey areas were less diverse. Riverwash occurred as the dominant series within the active channel (Figure 4), and Molinos soils occurred on the floodplains (Figure 5). Soils in the Vina series tended to occur farther from the channel and covered more extensive areas beyond the survey boundaries. At the upstream end of the project, a small area of moderately deep Keefers loam (Km) occurred on the north side of the creek upstream of Red Bridge and beyond the levee (Figure 4). Most of the vegetation in the survey areas was growing on riverwash and Molinos soils.

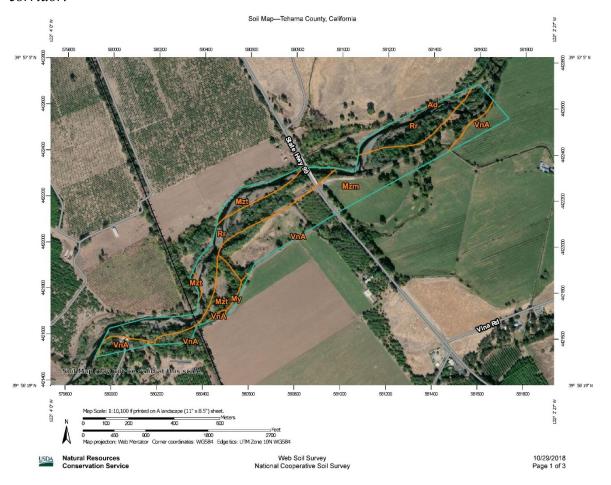
Figure 5. Soil map of downstream project area. Soil types are delineated in orange, and the approximate survey area is shown in teal. Riverwash (Rr) was the most abundant soil type in the survey area. Other soil types were predominantly in the Molinos series, including moderately deep Molinos fine sandy loam (Mzm) and channelized Molinos complex (Mzt). Vina loam (VnA) occurred in the agricultural lands outside of the riparian corridor.

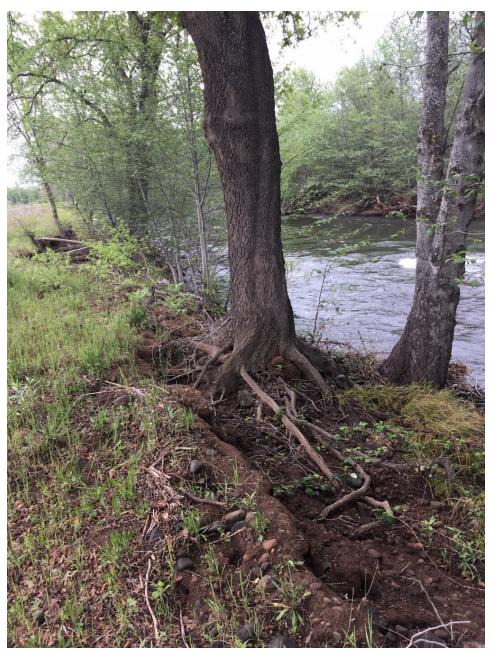
Figure 6. Legacy valley oak tree in a narrow band of Great Valley valley oak riparian forest growing on a levee on Deer Creek, showing highly exposed roots and the likelihood for scour once levees are set back. In this case, the Great Valley valley oak patch is a single tree wide, and the area of this sensitive natural community would be greatly reduced if the tree were lost to scour.

Following project implementation, the overall extent of the sensitive natural communities may decrease in the short term due to streambank erosion. The levee setbacks proposed between Red Bridge and the SVRIC Diversion Dam, and the flood easement on the north bank upstream of Red Bridge, will increase the floodway width and allow for natural channel migration. Several patches of sensitive natural communities occur on the levee banks and are only a single tree wide. Many of the legacy trees (i.e., 100 years or older) in these patches have at least half of their root volumes exposed (Figure 6) and will very likely be scoured away as the channel migrates into its wider floodway. While the restoration of this natural process is one of the objectives of the Deer Creek Flood and Ecosystem Improvement Project, it will result in localized loss of mature riparian trees that will take at least 50 years to replace structurally. However, the contribution of large wood to the channel will improve salmonid habitat and geomorphic processes that facilitate longterm riparian vegetation initiation, establishment, and resiliency. The sensitive natural communities in the survey area will also likely benefit from the increased area for colonization and growth, hydrologic connection between the floodplain and the channel, and increased in-channel substrate diversity.

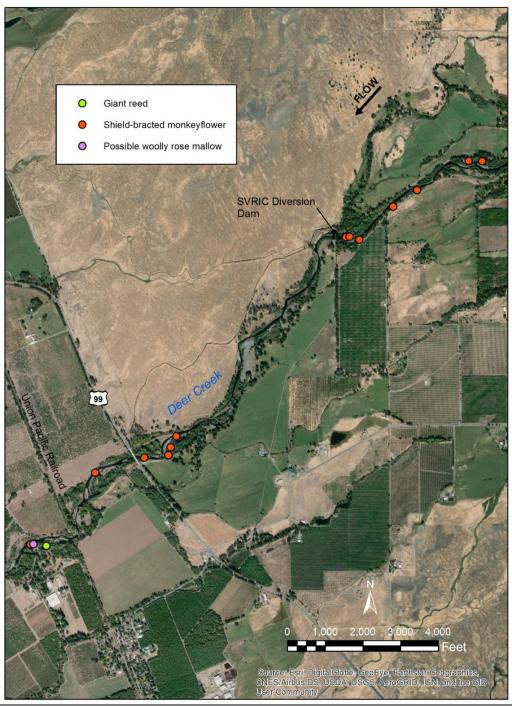
Figure 7. Locations within the four survey areas where rare and noxious weed species were encountered during rare plant and sensitive natural community surveys on Deer Creek in 2018. One potential rose mallow (Hibiscus lasiocarpos var. occidentalis) seedling was encountered downstream of the Union Pacific Railroad. Shield-bracted monkeyflower (Erythranthe glaucescens) was encountered as mostly scattered individuals throughout the survey areas downstream of Red Bridge.

During the summer survey, a seedling with the potential to be woolly rose mallow (*Hibiscus lasiocarpos* ssp. *occidentalis*) was observed (Figure 7). It had two heart-shaped leaves with irregularly dentate margins and palmate venation. The upper surface of each leaf was velutinous (i.e., velvety) and the underside had stellate hairs along the veins. This combination of traits strongly suggests the plant may have been woolly rose mallow. No mature individuals were identified during surveys. Woolly rose mallow blooms from June to September and has very showy, distinctive flowers that range from 2.5 to 4 inches wide. The summer survey occurred well within the blooming period and it is likely that mature individuals would have been located if they were present. Woolly rose mallow has a California Rare Plant Rank 1B.2 (Appendix B) and is protected under CEQA (Appendix B).

Within the four survey areas, 39 shield-bracted monkeyflower plants (*Erythranthe glaucescens*) were encountered (Figure 7, Figure 8, Appendix E). Shield-bracted monkeyflower has a California Rare Plant Rank 4.3 (Appendix B) and is recommended by CNPS for protection under CEQA (CNPS 2018). In the survey areas, shield-bracted monkeyflower occurred within the active channel, on cobble bars and streambanks, and in sand deposits near slow-moving or ponded backwater areas. Many plants occurred singly or in small groups, and it was possible to count all individuals encountered.

A single patch of giant reed (*Arundo donax*) was observed within the four survey areas (Figure 7). Giant reed is a non-native species designated as a noxious weed that threatens riparian areas by outcompeting native hardwoods, such as willows and cottonwoods (Cal-IPC 2009). It often forms dense monocultures and is extremely difficult to remove once established (DiTomaso et al. 2013). The giant reed patch was located near the proposed ring levee location on Monastery property. During any proposed heavy equipment activities, the patch of giant reed should be carefully removed and disposed of following the control method most likely to succeed under project-specific conditions (DiTomaso et al. 2013). A non-native plant management plan for the Deer Creek Flood and Ecosystem Improvement Project would help to improve the project outcome by reducing the risk of non-native plant invasion.

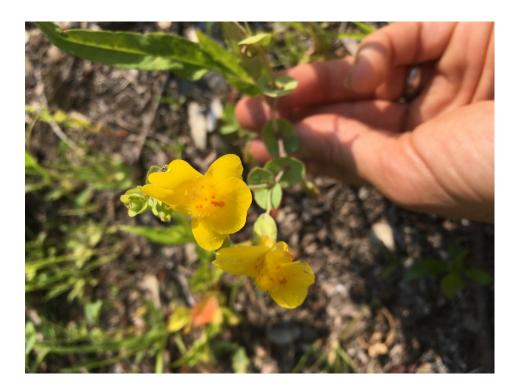
Figure 8. Shield-bracted monkeyflower (Erythranthe glaucescens) found on Deer Creek July 1–3, 2018. Note fused bracts below inflorescence. Shield-bracted monkeyflower has a California Rare Plant Rank of 4.3 (see Appendix B).

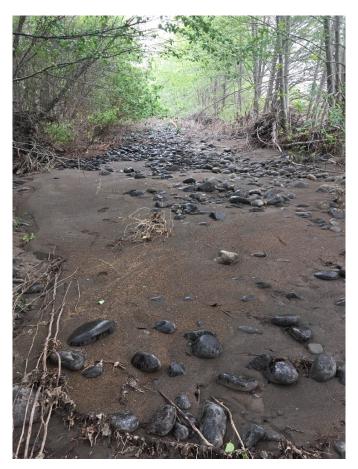
Figure 9. A high flow channel showing recent scour and deposition resulting from April 7, 2018, rainfall event. Photo taken April 10, 2018, when flows in the main channel of Deer Creek were approximately 1,000 cfs.

The spring survey on April 9–12 occurred two days after a spring rainstorm that caused Deer Creek flows to increase from approximately 500 cfs to over 3,000 cfs at the Deer Creek near Vina USGS gage. Flows had decreased to approximately 1,000 cfs at the start of the spring surveys and continued to decrease to around 700 cfs by April 12. During the April survey, much of the active channel showed very recent silt deposits and scour (Figure 9). Additionally, a large proportion of the riparian areas within each survey area was either under water or isolated by deep channels of flowing water and therefore inaccessible. Streamflows continued to recede gradually throughout the summer. The timing of the spring survey coupled with the timing of spring runoff may have reduced the ability to detect silky cryptantha (*Cryptantha crinita*), which blooms from April to May, and typically grows on gravelly streambanks (Table 3). Habitat for silky cryptantha was under water during the April survey, and silky cryptantha was no longer blooming during the July survey; therefore, it may not have been detected even if it was present.

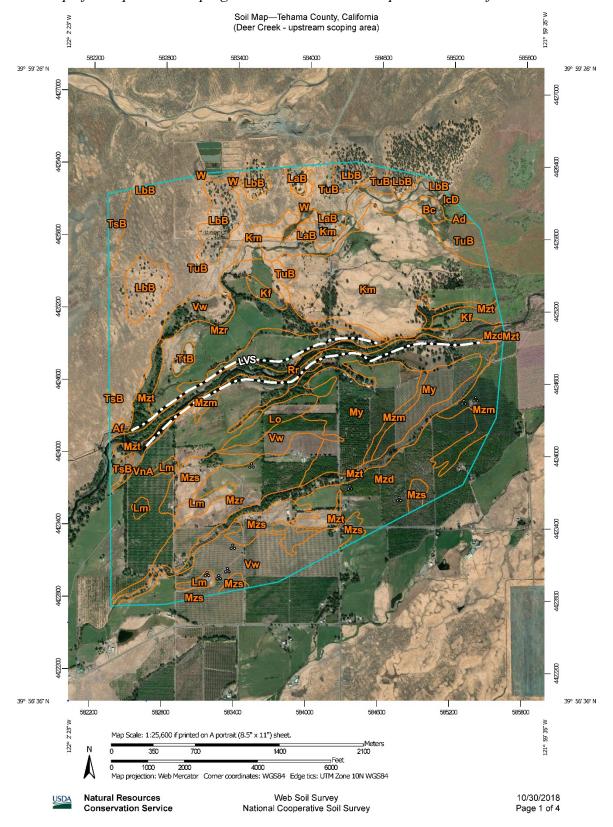
Soil map of the upstream scoping area on Deer Creek. Map codes can be found in Table 2.

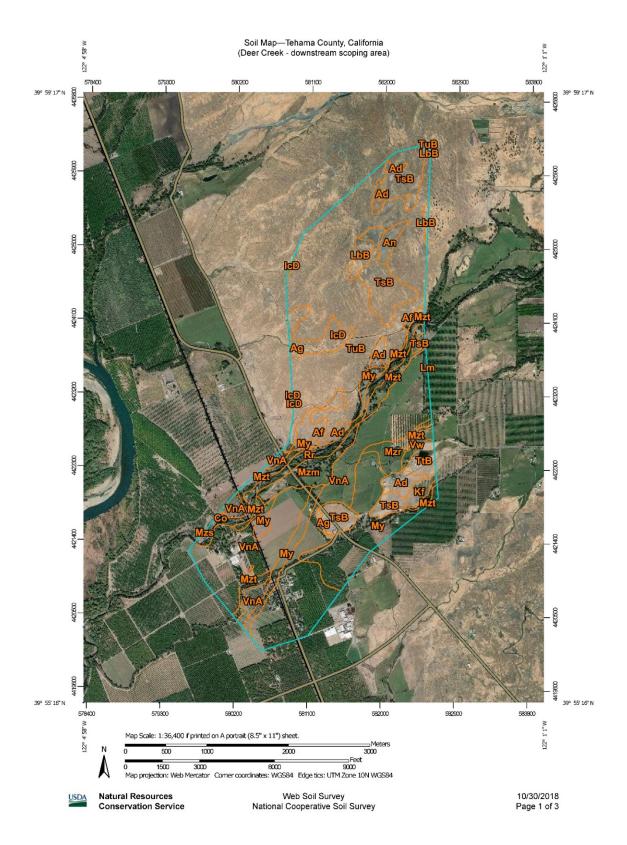
Soil map of the downstream scoping area on Deer Creek. Map codes can be found in Table 2.

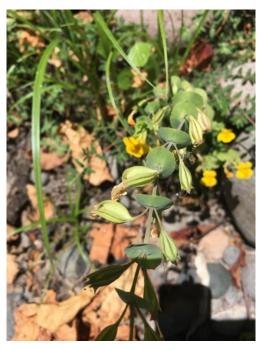
Shield-bracted monkeyflower (Erythranthe glaucescens) found on Deer Creek July 1-3, 2018. Note fused, glaucous bracts below inflorescence and asymmetric calyces.

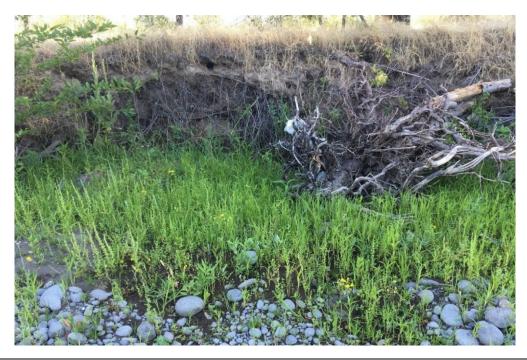
Shield-bracted monkeyflower (Erythranthe glaucescens) found on Deer Creek July 1–3, 2018. Approximately 20 plants growing on moist sand deposit on mostly open cobble bar.

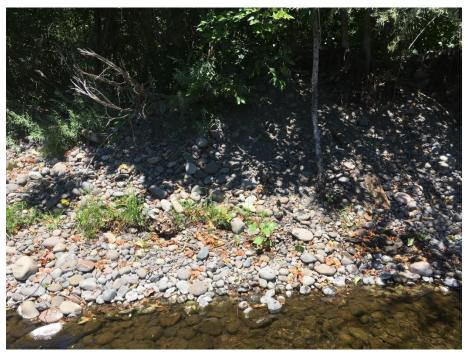
Shield-bracted monkeyflower (Erythranthe glaucescens) found on Deer Creek July 1-3, 2018. Two plants growing on cobbly edge of streambank within the active channel.

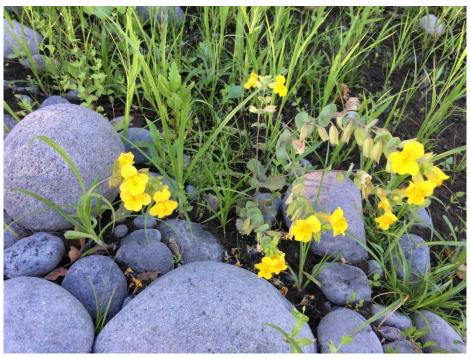
Shield-bracted monkeyflower (Erythranthe glaucescens) found on Deer Creek July 1–3, 2018. Growing on sparsely vegetated, moist sand deposit between large cobbles and boulders within the active channel.

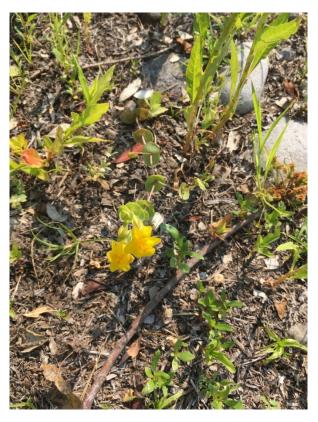
Shield-bracted monkeyflower (Erythranthe glaucescens) found on Deer Creek July 1–3, 2018. Growing on coarse organic material between large cobbles and boulders within the active channel.
