LOWER DEER CREEK FLOOD AND ECOSYSTEM IMPROVEMENT PROJECT GEOMORPHOLOGY ANALYSIS

Prepared for
Deer Creek Watershed Conservancy

Prepared by
FlowWest

April 20, 2021

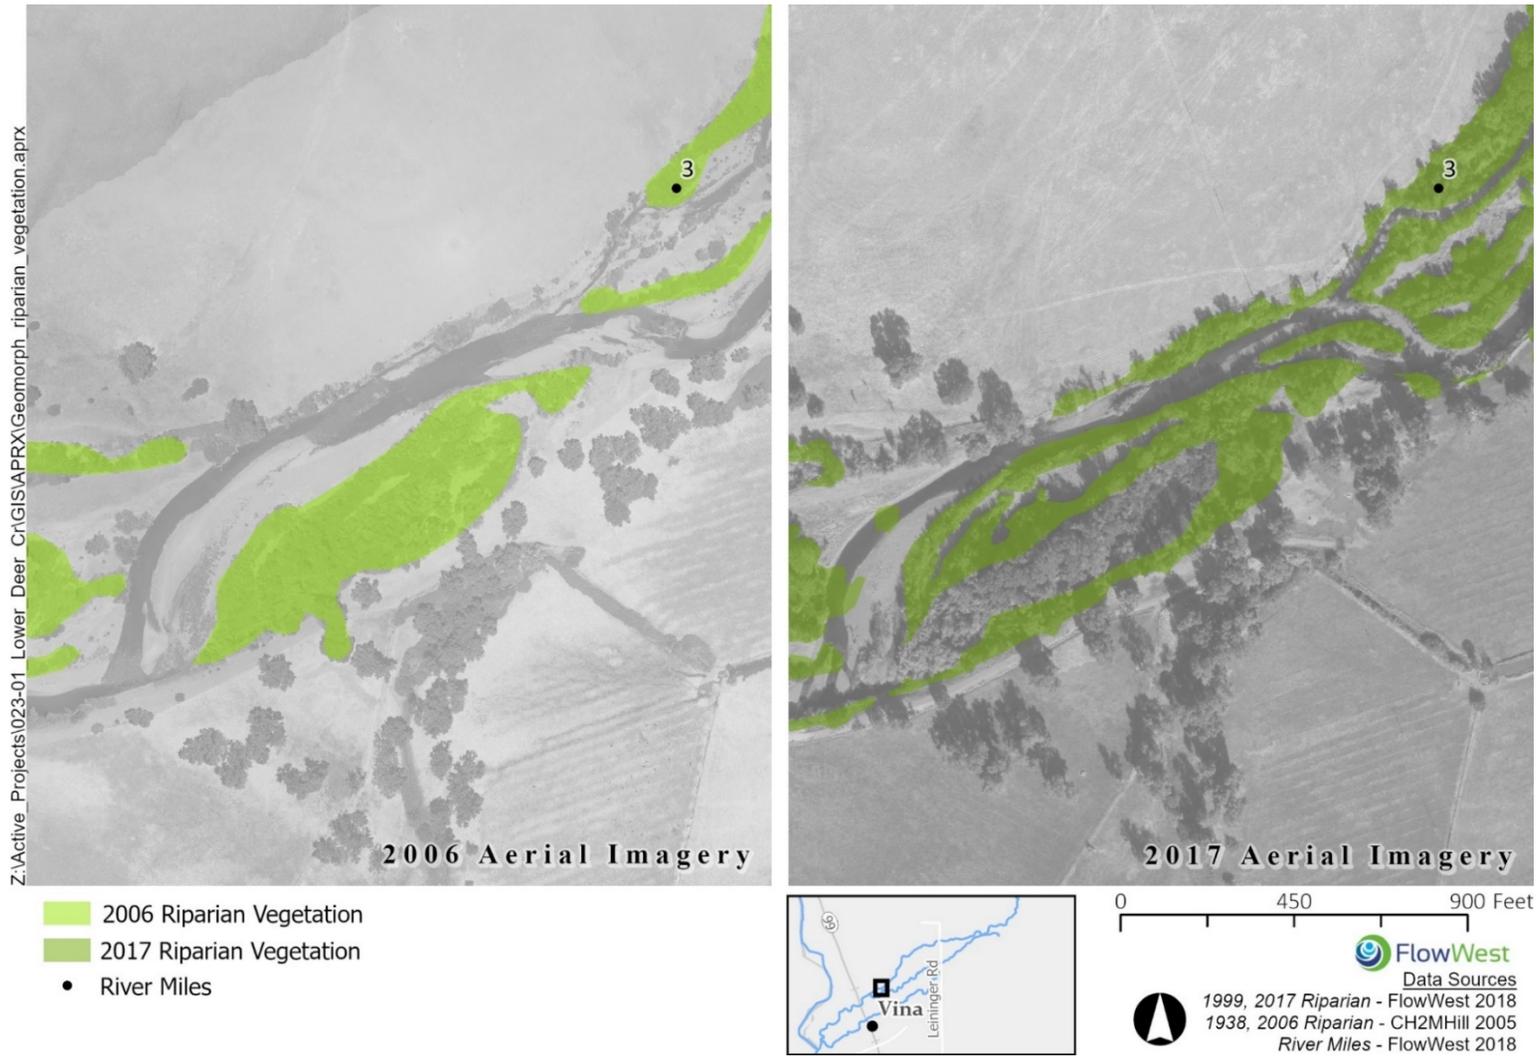
FIGURE 18: 2006 AND 2017 AERIAL IMAGES SHOWING THE CHANGE IN RIPARIAN VEGETATION FOR THE IN-LEVEE REACH AT RM 3. THE APPARENTLY VEGETATED AREA IN 2017 THAT WAS NOT DIGITIZED IS A RESULT OF A BUFFER FROM THE ACTIVE CHANNEL.
