# **500 EAST BASELINE ROAD RESIDENTIAL PROJECT AIR QUALITY, GLOBAL CLIMATE CHANGE, AND ENERGY IMPACT ANALYSIS**

City of La Verne

April 15, 2020

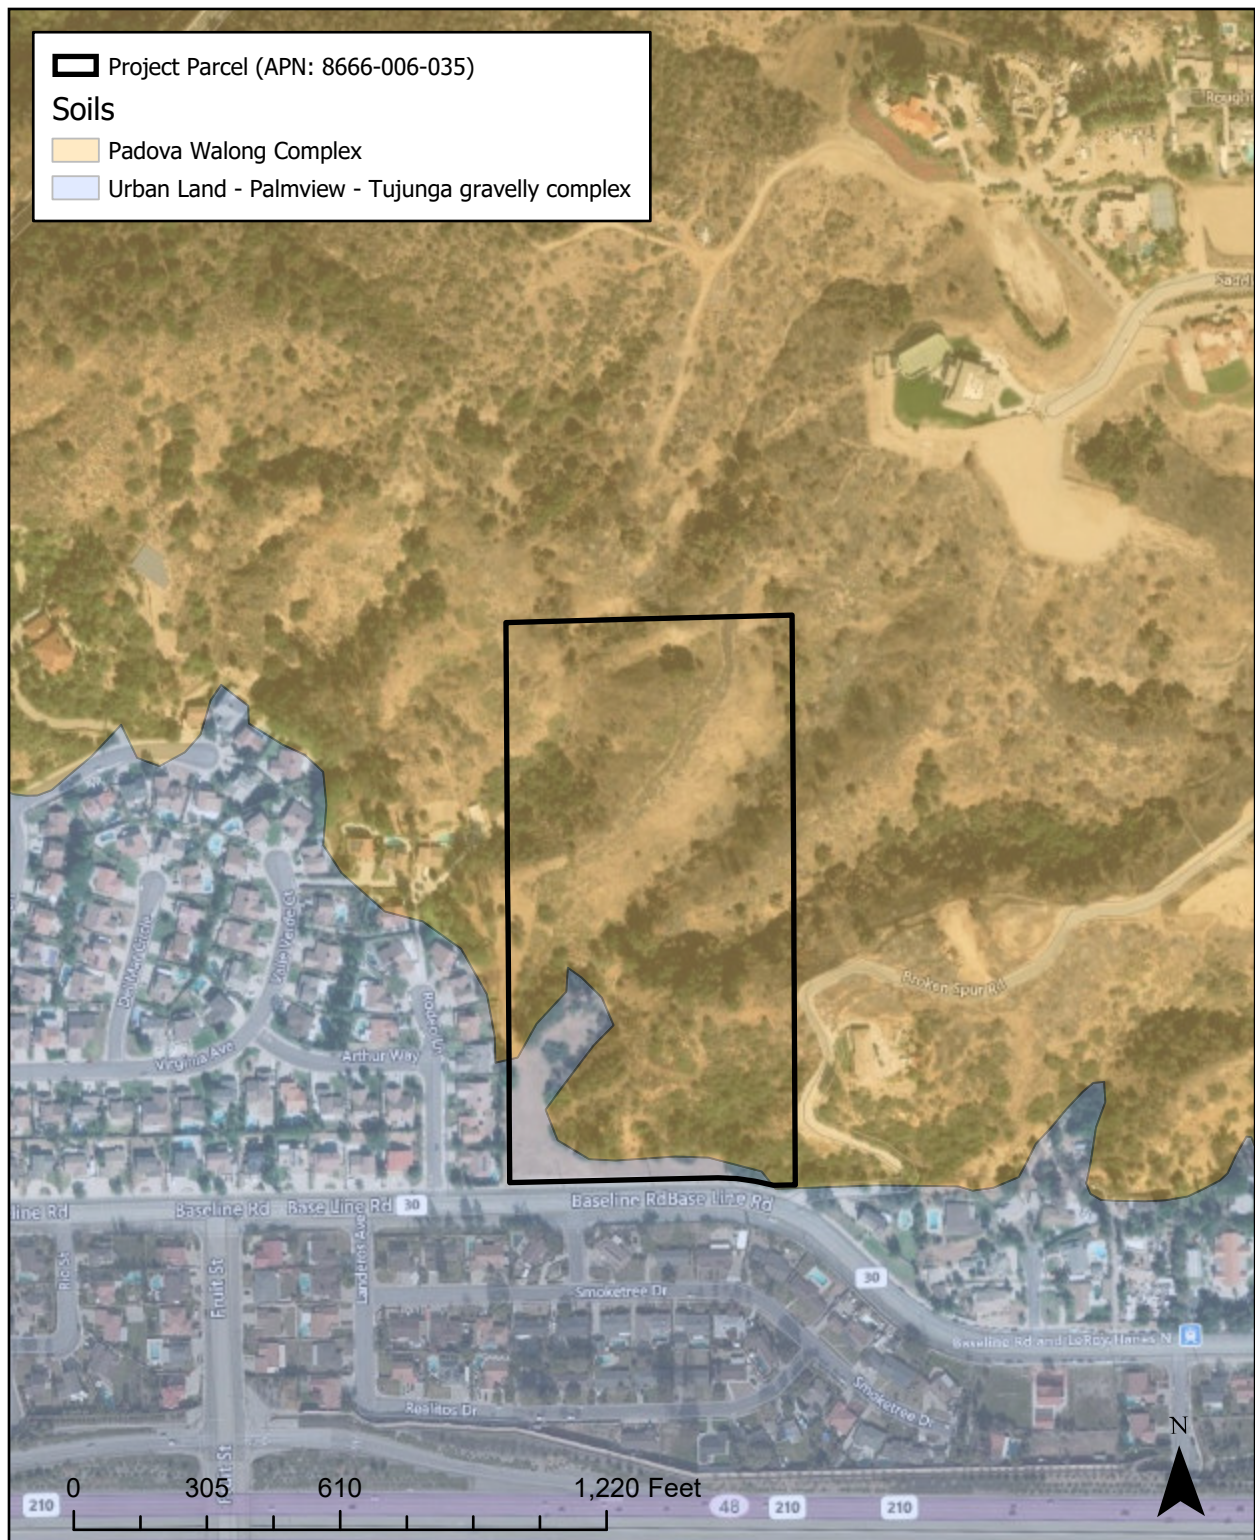
Figure 4. Soils

- **Padova-Walong complex, 30 to 85 percent slopes** occurs on the majority of the parcel in the steeper sloped areas. This soil complex consists of moderately deep to deep, well drained soils formed in residuum from gneiss and igneous rock and in material weathered from granite rock. These are upland soils that are found on foothills.
- **Urban land-Palmview-Tujunga, gravelly complex, 2 to 9 percent slopes** occurs to the flatter southwest corner of the parcel adjacent to the existing developments. This soil complex consists of very deep, well drained to somewhat excessively drained soils that formed in alluvium from granitic or related rock sources. These are gravelly soils that are typically found in alluvial fans and in floodplains.

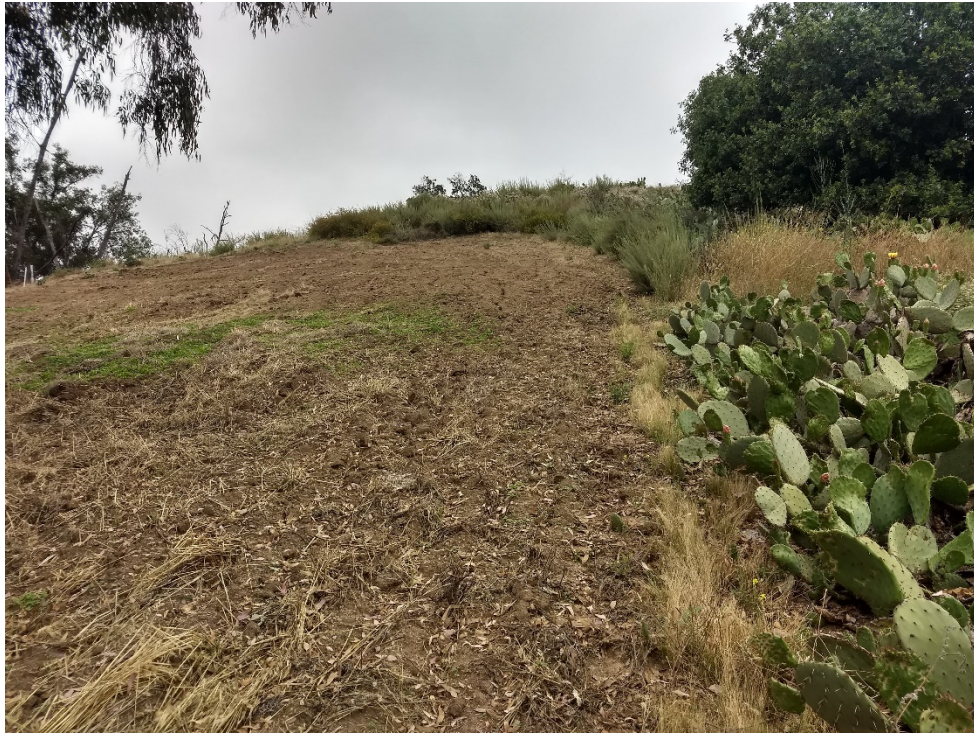
**Image 1:** Depicts the northernmost tilled areas that are subject to fuel modification from adjacent developments. Photo taken at the north end of the tilled area facing north.

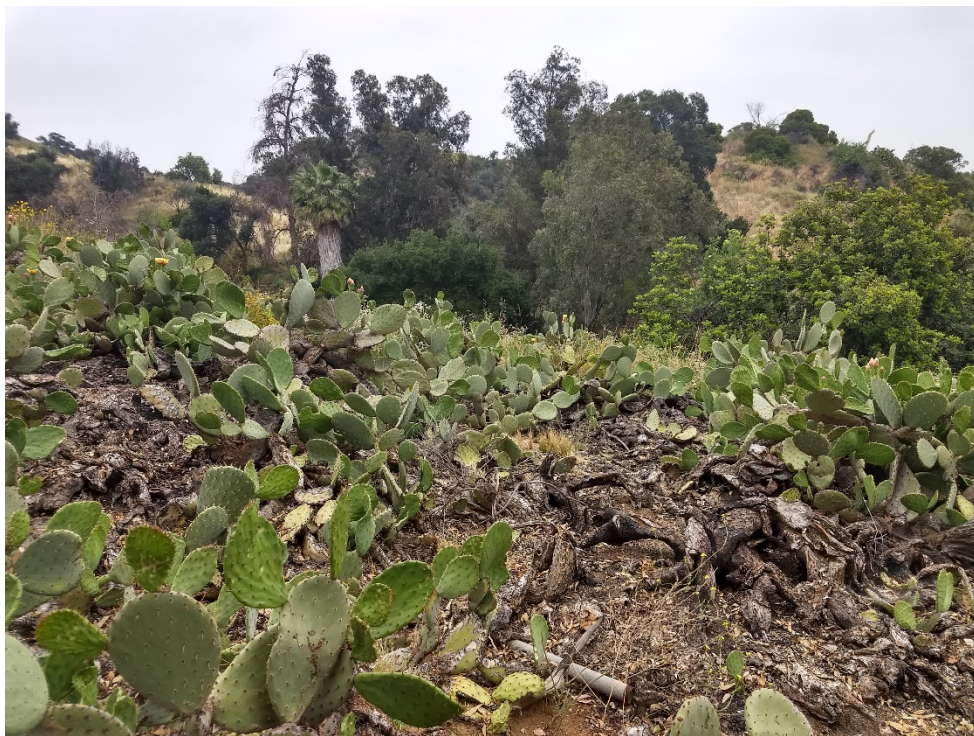
**Image 2:** Depicts the dense coast prickly pear where the coastal cactus wren nest is located. Photo taken from the edge of the tilled area facing southeast.

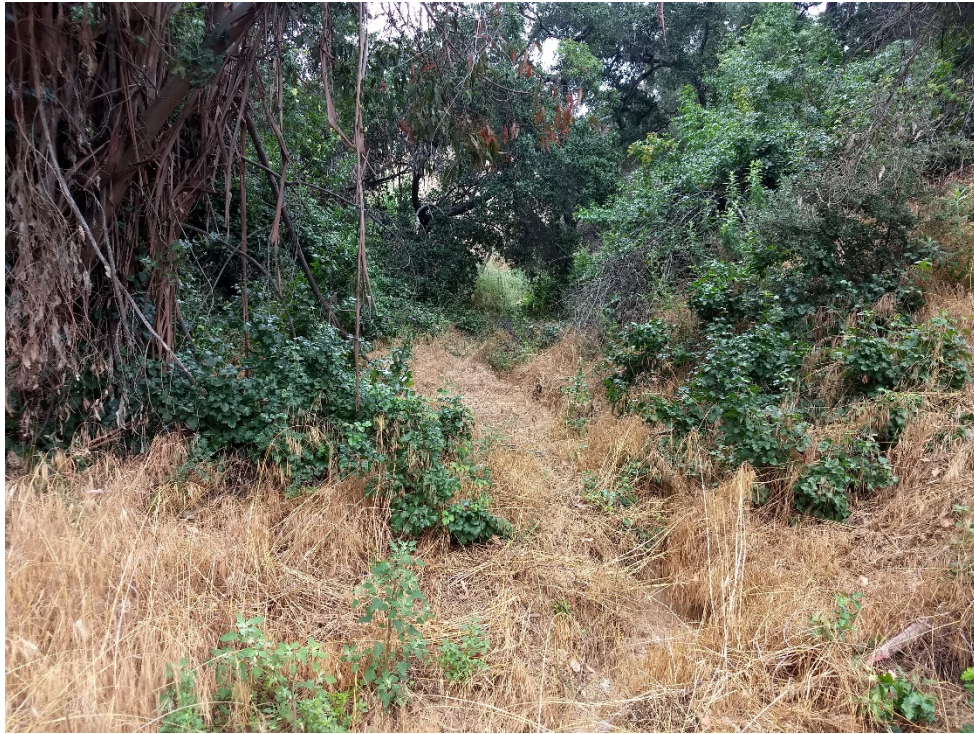
**Image 3:** Depicts Drainage 2 surrounded by poison oak, non-native grasses, and canyon live oak woodland. Photo was taken at the edge of the tilled area facing northeast.

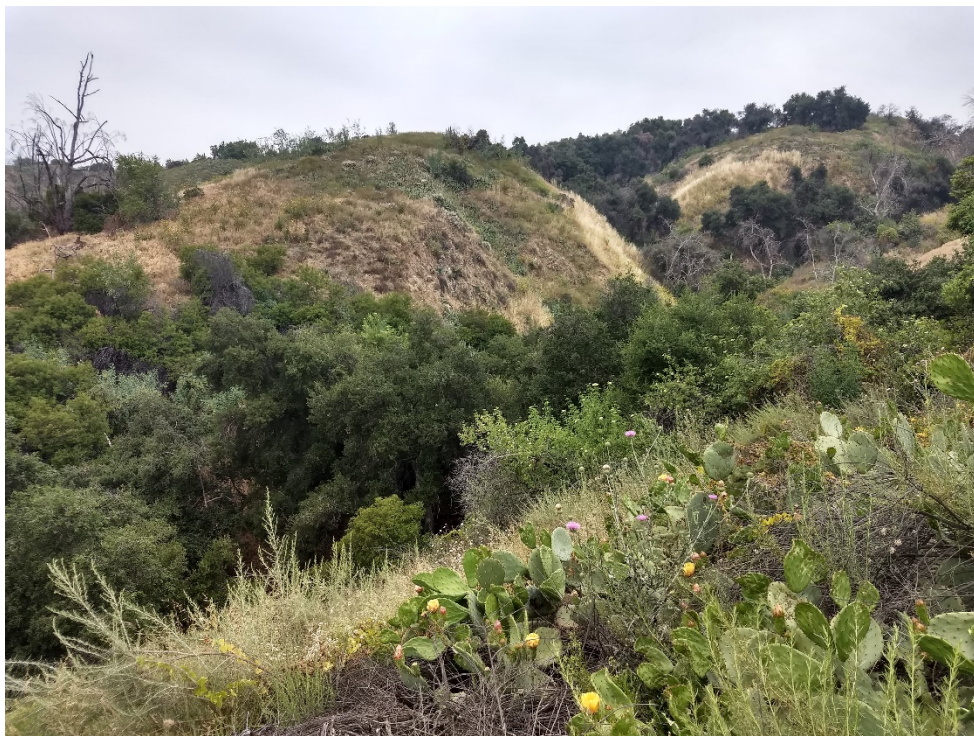
**Image 4:** Depicts the coast prickly pear scrub in the foreground and the canyon live oak forest in Drainage 1, which goes to a y-shape in the distance. The photo is taken from the north edge of the coast prickly pear facing northeast.

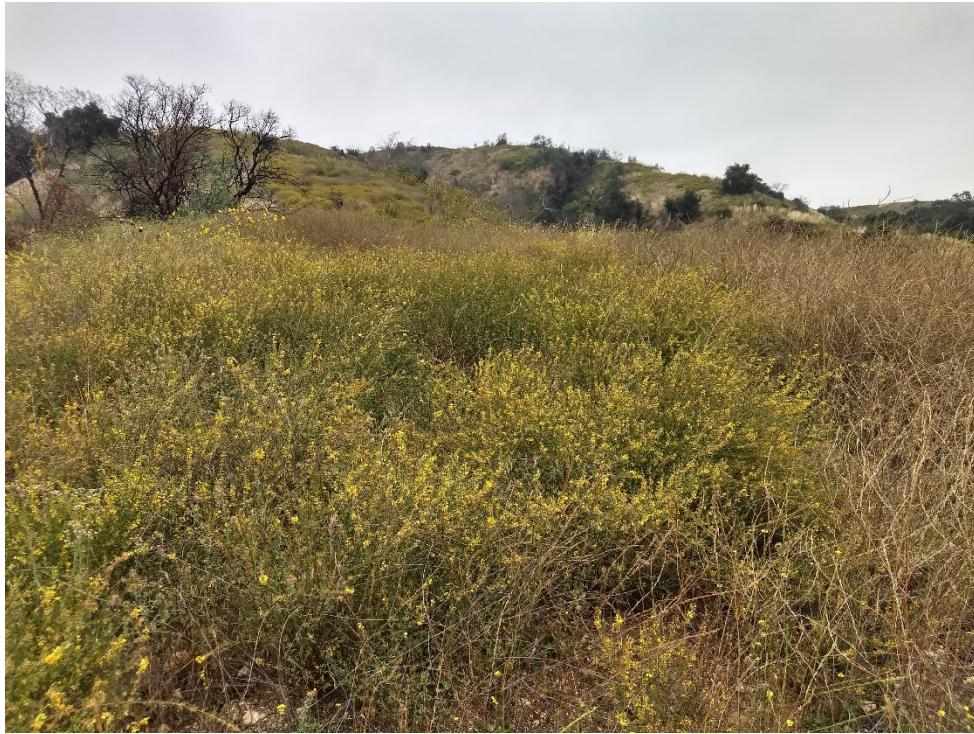
**Image 5:** Depicts the deer weed scrub and invasive mustard on the ridge in the center of the parcel. Photo taken from the center of the parcel facing northeast.

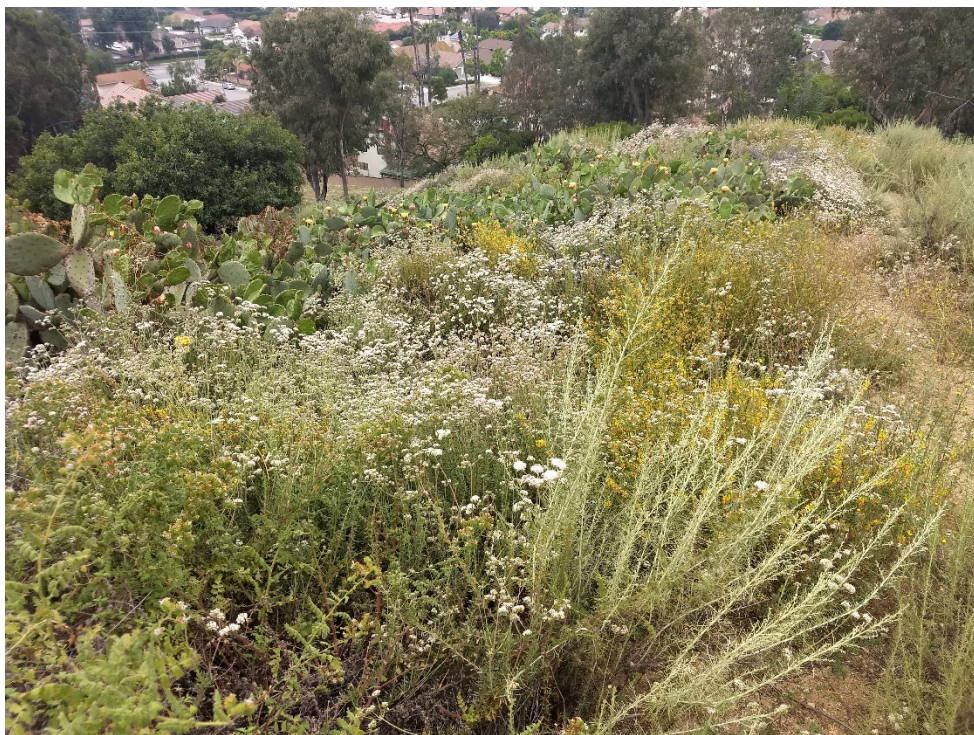
**Image 6:** Depicts diverse areas of the coast prickly pear scrub in full bloom. Photo taken from the ridge in the center of the parcel facing southwest.

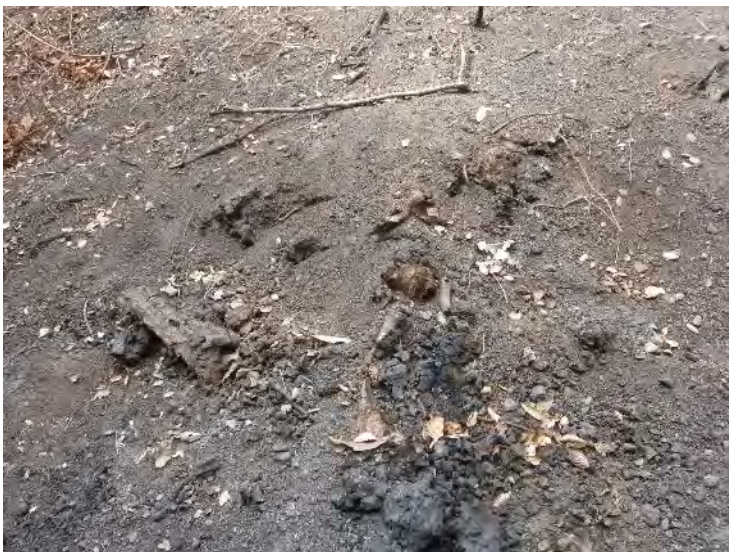
**TREE #28**  
(Gone – due to fire)

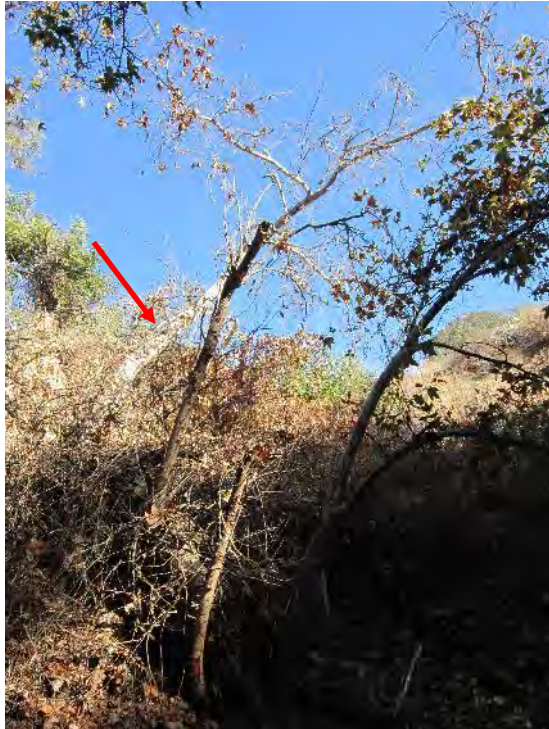
**TREE #30 (photo from 2014)  
(Gone – due to fire)**

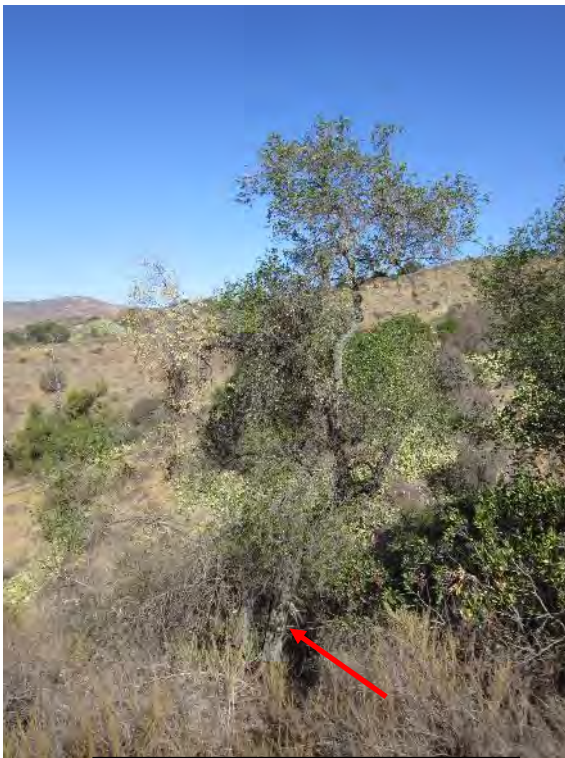
TREE #42 (photo from 2014)  
(Gone – due to fire)

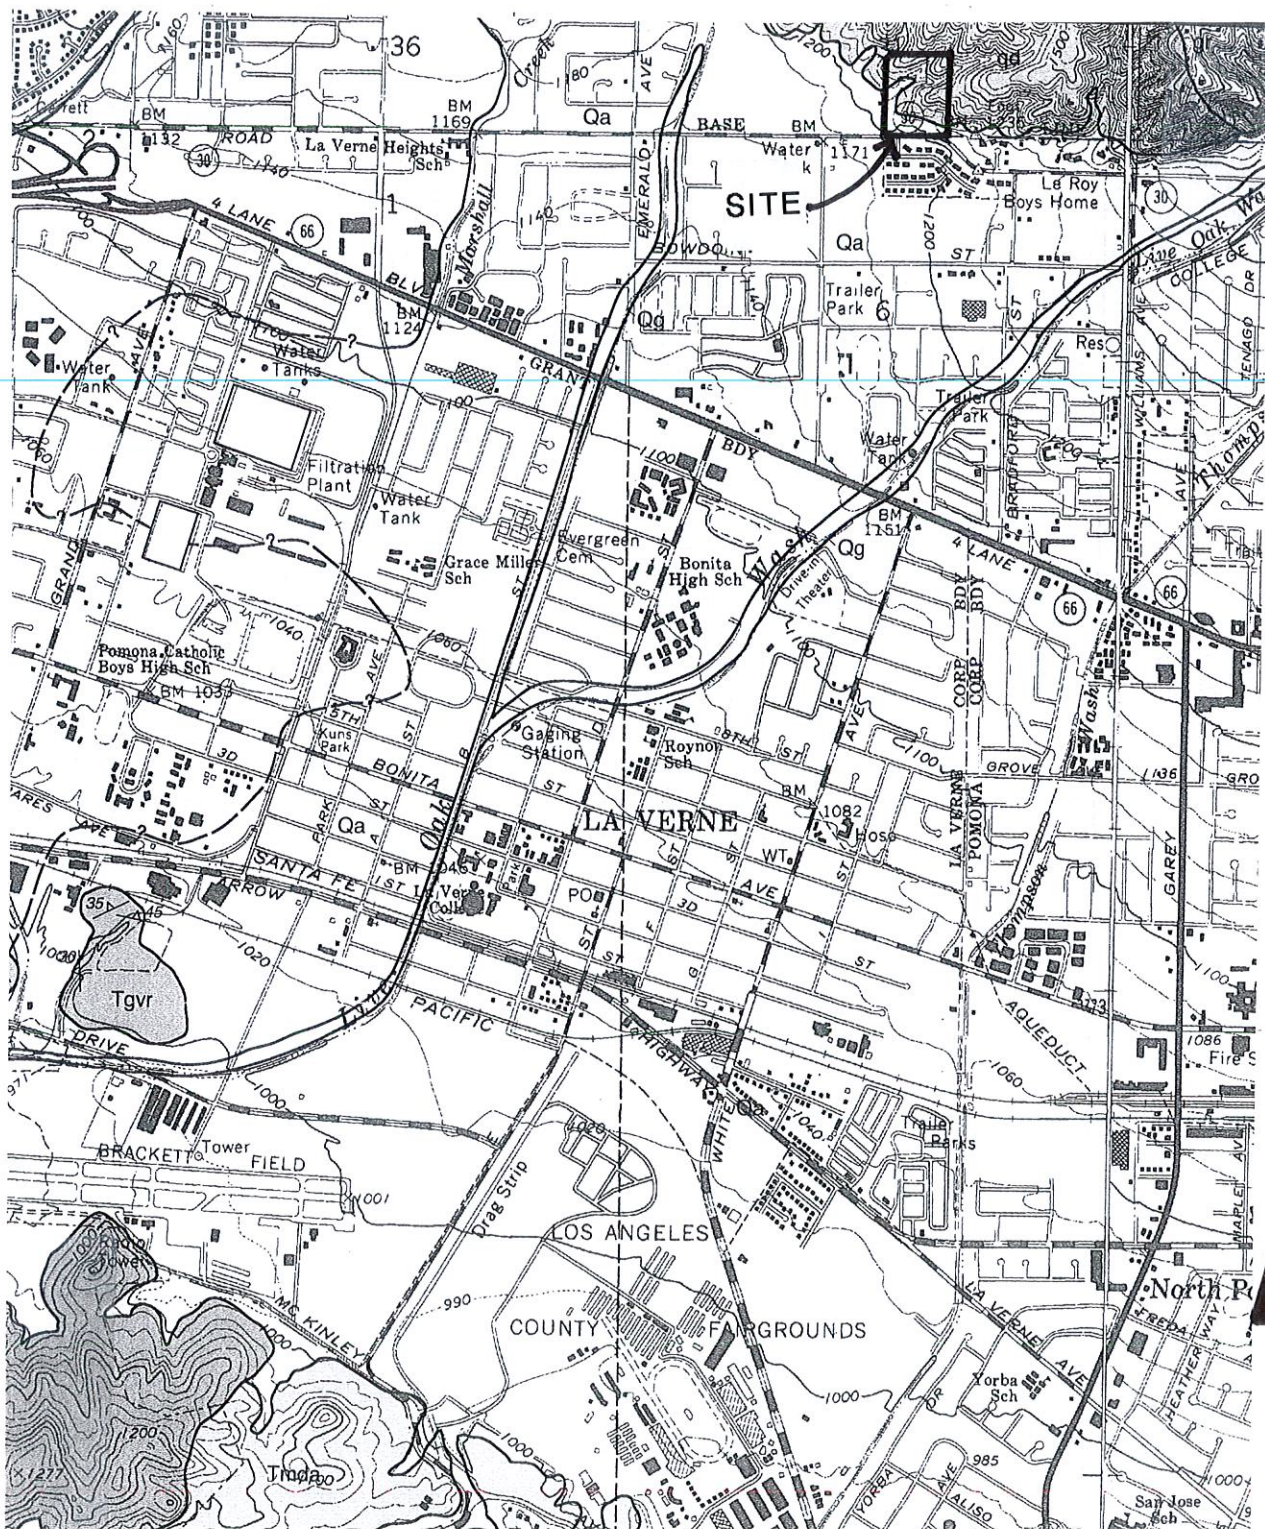
MODIFIED FROM DIBLEE, 2002

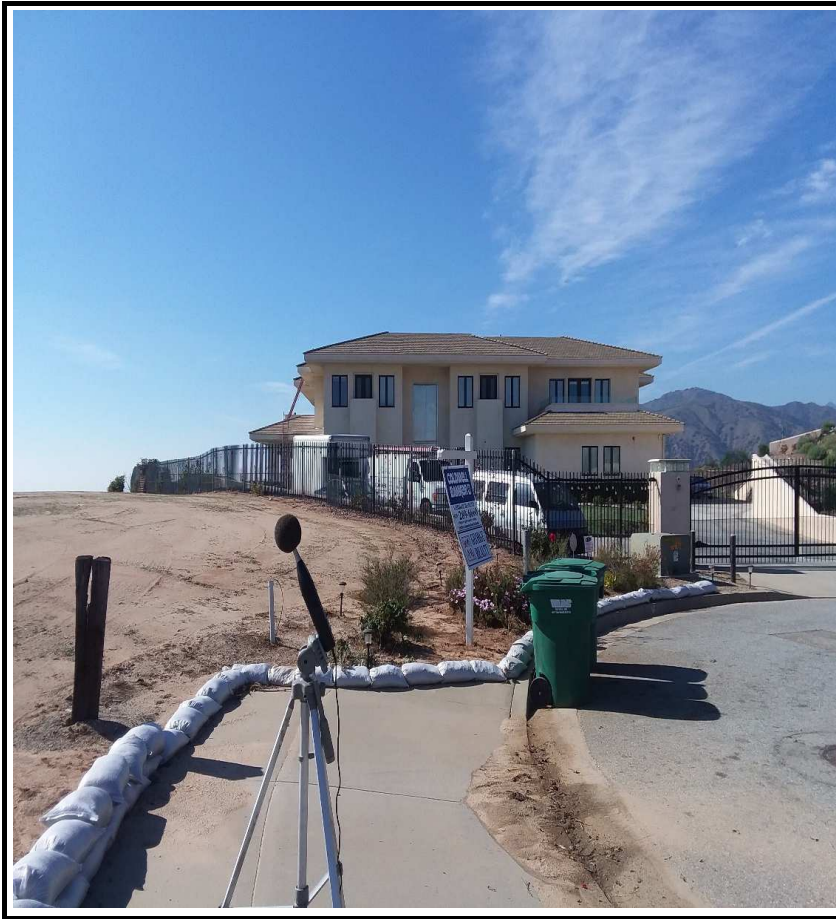
NM3 looking NW at residence 383 Saddle Horn Lane, La Verne.

Summary			
File Name on Meter	LxT_Data.365		
File Name on PC	SLM_0003099_LxT_Data_365.00.ldbin		
Serial Number	0003099		
Model	SoundTrack LxT®		
Firmware Version	2.301		
User	Ian Edward Gallagher		
Location	NM3 JN 19232 383 Daddle Horn Lane 34° 7'35.40"N 117°45'18.59"W		
Job Description	15 minute noise measurement ( 1 x 15 minutes )		
Measurement			
Start	2020-02-24 14:47:37		
Stop	2020-02-24 15:02:37		
Duration	00:15:00.0		
Run Time	00:15:00.0		
Pause	00:00:00.0		
Pre Calibration	2020-02-24 14:39:35		
Post Calibration	None		
Overall Settings			
RMS Weight	A Weighting		
Peak Weight	Z Weighting		
Detector	Slow		
Preamp	PRMLxT1L		
Microphone Correction	Off		
Integration Method	Linear		
OBA Range	Low		
OBA Bandwidth	1/1 and 1/3		
OBA Freq. Weighting	Z Weighting		
OBA Max Spectrum	Bin Max		
Overload	122.7 dB		
Results			
LAeq	48.0		
LAE	77.5		
EA	6.253 µPa²h		
EA8	200.092 µPa²h		
EA40	1.000 mPa²h		
LZpeak (max)	2020-02-24 14:54:38	101.3 dB

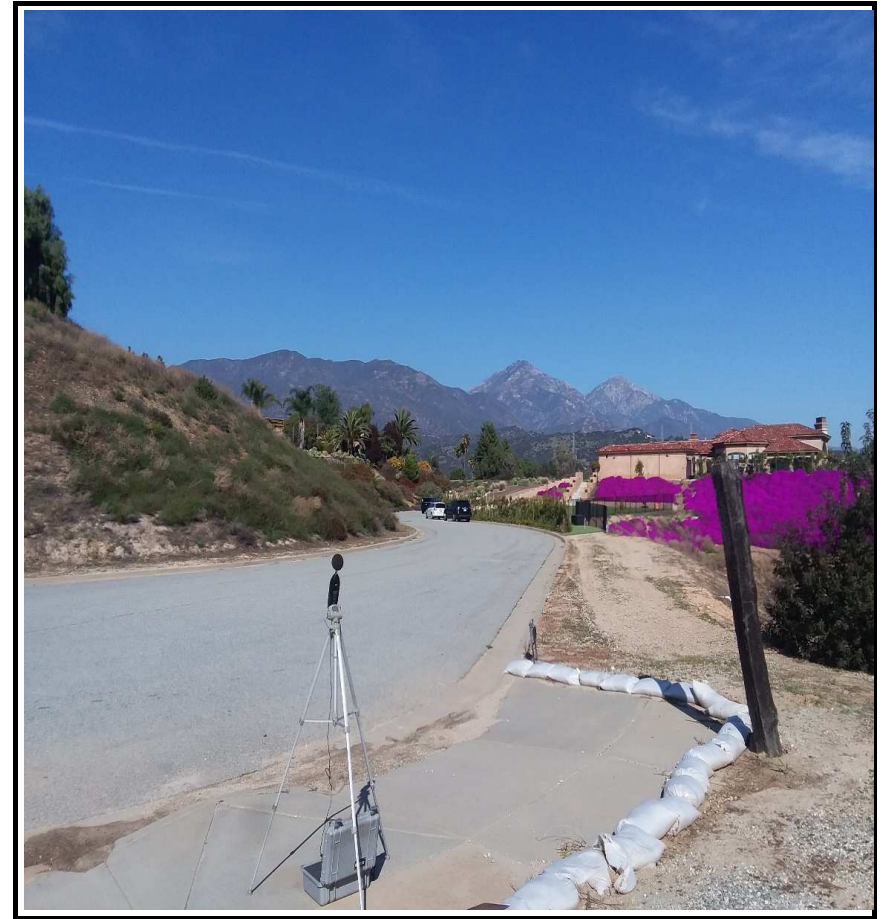
NM3 looking NE at residence 328 Saddle Horn Lane, La Verne.

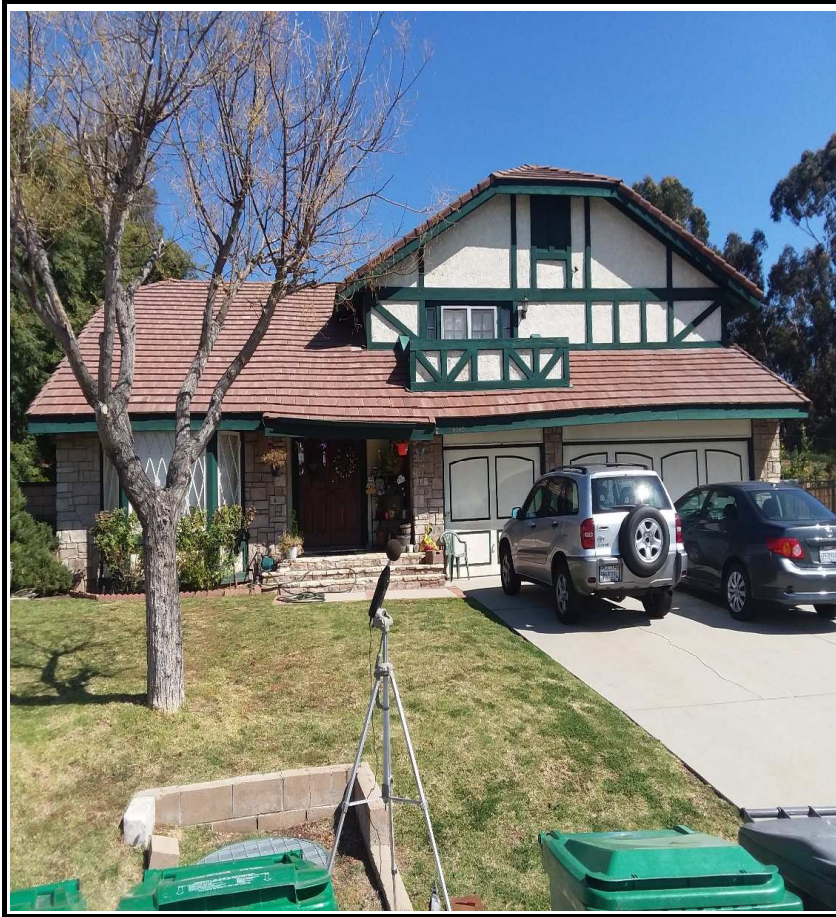
NM4 looking east at residence 4746 Rodeo Lane, La Verne.
