INVESTIGATION OF POTENTIAL WATERS OF THE UNITED STATES LA PALOMA-ROBLEDA PATHWAY TOWN OF LOS ALTOS HILLS, CALIFORNIA

October 5, 2020

PN 2495-01

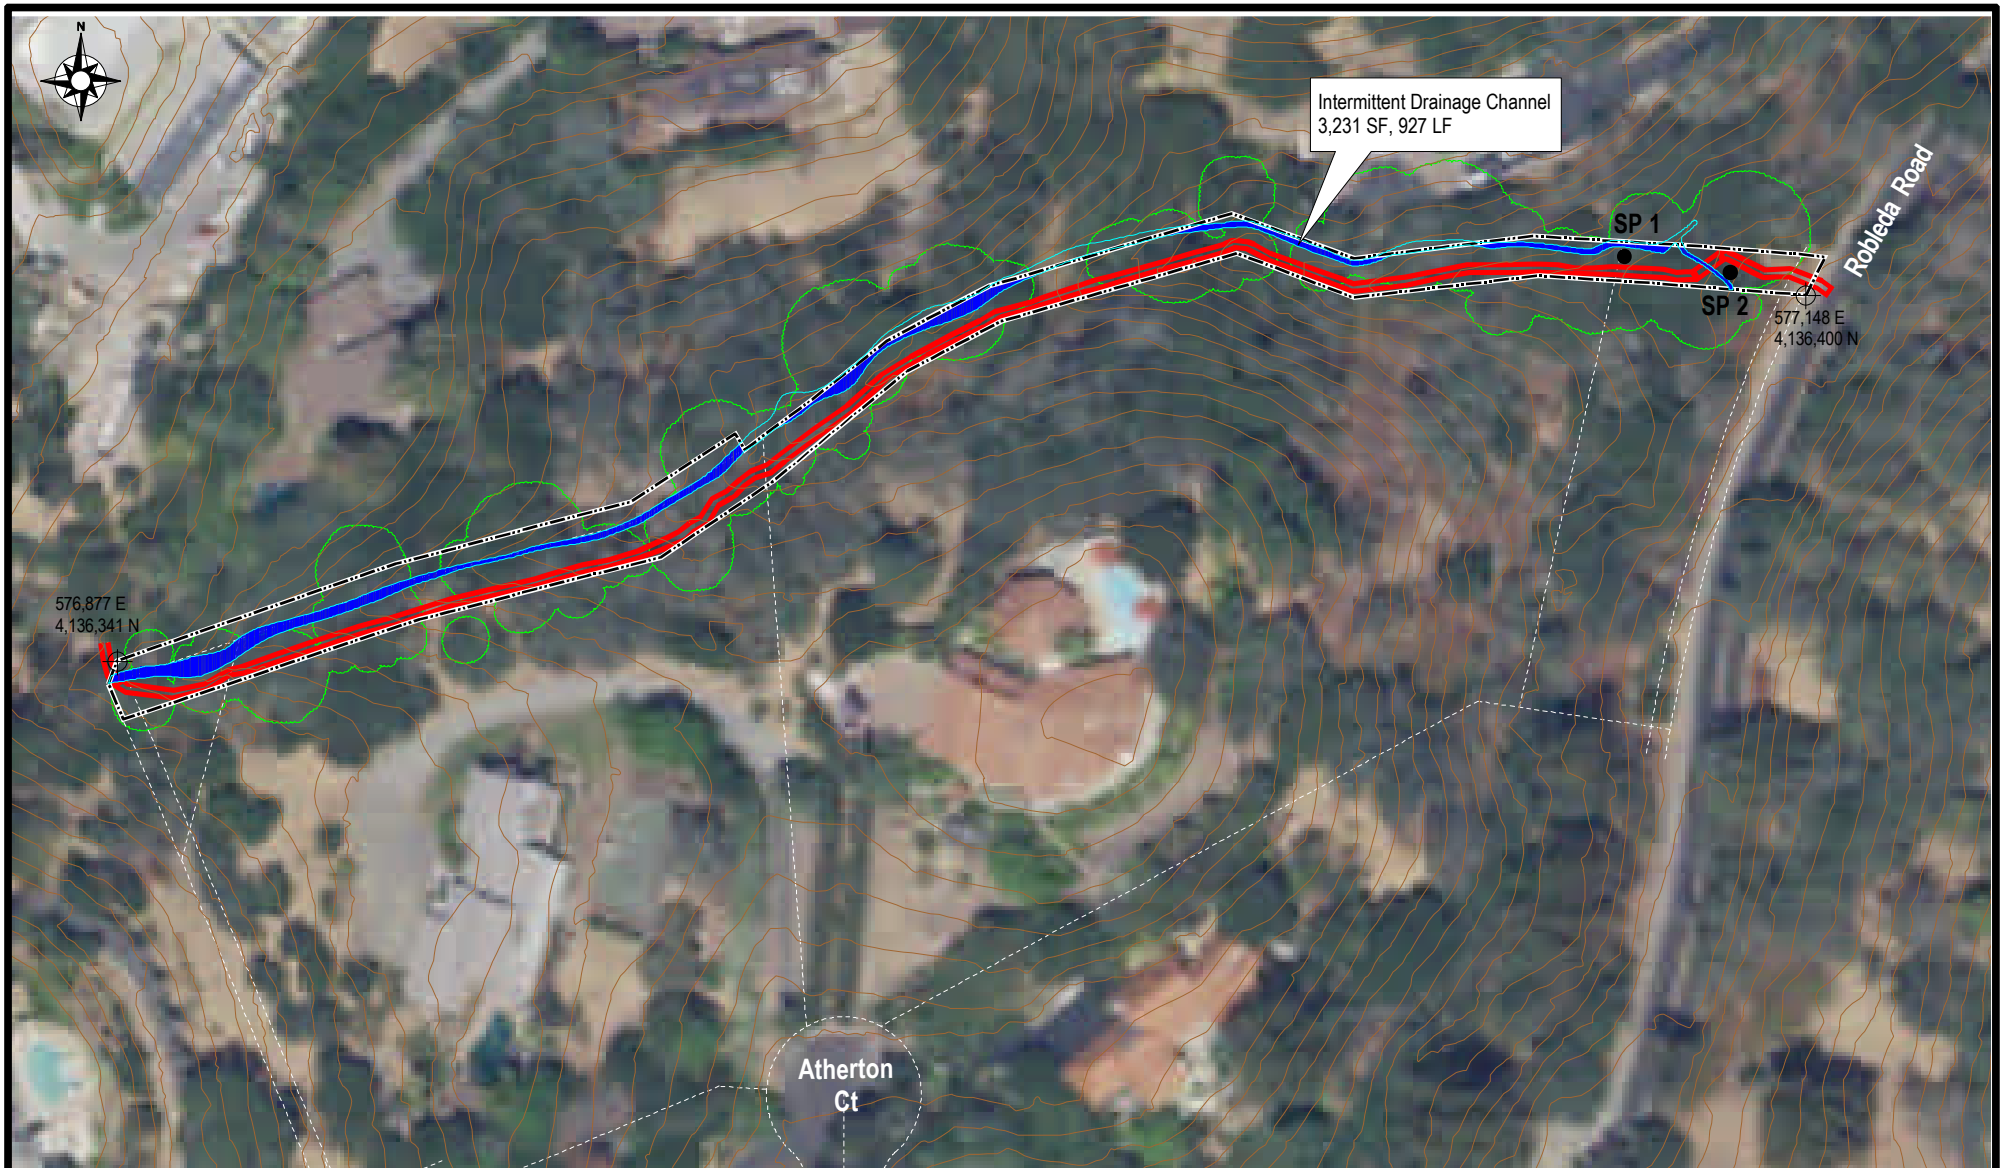
Live Oak Associates, Inc.		
	La Paloma-Robleda Pathway Potential Waters of the U.S.		
Date 8/26/2020	Project # 1851-01	Figure # 4

The only potential water of the U.S. occurring within the study area is the unnamed intermittent drainage channel (Figure 4). The reach of channel occurring onsite is approximately 927 ft in length and has an average width of 4.75 feet at its ordinary high water mark (OHW). The approximate area of the channel occurring below the OHW is 3,231 square feet (0.07 ac). Further details documenting onsite hydrological features using the Cowardin System is provided in the USACE Aquatic Resources Table found in Appendix C (Cowardin et al. 1979).

Intermittent Drainage Channel
(3,231 SF / 0.07 Acres 927 LF)

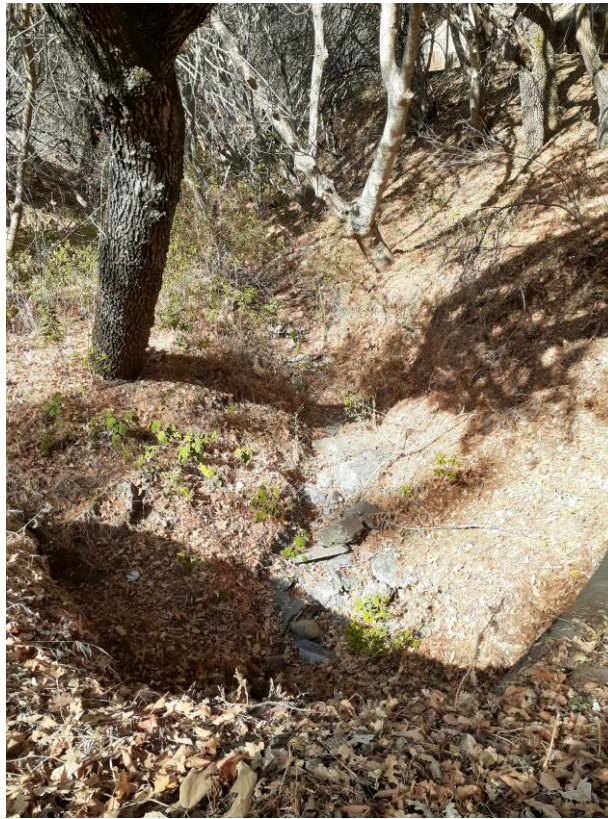
The onsite intermittent drainage channel is a tributary to Adobe Creek that flows into the San Francisco Bay, a navigable water of the U.S. The intermittent drainage conveys water to an unnamed channel adjacent to Robleda Road. The USGS National Map and Hydrography dataset (Appendix D) identifies the unnamed channel as a tributary to Adobe Creek. The USFWS National Wetlands Inventory (NWI) map does not identify the onsite channel as an in-stream wetland (Appendix E). Photos of the intermittent drainage channel and sample points are provided in Appendix F.

Photo 1: Overview of intermittent drainage channel at its highest point (78 m) by Atherton Court.

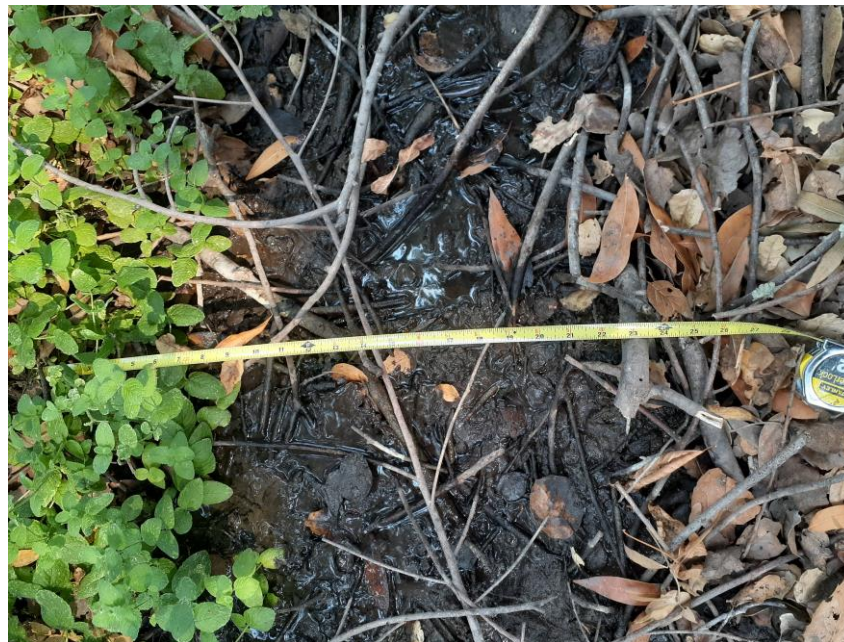
The channel did not meet all of the technical criteria for wetlands within the ordinary high water mark (OHW) on opposing banks as shown in sample point 1. While the channel met the soil and hydrology indicators of a wetland, the channel did not meet the criteria for hydrophytic vegetation. Although some hydrophytic vegetation species occurred in the channel's upper margins, the channel bed was largely devoid of vegetation and hydrophytic vegetation coverage was insufficient to pass the hydrophytic vegetation dominance and prevalence index test. Some of these species, along with their wetland indicator status, included poison oak (*Toxicodendron diversilobum*) (FACU), flat sedge (*Cyperus eragrostis*) (FACW), and several species of rushes (*Juncus* spp.) (FACW).

Soils had a sandy texture and were saturated at the time a soil pit was dug at sample point 1. The soil profile at sample point 1 had a moist Munsell color notation of 10 YR 2/1 in the first inch and Gley 1 2.5/N between 2-12 inches in depth. These soils would be considered a sandy mucky mineral, which is a primary indicator of hydric soils. Primary wetland hydrology indicators present in the channel included surface water and water-stained leaves. The channel also

Photo 2: Intermittent drainage channel with saturated soils and water pooling in downstream locations near Robleda drive (sample point 1).

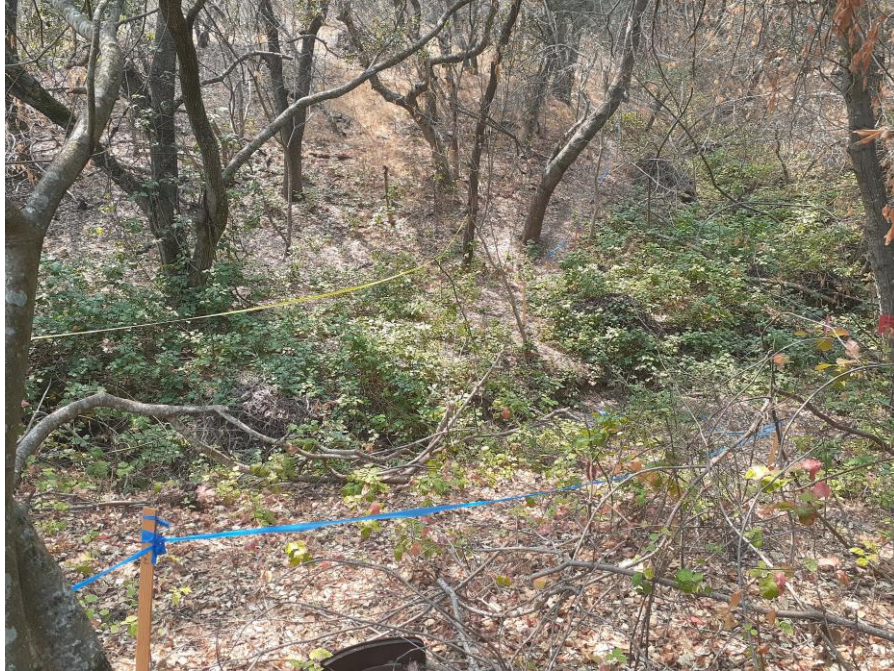
Areas above the OHW level of the intermittent drainage channel were comprised of upland habitats that did not meet any of the definitions of a jurisdictional water of the U.S. (Figure 4; Sample Point 2). The dominant plant species in the understory consisted of poison oak. Dominant species in the overstory consisted of coast live oak (*Quercus agrifolia*) (UPL), California bay (*Umbellularia californica*) (FAC), and buckeye (*Aesculus californicus*) (UPL). Soils had a moist Munsell color notation of 10 YR 3/2 at 0-14 inches in depth with no presence of redoximorphic features nor any other hydric soil indicators. Indicators of wetland hydrology were absent.

Photo 3: Upland areas of the site displaying coast live oak riparian woodland and forest community.

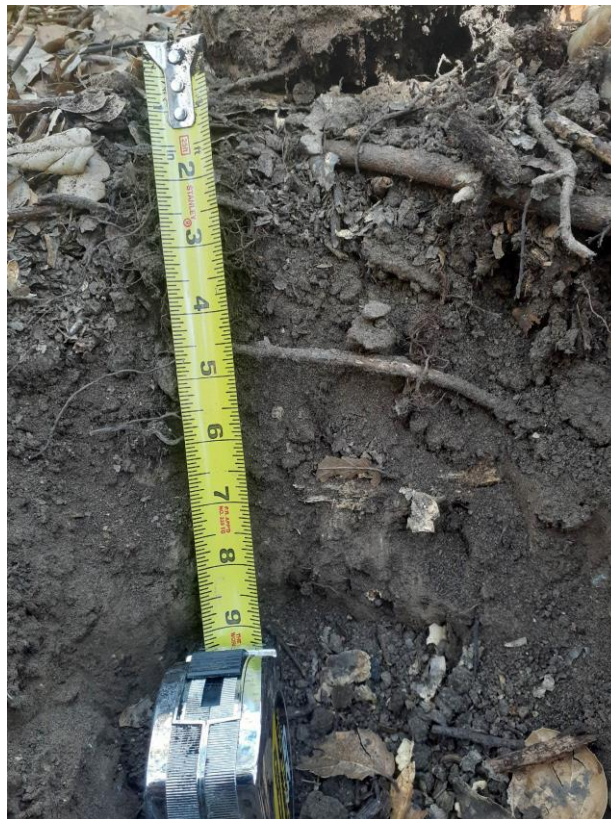
Photo 4: Soils profile at sample point 2 displaying Munsell color notations of 10 YR 3/2 and representing upland areas of the site
