**TO:** Tom Lagerquist, Parus Consulting  
**FROM:** Patrick Cuthbert  
**DATE:** October 26, 2020  
**SUBJECT:** Biological Assessment of Fisheries Resources Near the Mormon Slough  
Erosion Repair Project

### **Project Description**

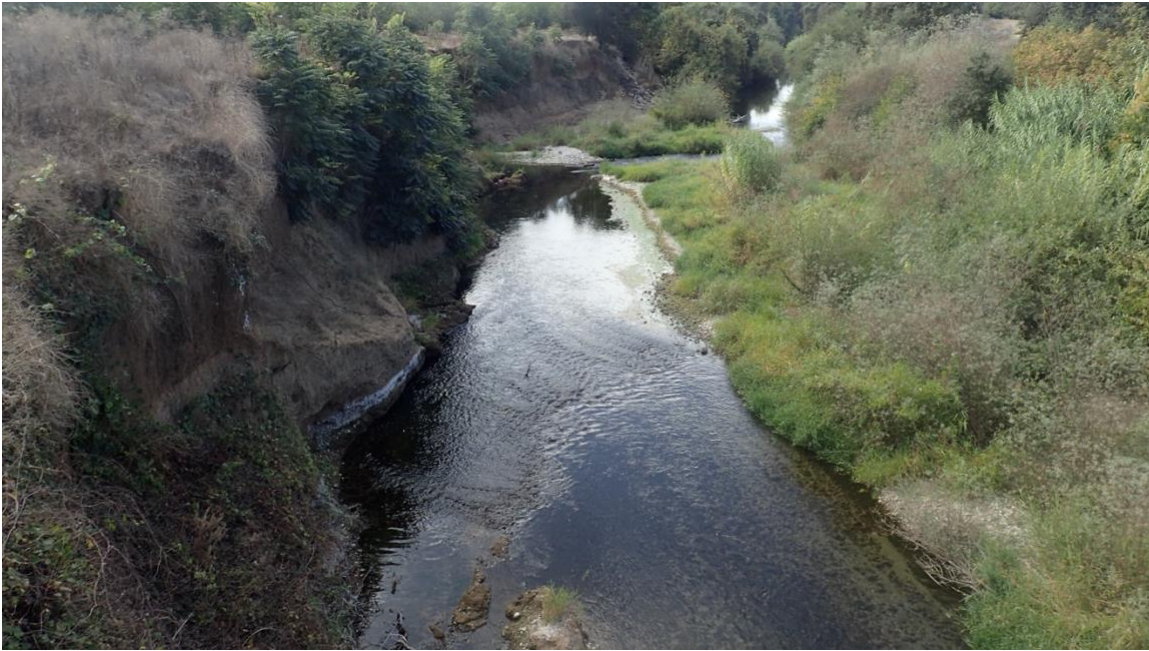
**Figure 1A. View of the project area looking downstream from the Escalon-Bellota Rd. Bridge.**

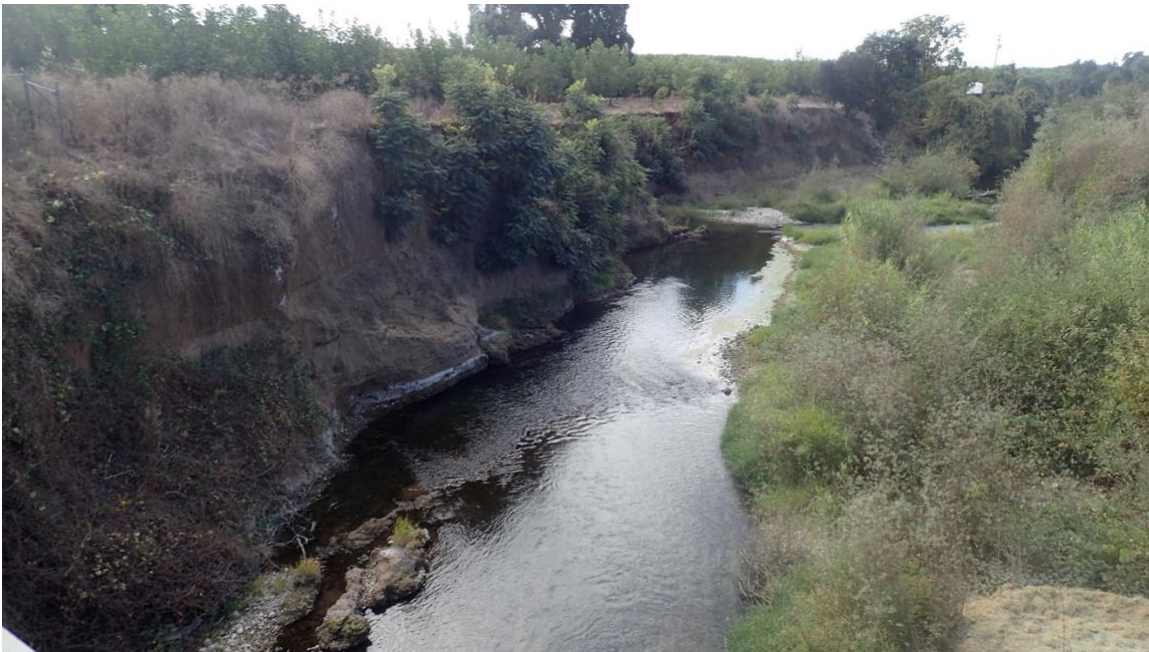
**Figure 2A. Better view of the south bank where evidence of bank shearing has occurred. This has led to the increase of sediment inputs in the thalweg.**

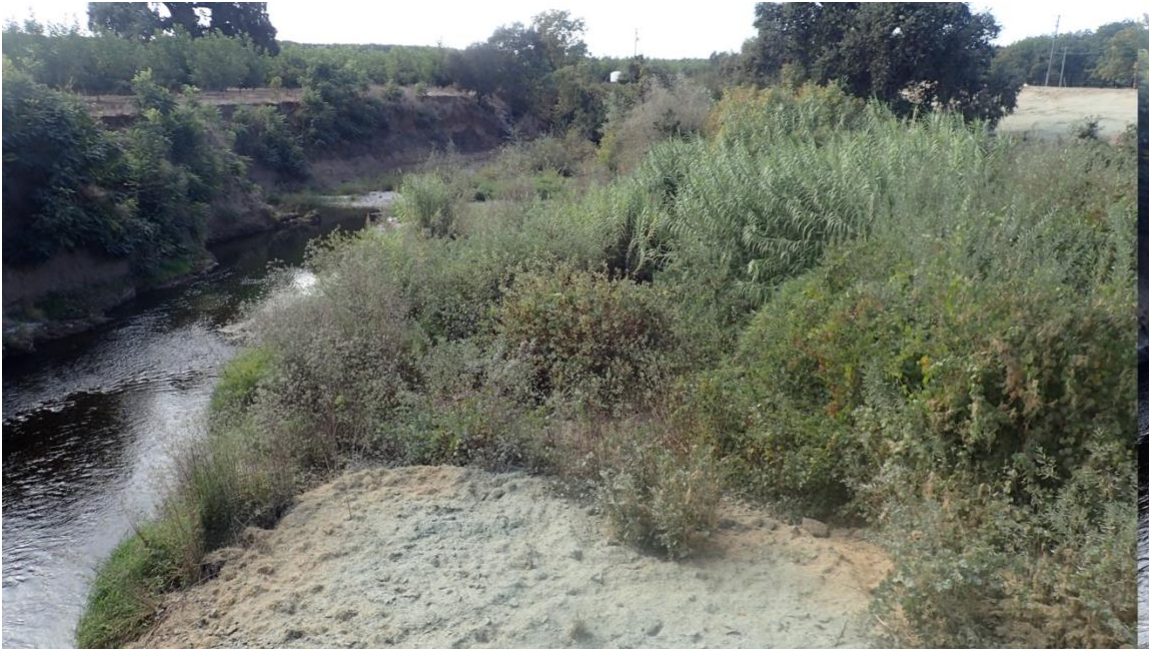
**Figure 3A.** Some repair work (clearing of a work area) appears to be completed on the north bank just below the bridge. Bank dominated by mixed vegetation, primarily composed of willow and Himalayan blackberry.

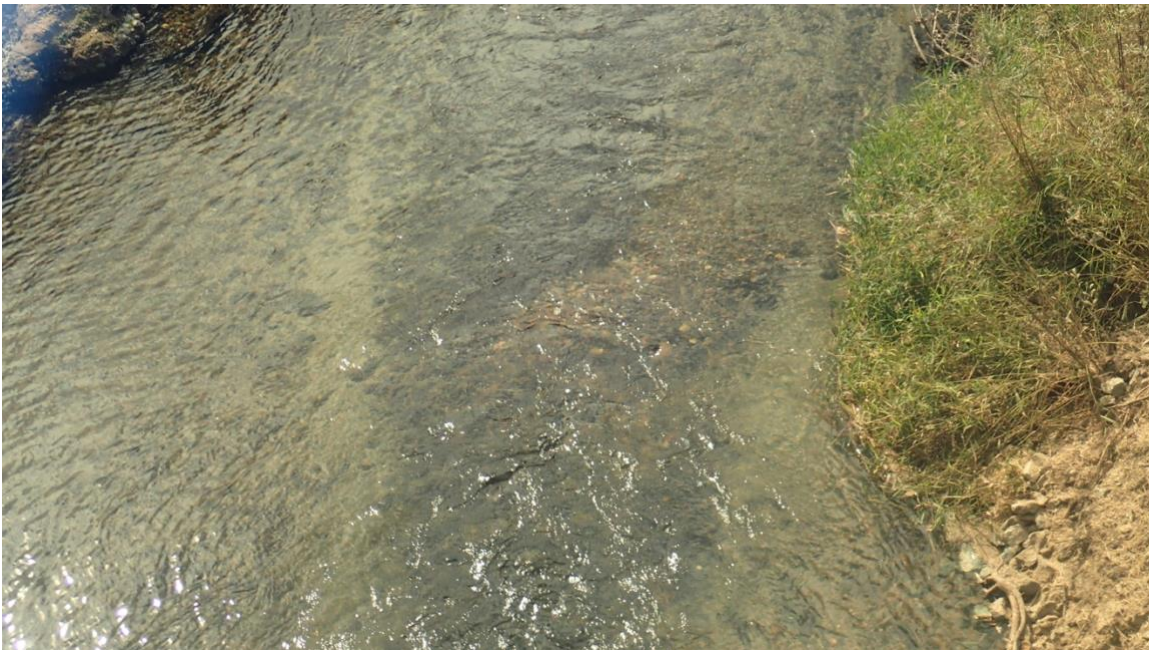
**Figure 4A.** Example of current substrate composition present within the work area. Sparse gravel with sandy substrate throughout.

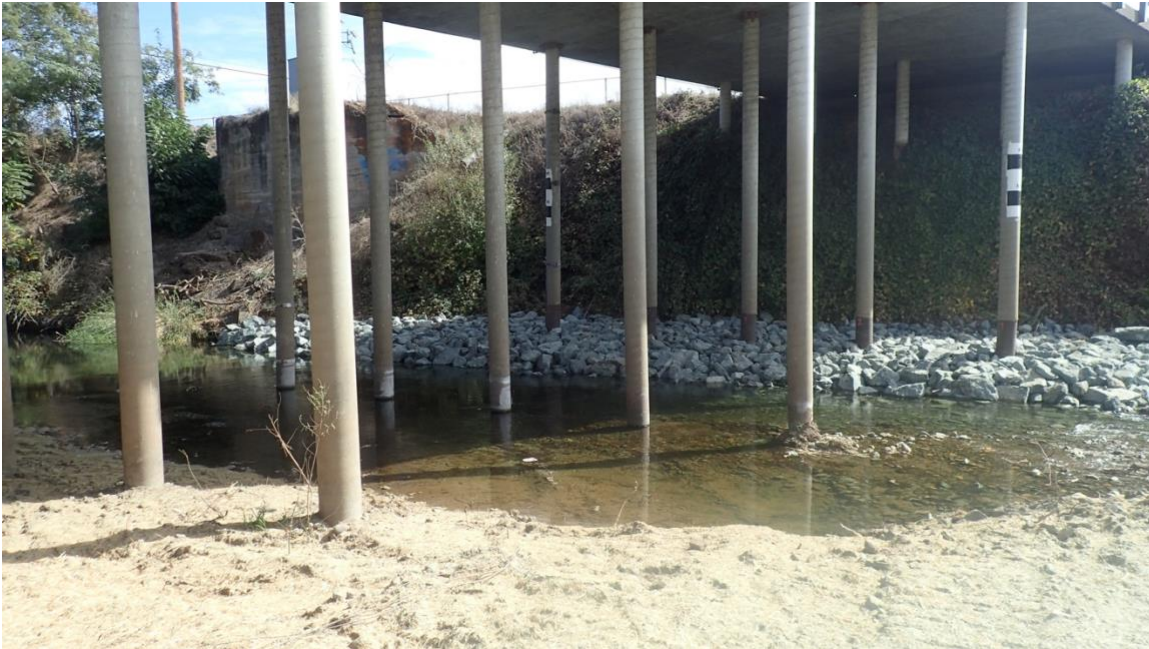
**Figure 5A.** Due to erosion issues at the bridge, some emergency repairs have already completed directly beneath the bridge and fresh rip-rap has been placed.

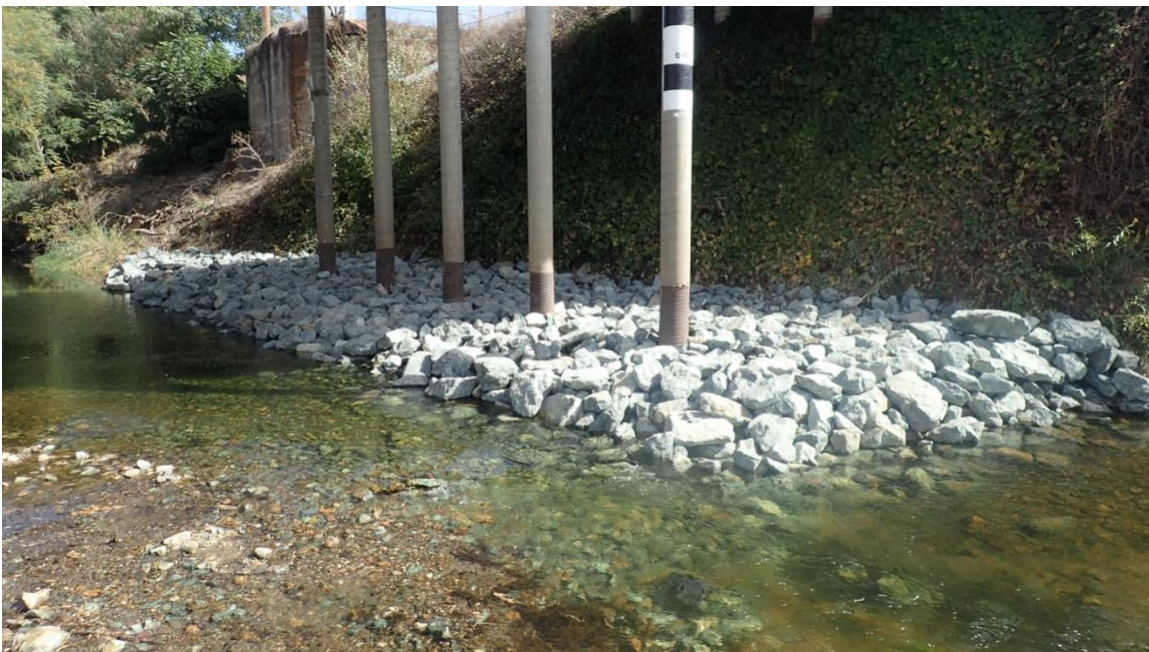
**Figure 6A.** Close up of the instream component of the emergency repair. Rip-rap intrudes into the thalweg, reducing wetted width at base flows.

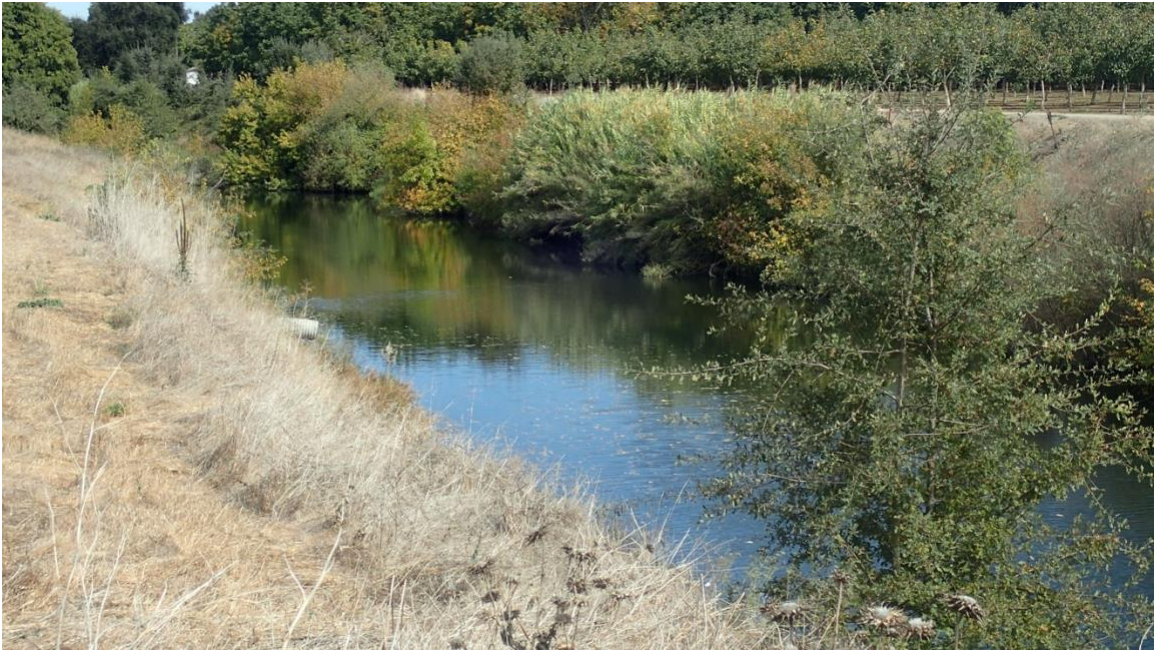
**Figure 7A. Downstream of the primary work area; example of habitat available in the lower end of the worksite. Little overhead vegetation and shaded riparian habitat available along the banks.**
