Initial Study/Environmental Checklist

Watsonville Lee Road Trail

December 2020

**County of Santa Cruz
Planning Department
701 Ocean Street, 4th Floor
Santa Cruz, CA 95060
Contact: Randall Adams, 831.454.2000
Application: 201188**

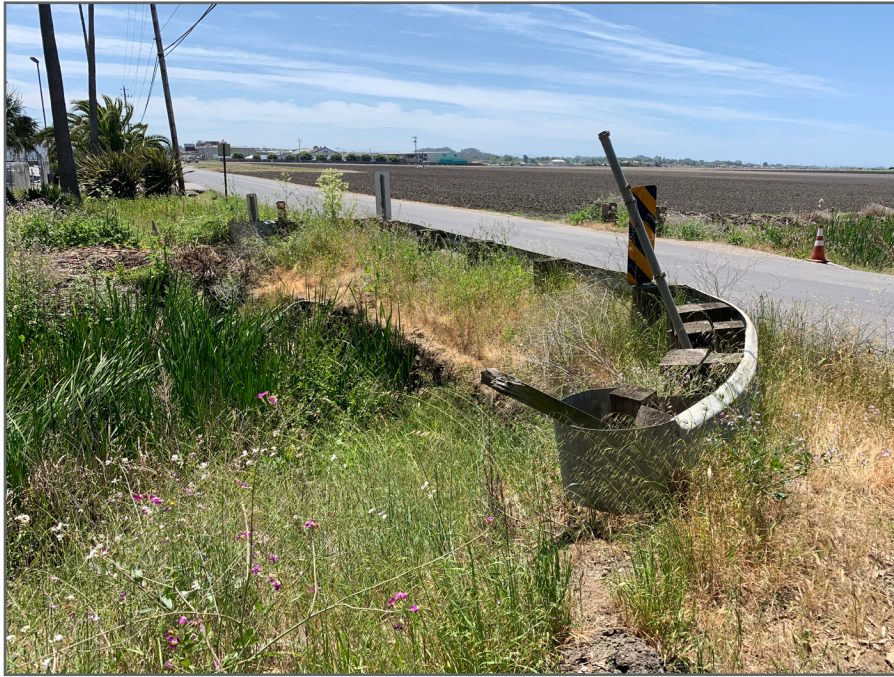
11. Lee Road South section: Photo of Watsonville Slough culvert under Lee Road (facing southwest).

- **Lee Road South.** As described in the Lee Road South section above, the project includes replacement of the existing culvert, two aged 60-inch-diameter corrugated metal pipes (CMP), where Lee Road crosses Watsonville Slough channel. The proposed culvert would be a precast concrete box culvert with an invert elevation of 5 feet, a crown elevation of 10 feet, a width/span of 10 feet, and a length of 55 feet. The preliminary modeling results for the existing and proposed conditions, show the proposed culvert design would not cause a rise in the 100-year water service elevation of the Watsonville Slough at the project location (Balance Hydrologics 2020b).

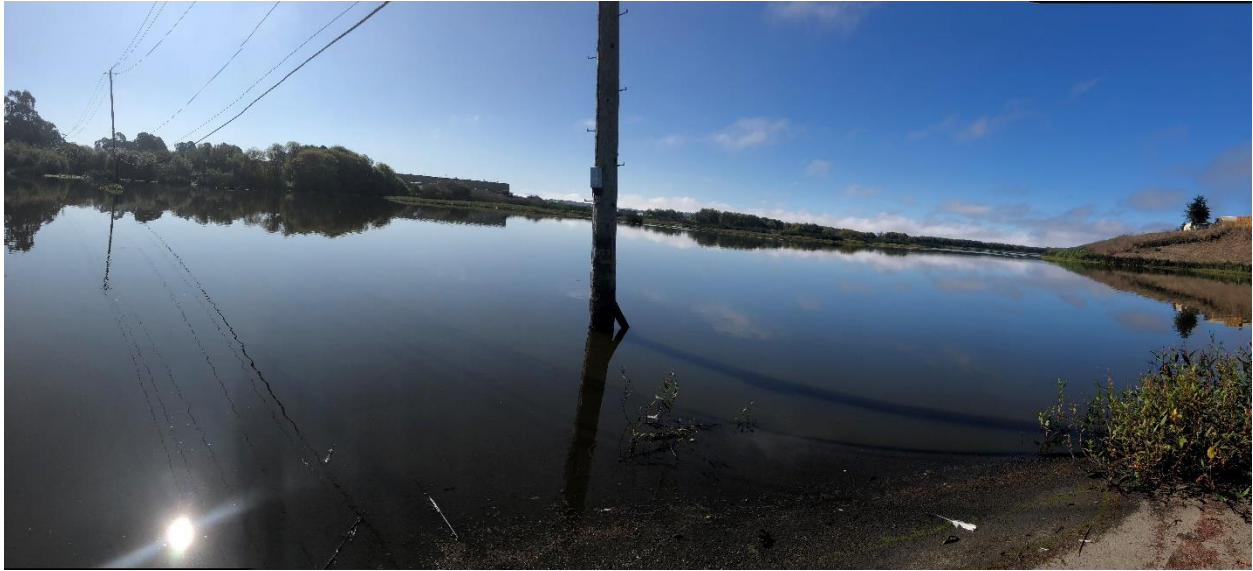
Figure 3. Lee Road is submerged at Struve Slough. The view is looking from north to south.

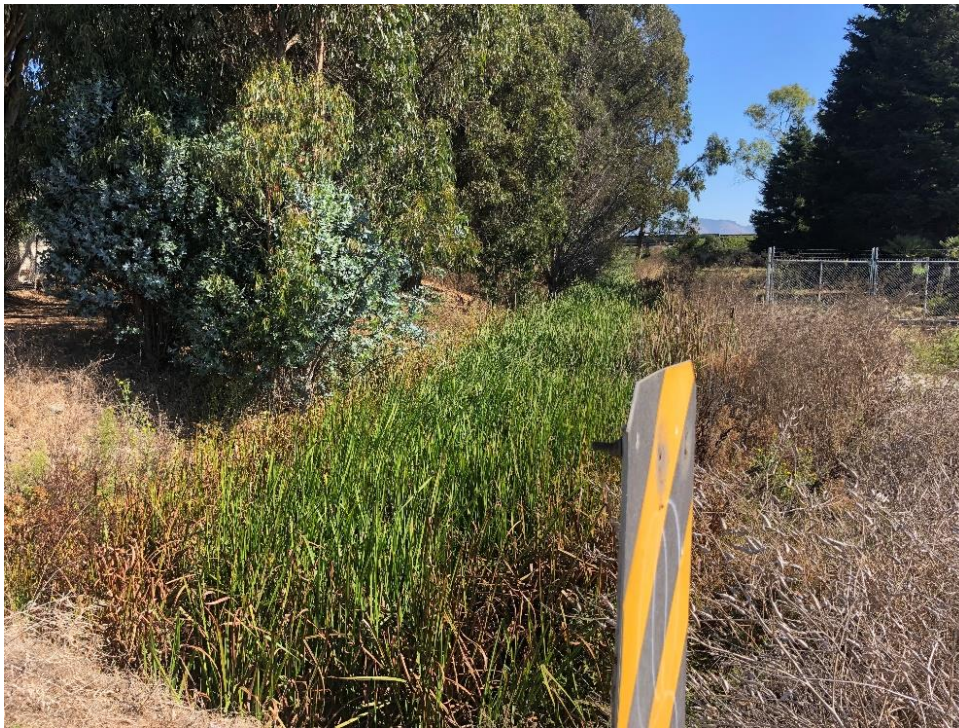
Figure 4. Channelized section of Watsonville Slough, looking upstream from Lee Road.

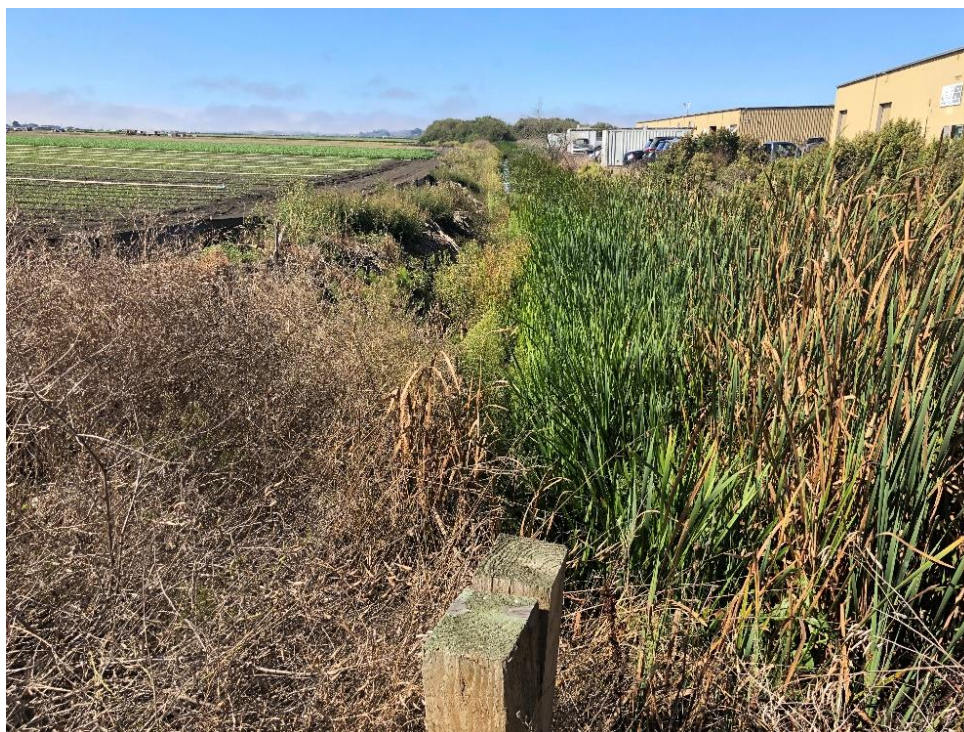
Figure 5. Channelized section of Watsonville Slough, looking downstream from Lee Road.

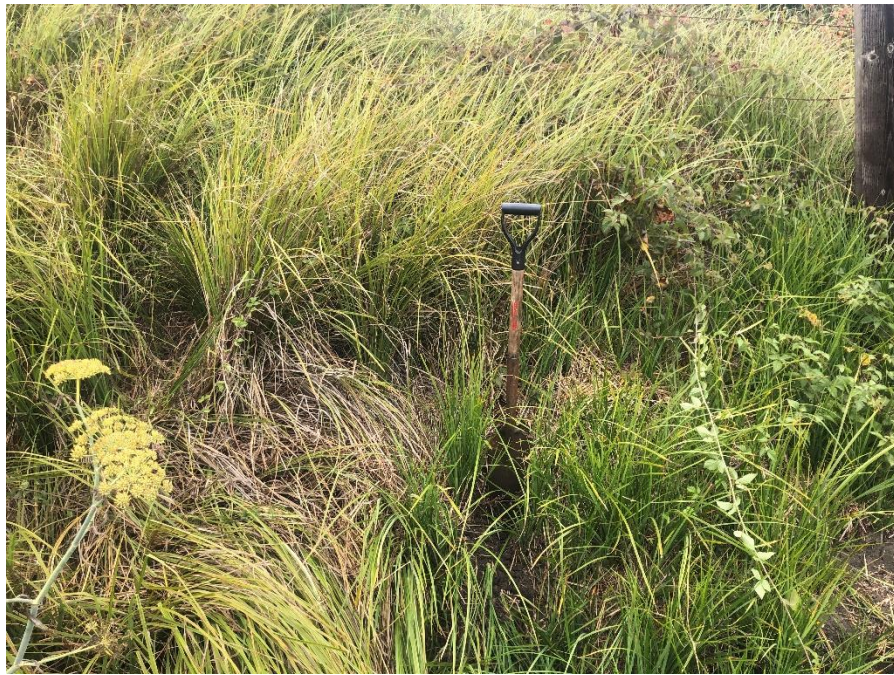
Above. Seep Wetland (SP-10) located on eastern roadcut of Lee Road immediately north of Struve Slough.

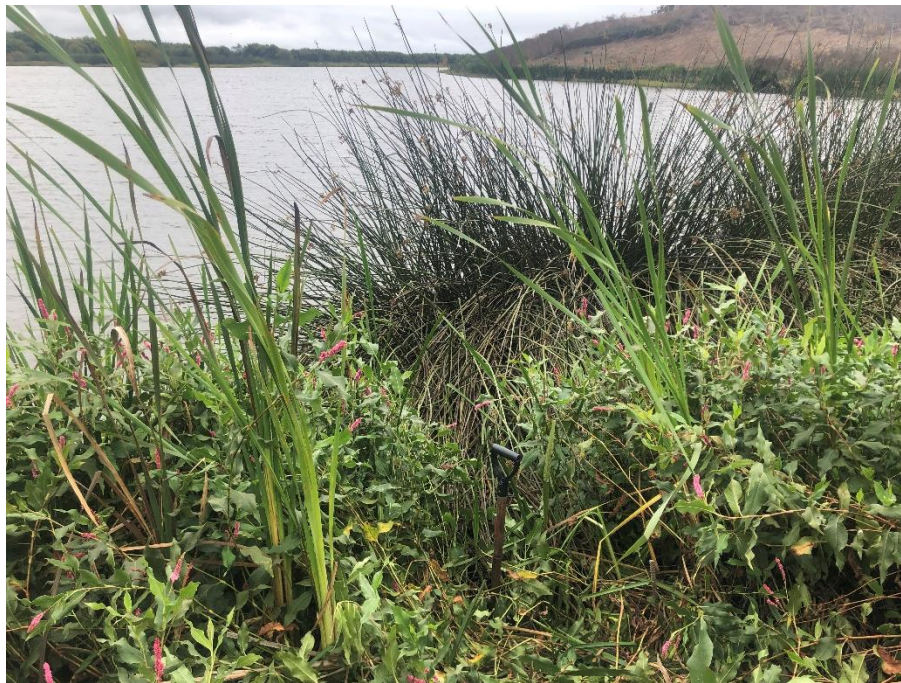
Below. Freshwater emergent marsh fringe (SP-11) on northern embankment of Struve Slough west of Lee Road.

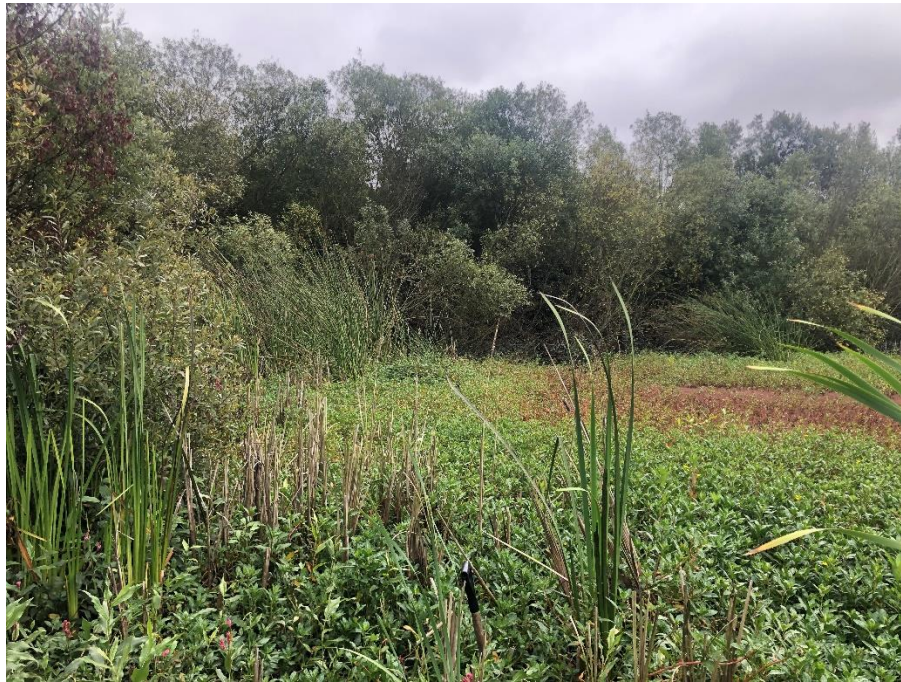
Above. Freshwater emergent marsh (SP-14) dominated by smartweed and floating primrose along southern fringe of Struve Slough.

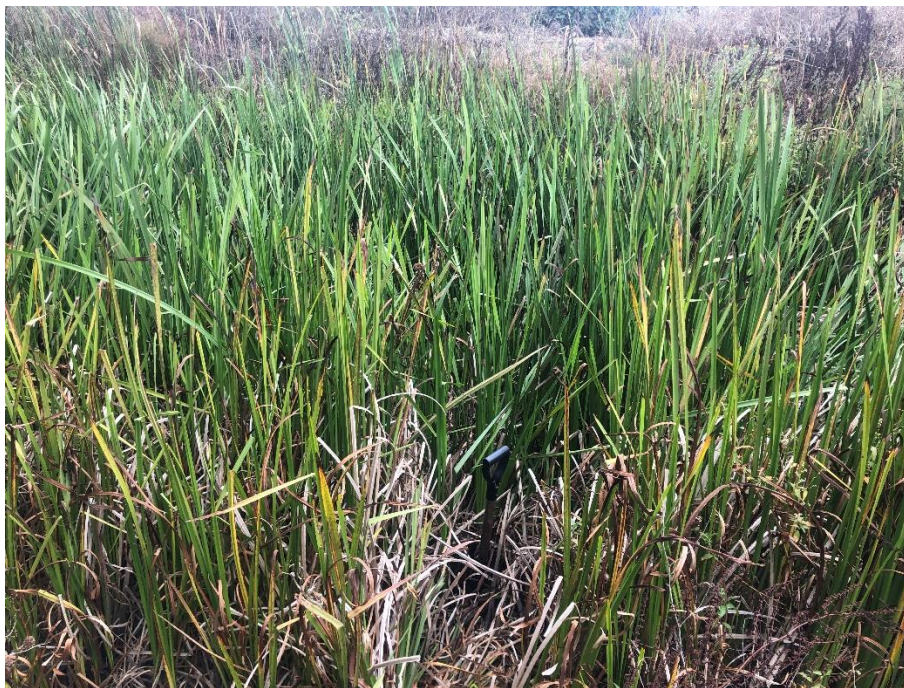
Below. Emergent marsh dominated by narrowleaved cattail (SP-12) in the channelized portion of Watsonville Slough east of Lee Road.

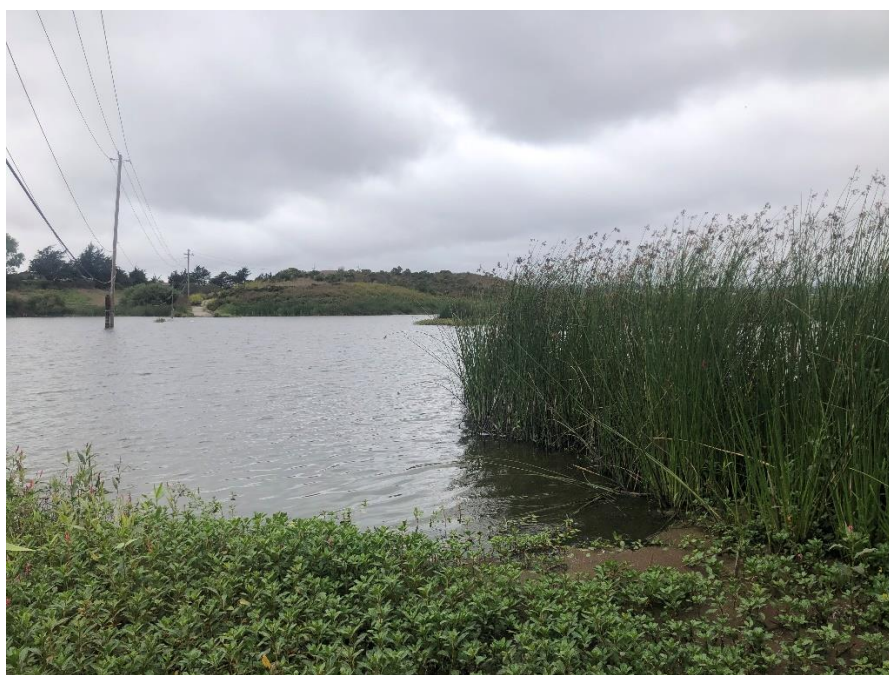
Above. Mudflat dominated by California bulrush marshland looking north into open water of Struve Slough along submerged roadway.

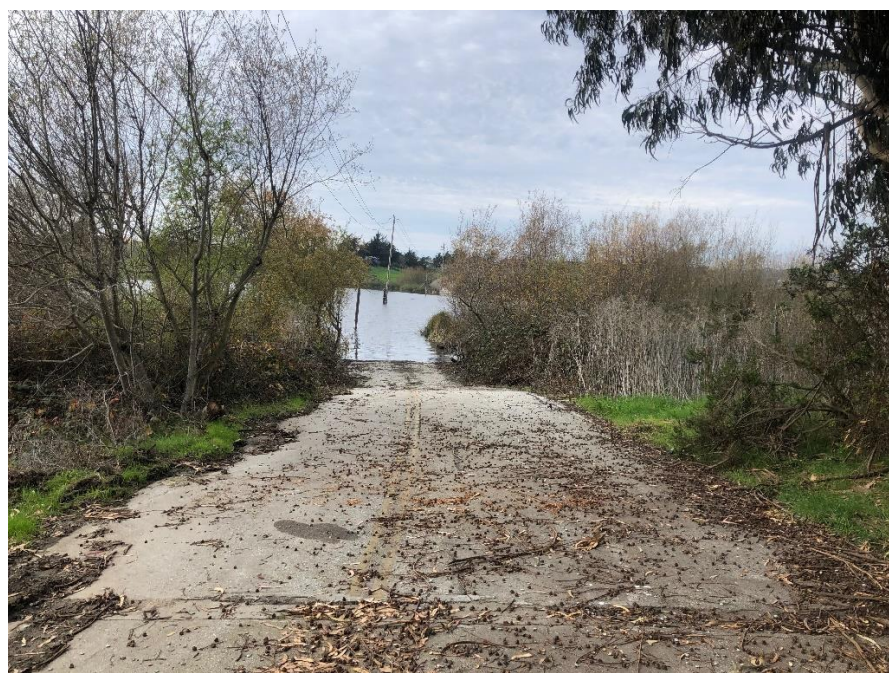
Below. Lee Road looking north entering submerged portion within Struve Slough with arroyo willow riparian straddling the roadway.

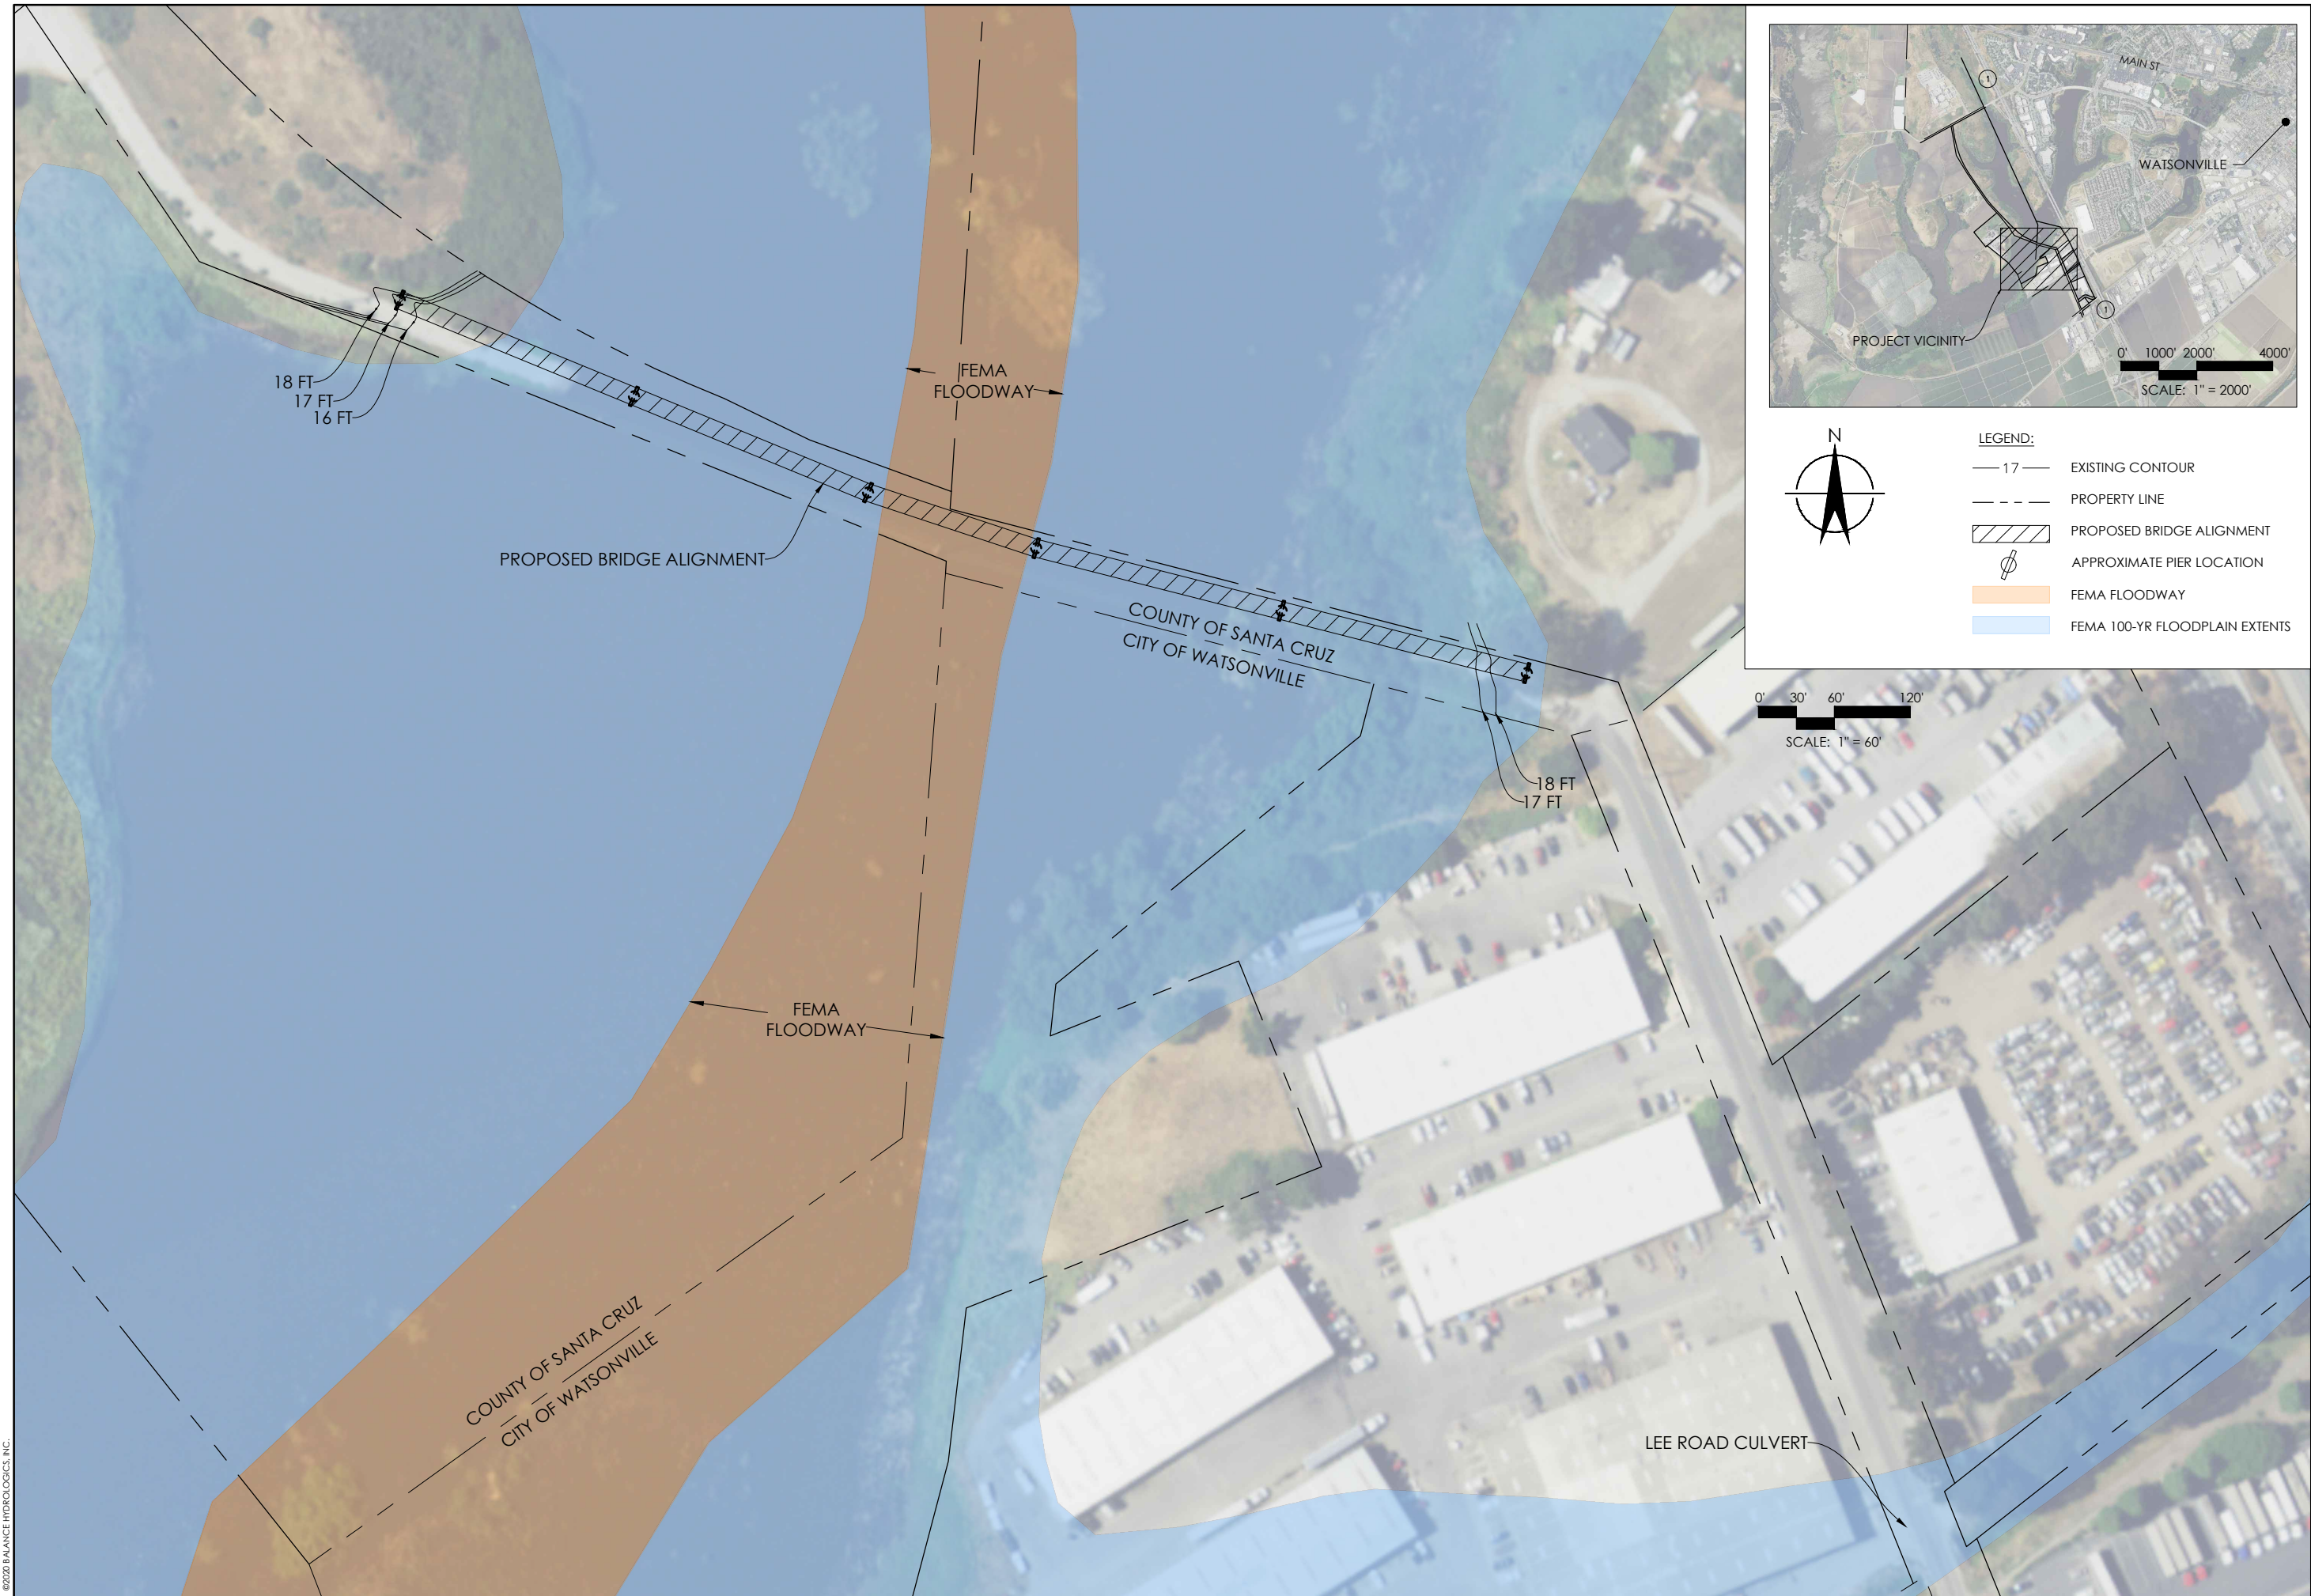
ATTACHMENT 1.
LEE ROAD TRAIL – WORKMAP

- 17 — EXISTING CONTOUR
- - - - - PROPERTY LINE
- PROPOSED BRIDGE ALIGNMENT
- APPROXIMATE PIER LOCATION
- FEMA FLOODWAY
- FEMA 100-YR FLOODPLAIN EXTENTS

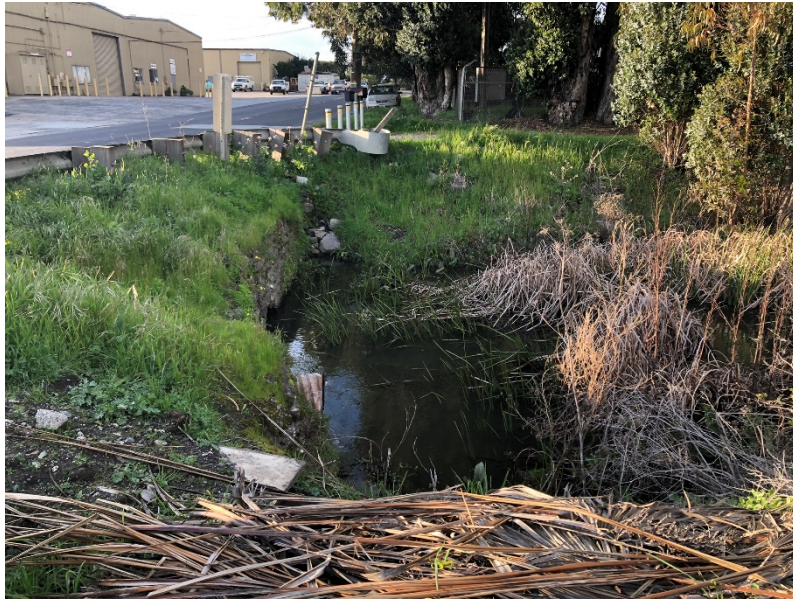
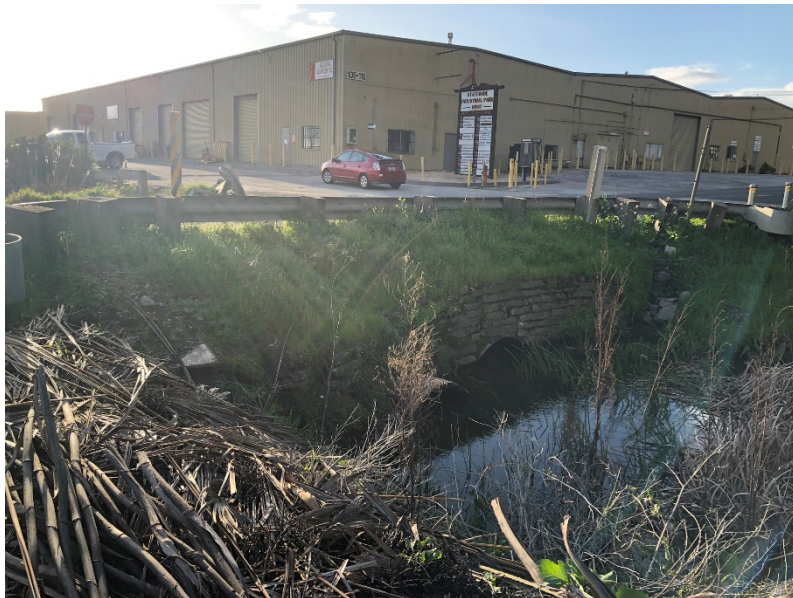
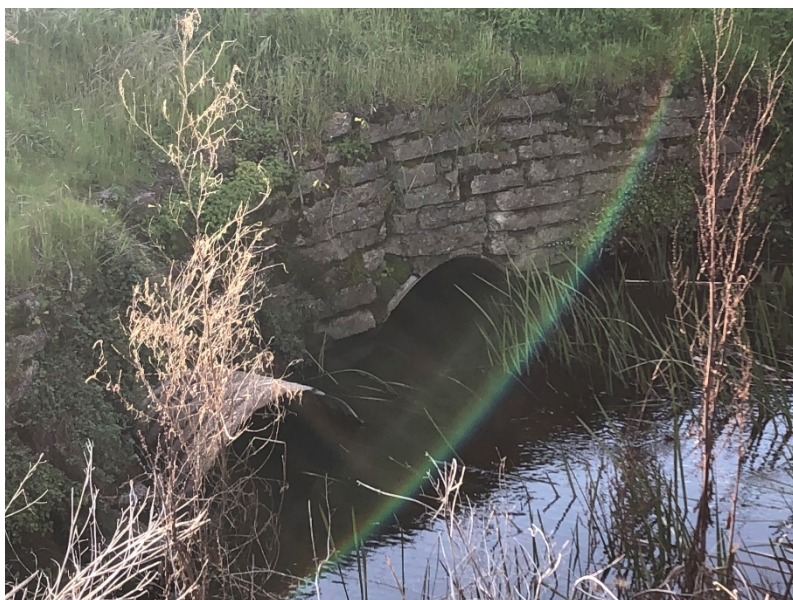
Looking downstream

ATTACHMENT 5.
LEE ROAD CULVERT, EXISTING CONDITION

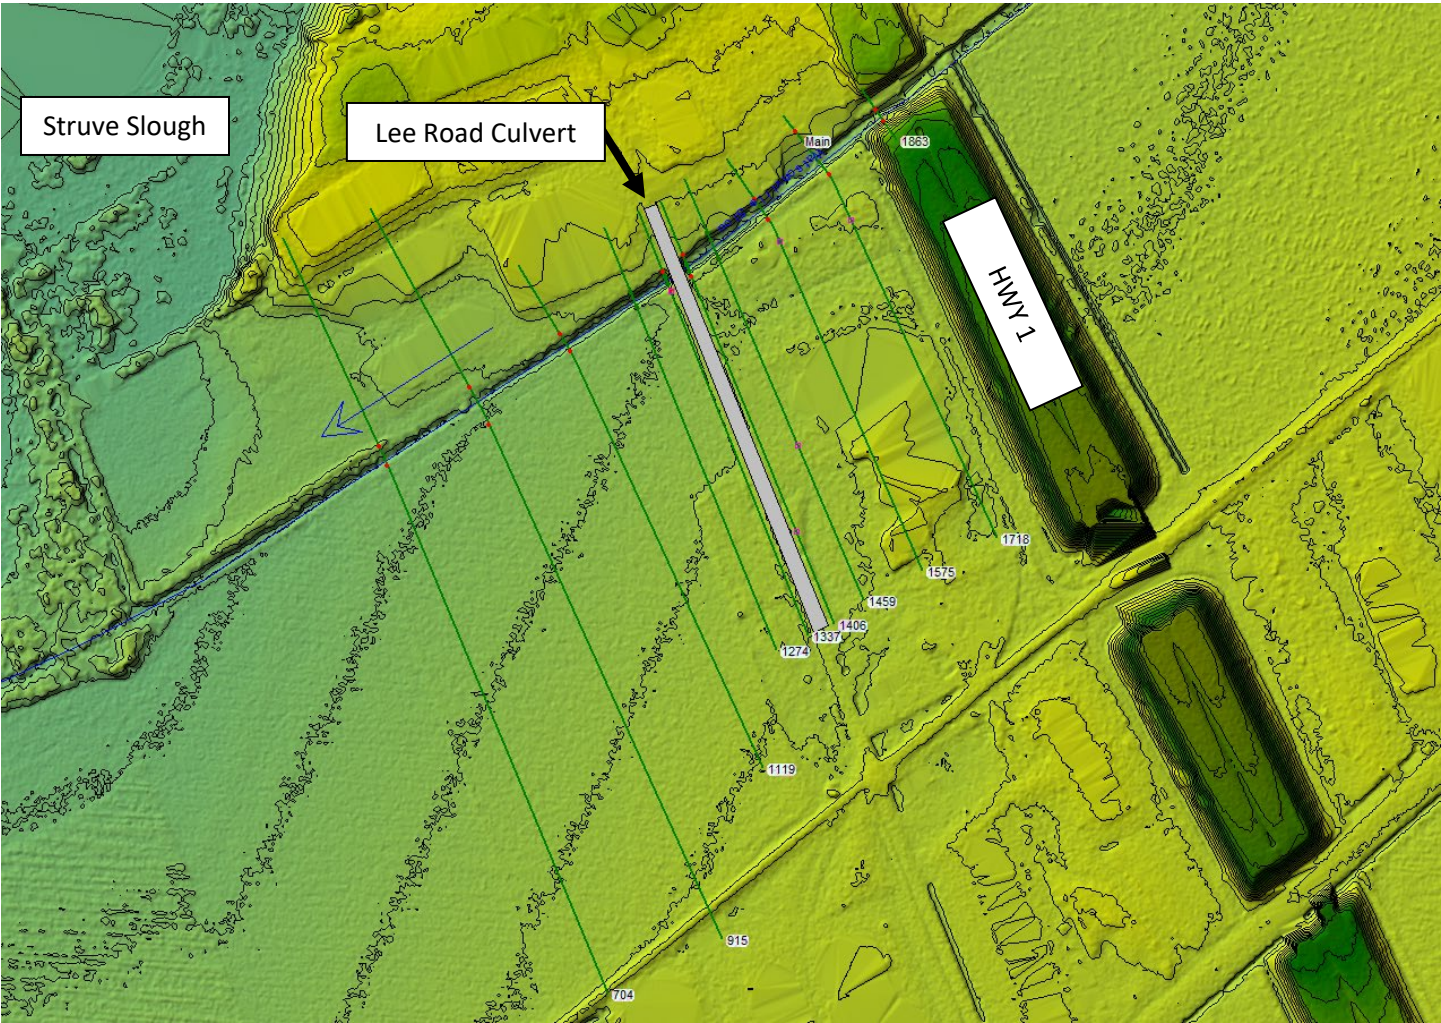
Model Layout

ATTACHMENT 5.
HEC-RAS MODEL INFORMATION AND RESULTS
