APPENDIX H3: PHASE I ENVIRONMENTAL SITE ASSESSMENT FOR SITE 2

Phase I Environmental Site Assessment of the Bloomington Business Park - Block 2 Properties, Bloomington, San Bernardino County, California

RG Bloomington LLC
c/o Rockefeller Group Development Corporation

Project Number: 60620647

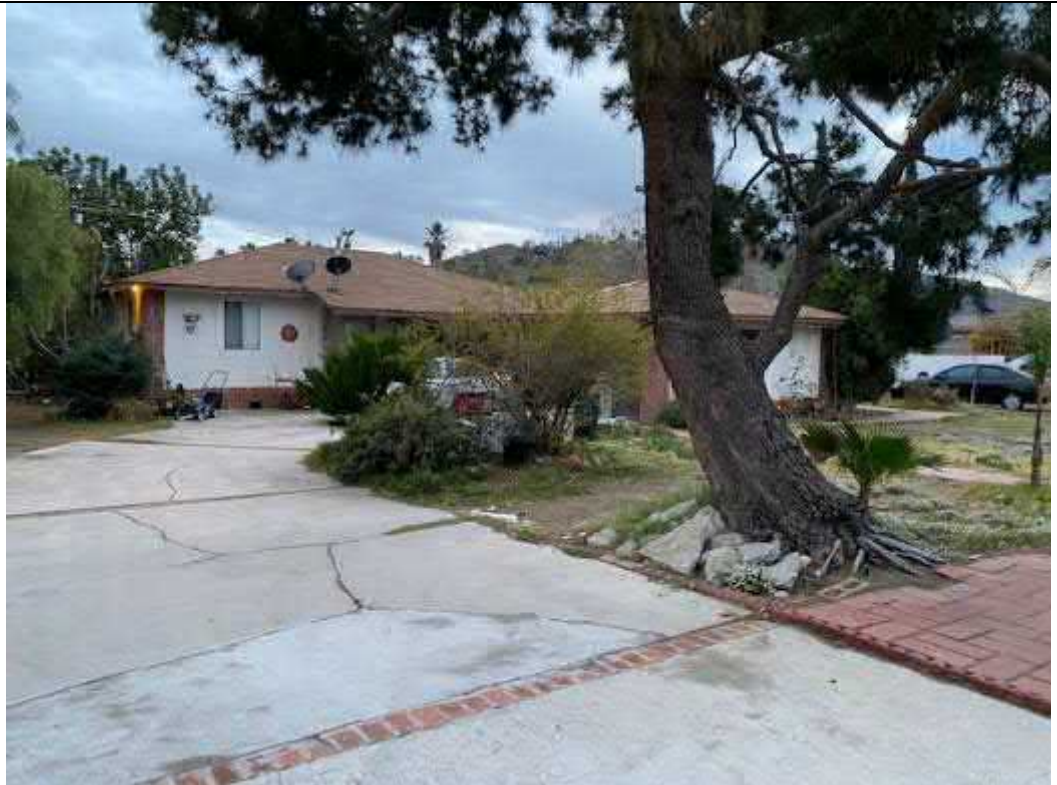
View of a one-gallon oil
container and de minimis
oily staining
(approximately 2 feet by 2
feet) on the bare ground
surface located along the
northern boundary of Site
No. 15.

- A one-gallon oil container and de minimis oily-type staining (approximately 2 feet by 2 feet) on bare ground surface were observed along the northern boundary of Site No. 15 (18143 Rose Ave).

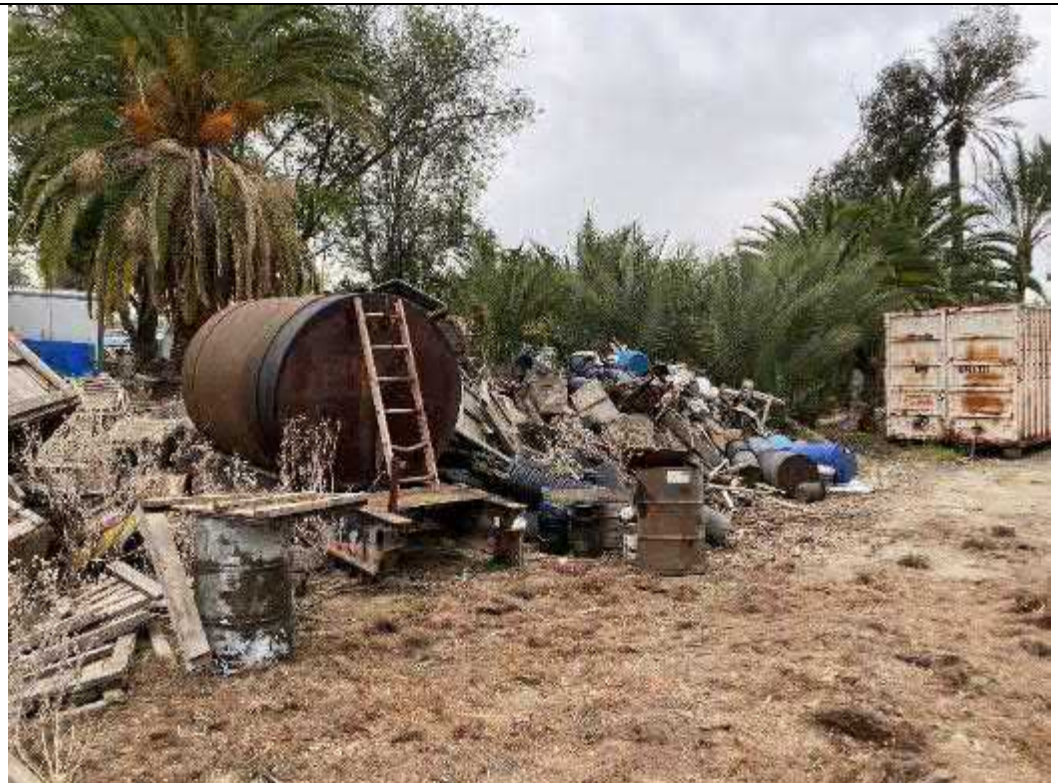
Alternative view of the waste oil AST at the time of the initial site visit. The AST was observed to be single-walled, heavily rusted, and spillage was observed on the sides of the tank from the fill port.

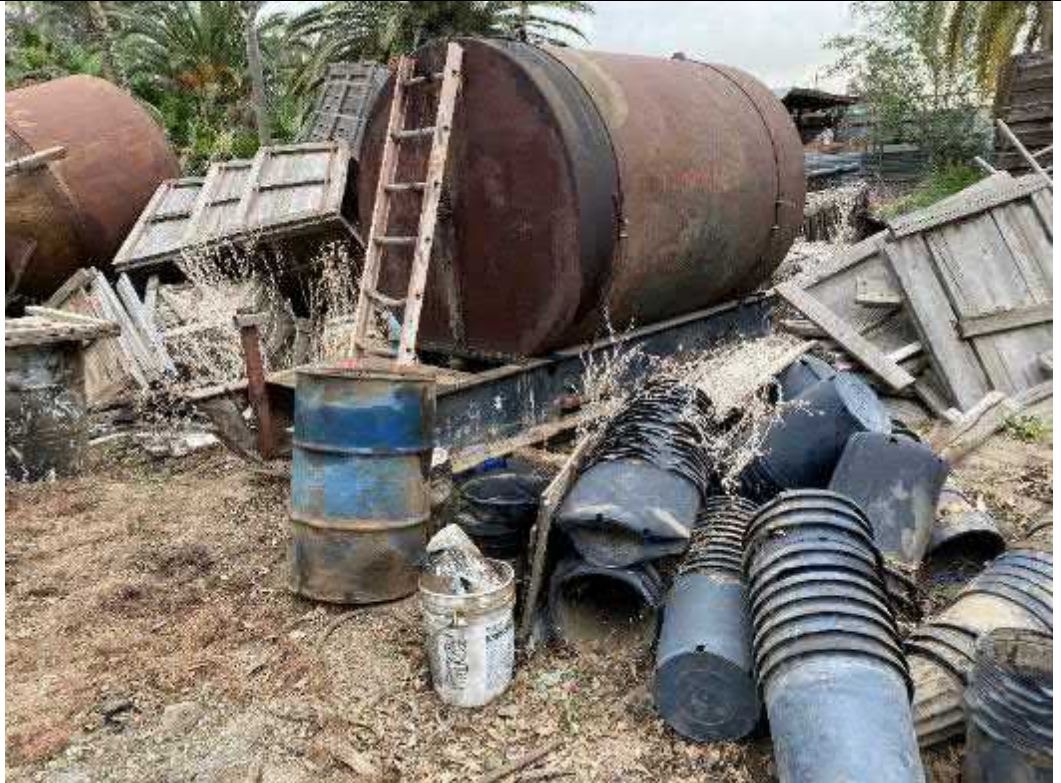
View of bare ground surface beneath the waste oil AST with apparent de minimis oily-type staining on Site No. 18 at the time of the initial site visit.

- De minimis oily-type staining (approximately 1 foot by 1 foot) was observed on the bare ground surface beneath the AST trailer on Site No. 18 (11146 Maple Ave) at the time of the site visit, which was not readily visible at the time of the follow-up site visit. In addition, several used oil filters were observed on the bare ground surface in the vicinity of the AST. De minimis oily-staining (approximately one foot by one foot) was observed in the area of the used oil filters.

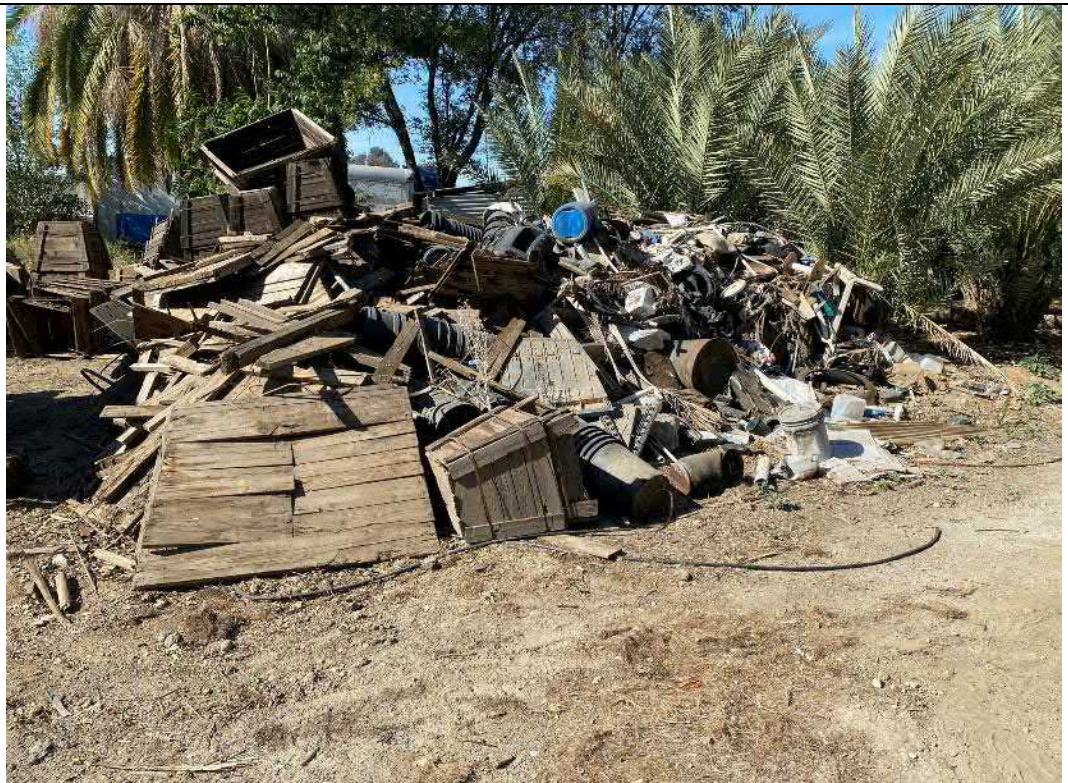
View of a roll-off dumpster observed to the east of the AST and debris pile at the time of the follow-up site visit, in which some of the oil containers that had been removed from the debris pile had been placed. Note: The side doors to the roll-off were observed to be cracked open during the follow-up site visit.

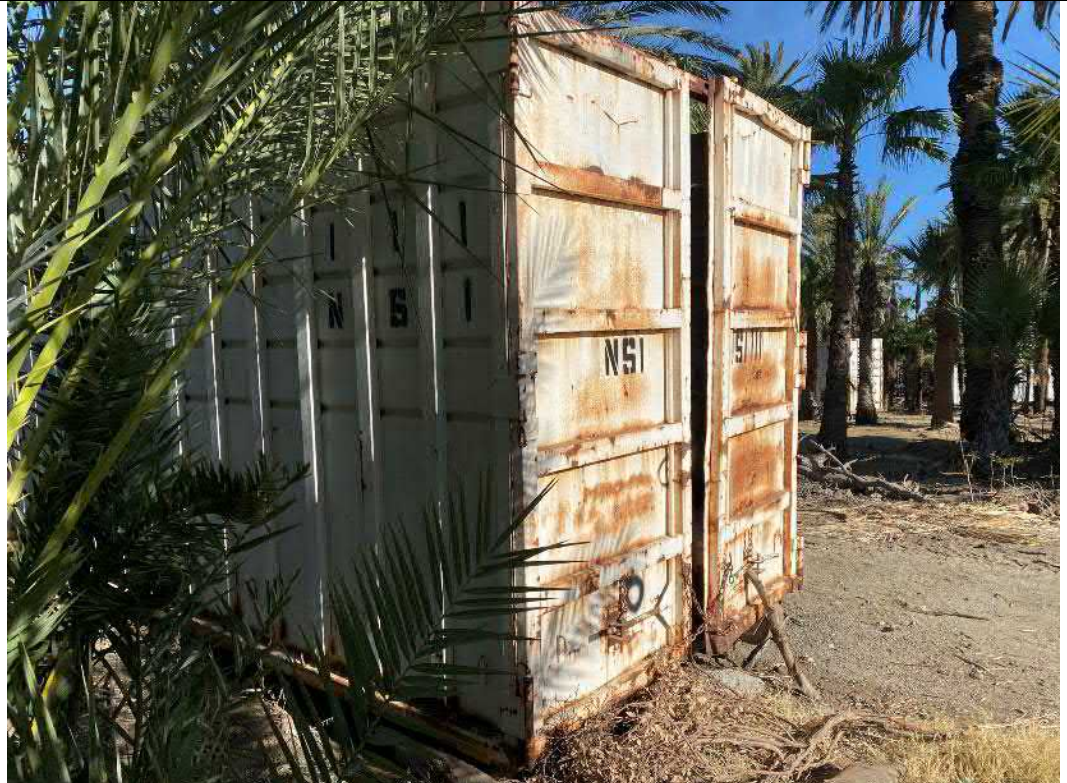
Interior view of the roll-off dumpster to the east of the AST and debris pile, which was observed to contain various oil drums and containers that had been removed from the debris pile since the initial site visit.

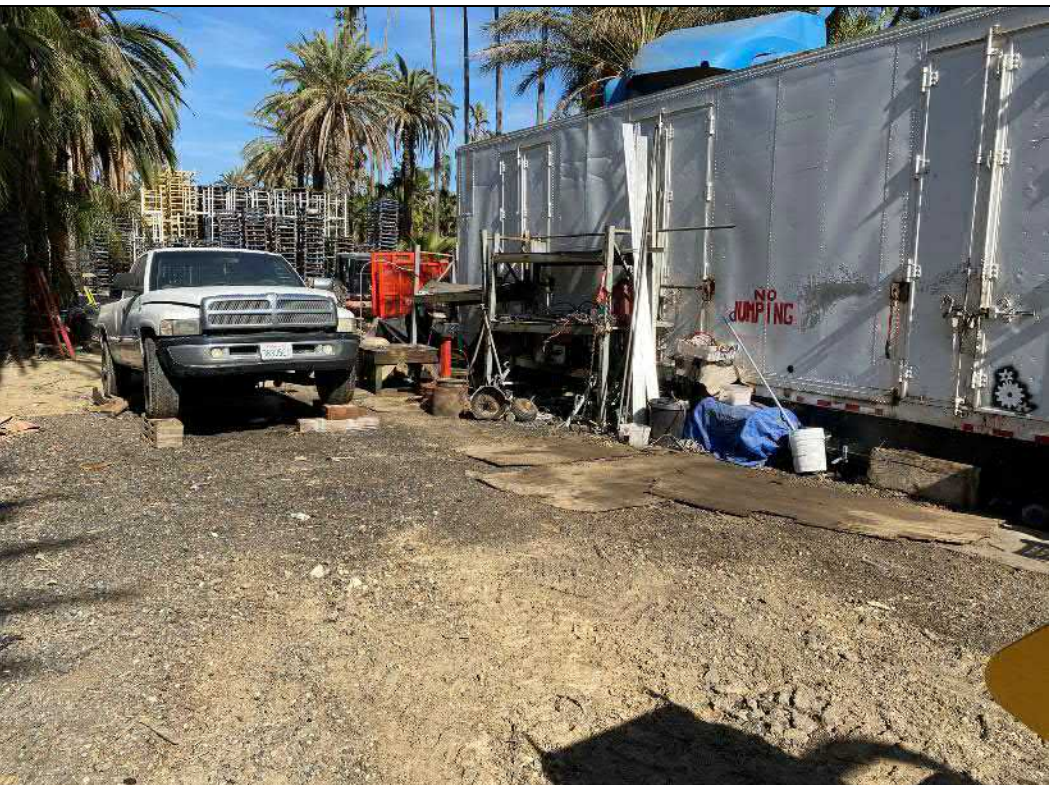
Photo No. 29	Date: 4/29/21

Direction Photo Taken: Southeast		
Description: View of the equipment/vehicle repair area (on bare ground) located in the central portion of Site No. 18 during the follow-up site visit (dry weather conditions). The ground surface in the equipment/vehicle repair area appeared to be covered with crushed asphalt and several pieces of stained plywood were observed on the ground surface.

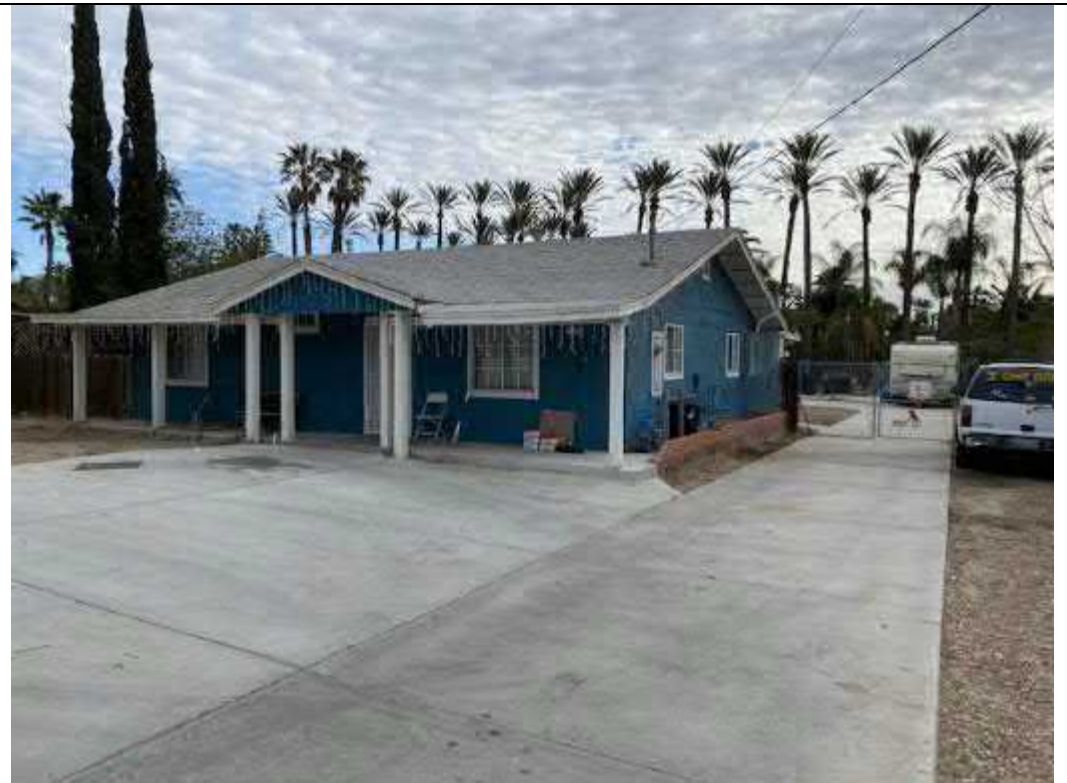
View of de minimis oily staining (approximately 5 feet by 3 feet) observed on the intact concrete driveway at Site No. 22.

- Two areas of de minimis oily-type staining (approximately 5 feet by 3 feet each) were observed on the intact concrete driveway of Site No. 22 (11215 Locust Ave).

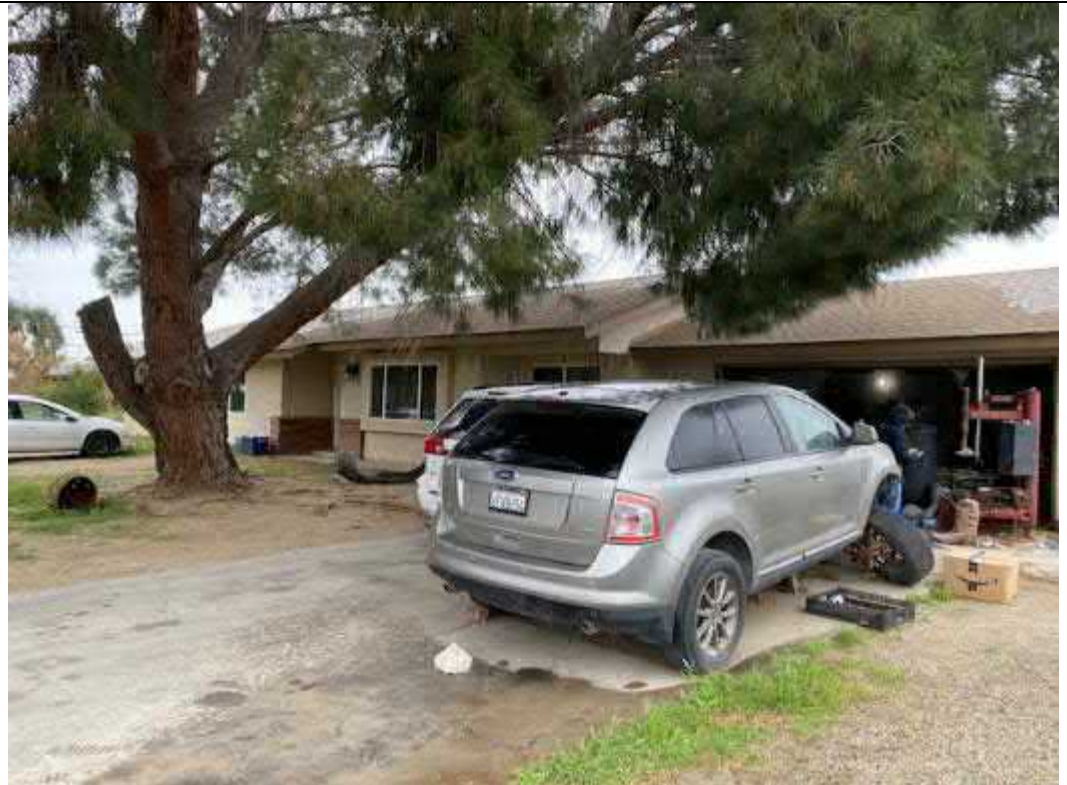
View of an automotive salvage yard located in the eastern portion of Site No. 33. Two 55-gallon drums of motor oil and hydraulic oil were also observed in this area.

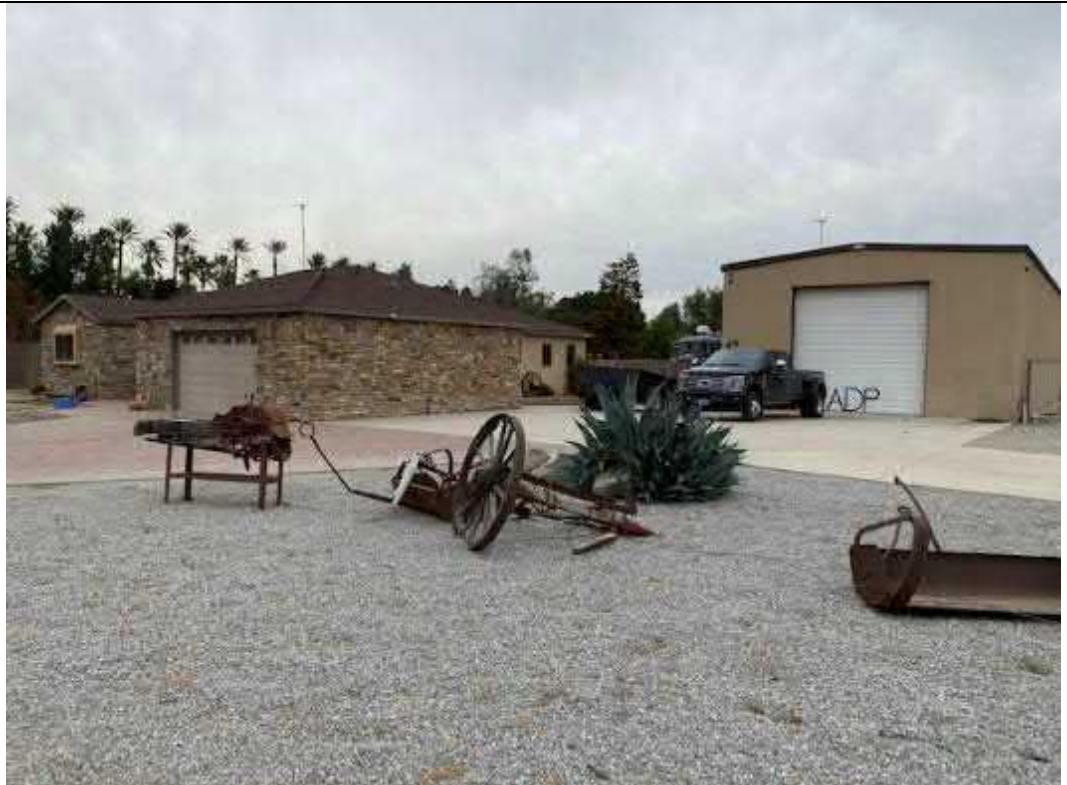
View of de minimis oily-
type staining and
concrete-paved outdoor
repair area located at
Site No. 36.

- De minimis oily-type staining (approximately 2 feet by 2 feet) was observed on the intact concrete driveway of Site No. 23 (11227 Locust Ave).
- De minimis oily-type staining (ranging from approximately 1 foot by 1 foot to 2 feet by 2 feet) was observed on the intact concrete of the outdoor repair area of Site No. 36 (18212 Jurupa Ave).

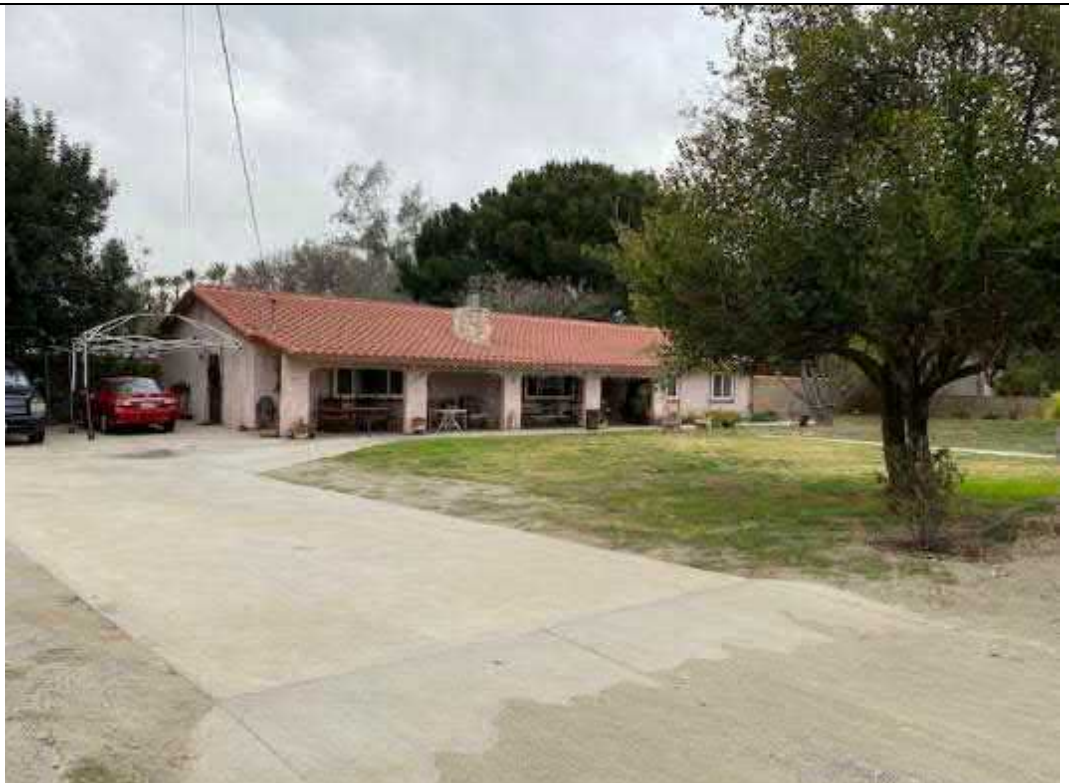
View of de minimis oily staining (approximately 3 feet by 3 feet) observed on the intact concrete driveway of Site No. 39.

- De minimis oily staining (approximately 3 feet by 3 feet) was observed on the intact concrete driveway of Site No. 39 (11266 Maple Avenue).
- De minimis oily-type staining (areas of approximately 1 foot by 1 foot) was observed on the asphalt-paved driveway along northern boundary of Site No. 41 (11279 Locust Ave).
