Pacheco/Santa Clara Conduit Right-of-Way Acquisition Project

CEQA Draft Mitigated Negative Declaration Project No. 92144001

November 2020

Valley Water (Santa Clara Valley Water District)
Environmental Planning Unit
5750 Almaden Expressway
San Jose, CA 95118-3686

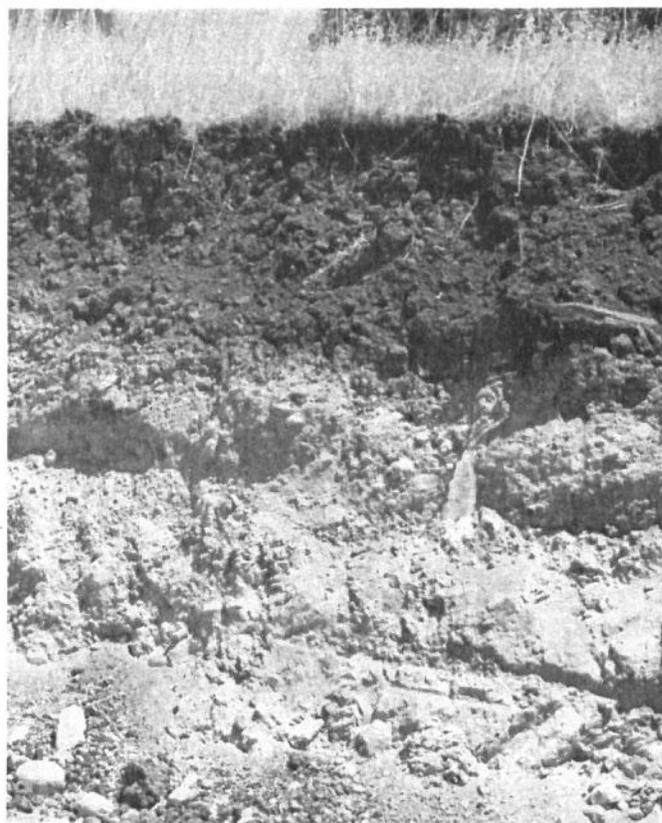
Figure 3.—Profile of Diablo clay, 9 to 15 percent slopes.

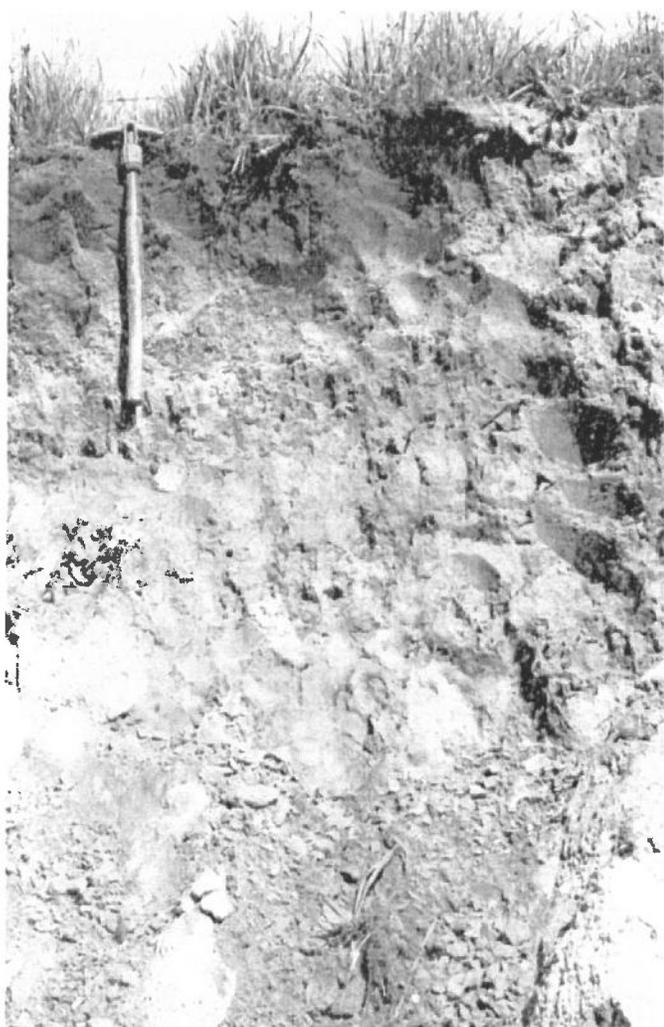
Figure 5.—Road cut through Cotati loam, 9 to 15 percent slopes, eroded. This soil has a dark-colored surface layer, a leached layer, and a sandy clay subsoil. The sandy clay subsoil severely limits the growth of roots and the penetration of water. The entrenching tool is about 20 inches long.

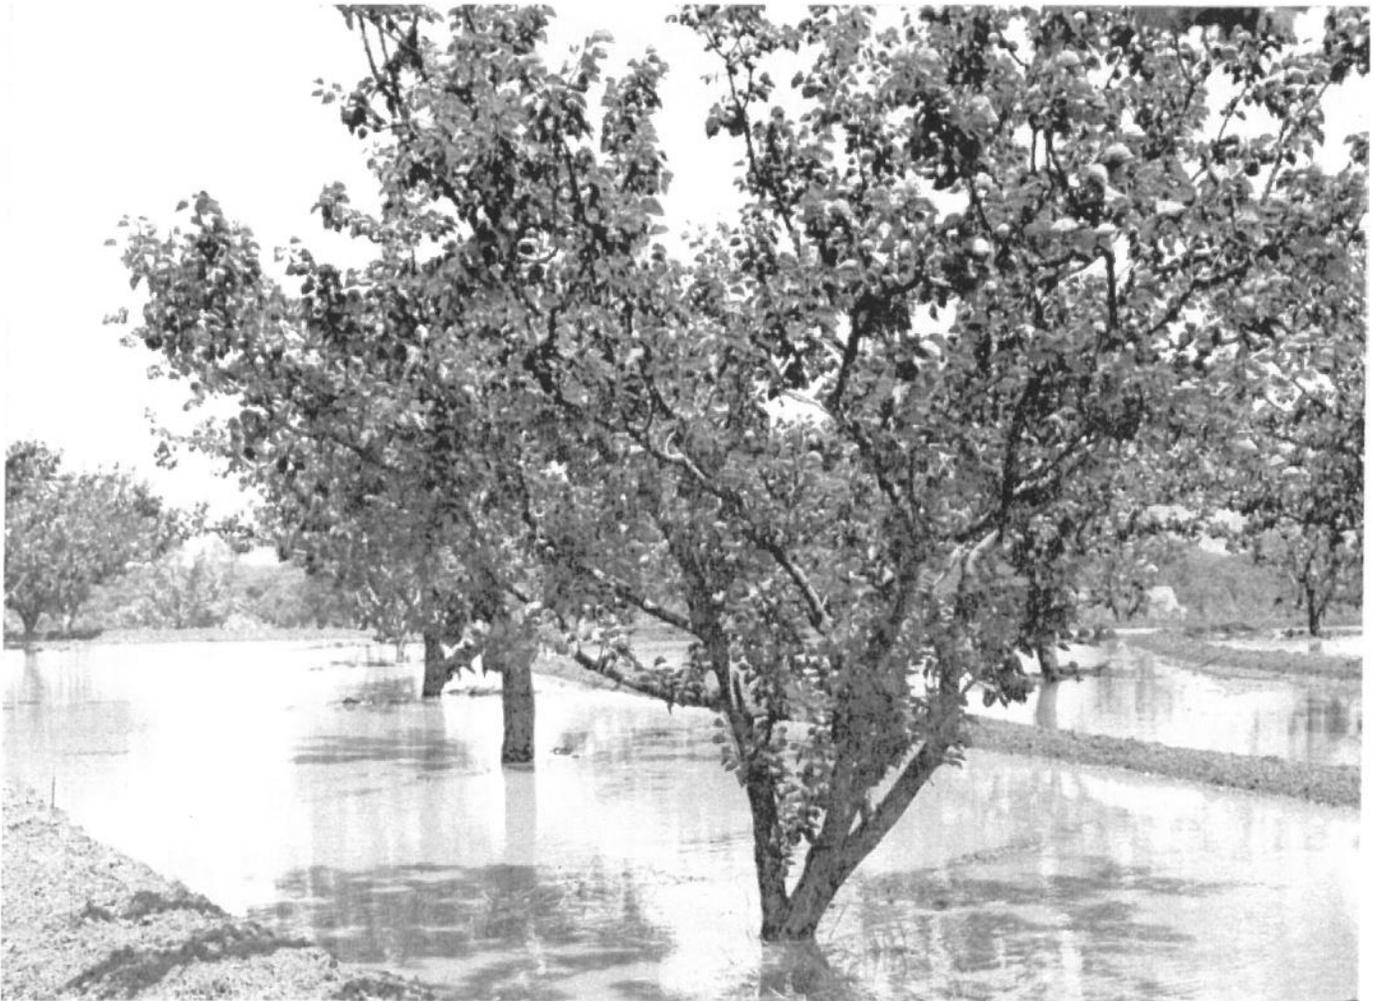
Figure 10.—Contour basin irrigation (a form of flood irrigation) in an apricot orchard on Pacheco silty clay.

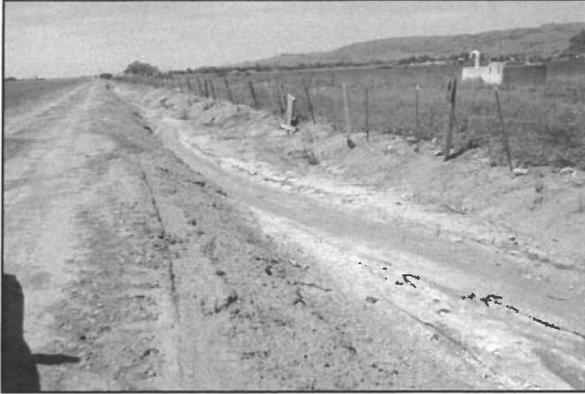
Photo 13. Irrigation ditch at SCC21 is routinely cleared of vegetation.

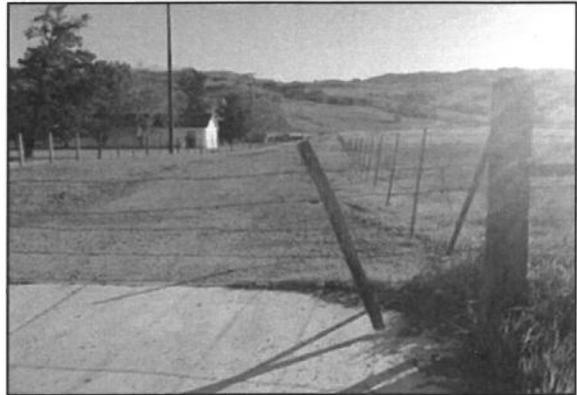
Photo 33. Gate location at SCC53. Driveway passes over culvert and ephemeral stream.

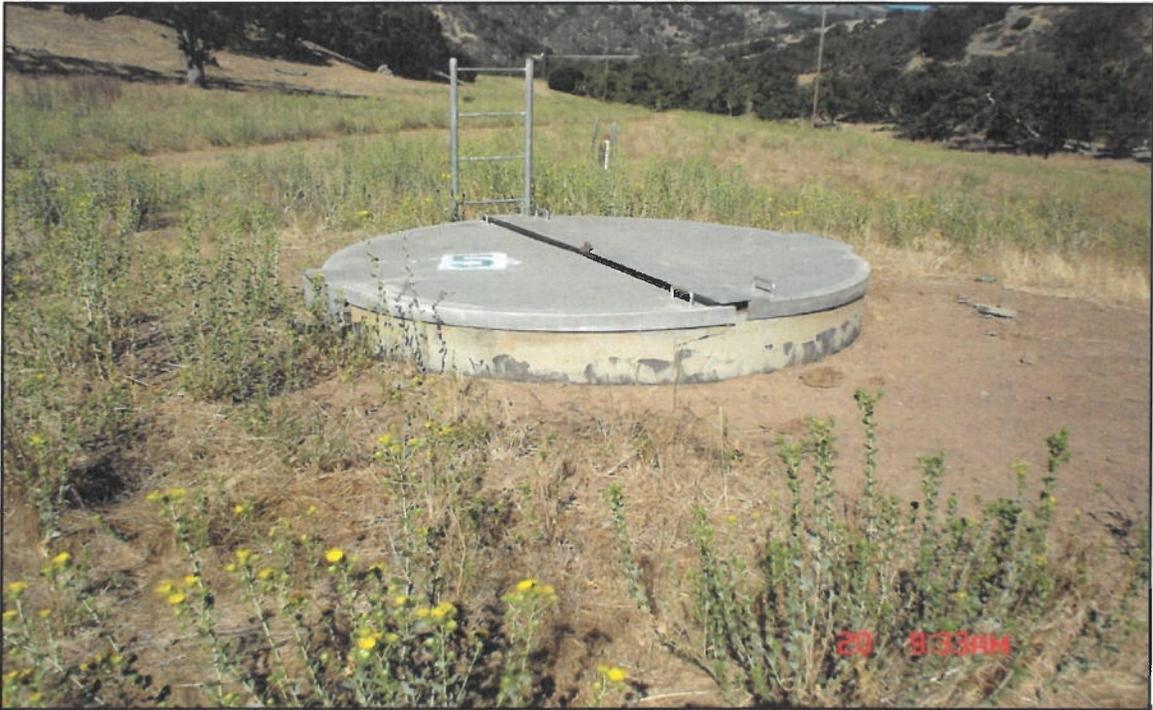
Typical Vault

This type of vault is a location where maintenance workers can access devices attached to the pipeline to maintain air relief valves (Devices that release entrapped air in the pipeline). There are other vaults that contain blow off valves that allow Valley Water work crews to drain portions of the pipeline for maintenance.
