# Old Arcata Road Rehabilitation & Pedestrian/Bikeway Improvements

## Public Circulation Draft Initial Study/ Proposed Mitigated Negative Declaration

**GHD** | 718 3<sup>rd</sup> Street, Eureka, CA 95501 USA

January 2021

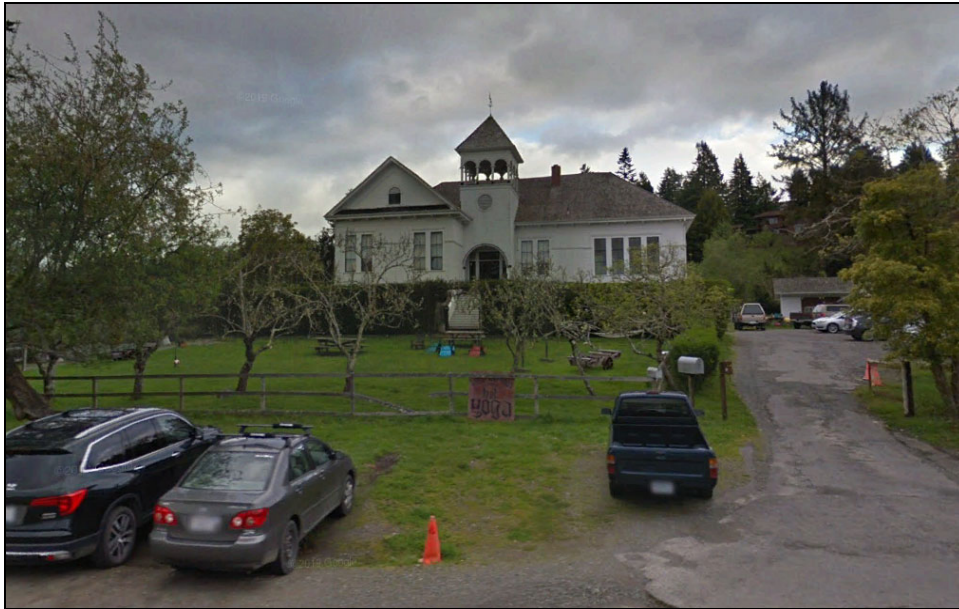
**Photograph 1: 2212 Jacoby Creek Road (Google Earth, Imagery Date 4/2019), facing north.**

aerial photography indicates that the extant trees and parking areas appear to have been added since the early 1950s and that an older large tree east of the driveway was removed. In recent decades, some trees lining Jacoby Creek Road at this property appear to have also been removed and there are currently multiple trees located at the west corner of the property by the post office.<sup>7</sup>

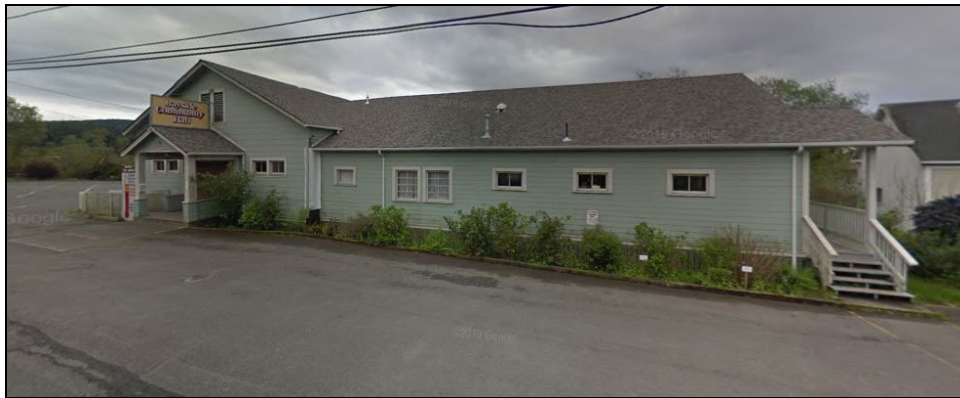
**Photograph 2: 2297 Jacoby Creek Road (Google Earth, Imagery Date 4/2019), facing south.**

JRP assessed the character-defining features of this property during the desktop review. The building, designed in the Minimal Traditional style, sits on a raised L-shape foundation with vertical wood siding on an angled grade. The rest of the building has horizontal wood siding. The cross-gable roof has both wide and narrow eaves and is covered in composite shingles. Each gable has a louvered vent. Underneath a front gable, a composite shingle gable porch with square half-posts serves as the north entry. It is framed by double horizontal sliding windows. On the west side, a gable projection with exposed rafters is supported by square posts and

The Bayside Community Hall (OHP #131410, Cal. Reg #12-0016) at 2297 Jacoby Creek Road was formerly known as the Bayside Grange (**Photograph 2**). The Office of Historic Preservation (OHP) listed the building on the CRHR in 2002 as the Bayside Grange Hall with a construction date of 1940.<sup>10</sup> While it is known that the Community Hall / Grange Hall is listed in the CRHR, no other documentation for this property was found during research for this report or included in the HPSR.<sup>11</sup>

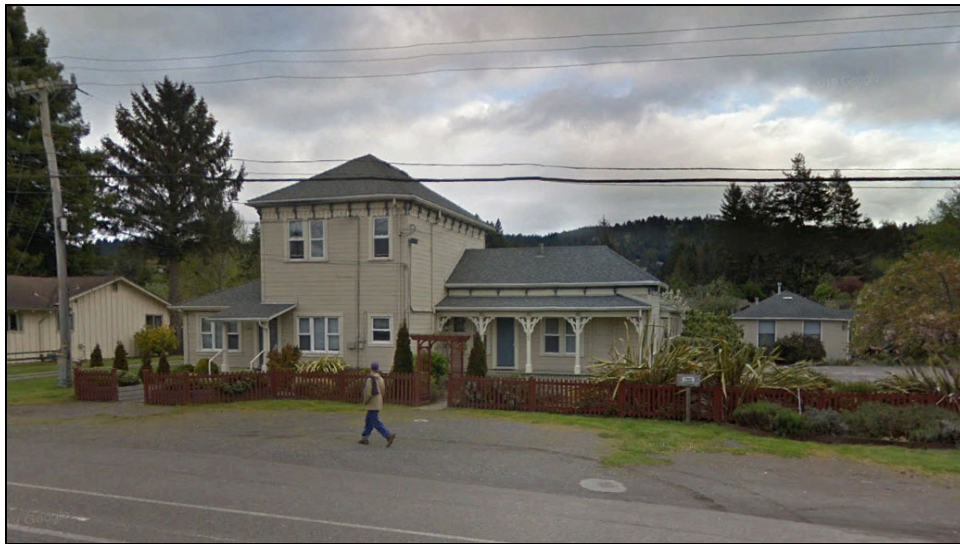
**Photograph 3: 1788 Old Arcata Road (Google Earth, Imagery Date 4/2019), facing north.**

The Folk Victorian residence is largely unchanged since Hedlund's recordation, in which he described it as a multi-sectioned building:

The Charles Monahan-Dexter House and former Bayside Post Office (P-12-003658, Hedlund P-04) was built at 1788 Old Arcata Road circa 1887 (**Photograph 3**).

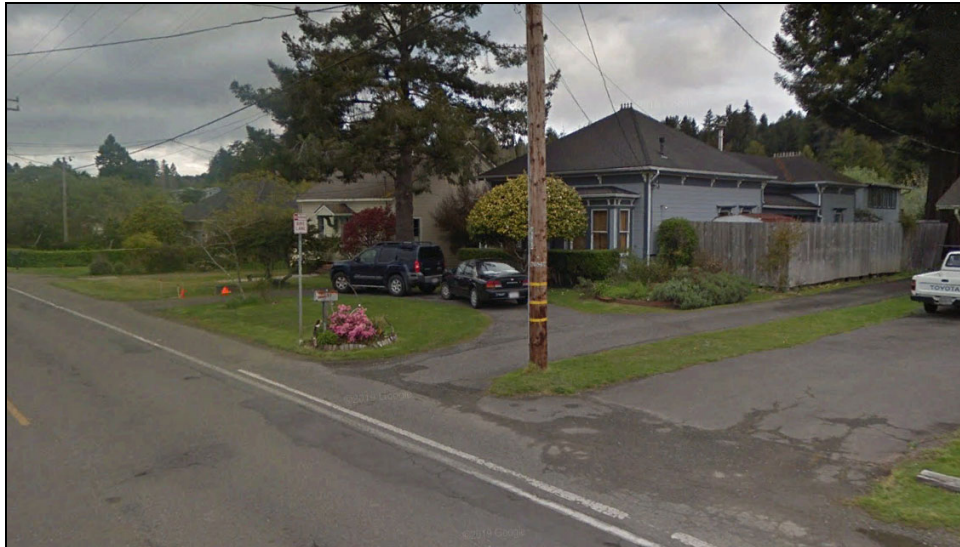
**Photograph 4: 1752 Old Arcata Road (Google Earth, Imagery Date 4/2019), facing north.**

When Hedlund recorded this property as 9-05, he observed that this multi-part Folk Victorian house was likely built in phases. Sitting on an irregular rectangular plan, the house incorporates a pyramid roof on the front building. Its east wall is bisected by a T-shape gable roof with north-south hipped sections. Overall, the rectangular plan is flanked on the north and south sides by shed roof extensions. A flat-roofed structure is visible at the rear and includes vertical ribbon windows. Hedlund briefly describes the facade's character-defining features as "[bay] windows at front [that] are joined by a roof, all of which together form a recessed front entrance...Both porch roof and main roof have boxed cornice and frieze, with ornamental bracket trim."<sup>13</sup> The house is set back from the roadway approximately 35 feet. Its front yard features a semi-

The Nellist-Zucar-Smith House was built circa 1889 and located at 1752 Old Arcata Road (**Photograph 4**).

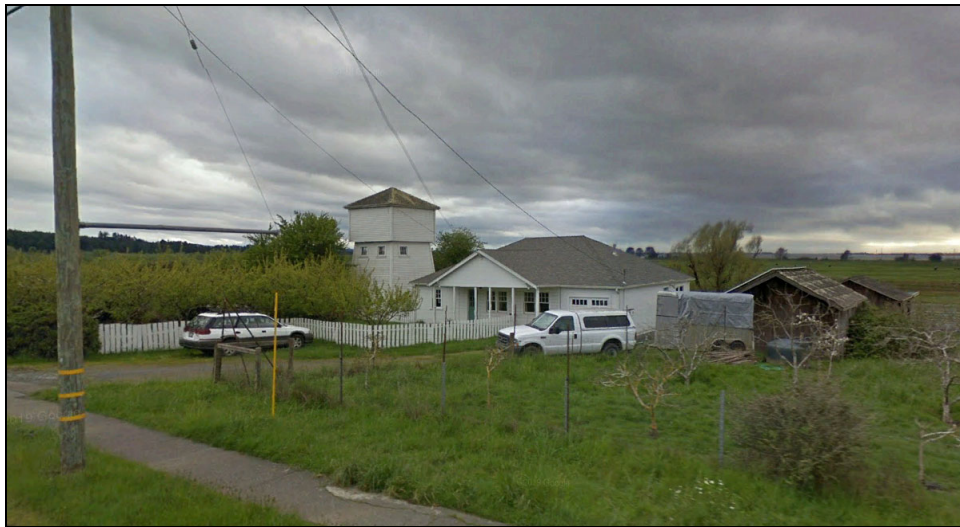
The three-story water tower is sided with shiplap and six-light fixed windows. Like the house, it has a pyramid shingle roof. The property also has two wood-sided front gable sheds located north and northwest of the house. Both the house and water tower were recorded in Hedlund’s 1978 survey, and the OHP data file notes the house was determined ineligible in 1979.<sup>17</sup>

**Photograph 5: 1401 Old Arcata Road (Google Earth, Imagery Date 4/2019), facing southwest.**

For purposes of this report, the property’s character-defining features include the house and water tower’s design, along with the front yard that includes orchard trees, a picket fence, and unpaved driveway. There is also a sidewalk and mow strip in front of this house, separated from the front yard by a hedge and a fence. Thus, the sidewalk and mow strip are not considered part of the character of this property. It is unclear whether the sidewalk and mow strip are located within the road right of way.

The Rhodes-Marsh House & Trinidad Water Tower Complex (P-12-003681, Hedlund 9-14) is located at 1401 Old Arcata Road (**Photograph 5**). Built in 1930 and set back from the road, the house is a folk structure with Neoclassical details. Hedlund describes the house as covered with “shiplap siding” and “two sash plan molding windows with lugsills, one sash and transom.”<sup>16</sup> The house’s hipped pyramid composite shingle roof has small eaves and features a cross gable pedimented porch supported by square posts. That porch shelters double-hung multi-light windows and an off-center front door. The house is entirely sided with horizontal wood and includes an attached double-door garage.

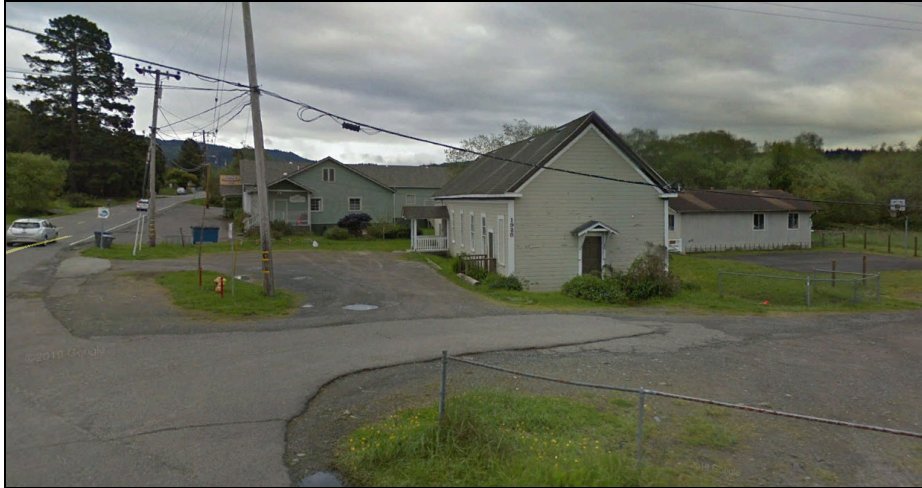
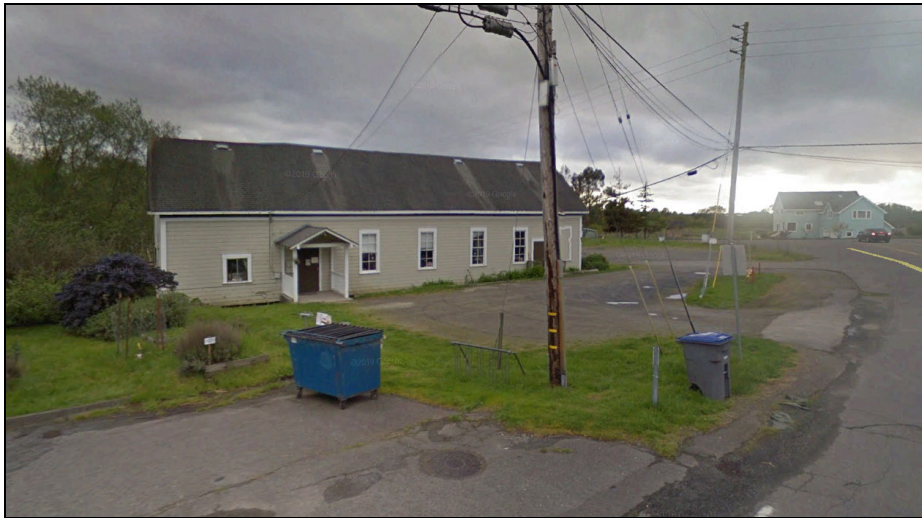
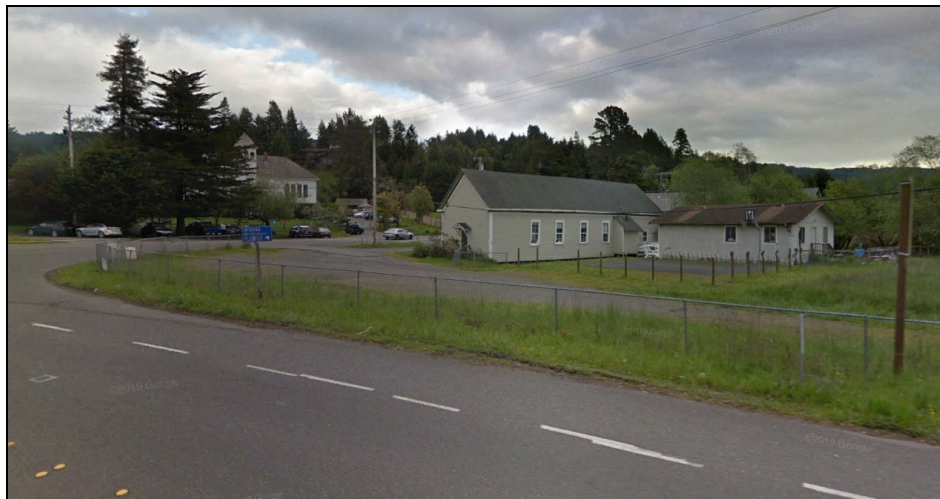
**Photograph 6: 1928 Old Arcata Road (Google Earth, Imagery Date 4/2019), facing southeast.**

**Photograph 7: 1928 Old Arcata Road (Google Earth, Imagery Date 4/2019), facing west.**

**Photograph 8: 1928 Old Arcata Road (Google Earth, Imagery Date 4/2019), facing east.**

The property at 1928 Old Arcata Road (P-12-003770) is today known as the Mistwood Educational Center (**Photograph 6**, **Photograph 7**, and **Photograph 8**). When Van Kirk recorded the property in 1979, she described the building as “this little classic-style building, lined with eight-pane windows.” The building was constructed in 1882 for the Bayside division of the Sons of Temperance.<sup>18</sup>

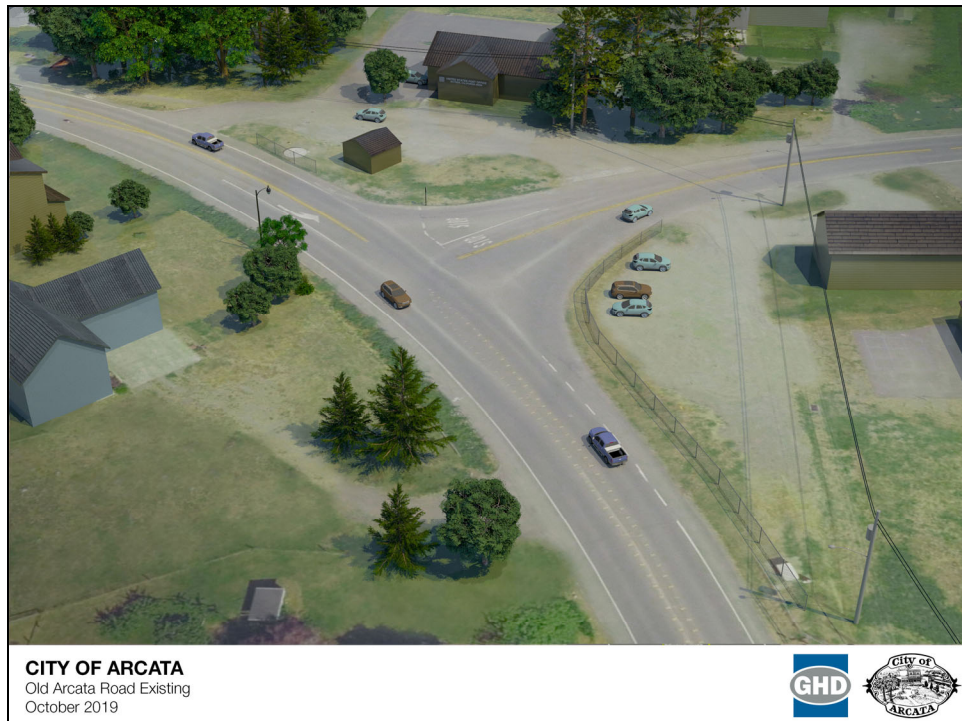
**Figure 1: Rendering of Existing Intersection of Old Arcata Road and Jacoby Creek Road.**  
Mistwood Education Center is on the right side of this image. No other known or potential historical resources are depicted.

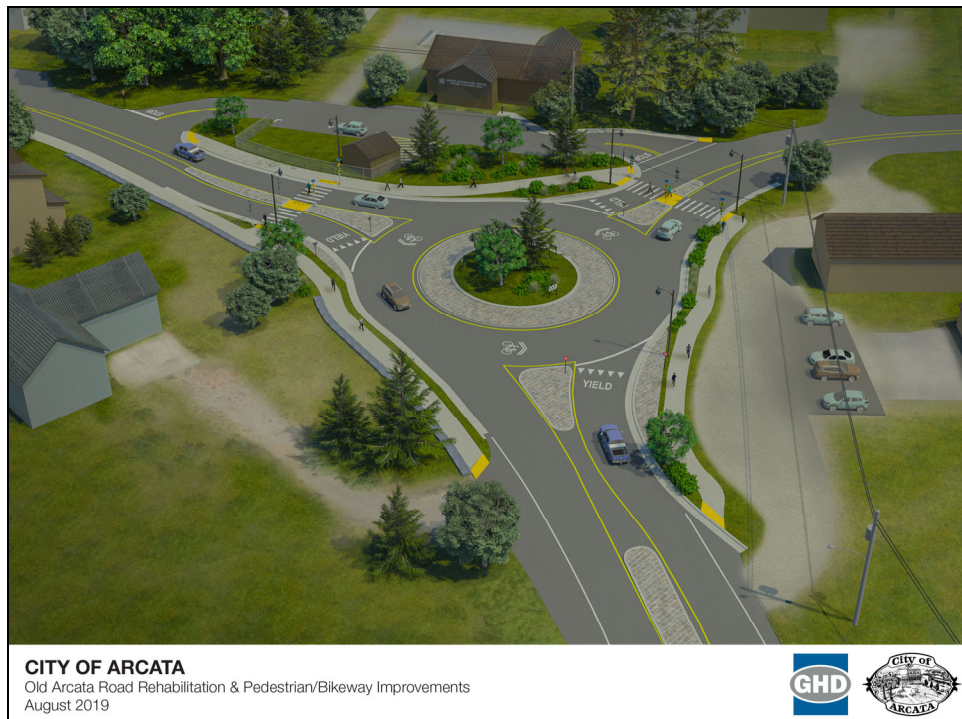
**Figure 2: Rendering of the Proposed Roundabout at the Intersection of Old Arcata Road and Jacoby Creek Road**

The Old Jacoby Creek School / Bayside School building is set well back from the road and has a wide parking area along Jacoby Creek Road that is within the road right of way. The Bayside Community Hall has paved parking along Jacoby Creek Road. The Charles Monahan-Dexter House has a front parking area and narrow front yard with recent landscaping, and the Mistwood Educational Center has the unpaved parking area north of the building that is actually within the right of way of Old Arcata Road. In addition, only a portion of this parking area would be affected and the former Bayside Community Hall (now Mistwood Educational Center) would still be set back from the intersection with space for parking on that side of the building.
