Initial Study/Proposed Mitigated Negative Declaration
**Sutter Slough Critical Erosion Repairs
Flood System Repair Project**

Prepared for:
Reclamation
District No. 999

January 2021

Sutter Slough Critical Erosion Repairs Flood System Repair Project

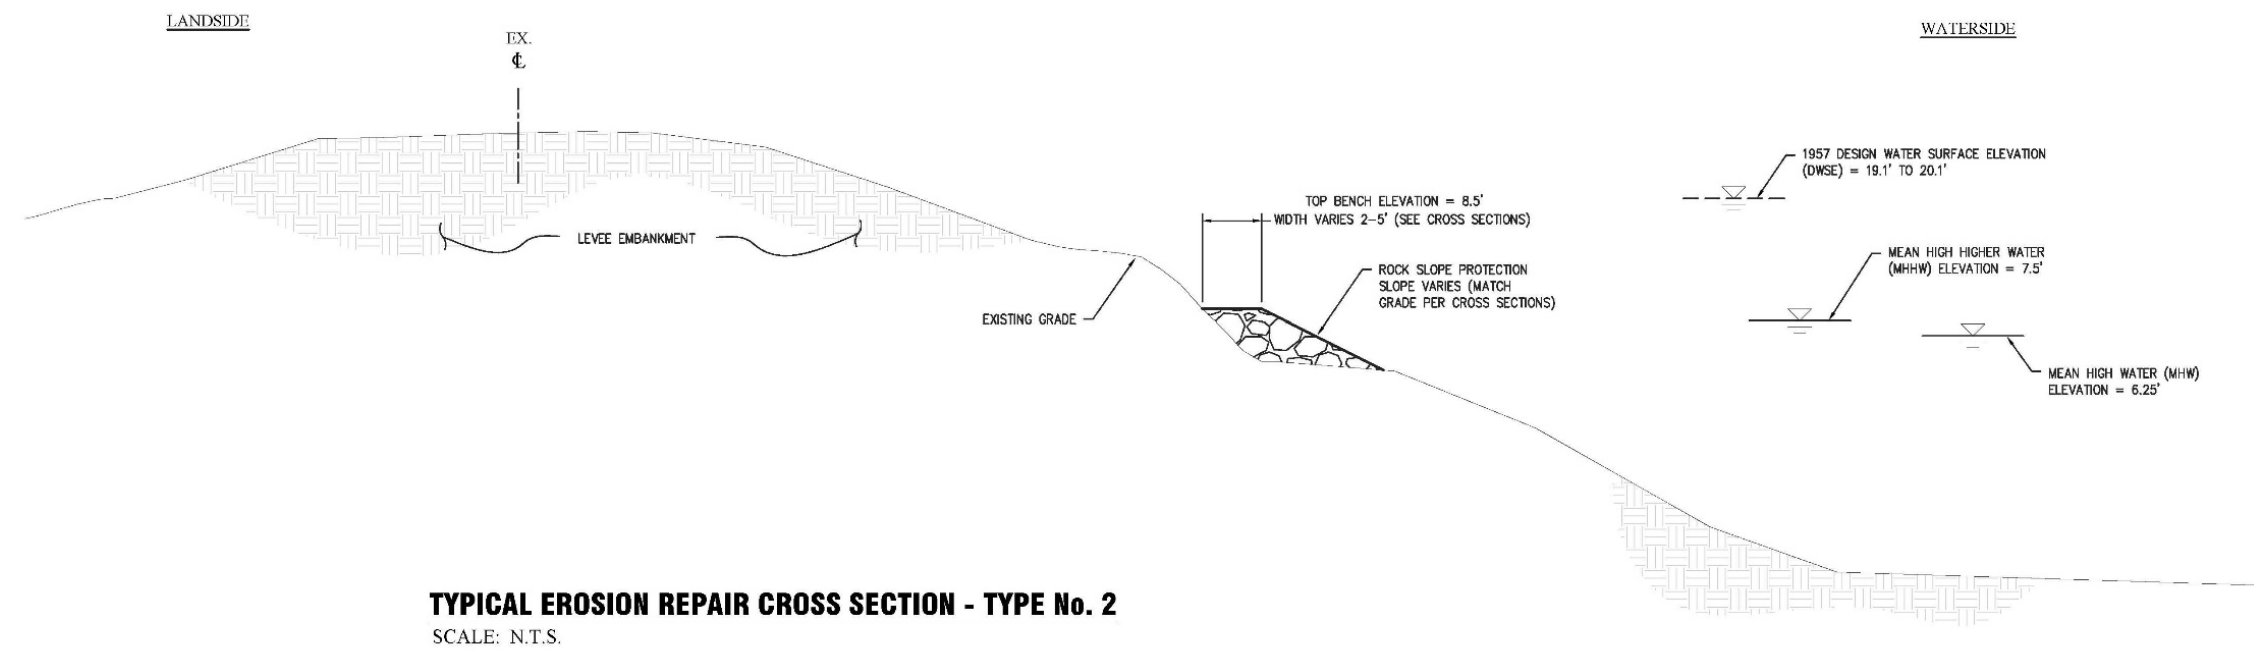
Figure 2-3: Erosion Repair Types 1 and 2 Typical Cross-Section

Site repairs of either type would share several common elements, including: placement of approximately 18- to 24-inch riprap along the levee slope; a variable bench at the top of the repair, with widths ranging from 2 to 5 feet; and a variable constructed slope ranging from 2 horizontal [H]: 1 vertical [V] to 3H:1V. **Erosion Repair Type 1 – Critical Site.** The first typical repair would address sites with severe erosion where the bank slope has been eroded into the levee prism. This repair consists of placing riprap along the levee slope to the levee toe at variable elevations depending on site-specific conditions, ranging from approximately elevation² 8 feet to elevation - 15 feet.

Erosion Repair Type 2 – Serious Site. The second type of repair, where the erosion is less severe, consists of repairing areas where erosion likely caused by boat wake, tidal action, and bank instability has created a cut into the levee toe near the water level. This repair would consist of placing a thin section of riprap at variable elevations depending on site-specific conditions, ranging from approximately elevation 8 feet to elevation 1 foot.

Table 2-1 shows the total length within each erosion repair site that Repair Types 1 and 2 are proposed and the quantity of riprap associated with the repairs. Erosion Site 3, where erosion is not severe, would not be repaired as part of this project. Site 3 conditions would instead be monitored as part of the District’s routine monitoring activities and are not analyzed further in this IS. Appendix A includes photos of representative sites for Erosion Repair Types 1 and 2 and monitoring sites. **Figure 2-3** shows typical cross-sections of Erosion Repair Types 1 and 2.

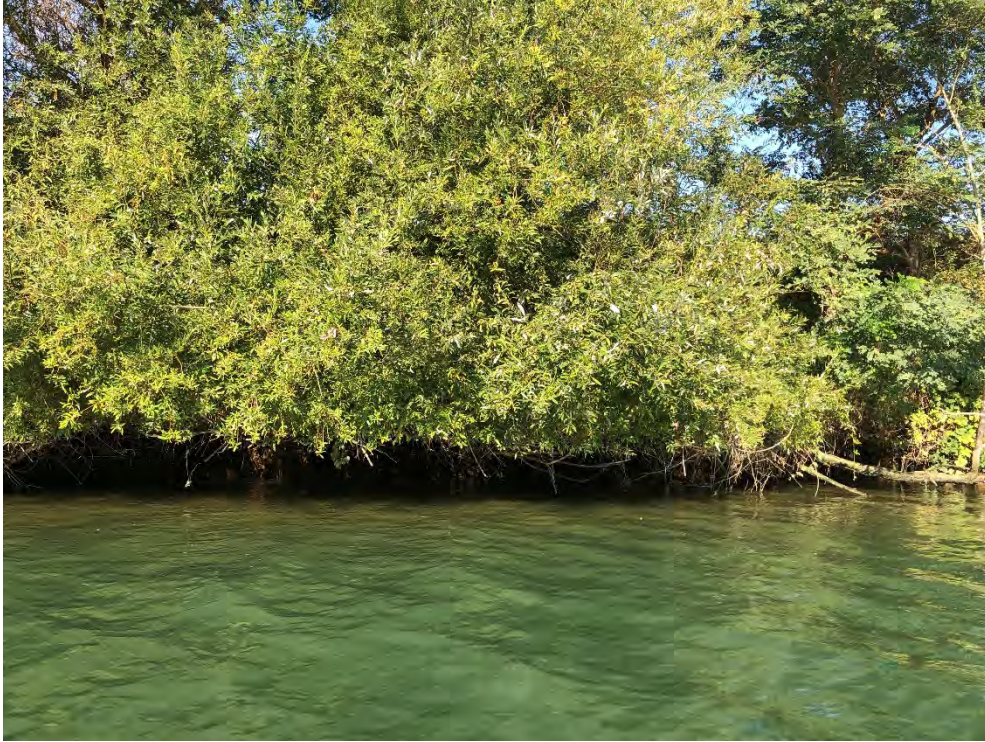
Photo 1: Typical Erosion Site – Type 1 Repair

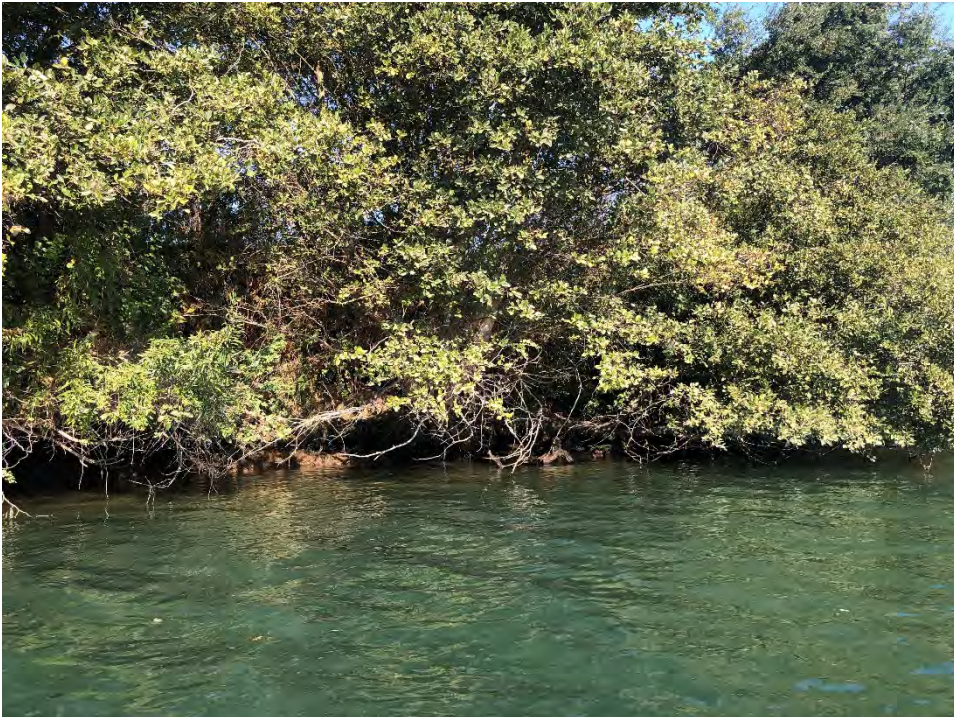
Photo 2: Typical Erosion Site – Type 2 Repair

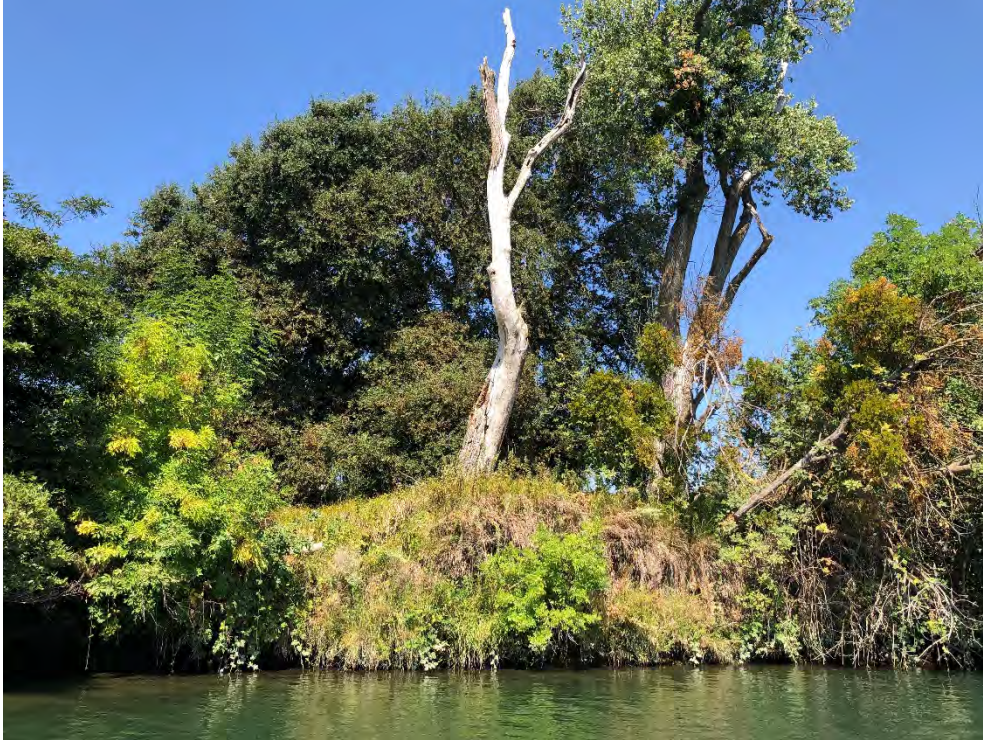
Photo 3: Typical Erosion Site – Monitoring Only Example (Site 3)
