APPENDICES

**18061 SARATOGA-LOS GATOS ROAD
MONTE SERENO, CALIFORNIA**

HISTORICAL and ARCHITECTURAL EVALUATION

PRELIMINARY GRADING AND DRAINAGE PLAN
LANDS OF KARCHGANI AND MALEKI
18061 SARATOGA - LOS GATOS ROAD, MONTE SERENO, CA

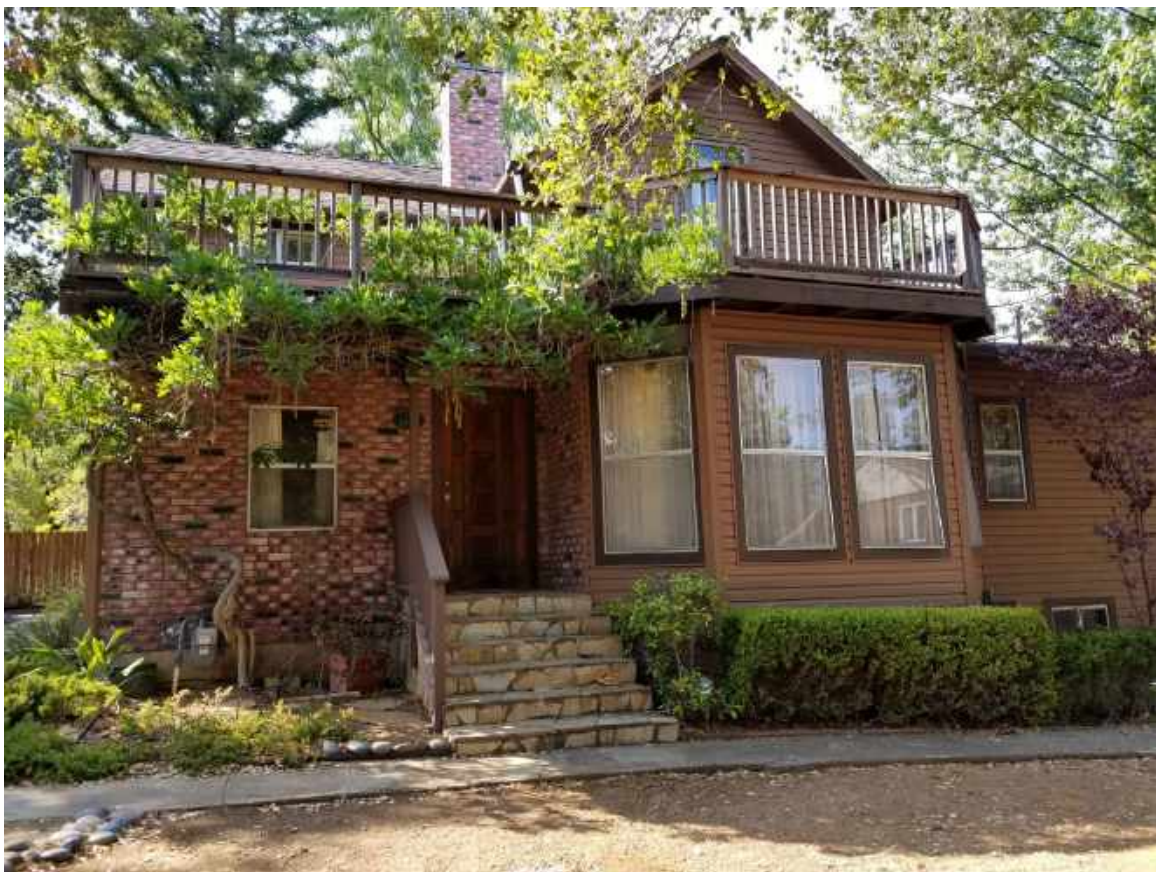
Photograph 1 18061 Los Gatos Saratoga Road, Monte Sereno CA

View: Front façade, entrance with used brick veneer, recessed porch, stairs of stone veneer and upper level decks with contemporary railings. The single story addition is to the right.

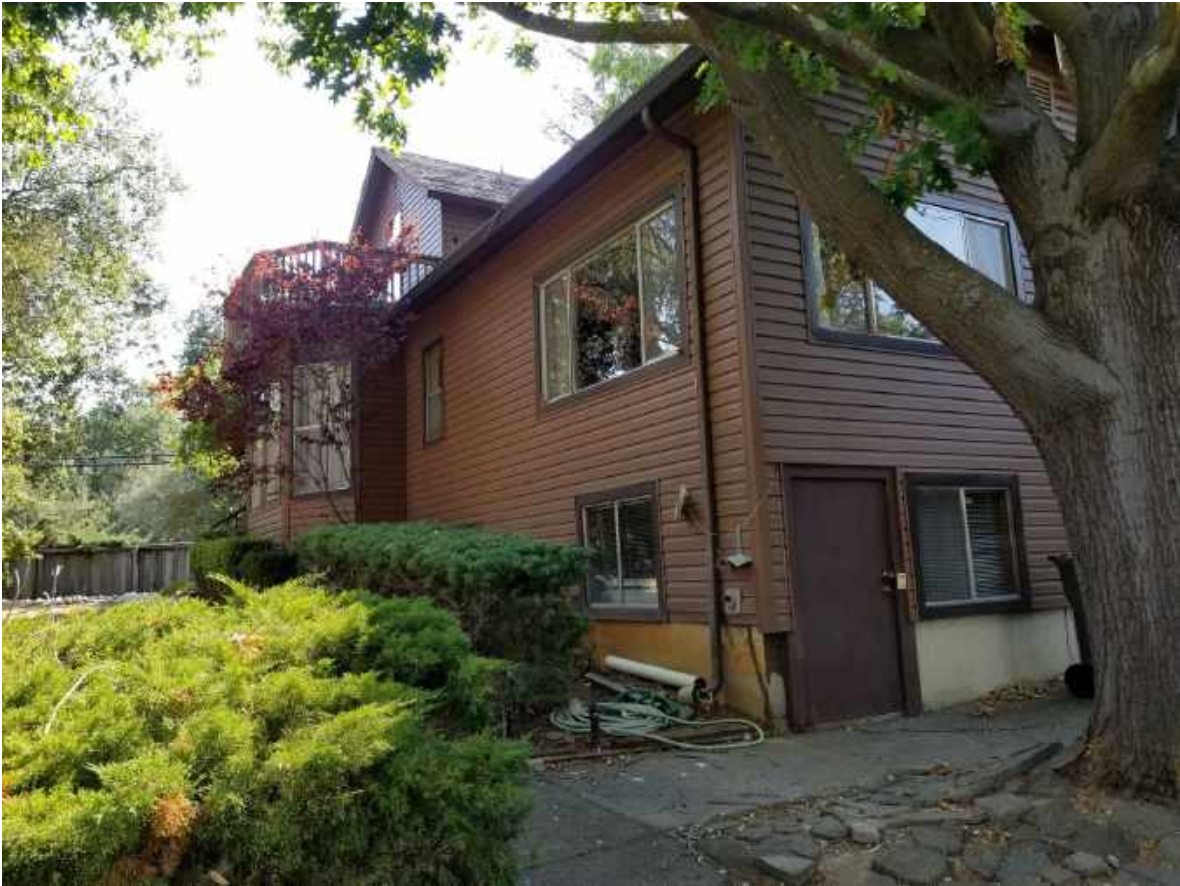
Photograph 2 18061 Los Gatos Saratoga Road, Monte Sereno CA
View: Front and north side façade showing the single -story addition over the full basement.

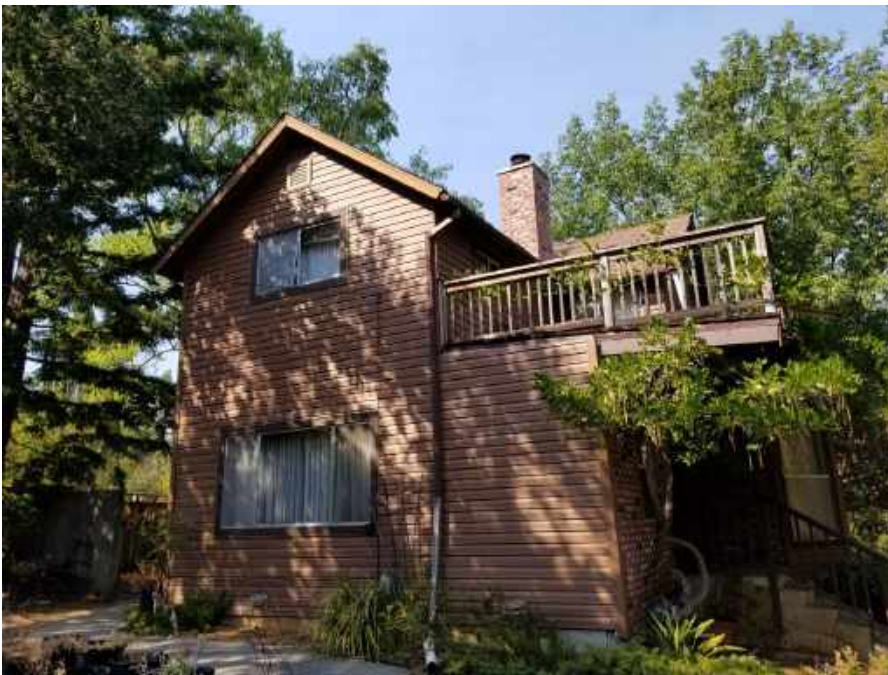
Photograph 3 18061
Los Gatos Saratoga
Road, Monte Sereno CA

View: South side façade (facing the road). The front addition and deck above are alterations. Used brick covers the chimney matching the front entry. This area may have started as a small open sided porch for the original house.

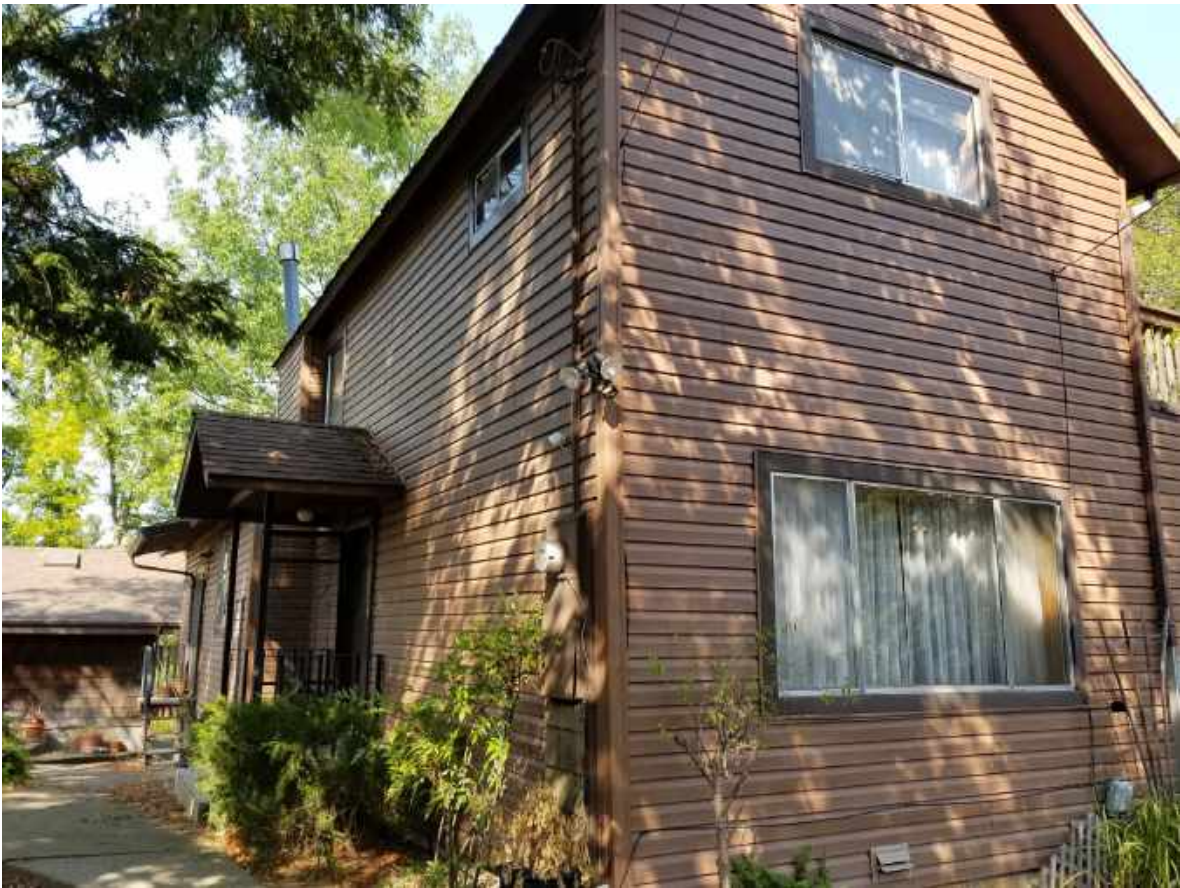
Photograph 4 18061 Los Gatos Saratoga Road, Monte Sereno CA
View: South (facing the road) and west (rear) facades. The contemporary window size and placement do not represent a historic style.

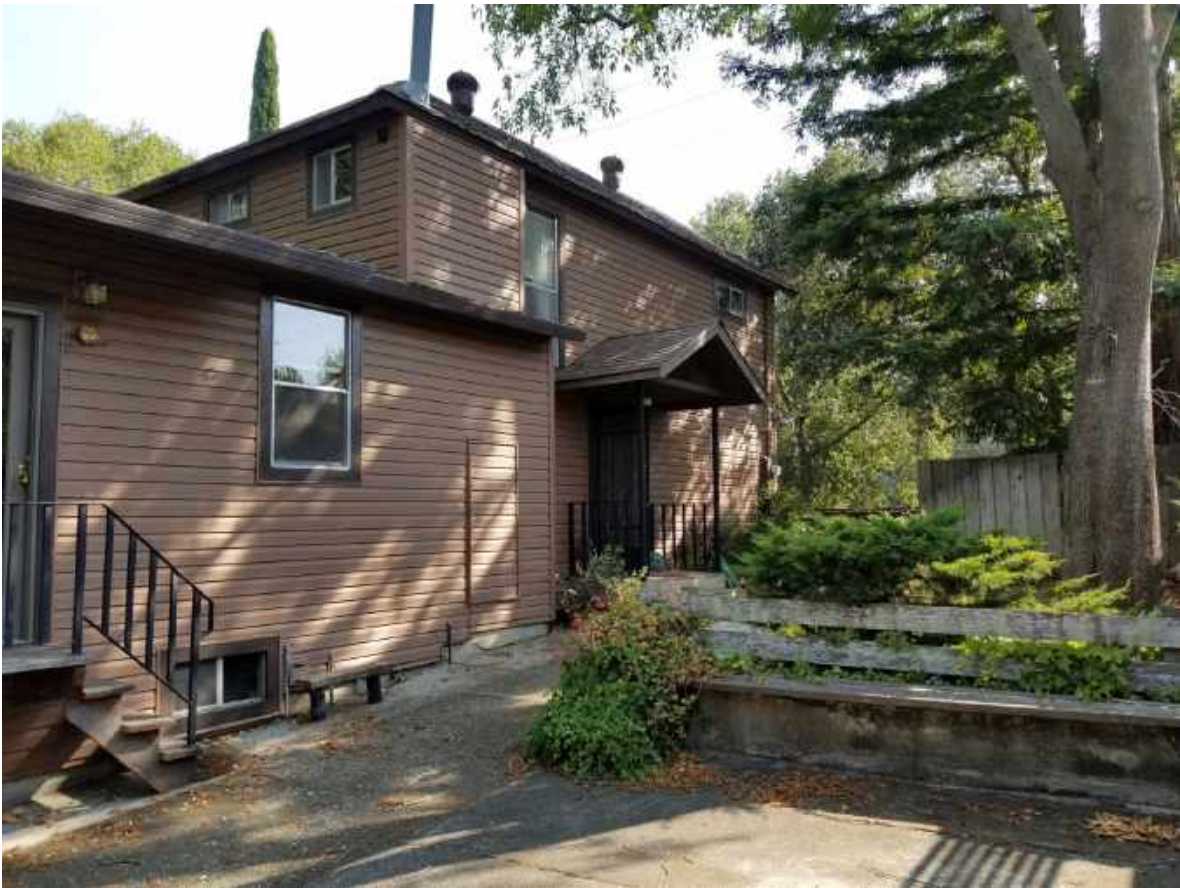
Photograph 5 18061 Los Gatos Saratoga Road, Monte Sereno CA
View: West side façade addition with overhanging eave on left contemporary porch and pitched rooflet attached to what appears to be the original house.

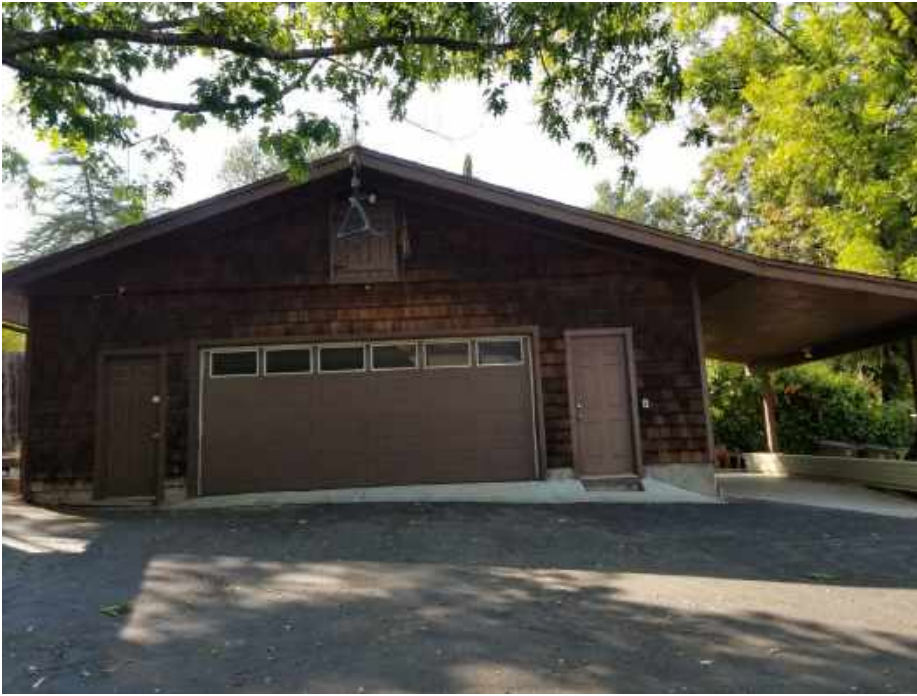
Photograph 6 18061 Los Gatos Saratoga Road, Monte Sereno CA
View: Garage and carport c. 1980s.

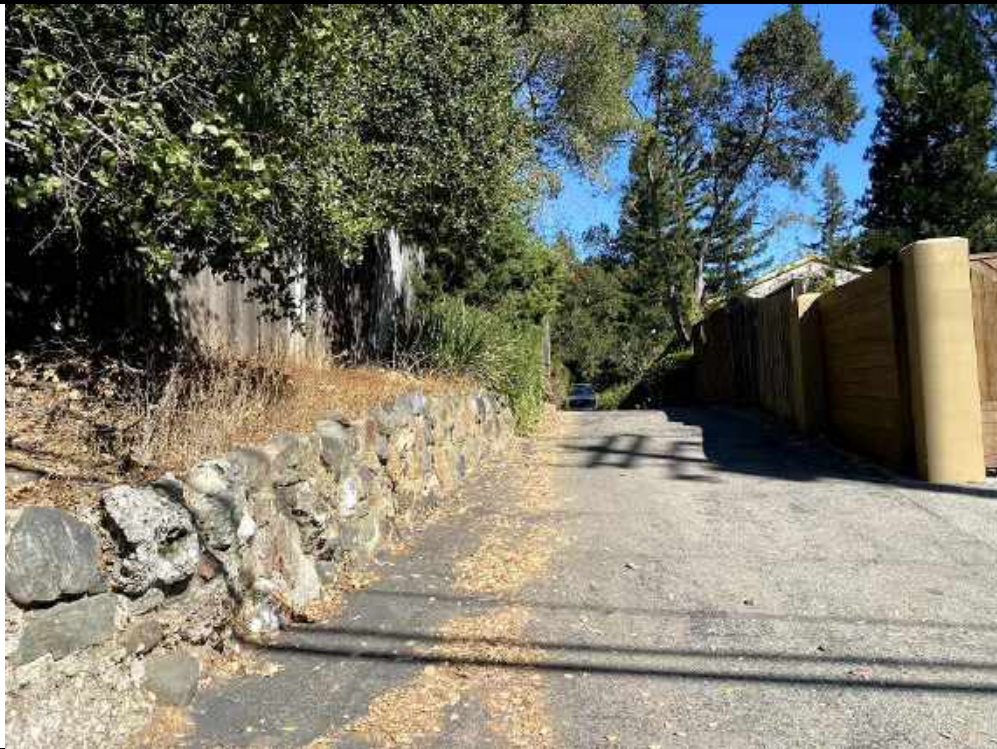
Photo 1: Entrance to 18061 Los Gatos-Saratoga Road, looking northeast at the driveway to the Property.

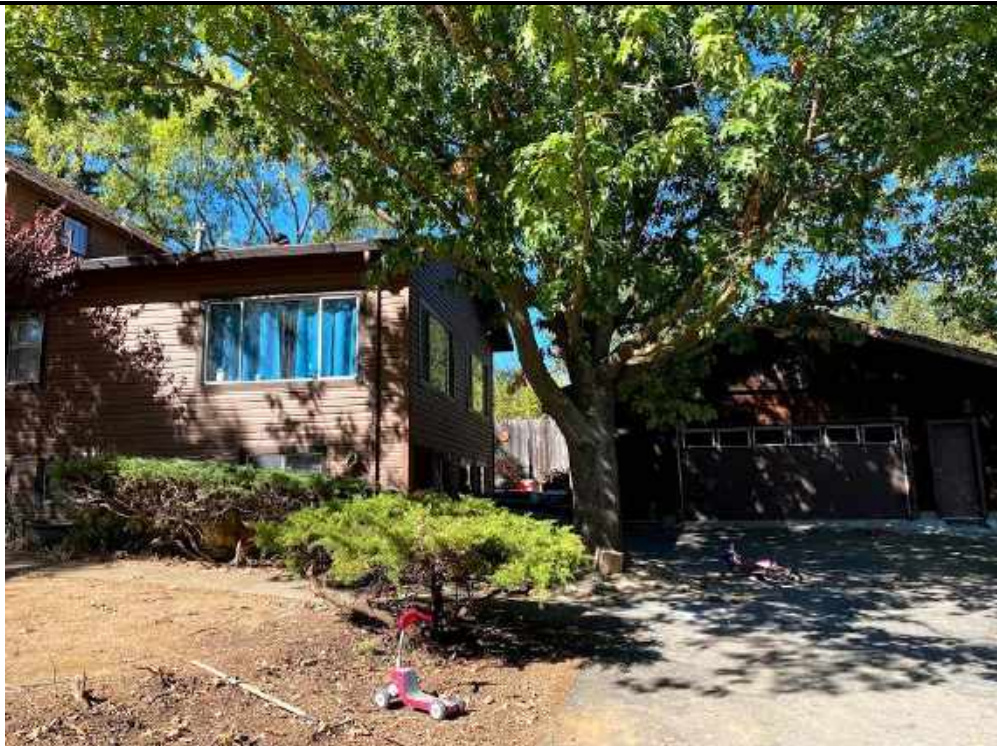
Photo 2: Facing north, photo shows a portion of the existing house and structures with mixed ornamental woodland in the background.

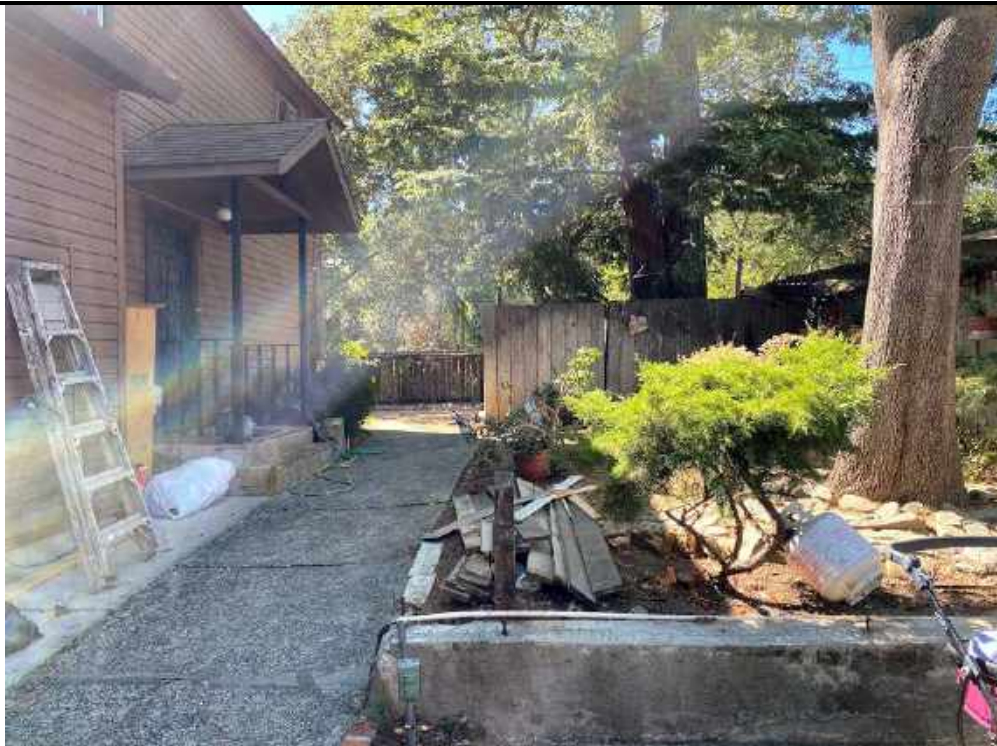
Photo 8: Facing southwest, photo shows house, raised ornamental bed, and the fence perimeter of the Property.

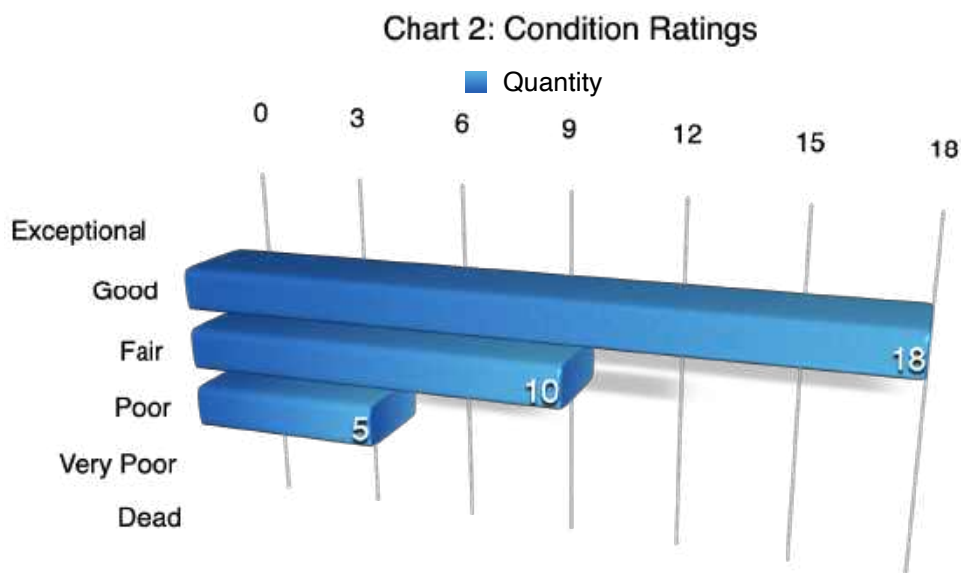
Eighteen trees are in good condition, ten fair, and five are in poor shape (Chart 2). Many of the trees in “good” condition originate on the adjacent property.

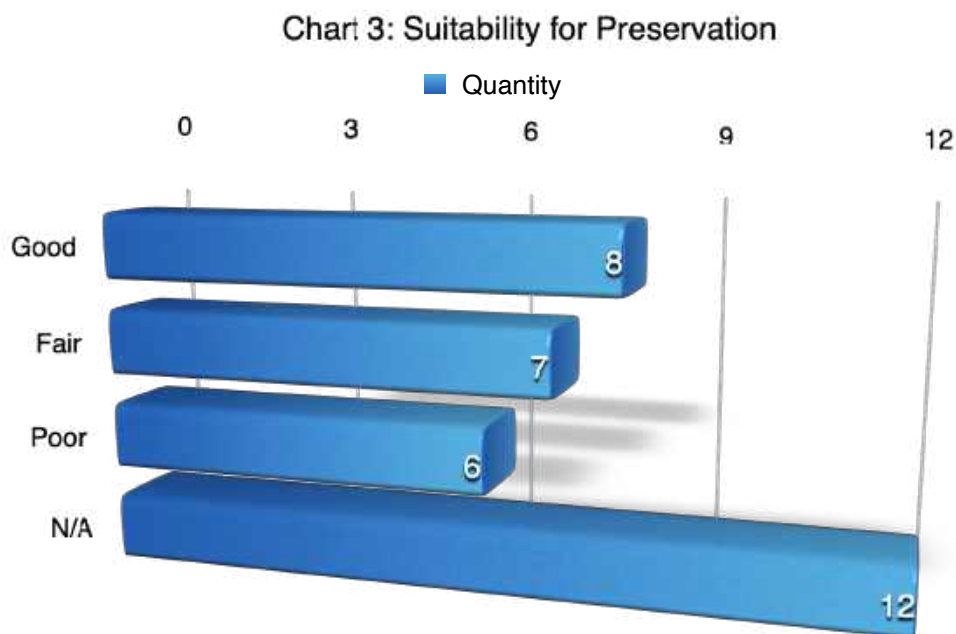
Eight trees have good suitability, seven fair, six poor, and twelve originate on other sites and their suitability is irrelevant. Trees with poor suitability are small, declining, or invasive volunteers while those fair are well adapted but have some structural issues such as codominant stems or multiple branches originating in the same location (Chart 3).

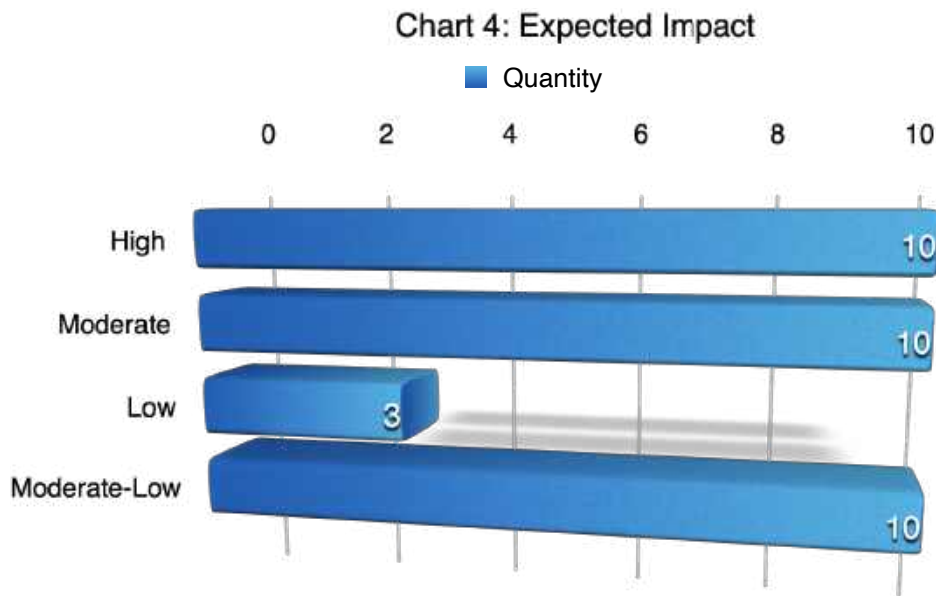
Ten trees will be highly impacted and caused to be removed. Two trees are poor specimens (giant sequoia #1853 and apple #1868), six will be removed to accommodate the driveway (#1842, #1843, #1845, and #1846) and two are in the footprint of proposed homes on parcel 1 (#1849 and #1850) (Chart 4, Table 2).

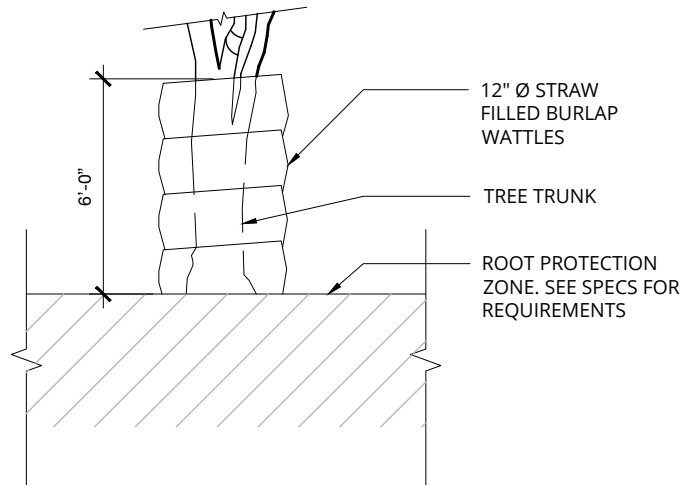
TREE PROTECTION

URBAN TREE FOUNDATION © 2014
OPEN SOURCE FREE TO USE
Modified by Monarch Consulting
Arborists LLC, 2019

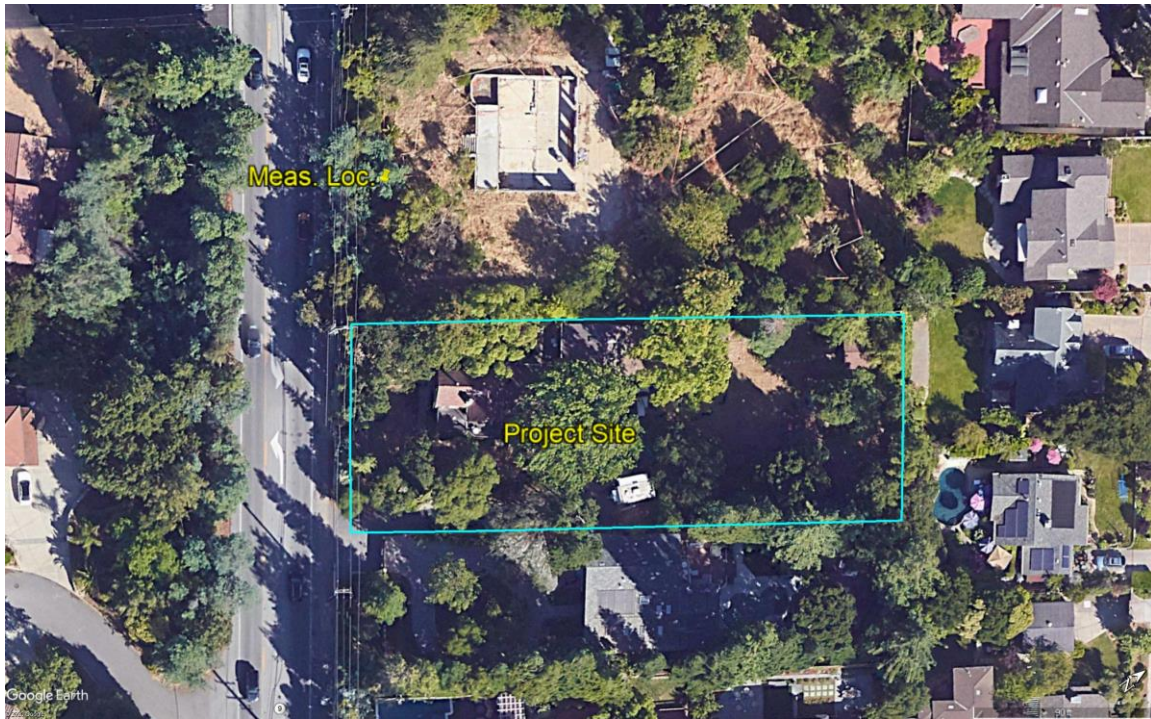
FIGURE 3 – Noise Measurement Location

As shown in the Appendix C data table, the L_{eq} 's at the measurement location, 46 ft. from the centerline of Saratoga - Los Gatos Road, ranged from 63.1 to 69.0 dBA during the daytime and from 53.6 to 65.4 dBA at night. The raw measurement data printouts are also provided in Appendix C.

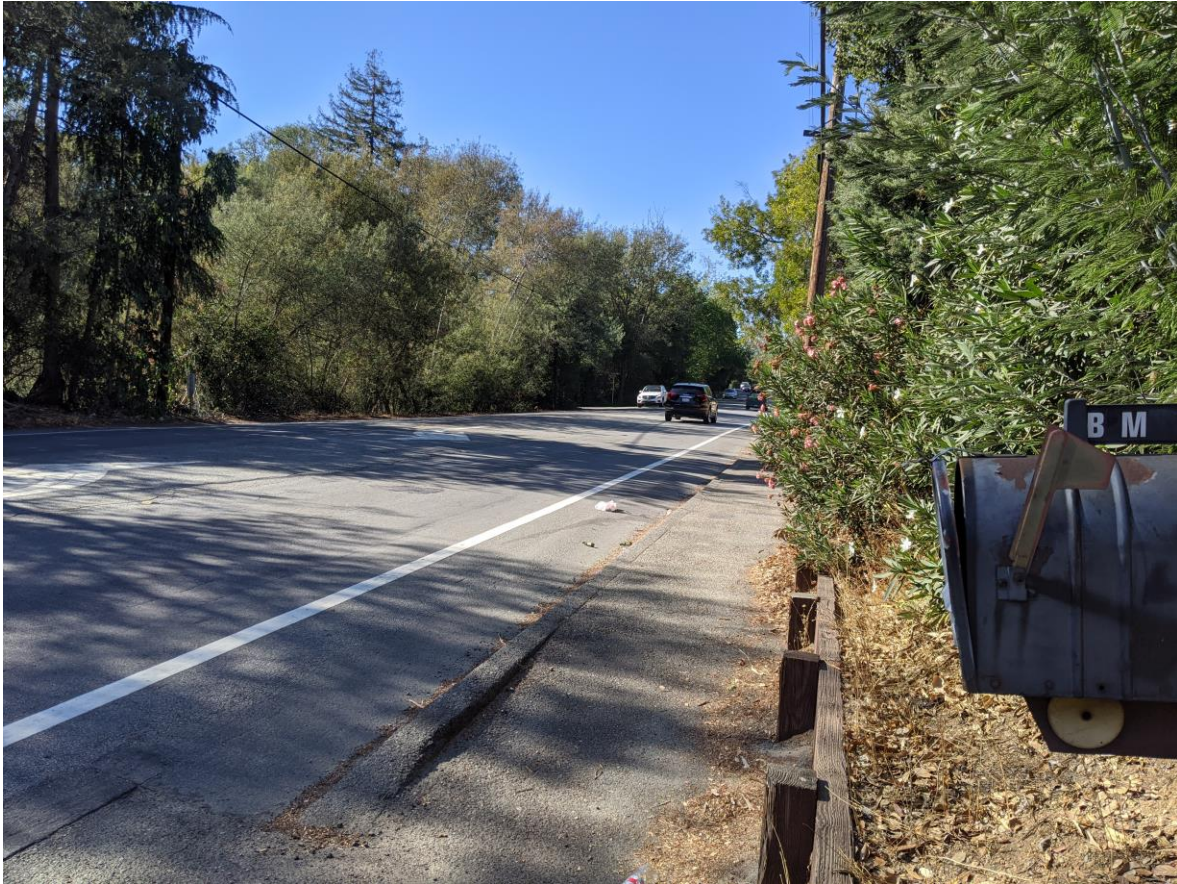
Figure 2
Visibility from Driveway Looking Toward Saratoga

As shown in Figure 2, the visibility from the driveway to the west, toward Saratoga, is adequate. Over 500 feet of upstream visibility is afforded. Beyond 500 feet, visibility is obstructed by vegetation, but pruning of vegetation would lengthen the sight distance.

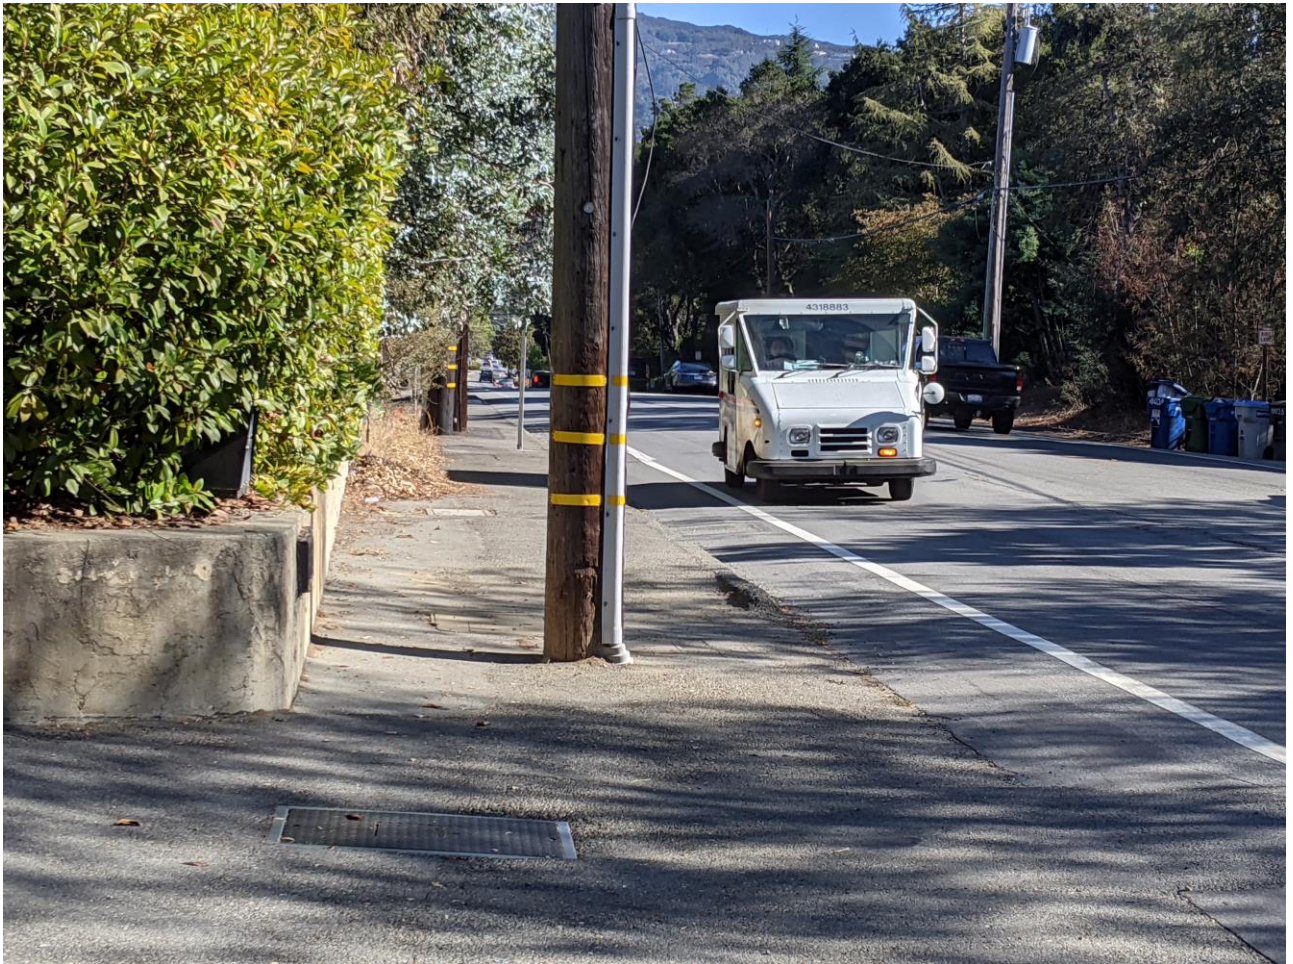
Figure 3
Visibility from Driveway Looking Toward Los Gatos

As shown in Figure 3, visibility from the driveway to the east, toward Los Gatos, is adequate. Over 400 feet of upstream visibility is provided, despite the presence of a wood utility pole.

Once egressing vehicles cross the property line and begin to enter the public right of way, adequate sight distance becomes available due to the presence of both the four foot wide sidewalk and the adjacent five foot wide westbound bike lane. These facilities enable drivers to see oncoming vehicles in both the eastbound and westbound directions without encroaching onto the path of travel of oncoming vehicles.

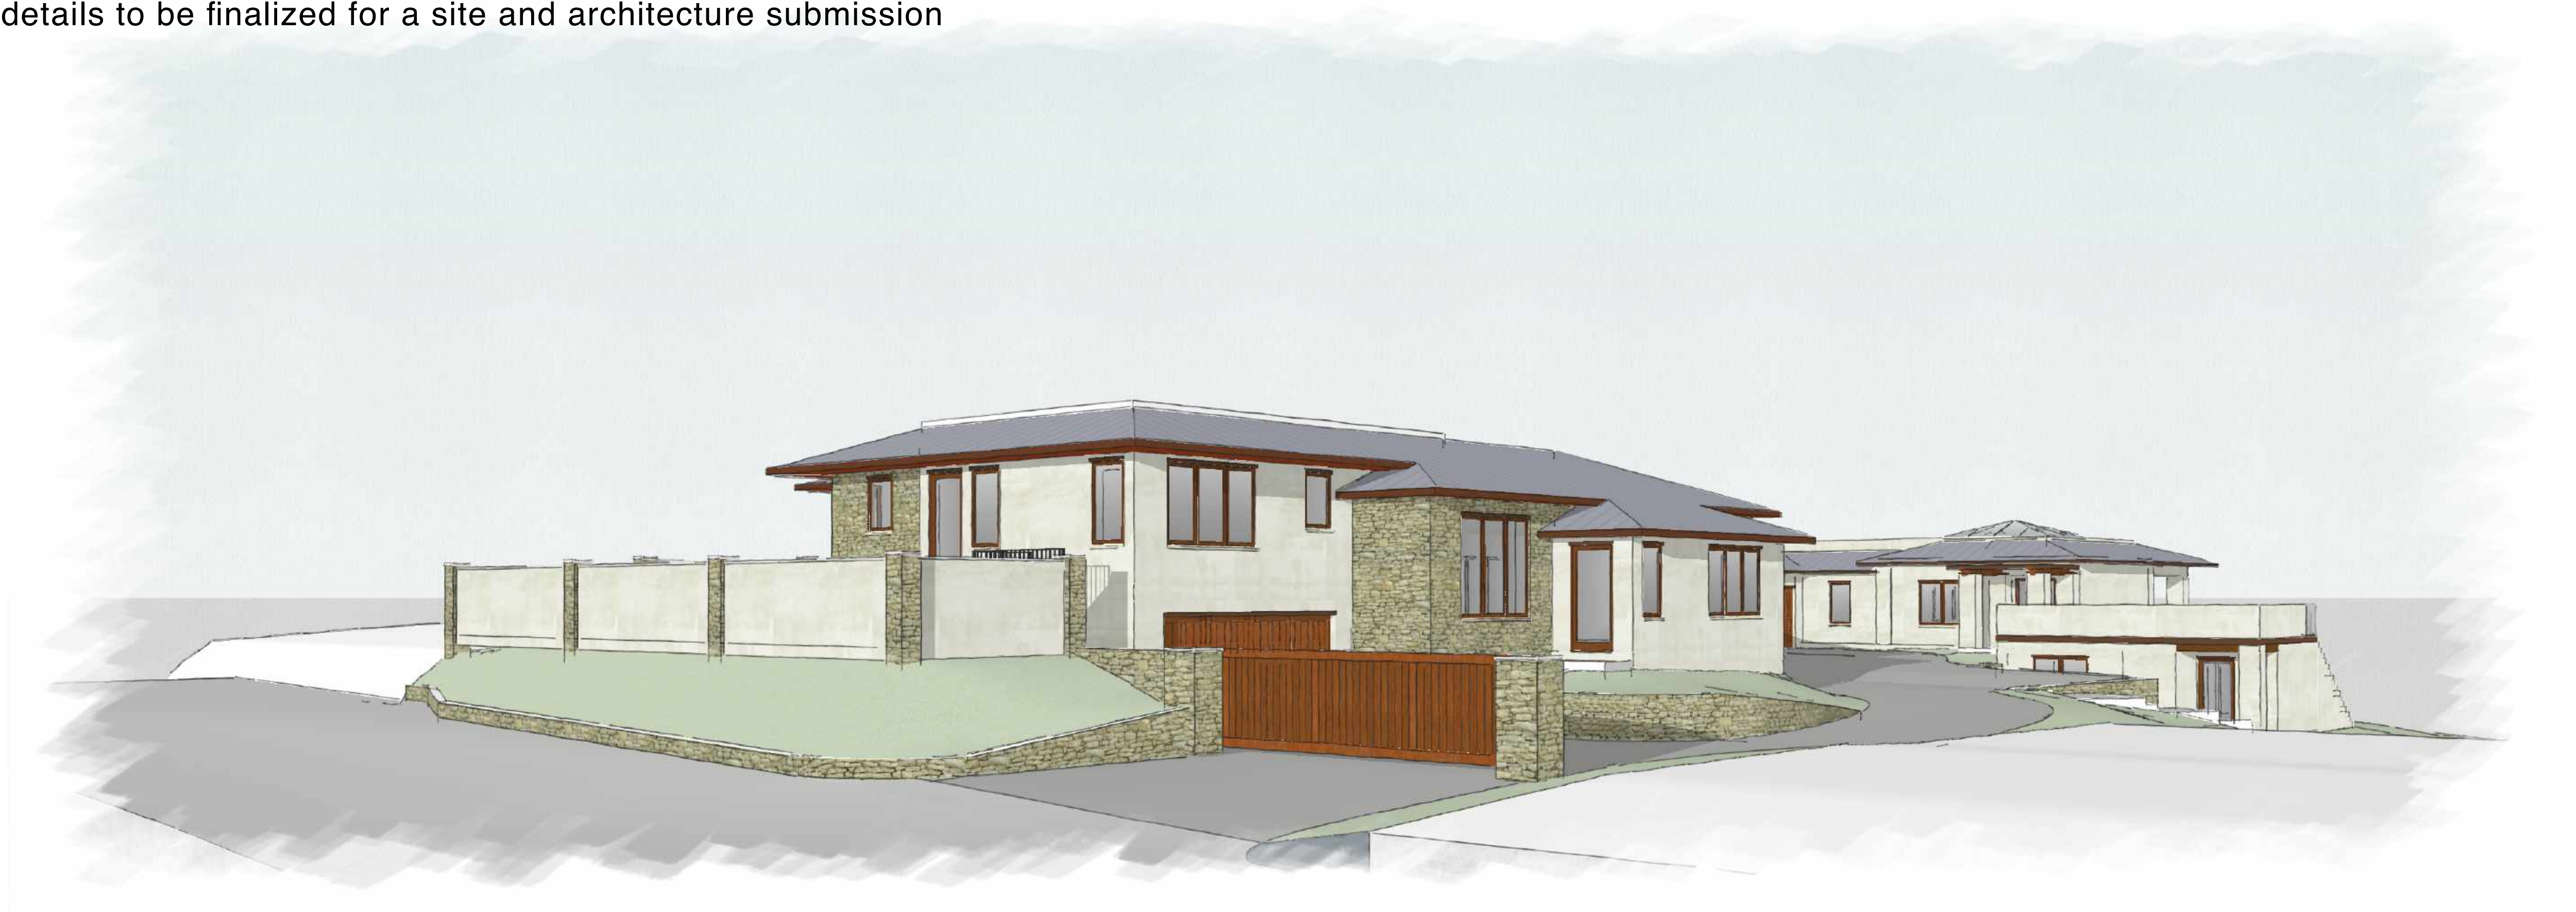
∴ FRONT (NORTHEAST) ELEVATION

scale: 1/8" = 1'

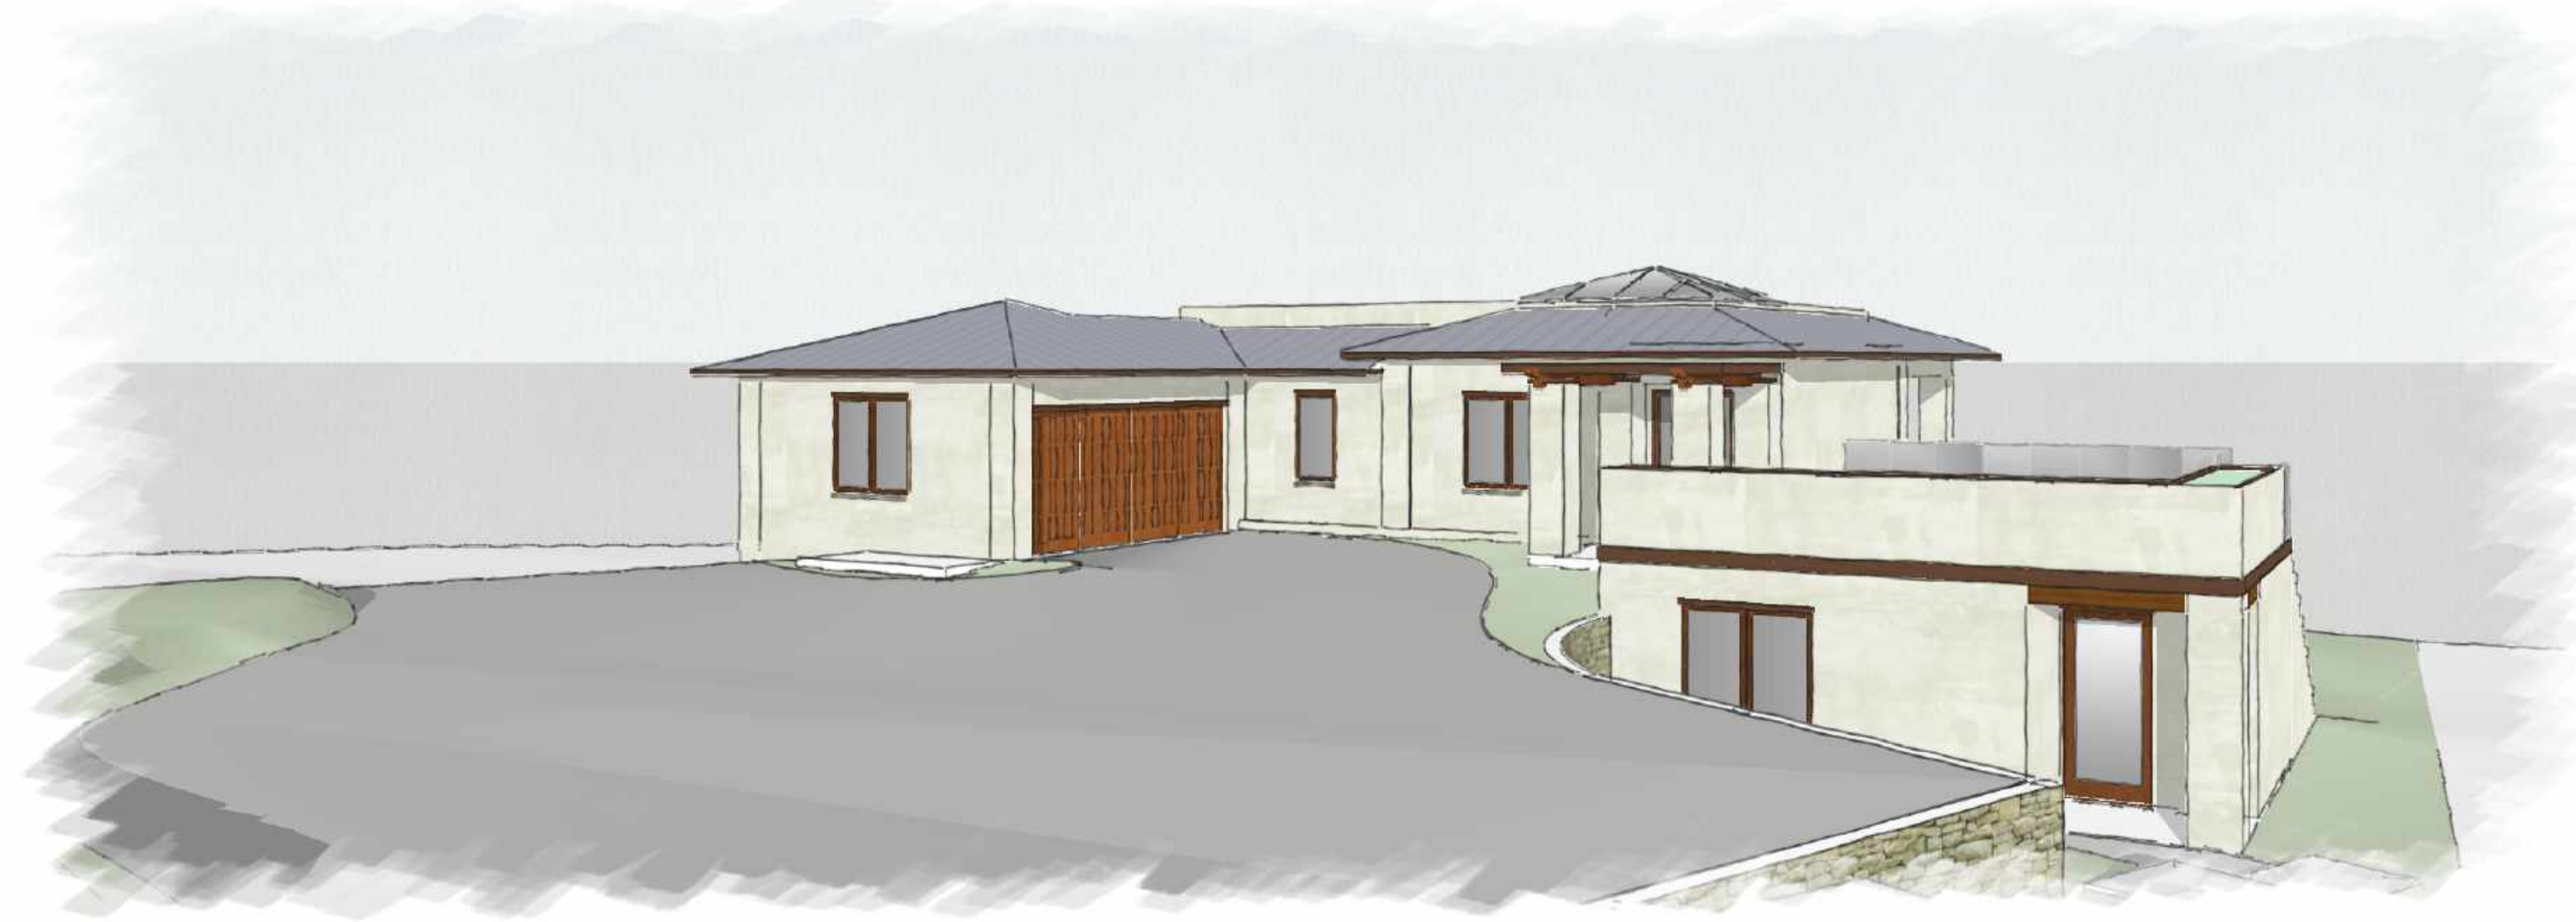
∴ REAR (SOTHWEST) ELEVATION

scale: 1/8" = 1'

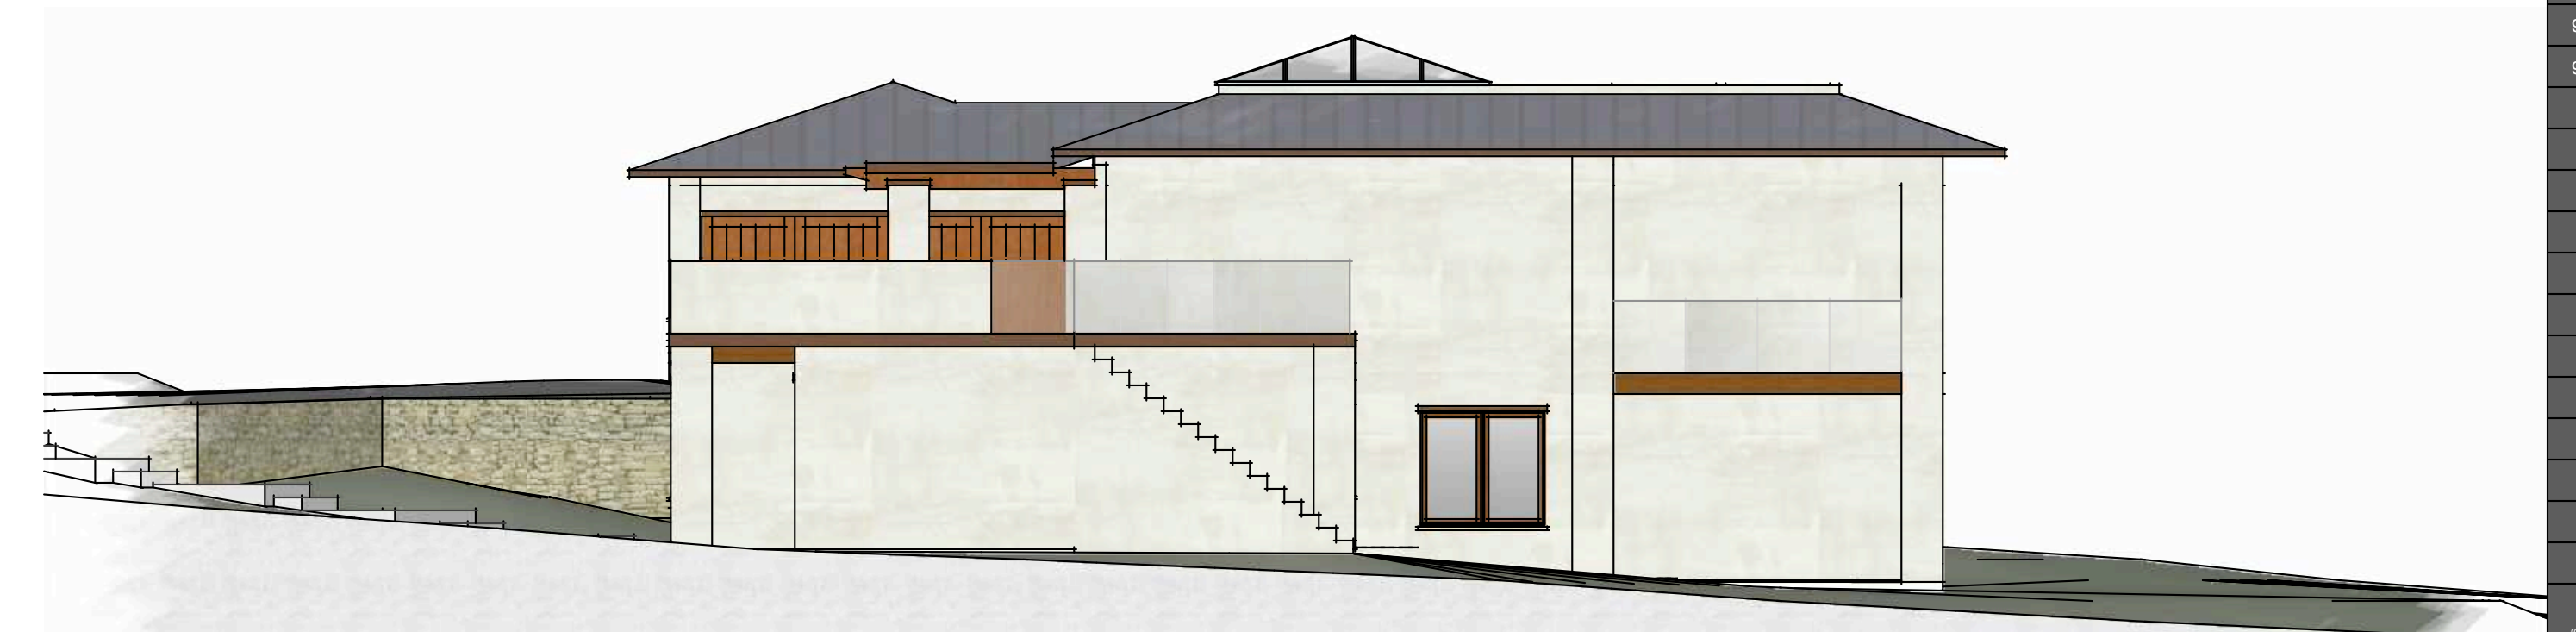
:: RIGHT (NORTHWEST) ELEVATION

scale: 1/8" = 1'
