APPENDICES

**18061 SARATOGA-LOS GATOS ROAD
MONTE SERENO, CALIFORNIA**

HISTORICAL and ARCHITECTURAL EVALUATION

PRELIMINARY GRADING AND DRAINAGE PLAN
LANDS OF KARCHGANI AND MALEKI
18061 SARATOGA - LOS GATOS ROAD, MONTE SERENO, CA

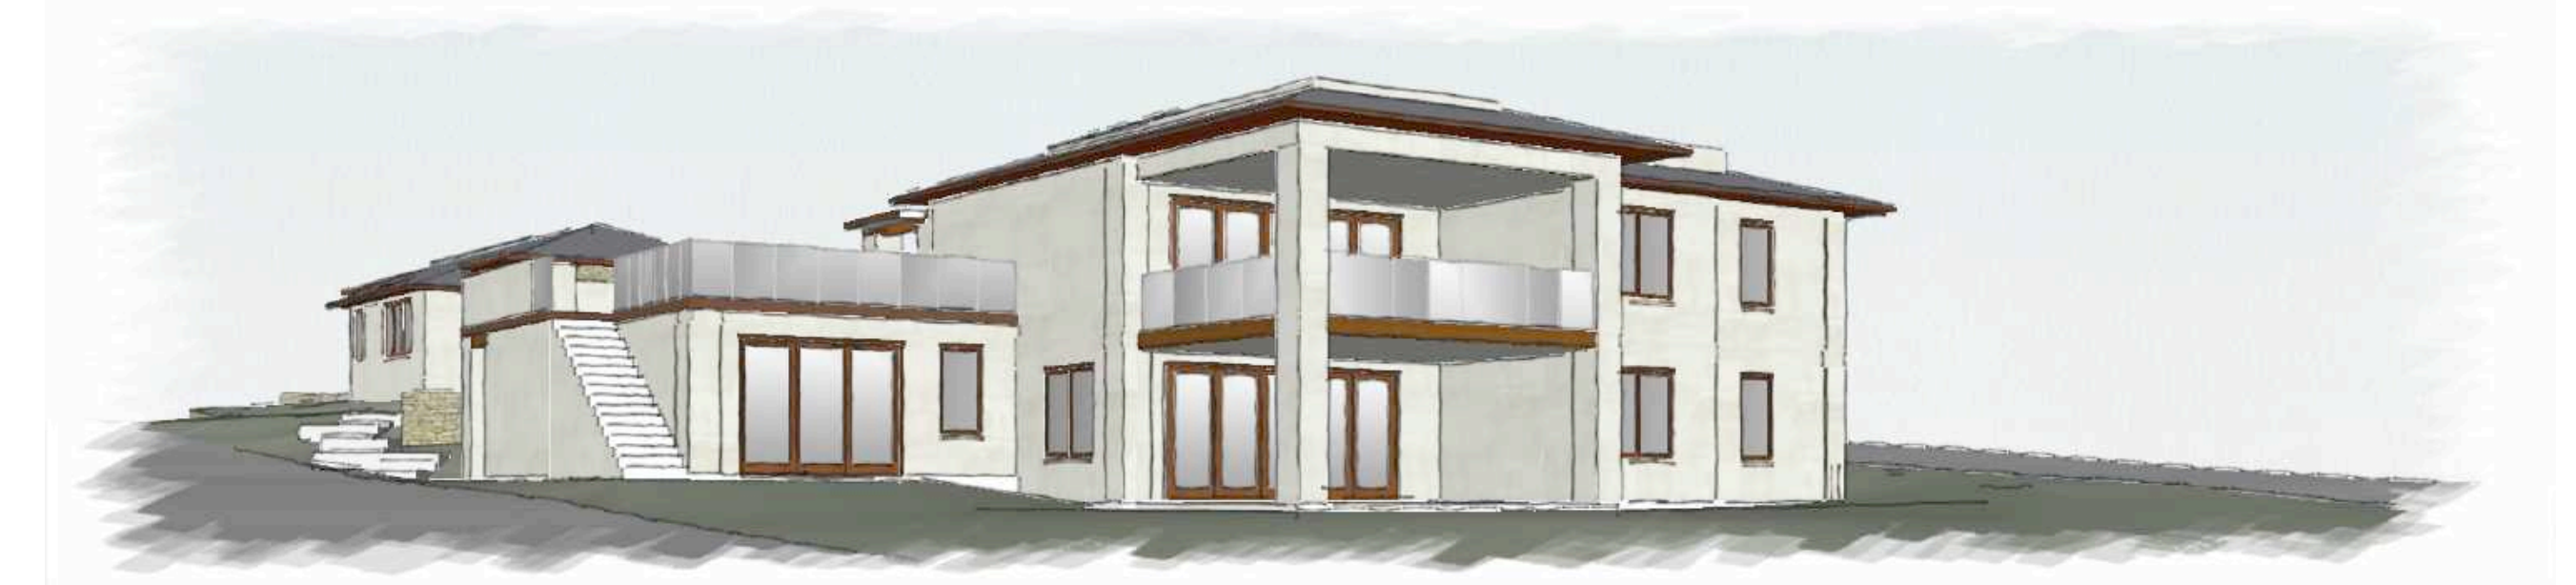
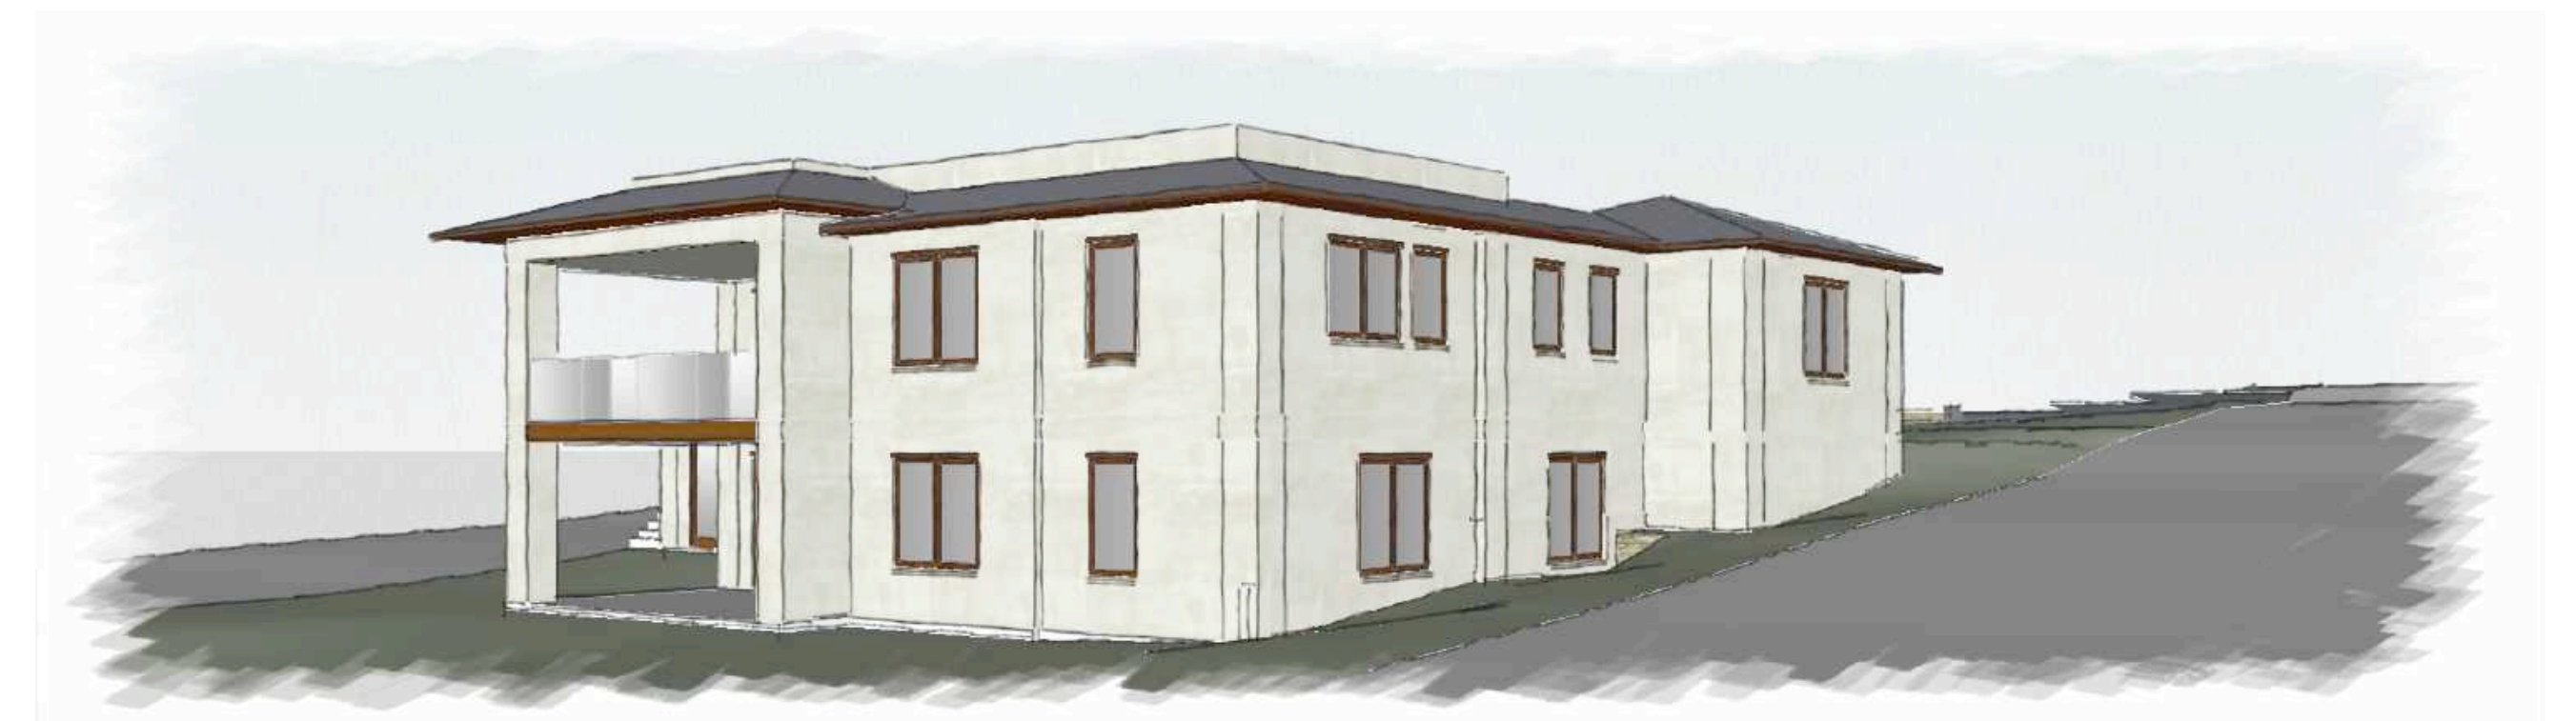
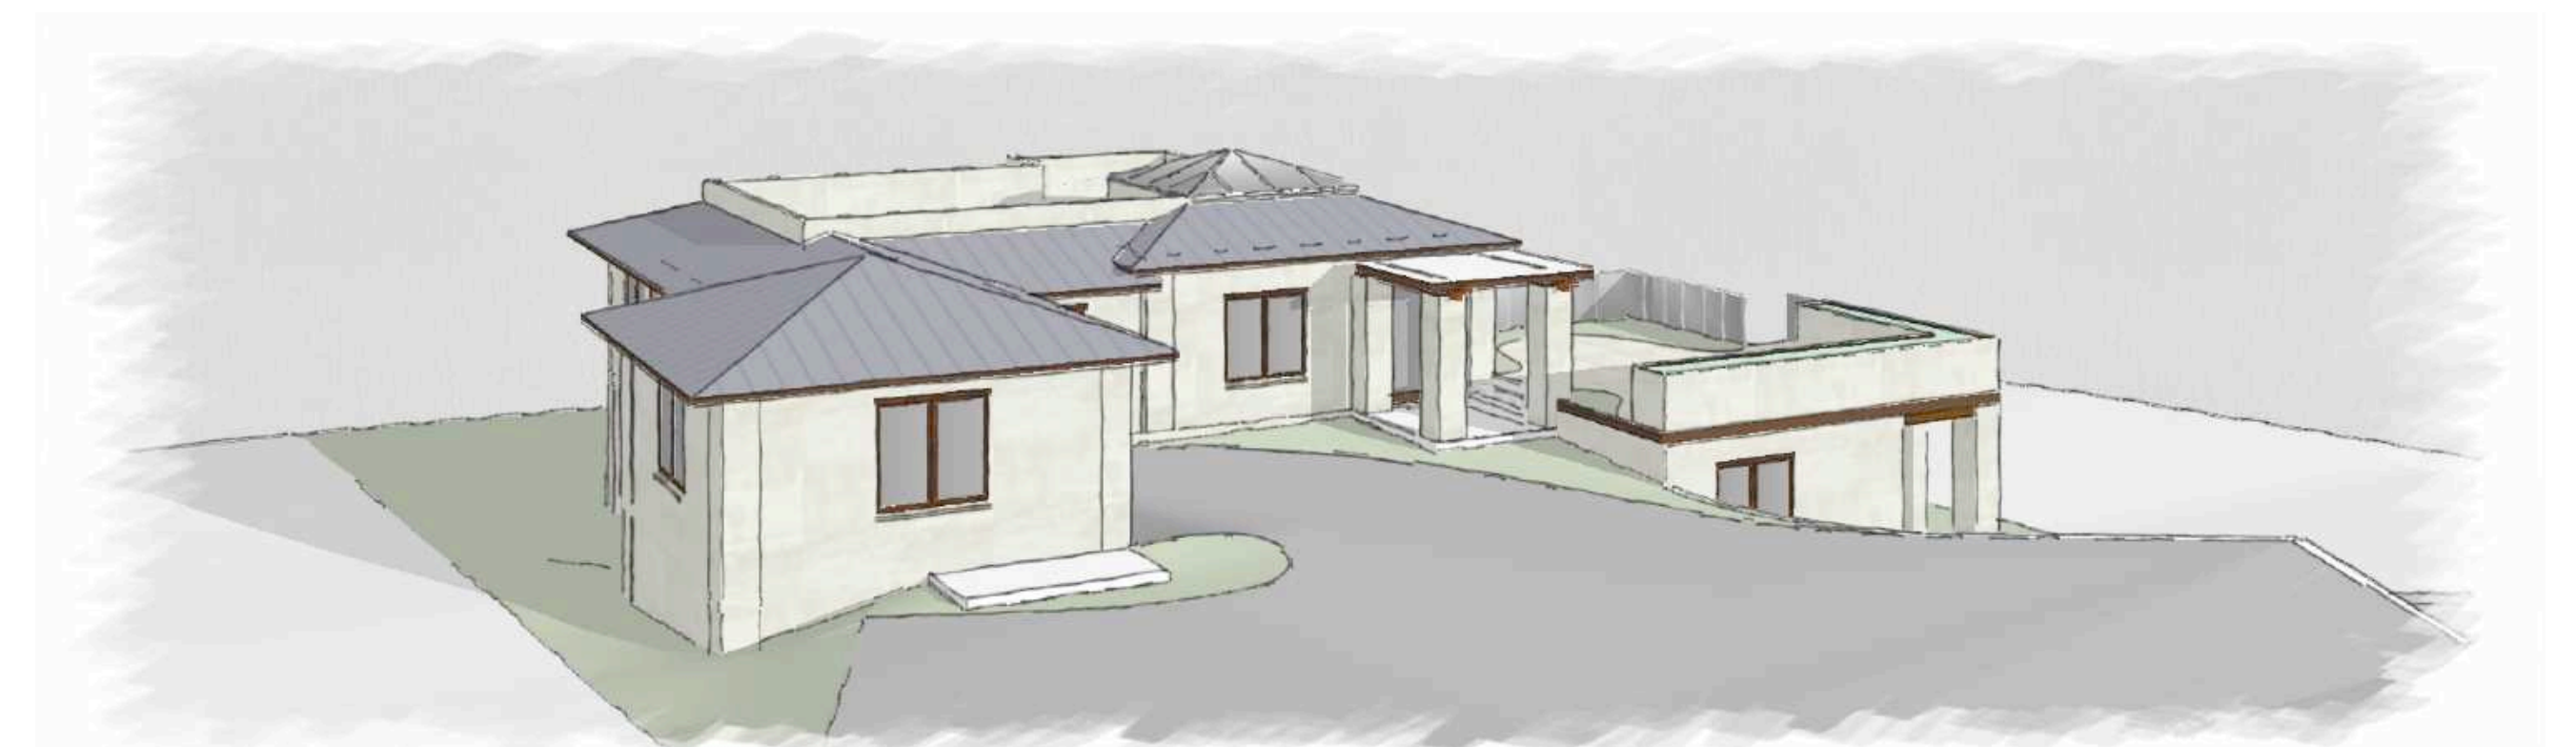
:: LEFT (SOUTHEAST) ELEVATION

scale: 1/8" = 1'
